ENGLISH HERITAGE

# **Solent Marine Heritage Assets: Defining, investigating, monitoring and reporting 2008-2011**

## **Yarmouth Roads Protected Wreck Site**

This report particularly focuses on the site monitoring which was undertaken on the Yarmouth Roads protected wreck on 29<sup>th</sup> June 2009, in accordance with a Brief drafted by EH and agreed by the HWTMA. The site is located at a 50m radius from the point 50° 42. 31' North, 01° 29. 597' West (WGS84). The site is the wreck of a late 16<sup>th</sup> or early 17<sup>th</sup> century merchant carrack, possibly of Spanish origin. It may be the *Santa Lucia*, lost in 1567.

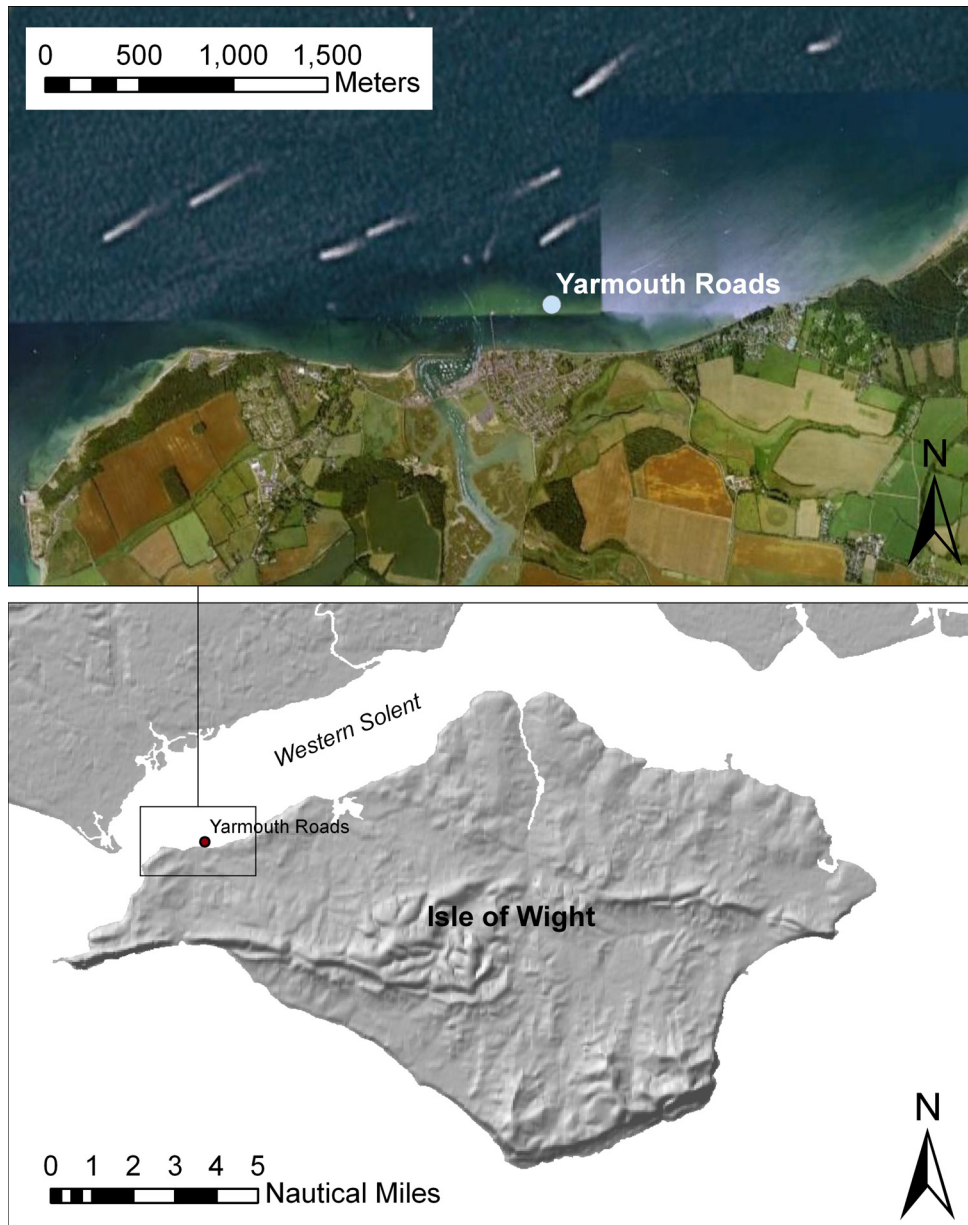
*Figure 1 - Yarmouth Roads wreck, site location (HWTMA)*

The wreck is located less than 200m from the shore of Yarmouth on the Isle of Wight (Figure 1) at a depth of 4 to 8m. The seabed comprises featureless clay beds with overlying mobile silty sand / shell / pebbles. Diving is best carried out at slack water on a neap tide. The tidal regime produces water movement of up to 3.5 knots across the area.

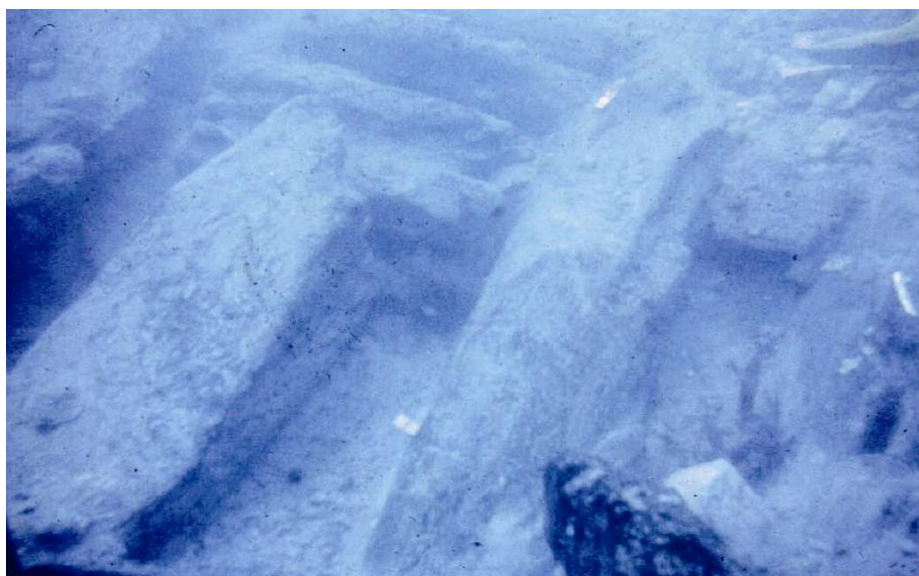
The 1988 excavation revealed that all the excavated fragments lie with their outboard faces downwards, which suggested that they fell away from the

centre of the vessel (Figure 2). The vessel is of carvel construction and fastened largely with iron. The size of the site and individual elements suggest a vessel around 32m in length. Exactly how much of the ship remains buried within the seabed sediments is unknown.

*Figure 2 - Timbers revealed during the 1988 excavation  
(copyright Isle of Wight Museums Service)*

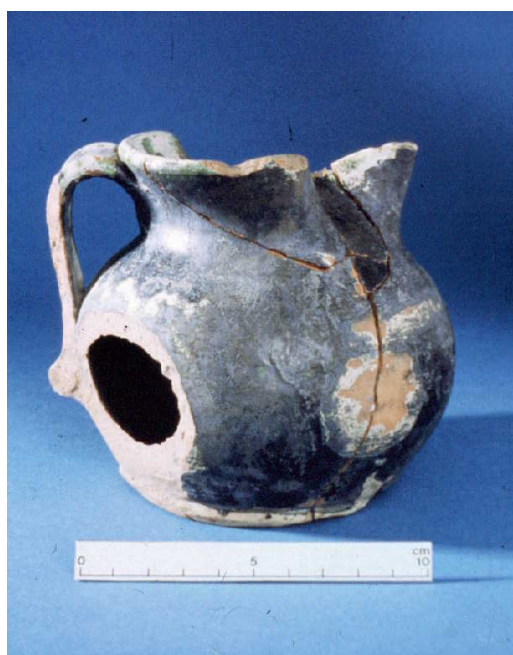
Following the 1988 excavation the total number of artefacts retrieved from the site was 256. These include ceramics in the form of Italian pottery dating from 1590 to 1620 (Figure 3); lead and pewter artefacts such as a collection of spoons; copper alloy scraps; a bronze pestle (Figure 4); stone shot; a bone comb (Figure 5) and a wooden component of a lantern.

*Figure 3 – Pottery jug recovered from the Yarmouth Roads wreck site  
(copyright Isle of Wight Museums Service)*

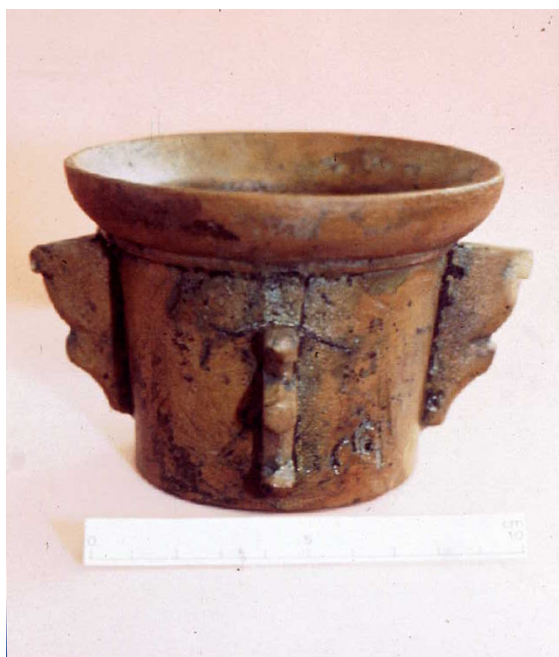
*Figure 4 – Bronze pestle recovered from the Yarmouth Roads wreck site  
(copyright Isle of Wight Museums Service)*

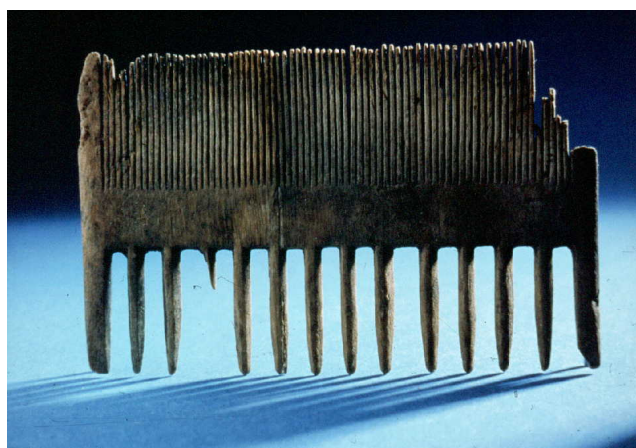
*Figure 5 – Bone comb recovered from the Yarmouth Roads wreck site  
(copyright Isle of Wight Museums Service)*

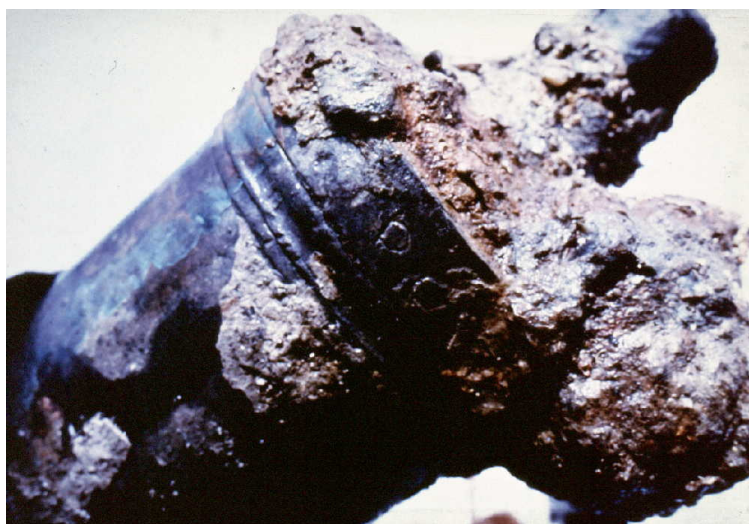
In 1983, prior to the discovery of the wreck site, a 16<sup>th</sup> century bronze cannon bearing the initials Z A, presumed to be the work of the Italian bronze-founder Zuane Alberghetti, was lifted by members of the Portsmouth Royal Navy B.S.A.C. Special Branch under the direction of Commander John Bingeman (Tomalin *et al*, 1988). An association has been assumed between the Alberghetti minion and the Yarmouth Roads wreck, however the minion lay 150m to the east of the wreck site and, at the time of excavation in the 1980s, no immediate parallels between this loose find and those excavated from the site itself were determined (Watson & Gale, 1990). The Alberghetti minion is on display at the Underwater Archaeology Centre run by the HWTMA, located at Fort Victoria on the Isle of Wight.

*Figure 6 - Alberghetti minion  
(copyright Isle of Wight Museums Service)*

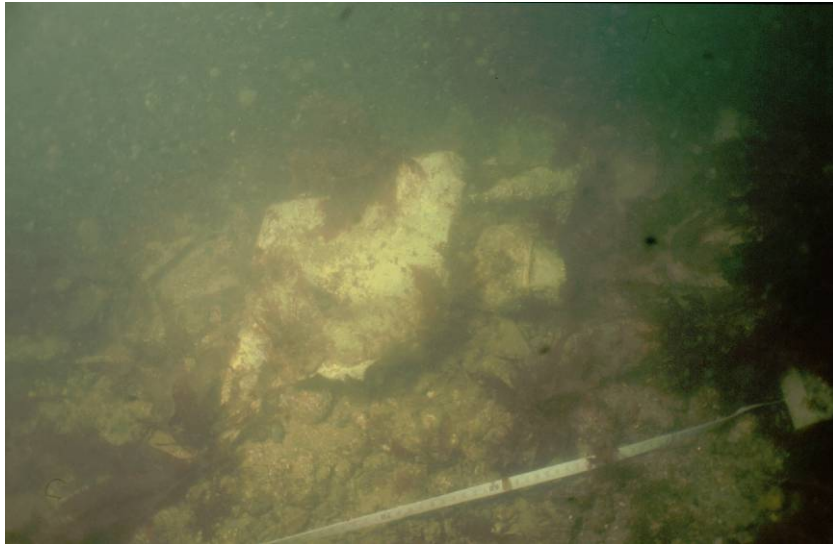
On completion of the excavations in 1988 the structure visible on the seabed was sandbagged for protection, and these remain to date. In 2003 steps were taken to remove objects such as mooring lines and anchors which were illegally placed within the designated area and posed a threat to the wreck remains. The HWTMA became licensee of the site in 2004 and has been undertaking some work to identify all archive material related to the site. Contact with members of the 1980's excavation team has resulted in the collection of some paper and photographic material relevant to the site. An exhibit consisting of display boards presenting details of the site and a number of artefacts from the site was installed into Yarmouth Castle, an English Heritage property which overlooks the site, as part of an EH funded project in 2005. These items can still be viewed today. In the same year diving was undertaken with a mixture of professional and volunteer divers. Visual inspection revealed the sand bags covering the site were still largely in place; however they were beginning to degrade (Figure 8). Only very limited amounts of wooden structure were visible above the seabed, as recorded in the licensee report to the Advisory Committee for Historic Wreck Sites in 2005.

*Figure 7 – 2005 image of sandbags covering the structure of the Yarmouth Roads wreck (copyright HWTMA)*

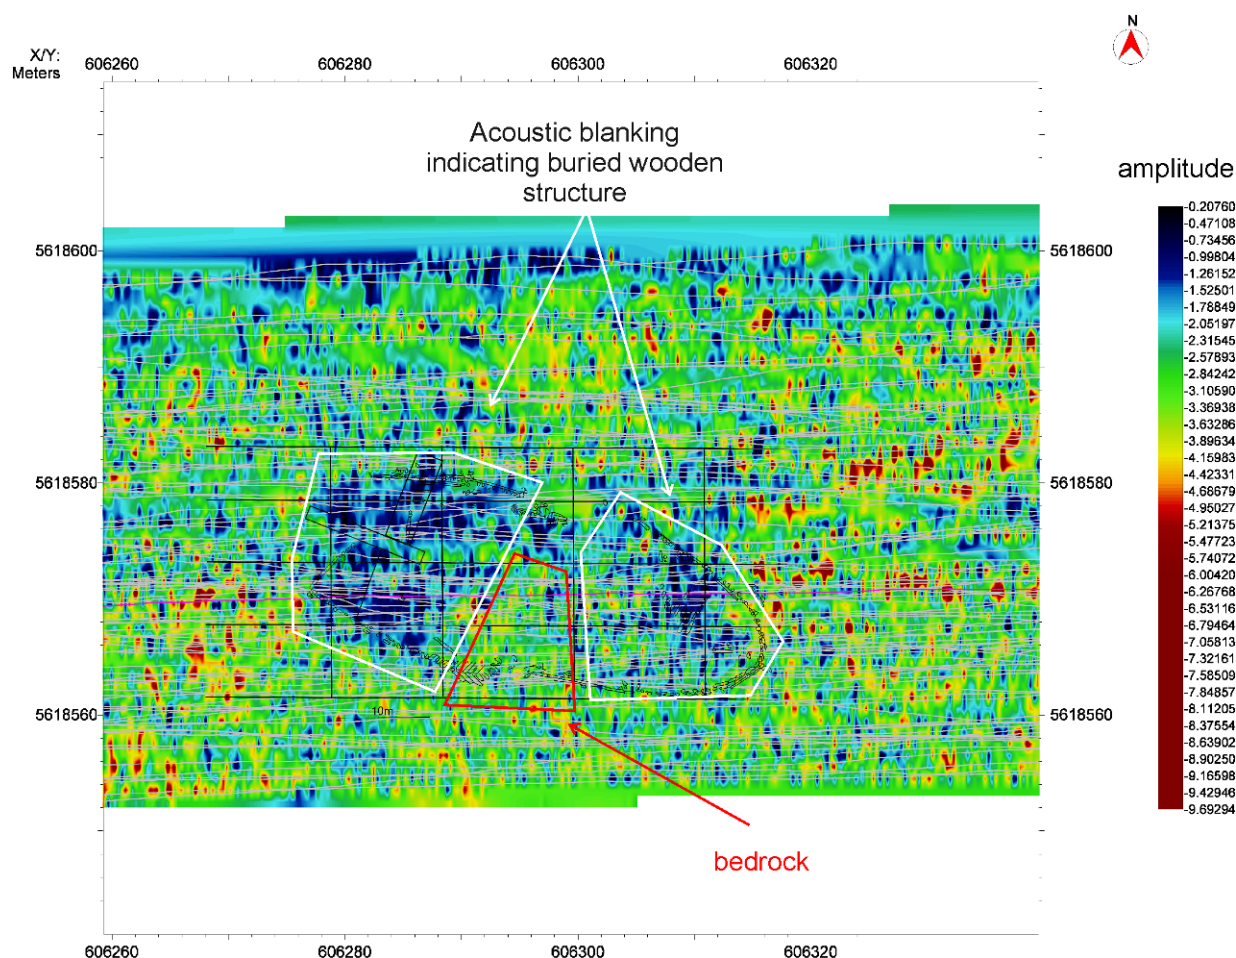
In September 2005 a geophysical survey was undertaken of the site by Dr Justin Dix of the University of Southampton. The principle objectives for the survey were to gain data for use in monitoring the site and the surrounding area and to assess the potential for sub-surface imaging of the buried remains. The aim was to 'image' the buried hull structure to create a 3-D reconstruction. A single line of chirp seismic data was acquired over the site as poor weather conditions led to only a limited amount of data being acquired and this was of modest quality. A second geophysical survey was carried out in March 2006 using a chirp sub-bottom profiler. The results illustrated that the remains of the vessel were segmented and concentrated in the bow and stern sections, with bedrock situated in the middle of the wreck (Figure 9). The western stern section was demonstrated to be the most promising area for finding buried hull remains, remains do not appear to have survived in the amidships section. The geophysical survey suggested that the remains on the port side of the stern section were likely to extend further to the west than indicated on the original site-plan (Watson & Gale, 1990); and there appeared to be buried remains towards the bow section, mainly towards the port side (Plets *et al*, 2007).

Figure 8 - Amplitude map courtesy of Ruth Plets & Justin Dix, National Oceanography Centre

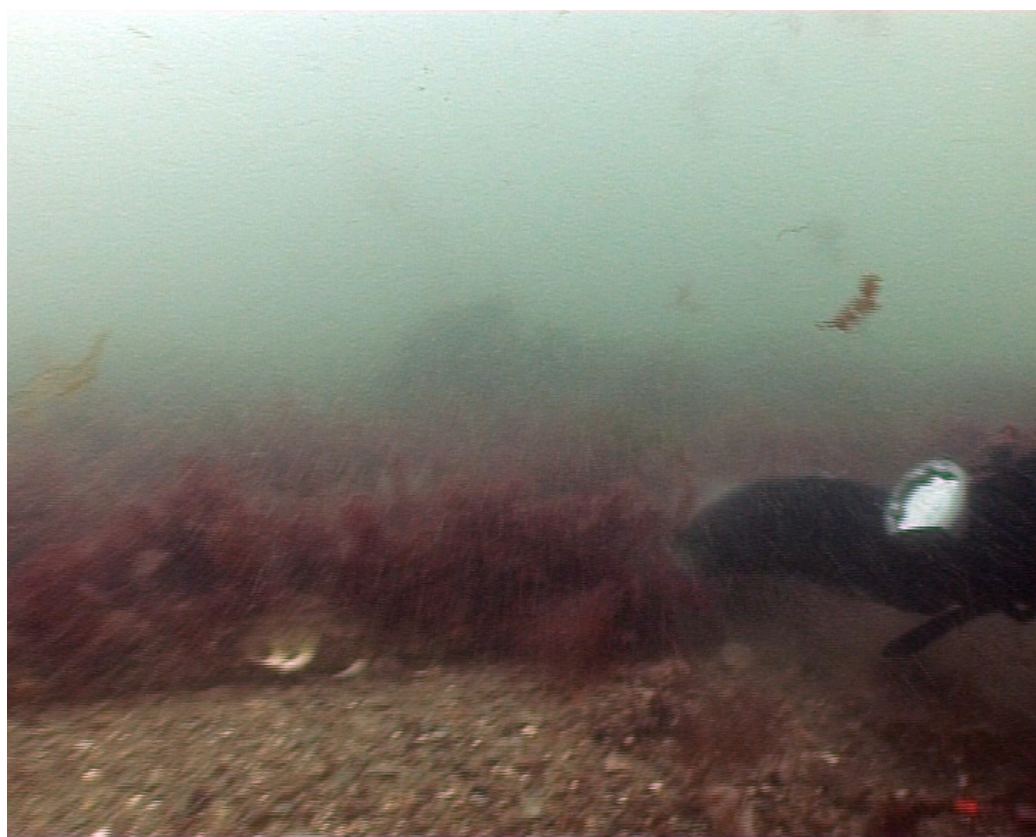
The visible cultural material at the site consists of structural remains. The majority of material at the Yarmouth Roads wreck site lies in hollows in the Eocene bed rock where the archaeological material is contained within fine silts, and is either still buried or has been protected using sandbags. The diver survey carried out in 2009 recorded extant structure on the seabed, and the sandbags which cover the site.

*Figure 9 - Structure on seabed  
(copyright HWTMA / Trevor Jenkins)*

The structure that is exposed lies close to the seabed as can be seen in Figures 9, 10 and 11. One of the aims of the monitoring dive had been to record measurements of the exposed structure and install monitoring points to help assess the speed of erosion at the site. Unfortunately tidal conditions on the day limited the tasks that were able to be completed. A video record of the site was created providing evidence of the current conditions of archaeological material on site.

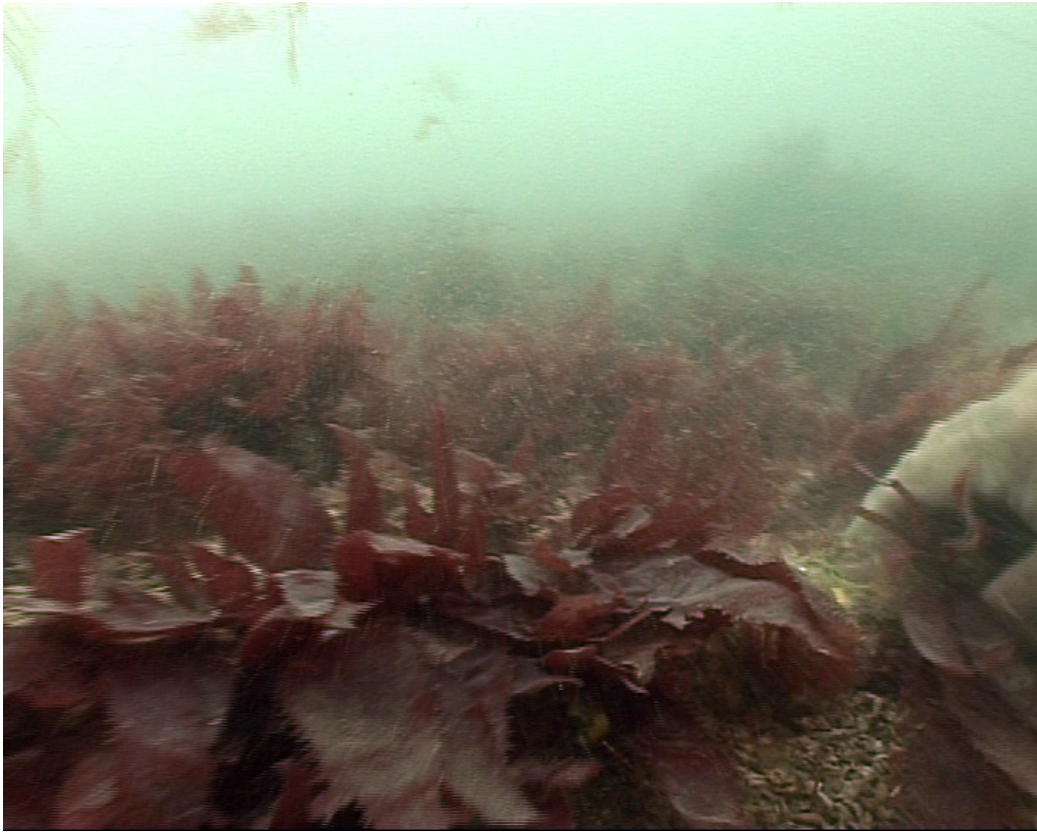
*Figure 10 - Diver highlighting structure  
(copyright HWTMA / Trevor Jenkins)*

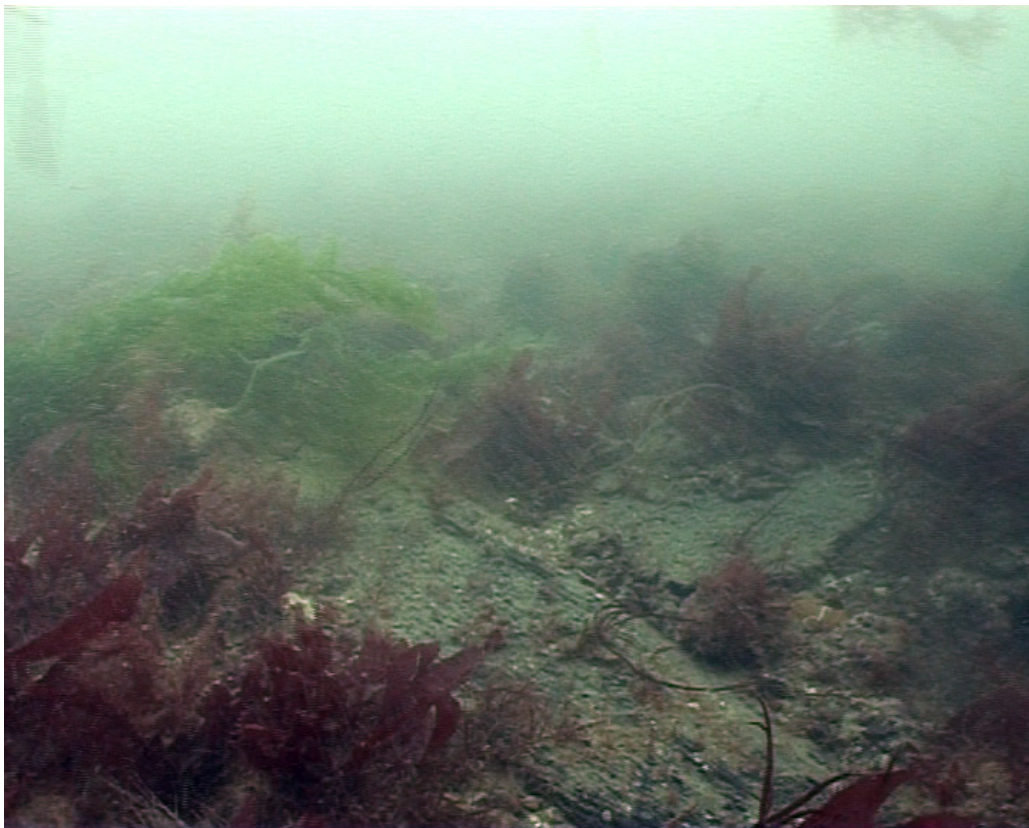
*Figure 11 - Structure on seabed  
(copyright HWTMA / Trevor Jenkins)*

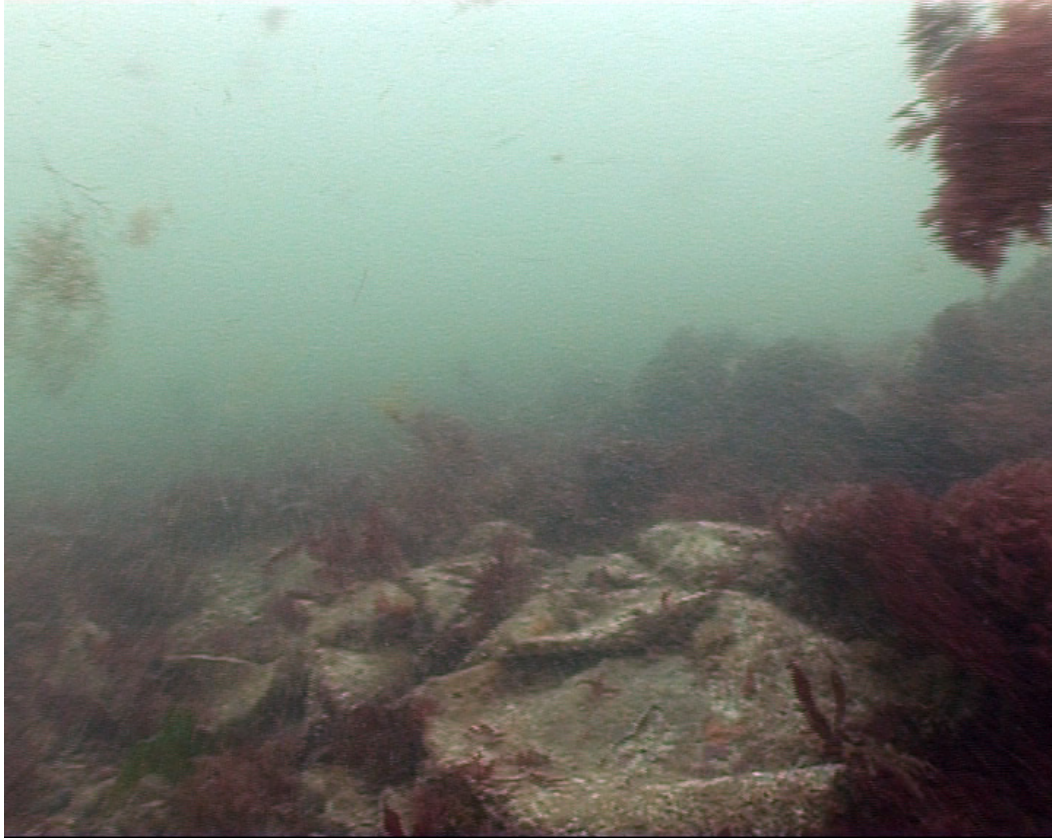
The majority of the structure is covered by sandbags. The sandbags are in a degraded condition (Figure 12), but have not altered considerably since they were last surveyed in 2005 (Figure 7). As such the majority of exposed material is still protected, and is therefore assumed to remain stable.

*Figure 12 - Image of sandbags at the Yarmouth Roads wreck site  
(copyright HWTMA / Trevor Jenkins)*

HWTMA recognises the need to continue to monitor the site as the level of risk can be subject to change. Physical erosion is possible due to the location of vulnerable wooden remains on the surface of the seabed. The installation of monitoring points may help with an assessment of the speed of erosion taking place. Further monitoring work will be undertaken in 2010 to help establish the stability of the site. The condition of the remaining sand bags has been assessed and a more detailed survey of any wreck structure may now be undertaken.
