LCT(A) 2428

An Assessment
for Scheduling in
the Marine Zone

Project Report

Prepared by
Hampshire & Wight Trust for Maritime Archaeology
National Oceanography Centre, Southampton

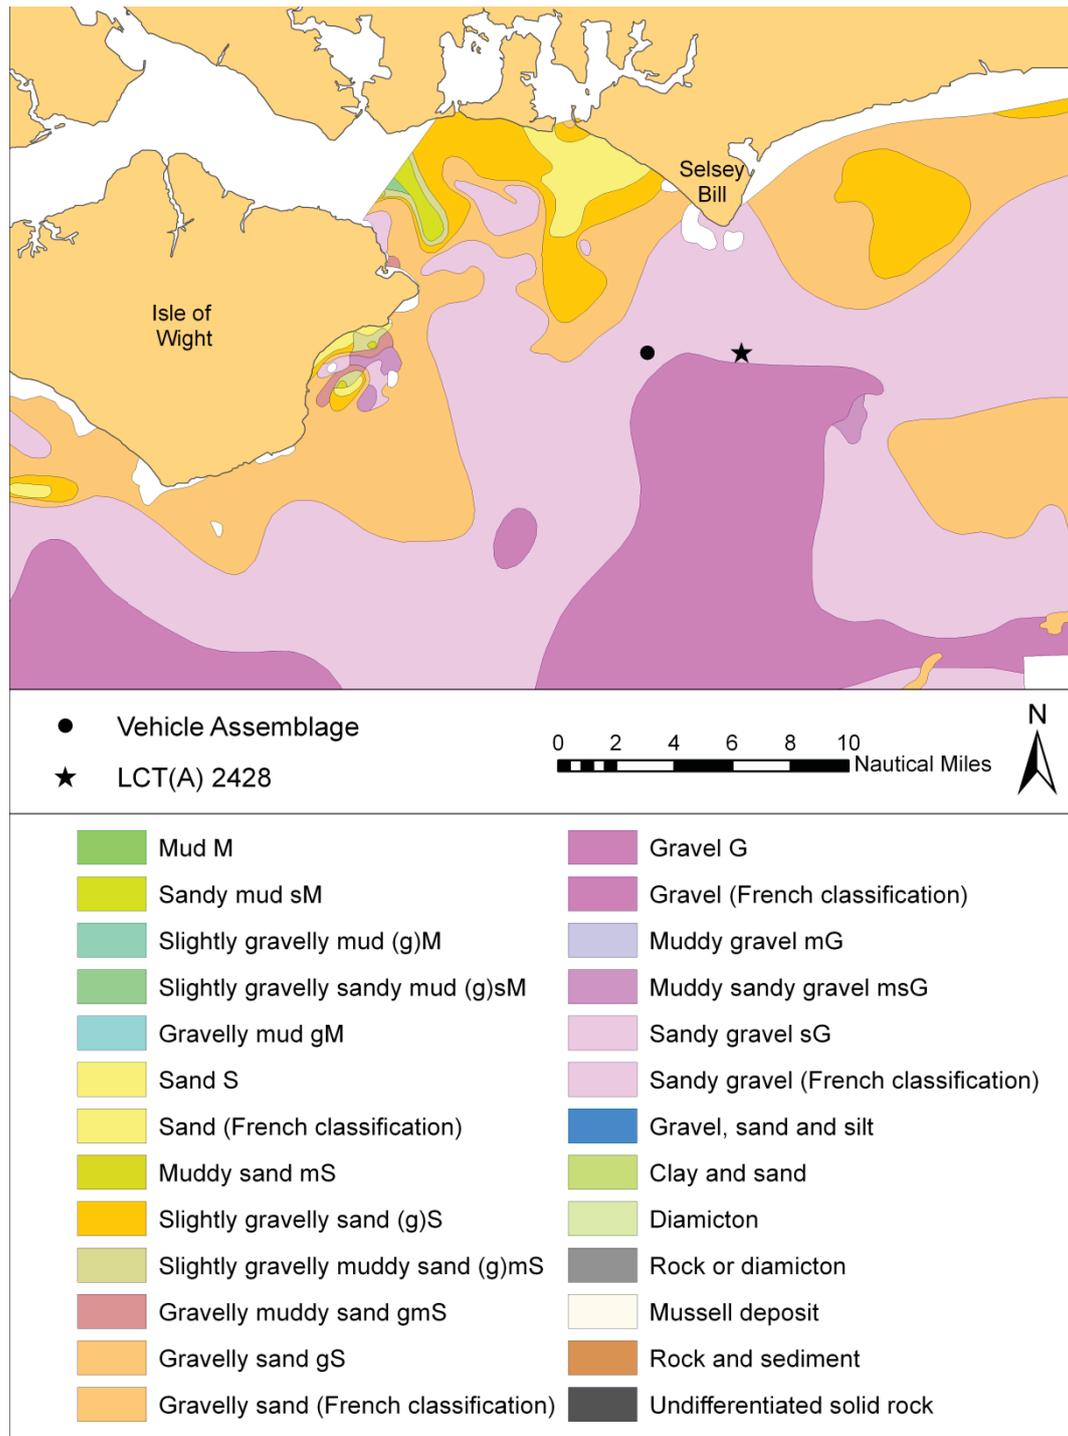
In both cases the sediment is characterised as Sandy Gravel (sG), by both the SCREC and the British Geological Survey (BGS) (Figure 4.2). Data from the latter is included in the SCREC as additional data. The sediment is considered to be poorly sorted across the vehicle assemblage and very poorly sorted across the landing craft site. Classification is of pebbles, with a mean diameter greater than 4mm (Figure 4.3). At either site, mud comprises less than 5% of the observed seabed (Figure 4.4). Some difference can be noted in the ratio of sand to gravel at each site. The vehicle assemblage is between 40-50% sand and 50-60% gravel, while the landing craft site is between 20-30% sand and 70-80% gravel (Figure 4.5 and 4.6).

Figure 4.2. Seabed sediment for the area surrounding the vehicle assemblage and LCT(A) 2428. Data derived from the British Geological Survey via the South Coast REC.

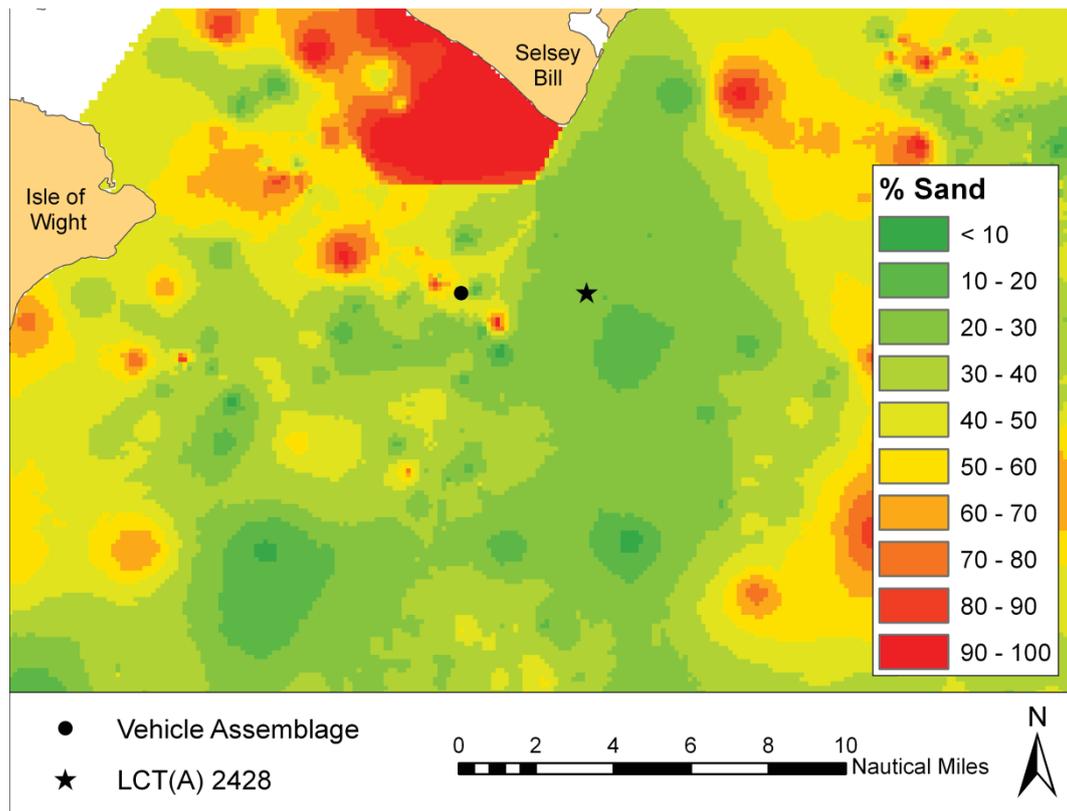
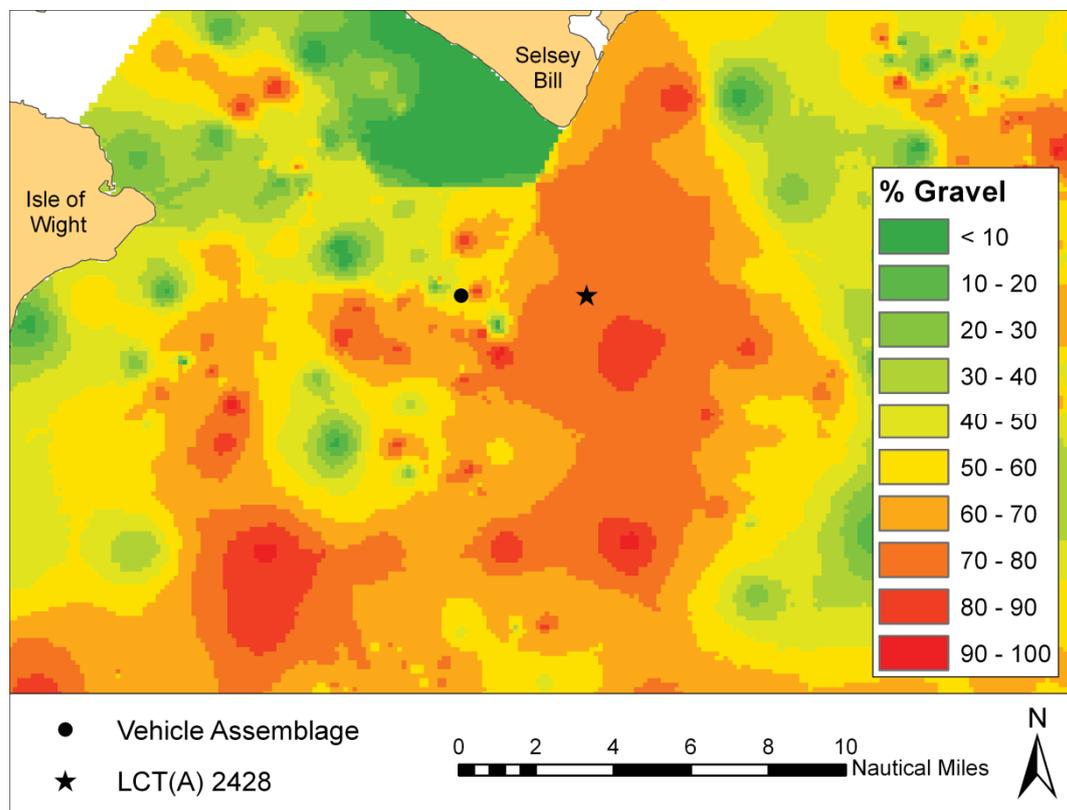
Figure 4.5. Percentage of sand as seabed sediment for the area surrounding the vehicle assemblage and LCT(A) 2428. Data derived from the South Coast REC.

Figure 4.6. Percentage of gravel as seabed sediment for the area surrounding the vehicle assemblage and LCT(A) 2428. Data derived from the South Coast REC.

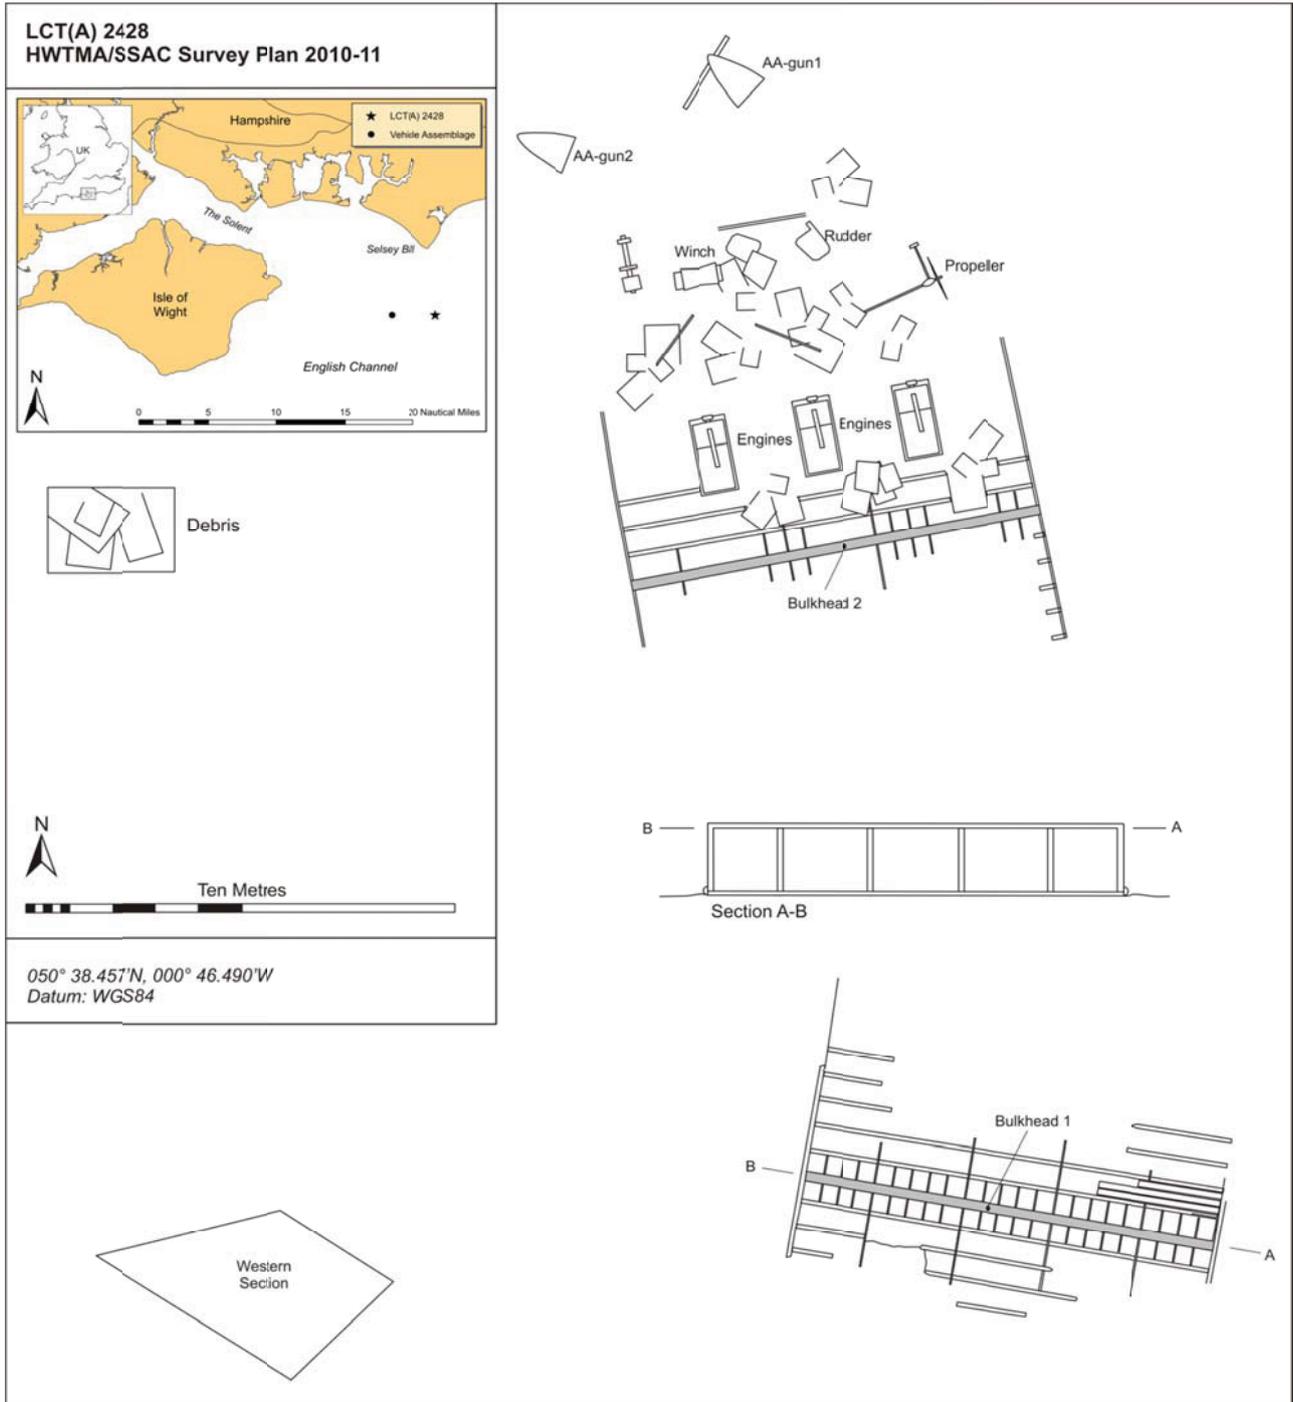
Figure 4.12. Overall site plan of LCT(A) 2428.

The site of LCT(A) 2428 has lost much of its structural integrity as the coherent remains of an LCT. As might be expected, given the capsized of the vessel prior to sinking, the remains lie upside down on the seafloor. The vessel remains lie along a general north/south axis and the site measures c. 40m (north/south) by c. 30m (east/west) giving an area of 1200m². The site can be considered to be contained within a circular area, radius of 25m. The vessel is broken into three areas (Figure 4.12);

- A northern section relating to the stern of the vessel, containing the engines.
- A southern section located at the forward end of the central body of the vessel. No debris or structure has been observed to the south of this structure.
- A small western area of steel plating that may relate to the deck of the vessel, or possibly the bow doors.

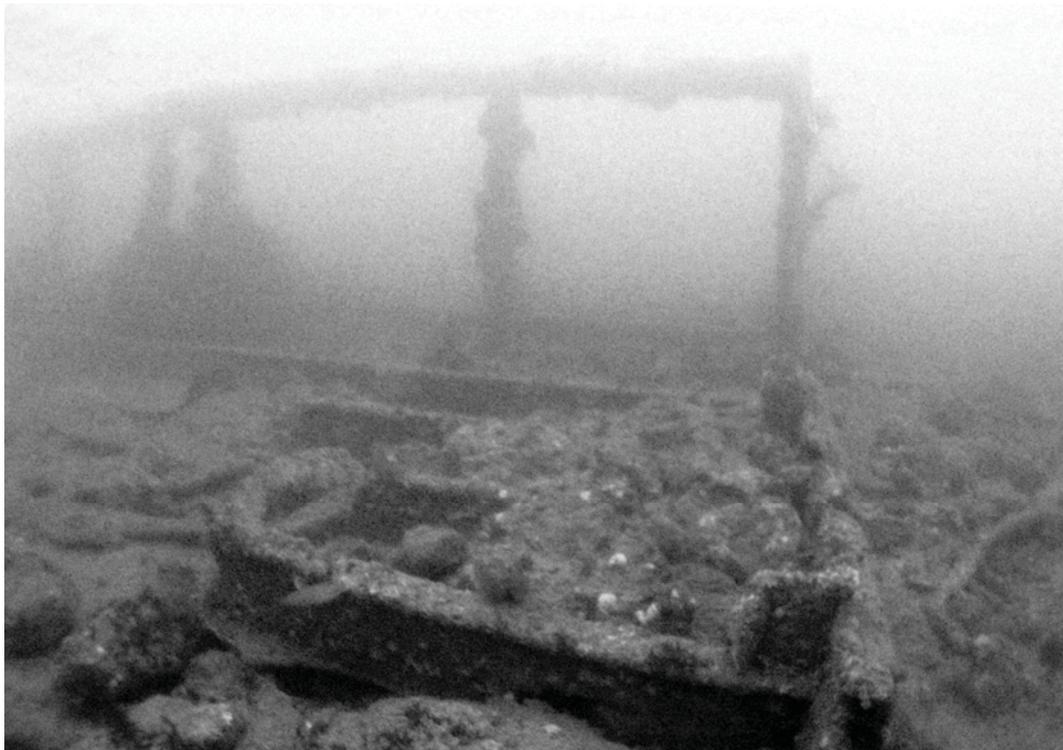
Figure 4.13. General view of the southern section of remains and bulkhead 1, further framing, originally on the underside of the deck is visible in the foreground (Source: HWTMA).

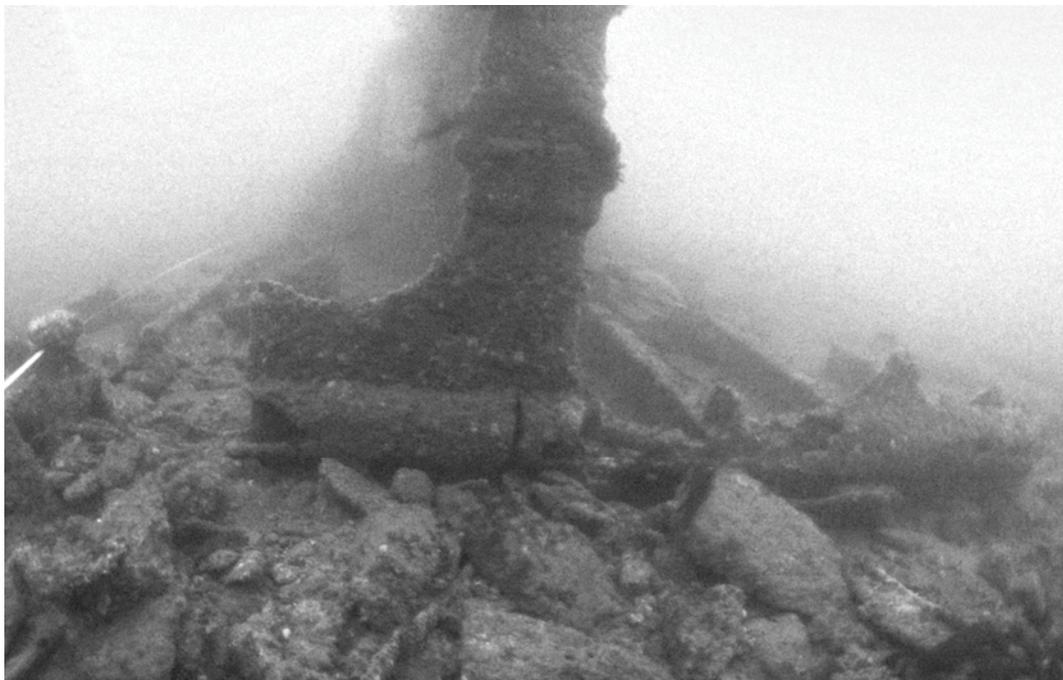
Figure 4.14. Pipe fender running along the side of the vessel at bulkhead 1 (Source: HWTMA).

The upside-down orientation of the vessel noted by the UKHO (Section 2.3.2) was confirmed through the survey of the southern section of remains. Original plans of LCT MkV show the presence of an 8" pipe fender running along the outside of the vessel, just below the level of the deck. The remains of this were observed at either side of the southern section (Figure 4.14). The distance between this pipe fender and the top of the bulkhead corresponds with the distance shown in plans from the pipe fender to the bottom of the vessel. The steel plate visible on the seafloor underneath the southern bulkhead is therefore very likely to be the remains of the vessel's deck, seen from the underside. This also explains the structural elements that are visible in this area, between the deck, the bulkhead and the other steel framing elements (Figure 4.15).

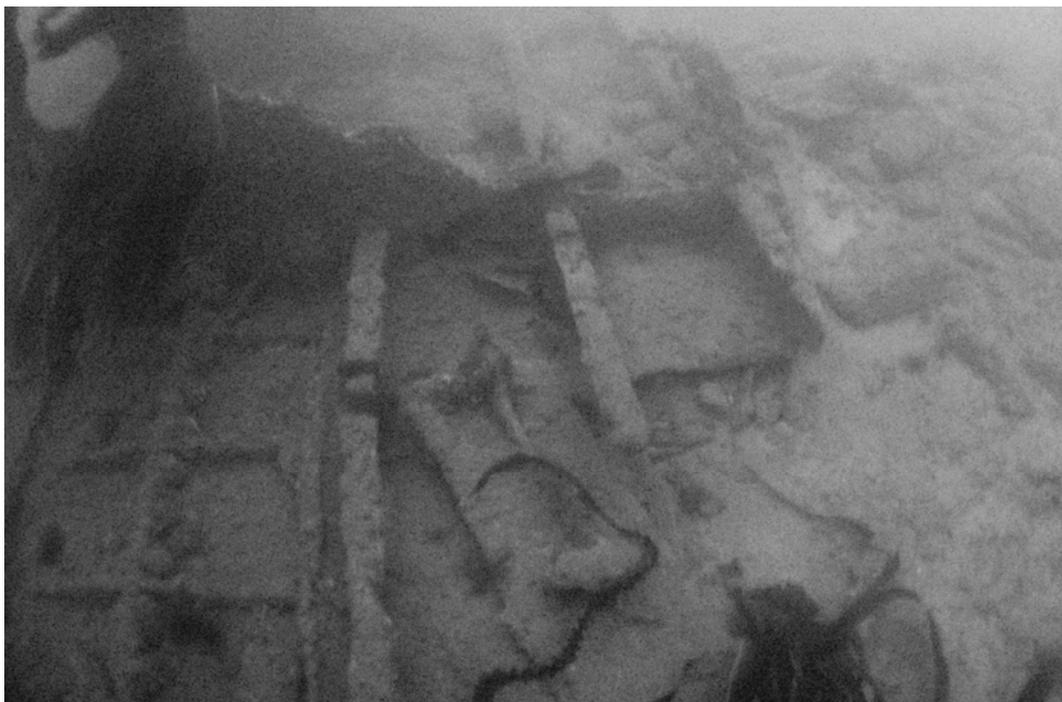
Figure 4.15. The southern extent of the vessel remains, including the broken edge of the vessel's deck, seen from the underside (Source: HWTMA).

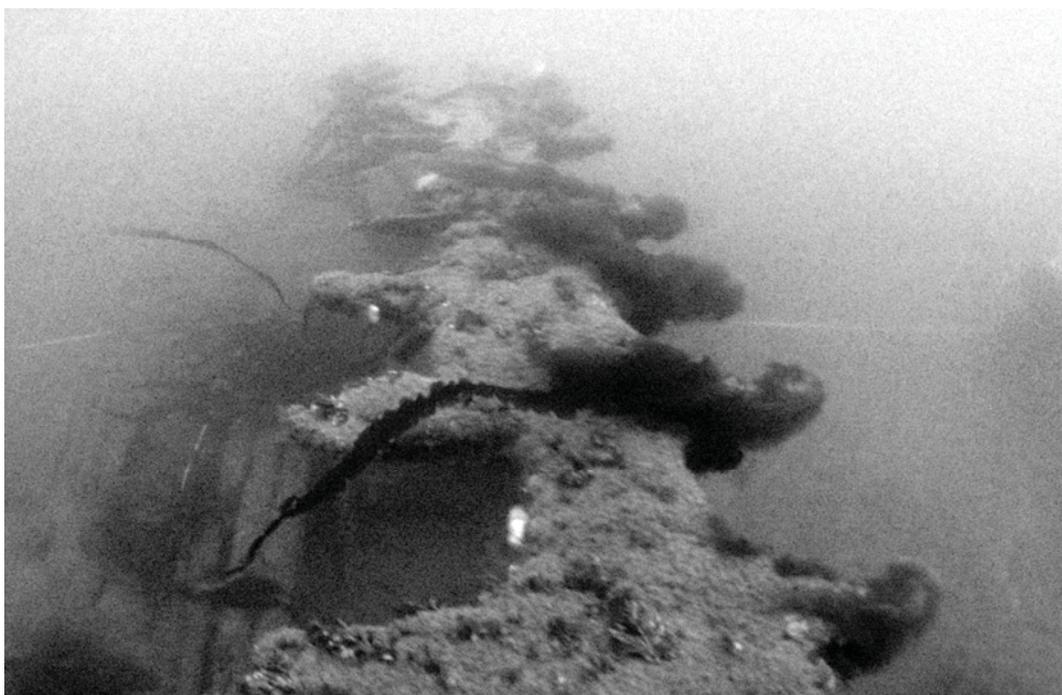
Figure 4.16. The upper face of bulkhead 1, with remnants of what was formerly the bottom of the landing craft (Source: HWTMA).

Establishing the upside-down orientation of the vessel illustrates that virtually the entire hull of the vessel has been lost, with the exception of the small elements still attached to the bulkhead (Figure 4.16). The edge of the vessel's deck can be seen on both the north and south side of the southern section, suggesting that this section of the vessel has become totally detached from the northern section of remains. Mayor (2010: part 4, pp 7) notes that the wire sweep of the site in 2003 may have contributed to the overall broken-up nature of the site. This conclusion seems to be borne out by the observations made during the current survey and provides a striking contrast with the UKHO listing which describes the vessel as 'intact'. Figure 4.17 illustrates the extent of lost material by overlaying the current site-plan against the outline plan of an LCT MkV.

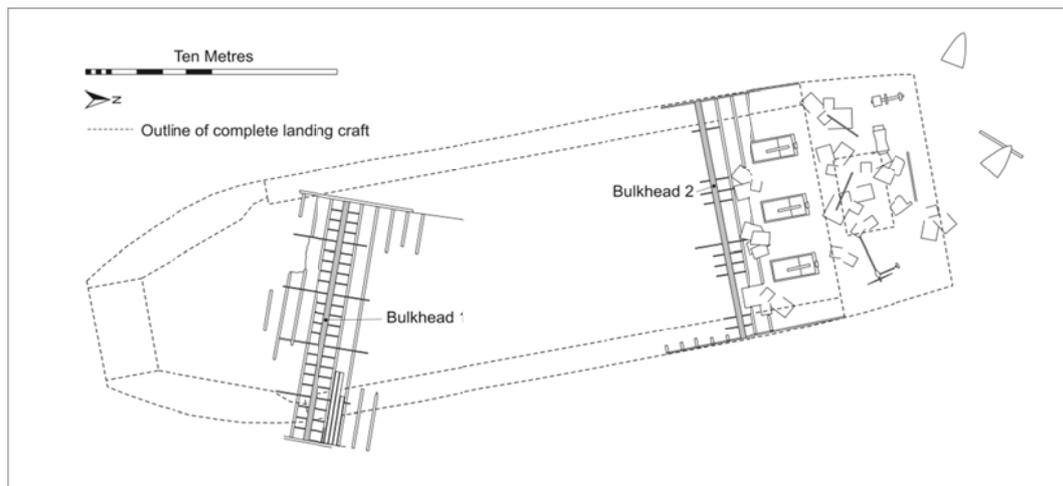
Figure 4.17. Current site extent/remains, overlaid on the outline of an LCT MkV, to illustrate the extent of lost structure.

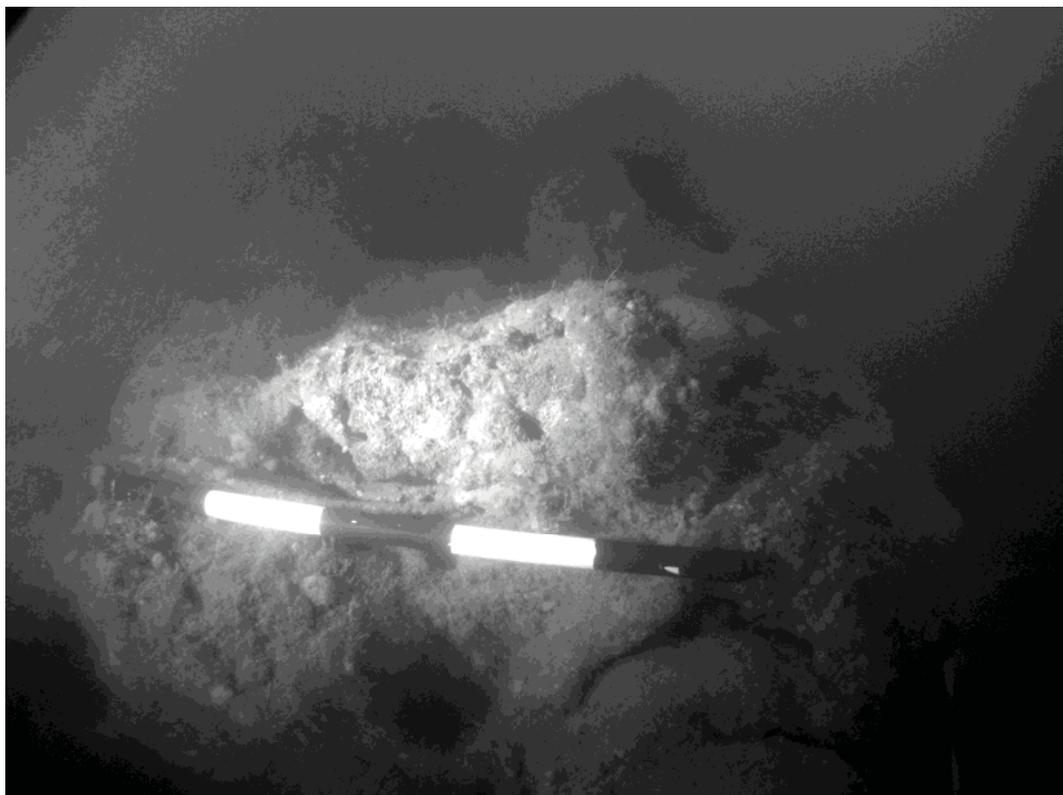
Figure 4.18. Concreted remains of an engine block, scale: 50cm (Photo: Jim Fuller, SSAC).

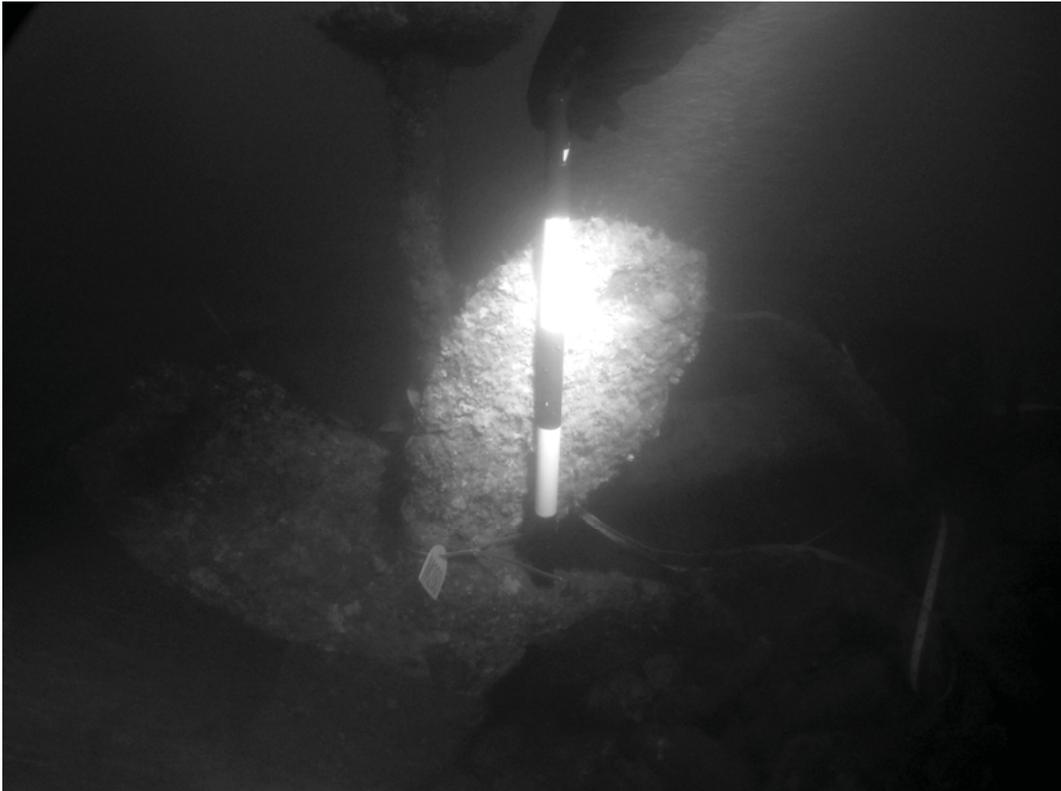
Figure 4.19. Surviving propeller in-situ, monitoring tag M280 is visible attached to the centre of the propeller, scale: 50cm (Photo: Jim Fuller, SSAC).

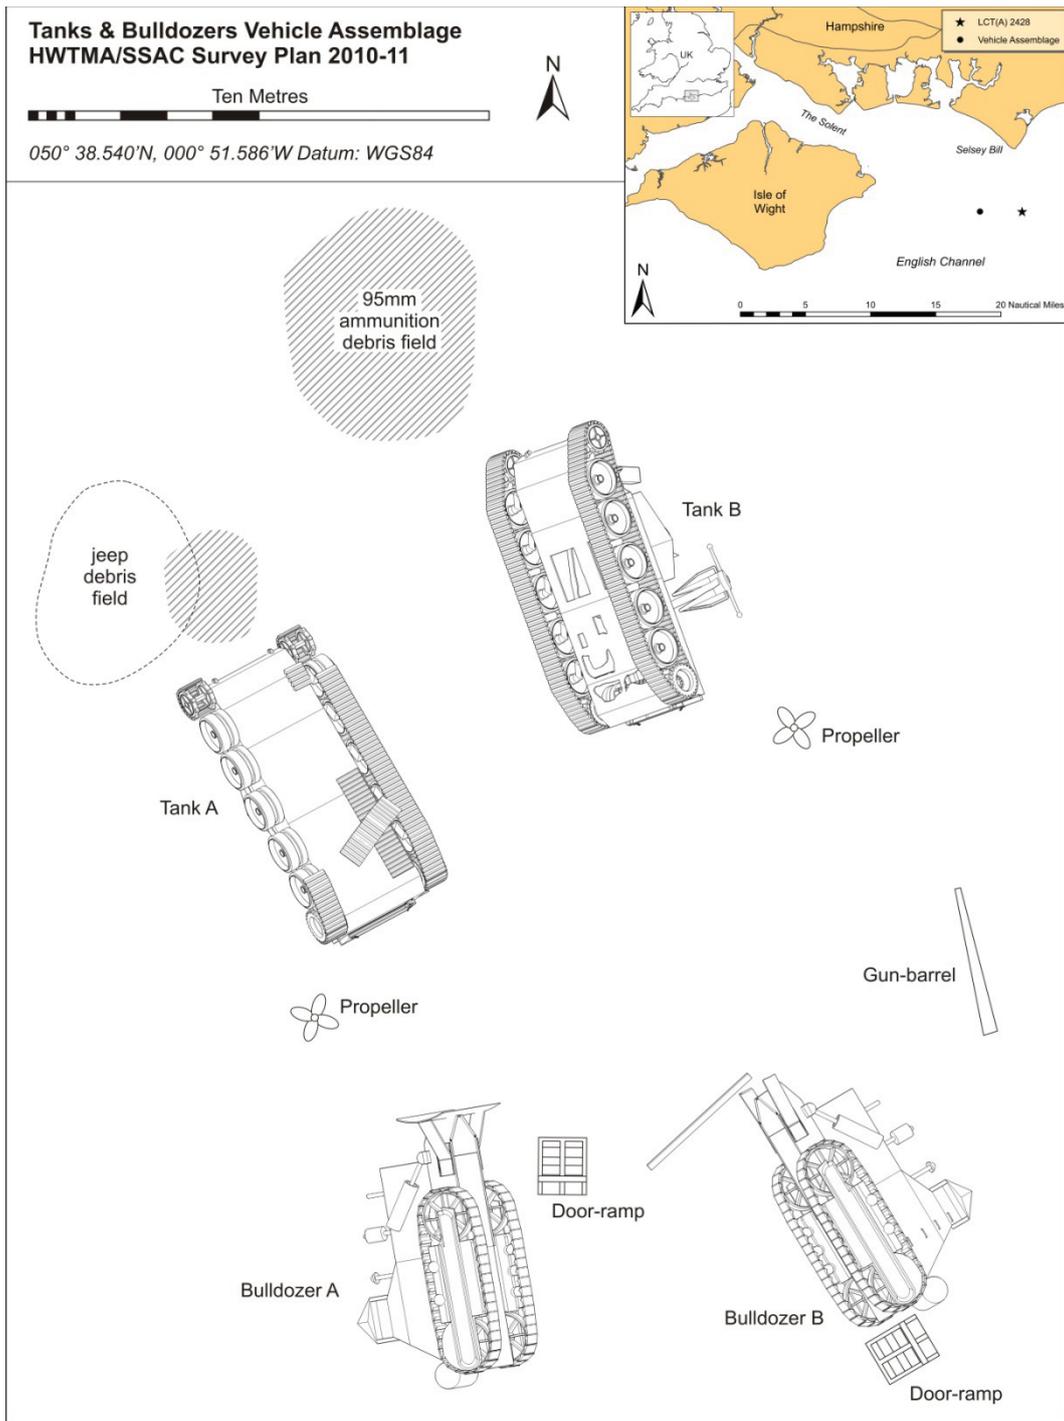
Figure 4.20. Overall site plan of the Tanks and Bulldozer vehicle assemblage.

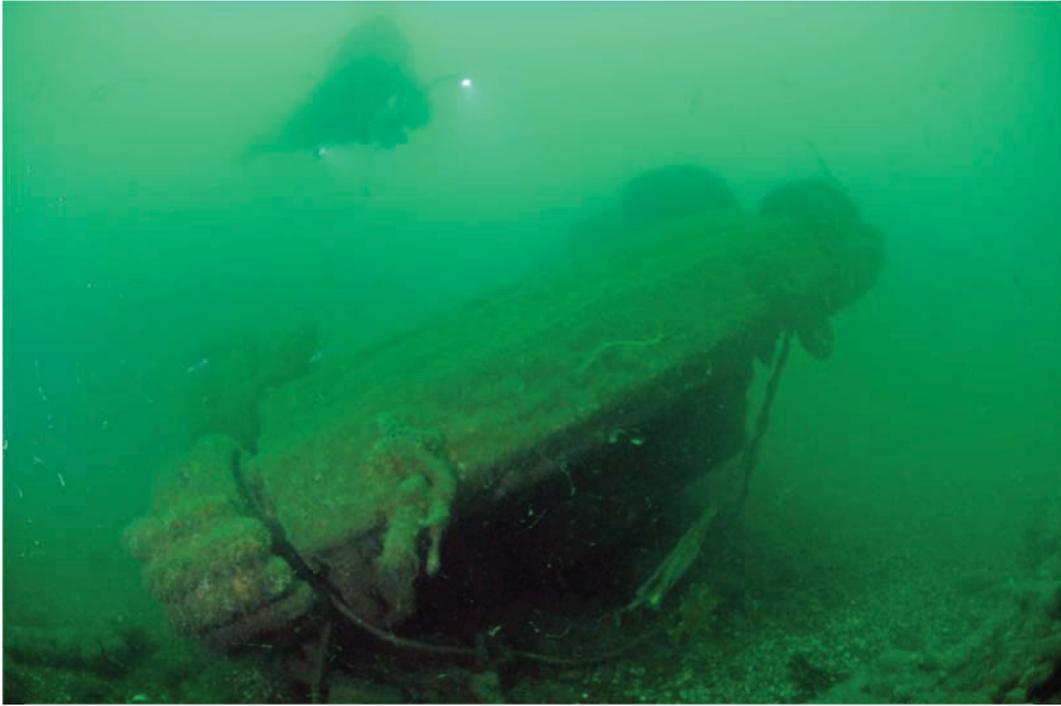
Figure 4.21. Tank A, viewed from the north (Image: Martin Davies, SSAC).

SSAC surveys of the site recorded ropes wrapped around Tank A, which were gone by the time of the present surveys in 2010. The damage to the tracks of Tank A seem to have occurred in a single incident, indicated by the corrosion and concretion on all of the resulting exposed areas of wheels, which is uniform in nature. The disposition of the displaced track elements suggests that the vessel was struck from its western side, resulting in segments of track lying across the underside of the vehicle. The fact that these track sections have stayed together, suggests a reasonable elapse of time between the deposition of the vehicle and the damage. At least long enough for the individual track pieces to become concreted together. The detachment and dislocation of the blade of Bulldozer B also seems likely to have occurred at a single point of time and provides a marked contrast with the coherent nature of Bulldozer A. The possible cause of these incidents of damage is discussed in Section 5.2.

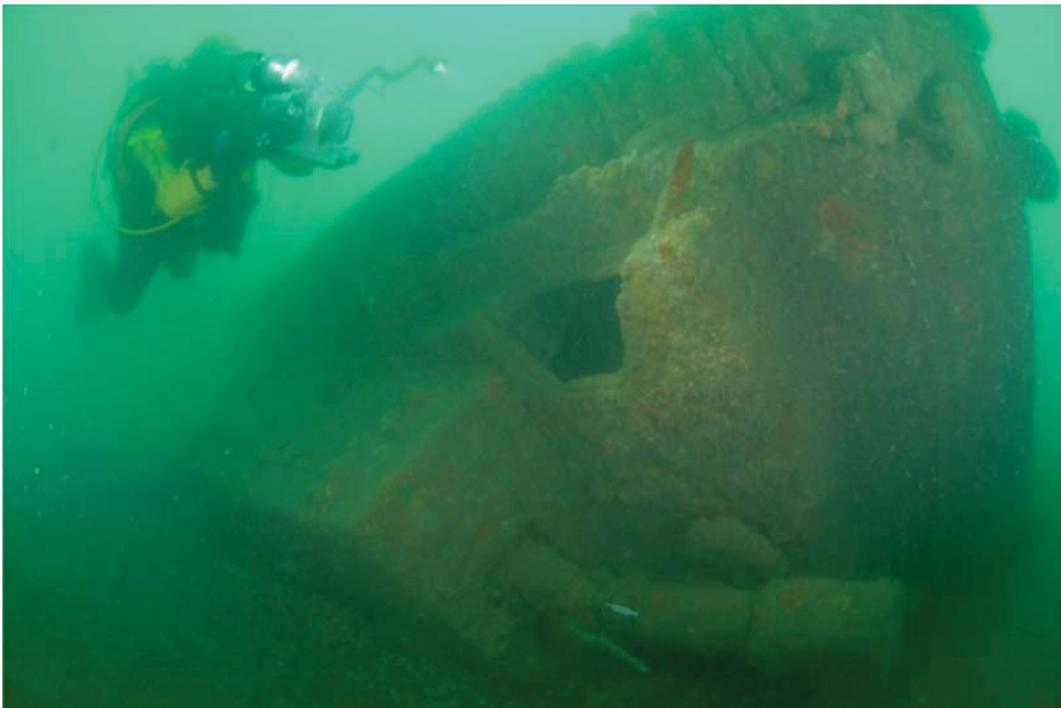
Figure 4.22. Tank B, viewed from the north-east (Image: Alison Mayor, SSAC).

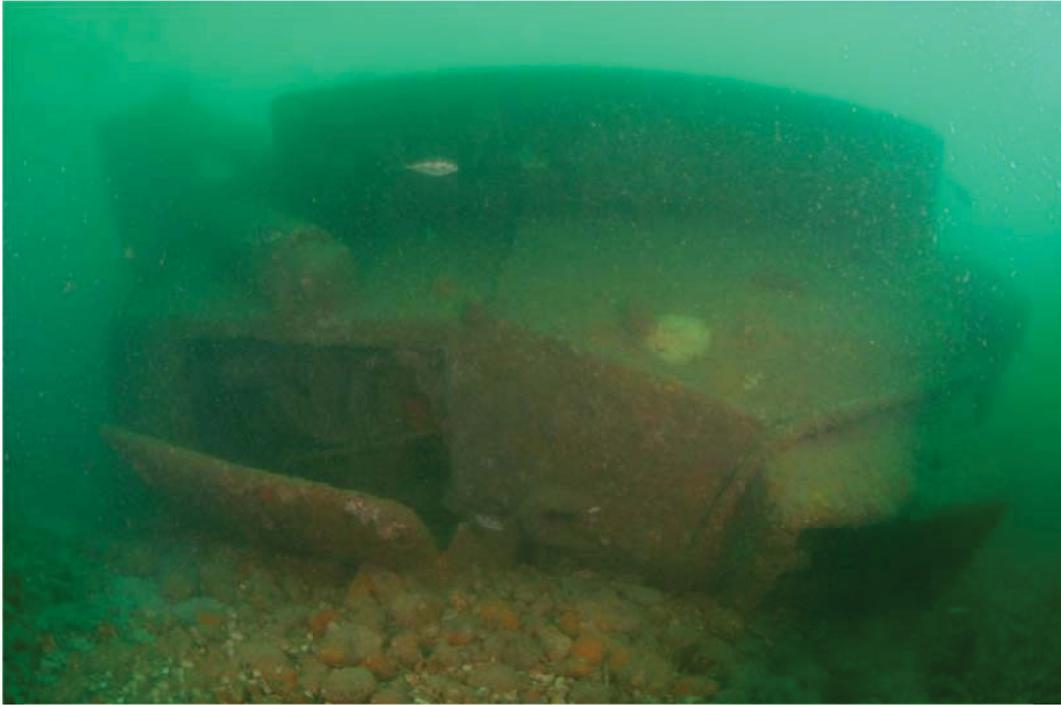
Figure 4.23. Bulldozer A, viewed from the west (Image: Martin Davies).

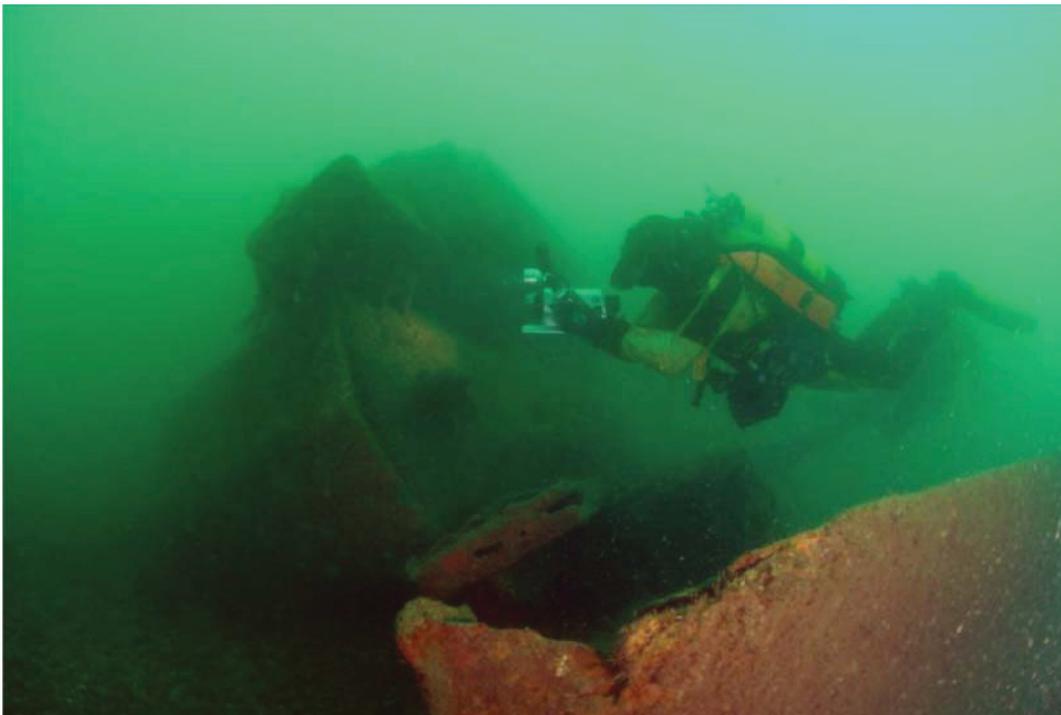
Figure 4.24. Bulldozer B, viewed from the north (Image: Alison Mayor, SSAC).

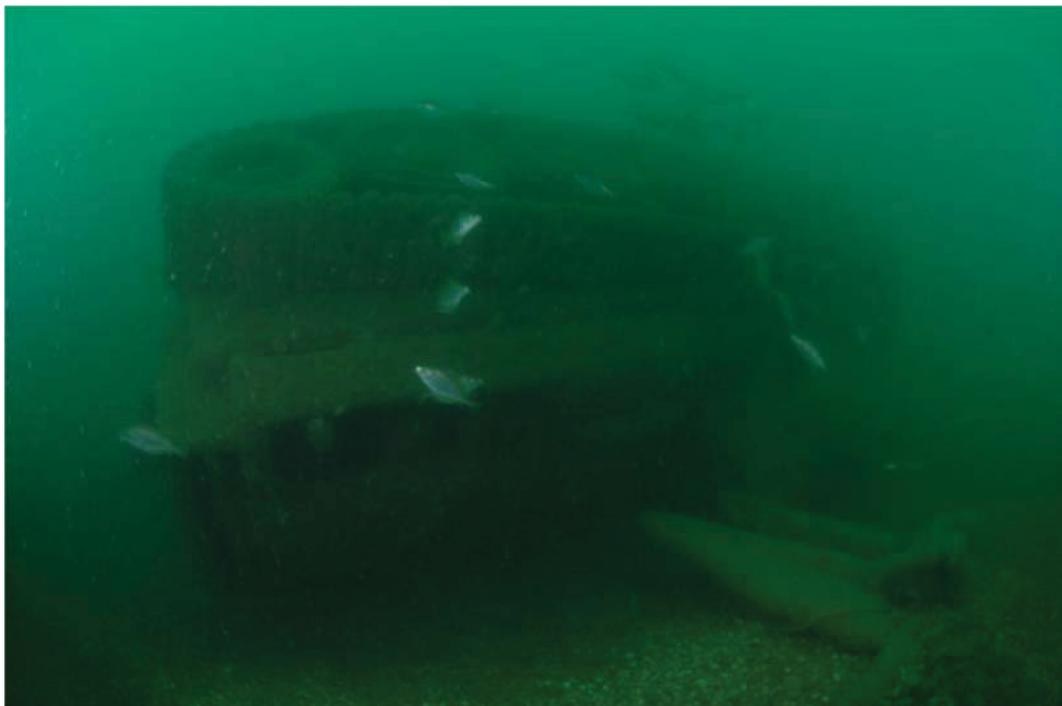
- A kedge anchor, partially lying under Tank B, on its eastern side (Figure 4.25).
- Vehicle remains, possibly that of a jeep, heavily degraded, lying to the north of Tank A (Figure 4.26).

Figure 4.25. Kedge anchor lying underneath the eastern side of Tank B (Image: Martin Davies, SSAC).

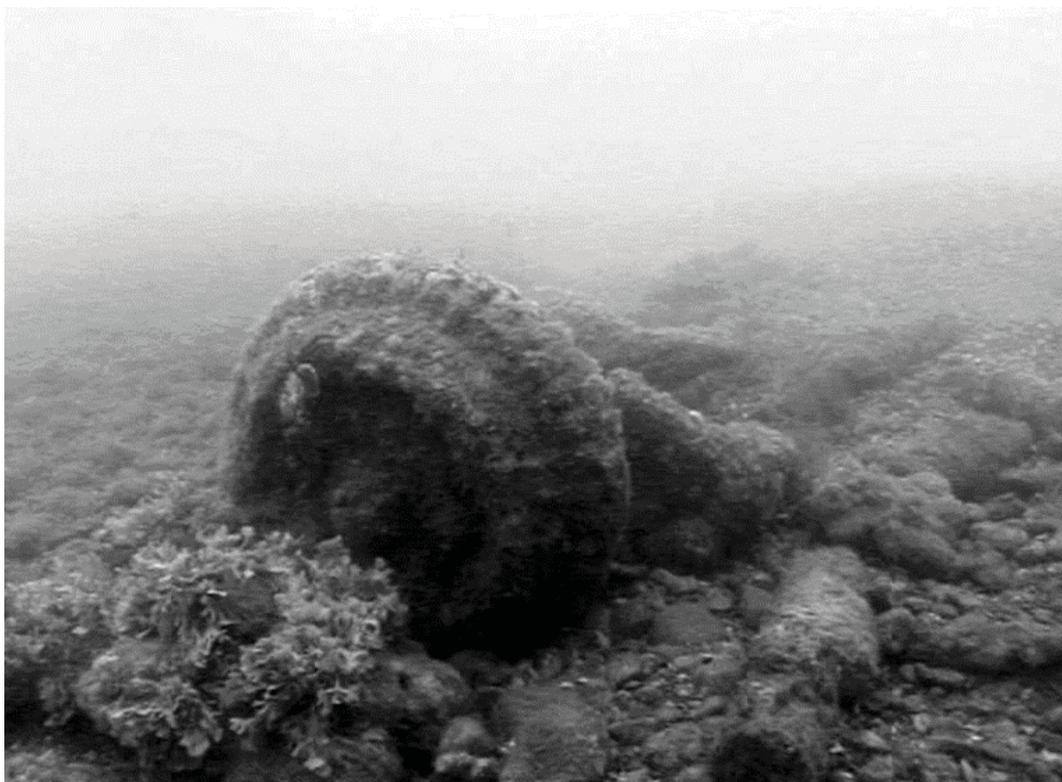
Figure 4.26. Heavily degraded remains of a jeep.

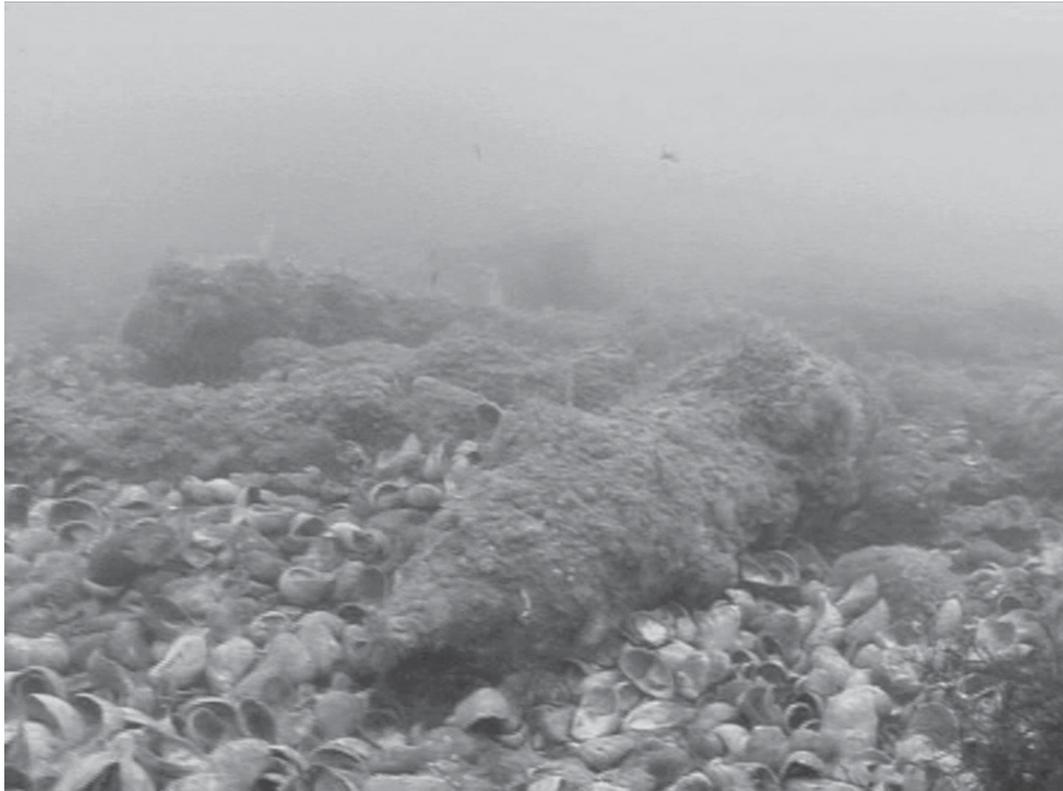
Figure 4.27. Remains of 95mm ammunition, located to the north of the tanks.

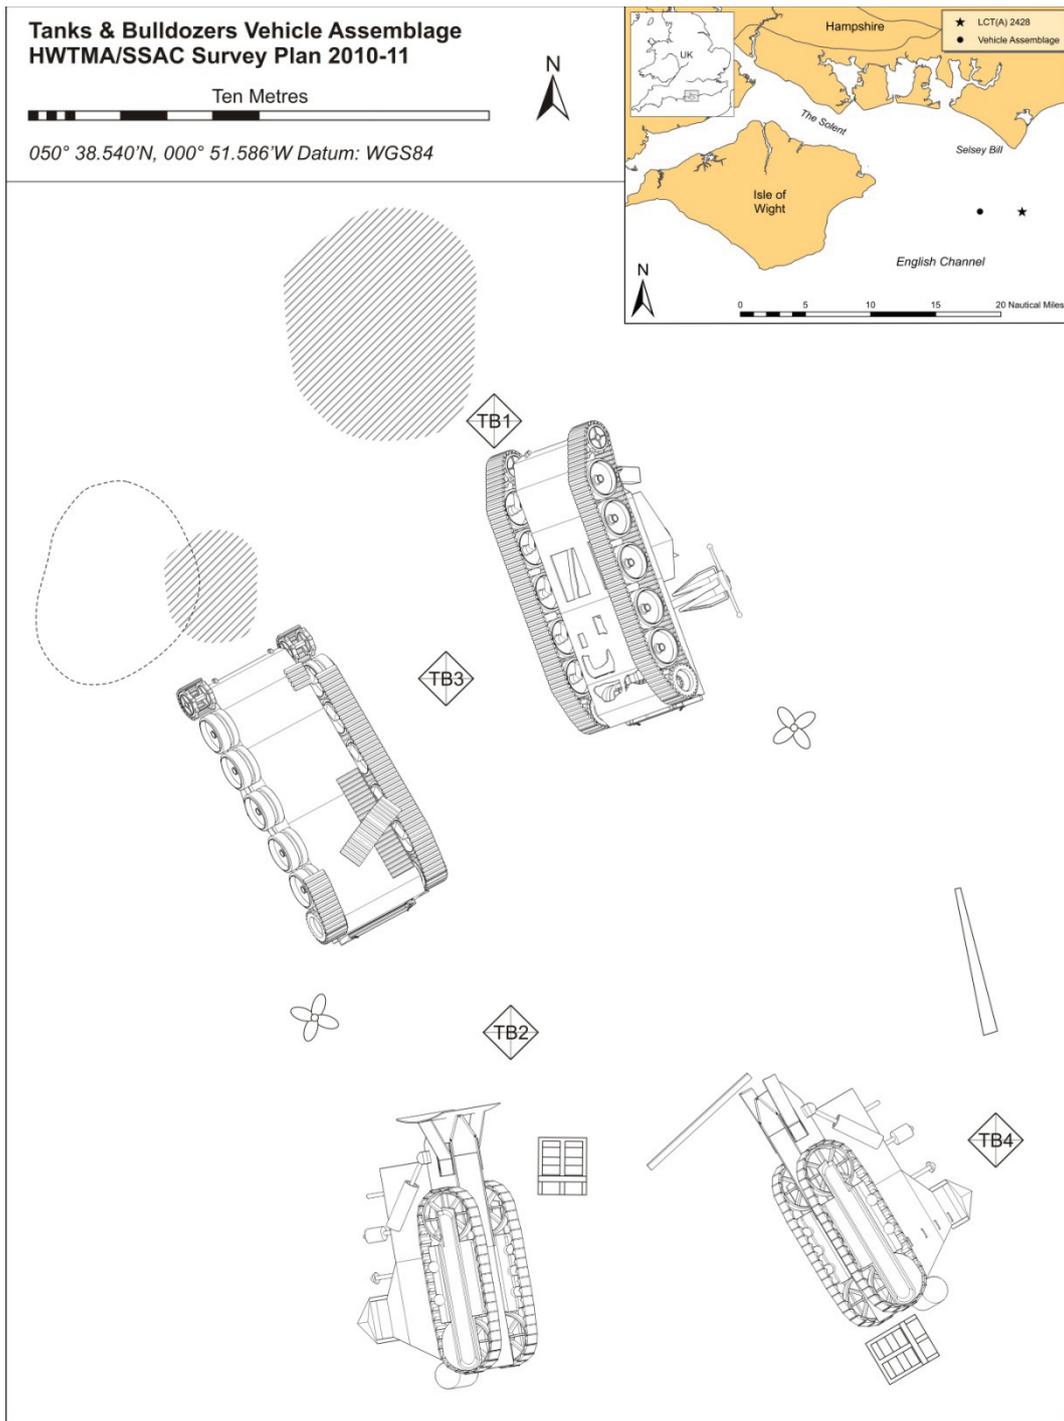
A series of monitoring points were installed on the seabed around the vehicle assemblage (Figure 5.1) (Section 3.1.2), in the form of steel stakes driven into the seabed, surmounted by an ID tag. Measurements were taken from the top of these to the seafloor in order to provide a benchmark for the future monitoring of the seabed height over the site in relation to the monitoring point (Table 6). It should be noted that the nature of the seabed on the site (Section 4.1) and the presence of relatively small artefacts still *in-situ* on the surface, eg. ammunition, indicates that little change has taken place to the seabed since deposition and that little future change should be expected.

Figure 5.1. Location of monitoring points on the Tanks and Bulldozer vehicle assemblage.

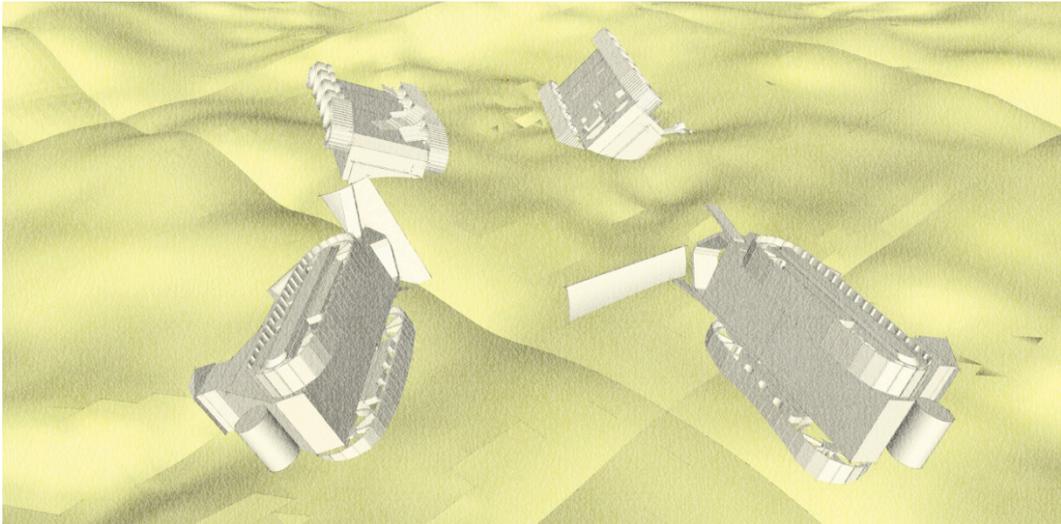
Additionally, the monitoring points are intended to serve as orientation points for the consistent inspection of specific areas of the vehicles in the future. The creation of a three-dimensional site plan (Figure 5.2) means that a view of the vehicles from each of the monitoring points can be created that is independent of visibility or lighting constraints both of which can be a problem at the site. These viewpoints can then be utilised by visiting divers to record, either through photographs, video, or written record (preferably all three) the condition of the remains visible from each monitoring point. An example of such a virtual viewpoint, along with a photograph taken from the same place, is included in Figure 5.3. A 'virtual dive' around the site stopping at each monitoring point will also be hosted on the HWTMA LCT project webpages in order to allow divers to orientate themselves prior to site visits.

Figure 5.2. Isometric view of the vehicle assemblage site, resulting from creation of 3D site plan.

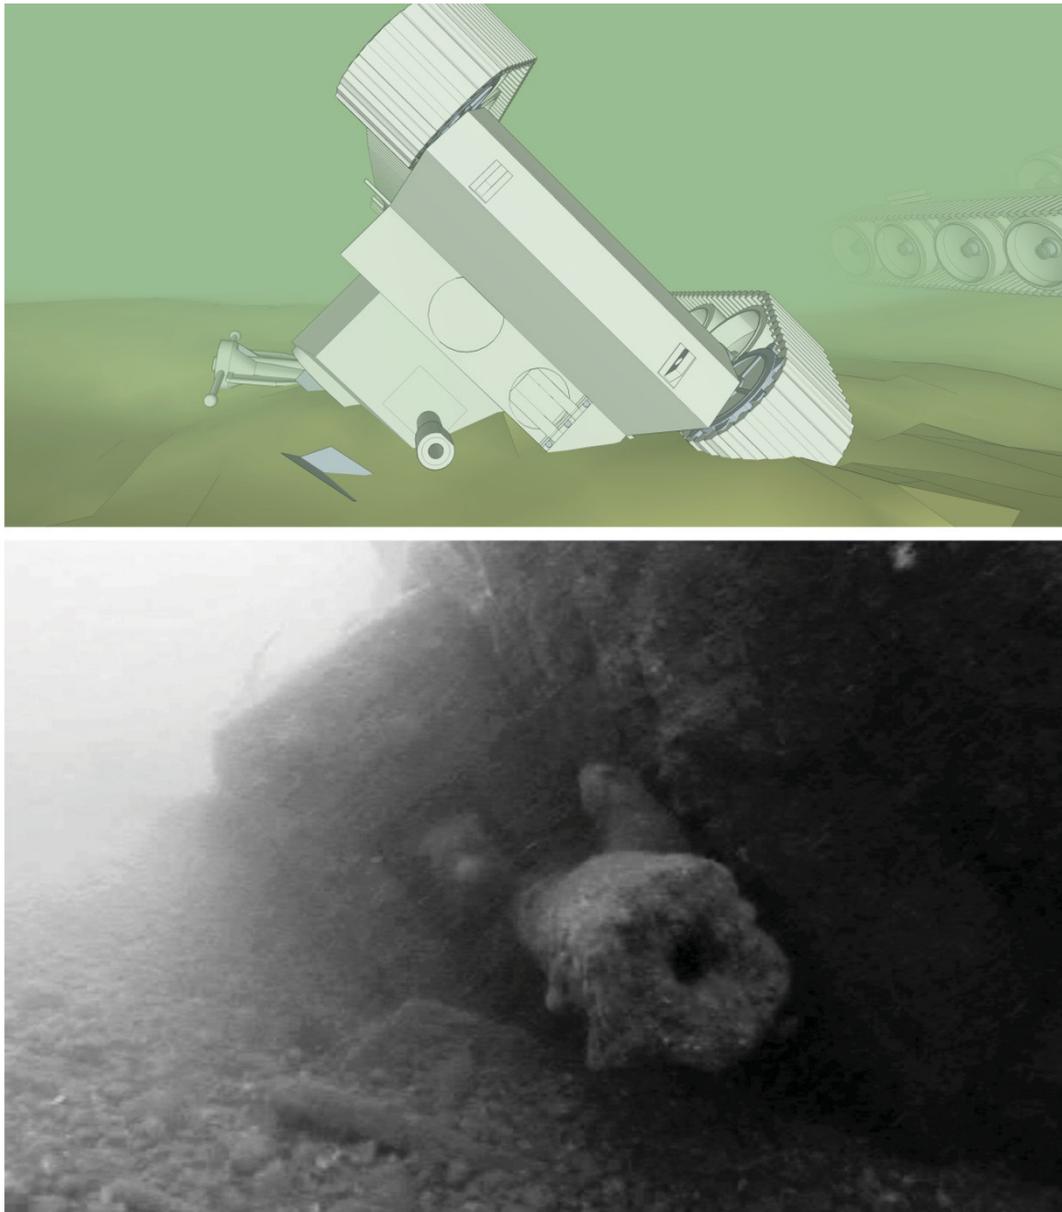
Figure 5.3. Example of virtual viewpoint on the vehicle assemblage site. Top: Tank B seen from monitoring point TB01. Bottom: Diver viewpoint from comparable position in average visibility.
