LCT(A) 2428

An Assessment
for Scheduling in
the Marine Zone

Project Report

Prepared by
Hampshire & Wight Trust for Maritime Archaeology
National Oceanography Centre, Southampton

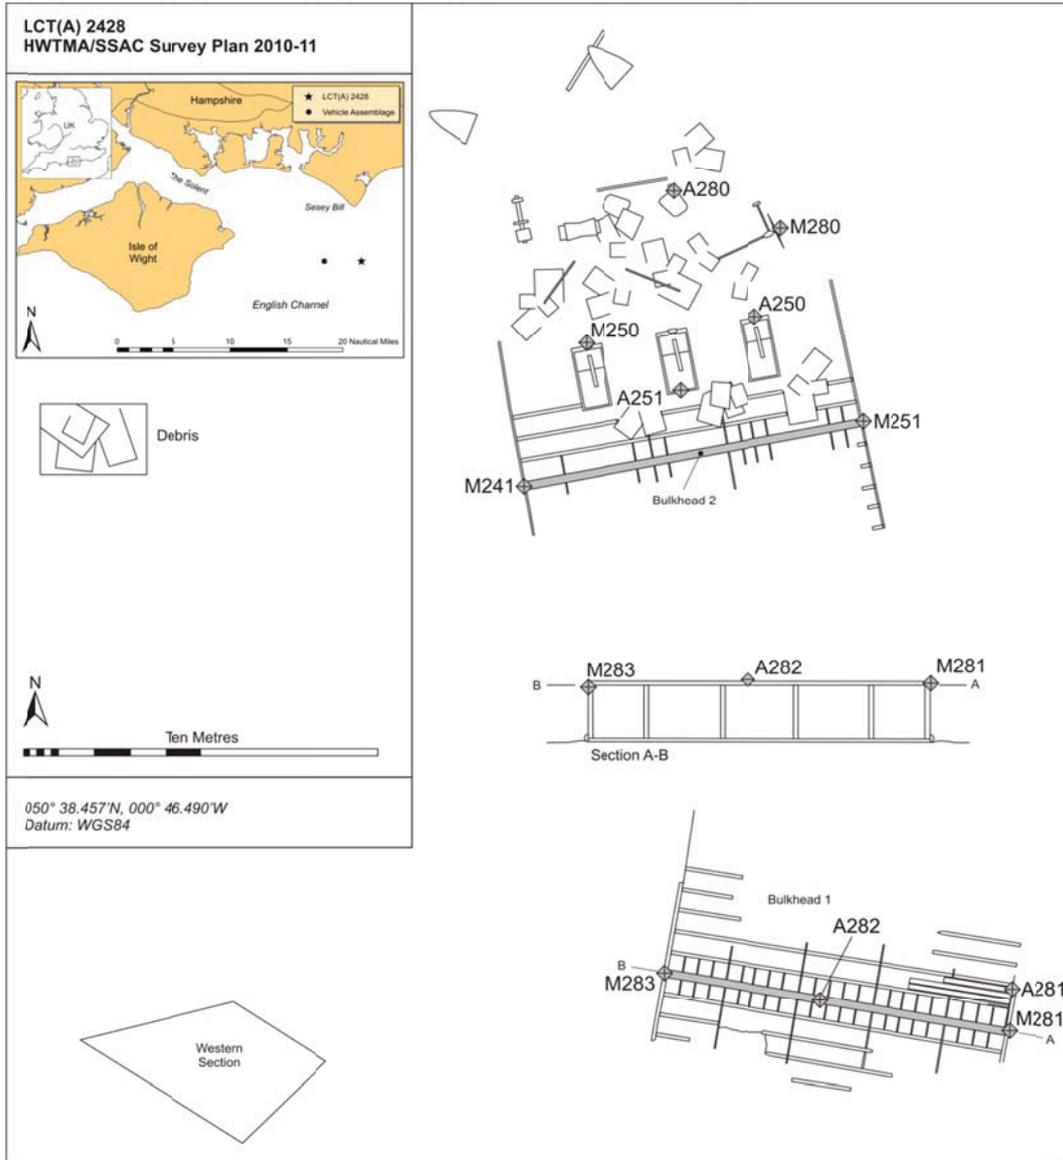
Figure 5.4. Location of monitoring points on the LCT site.

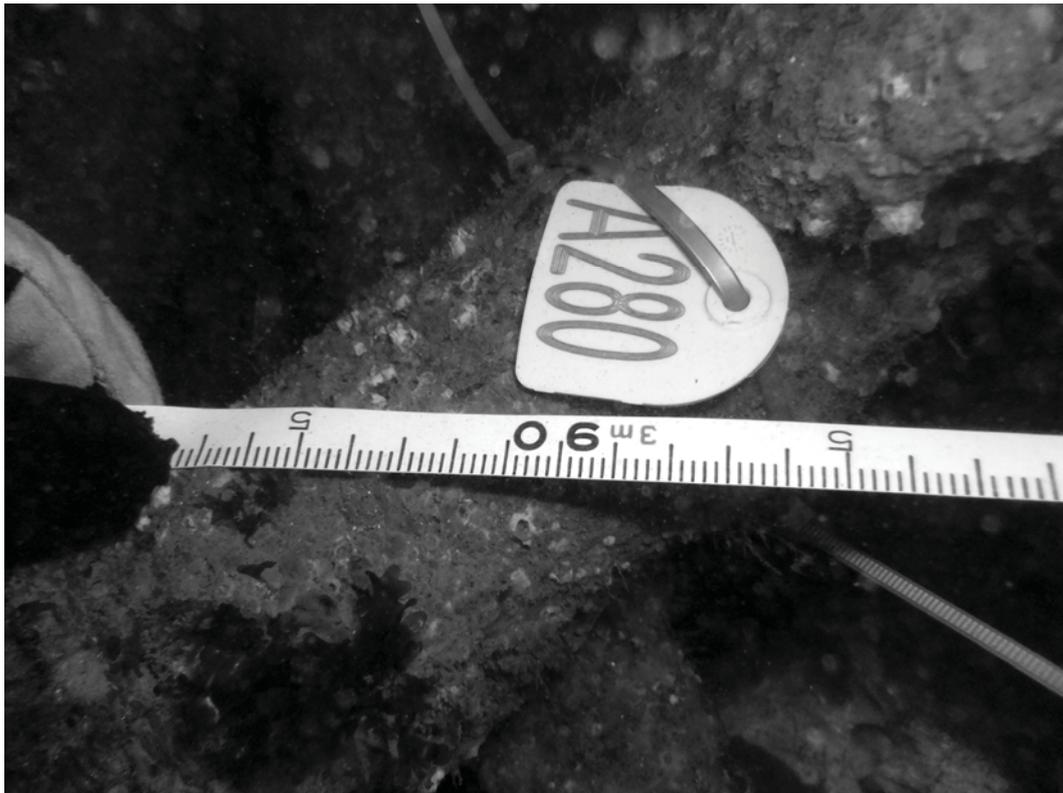
Figure 5.5. Monitoring point A280, one of the probable rudders of the vessel (photo: Alison Mayor, SSAC).
