1.5 BROAD CHARACTER: COASTAL INFRASTRUCTURE

1.5.1 CHARACTER TYPE: FLOOD AND EROSION DEFENCE REGIONAL PERSPECTIVE: EAST ANGLIA

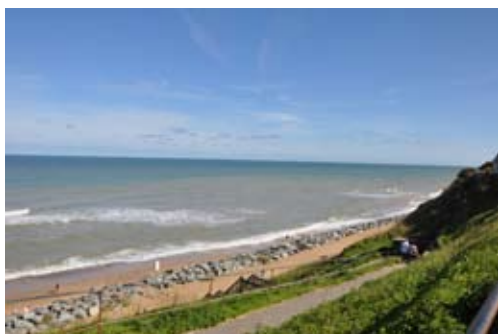
Rock berm at California

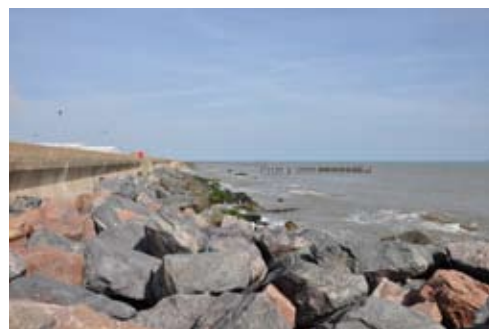
Seawall, rock armouring and old groyne at Lowestoft Ness

Fixed defences include concrete seawalls which are found all along the coast from the north of the region in Norfolk (Caister-on-Sea, Great Yarmouth, Gorleston, Hopton-on-Sea), throughout the Suffolk coast (Corton, Lowestoft, Kessingland, Southwold, Aldeburgh, Walberswick) and into Essex (Frinton-on-Sea, Jaywick). Seawalls are also found in the estuaries, most notably the Blyth, Deben and Orwell (the latter from Shotley point to Colton Creek on the south bank, Fagbury Point to Trimley on the north). Over 200 km of sea walls was recorded in the Suffolk NMP project alone (Hegarty and Newsome 2005). These features have been further reinforced with sheet piling and rock armouring (eg Lowestoft, Corton, Kessingland, Jaywick) a rock berm (California to Caister) and timber revetments (Kessingland to Benacre, Hopton-on-Sea). In some areas such as Gorleston to Hopton only timber revetments were constructed, while others possess embankments (Benacre 'cross wall', Suffolk Yacht Marina and Levington Creek in the Orwell and around the Walton end of Hamford Water).

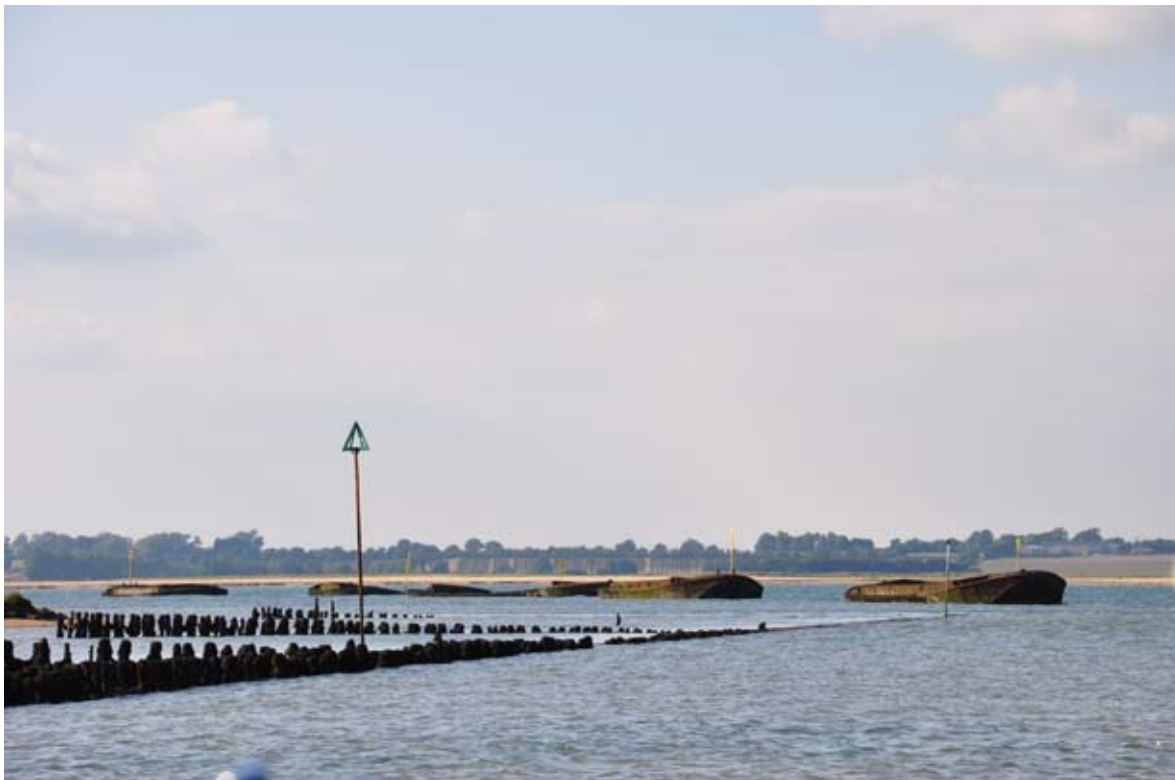
Barge barrage Walton Backwaters

One of the more unusual forms of flood and erosion defences in this area exists in Walton Backwaters. Here in 1988 a barrage breakwater of sunken Thames barges was put in place, backfilled and reinforced with 20,000 m² of mud from Harwich dredging to protect the saltmarsh and seawall behind.

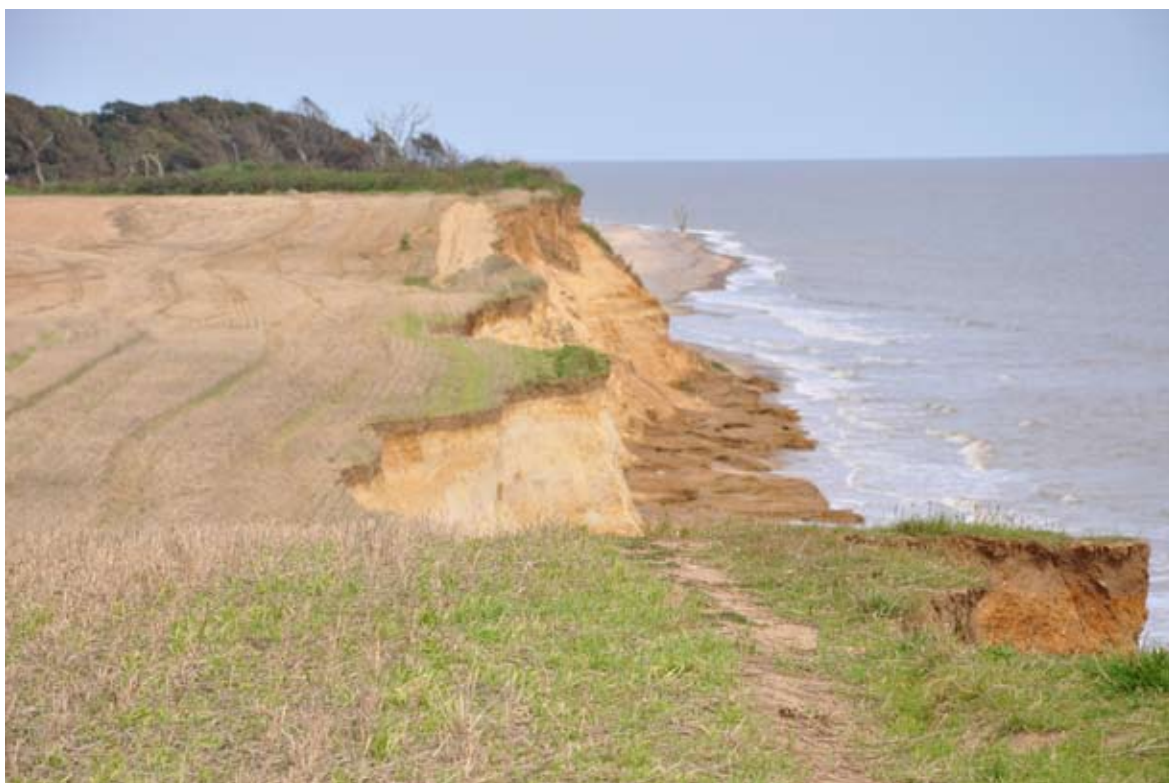
Active cliff erosion Coverhithe

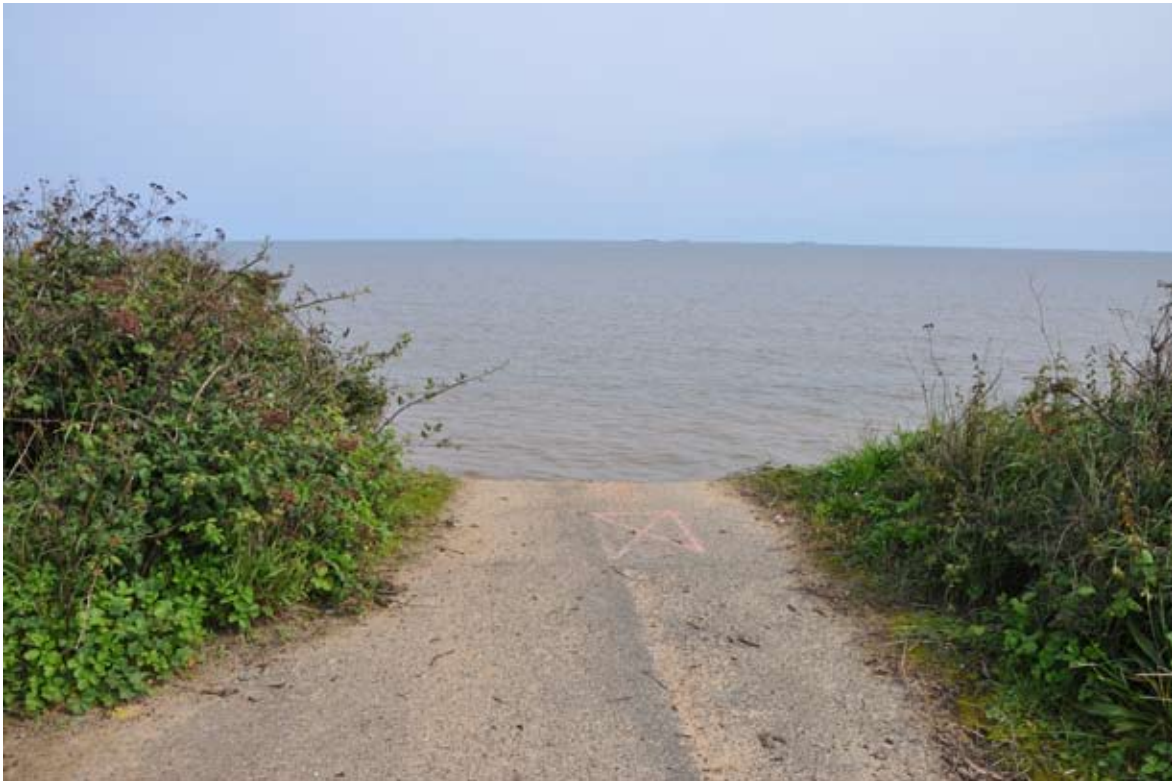
Road truncated by sea erosion near Covehithe

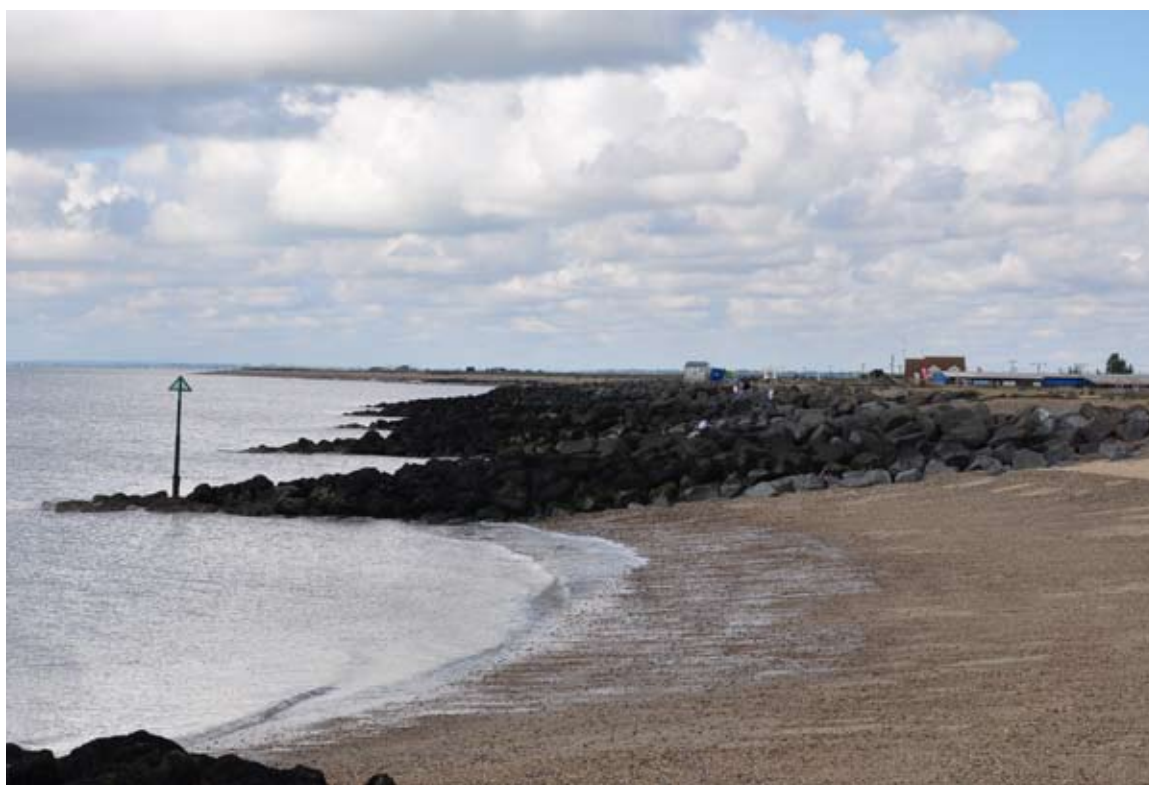
Breakwaters at Jaywick

In Jaywick, where the housing was particularly poor 35 people were killed during the storm and 600 people made homeless, leading to the construction of massive sea defences. However the shingle beach was all but washed away by successive storms battering against the sea wall, leading to a series of beach replenishments and construction of breakwaters since the 1980s (Strachan 1998). These have recently been completed as outlined above.

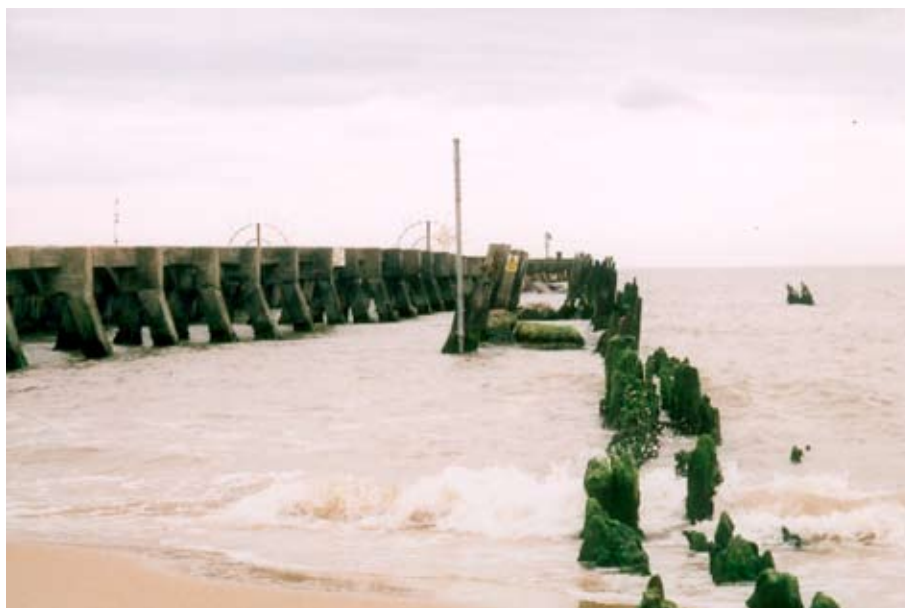
Past and present groynes at Southwold

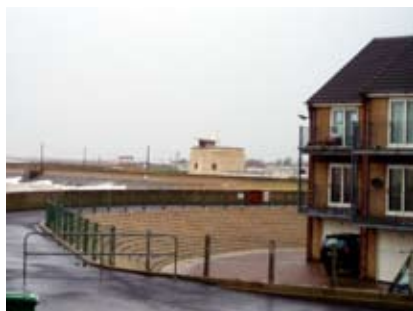
Sea defences at Jaywick 2007

The condition of flood and erosion defences along the coastline and estuaries varies dramatically. Some places have seen recent development in defences which have improved their effectiveness and contributed strongly to landscape changes in their area. (eg at Jaywick). Newer schemes are very often more aesthetically pleasing than the concrete walls they tend to replace or mask. In contrast many of the concrete walls or timber structures are in poor states of repair depending on when they were built and still require replacement or reinforcement.

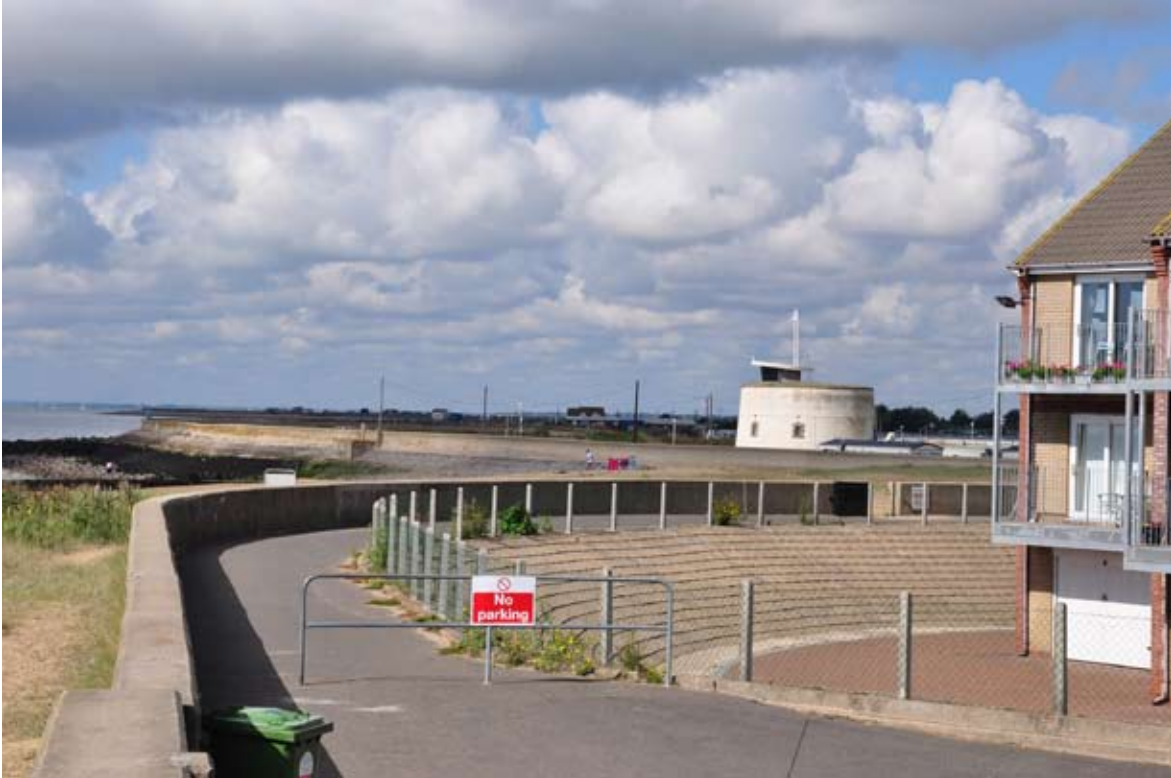
Sea defences at Jaywick 2010
