**AN ARCHAEOLOGICAL BUILDING SURVEY AT
NEWTON GARTH FARM, 1 BENTON ROAD,
EAST BOLDON, SOUTH TYNESIDE,
TYNE AND WEAR**

**An Archaeological Building Survey at Newton Garth Farm, 1 Benton Road,
East Boldon, South Tyneside, Tyne and Wear**

Central National Grid Reference: NZ 3549 6265

Site Code: NGB 03

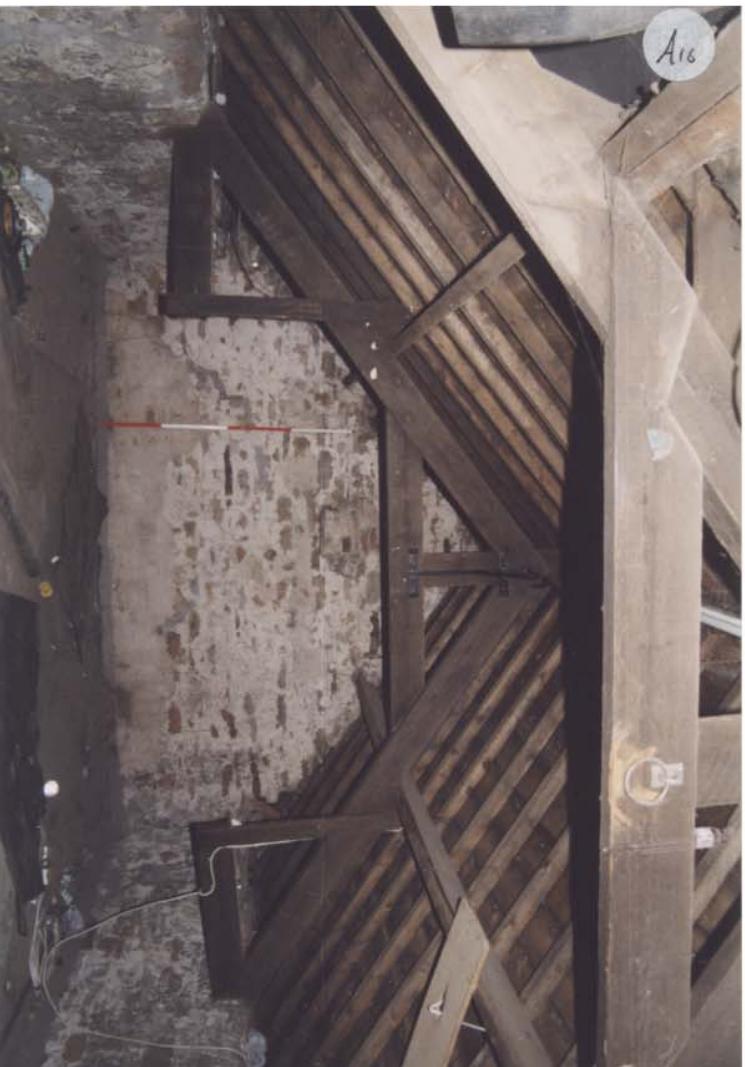
A16

A17	Interior Building 1, ground floor, 2m scale, facing north
A18	Interior Building 1, ground floor, 2m scale, facing south
A19	East wall of Building 1 from interior of gin house, 2m scale, facing north-west
A20	Interior of gin house, 2m scale, facing south
A21	Interior of gin house, 2m scale, facing north
A22	Detail of roofline of demolished annexe, Building 2, facing west
A23	Detail of window, Building 3, facing north-west
A24	Detail of door, Building 1, facing north
A25	Detail of buttress, Building 1, facing south-east
A26	Detail of window, Building 2, facing east
A27	Detail of joint between Buildings 2 and 3, facing north-east
A28	General shot of farm buildings, facing north-west
A29	General shot of farm buildings, facing north-east
A30	Detail of roof truss, Building 2, facing north
A31	Detail of floor, Building 2, vertical
A32	Detail of roof truss, Building 1, facing south

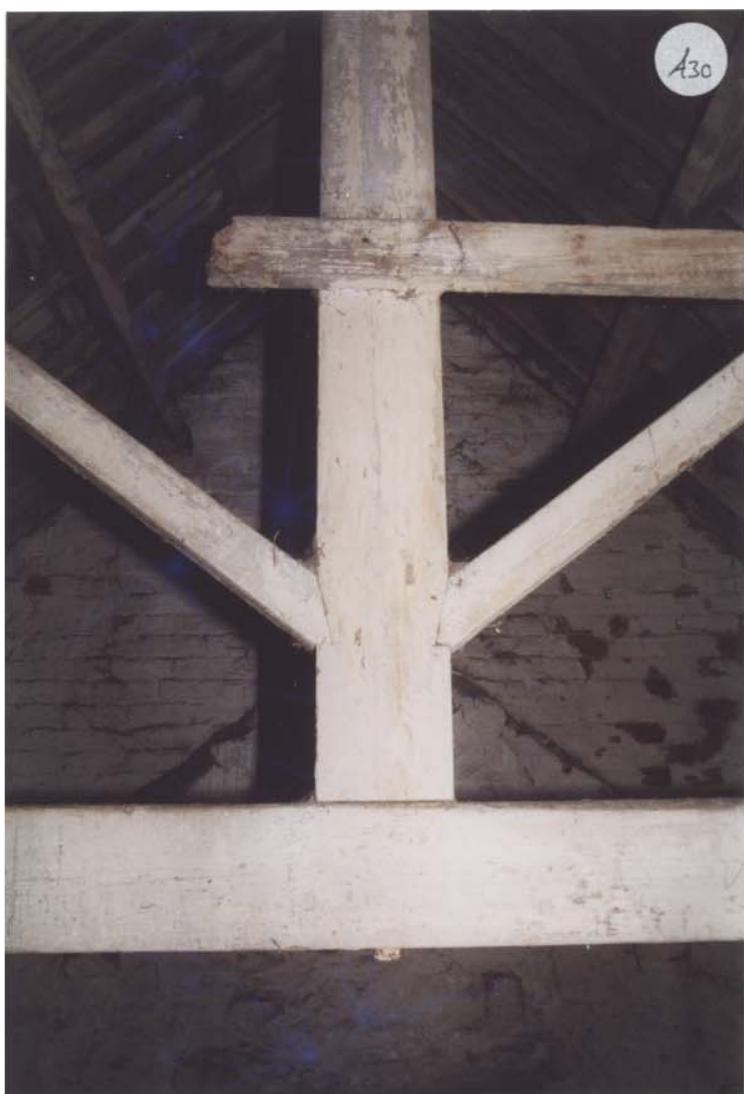
A30

- 4.2.2.2 On the upper storey of Building 2, the floor is again of flat-sawn floorboards, although in Building 2 there is considerably more evidence of decay and wear, and some of the boards are missing. The roof trusses (Plates A30, B28) are of kingpost construction, with diagonal braces between the kingpost and the principal rafters. The kingposts are secured to the tie-beams by iron bolts. The floor and kingpost trusses are probably contemporary with the raising of the original roofline, and are likely to pre-date the asbestos roof.

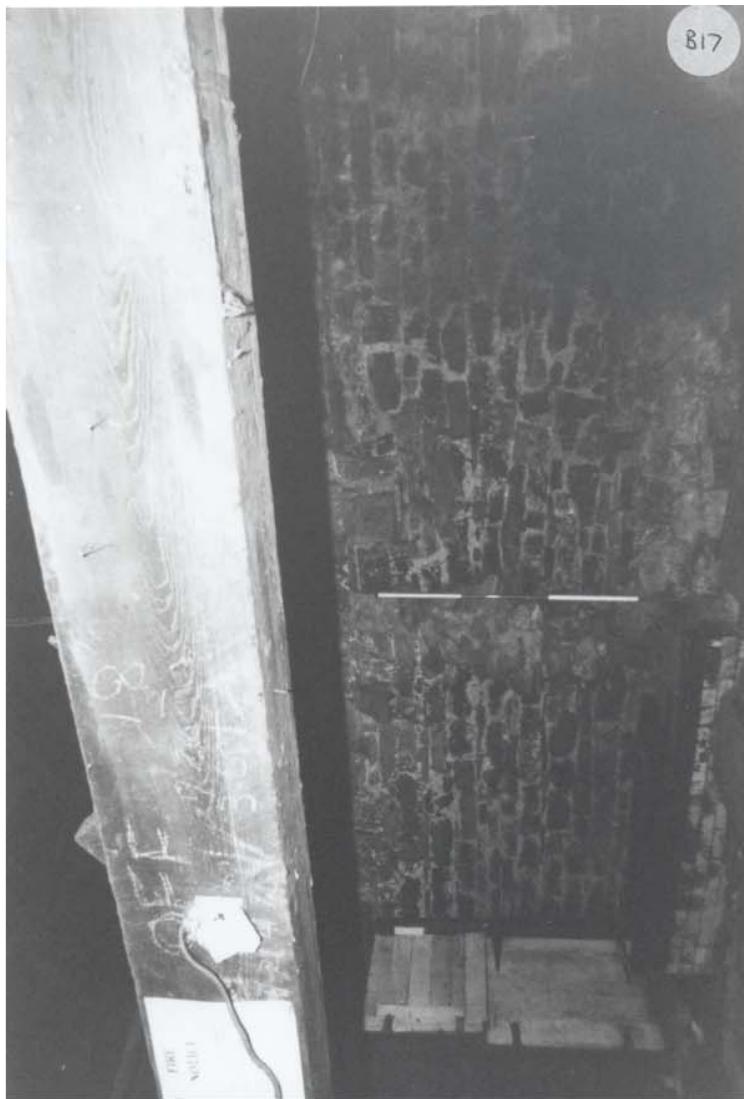
B17

- 4.2.1.3 The eastern wall of Building 1 largely forms the western, internal wall of the gin house (Plates A19, B17). Access from the interior of the original stone building to the gin house is provided by a stable door at the southern end of the wall. A single large sandstone block serves as a step up to the threshold of the door. The timber uprights and lintel forming the frame of the door are possibly original, although the door itself is of more recent origin. Two substantial sawn-off beams are set into the wall, held in place by sandstone and timber infill around the beams. Between the two beams there is an irregularly shaped area of sandstone blocking, the upper part of which possibly indicates the point at which the horizontal shaft of the gin passed through the wall.

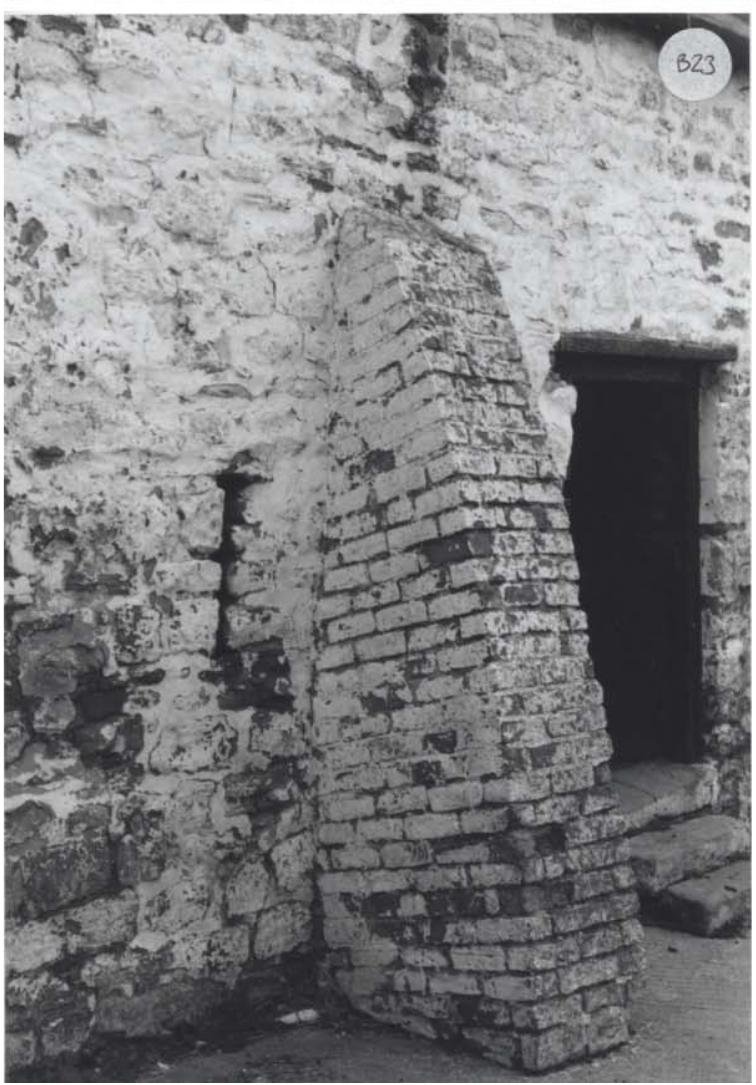
B22

- 4.1.1.4 The door in the southern elevation of Building 1 (Plates A24, B22) is an alteration to the original building. The jambs are of bullnose brick construction, laid in courses of three full bricks alternating with three half bats. The door is surmounted by a timber lintel. Further brickwork has been inserted on either side of the door at the level of the floor, which includes airbricks with cruciform perforations. At the top of the wall, in the south-east corner of the building, there are a number of noticeably larger and more prominent quoins. It is possible that the upper part of the south-east corner was re-built, perhaps during replacement of the roof, although evidence for a re-build was not conclusive.

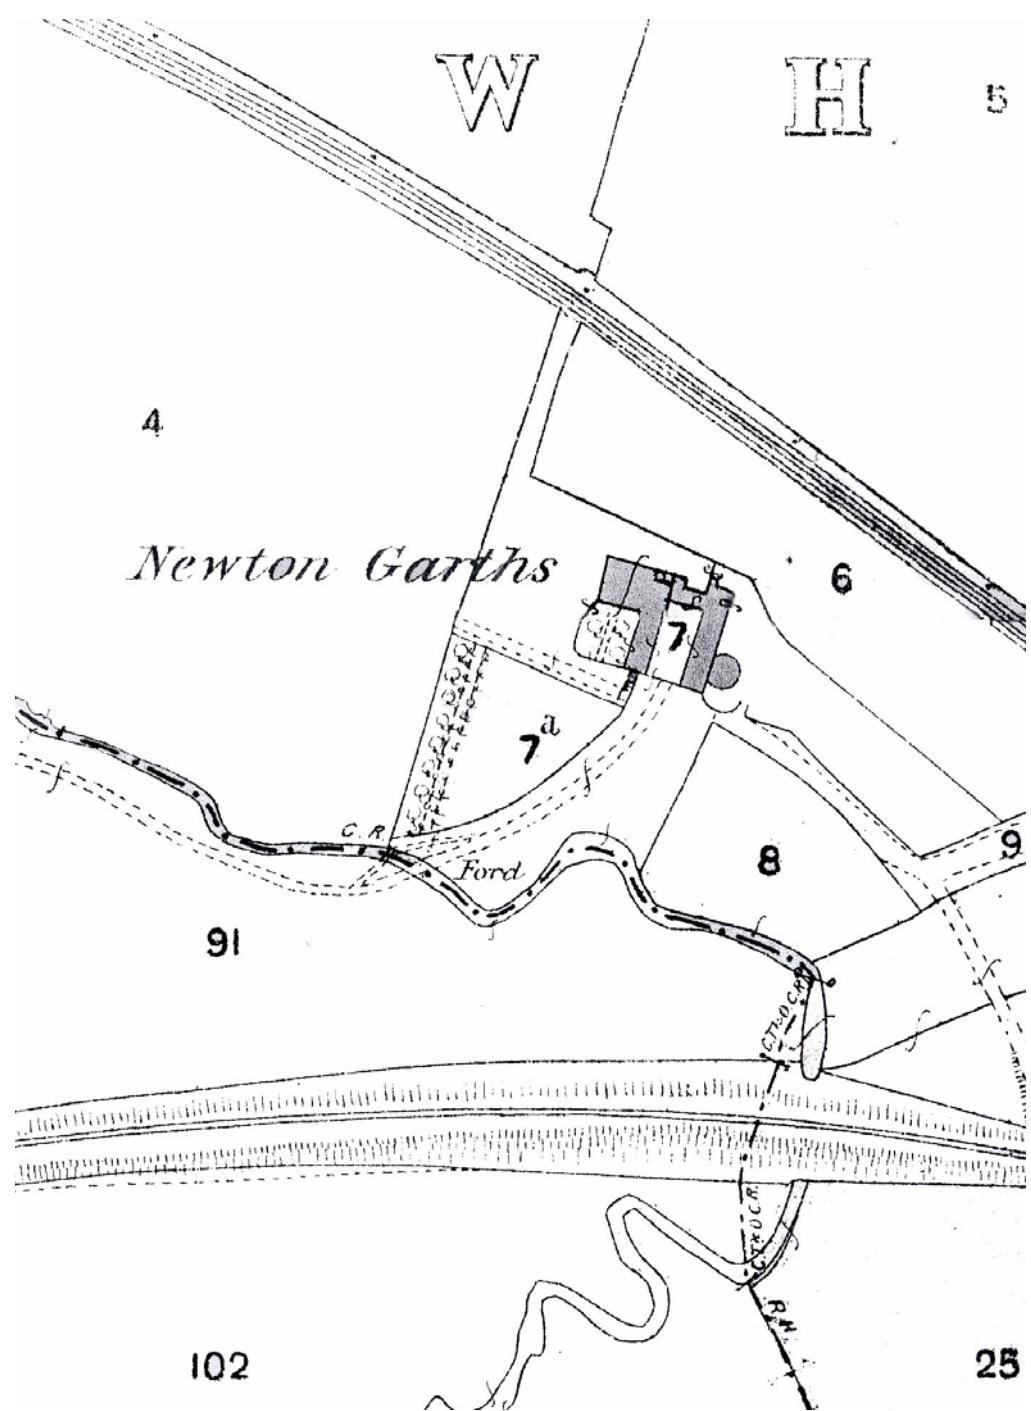
Figure 3. Ordnance Survey 1855

- 3.2 The 1st edition of the Ordnance Survey map of 1855 (Figure 3) demonstrates that the farm at the study site – now labelled '*Newton Garths*' - was, by the mid-19th century, in the basic form in which it survives today. Three ranges of buildings, to the north, east and west, surrounded a courtyard, open to the south. The gin house to the east of the eastern range is depicted as part of the complex of buildings, although at this date it was represented as a circular building abutting the eastern range. This representation suggests that the gin house was roofed, but probably had open sides. The map also depicts a similar structure, presumably also a horse mill, at Brockley Whins Farm, approximately 0.5km to the north-west of the study site. The buildings identified as '*Newton Garths*' on the 1840 tithe map are depicted on the 1st edition of the Ordnance Survey map as a single rectangular structure, labelled '*Site of a House*'. This suggests that by 1855 the former '*Newton Garths Farm*' was ruinous and the farm at the study site had adopted the name.

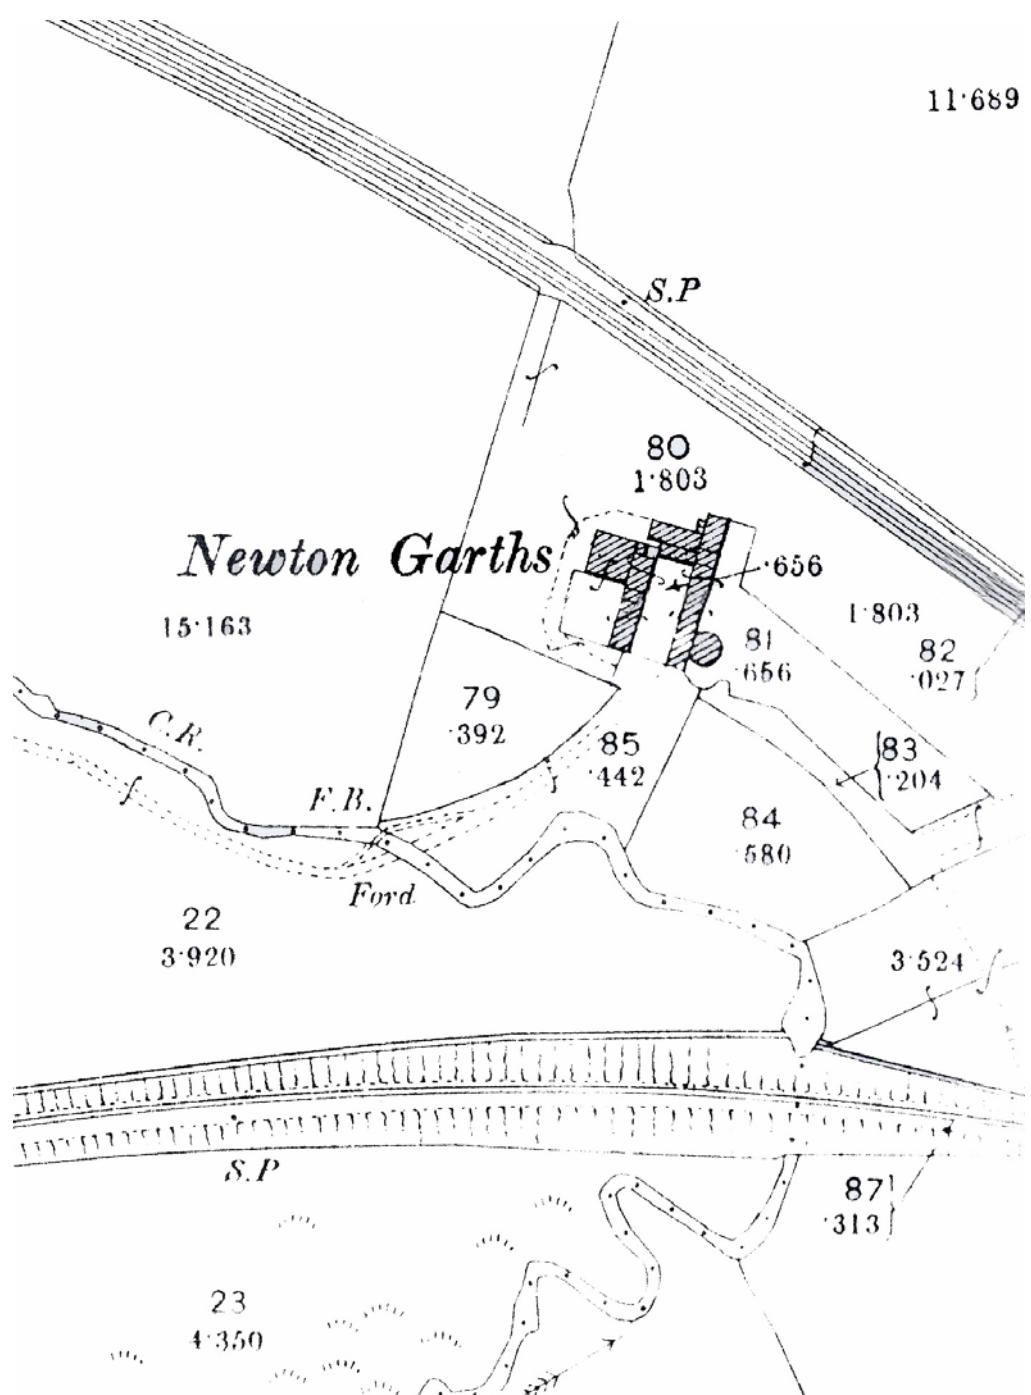
Figure 4. Ordnance Survey 1895

- 3.3 The Ordnance Survey 1895 edition (Figure 4) shows the eastern and western ranges of the farm little changed. The north range and the northern part of the east range, however, exhibit extensive change. The south wall of the north range has been rebuilt further to the north, and the entire north-eastern corner of the farm considerably extended northwards. This suggests a wholesale demolition and reconstruction of the north range, and it is probably during this period that the construction of Building 3 took place. The gin house is still shown as a circular building.

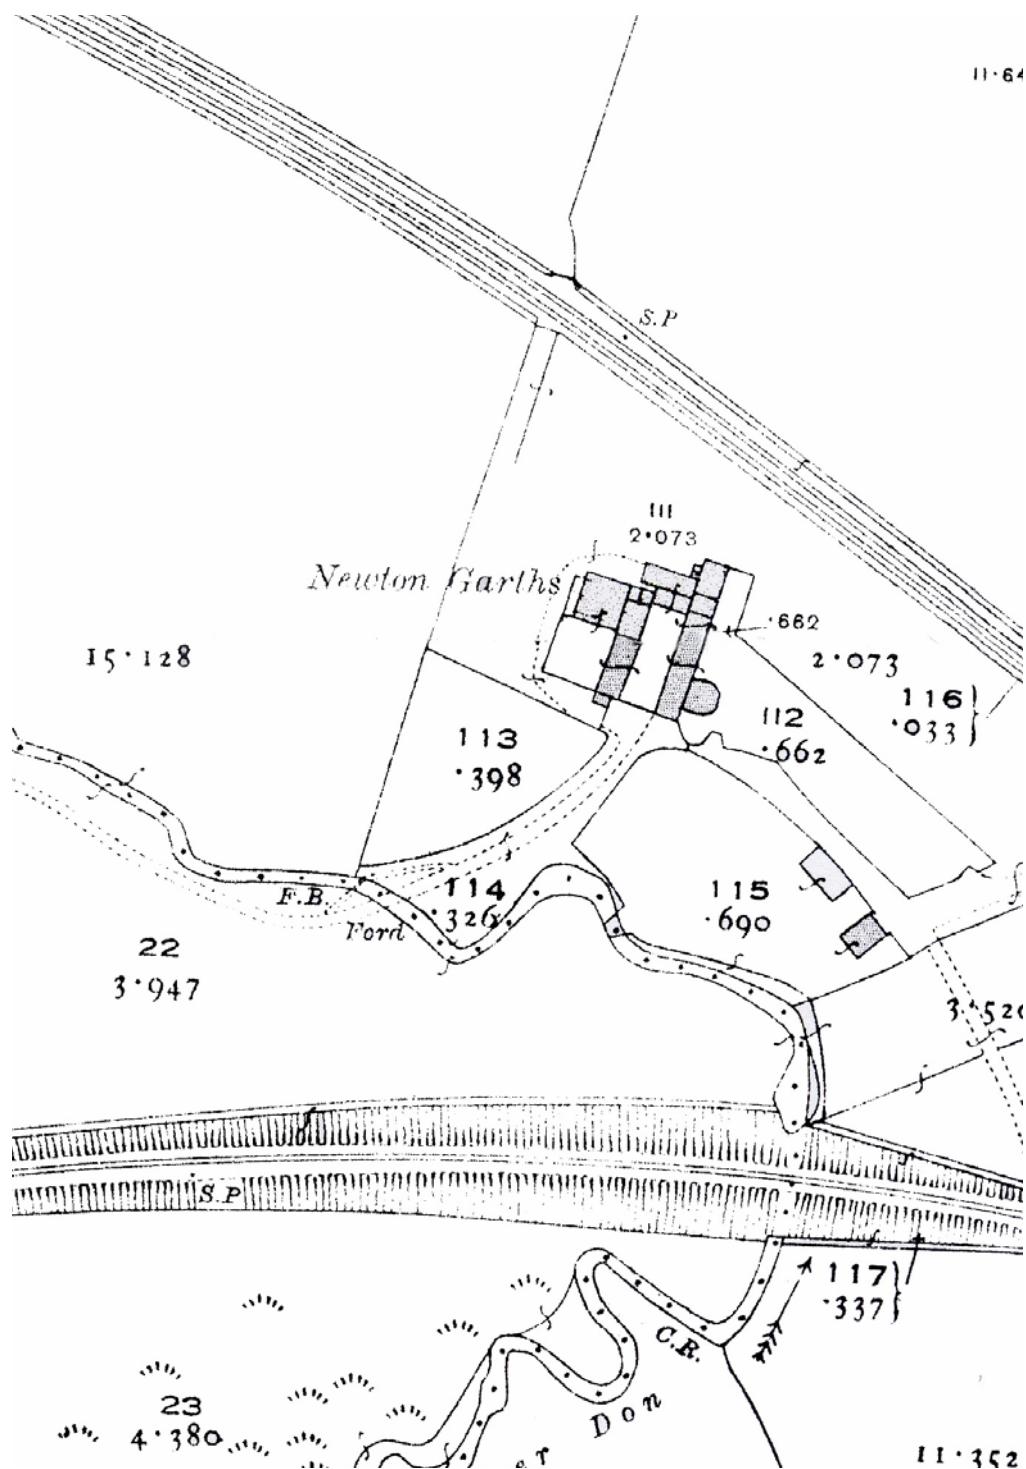
Figure 5. Ordnance Survey 1912

- 3.4 The only significant change on the Ordnance Survey 1912 edition (Figure 5) is the remodelling of the gin house. The north and south sides of the gin house are shown as straight, suggesting that in the early 20th century walls were added to the structure, engaging with the east wall of Building 1. The addition of side-walls to the gin house could be an indication of a change of function.

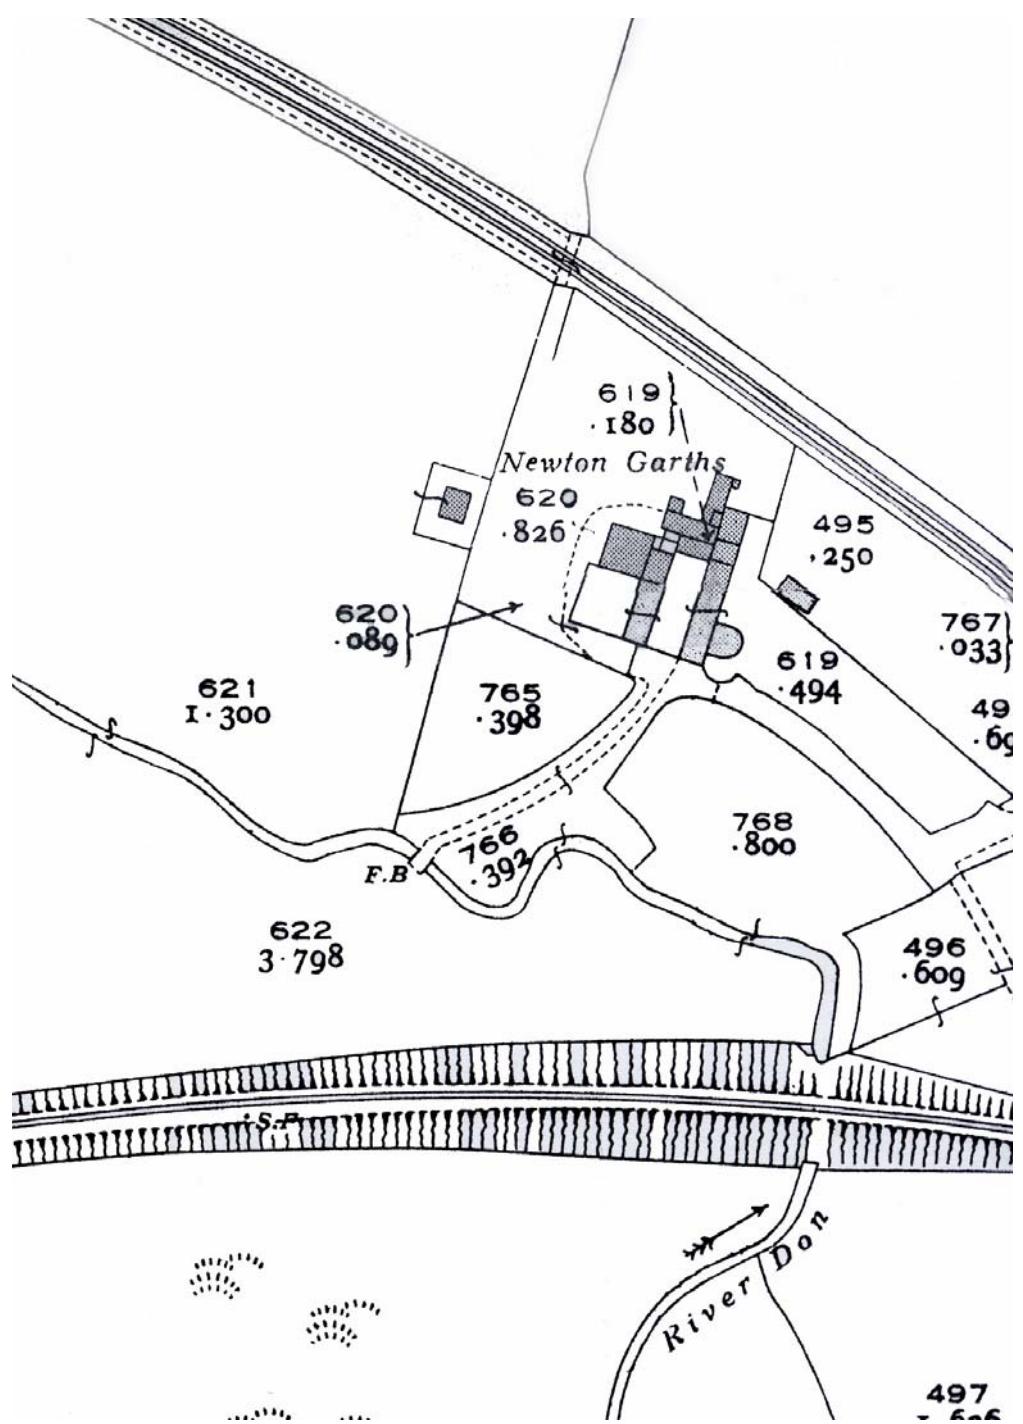
Figure 6. Ordnance Survey 1941

- 3.5 The Ordnance Survey 1941 edition (Figure 6) has the same representation of the gin house, with straight north and south walls, and a rounded east end. The gin house in its present form has a polygonal east end, suggesting that the existing walls, and possibly the roof, post-date 1941. The 1941 map also shows a further addition to the north range of the farm, referred to on the current architect's plans as Area 5, although this was not included in the survey.

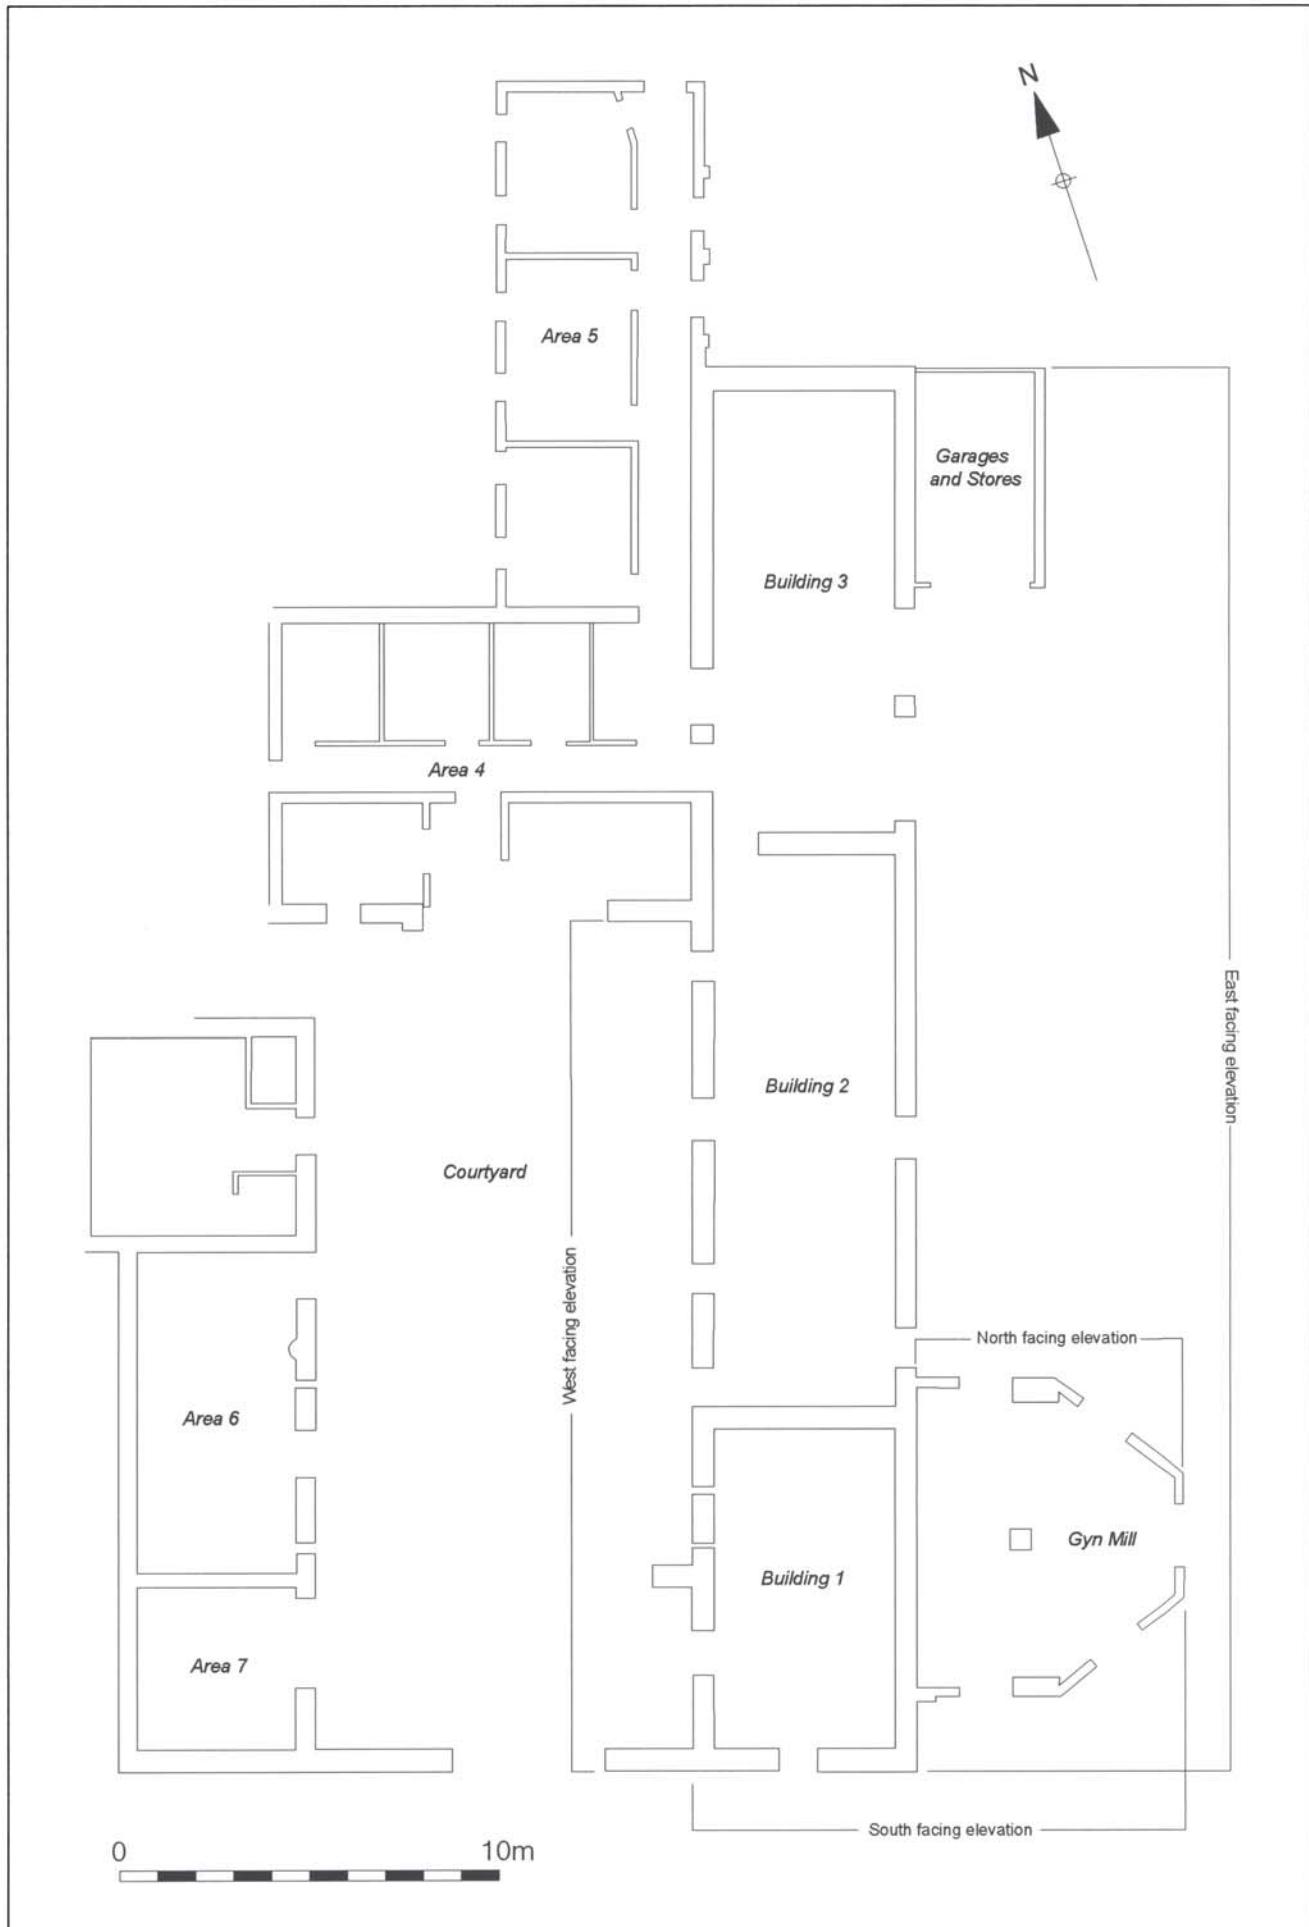
Figure 7. Existing ground floor plan
Scale 1:200

- 4.2.3.1 The ground floor of Building 3 comprises a garage/corridor to Area 4 to the south (Figure 7), with animal pens of wire-cut brick construction to the north. Floors are of concrete. The lintel above the garage door comprises a rolled steel joist; the door itself is missing. This entrance is certainly a late alteration to the building.
- 4.2.3.2 The upper storey of Building 3 was not closely investigated, as the floor was unsafe. The roof trusses are of kingpost construction with diagonal braces, similar to those in Building 2.
