# ST MARY'S CHURCH CHEPSTOW.

## NOTES ON THE NAVE OF CHEPSTOW PARISH CHURCH.<sup>1</sup>

By CHARLES LYNAM, F.S.A.

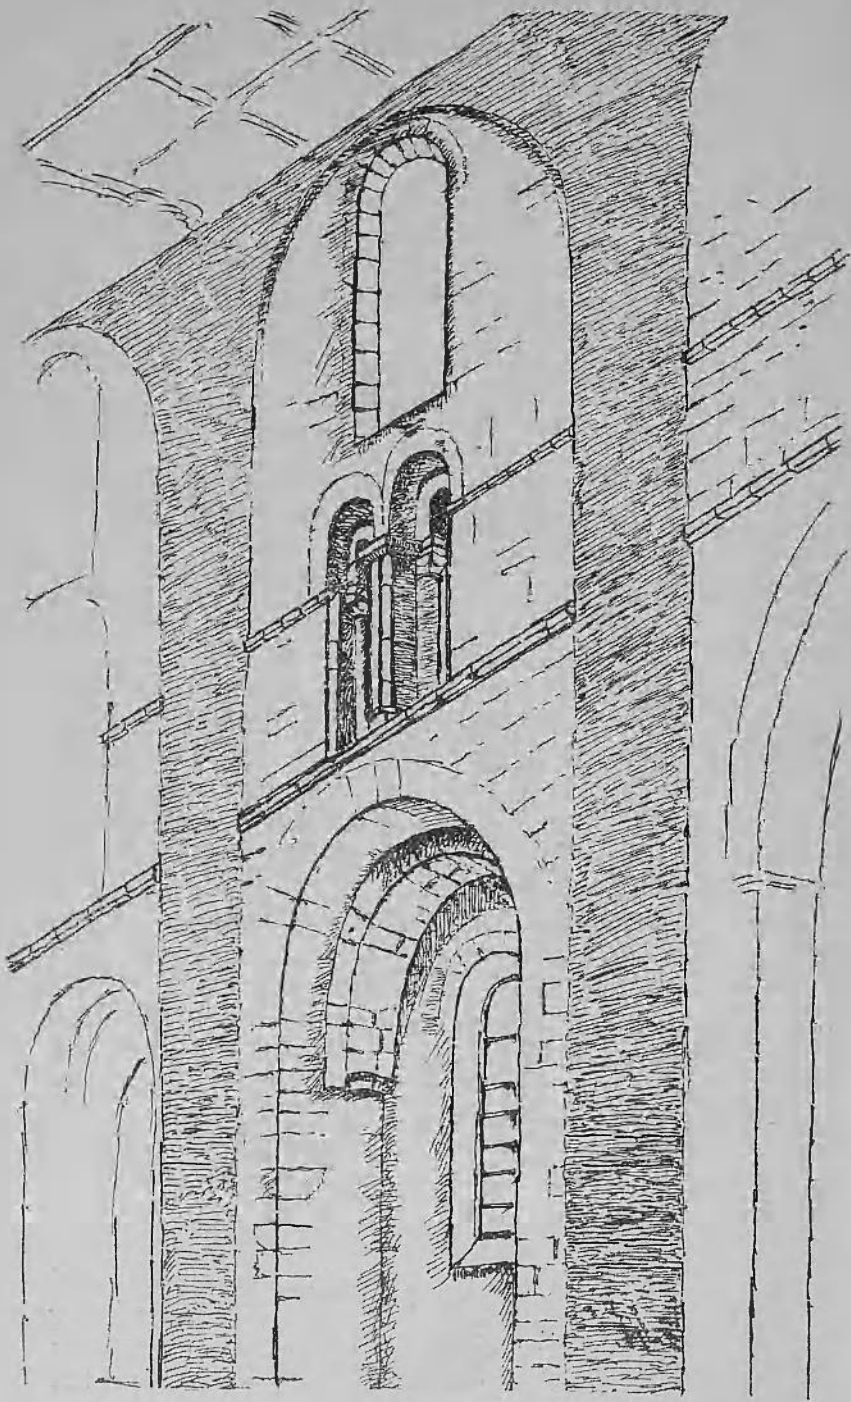
FIG. 2.—ST. MARY'S, CHEPSTOW. SOUTH SIDE.

There is a marked difference in the two sides in the triforium openings at Chepstow. The south has double openings and arches treated with architectural character, whilst the north side has a simple square edged single opening. What the *rationale* of this variation may be it is hard to say : much speculation may attend it, but of structural reason there would appear to be none. The sunny side may have been chosen for display. It may be due to the tendency of the Norman builders to elaborate *fronts*, both inside and outside.

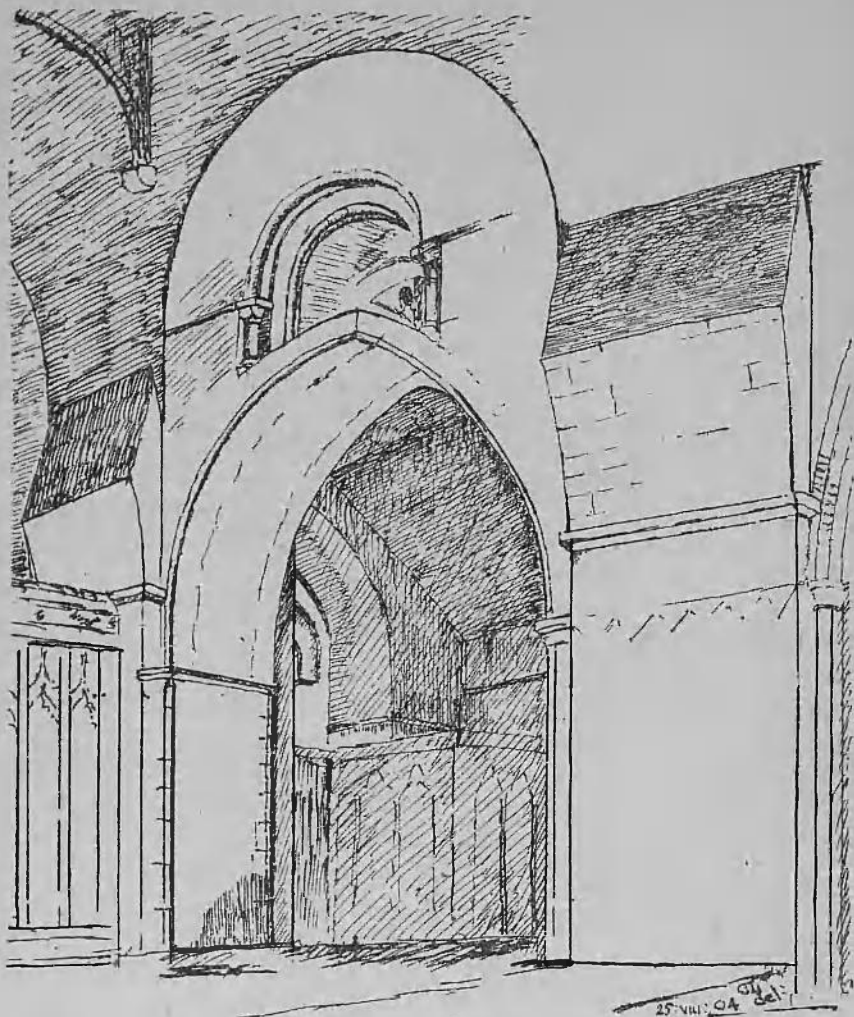
FIG. 4.—COFFORD CHURCH, ESSEX. SOUTH SIDE NAVE.

Chepstow the bare wall face is left. At Great Clacton there are projecting piers with just a suspicion of an arched continuation, whilst at Copford not only the projection but the impost to the arch and a portion of the arch itself, together with the lines of the cross vault of the nave, and of the form of the lateral vaulting all remain. These points collectively, together with the vaults to the Chapel of the Tower of London appear to be sufficient for the acceptance of the opinion that the nave of Chepstow had originally a semi-circular vault along its entire length simply intersected by smaller lateral vaults and projections to the piers as well as pilasters carrying cross strengthening arches to the nave vaulting. And it was these features—the wall pilasters with the arches they carried, the nave vaulting and the lateral intersecting vaulting—of which the “Progressives” of former years made a clean sweep. I have not yet entered upon the question of the original treatment of the soffits of the arches of the arcade nor the reveals of the piers, nor perhaps is this point involved in the subject in hand, but as there are some indications of what this treatment may have been it is as well just to mention them. To the reveals of several of the piers, there are remains of projecting plinths now unoccupied by anything above them, and in some cases the sub-arches in the reveals are still partly visible, and as before hinted the out-of-the-way western responds with their square and shafted projections may be the key to the point now raised. This character of detail is also borne out by the design of the remains of the great central tower pier, before described. At Copford this feature is dealt with as a square projection to both pier and arch. To give emphasis to the fitness of the comparison chosen some particulars of each may be given.

and has a chancel continuous with the nave 46 feet 7 inches long. At Copford the total length including an apsidal chancel is 79 feet 2 inches and the width 20 feet 8 inches with a height of 29 feet from floor to crown of the vault. It will be noticed that in width, which is the material dimension on account of the span of the vaulting, Chepstow is about the average. The great piers at Chepstow are 6 feet 6 inches east and west, and 6 feet north and south, whilst those at Copford are 6 feet 6 inches
