A LINEAR EARTHWORK ON GREENHAM COMMON, BERKSHIRE

By B. H. St. J. O'NEIL and H. J. E. PEAKE

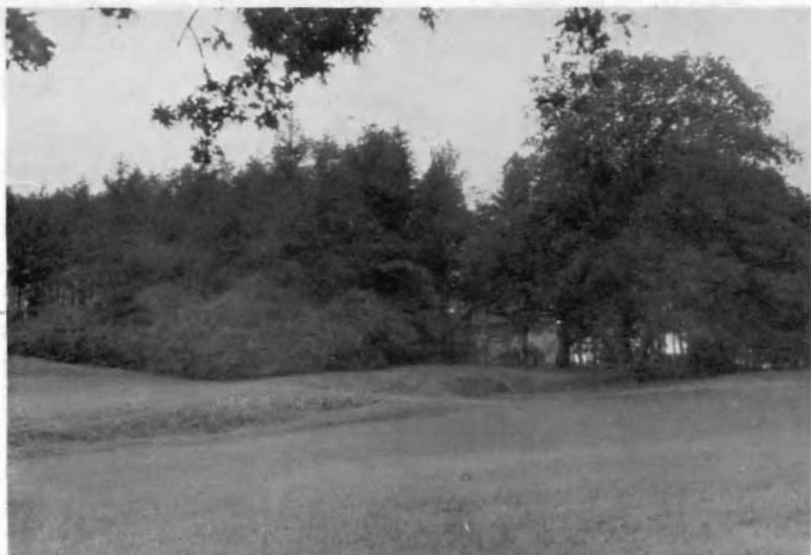
A. NORTHERN END OF BURY'S BANK, LOOKING SOUTH-EAST

At their northern end the bank and ditch, although now partially levelled, have clearly been constructed exactly as far as the spring which feeds the stream in the northern valley (pl. I A). Beyond this point the artificial defence or barrier was not needed, since its place was taken by the swampy ground, which must have existed in that valley under primitive conditions.

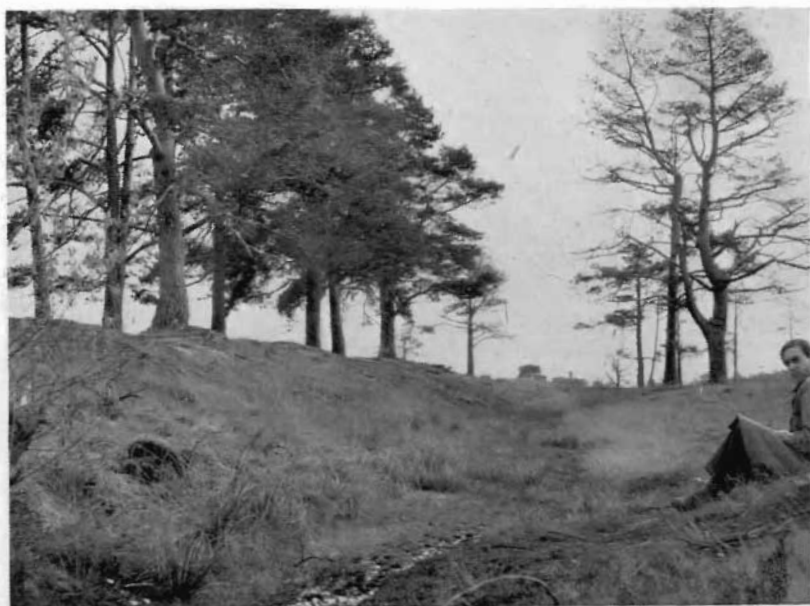
B. BEST PRESERVED PORTION OF BURY'S BANK, LOOKING SOUTH

Across the flat common the earthwork is aligned in straight lengths, changing direction slightly in three places (pl. I B and Fig. 2). Where best preserved (see Trench A), it is just over 4 ft. high and 30 ft. wide at its base and the ditch is 30 ft. wide. For a short distance south of the modern road it heads straight for the spring, which feeds the stream in the southern valley, but it has here suffered some disturbance since it ceased to be in use, and the indications of the earthwork are not clear. Immediately east of this spring also the ground has been dug away in an irregular manner for the sake of the gravel, and for some distance there are no certain signs of any continuation of the bank and ditch. Further south, however, there is a slight projection of the level common towards the line of the stream, and here there are clear indications along the brow of the higher land of a similar earthwork. This curves south-westwards, and is well preserved until it runs out on the comparatively steep slope down to the bed of the valley (pl. II B).

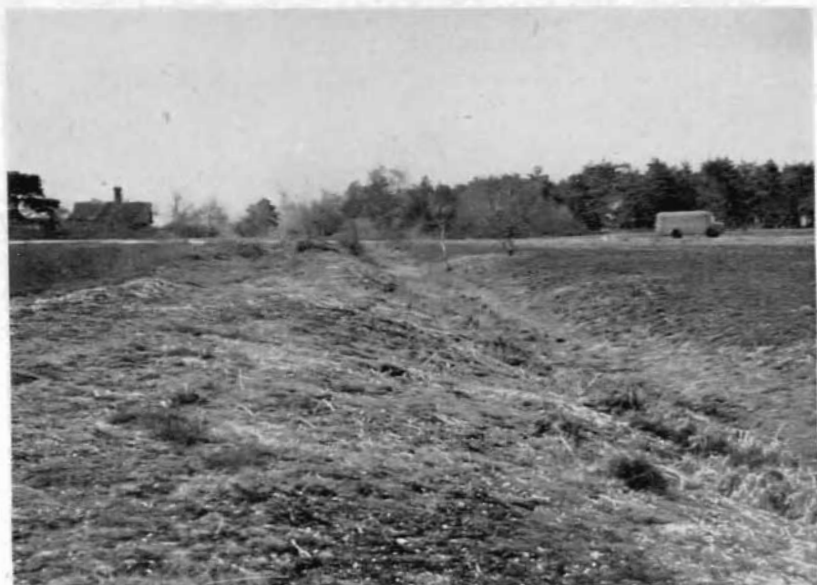
A. ROBBED BANK, BURY'S BANK, LOOKING SOUTH

Trench C was dug between Section A and the modern road, where the bank appears to be double (pl. II A). Although it seemed probable that this appearance is due to recent robbing, it was considered advisable to test this probability by excavation.

of the back of it remains. Since the earthwork went out of use some persons unknown, probably gravel-diggers, removed the turf and accumulated earth along the top of the bank for a considerable distance, and placed them on the eastern side, where they yet remain as the loose disturbed gravel and soil. They then removed the greater part of the gravel bank. The proximity to the road of this part of the bank, and the fact that it was apparently composed entirely of gravel without any clay core, may have attracted those who did this work.

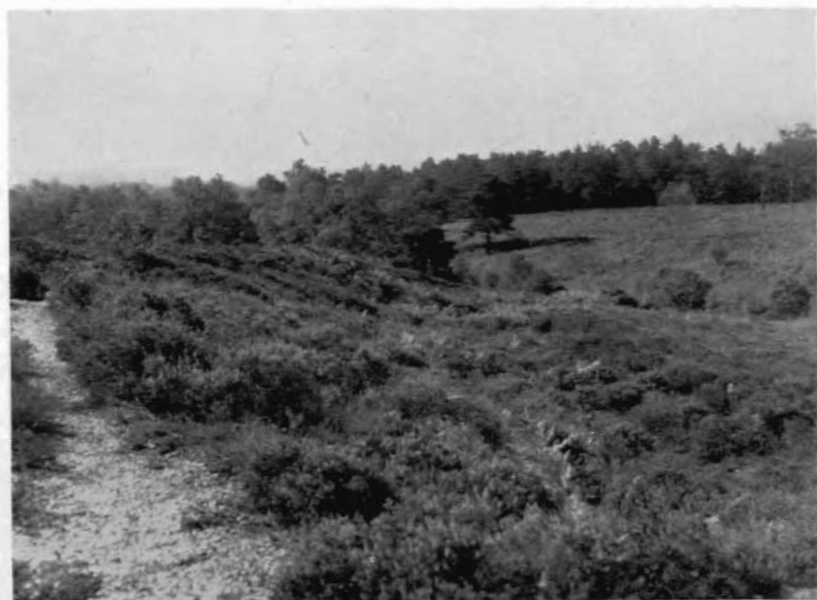
B. SOUTHERN END OF BURY'S BANK, LOOKING SOUTH

It seems certain that this work is part of the same system as the earthwork across the common, and that it was continued in this manner alongside the valley for a short distance ; otherwise access would have been easy across comparatively clear or dry ground below the spring and so beyond its southern end.
