## THE EXCAVATION OF A MOTTE AT ABINGER IN SURREY

By BRIAN HOPE-TAYLOR

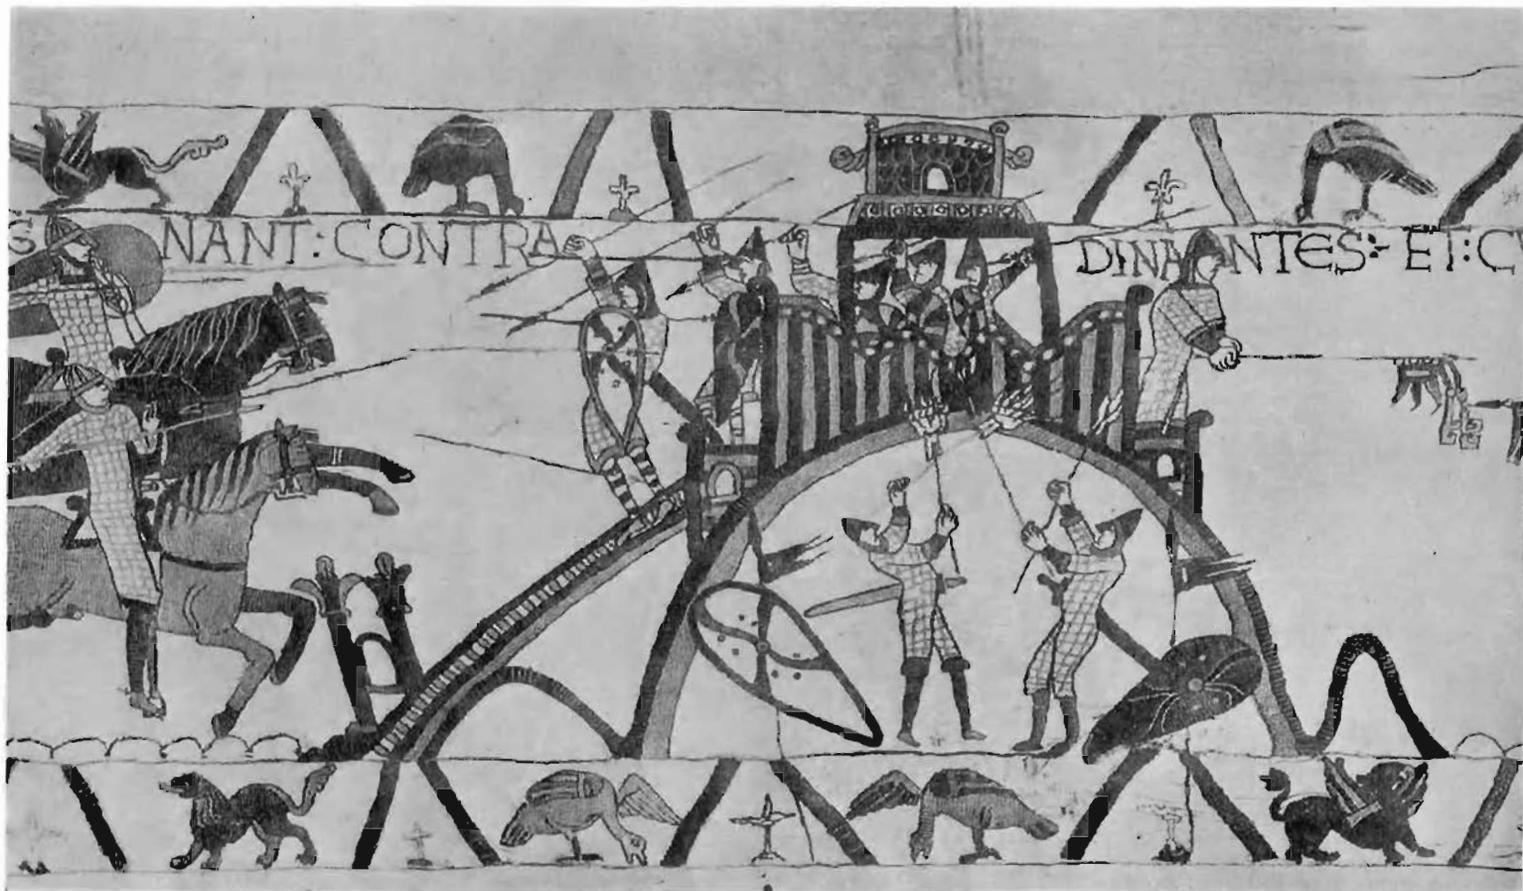
BAYEUX TAPESTRY : THE CASTLE OF DINAN

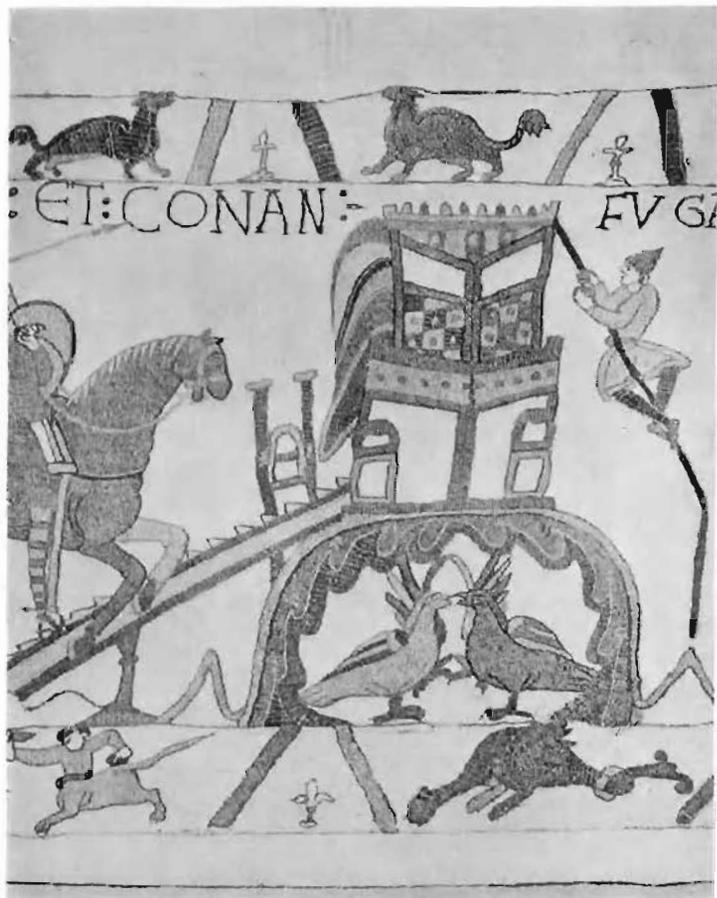
A. CASTLE OF DOL

BAYEUX TAPESTRY

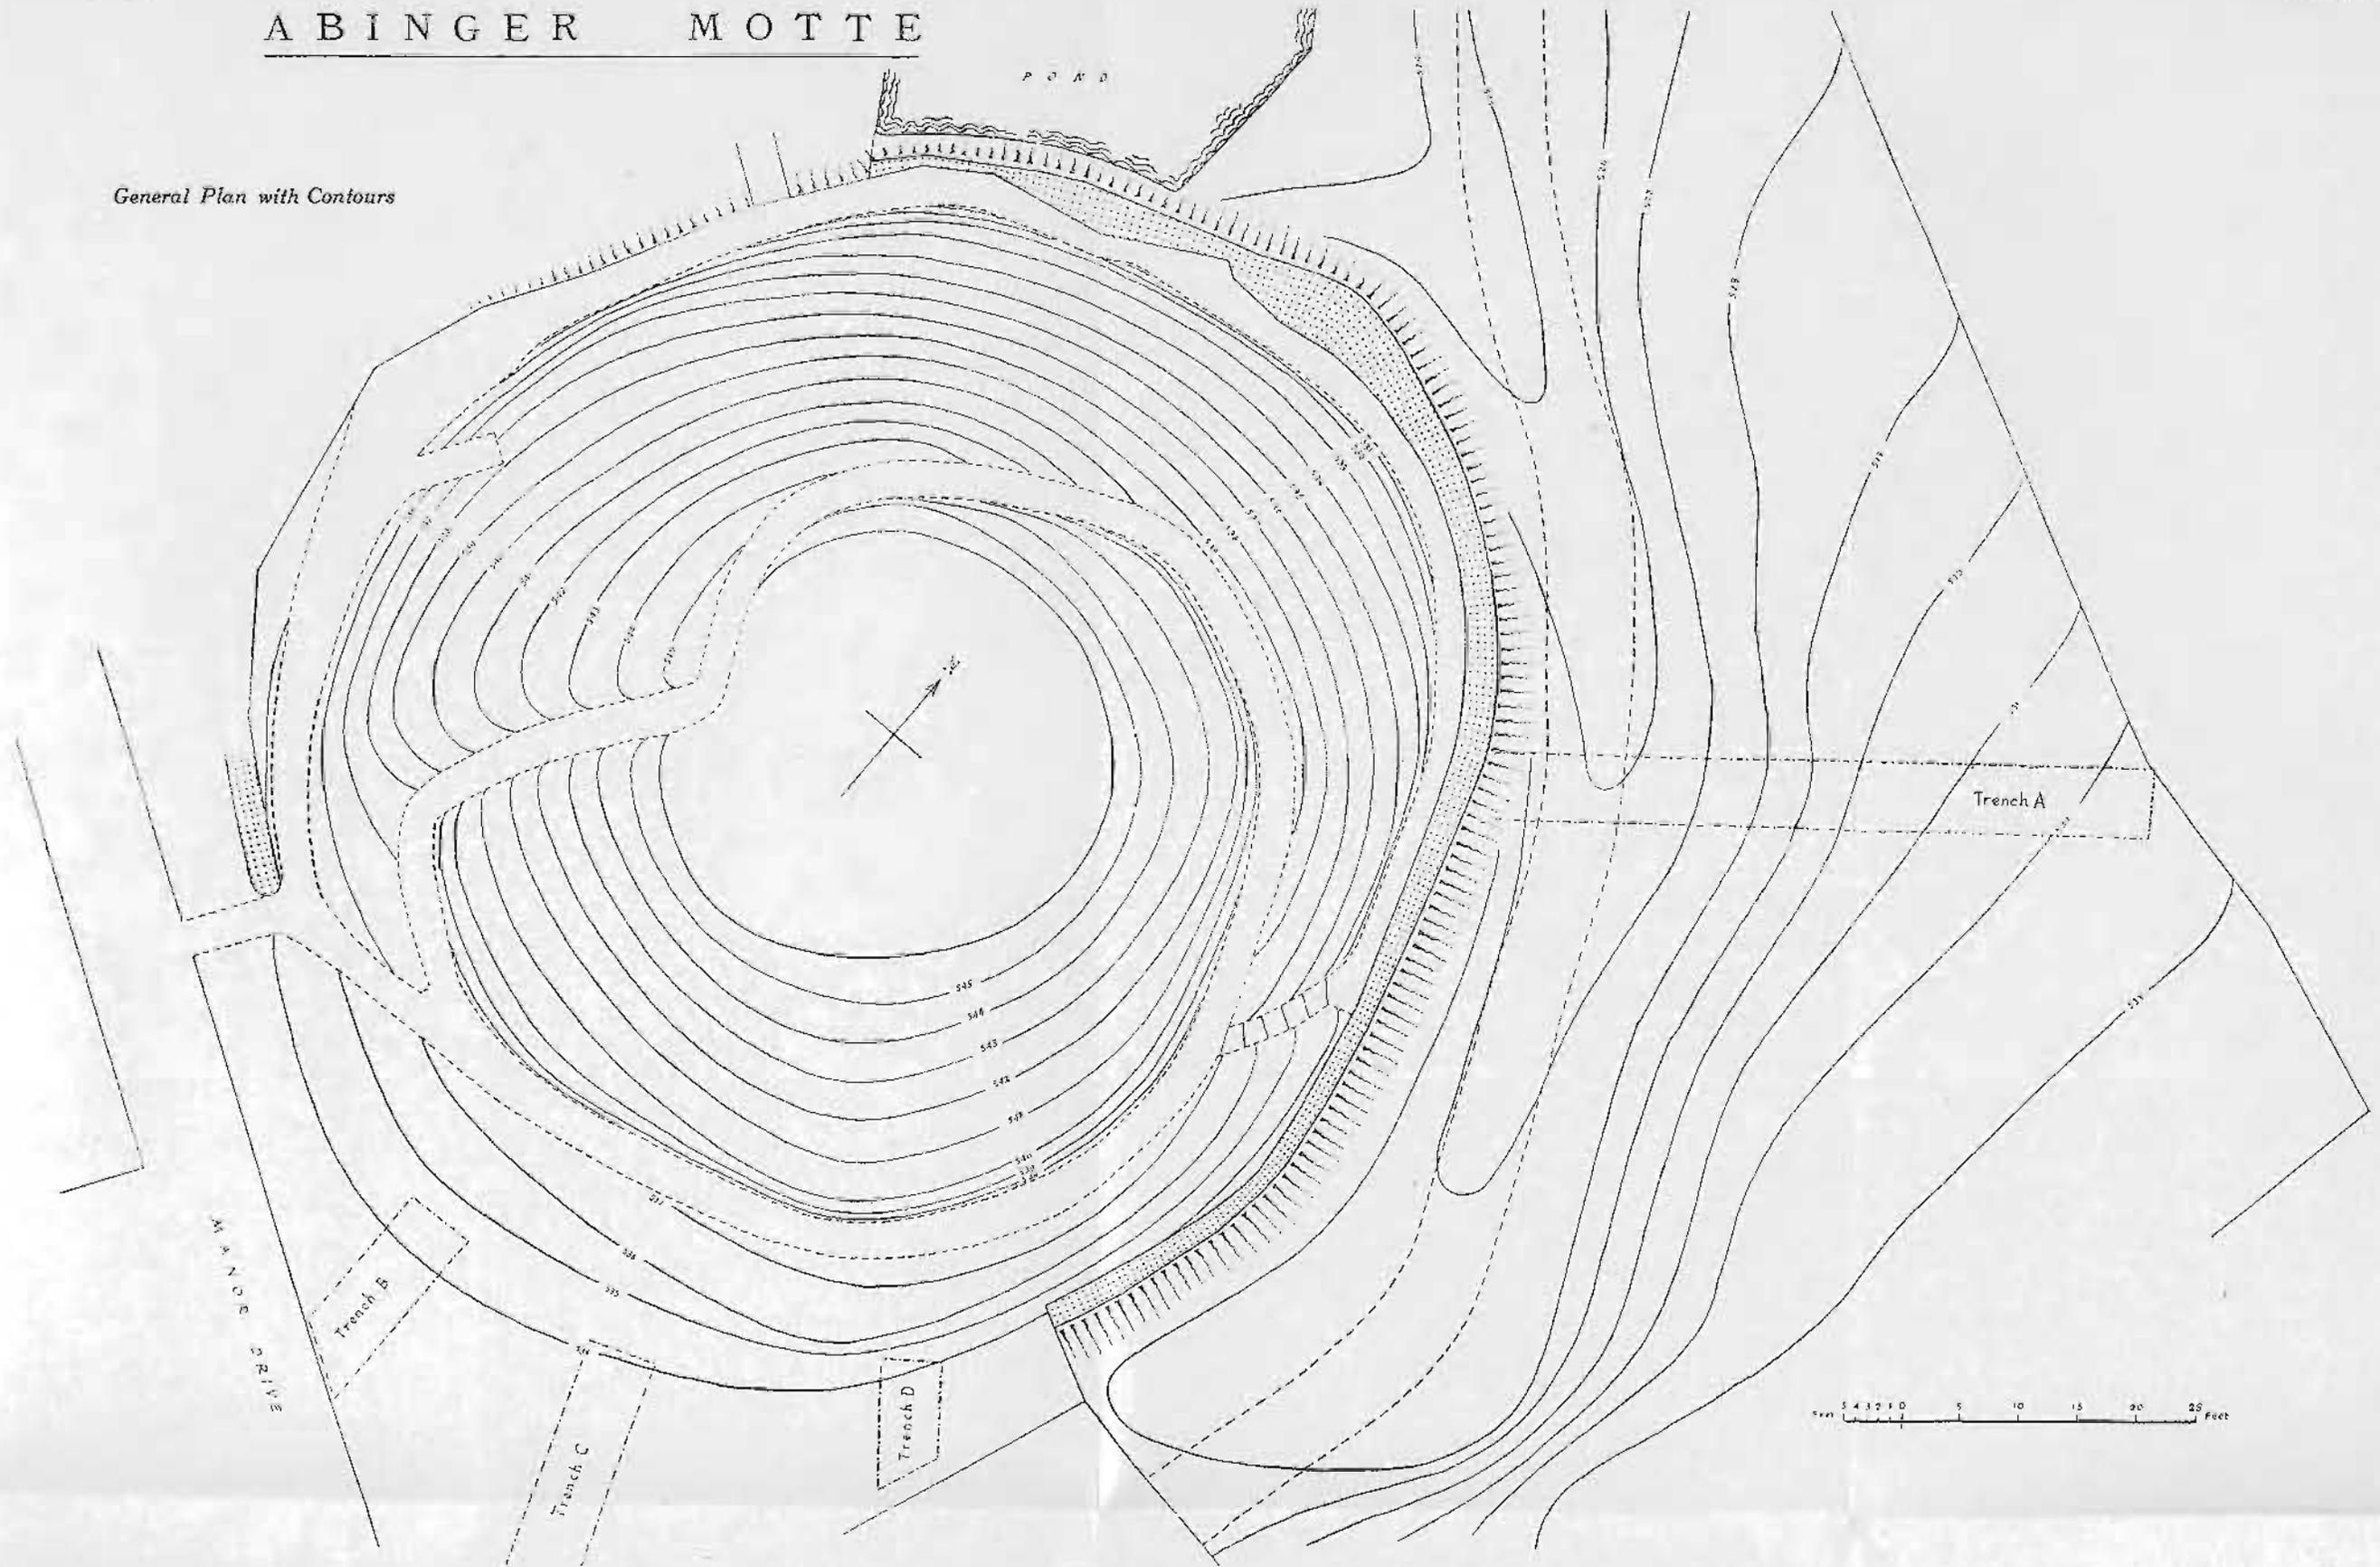
General Plan with Contours

CONTOUR-PLAN OF THE ABINGER MOTTE BEFORE EXCAVATION

Main trenches are indicated by dot-and-dash lines. The section of the moat between Cuttings B and D was completely excavated and preserved as nearly as possible in its original form. The path running directly to the top of the motte from the Manor has since been removed

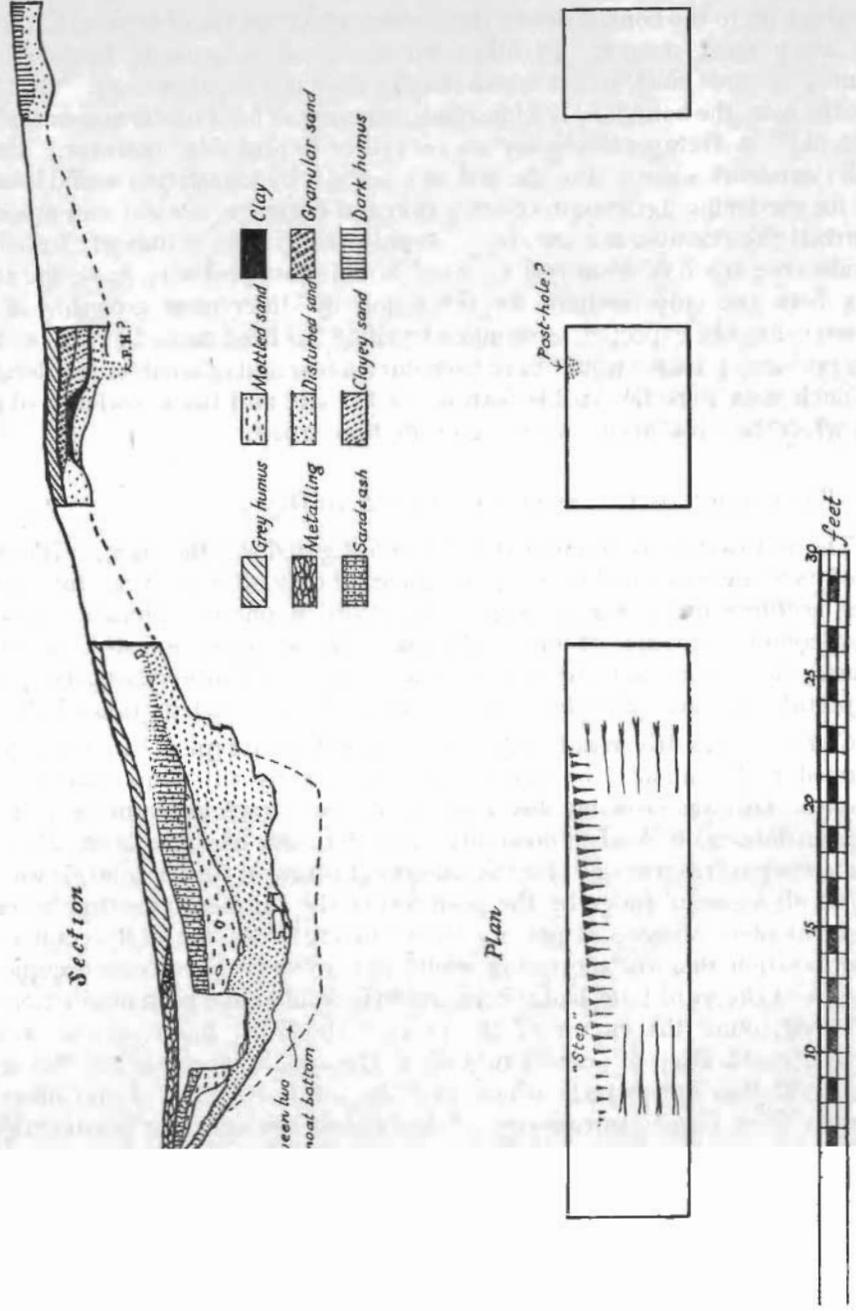
FIG. 3

# ABINGER MOTTE: moat cutting A

*Cutting A* was driven radially across the northern arc (pl. III). This, the section presumed to be outside the bailey, was less heavily silted up than the internal portions. This was probably due to its use as a cart-track in recent times, producing a loose surface easily washed downhill. No particular care had been taken in early times to keep it free from silt, for the amount of silting in the lower levels was roughly equal in all areas, to judge by the positions of the thirteenth-century layers. The almost complete absence of pottery from *Cutting A* was an early confirmation of the supposition that the motte-top would not prove to have been occupied in the real sense of the word; for had it been, rubbish would have been found more equally distributed round the circuit of the moat. The other moat-cuttings revealed a marked concentration of ancient rubbish in the area adjacent to the Manor House. The mound was an obstacle which gave to the north side of the moat virtual immunity from tipping of rubbish. A featureless thirteenth or fourteenth-century sherd was the only find from *Cutting A*.

But if this cutting was not distinguished by an abundance of pottery, it did reveal one or two structural features (fig. 3). Slight evidences of a counterscarp-bank thinly capped with sticky clay were found, with some indication of a post-hole; but erosion caused by weather and traffic made positive diagnosis impossible—the sand quickly assumes a homogenous appearance after disturbance. It was noted that the highest natural contours, lying on this, the north side of the site, had been used to give a greater relative depth to the external section of the moat. Here it had been cut through several natural sandstone strata, and its profile was irregular in consequence.

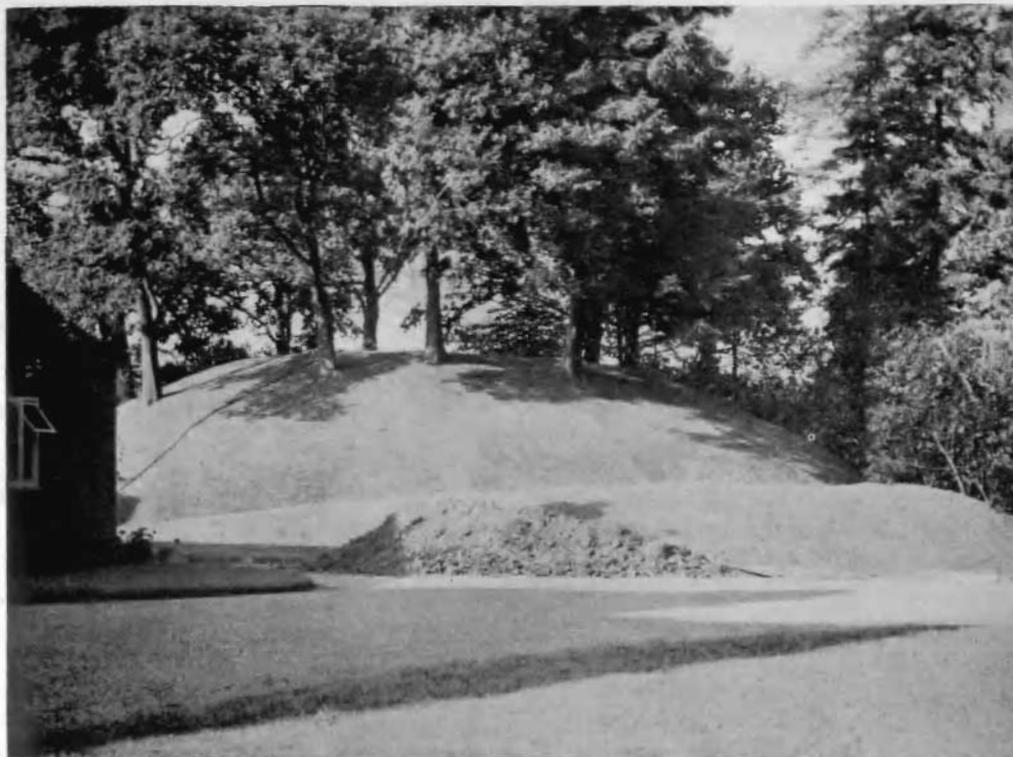
A. GENERAL VIEW OF THE ABINGER MOTTE FROM THE SOUTH

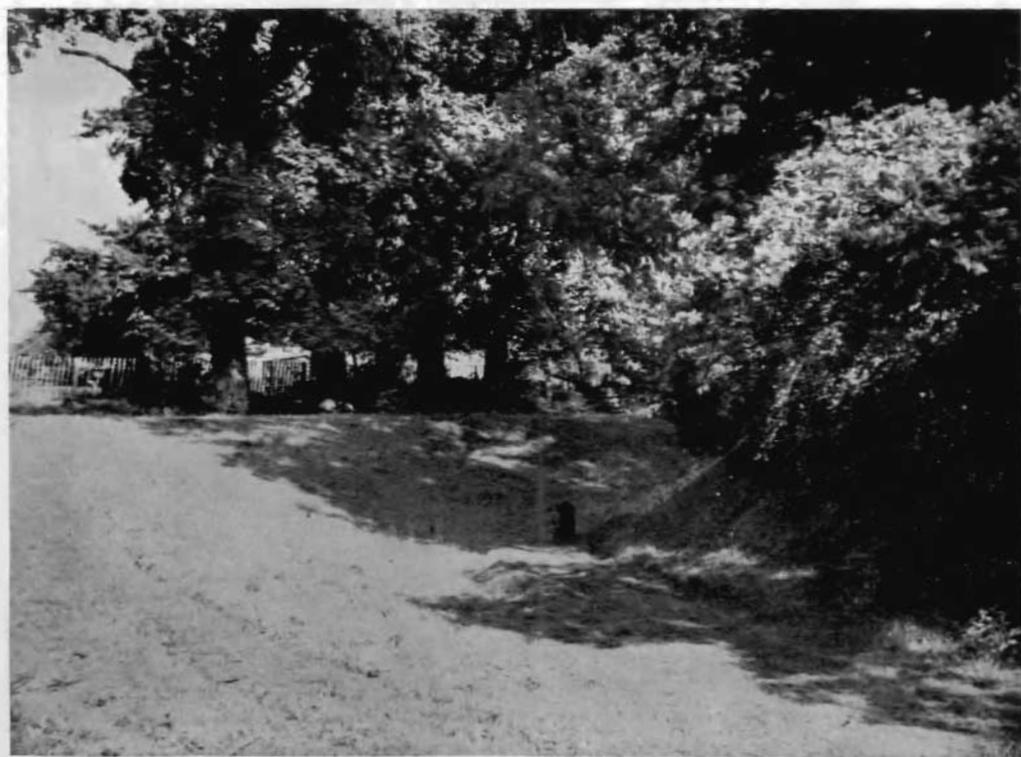
B. THE NORTHERN ARC OF THE MOAT BEFORE EXCAVATION

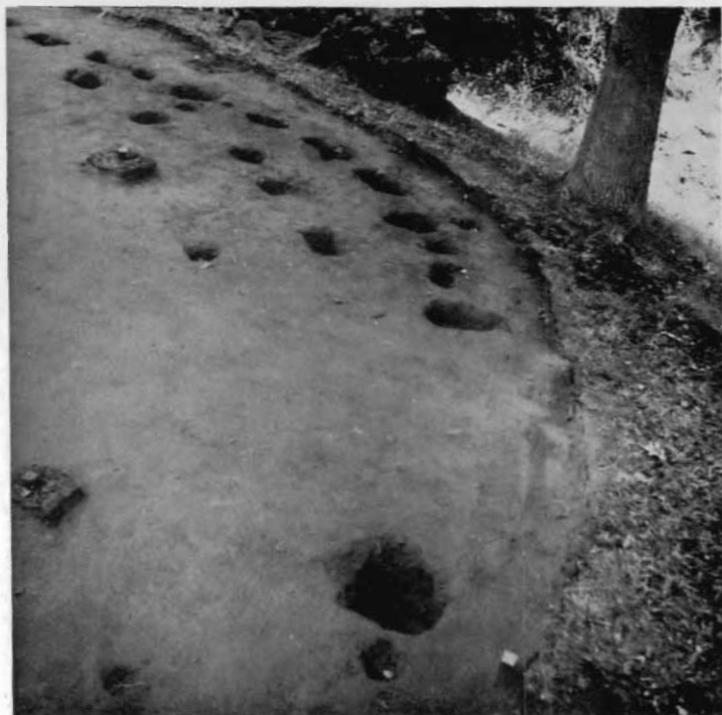
A. PALISADE POST-HOLES SHOWING GAP INDICATING GATEWAY (PHASE II)

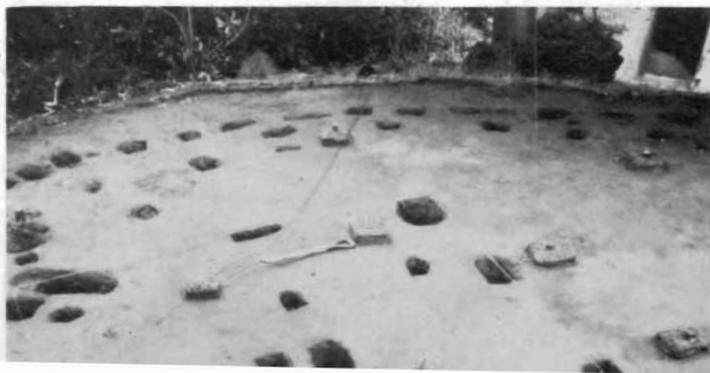
MOTTE-TOP (LOOKING EAST) AFTER EXCAVATION OF PHASE II GROUND-PLAN

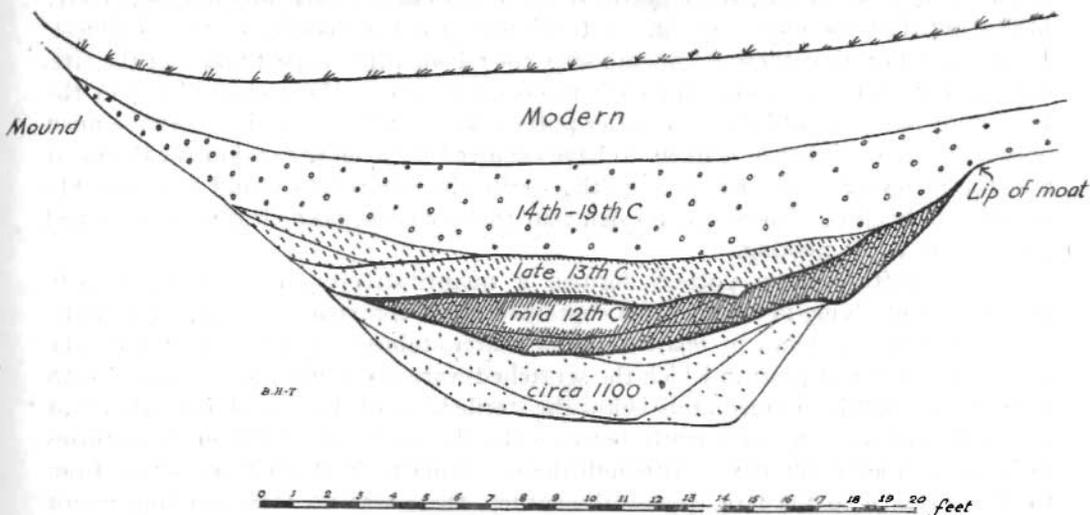
FIG. 4. CHRONOLOGICAL KEY TO PLATE VI

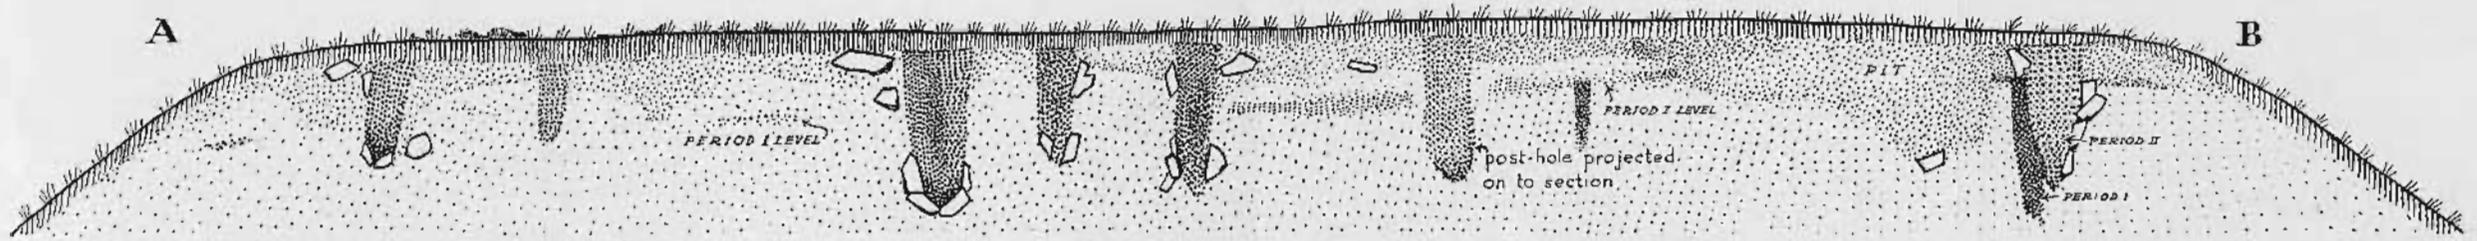
# ABINGER MOTTE section AB across top

Note: surface lowered in modern levelling

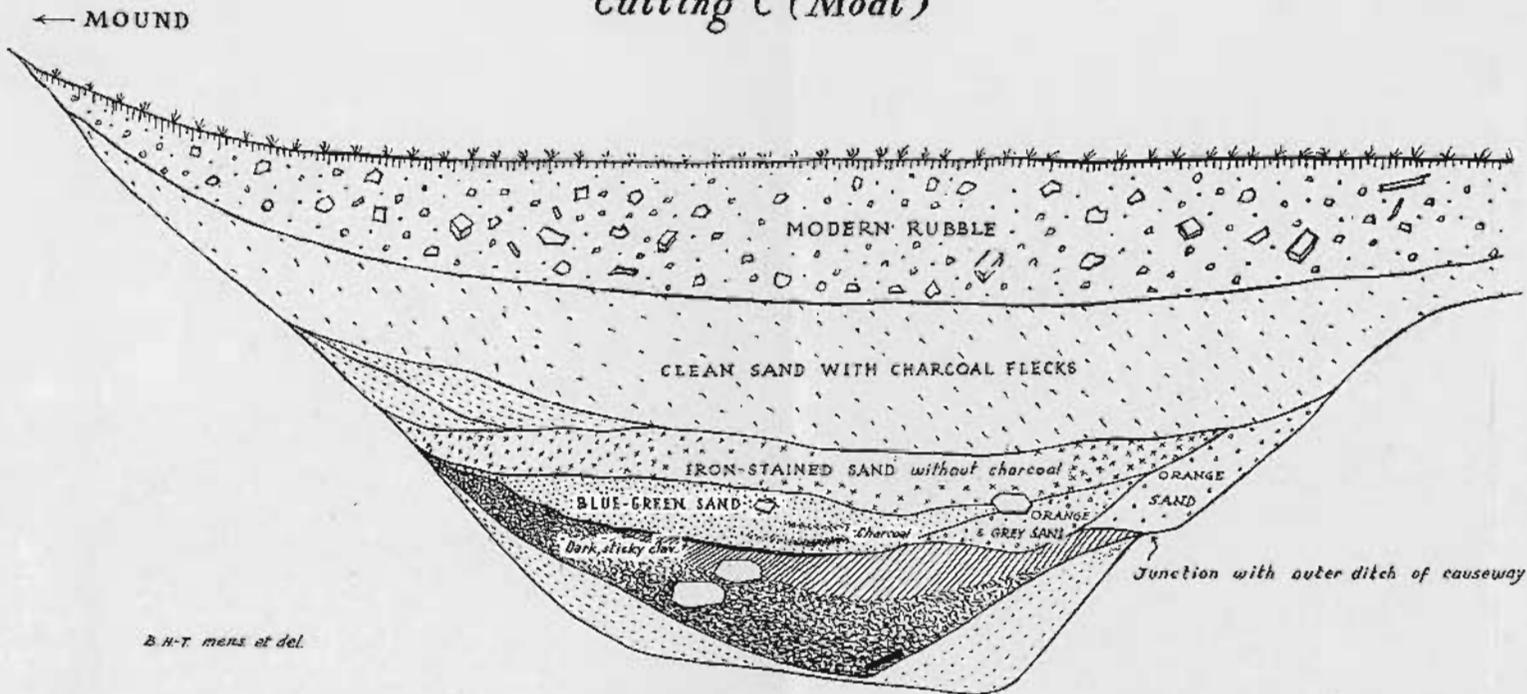
# ABINGER MOTTE Cutting C (Moat)

*Cutting C* (pl. VI) was the most informative of all these trenches, showing just such a section as might have been expected, deep and fairly regular, and by so doing made it evident that Cutting B must have encountered a causeway across the moat, an unexpected feature of some interest. This section was the richest in pottery. Scratched-ware (a name seeming to the writer neater and more in line with archaeological precedent than 'scratch-marked pottery', the term previously used) was found in the lower levels, and embedded in the sides of the moat and mound, clearly indicating that the motte was in existence within a few decades of the Conquest. It seems certain that these fragments were coeval with the earliest phase of the site, considering that they were stratified immediately above the sterile silting in the bottom of the moat and that no earlier pottery was found on the site. At the most only a very short interval is likely to have occurred between the making of the moat and the throwing of rubbish into it (the sterile silt referred to would form quickly on this sandy site). There was no sign that the moat had been cleared or deepened subsequent to its making.

Mid-twelfth-century pottery formed a quantitatively and stratigraphically superior group, lying in levels which contained much charcoal. The position of the thirteenth-century relics in relation to the water-stained levels (ranging from the blue-green clayey deposit in which the scratched-ware was found, to dirty sand with ferruginous mottling immediately below the sterile layer of clean sand) indicated that the moat had silted up sufficiently between the thirteenth and fourteenth centuries to become superficially dry. Although there is a hiatus in the pottery series, from the mid-twelfth to the late thirteenth-century, there was no corresponding major layer of sterile silt intervening between the relic levels in question: as there was not the slightest evidence for any clearing or recutting of the moat at any period, the absence of this feature is inexplicable. Probably thirteenth-century activity broke up a (then uppermost) soggy, sterile layer, resulting in the insertion into it of the pottery of that date; such an intrusion might well be concealed, for, as previously remarked, the sand quickly resumes a homogenous appearance after disturbance.

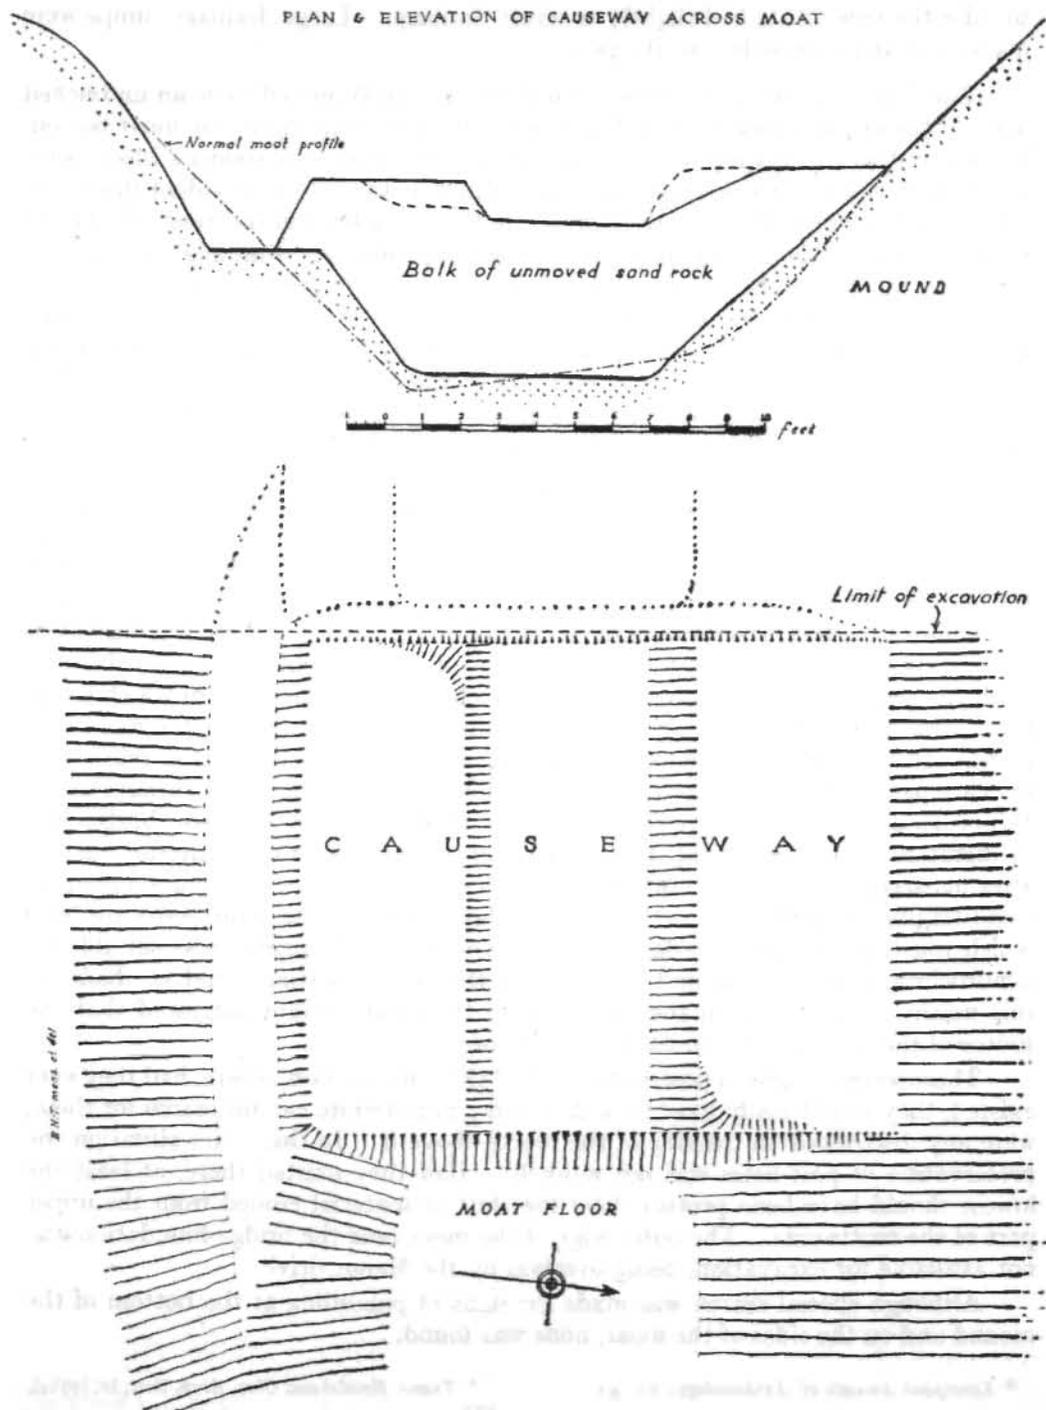
FIG. 5.

PLAN &amp; ELEVATION OF CAUSEWAY ACROSS MOAT

*The Causeway* (fig. 5) which was found by Cutting B proved to be an untouched mass of the original rock-sand and sandstone, its sides shelving to the moat bottom on east and west. Its top may perhaps be likened to an executioner's block, with two roughly level surfaces separated by one a little lower. It was evident that these heights had been calculated with reference to the water-level in the moat, the higher portions apparently having been just below the surface. Running outside this causeway was the ditch-like excavation first noted in Cutting B: it served to connect the south-east and south-west sections of the moat and to isolate the causeway from the side of the moat. The effect, in short, would have been that two rectangular platforms of the original sandstone would have lain a little below the surface of the water when the moat was full. There can be no doubt that this was the foundation on which were placed the lower structures of a light bridge of some sort. It may have been built on a rectangular timber sleeper-frame, in which were stepped timber uprights, as at West Derby Castle near Liverpool,<sup>1</sup> and at Leckhampton Moat, Bristol<sup>2</sup> (although these are recorded as being much later sites, and the wooden structures found lay directly on the moat beds). Fragments of oak were found in the mid-twelfth-century layers in the Abinger moat, on the east side of the causeway, and a few in the layers containing the scratched-ware. None of these fragments was sufficiently well-preserved to retain indications of its function. Two from the mid-twelfth-century levels were pieces of split logs, the original diameters of which would have been approximately 7 and 9 in. respectively. Another was a fragment of a plank which appeared to show adze marks, about 3 in. wide. These relics may indicate partial decay or reconstruction of the works of the motte, or perhaps of the Manor House, in the mid-twelfth century; or could it be that the bridge was deliberately destroyed during Henry II's campaign of slighting adulterine castles, after his accession in 1154? Whatever the explanation, there were more numerous wood-fragments in the mid-twelfth-century layer, than in the scratched-ware level which must be presumed to date *c.* 1100. None of the fragments was suitable for dendrochronological study and no check of the pottery-dating could be made by this means. Oak leaves in the blue clay on the moat bottom suggested that the source of the timber may not have been far away.

There were no signs of post-holes on the bridge-foundation, where, had they ever existed, they would easily have been detected; nor, despite careful search for them, were any discovered on the side of the motte above it. In this latter situation the preservation of post-holes was not unlikely. Had they existed there, at least the lowest should have been protected by the skirt of material eroded from the upper part of the motte-side. The outer edge of the moat near the bridge-foundation was not available for excavation, being overlaid by the Manor drive.

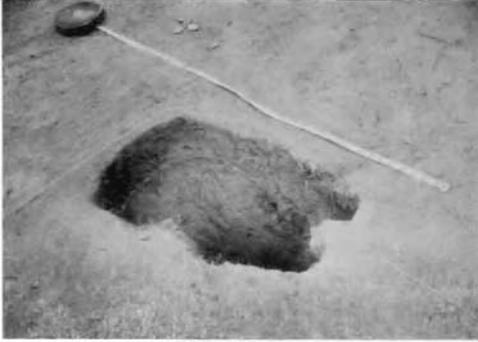
A. POST-HOLE AT N.W. CORNER OF PHASE II TOWER, SHOWING THE USE OF MORTICES

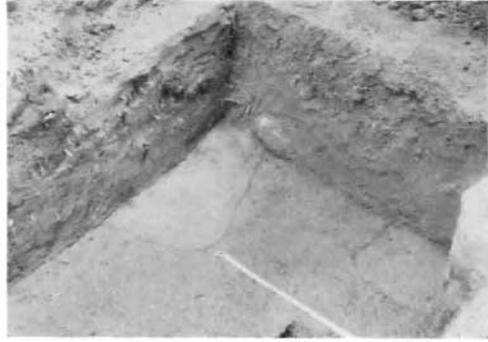
B. POST-HOLES AT W. SIDE OF PHASE I TOWER

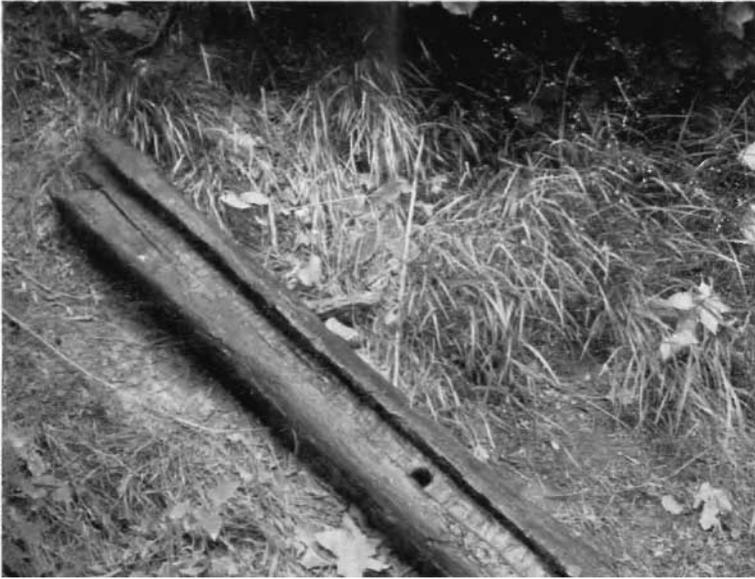
C. SLOTTED TIMBER FOUND IN DITCH OF A MOTTE AT KÆRSGARD, E. JUTLAND (see *Appendix C*)

A deep trench, cut through the mound disclosed a rectangular mass of stone rubble lying on the natural surface under the centre of the mound. Since our discussion Mr. Stiesdal has kindly given his revised interpretation of the site. Originally he considered that a primary tower had been erected upon the motte-top in the manner of the Abinger towers; but on further examination of the sections and photographs he detected two large post-holes based on the stone 'foundation', running vertically through the mound to the surface (about four metres). The excavations having previously been concluded, he was unable to trace further post-holes, but it would seem that we have here evidence of a timber tower actually incorporated in the earthen mound while the latter was being erected.<sup>1</sup> Such a device would indicate that the tower was required to be relatively lofty. Mr. Stiesdal accepts the possibility of the lowest storey of the Kaersgård tower having been unenclosed.

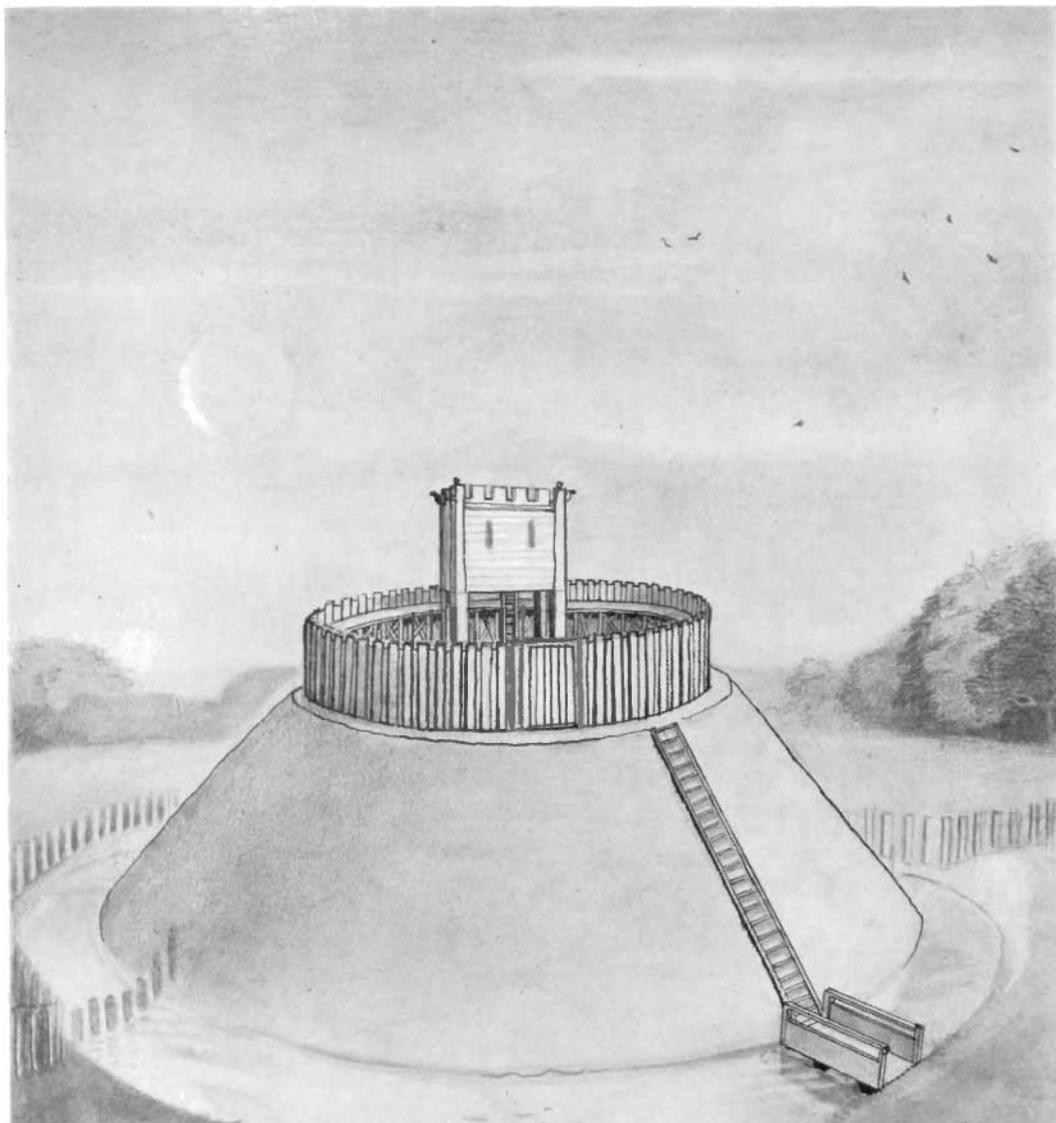
TENTATIVE RECONSTRUCTION OF THE STRUCTURES ON THE ABINGER MOTTE, BASED AS DIRECTLY AS POSSIBLE ON THE POST-HOLES FOUND BY EXCAVATION. THE BAYEUX ILLUSTRATIONS OF THE DINAN AND DOL TOWERS (PLATES I AND IIA) SUGGEST THAT THE UPPER STOREYS MAY NOT HAVE BEEN STRUCTURALLY UNIFIED WITH THE LOWER, BUT BUILT SEPARATELY UPON THEM. THE SMALL AREA OF THE ABINGER TOWER SUGGESTS A SIMPLER CONSTRUCTION

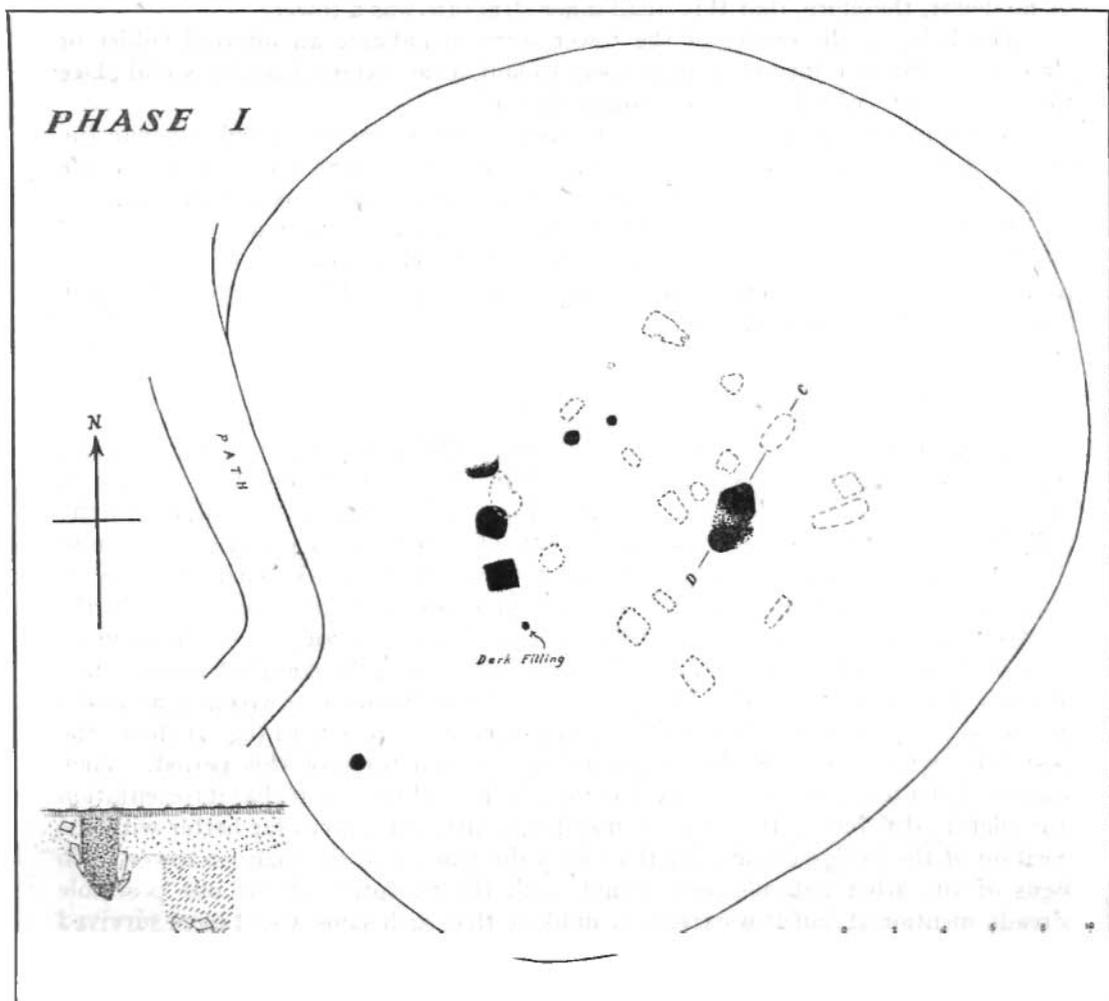
FIG. 7. THE ABINGER MOTTE-TOP: PLAN OF PHASE I POST-HOLES (FILLINGS LIGHTER THAN SUB-SOIL). THE PLAN OF THE PHASE II TOWER IS SUPERIMPOSED IN BROKEN LINE

The post-holes of the palisade and tower were filled with concrete before the next stage of the excavations was carried out. When the concrete was fully hardened, the surface of the mound was again shaved down, for when the post-holes of the palisade were emptied of their infillings it was observed that one had been cut into the side of another post-hole cut from a lower level, and that elsewhere there were indications of an earlier level. As the work proceeded it became obvious that the ground-plan already secured was not that of the original construction on the mound; that there were indeed two phases. Hopes of recovering the complete ground-plan of phase I were not realized. The phase I level was found to be wrecked, and only in one or two places had the original surface survived. The plan (fig. 7) shows the post-holes which were all that remained of the structures of this period. They suggest that a tower similar to that of phase 2 had stood there, but that its orientation was slightly different. It should be noted here that this agrees far better with the position of the bridge-foundation than does the placing of the phase 2 tower. No signs of an earlier palisade were found, with the exception of the one post-hole already mentioned, but it is extremely unlikely that such signs would have survived the later mutilation of the site. It seems a reasonable assumption that a palisade existed in the earlier period.

One important difference between the two sets of post-holes was that whereas those of phase 2 contained infillings darker than the surrounding soil, those of phase I were filled with sand lighter and more granular than that in which they were cut (pl. VIIB). So we can assume that the phase I posts were pulled out when the site was remodelled and that at the same time the mound was heightened and levelled. Most of the phase 2 posts were left to rot, evidently, and the fact that many of them were leaning well out of the vertical shows that the wooden structures remained as ruins and were not methodically disposed of. The leaning timbers might be evidence that the motte was slighted, but there is no evidence of extensive damage to the

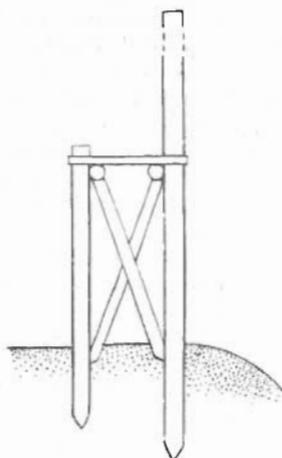
FIG. 8. DIAGRAM SHOWING HYPOTHETICALLY RECONSTRUCTED SECTION OF PALISADE WITH INTERNAL PLATFORM

A palisade encircled the top of the mound, strengthened on the inside by a series of bracing-posts which probably served also as the foundation for an internal platform from which the site could be defended when necessary. While the palisade holes had an average depth of over 2 ft. 6 in., measured from the modern surface, these secondary holes were rarely over 2 ft. deep. It should be remembered that natural erosion and the modern levelling have probably removed over a foot of soil from the top of the mound.

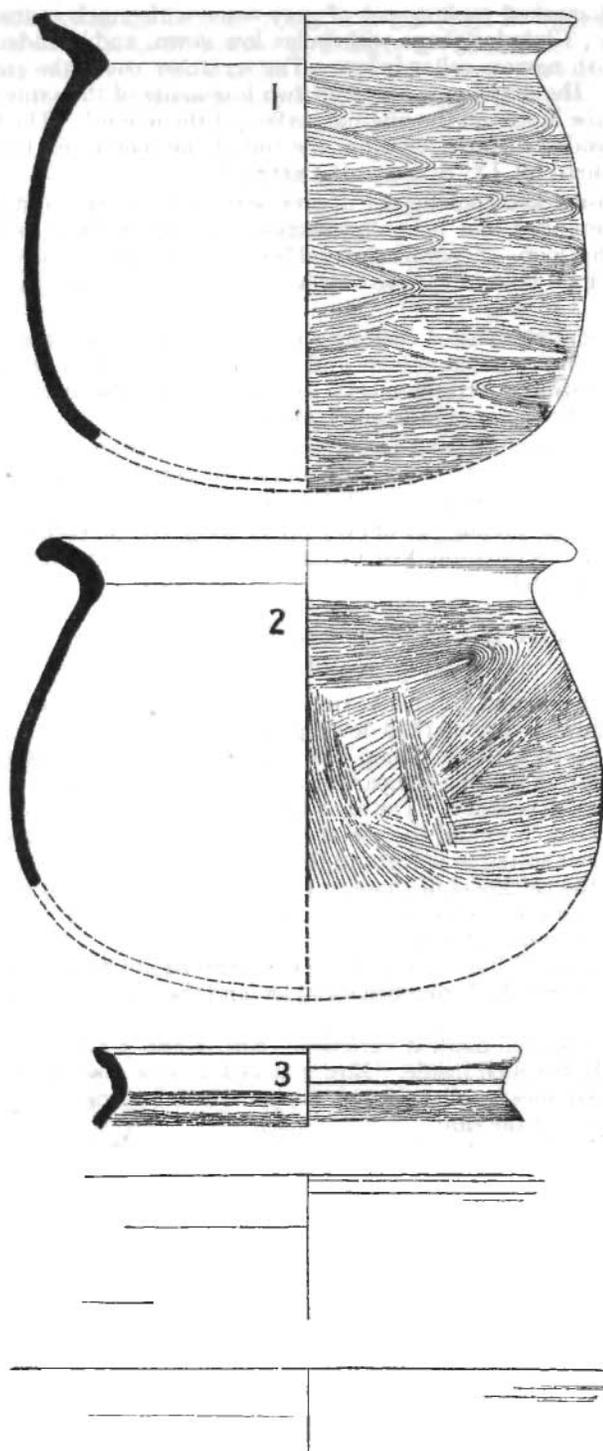
FIG. 9. ABINGER. SCRATCH-MARKED POTTERY OF *c.* A.D. 1100 ( $\frac{1}{2}$ ).

1. Scratch-marked cooking-pot of grey ware with much coarse sand, light-red-brown surface. Globular shape with bulge low down, and rounded base. Strongly everted rim with narrow collar below. The scratches cover the entire surface, with several loops. The drawing is based on two fragments of the same pot found on the lower slope of the Motte on the original surface of the mound. The rim sherd (pl. IX, A, 1) was embedded in early silt from the top of the mound on the south-west side, and the body sherd (pl. IX, A, 2) was in Cutting C.

2. Scratch-marked cooking-pot of grey ware with coarse sand, light red surface. Everted rim, rounded and bent downwards. Scratch-marked on body in crossing directions, with a loop. Separate rim and body sherds of the same pot (pl. IX, A, 3-4). Cutting C, lying on floor of eastern extremity of the ditch running outside the causeway.

The most distinctive feature, which is shared by all the pots of this group, is the surface treatment of the outside. The entire surface, except for the hollow of the neck, is covered by fine scratch-markings. The general direction of the scratches is horizontal, with loops or return strokes at various levels. The markings appear to have been caused by particles of grit on the potter's fingers in smoothing the surface of the rough pots. The scratch-marks are also sometimes found on the inside below the neck (nos. 3 and 4), as though to thin down and smooth over the join between the body and the neck.

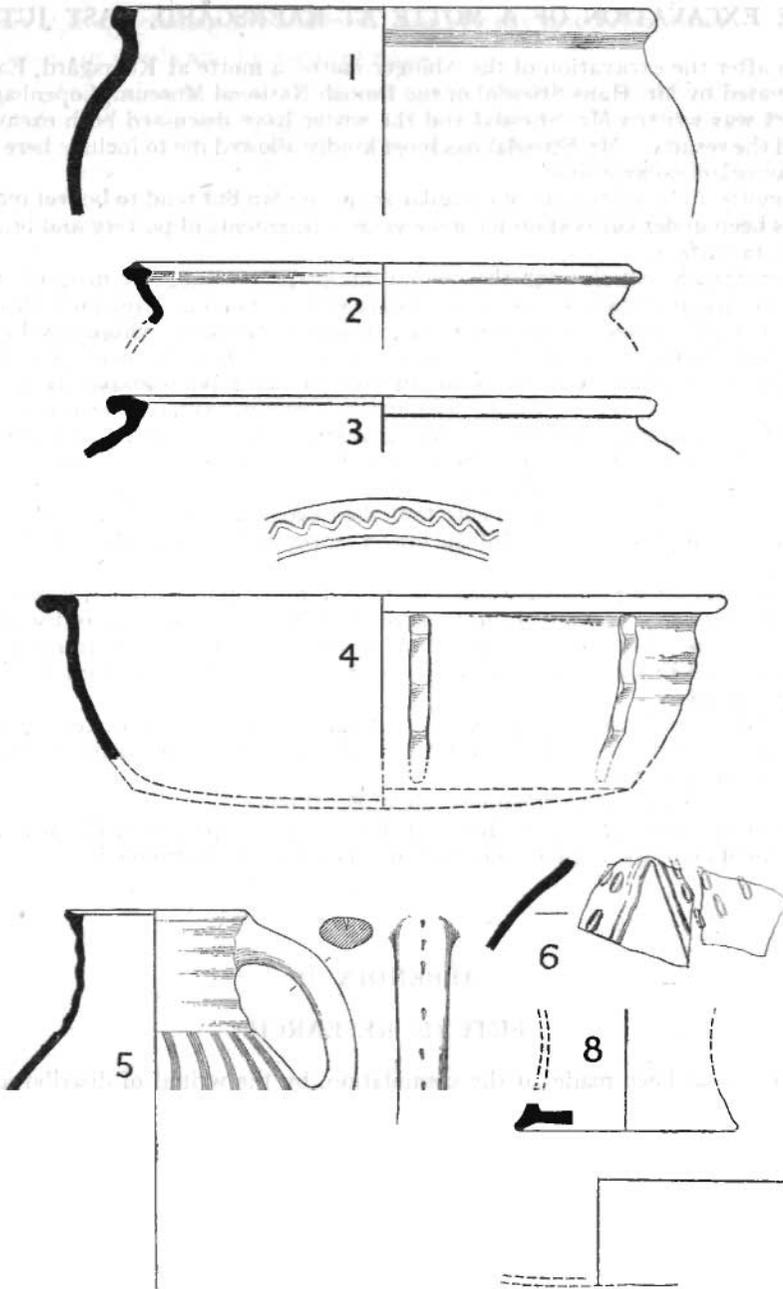
5. Small jug of fine sandy whitish-buff ware. Speckled green glaze on neck and body to the bulge, and in a few patches on underside of base. The rim is bifid, and the neck is corrugated producing the effect of a series of cordons. The handle is oval in section and has a line of stab-marks down the middle. The upper part of the body is decorated with vertical bands of combed lines. The base is sagging and the edge is marked by continuous thumb marks; these reach only slightly below the basal angle, so that the pot stands on its rounded base. Cutting C, filling above causeway.

6. Two sherds from upper part of body of jug. Fine sandy yellow ware, lustrous streaky green glaze of good quality, tinged red by iron-staining later. Decorated with diverging applied strips probably forming a chevron pattern. In the upper spaces are rows of oblong incised marks made by a blunt tool. Cutting C, top of iron-stained sand.

7. Base of large jug of grey ware, light red surface. Green glaze is splashed on the side and underneath the base. A girth-groove encircles the side. The base is sagging and the edge is pressed down in long ledges, marked above by finger-fluting, which reach the lowest level and support the vessel. Cutting C, filling above causeway.

8. Base of jug of grey ware with light red surface. Lustrous green glaze covers most of the underside of the base and is in patches up the outside. The glaze is marked by little dimples where bubbles have burst in the course of firing. The base is hollow and stands on its thin rounded edge. Probably the jug was of slender baluster shape. Cutting C, base of iron-stained sand.

FIG. 12. ABINGER. LATE THIRTEENTH-CENTURY POTTERY (1/4).
