EXCAVATION OF THE FORTIFIED MEDIEVAL HALL OF HUTTON COLSWAIN AT HUTTONS AMBO, NEAR MALTON, YORKSHIRE

By M. W. THOMPSON, with an appendix by J. T. SMITH

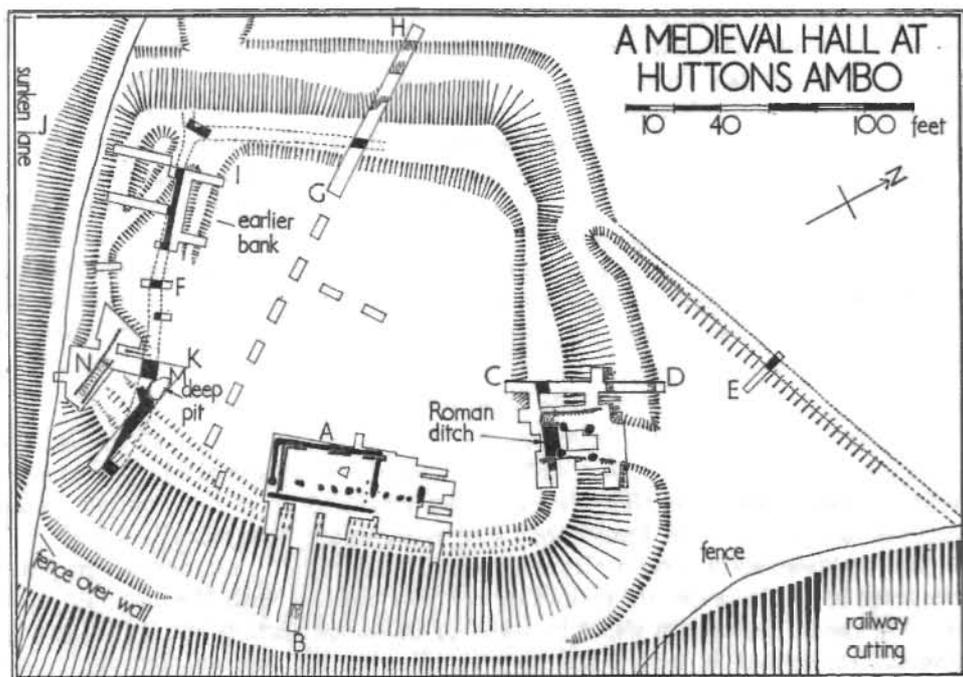
Fig. 1. Huttons Ambo, Yorkshire. Plan of the site

The enclosure consisted of two elements of which the later (henceforth referred to as Enclosure II) was the more prominent. Enclosure II was roughly oblong in outline, its main axis running parallel with the axis of the spur on which it lay. Its defences, where best preserved on the west and north, consisted of a broad bank and a ditch; but above the steep scarps on east and south the ditch was much less prominent and here, too, the bank had been considerably disturbed and reduced by

In the second period (Phase II) the defences were completely remodelled and enlarged to produce Enclosure II as already described and as shown on the plan (fig. 1), the lower levels of the ditch probably serving as a quarry for a rebuilt hall and perhaps for a curtain wall around the enclosure behind the earth and rubble bank. On the N. side the triangular extension of Enclosure I was retained as an outer ward covering the new entry. On the E. side the slope was steepened by deep scarping to form a very formidable defence for the hall overlooking it.

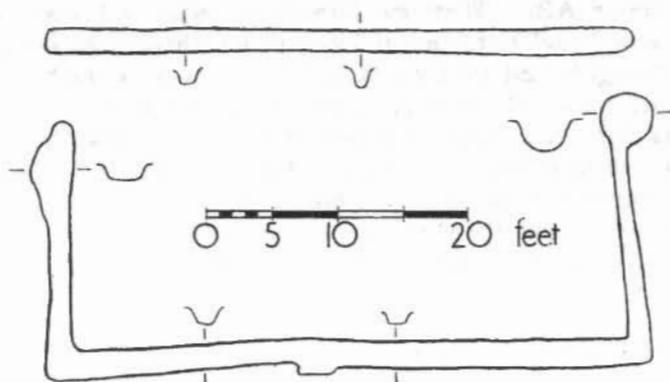
Fig. 2. Outline of hall, Phase I

The building, as defined by its wall trench, was roughly rectangular in outline, 45 ft. long by 25 ft. wide, its main axis roughly parallel with the rampart on this side. On the E. the trench was 2 ft. wide, of U-shaped section and 1 ft. 6 ins. deep below the rock (that is, 2 ft. 6 ins. to 3 ft. allowing for the soil covering); on the other three sides the trench was somewhat slighter and less regular. The continuity of the trench was broken by doorways at the S.E. and N.E. corners; the gaps were 3 ft. wide, and 5 ft. on the N., opening through the N. and S. walls. The trench was evidently the sleeper trench for a timber building, its regularity on the E. side suggesting that it may have held a single beam though the length is considerable, while on the W. a change in direction at about the middle suggests that two beams may have been used. An angular external projection on the W. side coincides with the change in direction and presumably carried a buttress to reinforce

the junction. An external bulge on the N. side near the doorway also may have held a buttress. The doorways themselves were treated differently. On the N., the ends of the trench which would have carried the door-jamb were featureless; on the S. there was a large round post-hole which was deeper than the wall-slots.

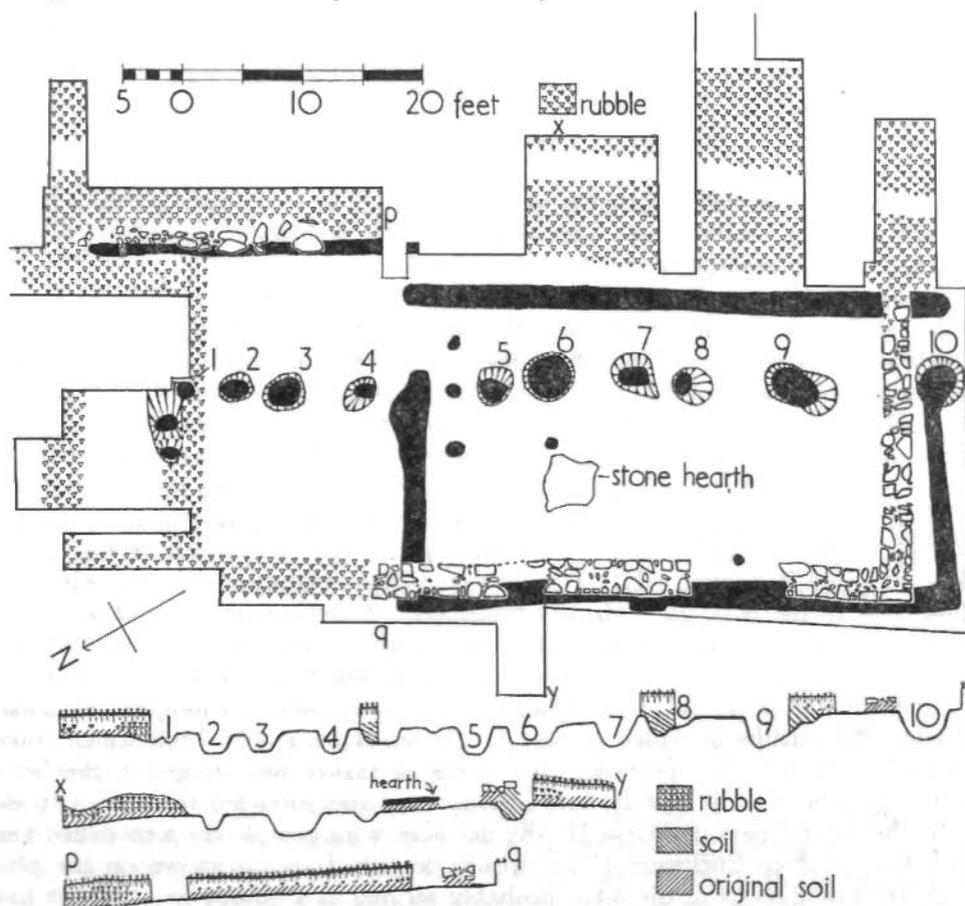
Fig. 3. Hall area, with superimposed buildings

The timber hall must have been entirely dismantled and removed and its sleeper slots filled in before the building of the stone hall could begin. The surviving stone foundations lie directly on the soil, well above bed-rock and with no foundation trench (fig. 5, section AB). They are formed of large undressed stones, 1-3 ft. long, 6-18 ins. broad and 6-12 ins. thick, laid lengthways as facing stones with a filling of very roughly laid rubble (Pl. XIII). Except in the S.W. corner rarely more than the bottommost course is preserved, where it can be seen that the bonding is extremely irregular. The northern gap in the W. wall is accidental; the N. jamb of the southern gap is finished square, and this with the single post-hole in the middle strongly suggests that there was an entry at this point. A series of nine (or ten) large post-holes parallel with the long axis of the stone building appears to belong to Phase II since they extend well beyond the end of the timber hall.

The post-holes nos. 1-10 are spaced at irregular intervals. As already noted, no. 1 is markedly smaller than the others and may not have served the same purpose, while no. 10, although connected with the timber hall, may have been enlarged and re-used, for an overhang from the roof or something of the kind. No. 6, although broader than the others, is fairly shallow. Allowing for a foot or so of soil above the grit these holes must have been 3-4 ft. 6 ins. deep, and were evidently intended to hold substantial posts. Sections yielded little information of value, the ground being too stony to retain the silhouette of the original posts. Nos. 2, 6 and 9 contained sherds of medieval pottery in their filling, which was also darker with more ash and charcoal than in the others. Looked at as a whole the posts fall into two distinct groups, nos. 2-5, and nos. 6-9 with 10. Nos. 2-5 are smaller than 6-9, and, moreover, 6-9 are on a slightly different alignment. This variation may be due to the enlargement of the hall already suggested, nos. 6-9 belonging to the original building and 2-5 to the extension. Nos. 8-9 have a ledge on the side and have almost certainly been used more than once.

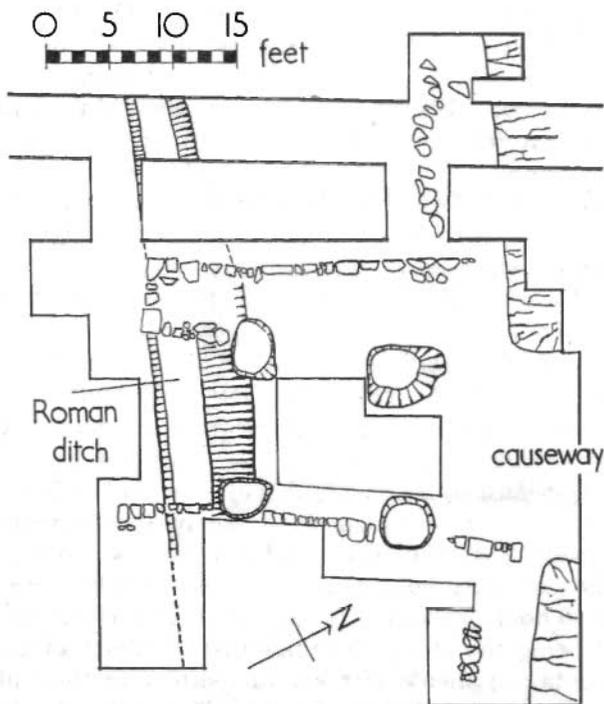
Fig. 4. Entry to Enclosure II

The entrance to Enclosure II, in the N.E. corner (fig. 4) is set aslant to the N. side, possibly to conceal the hall from direct line of view. The ditch here is interrupted by a causeway of solid rock 15-16 ft. wide. The entrance arrangements

The four holes have the following depths from the top of the grit (S. side): S.W.—1.3 ft., N.W.—2.6 ft., S.E.—1.8 ft., N.E.—1.8 ft. They would have held stout posts 1 ft. at best in diameter. The holes are cut more steeply at the back than they are towards the passage and leave the impression that they were dug from the entry passage after it had been faced. Presumably two lintel beams held each pair of posts back rigidly into the gaps in the wall designed for them, which would account for the shallowness of the holes compared to their diameter. The two western holes are closer together than the two eastern so that the two gates were not parallel and help to give the entrance its twist westwards. The passage between the gates was about 9 ft. wide. Owing to the slope of the hill the gates probably opened outwards.

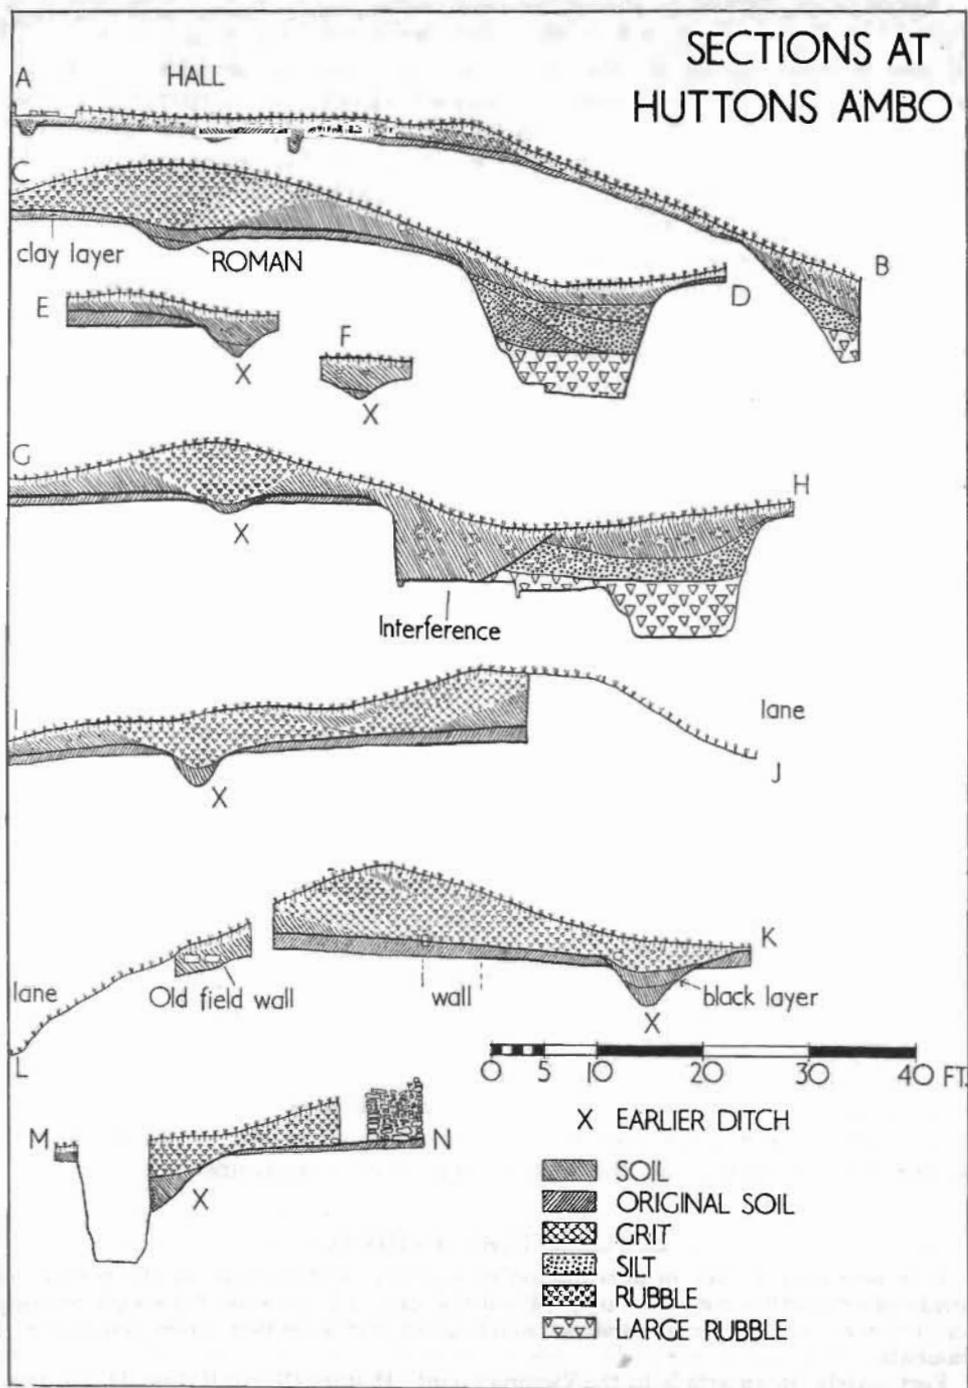
Fig. 5. Sections

At the entry the main ditch is 15 ft. broad and 13 ft. deep. It is flat-bottomed, with a slight step on the inside (fig. 5, section CD). On the W. the depth of the

On the E. side there are only two small rubble banks, the outer for the most part being larger and more earthy than the inner (fig. 5, section AB). On the N., W. and S. the banks are bigger and more complicated structures. On the N. side by the entry the bank is about 40 ft. thick. The structure of the bank from the bottom upwards consists of soil overlain by small rock rubble, then by larger rubble, the products of the progressive deepening of the ditch; the earth banks on the W. and S. sides tell much the same story. In the S.W. corner there is another bank within the corner forming a kind of loop. This may be due to a change of plan.

In the S.E. corner there are two complicating features. Just behind the bank and dug partially through the ditch of Enclosure I is a deep pit (fig. 1 for plan, and 5, section MN). It is an irregular oval in shape, about 11 ft. long, 6 ft. broad, and 11 ft. deep. The bottom is flat. On three sides the walls of the pit are formed by the rock face, but where the earlier ditch has been cut through, its filling has been revetted with undressed stones which were carried upwards slightly above the soft filling. The pit was thus provided with firm sides all the way round and was presumably some kind of storage pit or magazine, although its depth seems excessive. Apart from a few bones and sherds the pit was entirely filled with large rubble blocks, presumably fallen from the sides. There were no traces of organic matter, grain or other material in the bottom to give a clue as to its use.

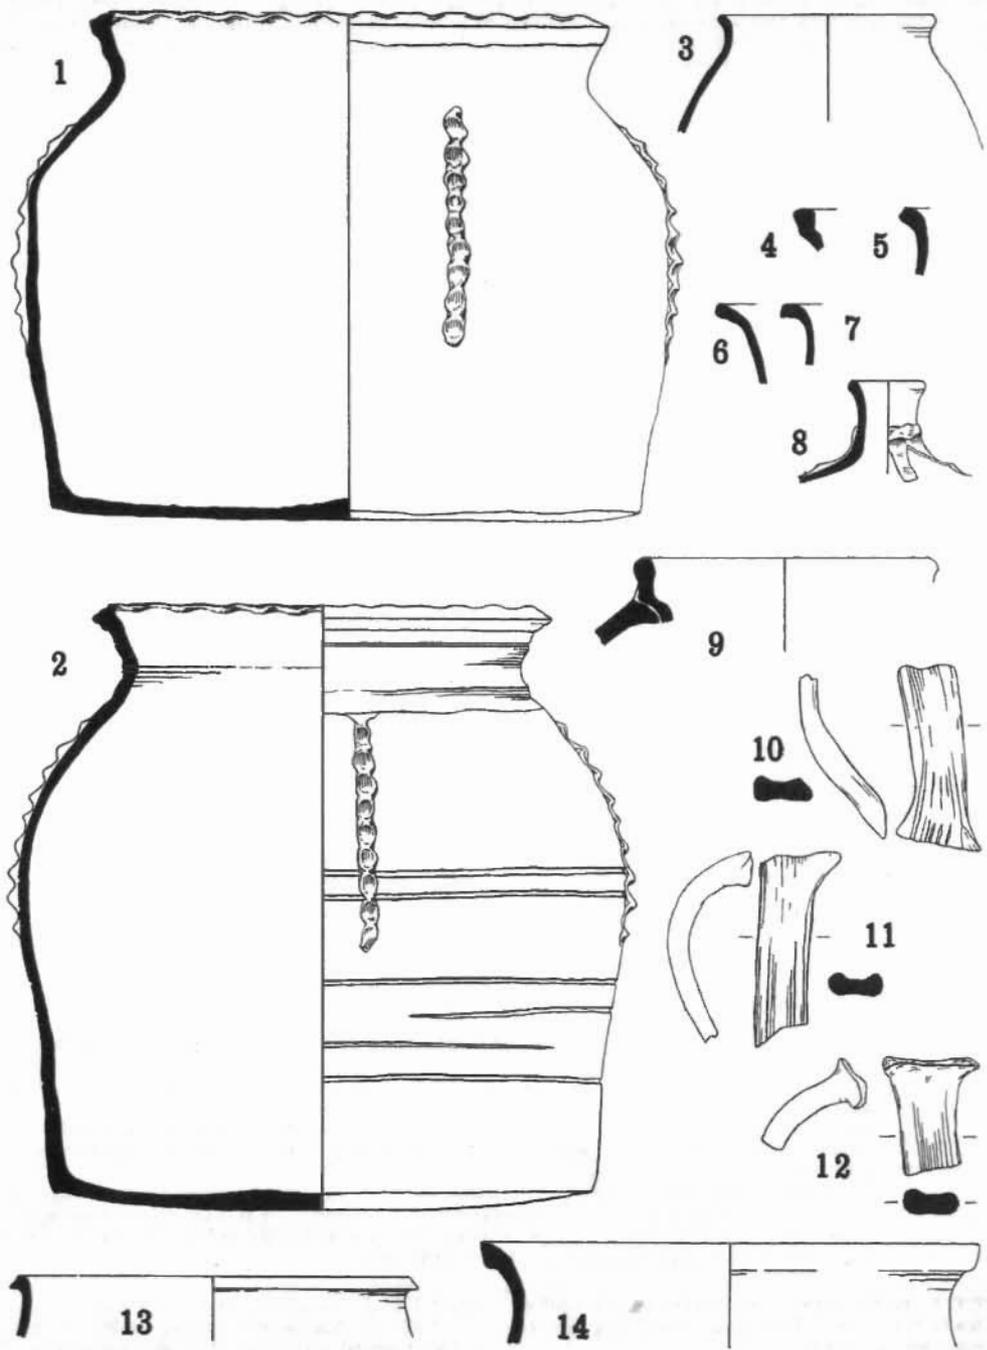
Fig. 7. Pottery (1)

Glazed wares were few, and included three sherds of hard grey porous ware bearing four incised lines with specks of glaze visible in the cracks. Spouts such as that illustrated in fig. 7, no. 8, would not be out of place in the 12th or 13th centuries (*cf.*, for example, *Oxoniensia*, V, 1940, 42-9). The absence of decorated handles and other later features may be noted.

1. Squat round-shouldered vessel with nearly flat base and applied vertical impressed bands and impressed rim. Found in the double-bottomed rubbish pit.

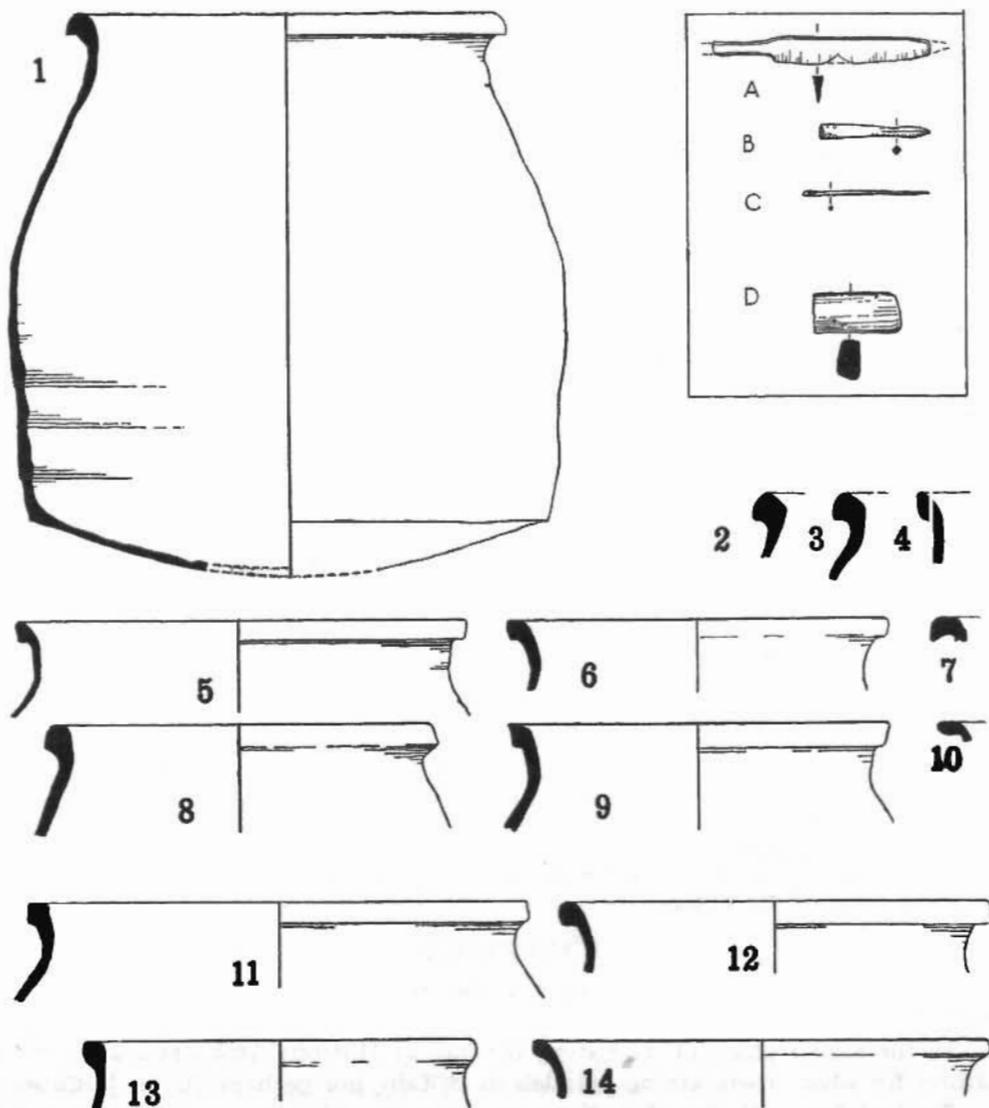
Fig. 8. Pottery and small finds (†)

BRONZE. *Needle* (fig. 8, C). The needle is 2.7 in. long and rather thick; the head hammered flat and a large oval eye bored through it. Found in the hall.

IRON. *Knife* (fig. 8, A). Blade and part of tang. The tip of the blade missing, but overall length 3.5 in. Found in the hall.

WHETSTONE. A fragment, 1.8 in. long, was found in the hall area (fig. 8, D). Both upper and lower surfaces were smoothed by rubbing. Mrs. June E. Morey of the Geological Survey has kindly written the following report:

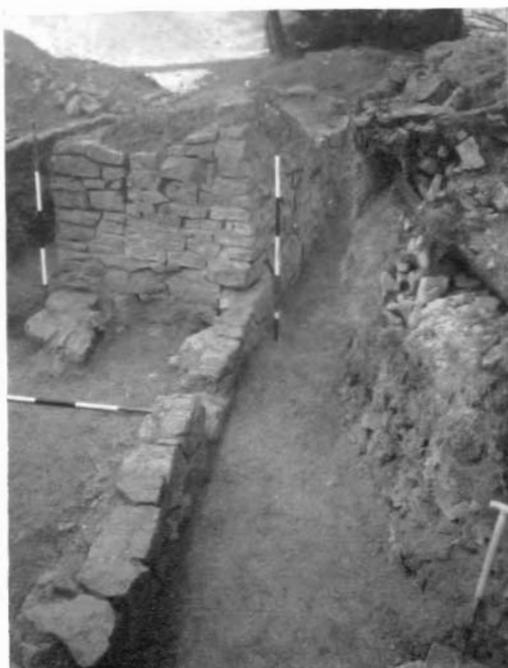
B. The wall embedded in the bank at the S.-E. corner of the enclosure
HUTTONS AMBO, YORKSHIRE

About 20 ft. further S. the rubble bank stood 8-9 ft. high. Excavation here revealed a wall 5 ft. 6 ins. to 6 ft. thick and preserved for a length of 35 ft. This wall was curiously placed in relation to the visible features (see fig. 1, letter 'N'). It was just beyond the S.E. angle of Enclosure II, across the main axis of the S. rampart at an angle of about 30°. At its S.E. end its foundations vanished very close to the ditch. To the N.W., 20 ft. away, the upstanding wall ended in a squared face 6 ft. high (Pl. XIVB), but the foundations continued on each side without a break, the N. face for only 2-3 ft., the S. for 14-15 ft., with a well-marked tendency to curve outwards to the S.
