# ROMAN BRIDGES ON DERE STREET, COUNTY DURHAM

## WITH A GENERAL APPENDIX ON THE EVIDENCE FOR BRIDGES IN ROMAN BRITAIN

By D. P. DYMOND

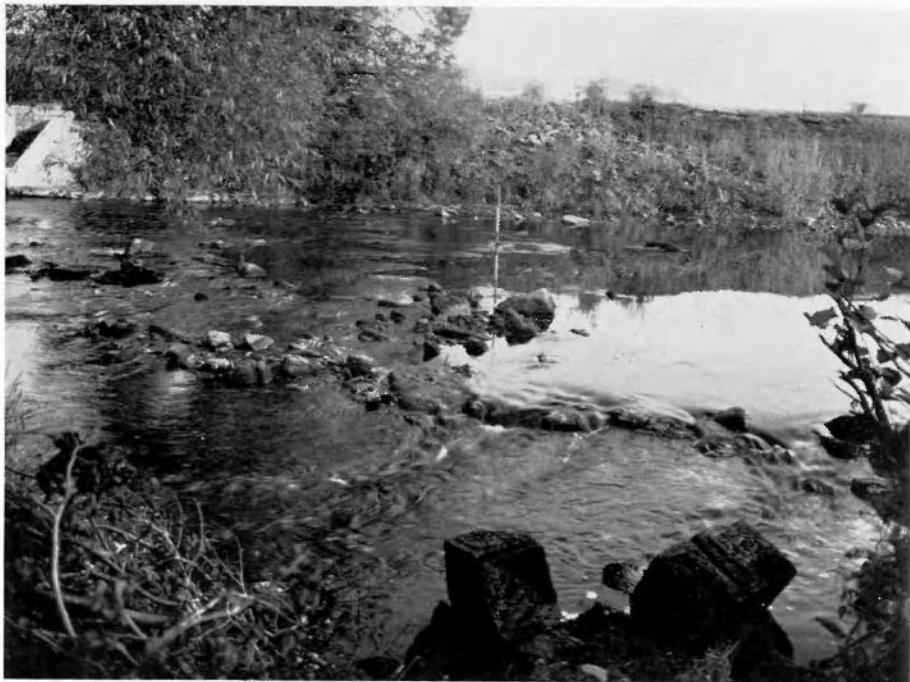
A. Site of bridge over river Wear, near Binchester  
*(Crown Copyright)*

There is no doubt as to the exact point where Dere Street crossed the River Wear. On the west side of the river the line is fossilized in a modern raised trackway, and on the east, although the course has not been visible for at least 100 years<sup>1</sup>, the metalling was found in 1911-12 during the making of the Sewage Farm<sup>2</sup>.

When the site was first visited in March, 1959, nothing was visible on the east bank of the river, but the western (under much undergrowth and half buried in mud and water) produced three rusticated stones. A further visit in August, 1959, during the exceptionally dry summer, revealed another rusticated stone and several squared blocks lying in the river-bed. It is significant that, where Dere Street crossed, a line of stones lies in the river-bed forming minor rapids. The present width of the river is 80 ft.; the width and direction may have been slightly different in Roman times.

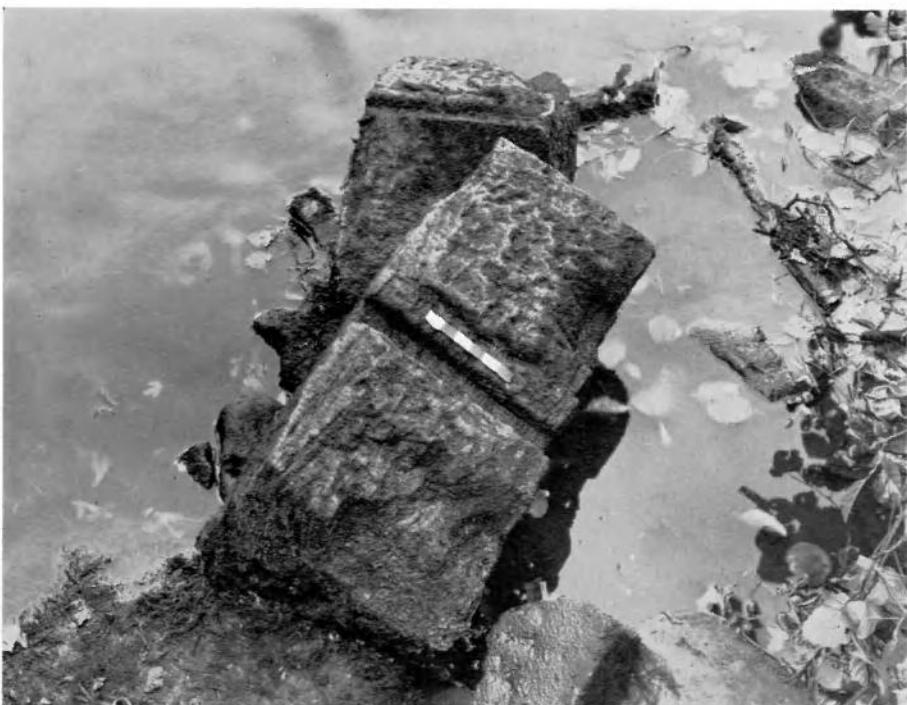
B. Fallen masonry in river Wear, near Binchester  
*(Crown Copyright)*

1. A large block, 2 ft. 8 in. by 1 ft. 2 in. by 1 ft. 4 in. The upper surface shows two distinct panels of rustication, with smooth chiselled edges, separated by a central groove. One end of the stone showed half a broken groove, similar to the central one. The other end was broken, but there seemed to be a rough chamfer for two-thirds of the width of the stone. At the side of one of the rusticated panels was a nick (possibly the remains of a cramp-hole). One surface showed distinct marks of rough dressing with a pick.

2. A trapezoidal block, 1 ft. 7 in. by 10 in. by 1 ft. 1½ in. Two surfaces bore rusticated panels with chiselled edges similar to the first stone; other resemblances were half a groove next to one rusticated panel, and a broken nick at the edge of another. The angle between the rusticated surfaces and the sloping one was approximately 128°.

3. A large stone buried in the western bank, with only one surface completely visible; this measured 3 ft. by 1 ft. 1 in. and bore distinct criss-cross tooling marks. It was possible to feel a small area of the under-surface; this was rusticated with chiselled edging.

4. A rectangular block in the stream-bed, approximately 20 ft. from the western bank, showing at least one rusticated surface with chiselled edging.

All the stones which had been shaped, rusticated and plain, consisted of the same yellow sandstone, the local carboniferous rock. The rusticated panels were not all of the same size, but there was an overall similarity, which implied that they came from the same structure — probably a bridge with stone piers and a timber superstructure<sup>1</sup>. Although the four rusticated stones had been eroded by the river, it seems probable that the rustication was artificial and that the panels had been considerably tooled to produce a vermiculated effect. No. 2 is particularly interesting for its shape. By analogy with the stones from the Roman bridge at Summerston or Chesters (see p. 157) it may come from a pier, at the angle where the cut-water joined. Alternatively, it could come from the angle of a splayed stone abutment. It is not yet possible to point to a similar use of rustication within the fort of Binchester — this might provide some clue to the date of the bridge. If the interval between the piers was the same as at Corbridge, the Binchester bridge would have had three or four piers in the river.

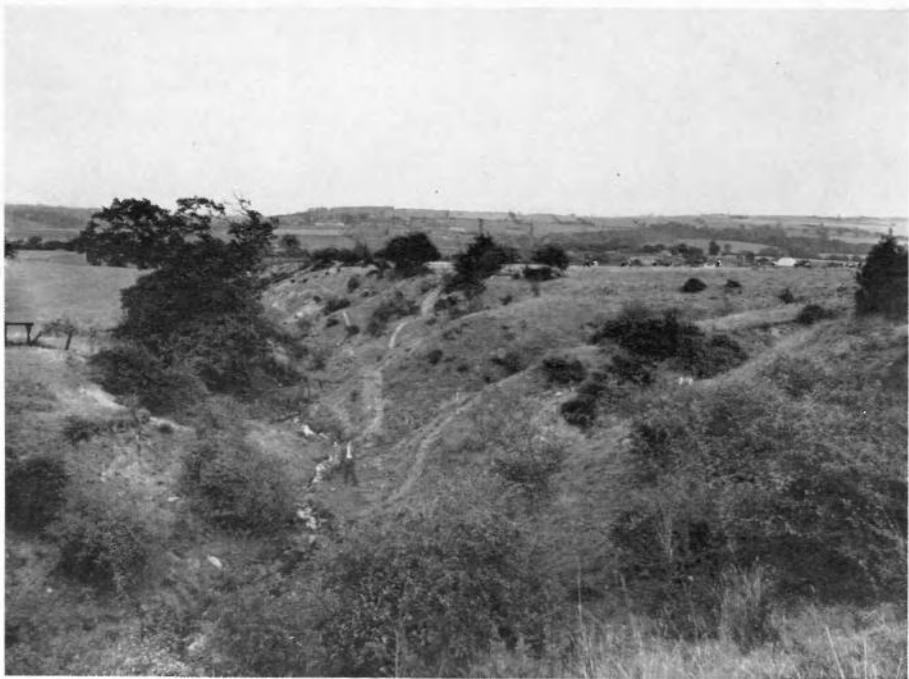
A. Site of bridge over Hunwick Gill from S.W.  
*(Crown Copyright)*

Three-quarters of a mile to the north-west of the Binchester crossing, Dere Street had to negotiate the steep-sided and narrow Hunwick Gill. This gill, 50 ft. wide from lip to lip and 20–25 ft. deep, is sharply riven in the surface of a plateau. It is therefore too steep and narrow to have been negotiated by a zig-zag. In addition, the road on each side leads to the very lip of the gill (Pl. VIII). The only possible interpretations of the existing earthworks are that the road crossed by a bridge or by a solid causeway. The latter can be dismissed, as there is no trace of the causeway or a washed accumulation of soil downstream. Dere Street must therefore have crossed the gill by means of a bridge, which was almost certainly wooden. The gill was carefully searched for dressed stones, but none were found. Although the abutments are somewhat eroded, excavation might well reveal the post-holes of a timber bridge<sup>2</sup>.

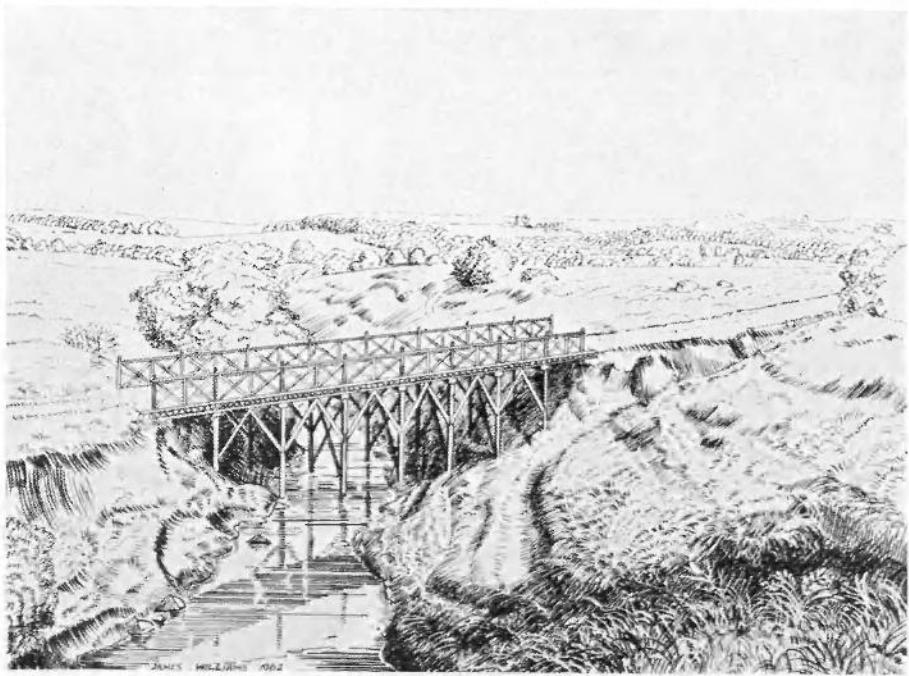
B. Reconstruction of bridge over Hunwick Gill

<sup>3</sup> A reconstruction of the Hunwick bridge, based on the military bridges illustrated on Trajan's Column in Rome is shown in Pl. VIIIB. The main structural features of these bridges seem to be the stout upright timbers and the diagonal bracing, a flat roadway and a criss-cross parapet.

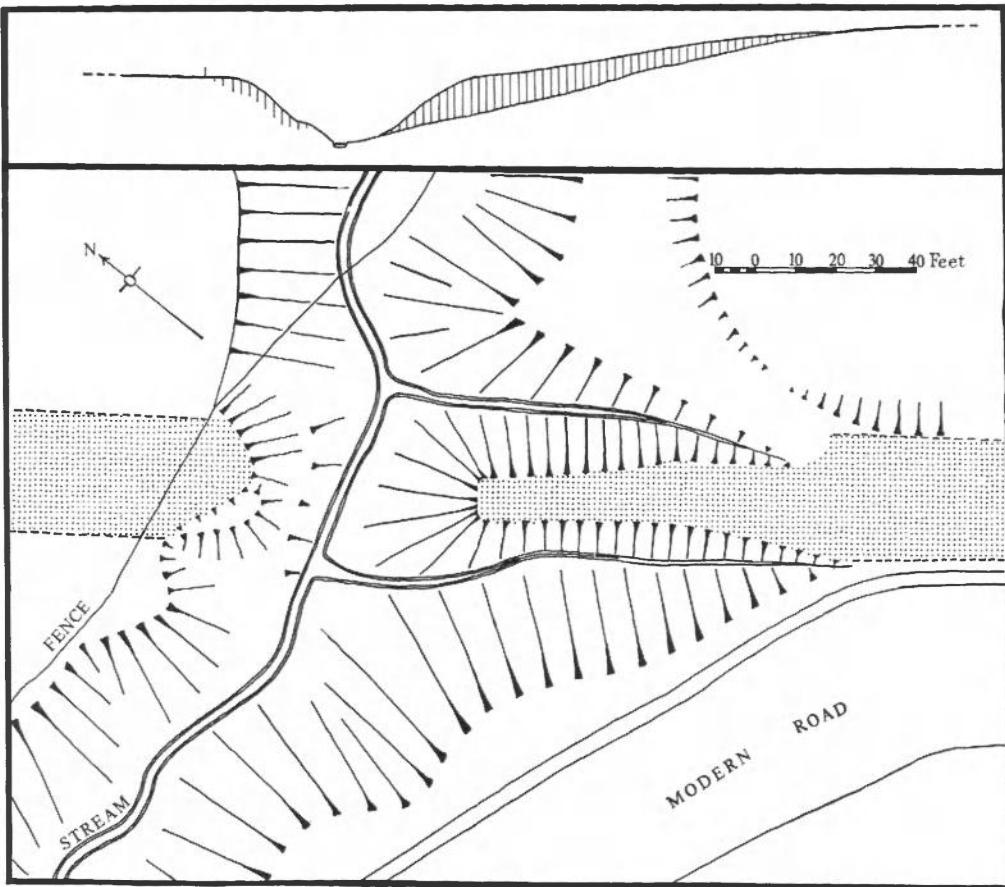
Fig. 2. Bridge abutments at Hunwick Gill

abutment is 40 ft. wide with a flat top, representing the roadway, 11 ft. wide. Although erosion has taken place, the original width of the bridge was probably not much greater than 11 ft. From this and other sites, it seems likely that the timber bridges and their abutments were narrower than the normal width of the roads. Perhaps such bridges would only be able to take one-way wheeled traffic<sup>1</sup>.

The eastern causeway and abutment undoubtedly carried a roadway which was narrower than the normal width of Dere Street (30–35 ft.)<sup>4</sup>. The present

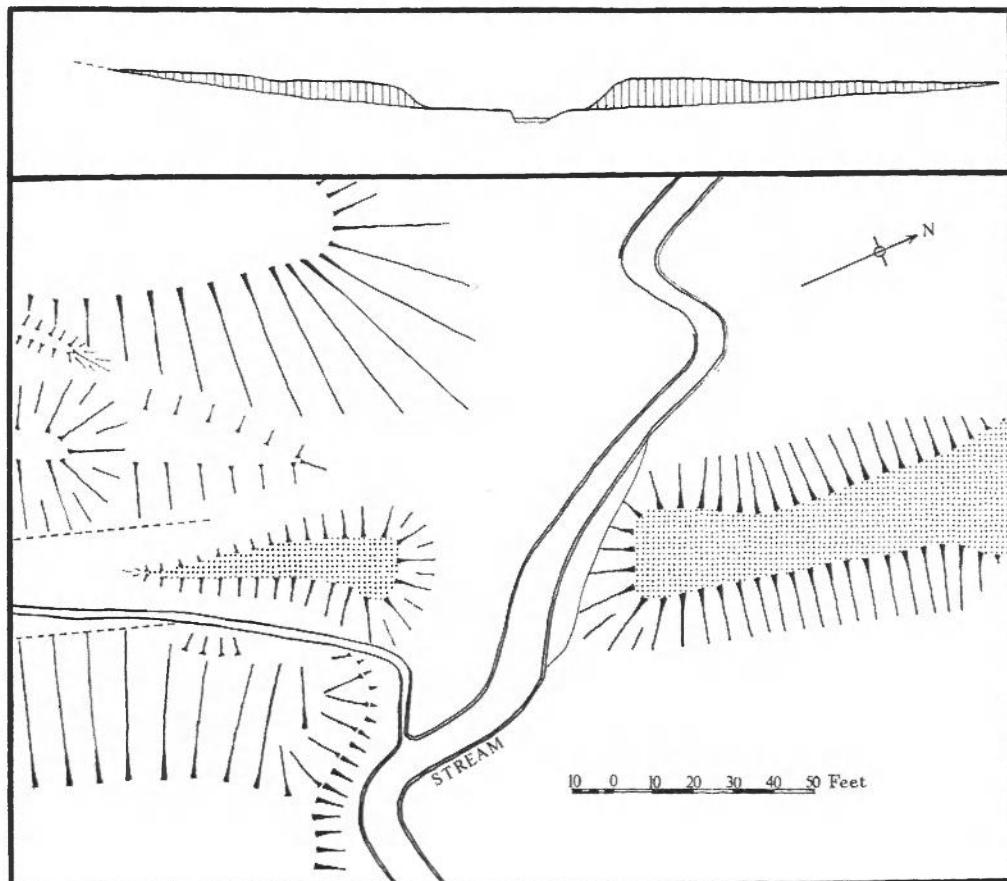
Fig. 3. Bridge abutments at Stockley Gill

On both sides the road ran up on to a considerable ramp or causeway, which stopped abruptly at the edges of the stream to form abutments 8-9 ft. high. The southern abutment was 36 ft. wide with a flat top 16 ft. wide; the

northern was 44 ft. wide with a flat top 22 ft. wide; they are thus wider on top than the eastern abutment at Hunwick Gill, but again not as wide as the normal agger. These large abutments consisted mainly of earth and cobbles and were 60 ft. apart<sup>1</sup>. No indication of a stone structure was found.

#### THE BRIDGE ABUTMENTS AT STOCKLEY GILL (Grid Ref. NZ 197380) (Fig. 3)
