HISTORIC BUILDING RECORD

EGLOSERME FARM BUILDINGS

ST ERME, CORNWALL

May 2013

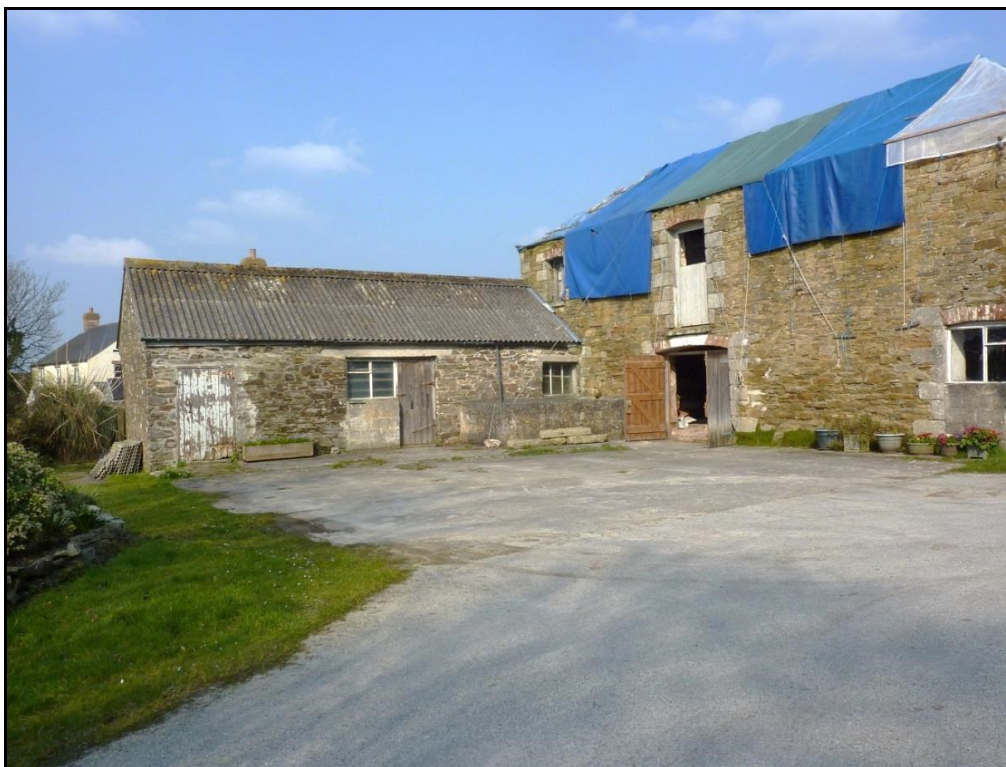
3.1 Yard and Cow House B (left) and Barn A (right) from the south east

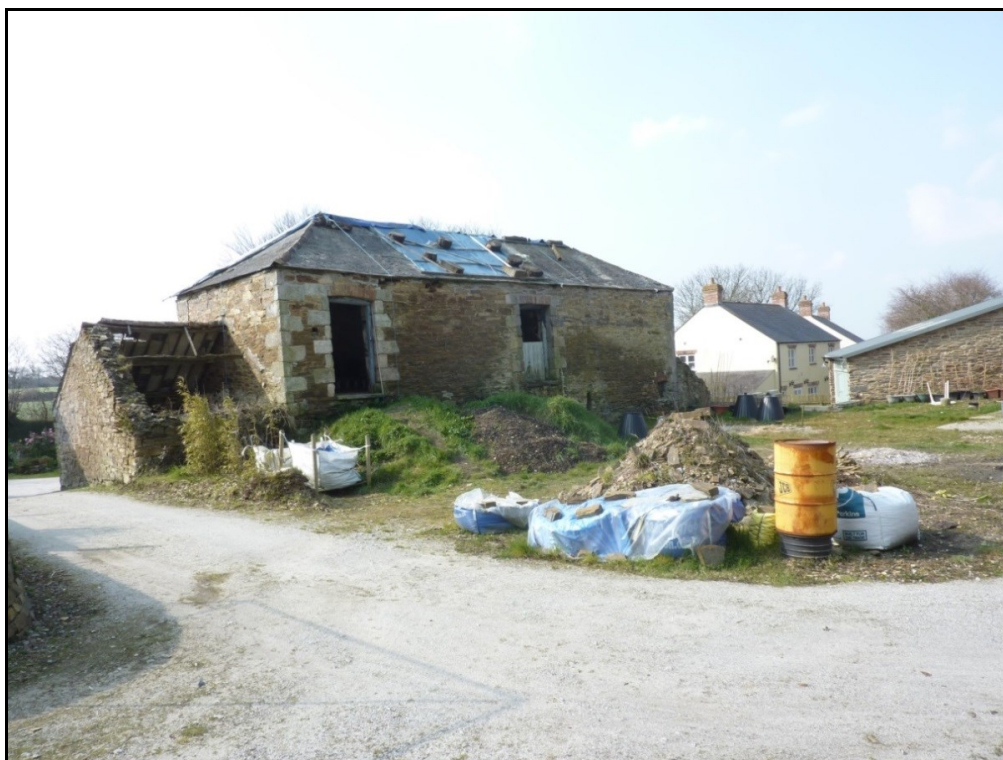
3.2 Cart Shed D and Barn A from the north east

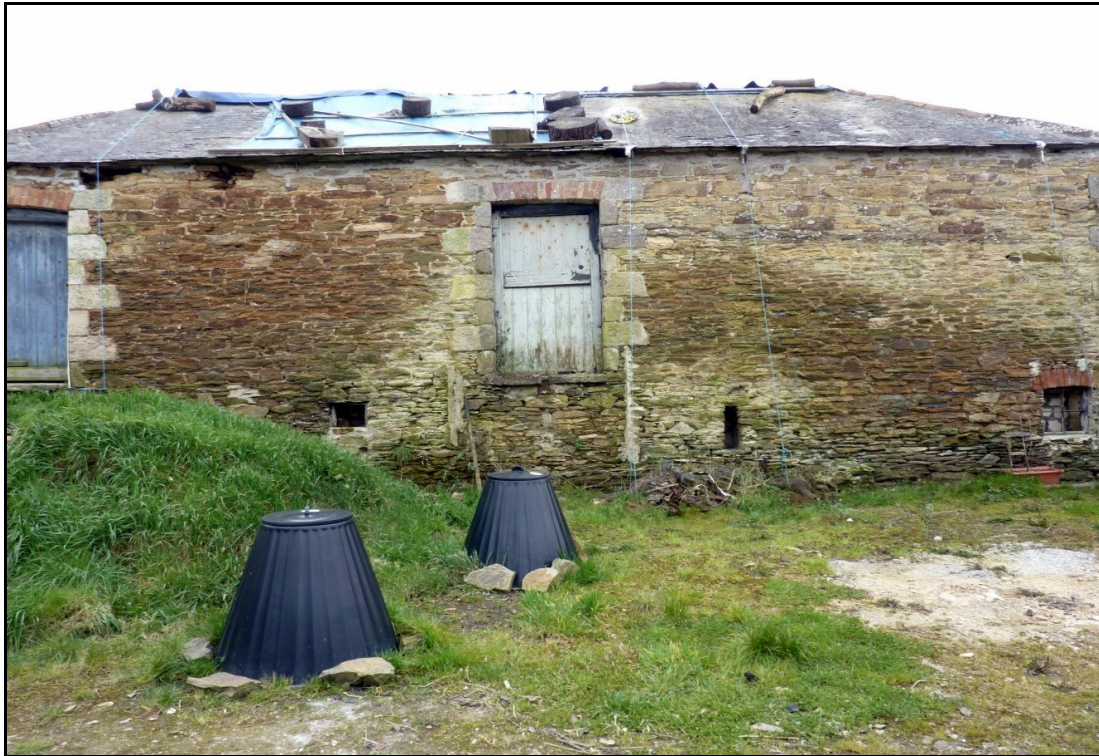
3.3 Barn A exterior of north face

The back (north) face of the barn had five ventilation and window openings at ground floor level which are all now completely or partially blocked. Two of these were vertical slits in the stone wall (O2 & O7). A wider square opening (O1) with a wooden frame, served as a window. A window opening with a brick head originally provided light into the west corner of the shippon. These were evidently blocked up when the interior was modernised and concrete facings were built against the inside of the north wall. A ceramic pipe ventilator (O6) was inserted later and is blocked with plastic sheeting.

The north face of the Barn has three doors at first floor level. The central door (DF3) is opposite the equivalent door (DF1) on the south side. These opposing doors indicate that this was originally designed as a threshing barn as they could have provided through draughts to separate the chaff from the grain.

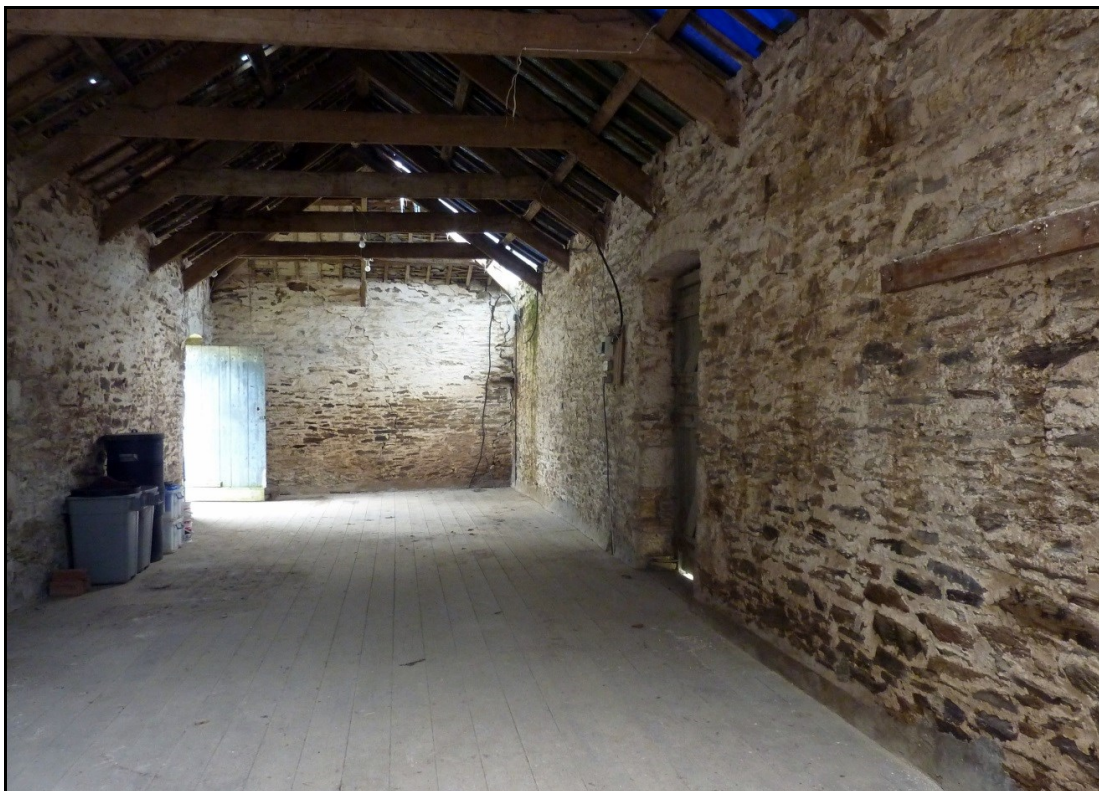
3.4 Barn A Upper Floor looking west

Roof. The hipped roof is of six bays with trusses halved and nailed to a ridge purlin. The trusses are set within the upper part of the wall and supported on small wedges. The collars are shaped, lapped and nailed onto the west side of the trusses. There are through purlins. The underside of laths are plastered in some places.

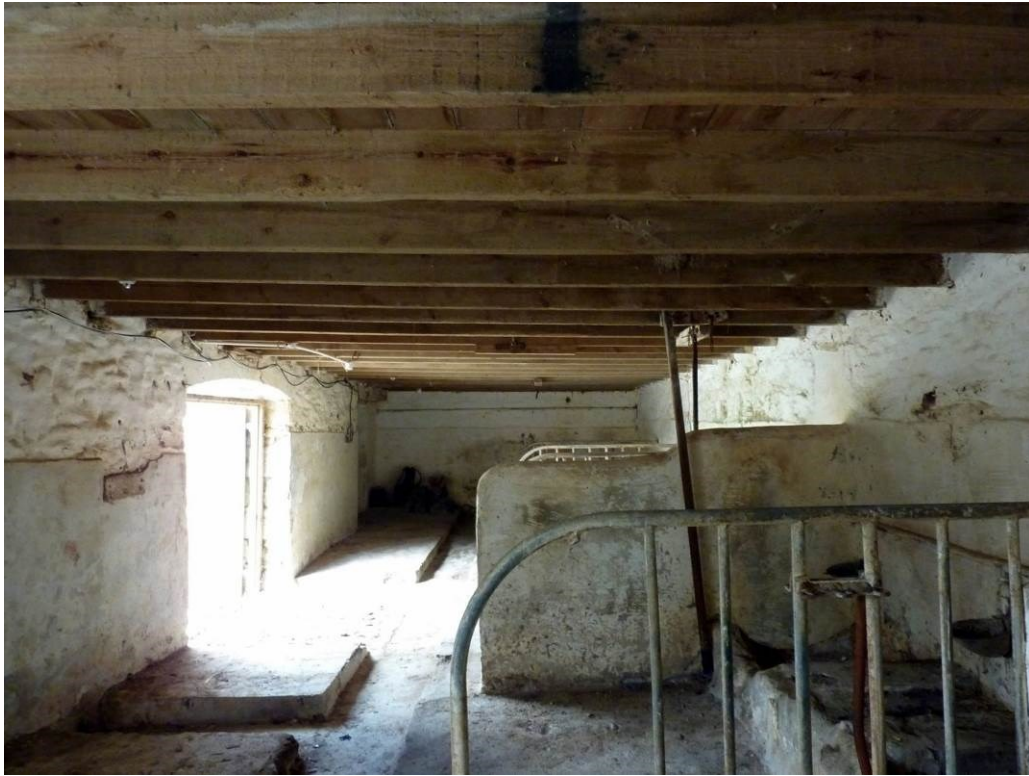
3.5 Barn A Ground floor Cow Shed looking west

This has a low wooden ceiling giving a height of around two metres above the concrete floor. This is typical of 19th century Cornish shippons with barns above. The cow house was modernised probably in the 1950s by creating concrete stalls and flooring within the original stone building. The walls are lime washed. It has six stalls along the north wall each designed to take two cows and has a potential capacity for twelve cows.

The cows would have entered from the south side of the building and been tethered by chains to metal poles known as *stiddles*. Paired concrete feeding troughs and automated water basins were provided in each stall against the north wall. There was no separate access on the north side to allow filling of the troughs.

Five patent metal partitions with adjustable tethering rods (with the maker's name of "King") remain *in situ*. Two home made metal stiddles were put up alongside the one concrete partition between stalls S4 and S5. Fragments of tethering chains survive with one complete example in stall S6.

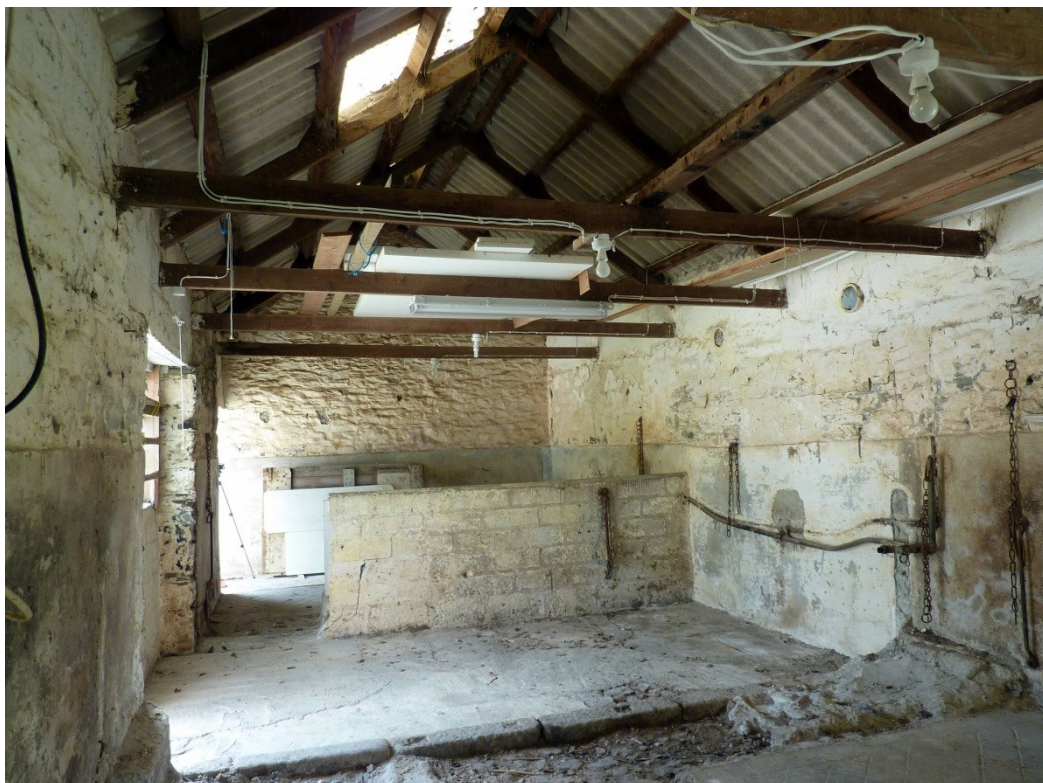
3.6 Cow Shed B looking south

This Shippon differs from that in Building A and originally was laid out as three bays, each with separate access. This, like the other cow house, had been modernised with concrete partitions and flooring and was lime washed.

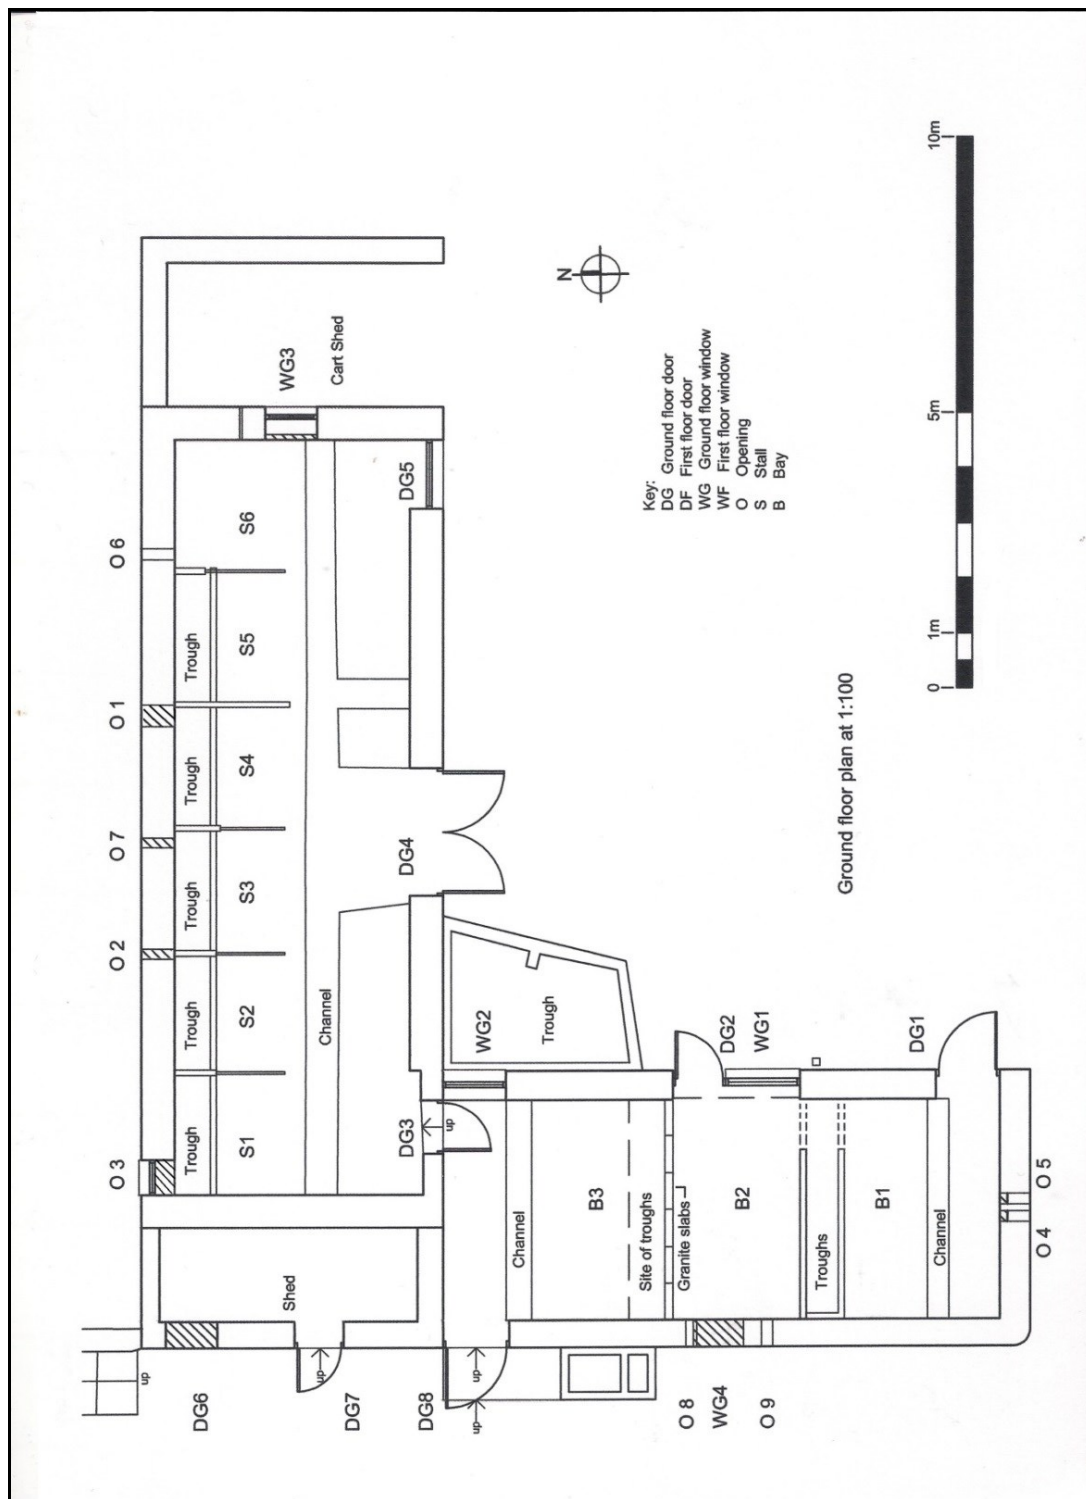
6.3 Ground Floor

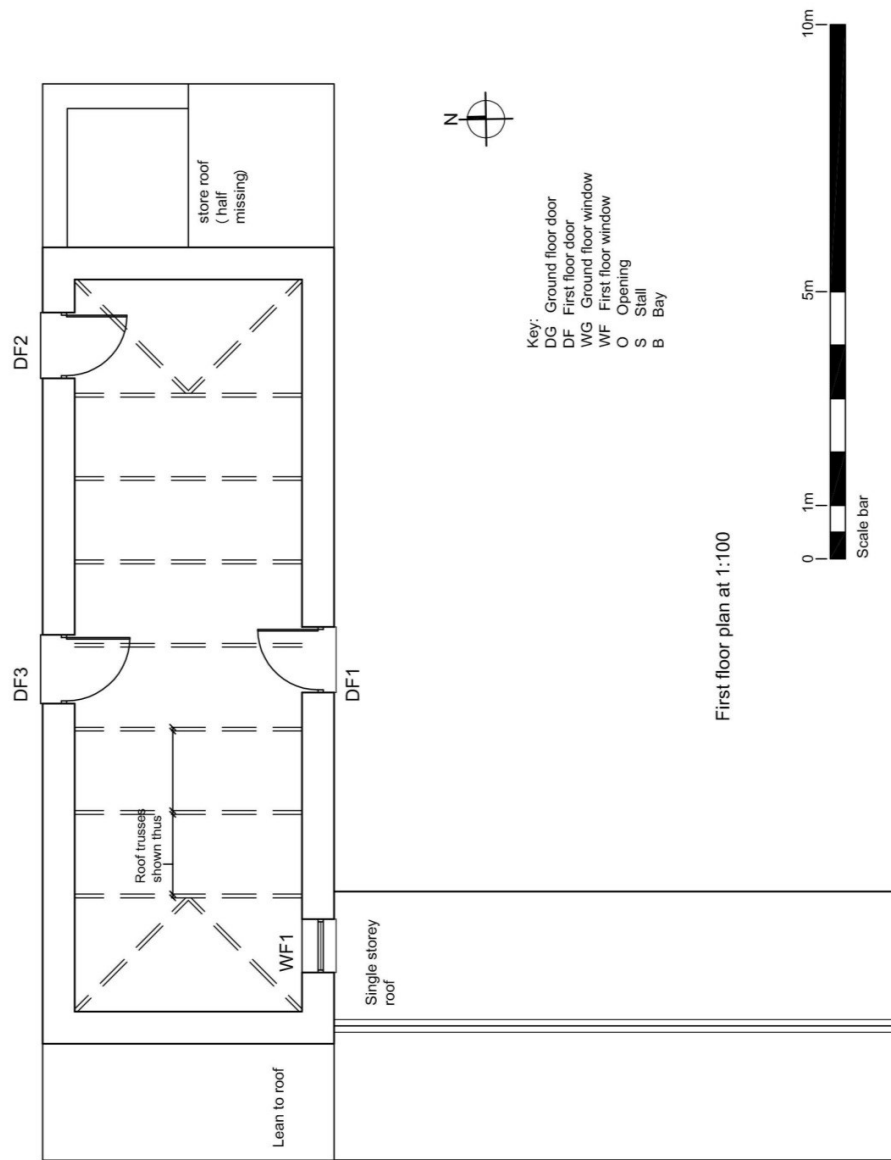
6.4 First Floor

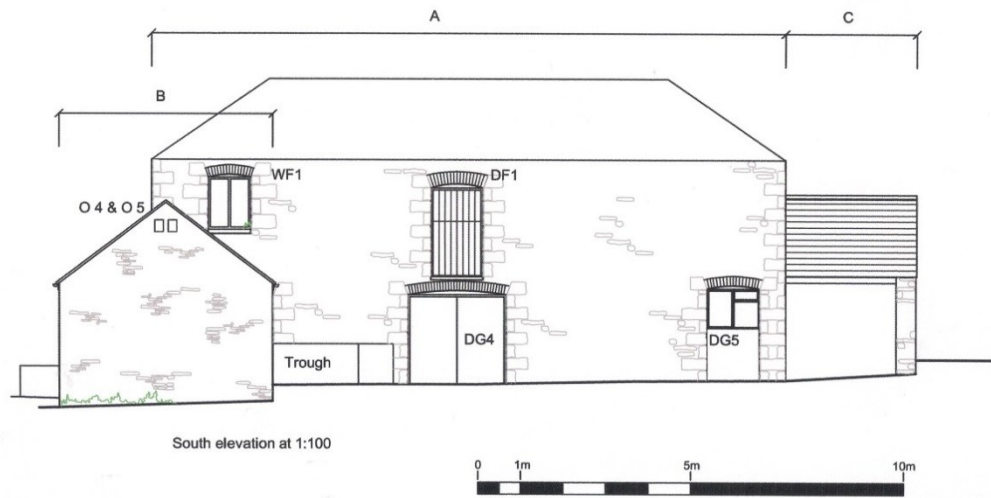
6.7 South Elevation

The two storey Cow House and Barn faces south and has three doors at ground level (DG3, DG4,DG5) and a window and central door at first floor (WF1, DF10) on the south face. The wide ground floor door (DG3) at the left end was later altered to provide access to the single

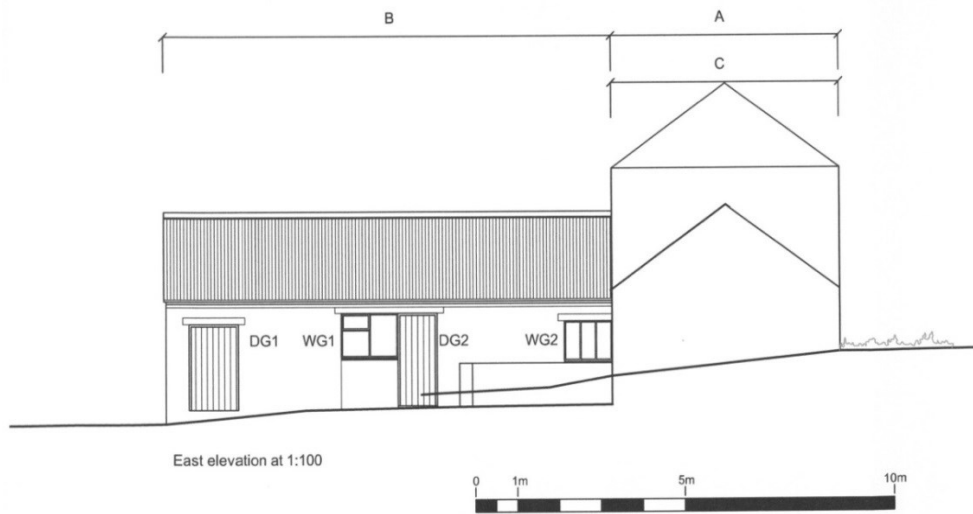
6.8 East Elevation

The east side of the building has a single ground floor window (WG3) now hidden by the Cart Shed. This still has its original wooden frame and shutters and has a failing brick arch. It is blocked on the inside.

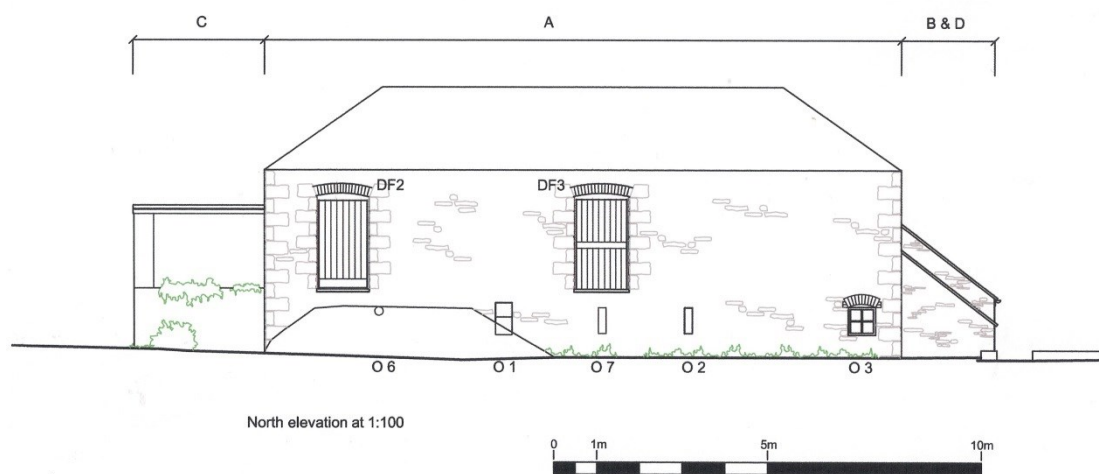
6.9 North Elevation

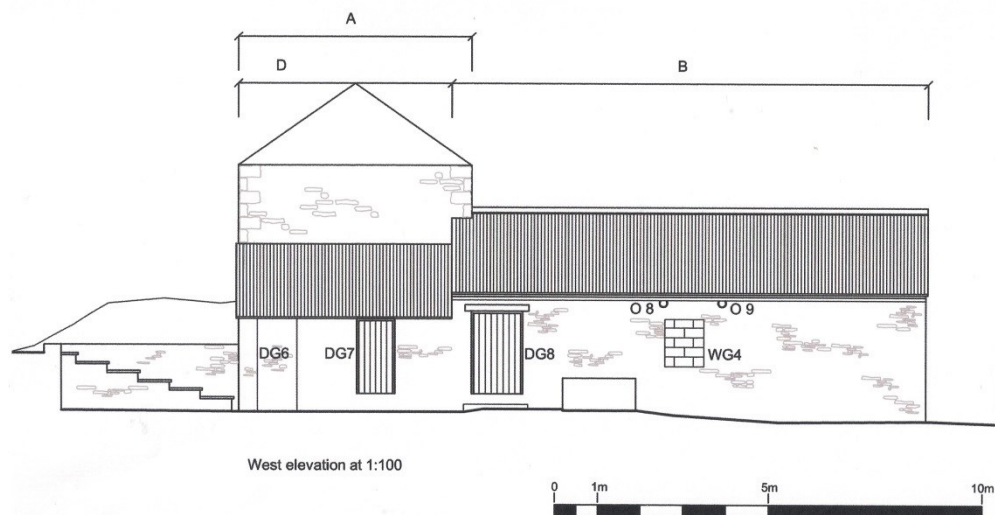
6.10 West Elevation

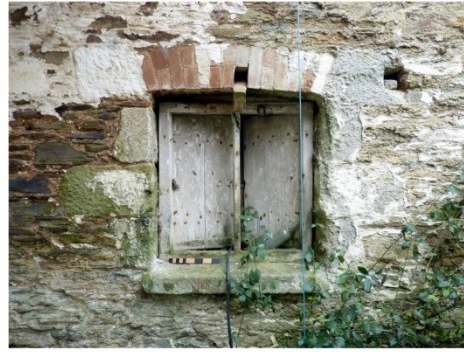
10 Egloserme A east face -Window WG3

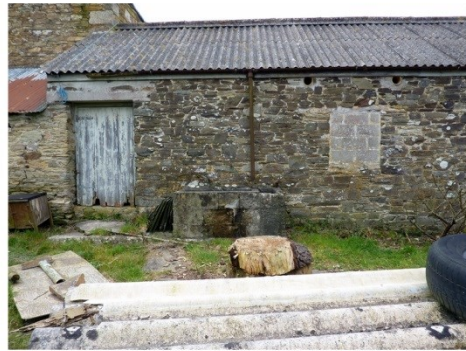
22 Egloserme B north side - DG8 and WG4

Bay B3 has a row of narrow granite stones lying east-west which originally supported a partition and support for concrete feeding troughs. The scar from the partition can be seen in the west wall. This partition and the troughs were removed after 1992. The slurry drain runs out through the door in the rear wall (DG8).

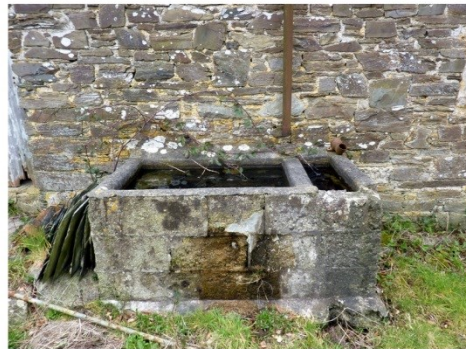
24 Egloserme B trough

A large concrete block-work trough in the angle between the buildings A and B is presumably a water tank. It has a small drain at ground level. A smaller block-work trough at the back of cow shed B collects rain water.

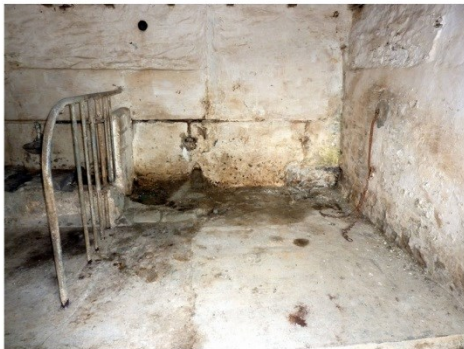
5 Egloserme A Cow House - stall S6 and chain

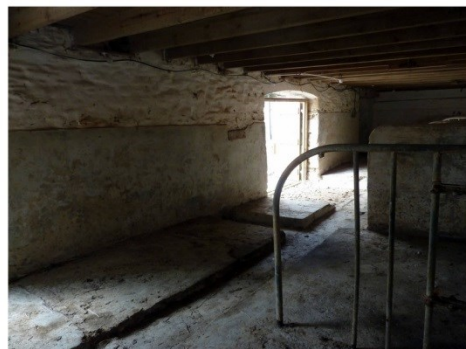
8 Egloserme A Cow House slurry channel and door DG4

A drain to take slurry runs the length of the building with three drainage channels into the yard to the south. Water pipes and electric wiring and lights are surface mounted.

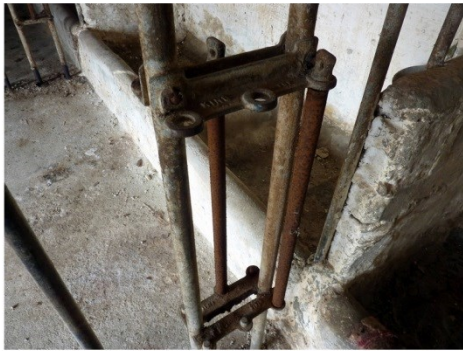
11 Egloserme A Cow House- adjustable tethering rods

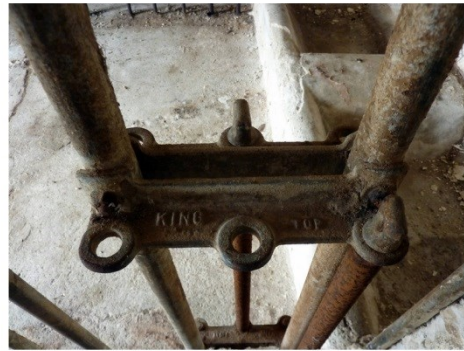
12 Egloserme A Cow House detail makers name

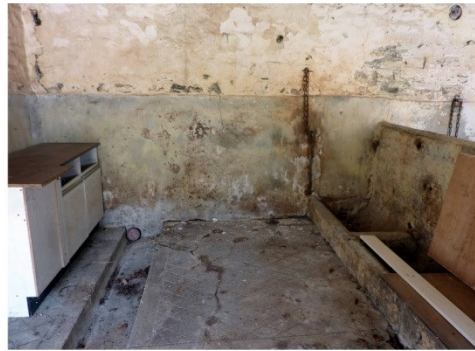
04 Egloserme B Cow shed - bay 1

Bay B1 at the south end originally contained four concrete feeding troughs against an east-west block work partition, now partly removed, which completely separated it from the next bay. It has tethering chains attached to the west wall and a slurry drain running east through the door into the central yard. It was accessed from the yard through door DG1.

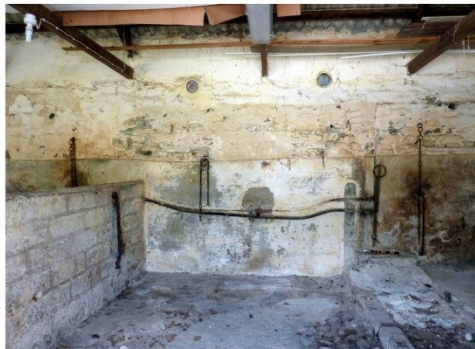
05 Egloserme B Cow shed - bay 2 west wall

Bay B2 in the centre of the building has the remnants of two troughs against the back wall with a water pipe and tethering chain. It is reported that this was the bull pen. The partition separating it from Bay 3 was removed after 1992. Access was from the larger doorway DG2 opening from the central yard (now modified to contain a window and door) and lit in the west wall by window WG4, now blocked.

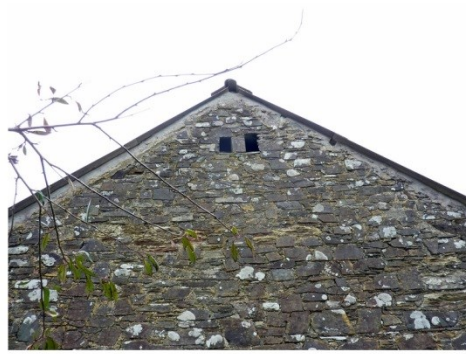
30 Egloserme B - vents near roof O4 and O5

The building was ventilated by slots in the apex of the roof at the south end (O4, O5). Ventilation was improved by secondary insertion of two ceramic pipes in the upper part of the west wall (O8,O9).

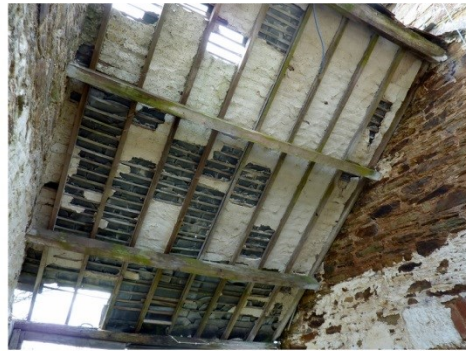
Egloserme C Cart shed roof (FILEminimizer)

An open fronted lean-to Cart Shed with stone walls and a ruinous slated roof has some remnants of plaster sealing between the rafters. It post-dates the main building A as it obscures the window in the east wall.
