**TREE-RING ANALYSIS OF TIMBERS FROM
LOW FARMHOUSE,
CHURCH LANE,
MAPLEBECK,
NOTTINGHAMSHIRE**

June 2007

**ALISON ARNOLD
ROBERT HOWARD**

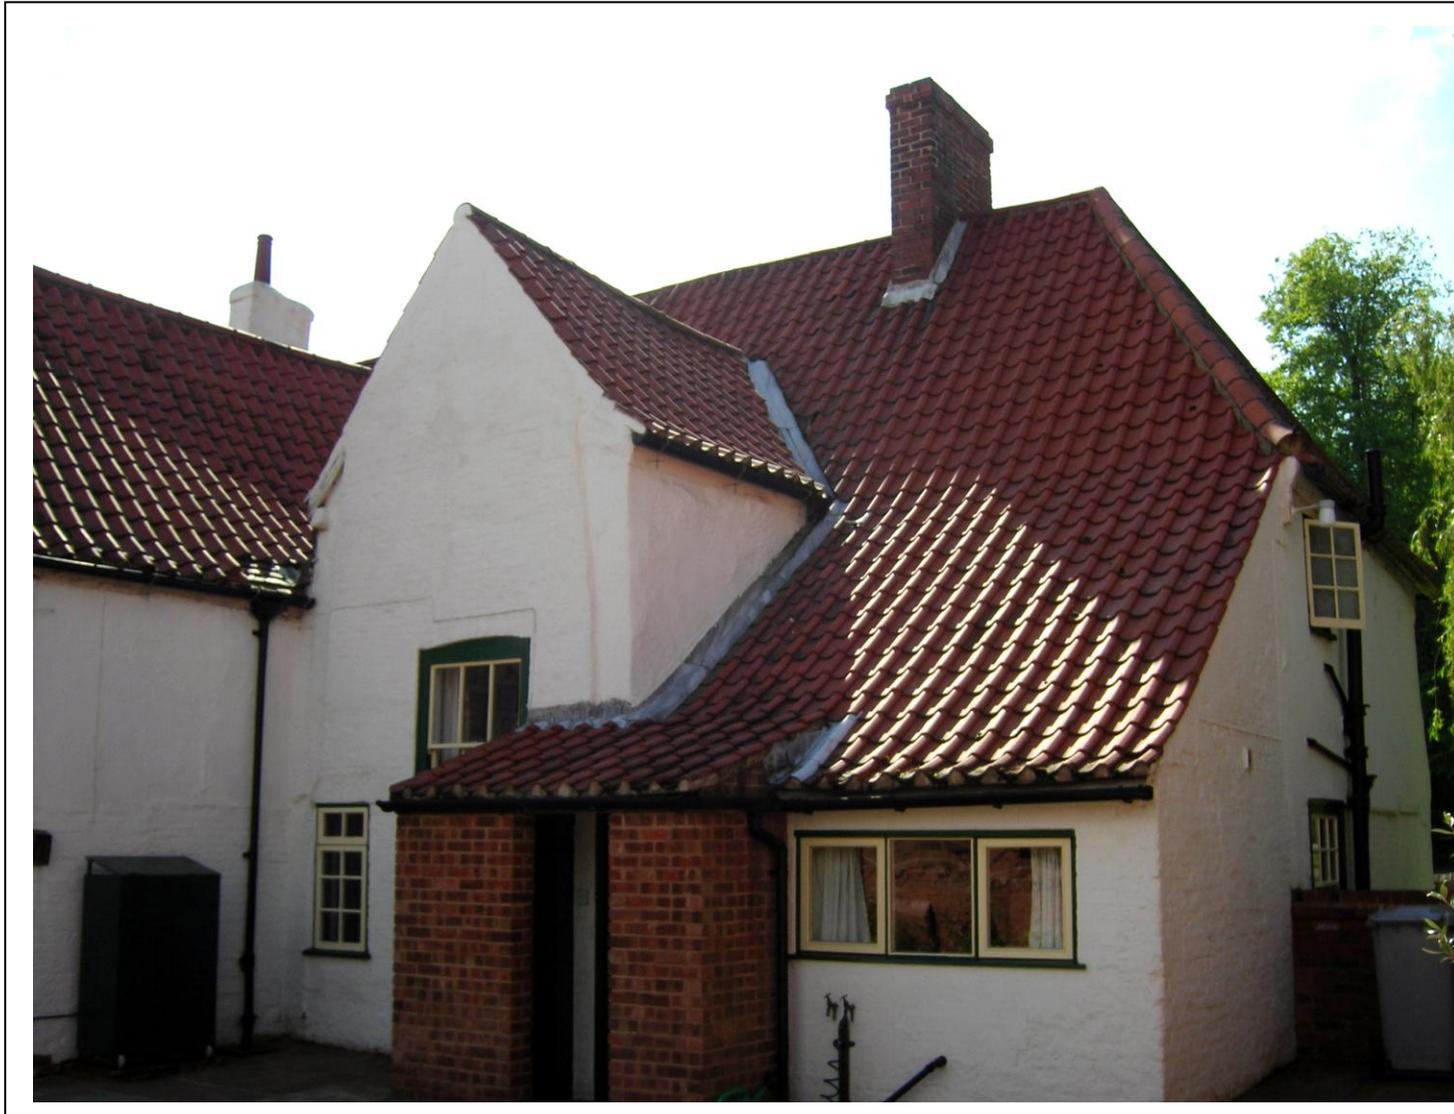
Figure 3: Rear of the property, with the gabled stair turret in the centre

The main range is orientated broadly north-south, is of two storeys, and hipped at the north end. To the rear left (or south) is a further range, orientated east-west. To the rear right (north) is a stair turret (Fig 3) within which is a seventeenth-century dogleg staircase with turned balusters. There is a relatively recent single storey addition to the right of this.

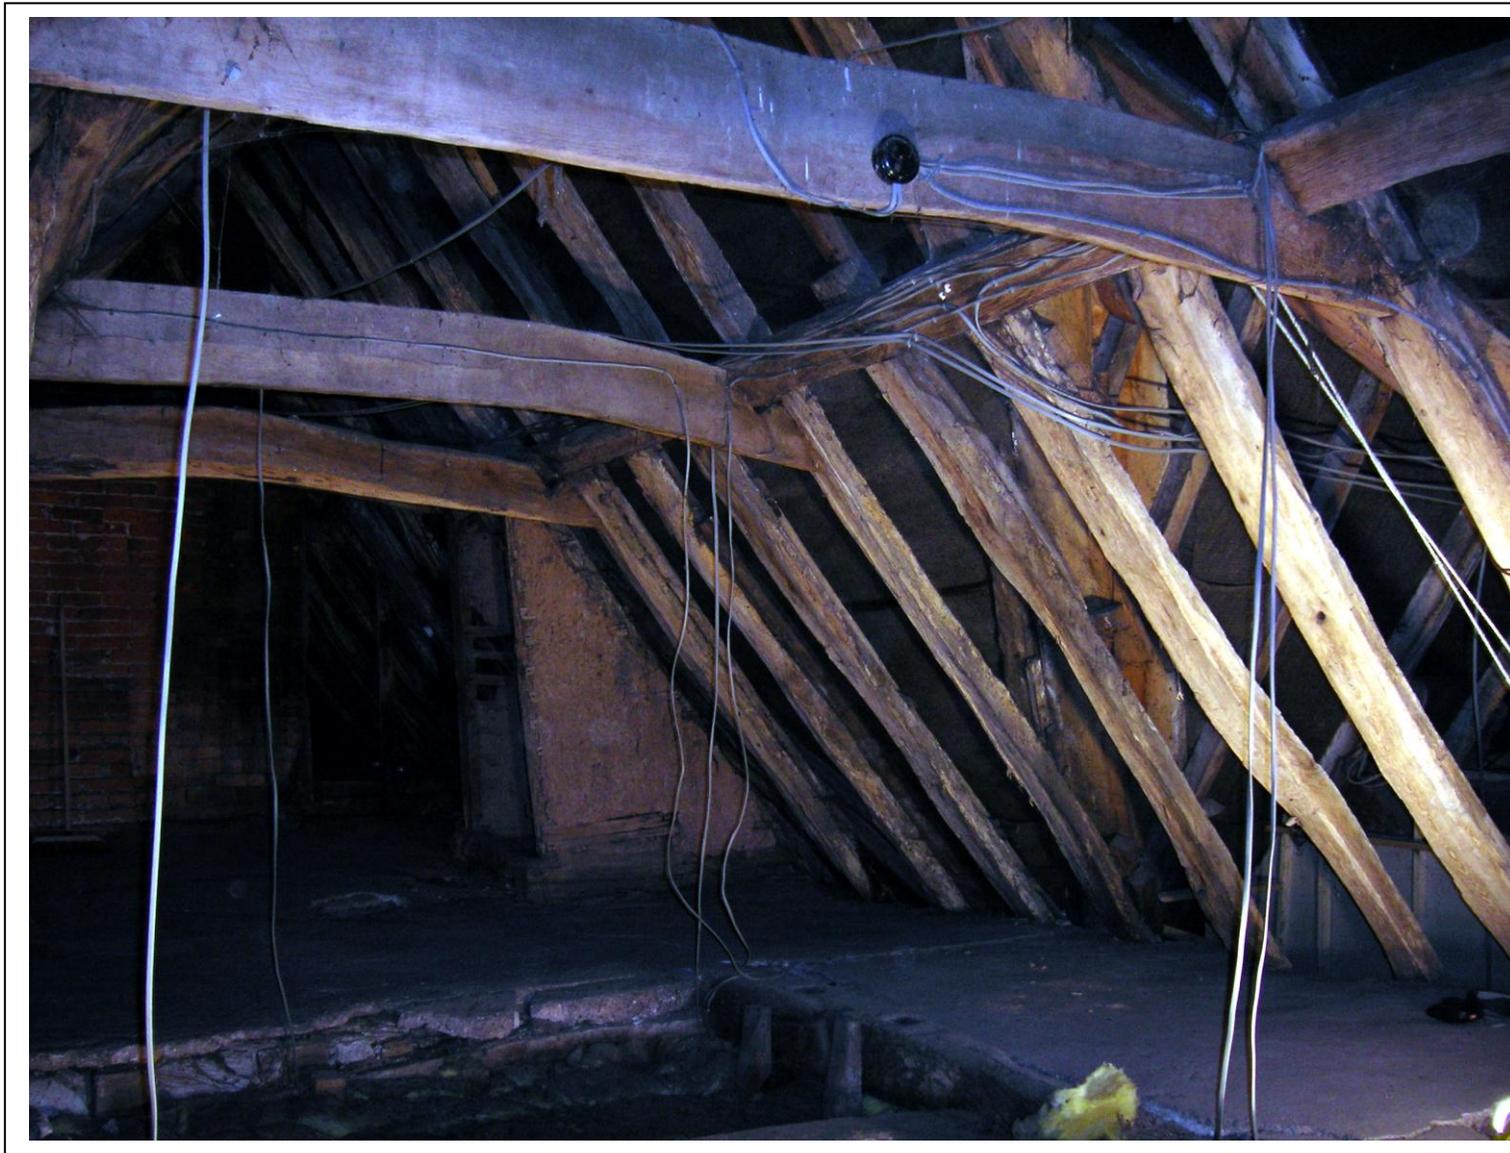
Figure 4: Roof over the main range

The main north-south range is covered by a single roof of eight common rafter trusses with collars, and single purlin to each slope (Fig 4). Between trusses five and six are the remains of a smoke hood (Fig 5). The roof over the stair turret consists of a single principal rafter truss with collar, common rafters between, and a single purlin to each slope. The roof over the second gabled rear wing appears to be a relatively recent replacement.

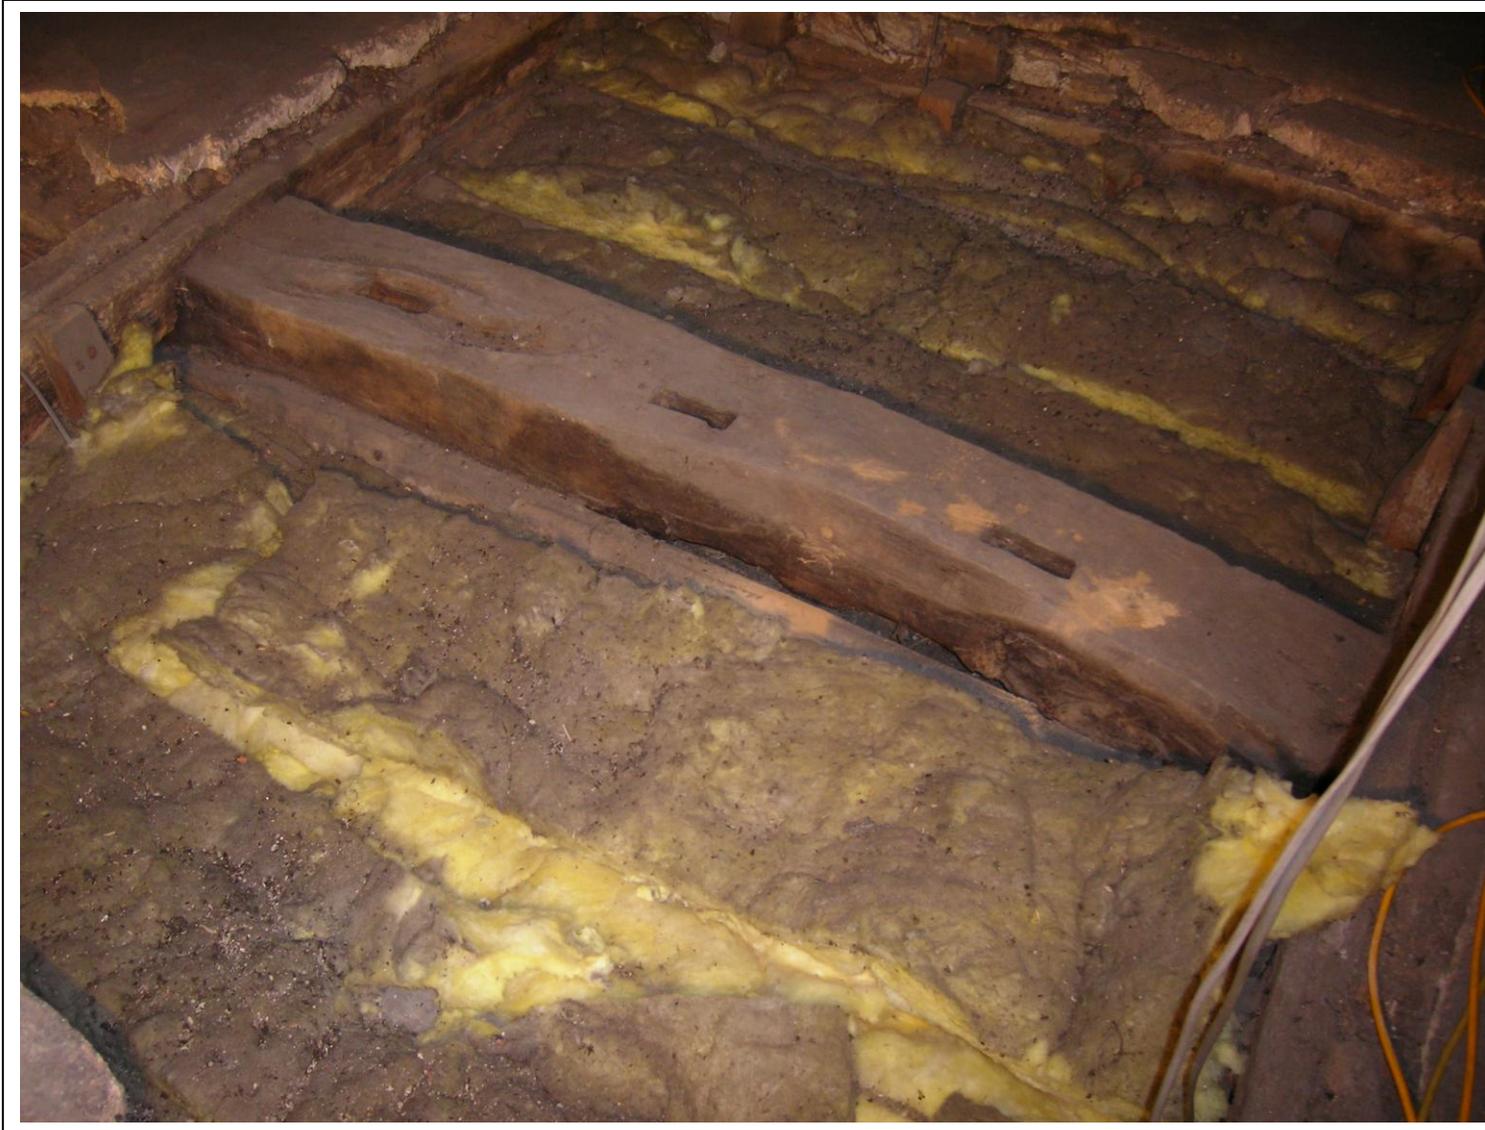
Figure 5: Remains of the smoke hood

Tree-ring analysis has shown that the roof over the main range of the building contains at least three timbers which were felled in AD 1587, with a number of the other roof timbers having a felling date or *terminus post quem* consistent with them also having been felled in AD 1587. Roof timbers have been dated from along the whole length of this roof with the results pointing to it being a single structure rather than being the result of several phases of construction. One of the timbers dated to AD 1587 is from the remains of the smoke hood, which suggests that the smoke hood is original to the extant roof. Therefore, it is thought

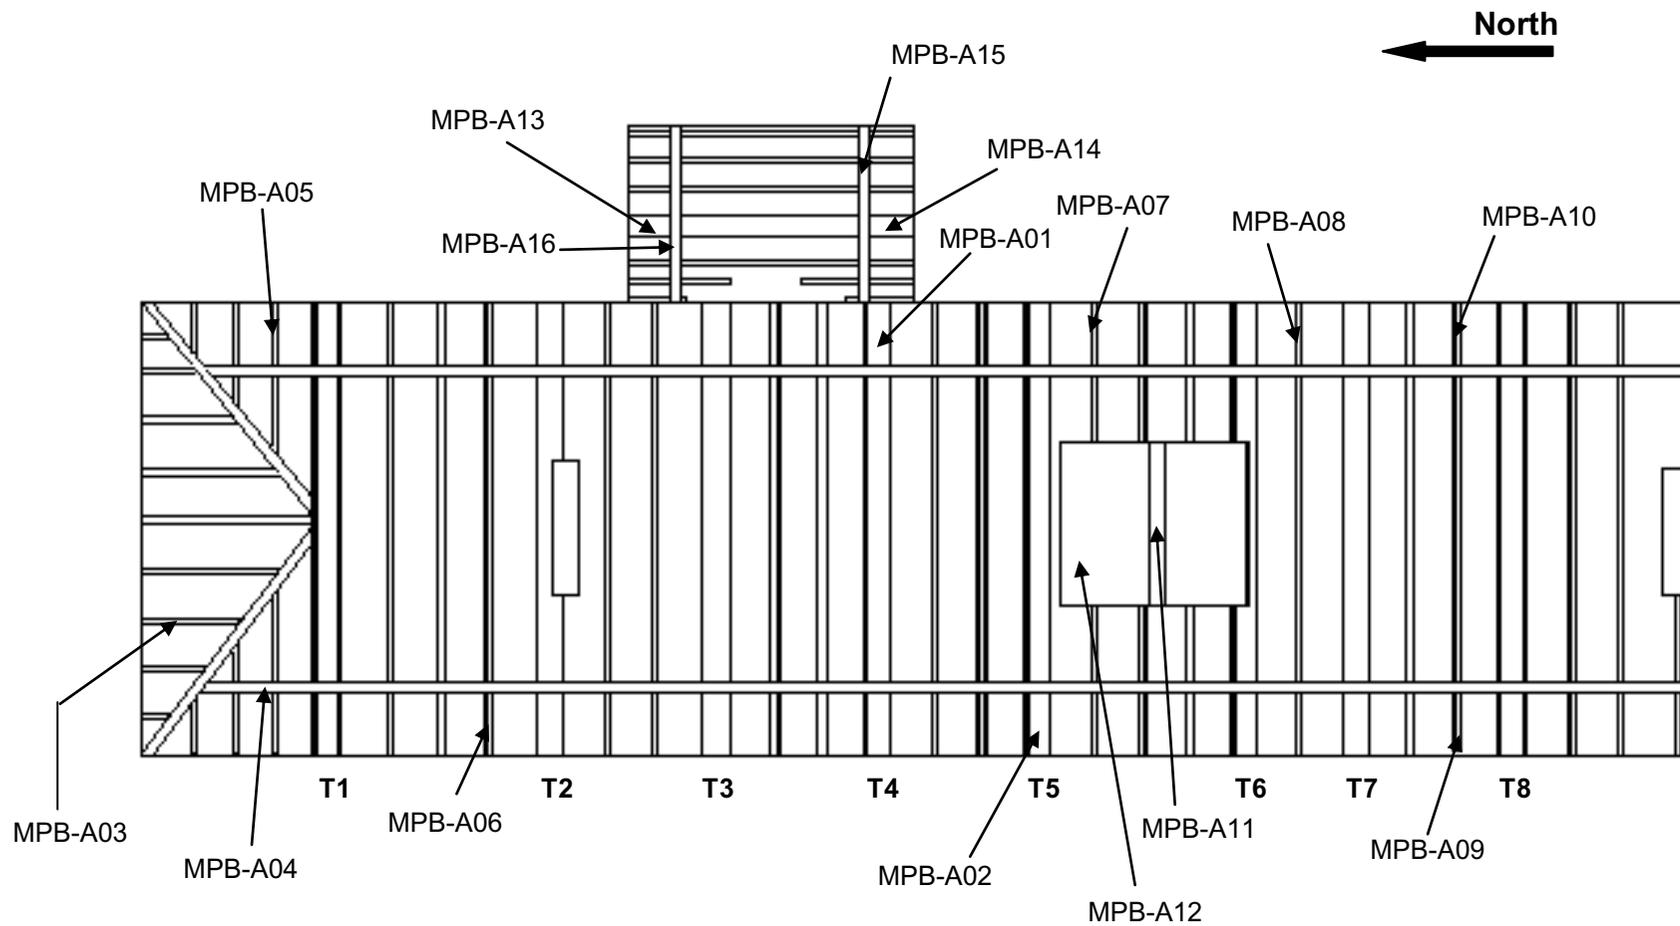
Figure 6: Sketch plan of the roof, showing the location of samples MPB-A01-16

A total of 25 timbers were sampled from various areas in the building. Each core sample was given the code MPB-A (for Maplebeck, site 'A') and numbered 01–25. Thirteen of these samples (MPB-A01–12 and MPB-A17) were taken from the main roof, including one from the smoke hood (MPB-A11) and one from a floor joist (MPB-A12). A further four samples were taken from the small roof over the stair (MPB-A13–16). The remaining samples (MPB-A18–25) were taken from timbers of the main structure of the building and ceiling beams. The location of each sample was noted at the time of sampling and these have been marked on Figures 6–10. Further details can be found in Table 1.

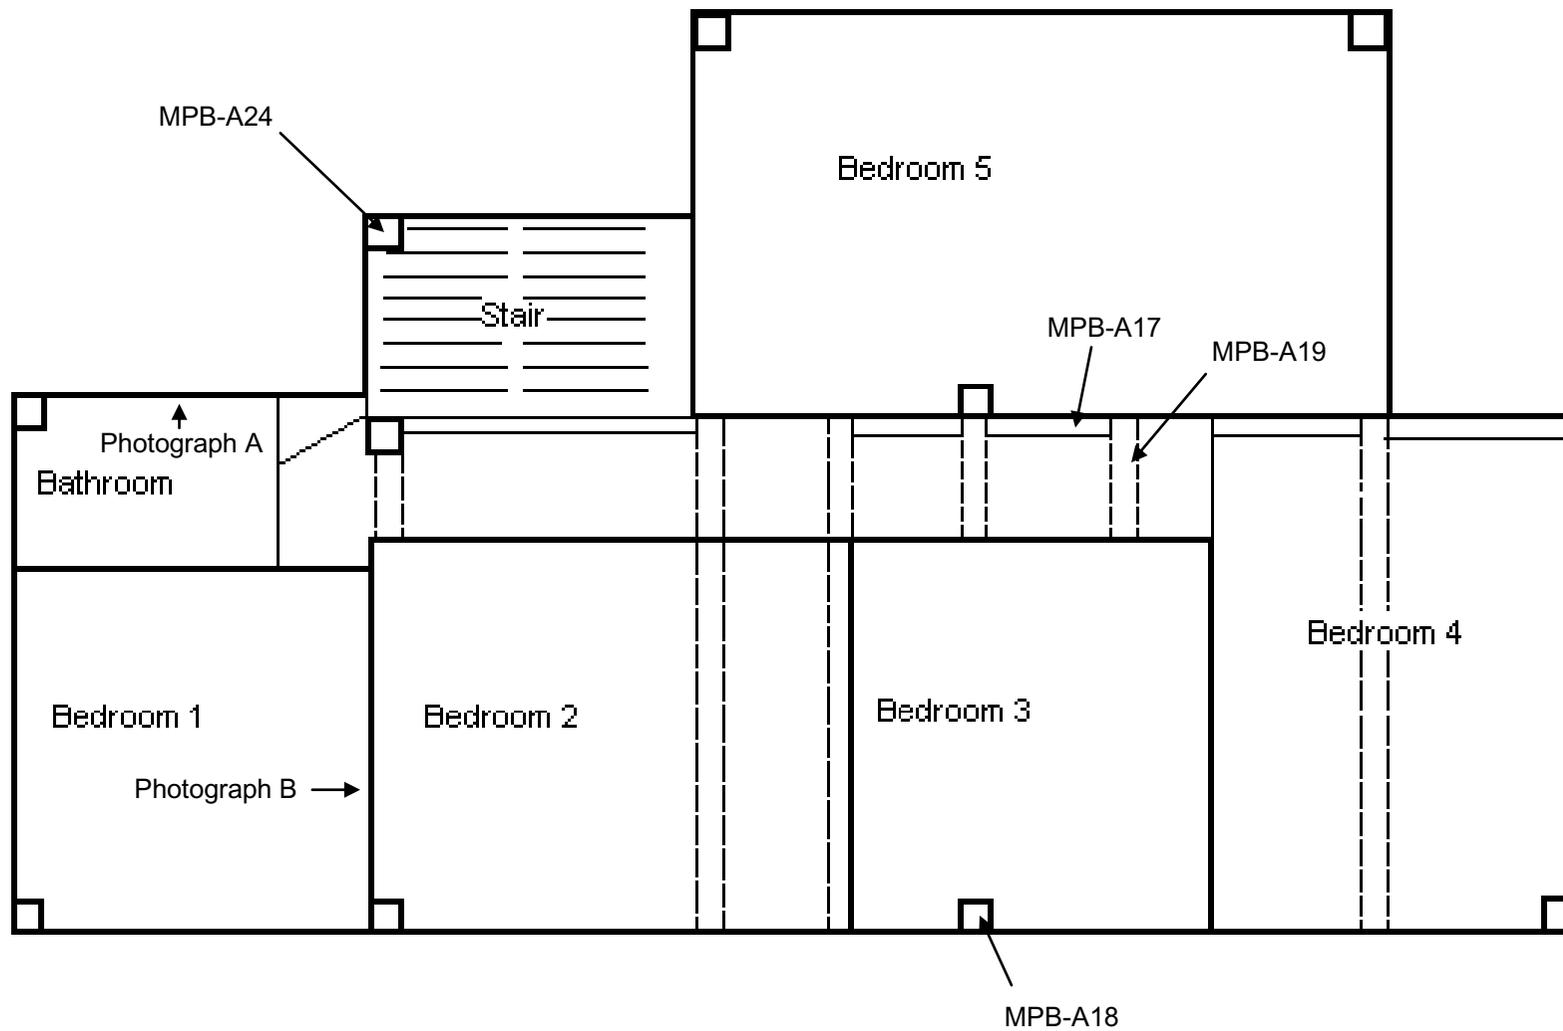
Figure 7: Schematic plan of the first floor, showing the location of samples MPB-A17-19 and MPB-A24

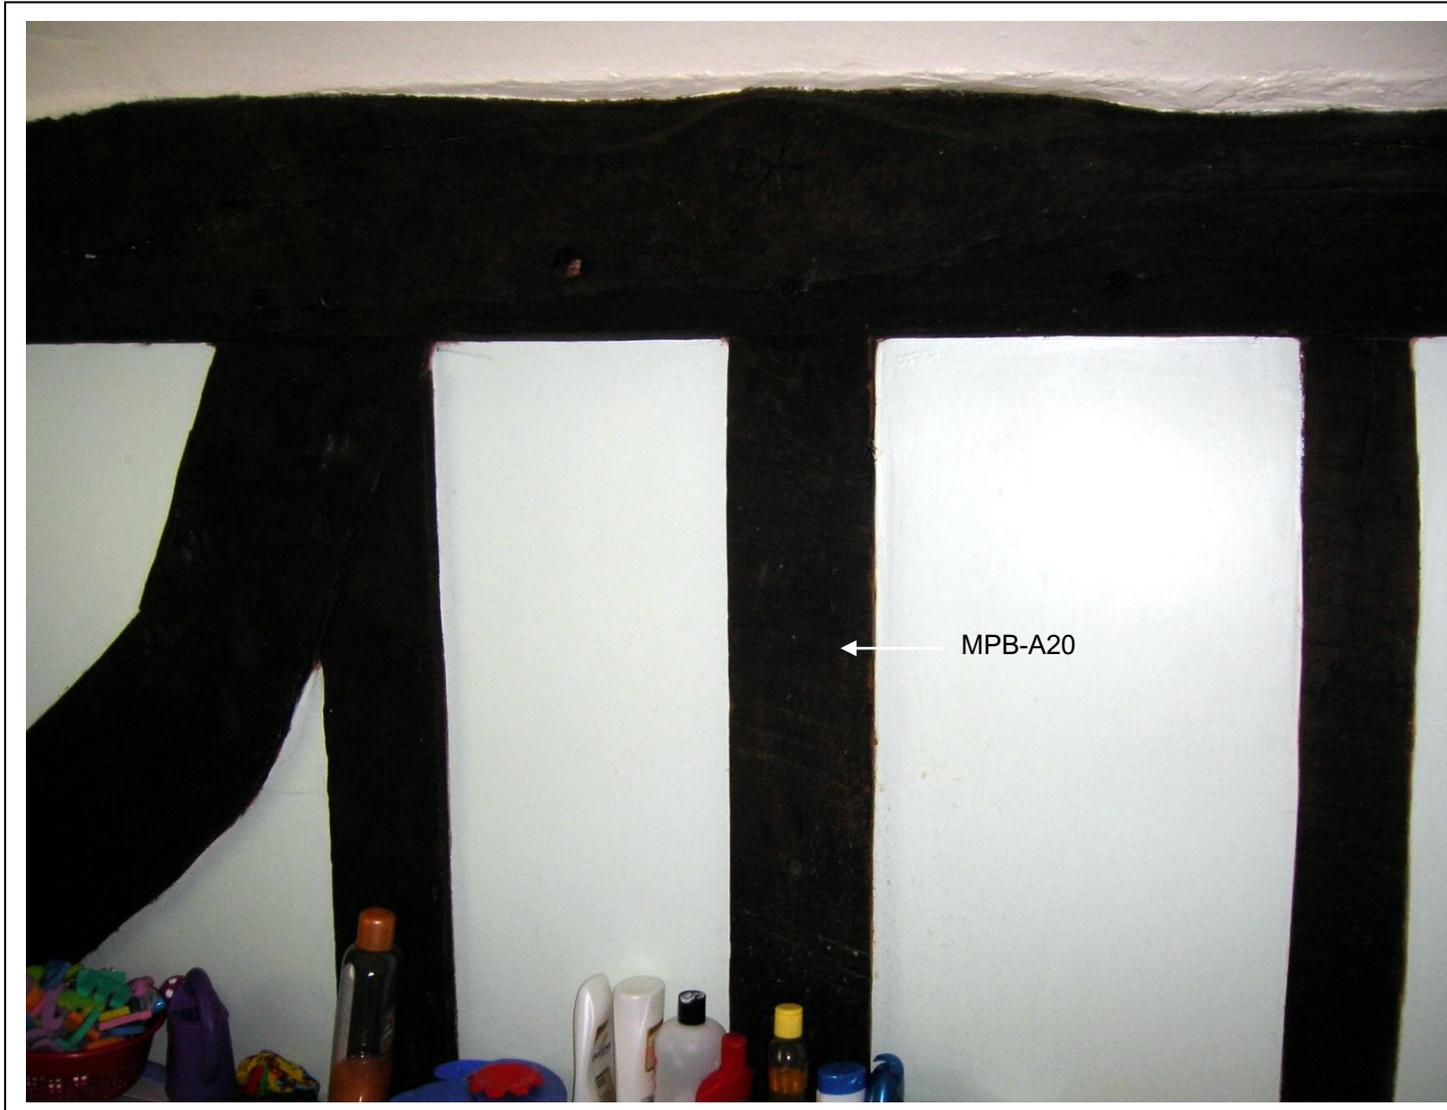
Figure 8: Photograph A, framing in bathroom, showing the location of samples MPB-A20

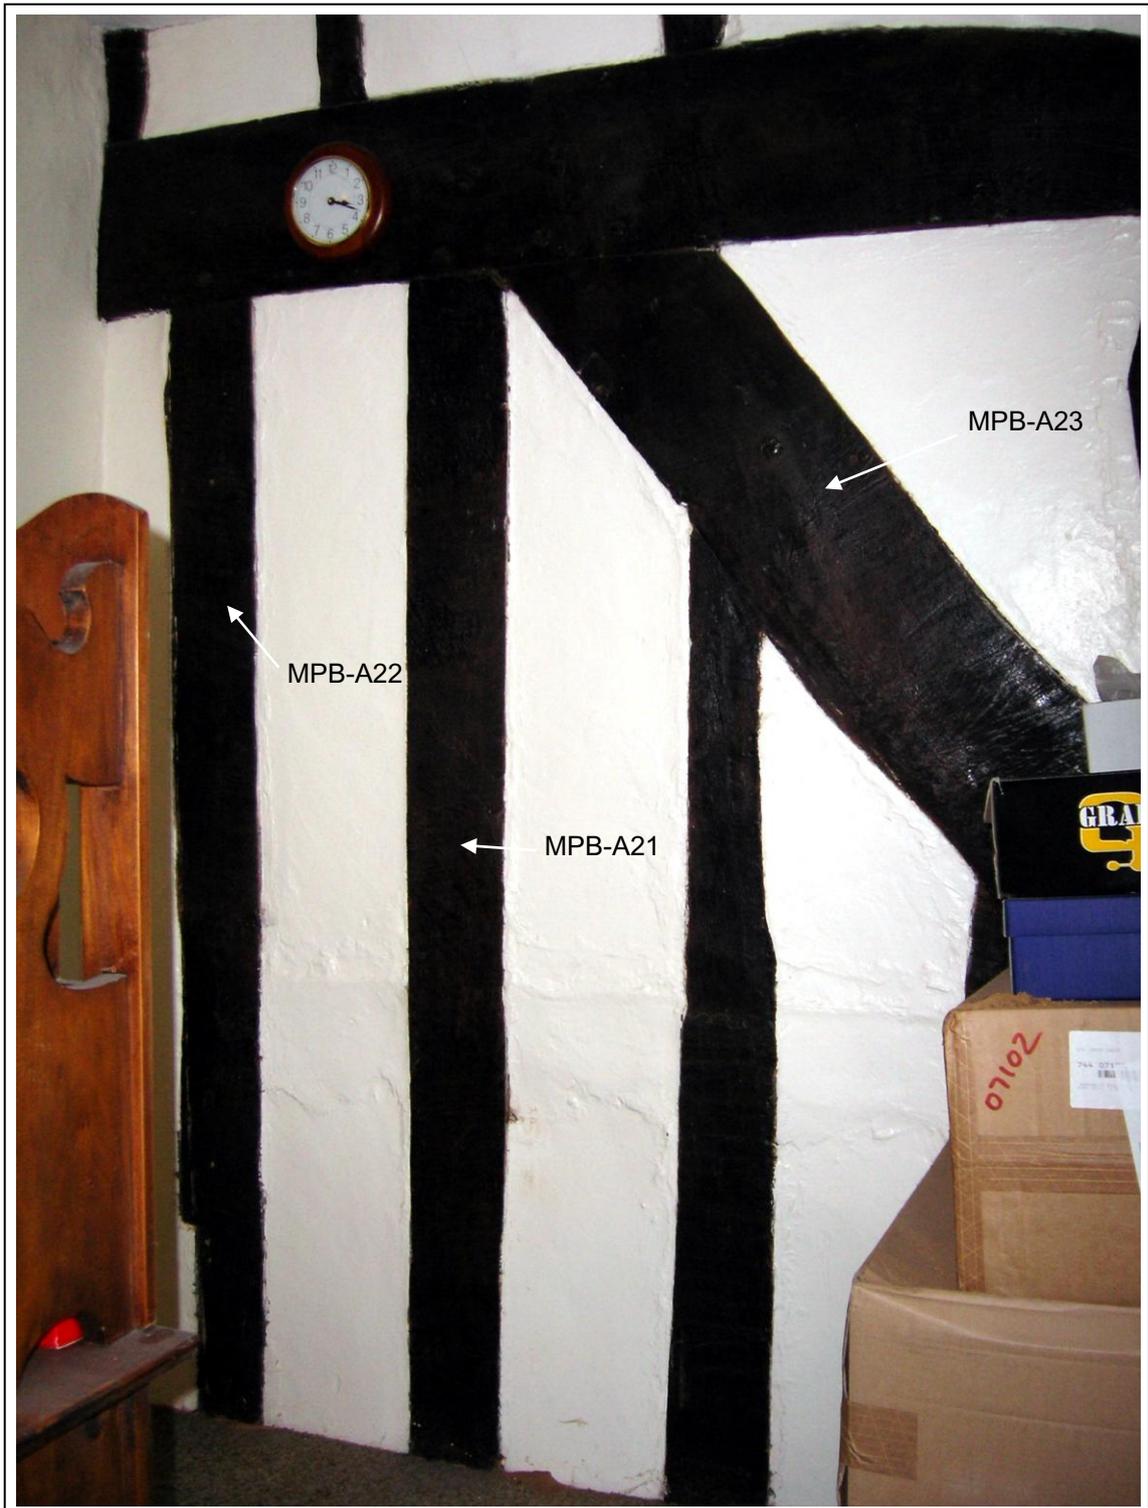
Figure 9: Photograph B, framing in bedroom 1, showing the location of samples MPB-A21-3

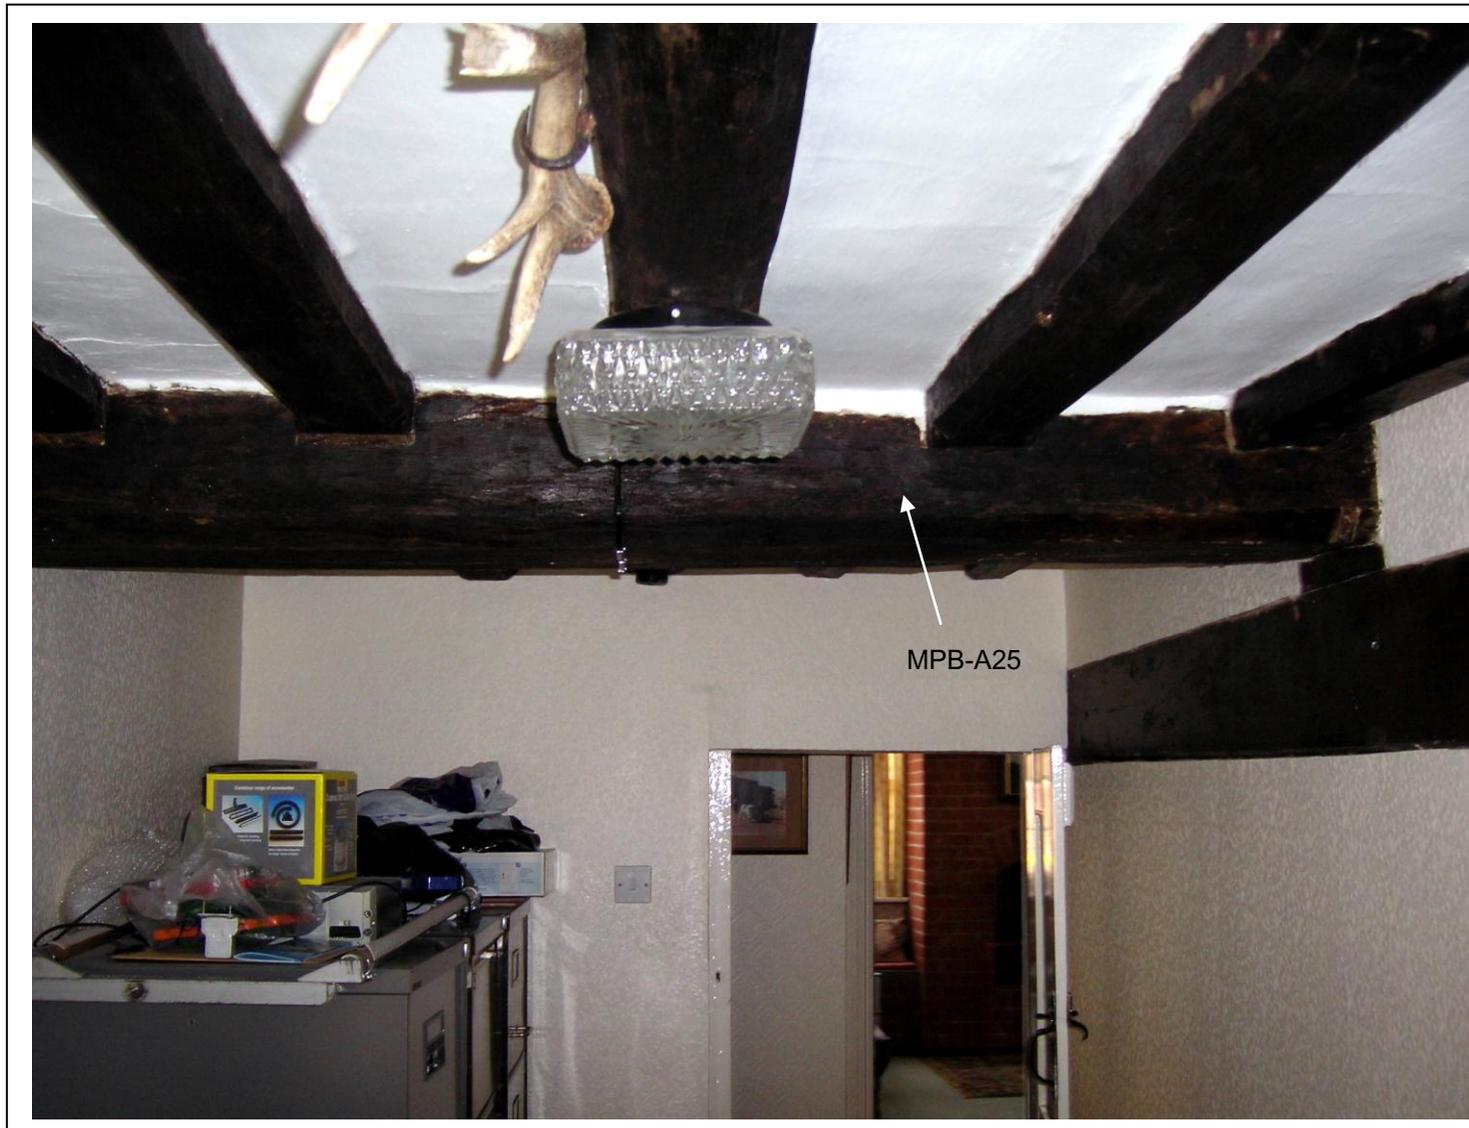
Figure 10: Study, ceiling, showing the location of sample MPB-A25

The last two dated samples are MPB-A19 from the upstairs hallway and MPB-A25 from a ground-floor ceiling beam. Sample MPB-A19 has the heartwood/sapwood boundary ring date of AD 1286 which gives an estimated felling date range of AD 1301–21 for the timber represented. Sample MPB-A25 does not have the heartwood/sapwood boundary ring date but with a last measured ring date of AD 1540, this is estimated to be AD 1555 at the earliest.

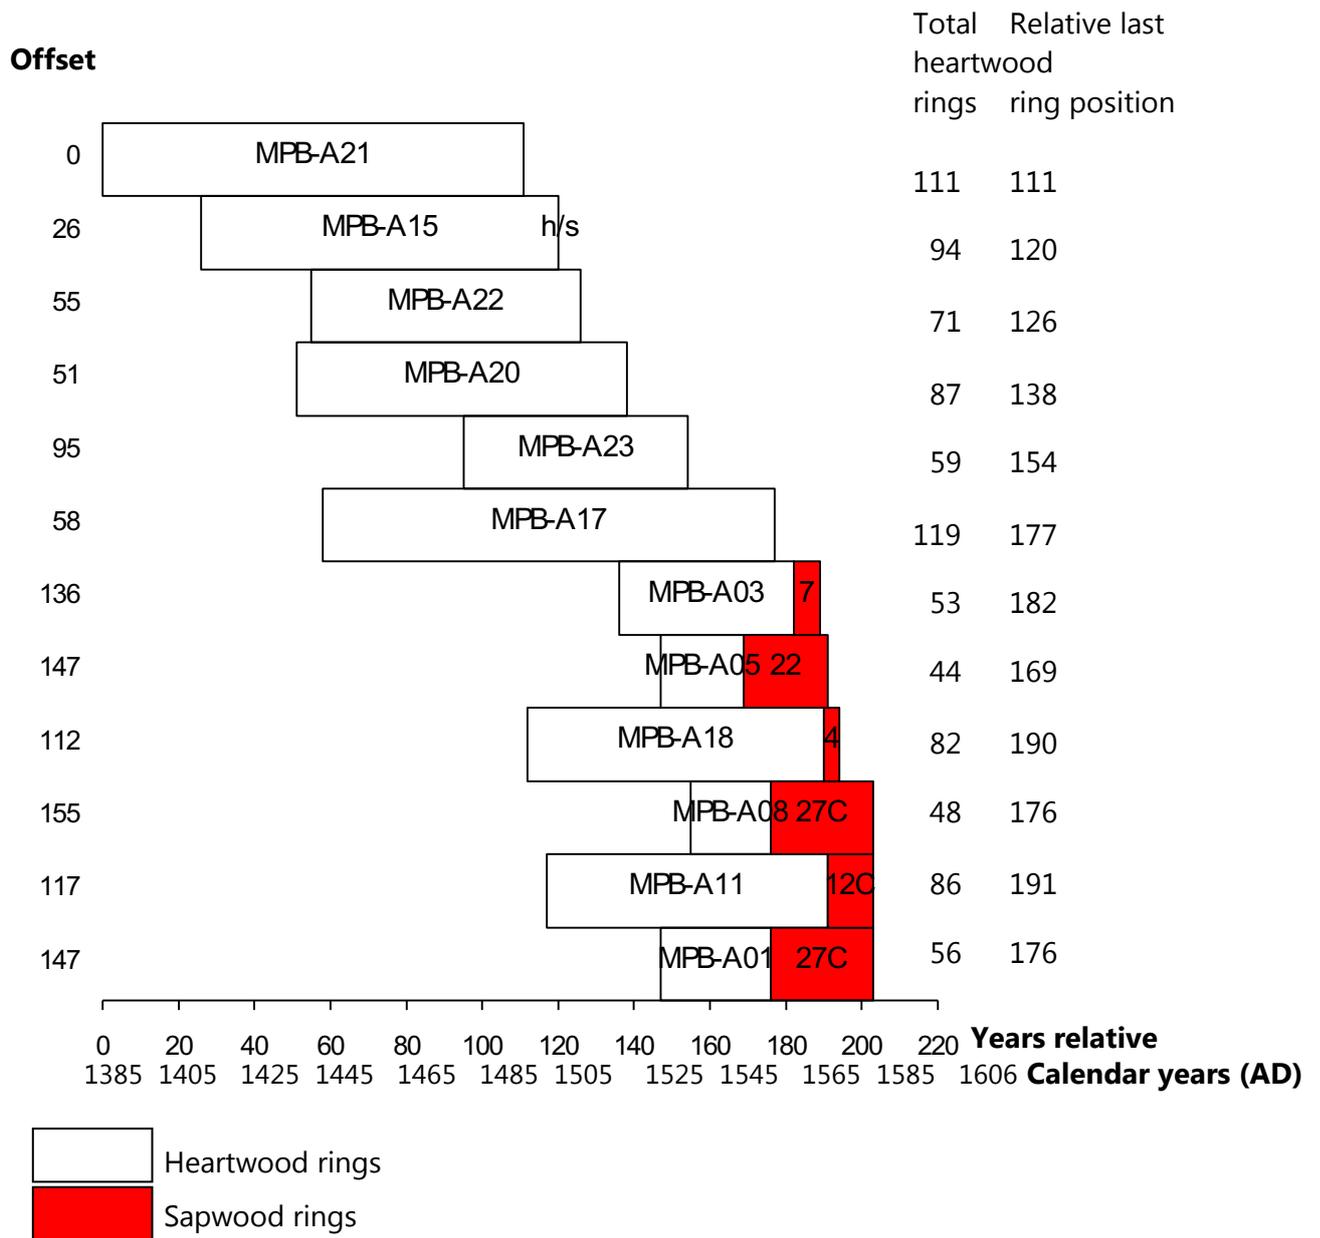
C = complete sapwood retained on sample, last measured ring is the felling date

Figure 11: Bar diagram of samples in site sequence MPBASQ01

Firstly, 12 samples matched each other and were combined at the relevant offset positions to form a site sequence of 203 rings (Figs 11). This site sequence, MPBASQ01, was then compared against a series of relevant reference chronologies where it was found to have a consistent match at a first ring date of AD 1385 and a last-ring date of AD 1587. The evidence for this dating is given by the *t*-values in Table 2.

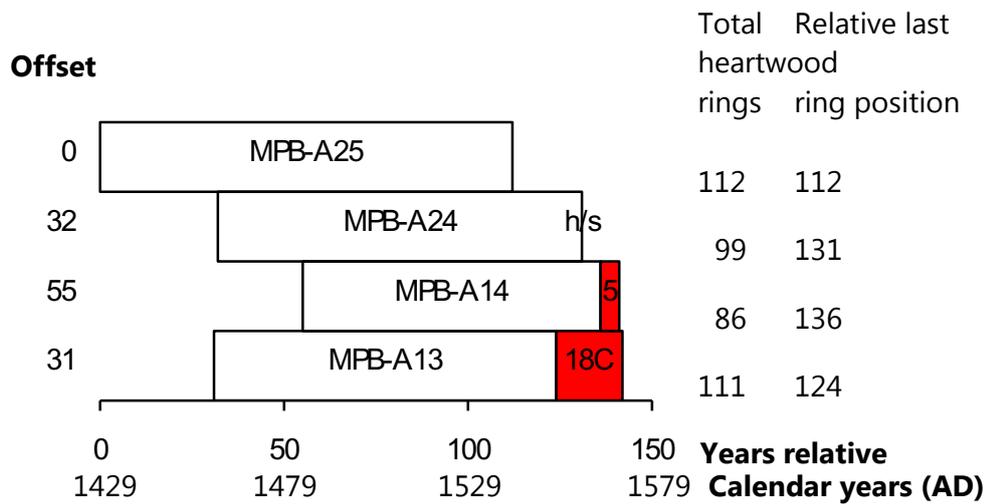
h/s = heartwood/sapwood boundary is the last measured ring
 C = complete sapwood retained on sample, last measured ring is the felling date

Figure 12: Bar diagram of samples in site sequence MPBASQ02

Secondly, four samples matched each other and were combined at the relevant offset positions to form a site sequence of 142 rings (Fig 12). This site sequence, MPBASQ02, was again compared against the reference chronologies where it was found to span the period AD 1429–1570. The evidence for this dating is given by the *t*-values in Table 3.

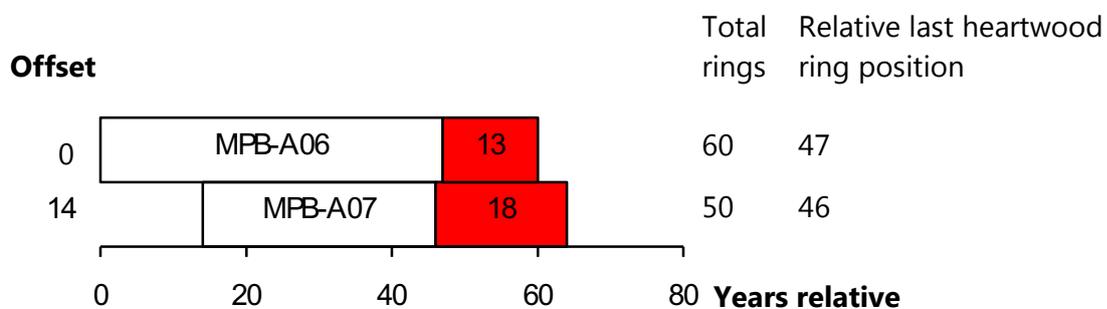
Figure 13: Bar diagram of samples in undated site sequence MPBASQ03

Two samples, taken from common rafters in the main roof, grouped to form a site sequence, MPBASQ03, of 56 rings (Fig 13). Attempts to match this site sequence against the reference material proved unsuccessful and it remains undated.
