**TREE-RING ANALYSIS OF TIMBERS FROM
THE CHAPTER ROOM ROOF,
ROCHESTER CATHEDRAL,
ROCHESTER,
KENT**

October 2013

Dendrochronological analysis was undertaken on timbers of the Chapter Room roof, resulting in the construction and dating of two site sequences and one single sample. Interpretation of the sapwood on these samples suggests felling of all dated timber in the second half of the fourteenth century with construction likely to have occurred shortly after.

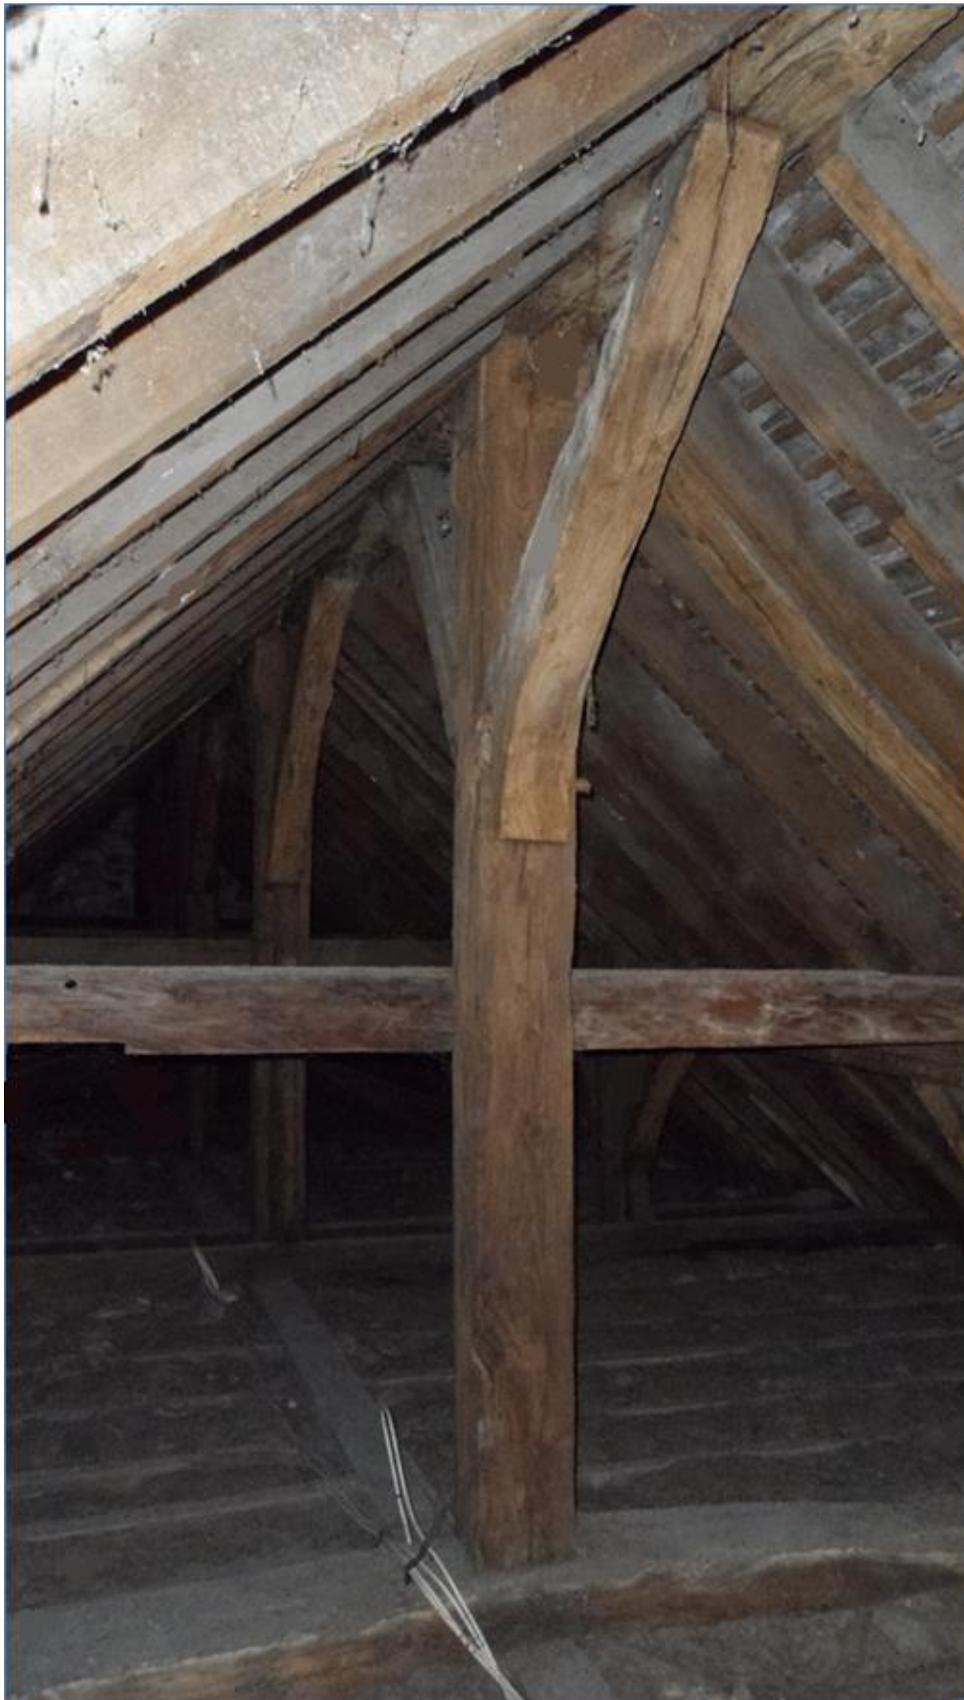
Figure 5: Chapter Room roof, truss 6 in foreground

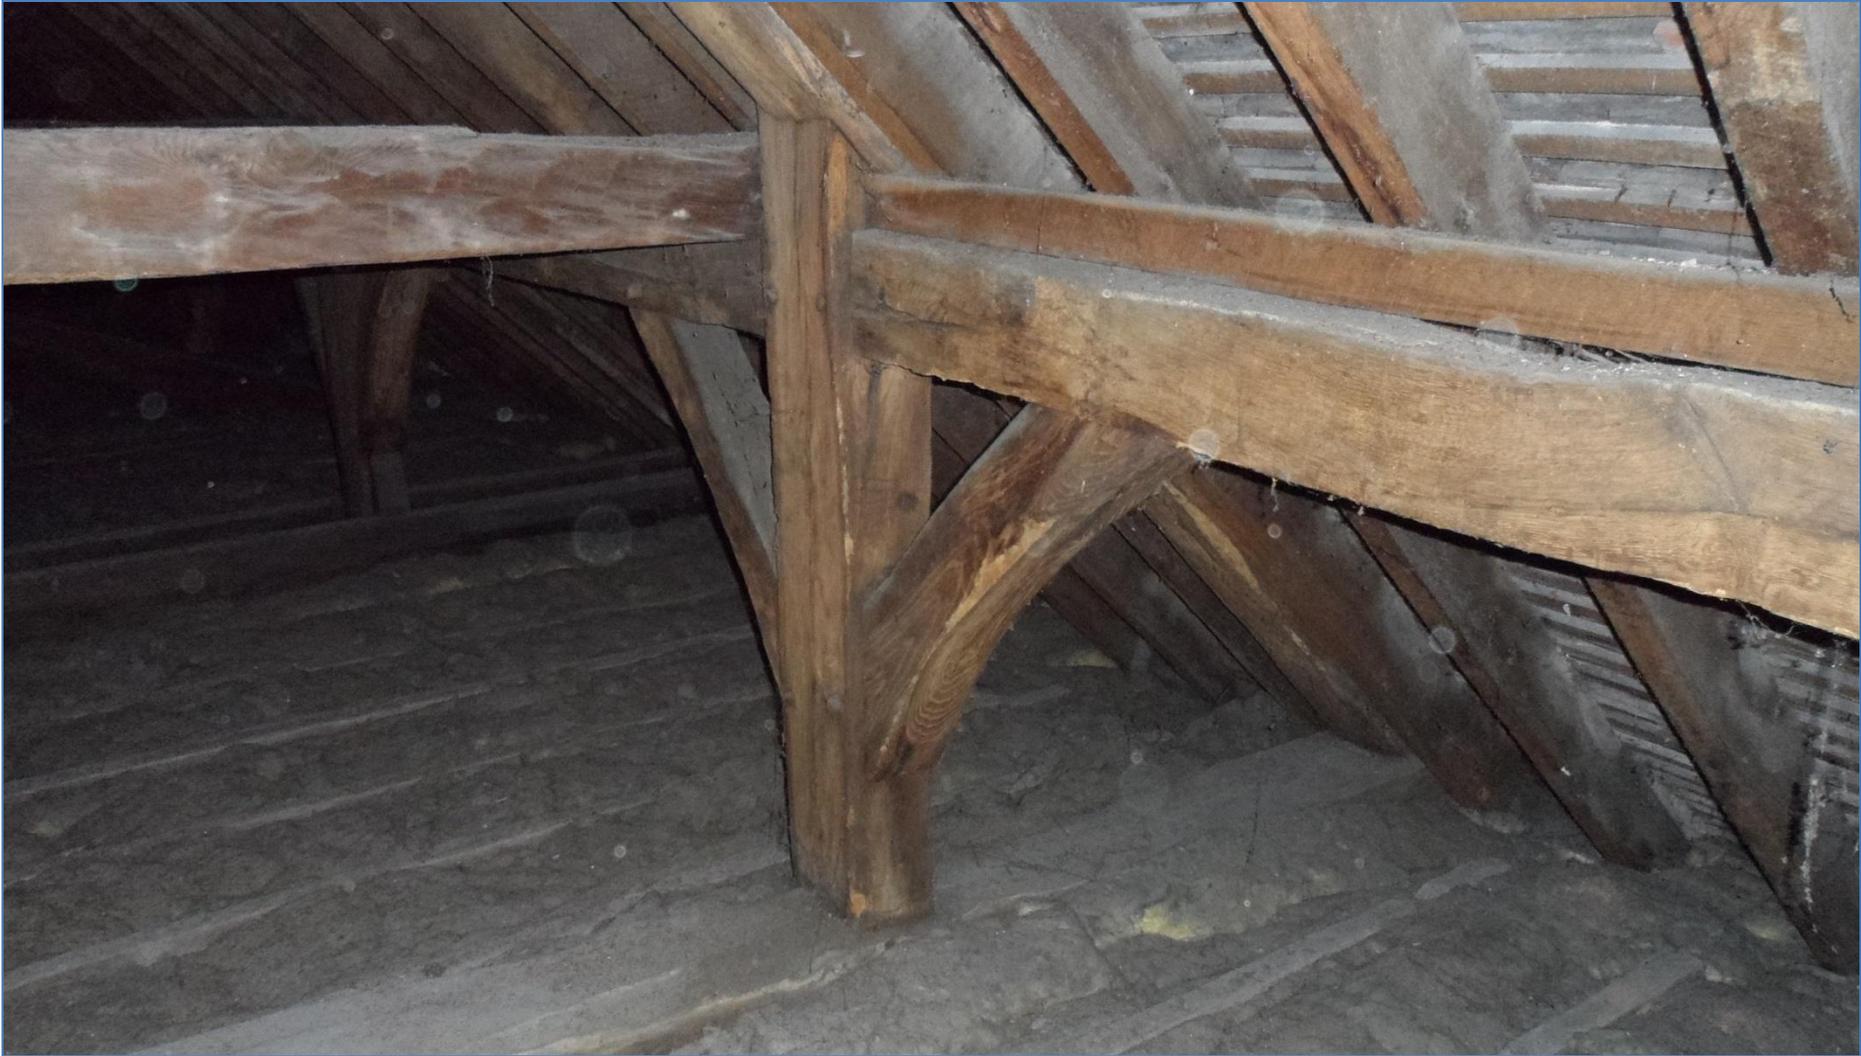
Figure 6: Chapter Room roof, south side
