**TREE-RING ANALYSIS OF TIMBERS FROM
THE CHURCH OF ST MICHAEL WITH ST MARY,
MELBOURNE,
DERBYSHIRE**

**A J ARNOLD
R E HOWARD**

Tree-ring analysis of 16 oak samples from Melbourne parish church indicates that a majority of the principal or main beams of the chancel roof are formed from trees likely to have been felled sometime between 1683 and 1692. This, and other inscriptional evidence, would suggest that a major programme of alterations to the church took place in the late-seventeenth and early-eighteenth centuries.

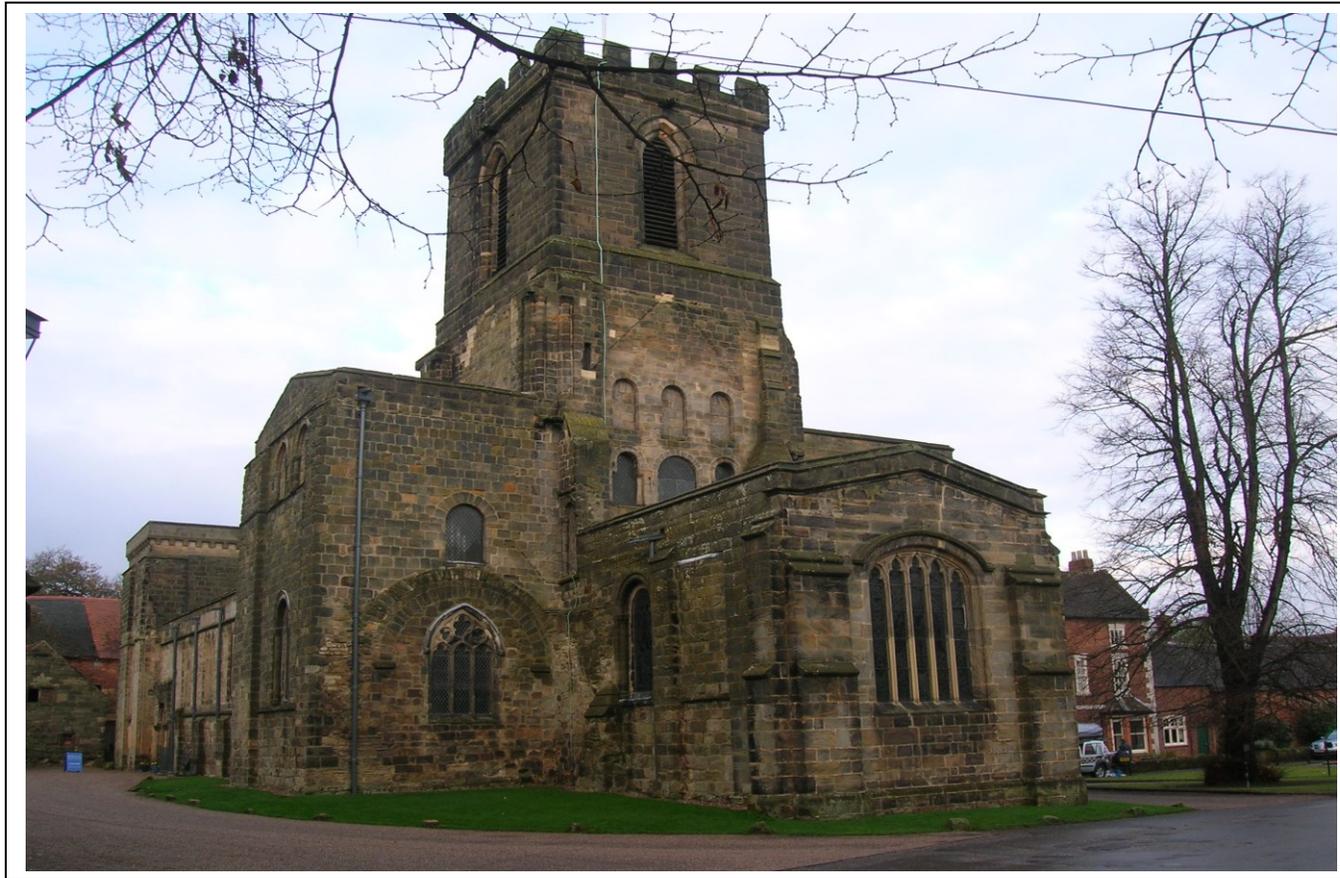
Figure 2: View of Melbourne Parish Church from the south-east showing the single-storied, square-ended chancel with its later shallow-pitch roof.

The height and pitch of the former roofs to the chancel and the south aisle may be seen as scars on the remaining stonework of the tower

end and there were apsidal chapels to the east side of the transepts as well). Thus, while the original stylistic evidence might place the construction of the church to between 1130 and 1160, its plan form appears to be older and might suggest that it is either slightly earlier than thought or there is a connexion with the Rhineland and Lower Saxony from whence the plan originated. A view of St Michael's is given in Figure 2. A recent guide and description of the church is available (Barman, 1974).

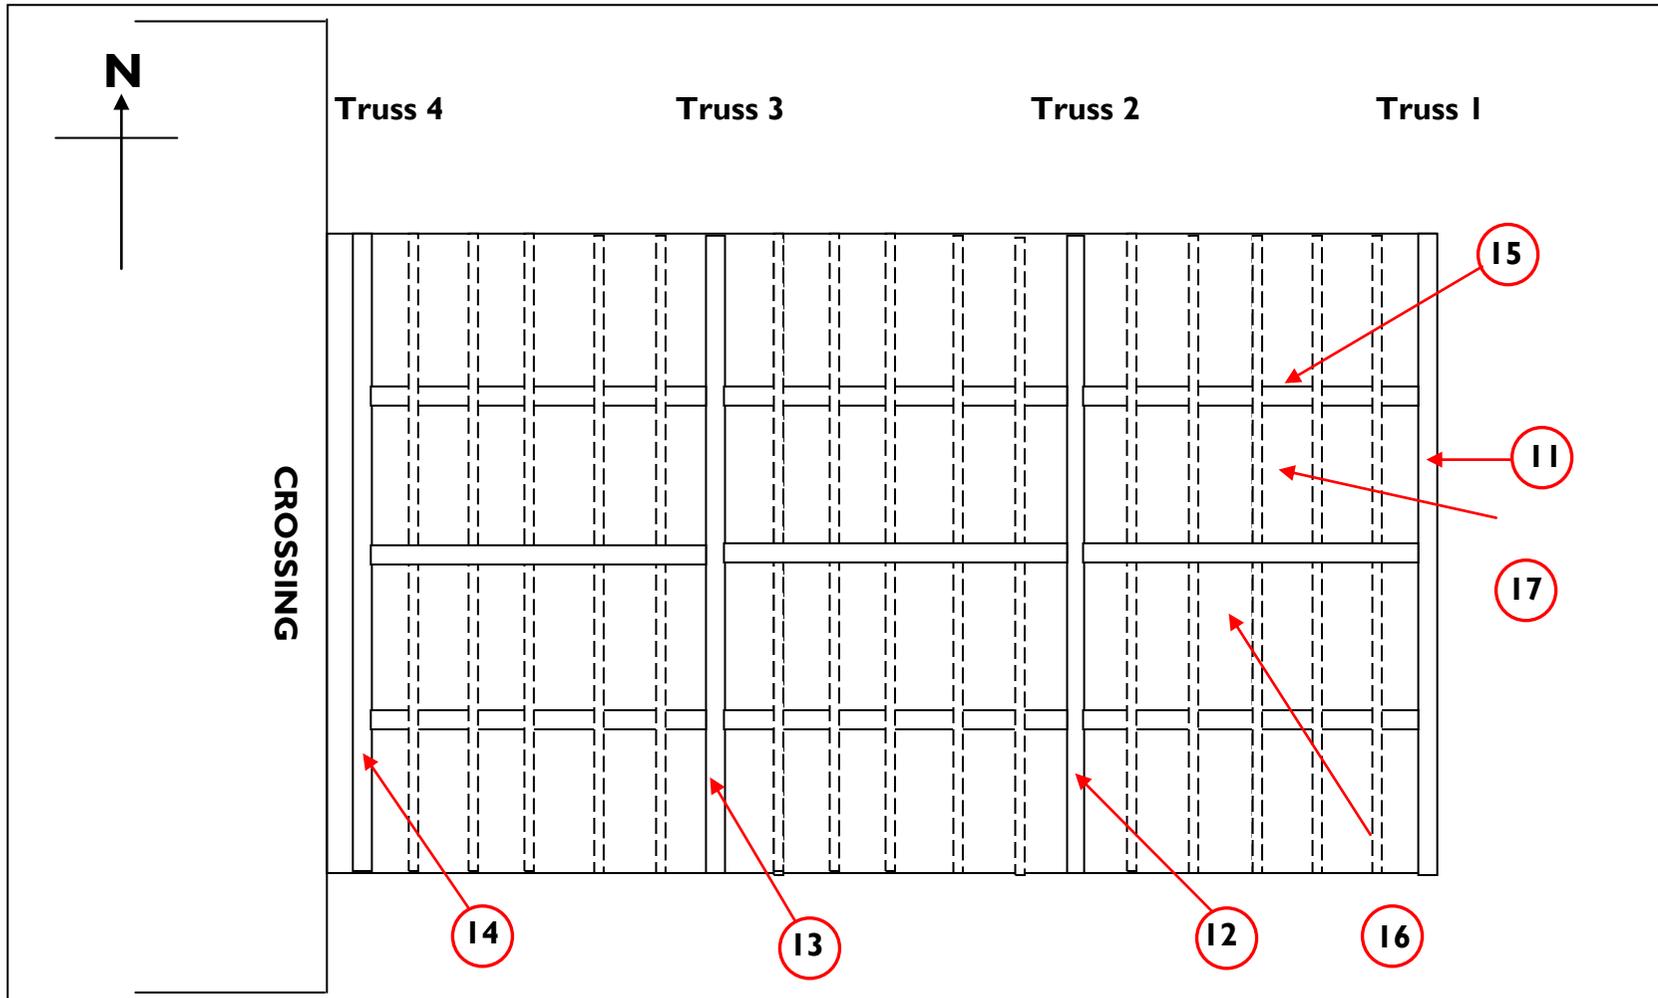
Figure 3: Plan of the chancel roof (viewed from above looking down) to show sampled timbers
(samples obtained in 1979 (MEL-C01-05 and MEL-C08-09) not shown)
(samples from roof of north-east chapel (MEL-C06 and C07) not shown)

Thus, from the timbers available a total of seven core samples was obtained, each sample from a different timber. Each sample was given the code MEL-C (for Melbourne Church) and, allowing for the samples obtained in 1979, were numbered 11–17. The positions of these samples have been marked on a simple schematic sketch plan made at the time of sampling, this being reproduced here

as Figure 3. Details of the samples are given in Table I. In this Table, and on the plan, all trusses and the individual timbers have been numbered and/or identified on a north–south, or east–west basis, as appropriate.

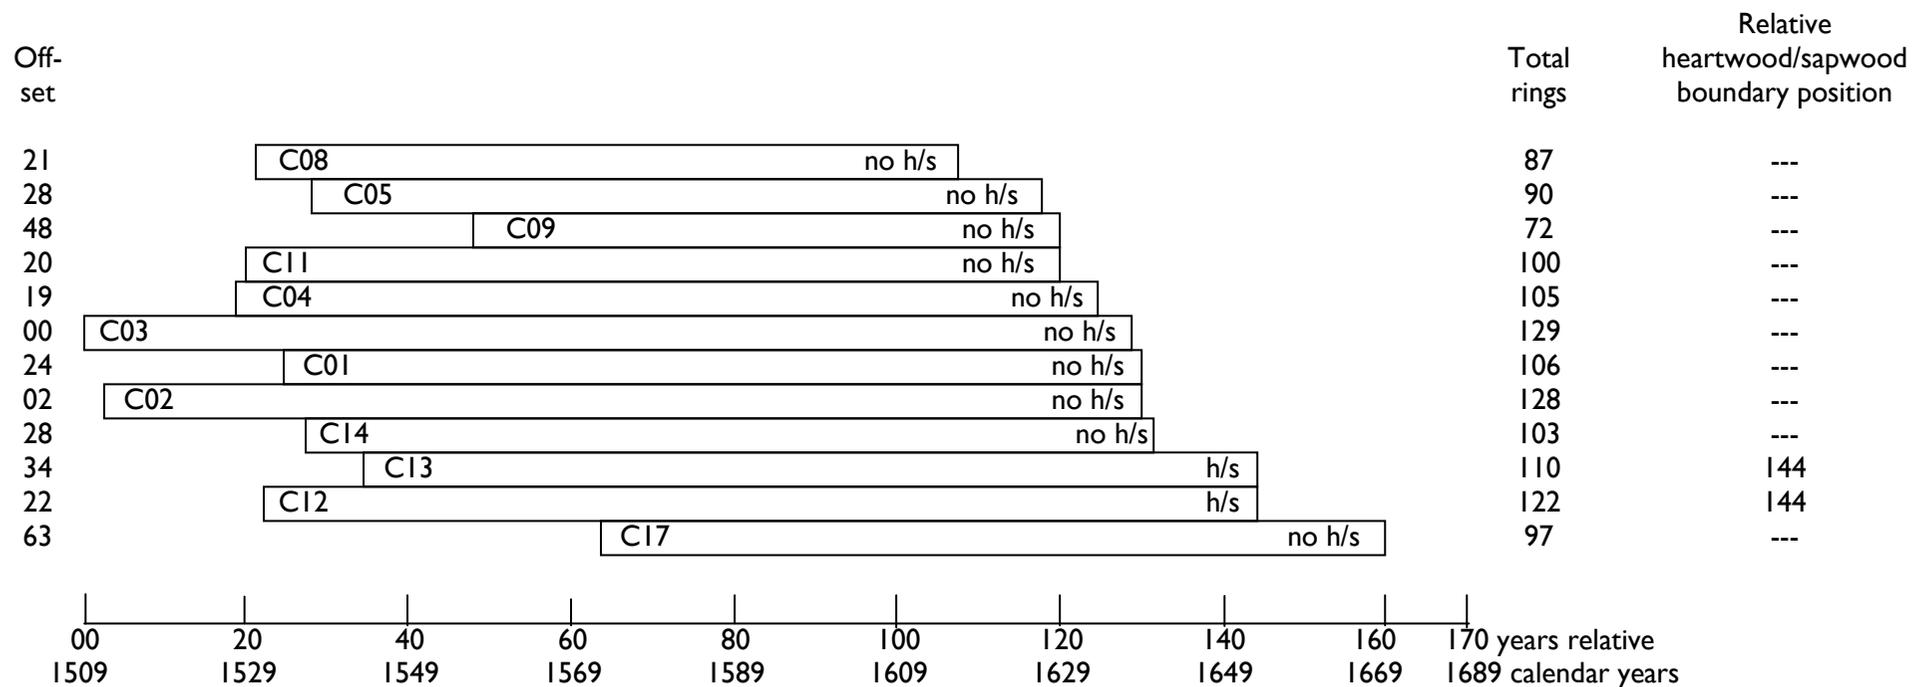
Figure 4: Bar diagram of the samples in site chronology MELCSQ01

White bars = heartwood rings

h/s = heartwood/sapwood boundary

At a minimum value of $t=4.5$ two group of cross-matching samples could be formed. The first group, comprising 12 samples, cross-matching with each other at the positions indicated in the bar diagram Figure 4 and all believed (certainly those most recently obtained) to be from the timbers of the chancel roof, were combined at these indicated off-set positions to form MELCSQ01, a site chronology of 160 rings. Site chronology MELCSQ01 was then satisfactorily dated by repeated and consistent comparison with a number of relevant reference chronologies for oak as spanning the years 1509 to 1668. The evidence for this dating is given in the *t*-values of Table 2.

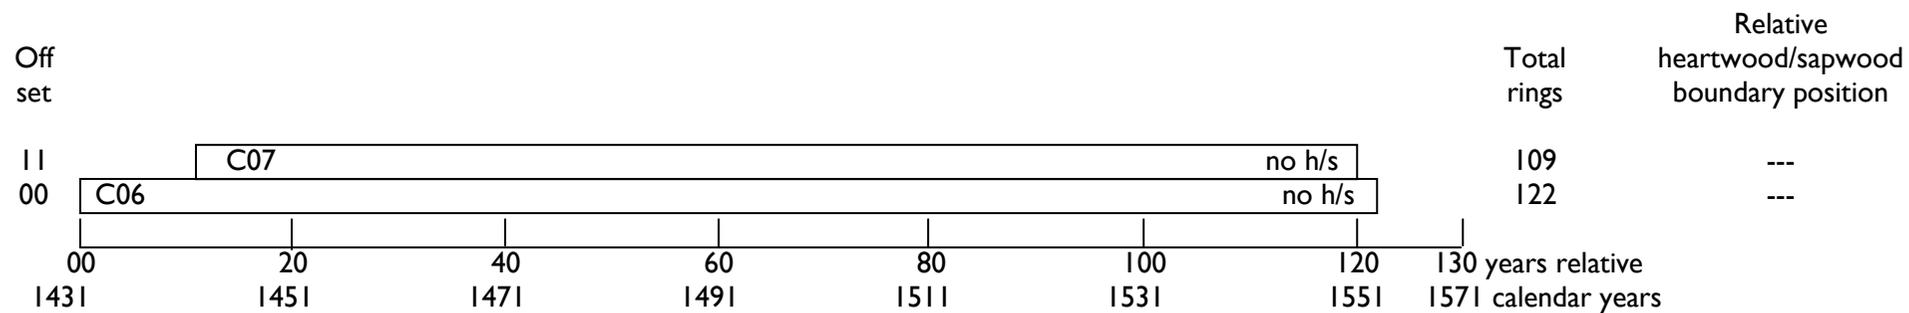
Figure 5: Bar diagram of the samples in site chronology MELCSQ02

White bars = heartwood rings
h/s = heartwood/sapwood boundary

The second group comprises two samples, cross-matching with each other at the positions indicated in the bar diagram Figure 5. Both samples are believed to be from timbers of the north-east chapel (though no record of the samples having been made in 1979). These two samples were combined at their indicated off-set positions to form MELCSQ02, a site chronology of 122 rings. Site chronology MELCSQ02 was then satisfactorily dated by repeated and consistent comparison with a number of relevant reference chronologies for oak as spanning the years 1431 to 1552. The evidence for this dating is given in the *t*-values of Table 3.
