**TREE-RING ANALYSIS OF TIMBERS FROM
COACH ROAD COTTAGE,
STAUNTON HAROLD,
LEICESTERSHIRE**

**A J ARNOLD
R E HOWARD**

SUMMARY

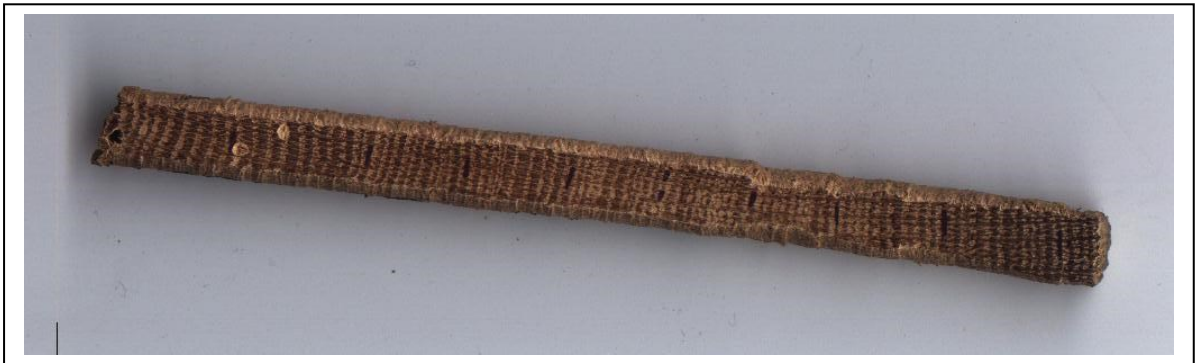
Core sample STH-F03 from the north-west purlin.
Its 94 rings span the years 1393 - 1486

The earliest phase of felling detected is represented by the individually dated sample STH-F03, from the north-west purlin in the main bedroom. This sample has a heartwood/sapwood transition date (ie, only the sapwood rings are missing) of 1486. Given that most oak trees have between 15 and 40 sapwood rings it is estimated that this timber was felled sometime between 1501 and 1526.
