**TREE-RING ANALYSIS OF TIMBERS FROM
LODGE FARM,
STAUNTON HAROLD,
LEICESTERSHIRE**

**A J ARNOLD
R E HOWARD**

SUMMARY

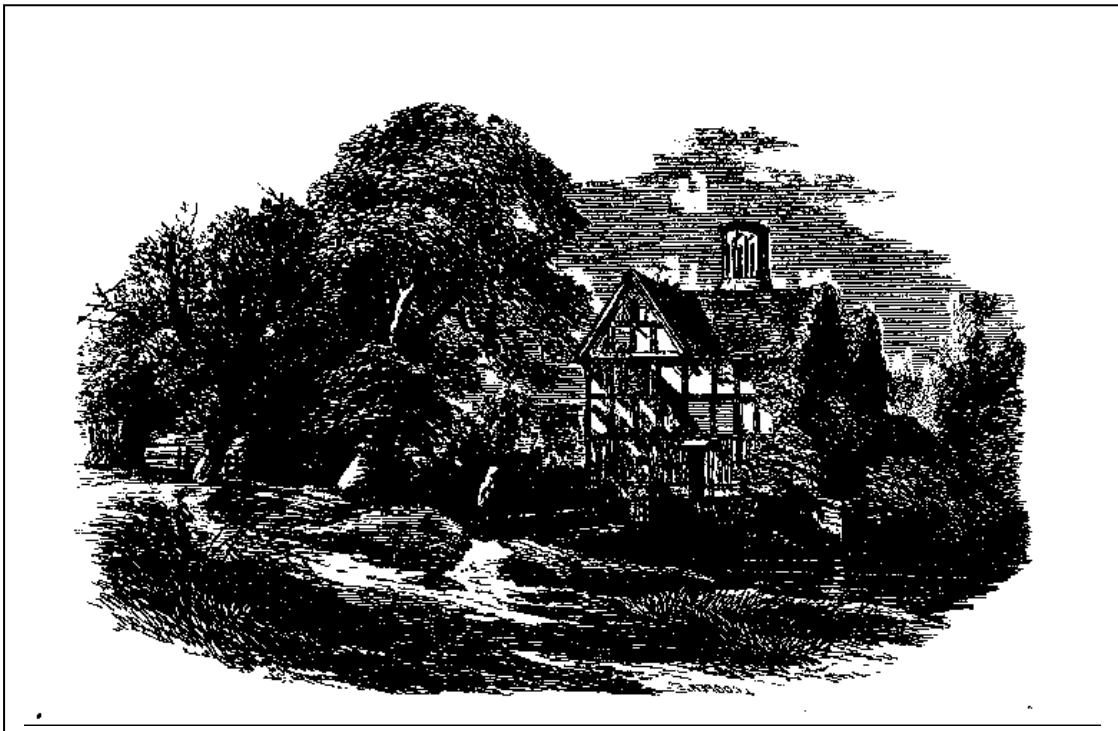
*The Lodge in the Great Park at Staunton Harold
(E.P. Shirley (1873) (Stemmata Shirleiana)*
