**TREE-RING ANALYSIS OF TIMBERS FROM
15 HALTON VILLAGE,
NEAR AYLESBURY,
BUCKINGHAMSHIRE.
HP22 5N5**

**A J ARNOLD
R E HOWARD**

Core samples were obtained from ten different oak timbers in this building at Halton Village Buckinghamshire. Analysis undertaken on these samples has resulted in the construction and dating of a single site sequence and the individual dating of a further single sample, HLT-A02.

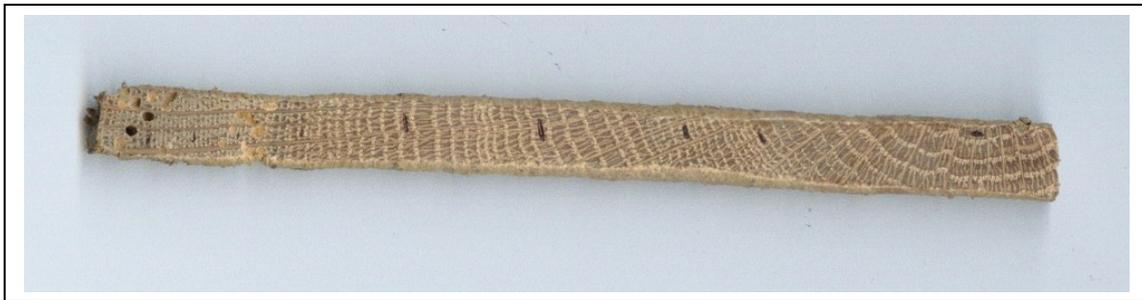
Sample HLT-A02 from the north main wall post of truss 2

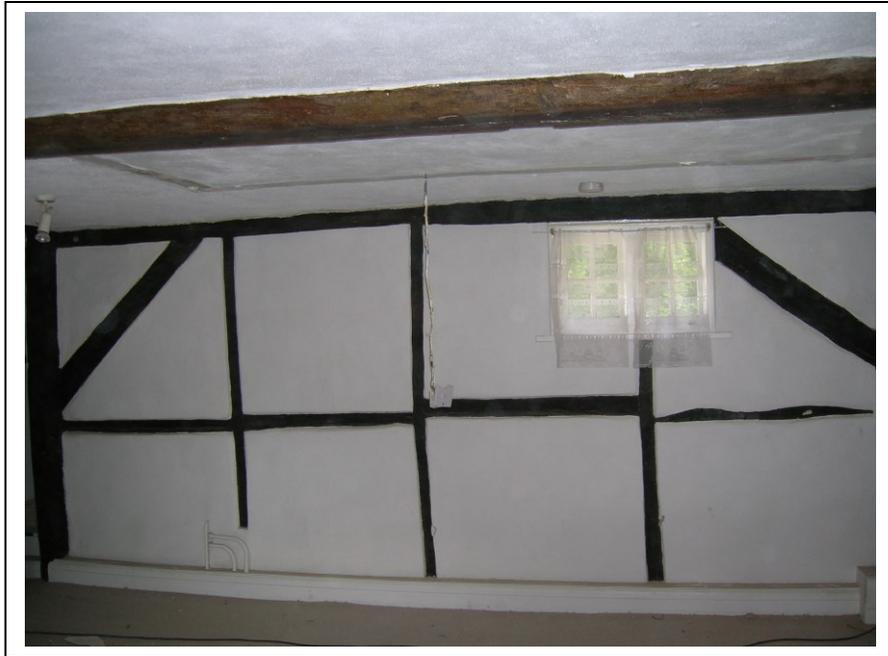
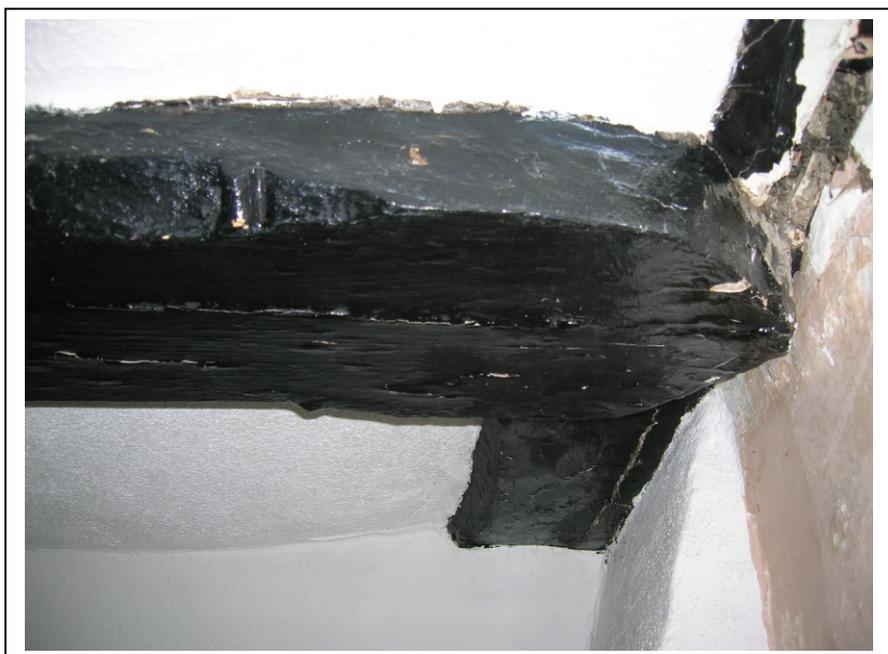
Figure 3a/b: View of the rear first-floor wall-frame of the west bay 2 (above); notice the light-weight framing, the braces to the wall-plate and the ceiling beam.

Below, the first-floor ceiling beam in the west bay; notice how it is shaped to fit in to a dovetailed lap mortise in a cross-beam

The roof trusses are supported by main wall posts from which braces may have risen to the tiebeams. Though such braces are no longer visible, there are mortices in the wall posts that may have housed them, and there are certainly straight braces from near the tops of the main wall posts to the wall plates. A view of the wall-framing is given in Figure 3a, with a schematic long section being provided in Figure 4.

The first-floor ceiling beam between trusses 2 and 3 might also be reused. Its unsupported west end, with its chamfer stops, is cut to fit into a dovetail lap mortice of a horizontal beam, such as a tiebeam (see Fig 3b). The fact that the ceiling beam does not reach the tiebeam here, and that in any case the tiebeam does not have a mortice to receive it, suggests a less than cohesive integral structure. Unfortunately, being apparently derived from a fast-grown tree with insufficient rings, this timber was not suitable for tree-ring analysis.
