# WILDERHOPE MANOR

Rushbury, Shropshire

## Historic Building Record and Assessment

Report Ref.: 2014\_013\_v.2

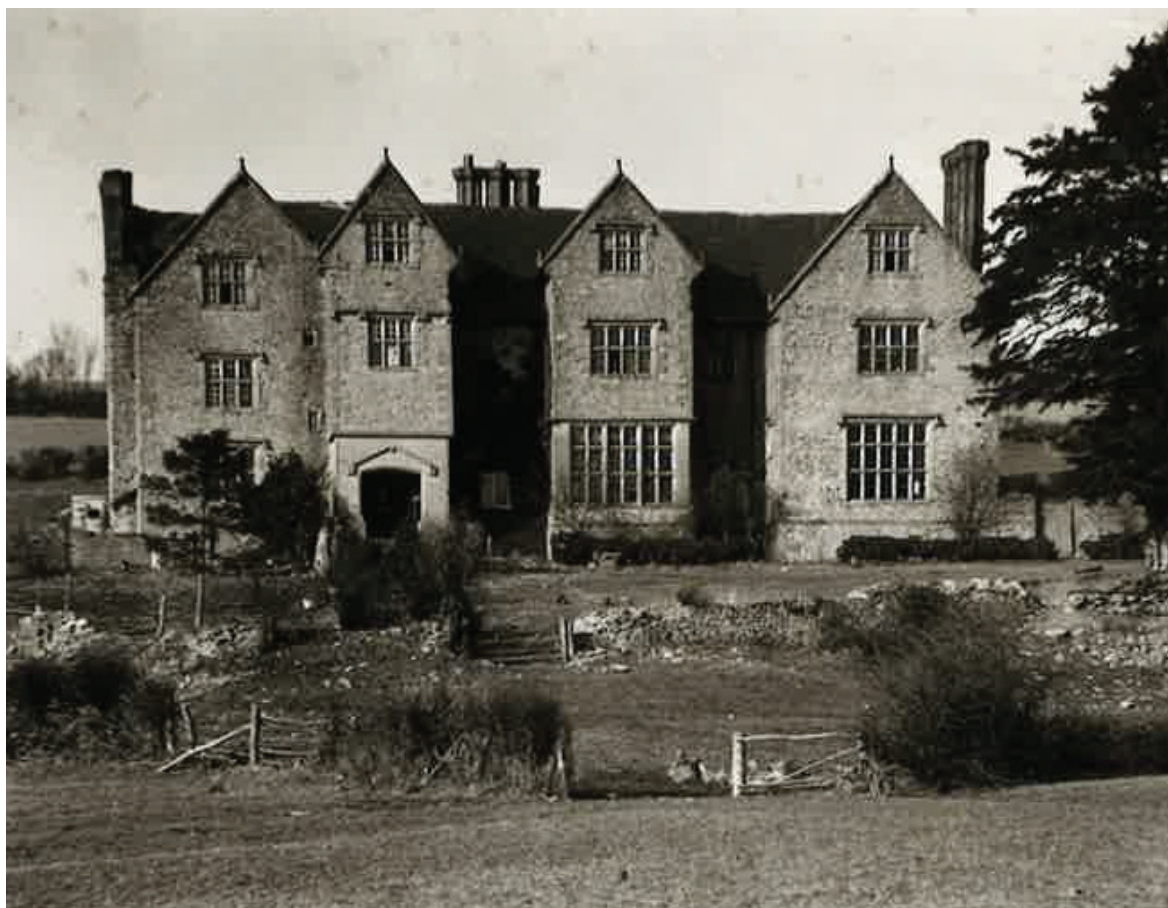
**(a)** View of south front, 1936, before consolidation, repair and construction of south terrace by W.A. Cadbury Trust.

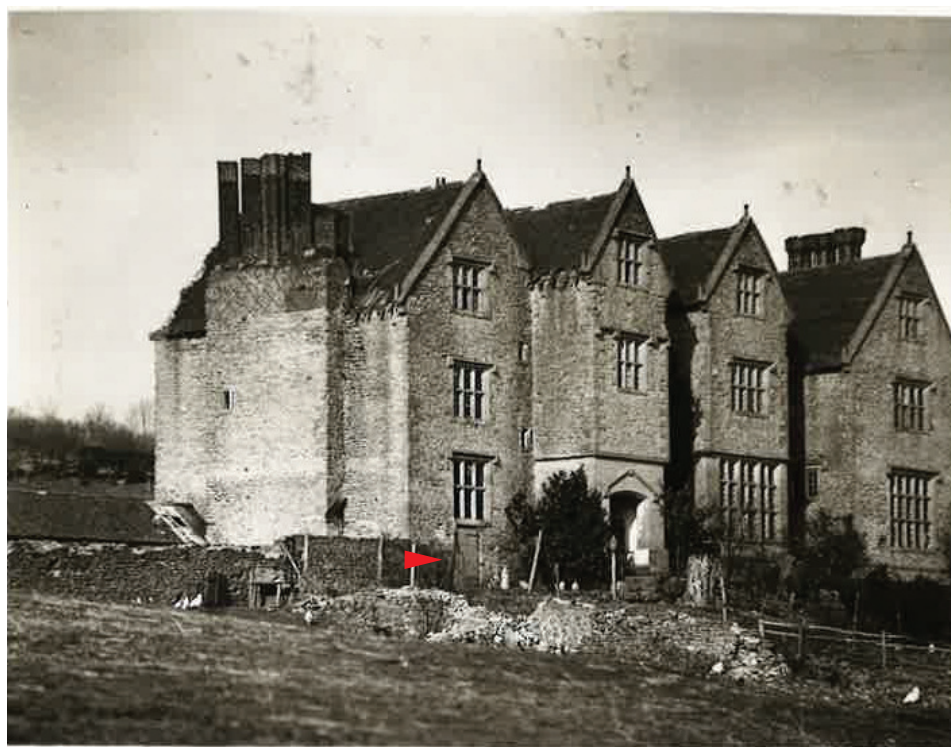
**(b)** Oblique view prior to repair, 1936; **NB.** inserted door to service range beneath kitchen window.

- 5.4.3 A series of 22 historical photographs dating to the 1930s survive within the Trust's photographic archive at Attingham Park, within an album entitled '*Wilderhope Manor; Restored 1936-7*'.<sup>29</sup> This album essentially presents a series of 'before', 'during' and 'after' views of the exterior of the house from a number of different angles and, in the absence of any other contemporary sources, represents a valuable witness to the condition of the property upon its acquisition by the W.A. Cadbury Trust. In particular, the dilapidated state of the western brick chimneys, noted above, is clearly evident in a number of views (Figure 8b/9a).

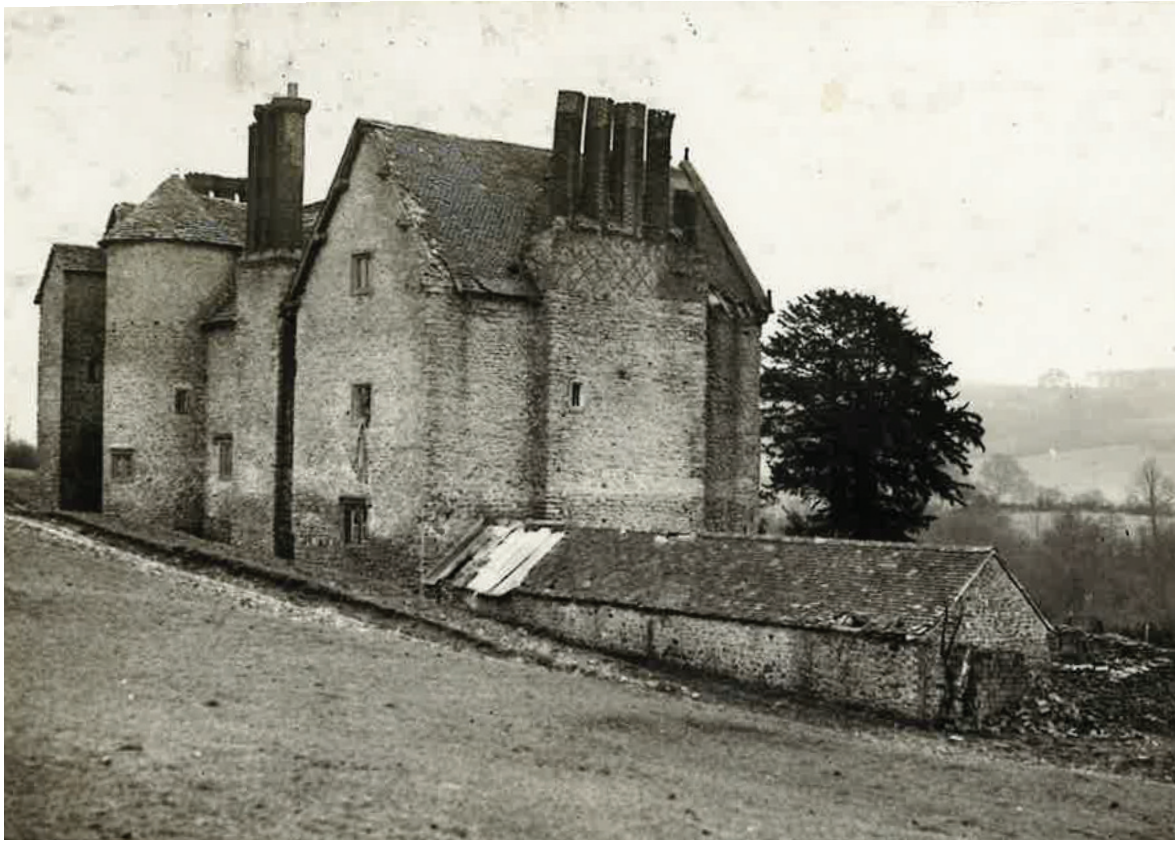
(a) Oblique view of north front, 1936, before consolidation and repair by W.A. Cadbury Trust; **NB.** 2-light windows to service wing.

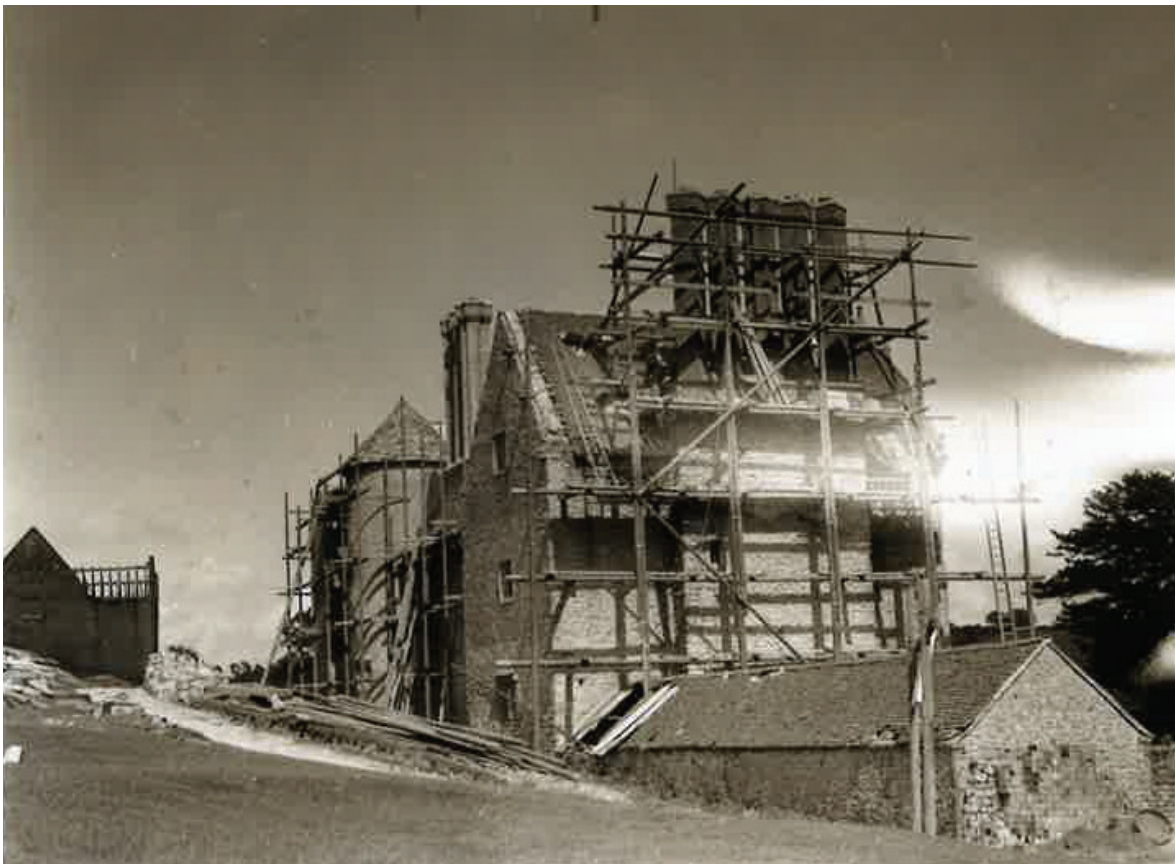
(a) Consolidation and repair works in progress, 1936/7.

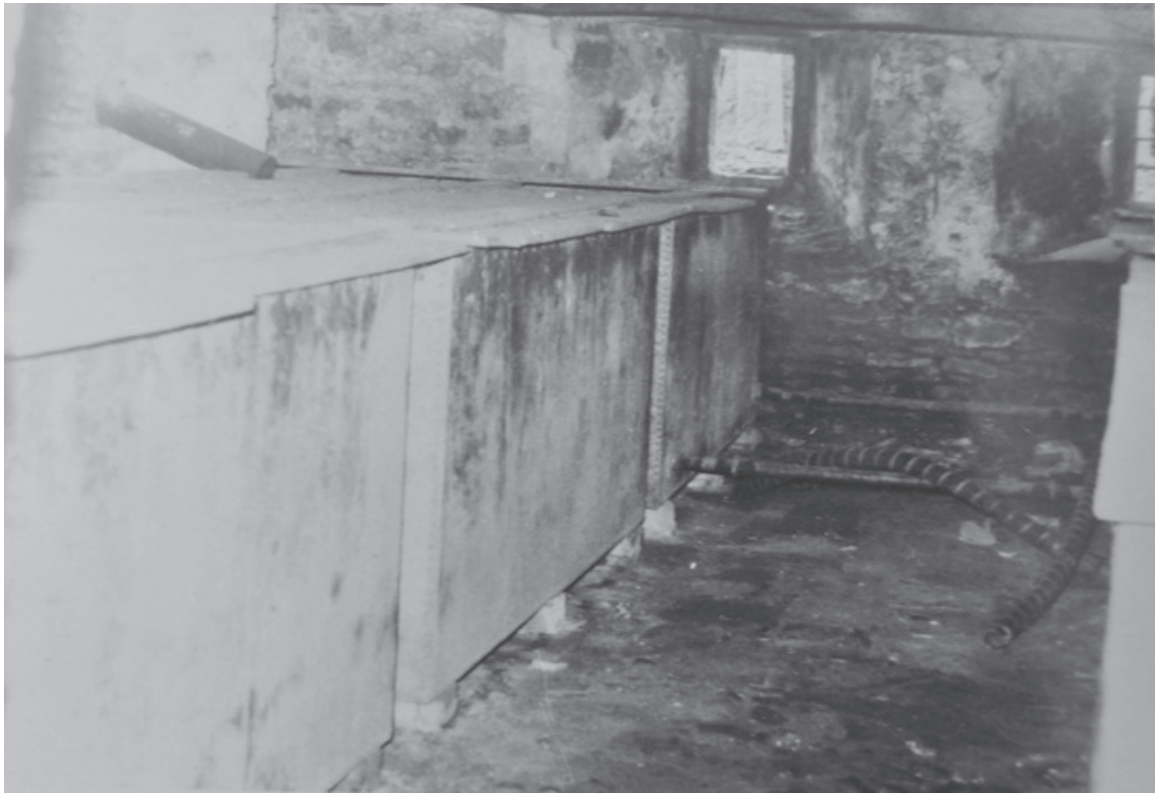
**(a)** Water tanks formerly located within basement of east wing, pre-1970s improvements **NB.** inlet pipe feeds collected rainwater from roof gutters.

- 5.4.4 As noted above (fn. 22), a series of undated photographs illustrate the meagre arrangements of the early youth hostel (Figures 10-12).<sup>30</sup> Lighting at ground floor level was by means of pressurised paraffin lamps with upper floors lit by portable paraffin lamps (Figure 11b) supplemented as required by candles. Heating to ground floor only was by means of open fires; an 'Aga' stove was installed in the warden's kitchen (Figure 10b) while the visitors' kitchen was furnished with six calor-gas rings (Figure 10d). Water supply was by means of two 5,000 gallon capacity tanks in the basement (Figure 12a), fed by rainwater collected from the roofs, with an alternative supply from a nearby pool.

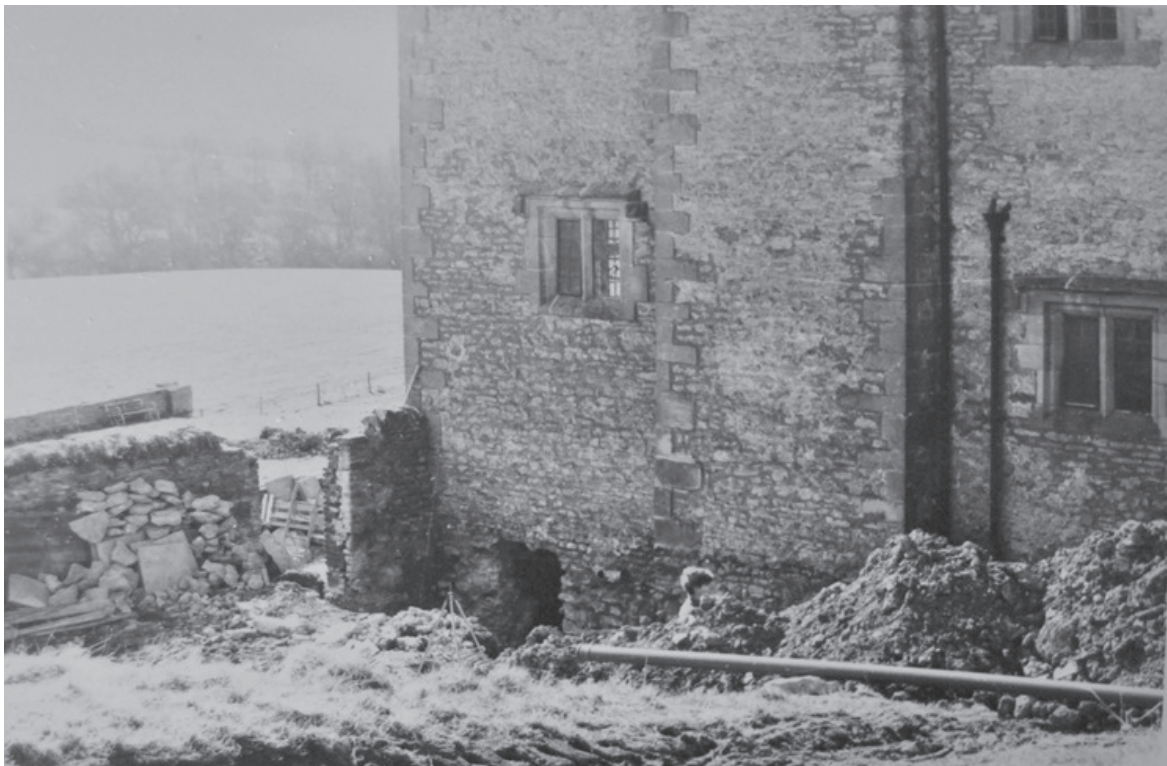
**(b)** Excavating steps to newly formed door into basement of east wing, 1975.

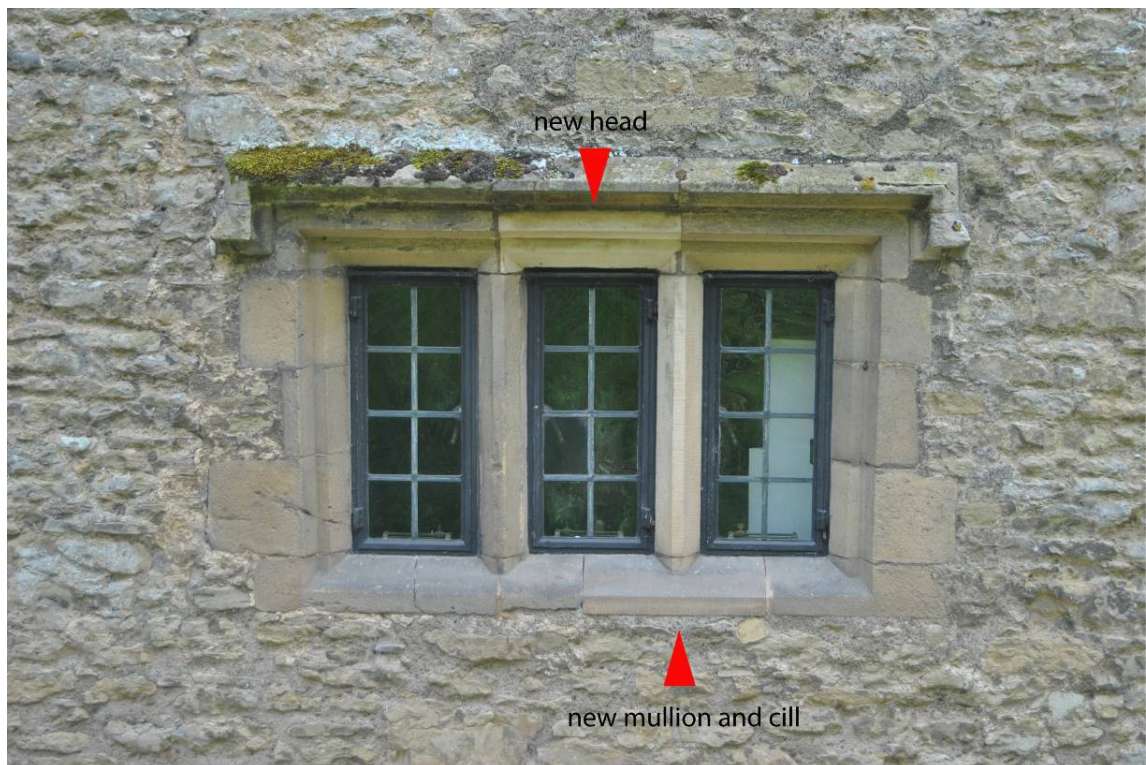
Plate 23: Adaptation of w16; widened by one light to west (right) in 1930s (see Figure 8b).

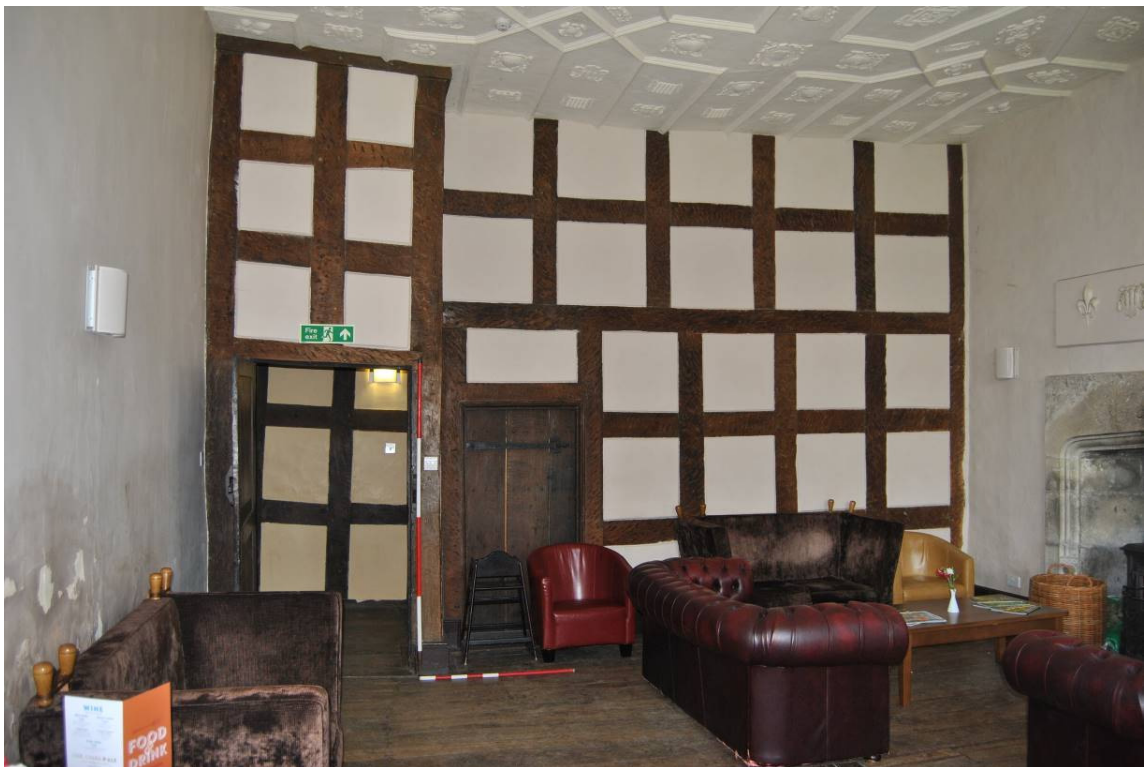
Plate 59: Timber-framed construction of north wall, Parlour [G8]; both door locations appear primary though d13 (left) has been adapted.

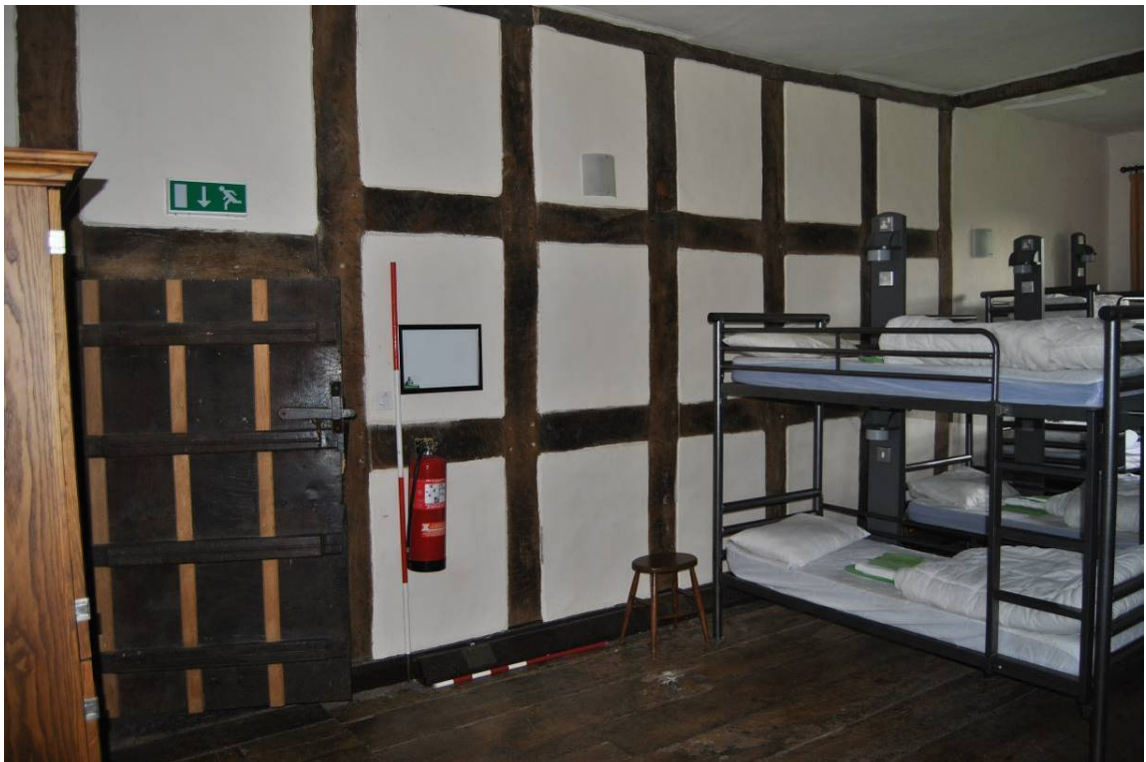
Plate 79: Principal chamber [F1], timber-framed east wall, NB. dropped rail over primary doorway d21.

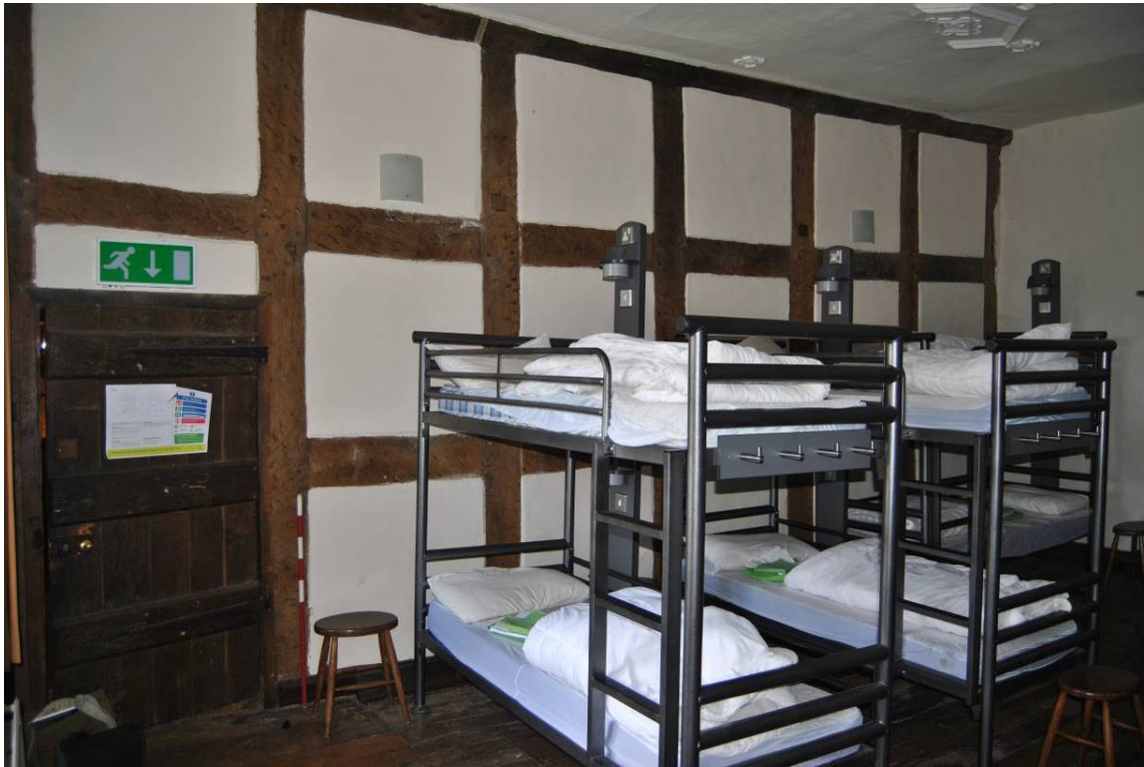
Plate 80: Principal chamber [F1], timber-framed west wall, NB. no dropped rail indicating inserted door d22.

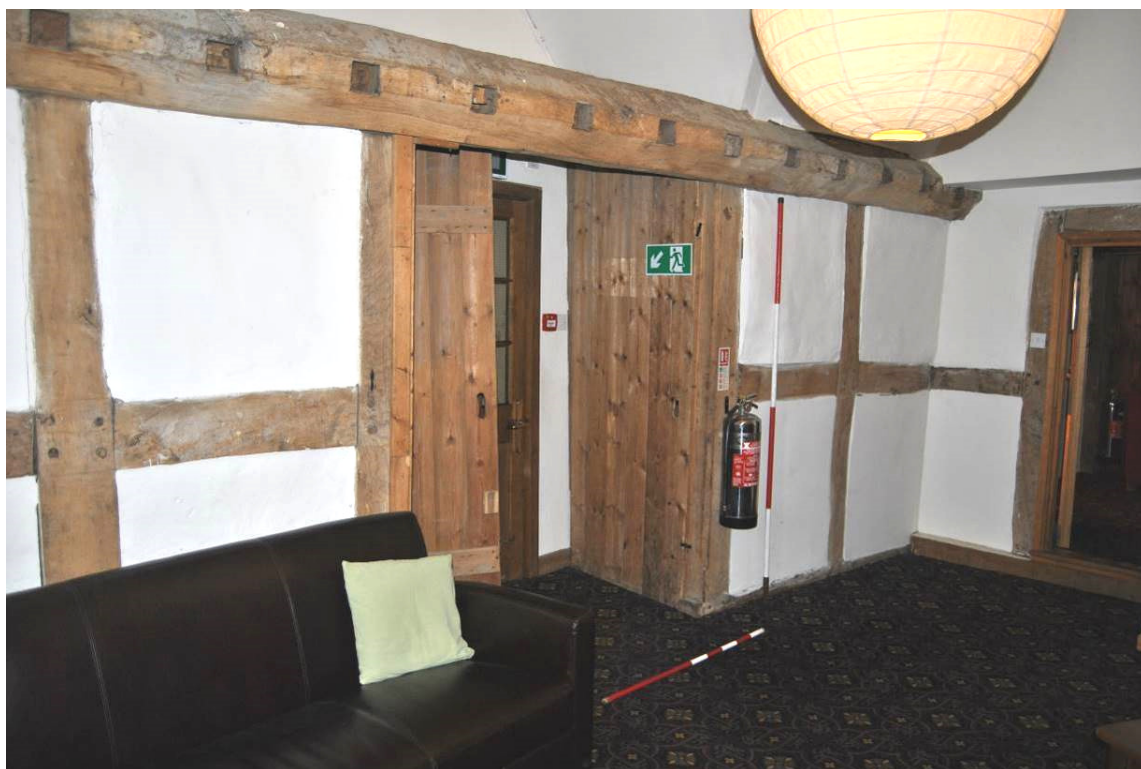
**Plate 104:** Room [S1] looking north-east, with timber-framed wall and doorway to Stair A; note joist sockets to purlin.

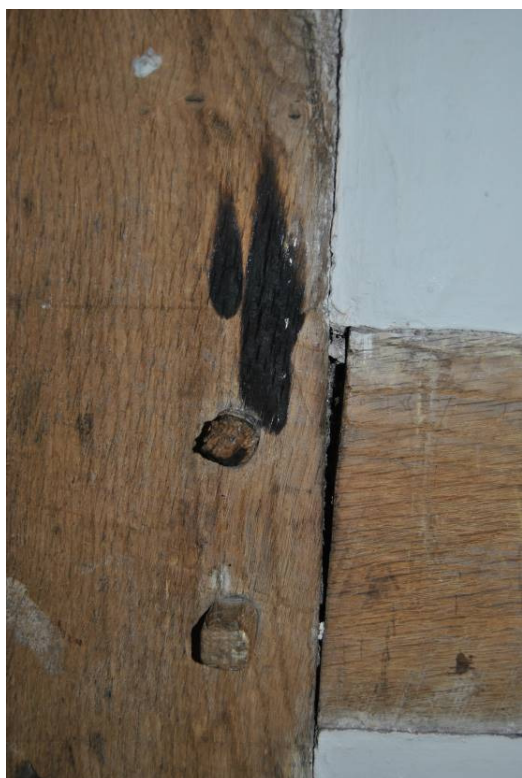
Plate 109: Detail of taper burn.

- 7.3.32 The insertion of shower and WC facilities to the northern side of the range has narrowed the access passage significantly and, in its current form, corridor **[S5]** (Plate 107) is only 3½ft wide. The southern wall is primary, retaining a section of exposed, timber-framed walling to the east end, though this is elsewhere obscured by modern plasterboard lining. Doorways **d30/31** are of similar form with plain-chamfered jambs and 'Tudor'-arched head formed of a raised mid-rail, double-pegged (Plate 108); evidence for former lighting was recorded in the form of taper burns around **d30** (Plate 109).

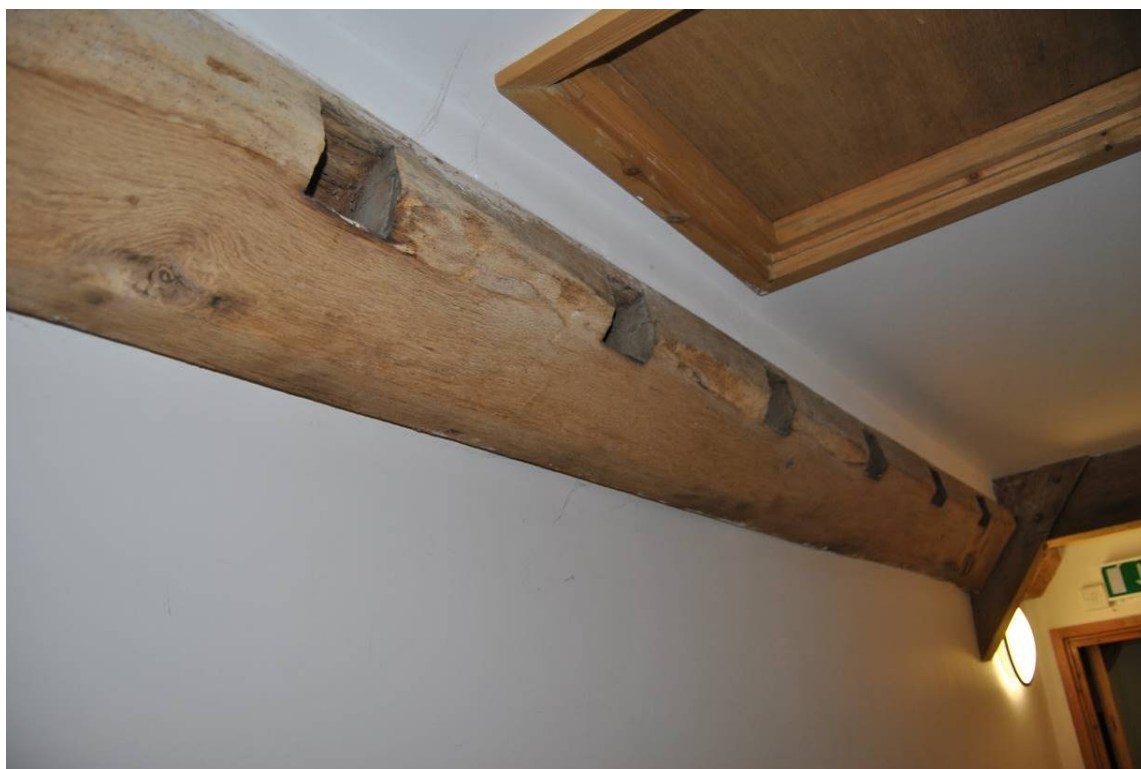
**Plate 111:** Redundant ceiling joist sockets within south purlin, hall range roof.

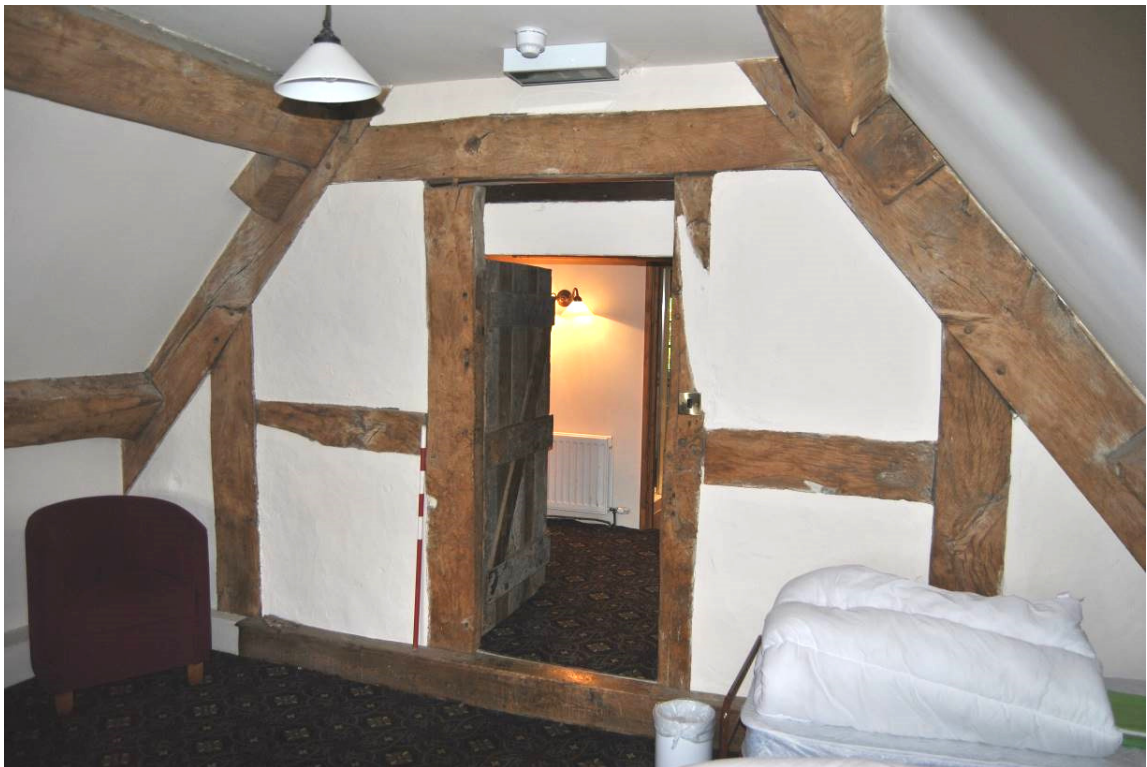
Plate 116: Infilled truss T6 between [S2/4]. NB. double purlin to south, single purlin to north.

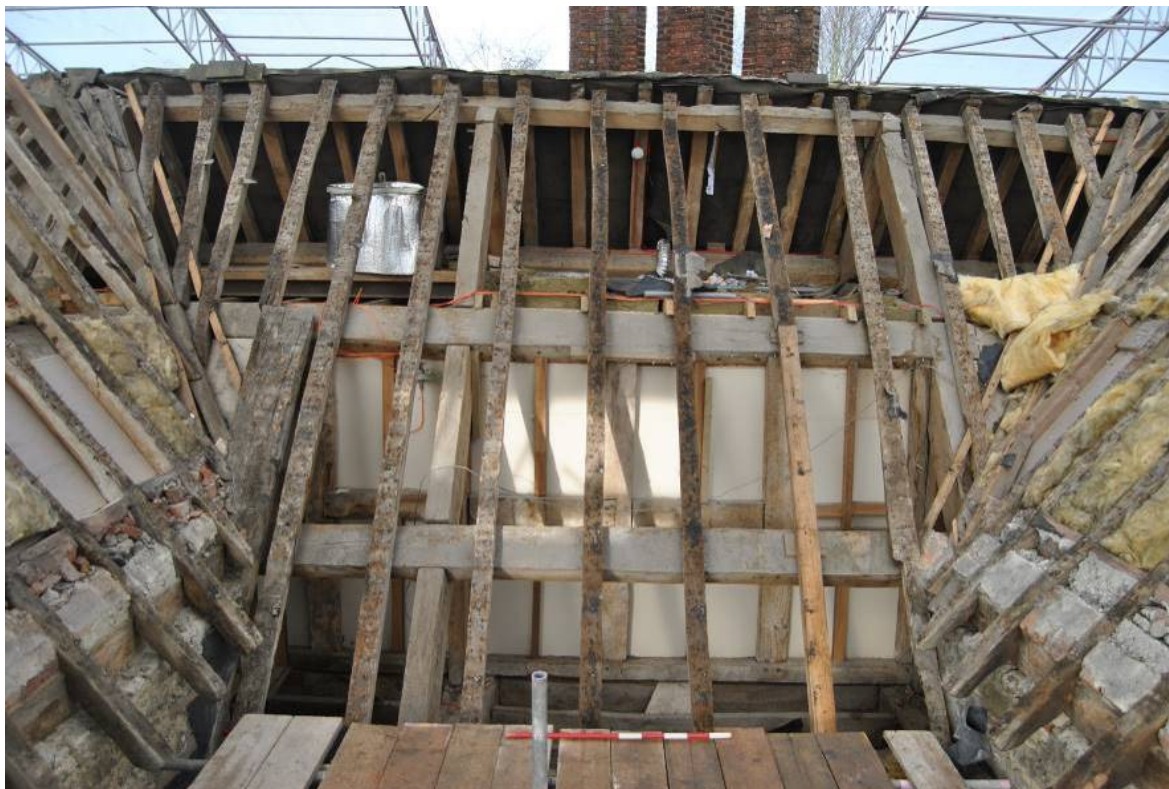
- D.3.1 As noted above (main text §.7.3.30, fn.69), the southern, framed wall of passageway [S5] was more fully exposed within Bay 3 during works, revealing details of construction previously inaccessible (Plate d, below).

**Plate d.** Exposed framed wall of [S5]; Bay 3.

A number of observations have implications for the original form of the space above the great chamber. Firstly, the fact that the lower studs of the partition are tenoned into an independent cill plate which sits atop the principal floor beam (Plate e; overleaf, left) and that the upper ends are simply nailed to the back of the upper purlin (Plate f overleaf) suggest that the partition may represent a secondary insertion, albeit most probably an early one or indeed, a variation/improvisation during the original construction. The fact that the lower purlin is chamfered and stopped to trusses **T2** and **T3** (Plate g, overleaf) supports the interpretation that it was originally envisaged to have been exposed. That the western mid-rail is tenoned into the principal rafter of **T2** though simply lapped at the adjacent stud is also suggestive of a secondary insertion (Plate h; overleaf, right).

<sup>69</sup> The structure of the southern wall was more fully exposed during roofing works where the queen-strut of **T2** was noted to be integral to the studwork wall. The lower end of the studs were noted to be tenoned into an independent sole plate, resting atop the principal floor beam while the tops were simply nailed to the outer face of the upper purlin, which together may suggest that the passage partition represents an early modification, or perhaps simply an on-site improvisation during construction (see **Appendix D**, §.D.3.1). This is further suggested by the details of the lower purlin, which was noted to be stop-chamfered, an unnecessary embellishment if intended to be obscured from inception, and the atypical jointing of the westernmost mid-rail.

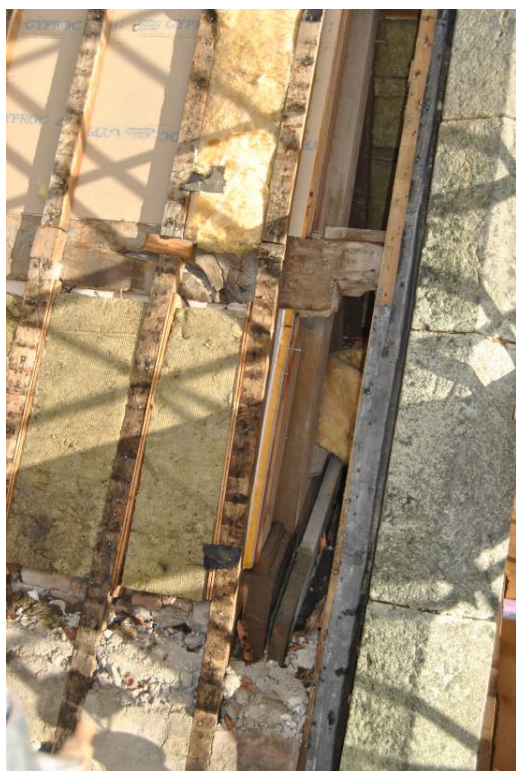
- D.3.3 As noted within the main text, the second floor room of the porch tower is furnished with a roof truss hard against the southern masonry gable. Observation at the western roof slope of the parlour wing at first suggested that this may also originally have been the case here, with the purlins stopping short of the gable and terminating in a notch (Plate k; below, left), though this detail was not repeated to the eastern slope, where the purlin was embedded in the masonry of the gable (Plate l; below, right). The southern truss of the parlour wing is a modern (1980s?) insertion.

k. Western purlins terminating short of gable wall.
