Harworth Colliery

Cultural Heritage Desk-Based Assessment

October 2009

Project: **Mixed Use Development at Harworth Colliery**

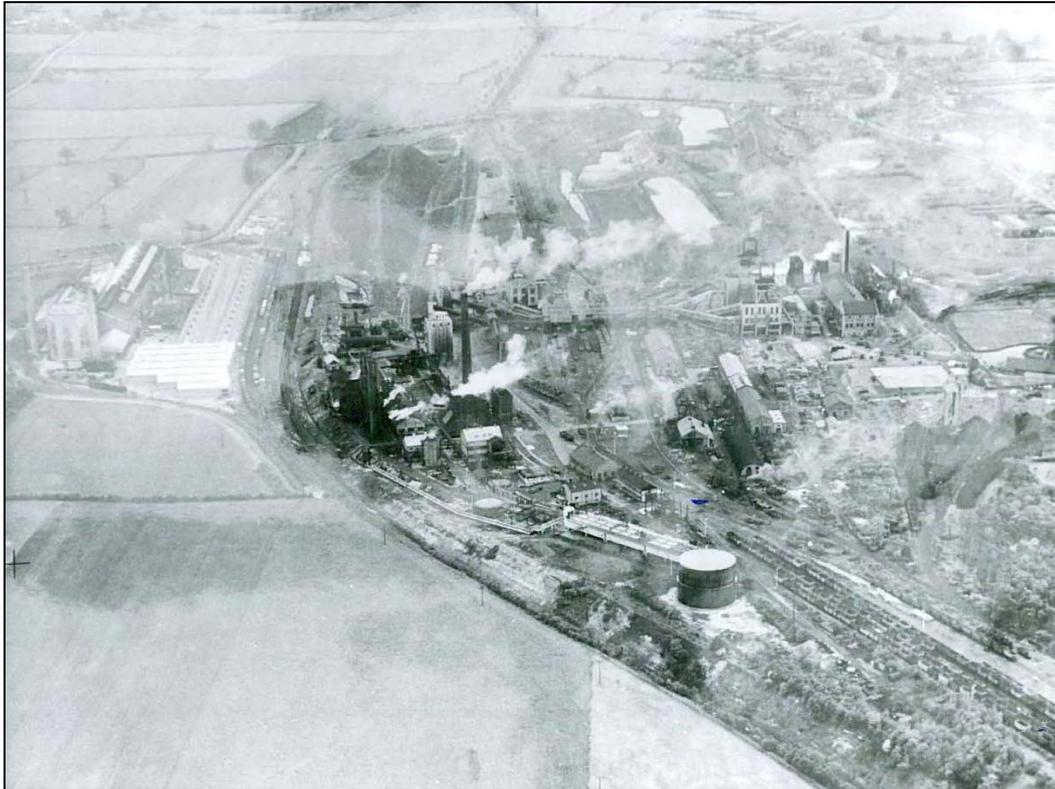
Plate 1: Aerial photograph of the colliery site looking west.

The southern boundary is delineated by the South Yorkshire railway with the glassworks to the south. The former ponds and initial phases of Tip1 can be seen at the far end of the site, whilst at the near end, on the right of the photograph the edge of Waterslack plantation can be seen.

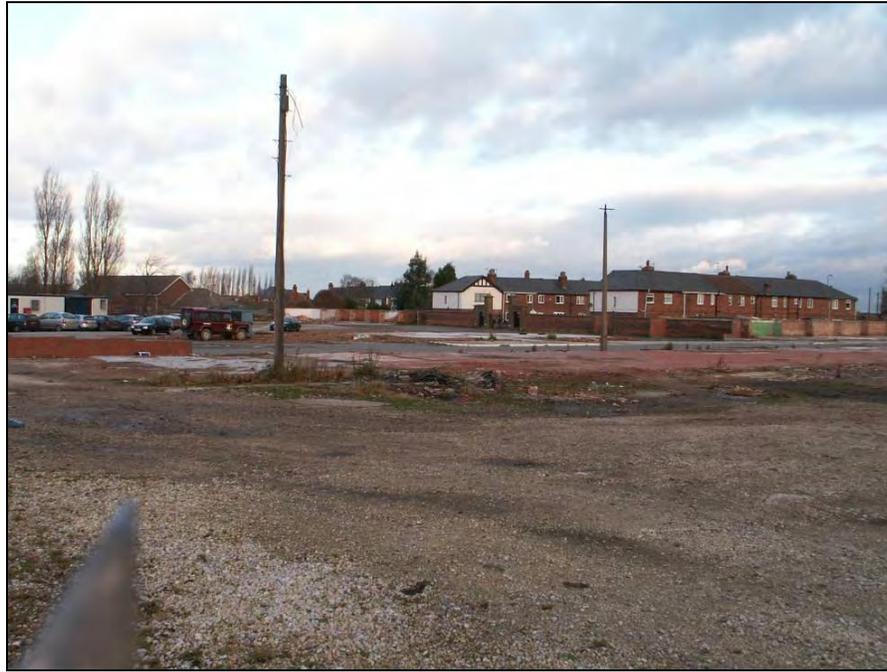
Photograph 1: Area of demolished former buildings showing remaining foundations

In the north of the site a number of former colliery buildings have been demolished and the above ground structures removed (indicated by the purple area on the site walkover plan). Concrete pads and buildings foundations are still extant. The west of the site contains nine settling ponds for waste water from the site. The areas of the main colliery area, demolished buildings and settling ponds on the site are anticipated to have experienced substantial ground disturbance in the past as a result of the building of colliery buildings, introduction of services and localised excavation.

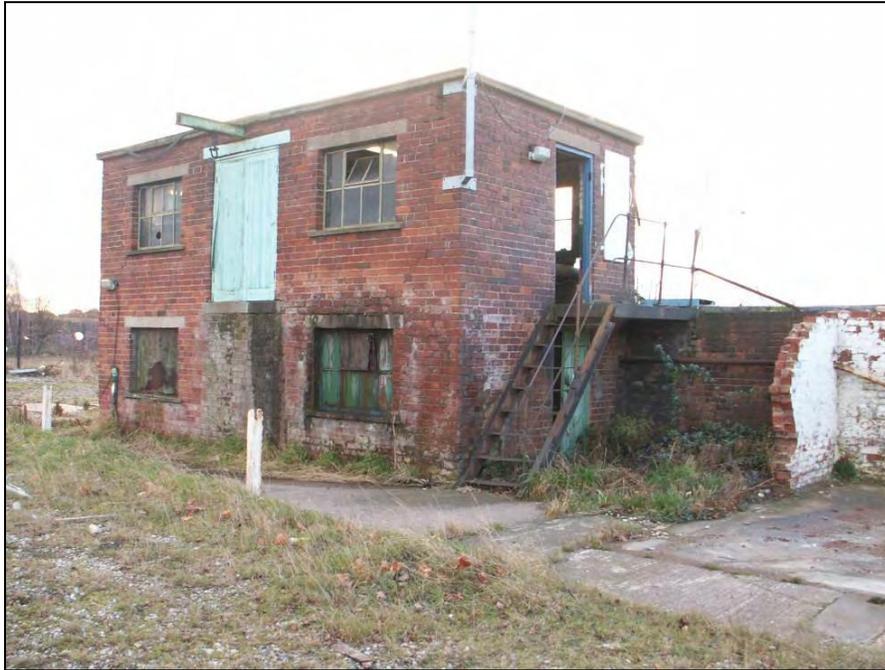
Photograph 3: Former pumping house to be demolished

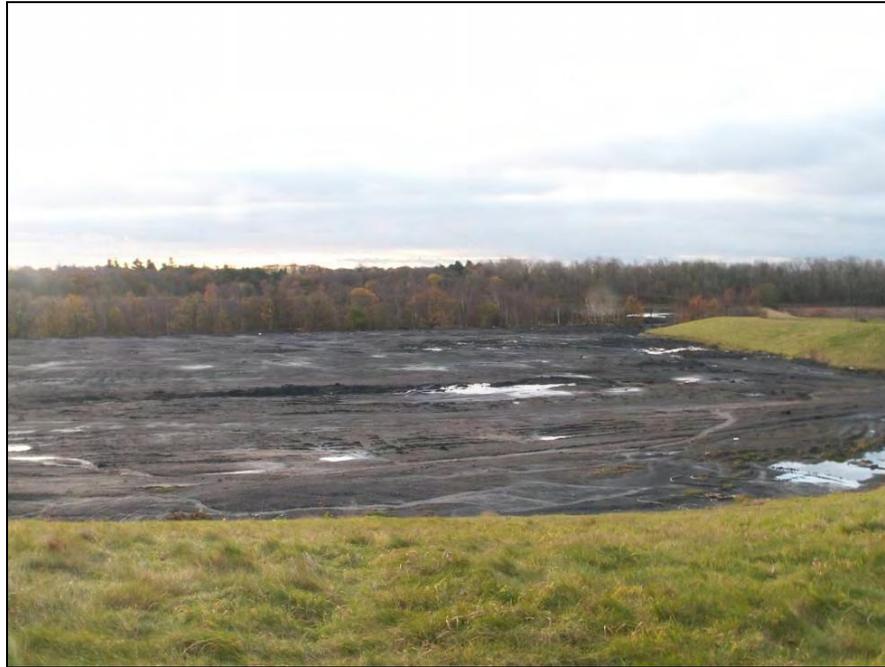
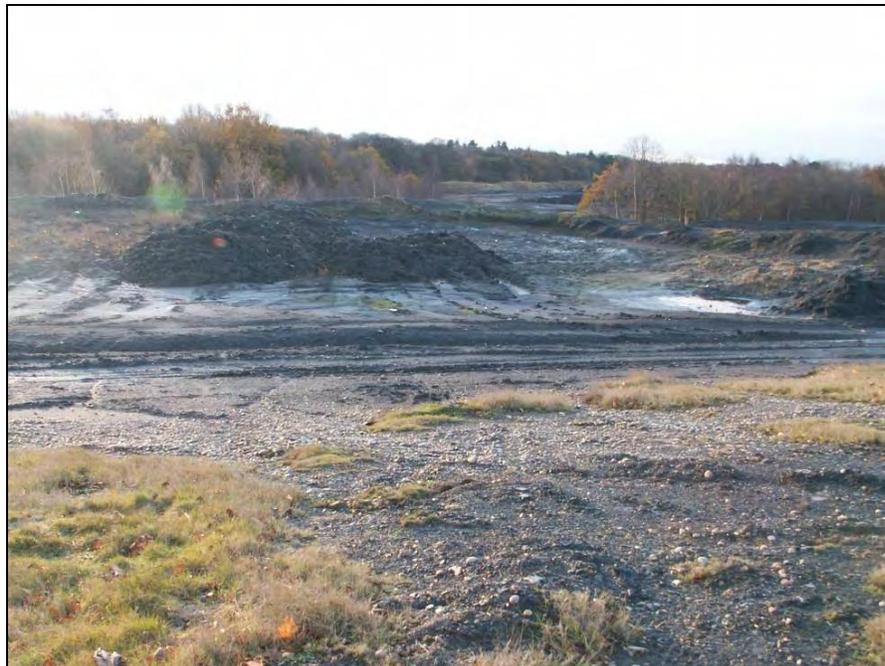
Photograph 5: Former northern colliery spoil storage area (west)

Photograph 5: Former northern colliery spoil storage area (east)

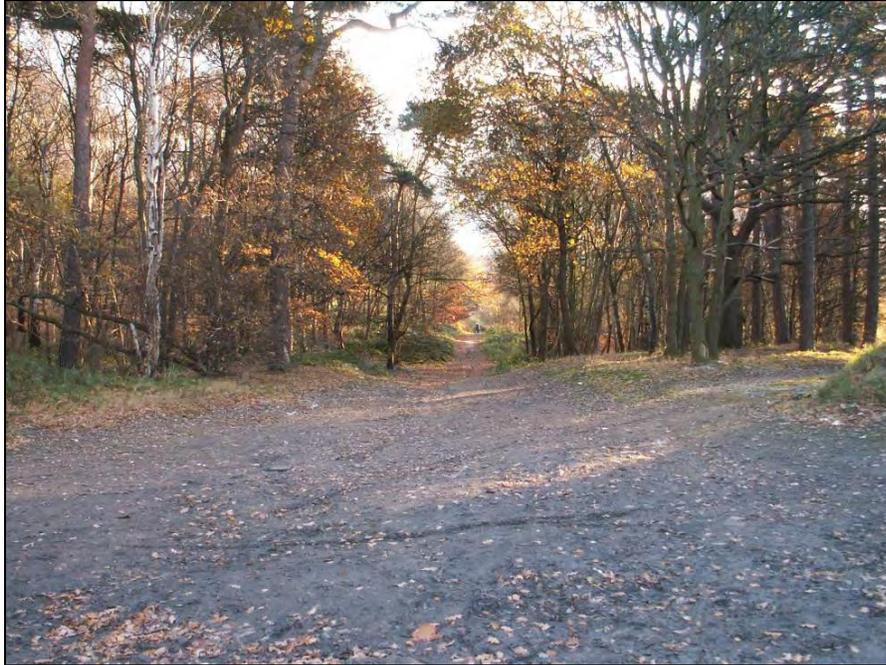
Photograph 6: Droversdale Woods to east of colliery

The east of the site is occupied by woodland. The woodland is crossed by a number of footpaths and is used for recreation by the local community. No features of historic interest such as earthworks were noted within the woodland, although there is some evidence that there has been limited management of the woodland in the past. The southern boundary of the site under consideration is formed of a dismantled railway. Whilst no visible features of the railway remain the line of the railway is clearly discernible and runs in a cutting through this area of woodland. Concrete fence posts from the former railway fence line are still visible; however the rest of the fence has since been removed.

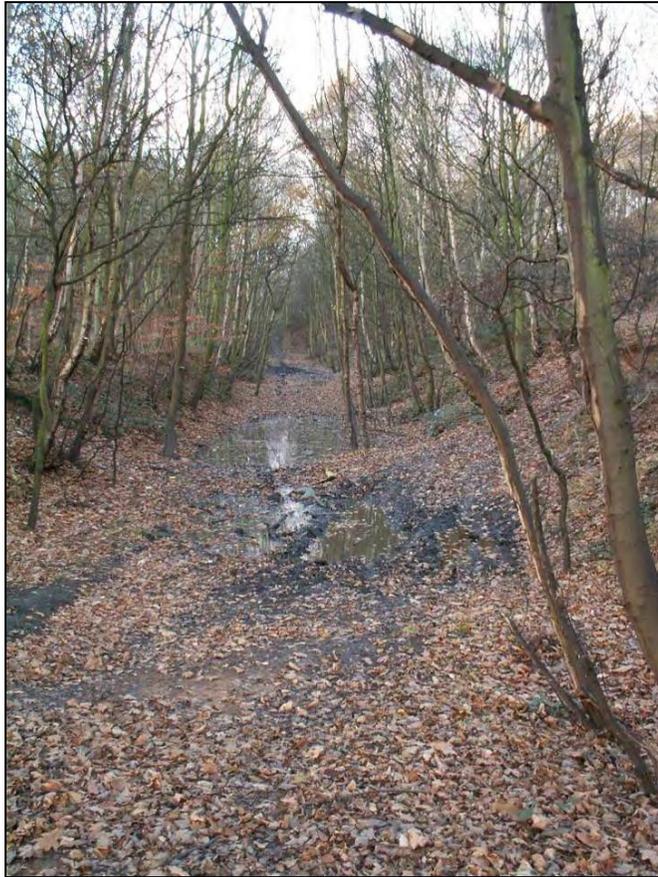
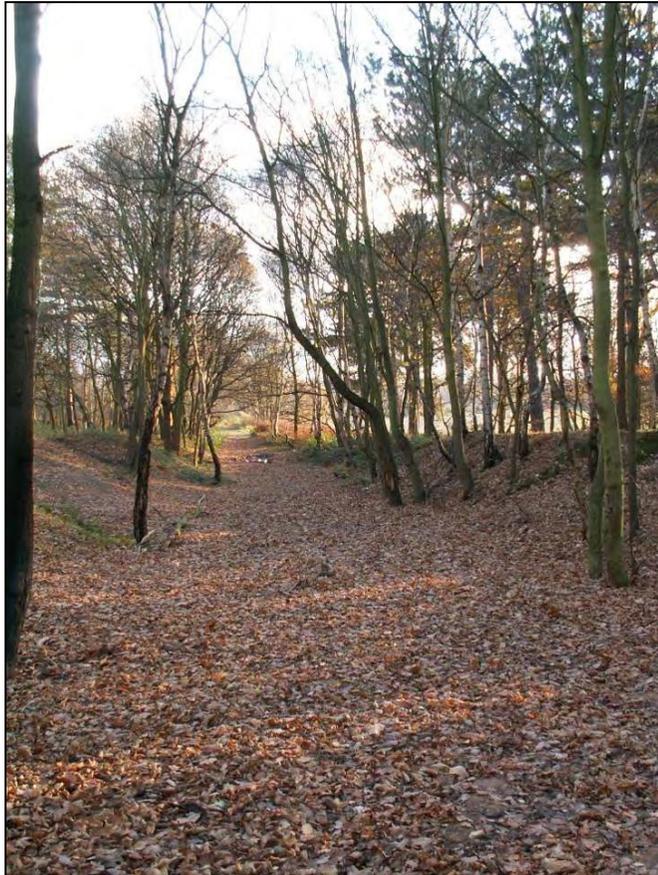
Photograph 7: Line of dismantled railway in Droversdale Woods, looking west

Photograph 7: Line of dismantled railway in Droversdale Woods, looking east

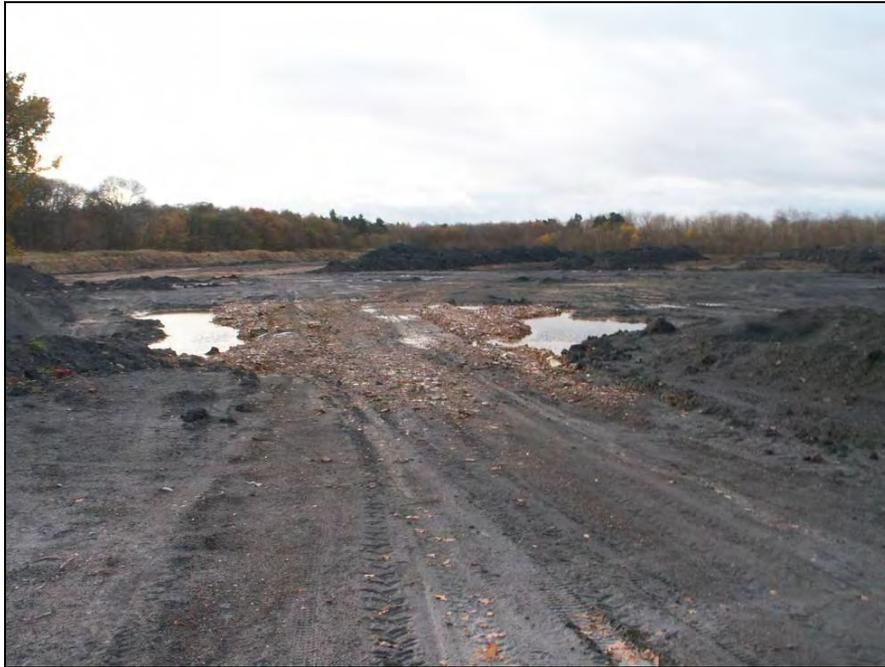
Photograph 8: Former southern colliery spoil storage area (east)

The extent of truncation and disturbance in the vicinity of the former brick and tileworks and the southern spoil storage area is unknown. There is a moderate potential that archaeological remains may still be present in these areas and therefore it is recommended that further evaluation is undertaken. The aim of the evaluation would be to confirm the presence or absence of archaeological remains, their form, extent, survival, period and potential significance. This will then allow an appropriate mitigation strategy to be devised for any future development within these areas.

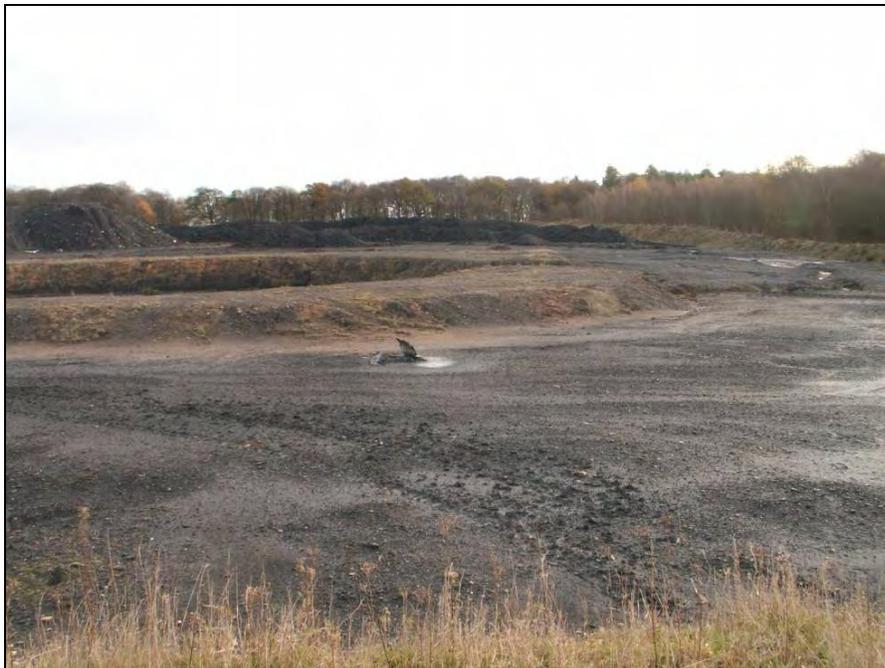
Photograph 9: Former southern colliery spoil storage area (west)

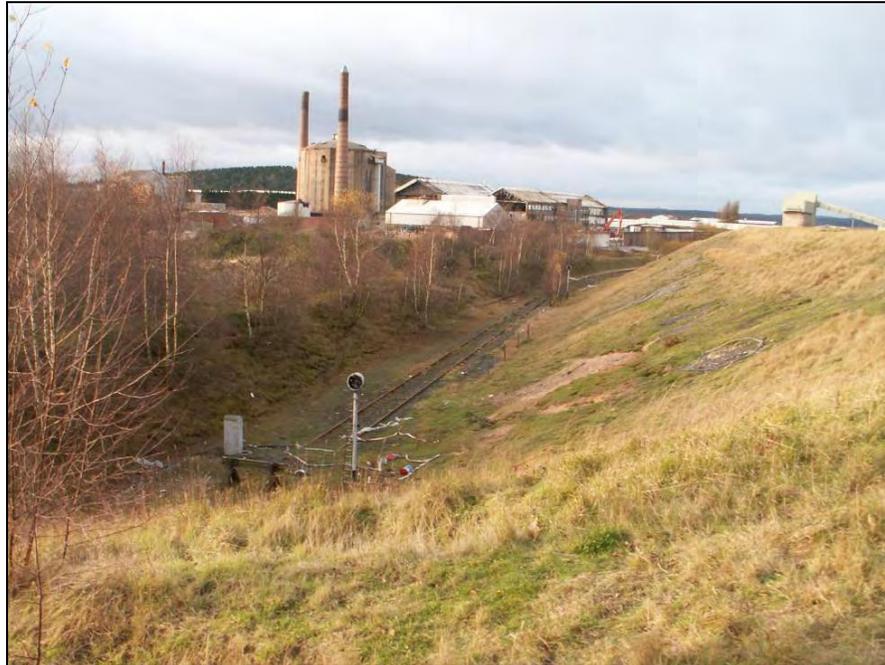
Photograph 10: End of railway line forming southern boundary of colliery site

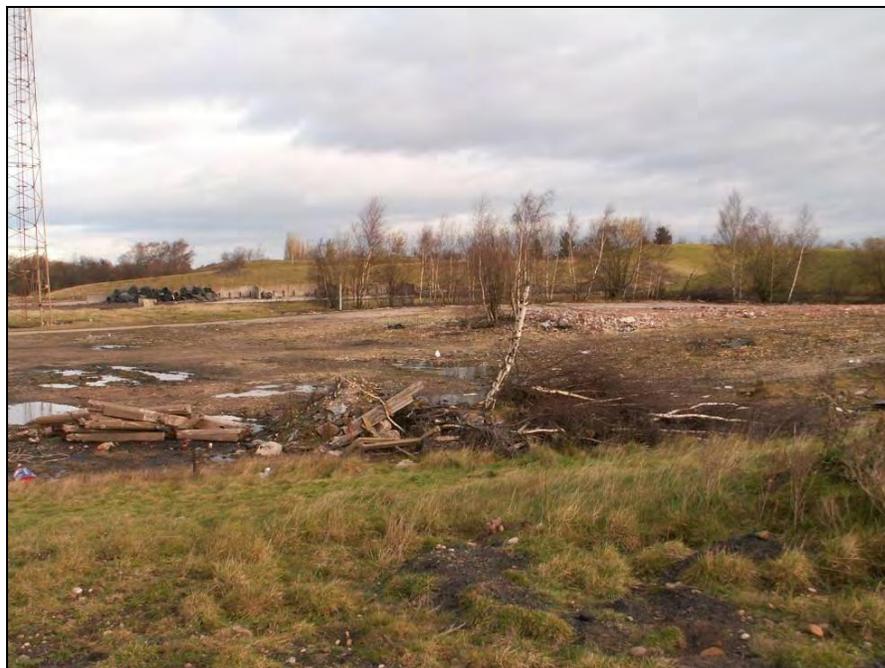
Photograph 11: Derelict ground in south of colliery site

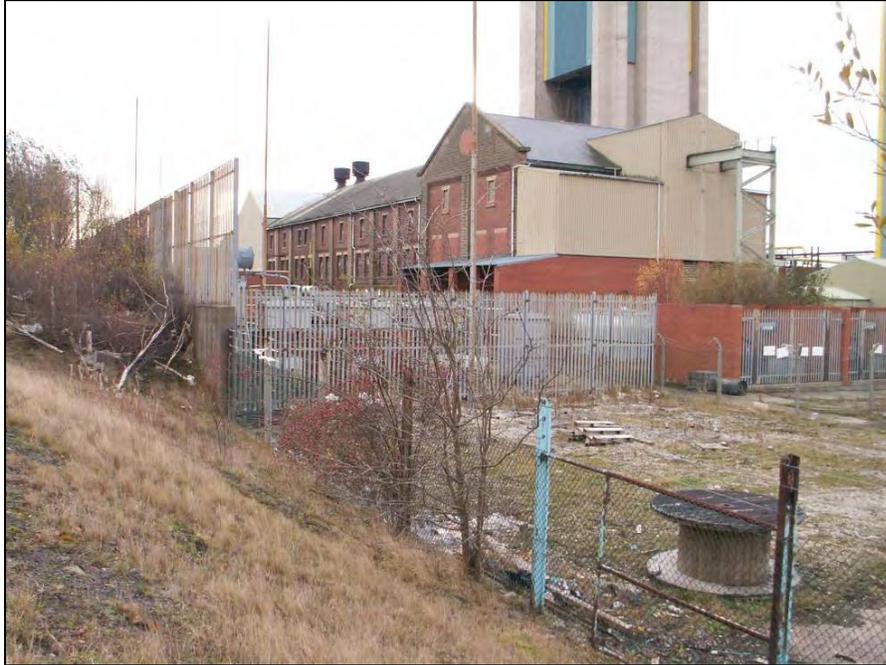
The powerhouse, winder and boiler room from one of the early phases of development remains within the site (Photograph 15), however the majority of the buildings associated with the early phase of development have been demolished and replaced. Bawtry coke works was established in the south –east of the colliery site in 1934 and remained in production until the late 1960s when it was demolished. The site was also formerly crossed by many branch railway and tram lines to transport the coal. These have now been removed and only the main distribution line of the South Yorkshire Joint Railway remains (Site 27) with a terminus to the south of the colliery site. The greatest density of development appears to have occurred by the 1960s and can be seen on an aerial photograph for the site (BWB Consulting, 2007).

Photograph 15: Powerhouse, winder and boiler room from early colliery development phase

It is anticipated that a substantial archive of drawings, specifications and records associated with the pit head buildings have been retained by UK Coal. If the pit head buildings are to be demolished it is recommended that the extent of this archive is reviewed and a built heritage report compiled which identifies the heritage significance of the buildings. This archival review may subsequently be supplemented by site inspection, recording and photographs of the pit buildings. This built heritage assessment may only be required in the event that pit head buildings are demolished and should be undertaken prior to their demolition.
