**Quarry House,
Rudchester,**

**Heddon on the Wall,
Northumberland**

Heritage assessment

**Archaeo-Environment
on behalf of Napper
Architects**

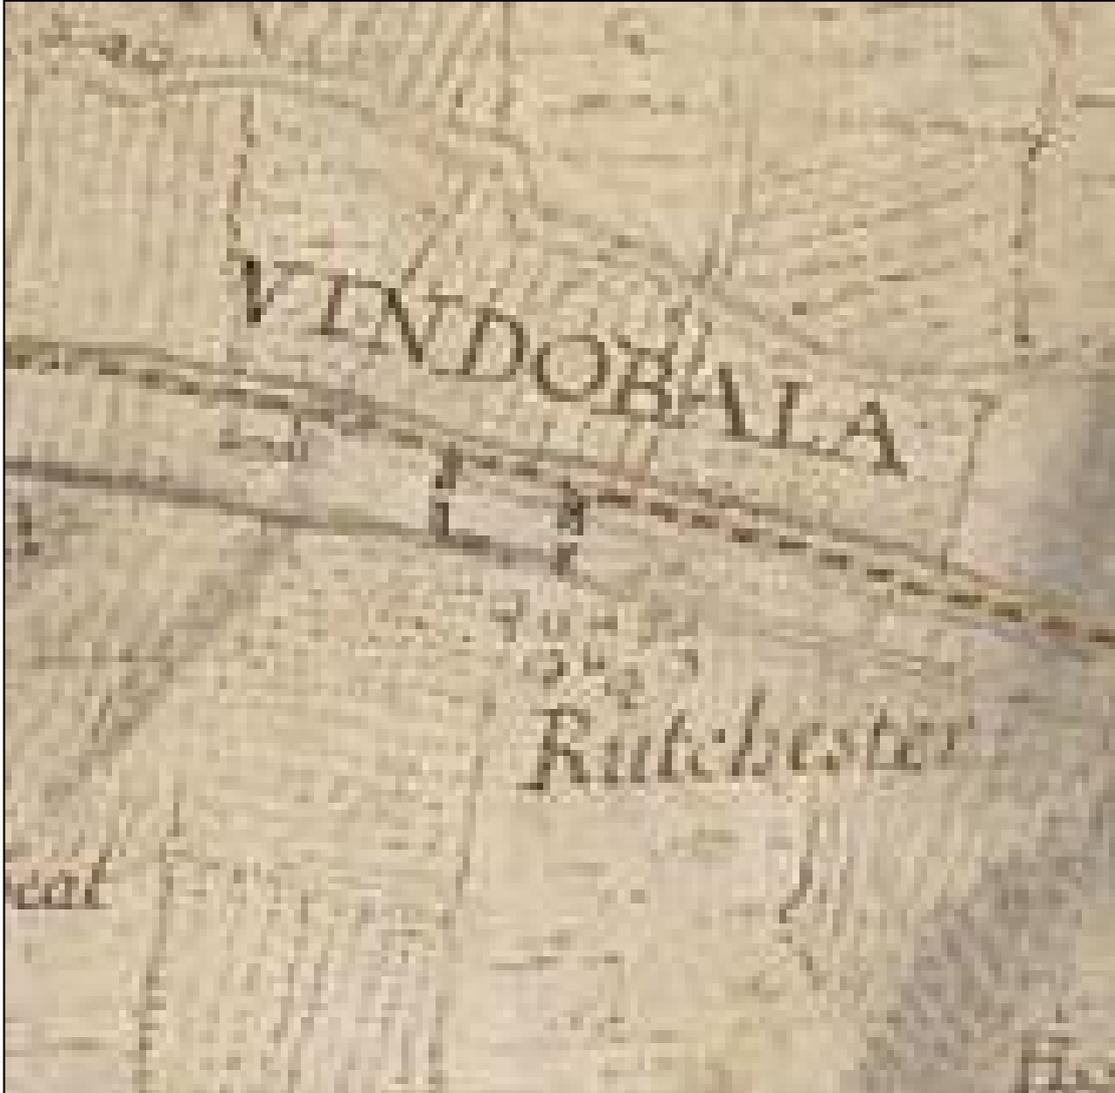
Figure 4. An enhanced image from the Military Way map of 1746 showing only trees to the south east of the fort

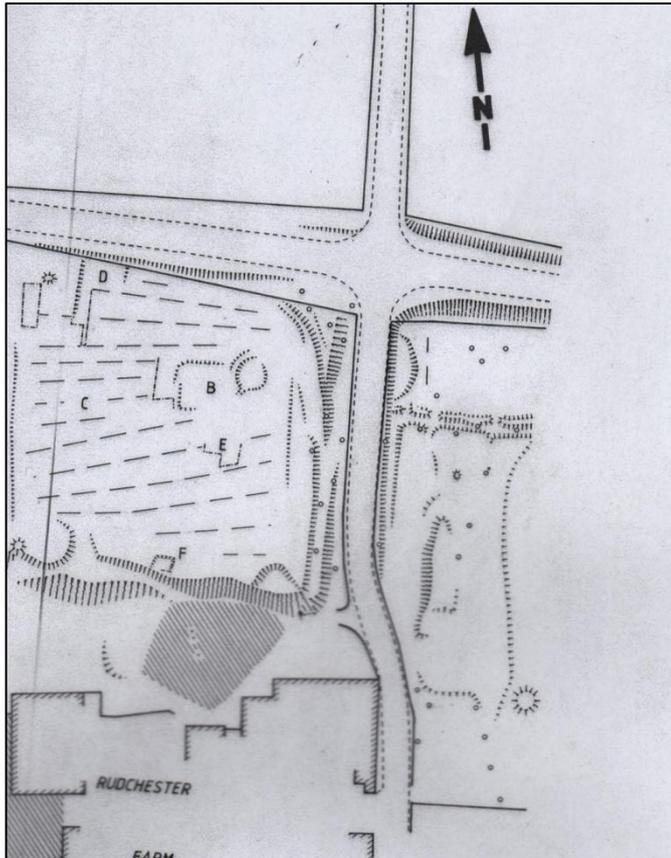
Figure 5. Extract from RCHME survey of 1990 showing earthworks to the east of the road between the quarry to the south and Hadrian's Wall to the north

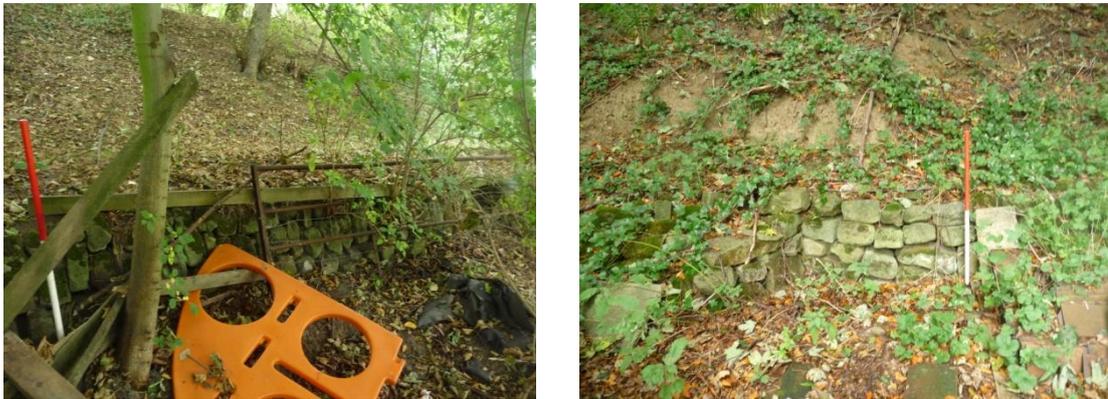
O). These are a distinctive shape found along Hadrian's Wall and while this is certainly not conclusive proof that they are dressed Roman masonry, they certainly appear to be so.

Plate 1. Retaining walls around the quarry at Quarry House appear to be constructed from dressed masonry which is typical of the shape of stone used along Hadrian's Wall.

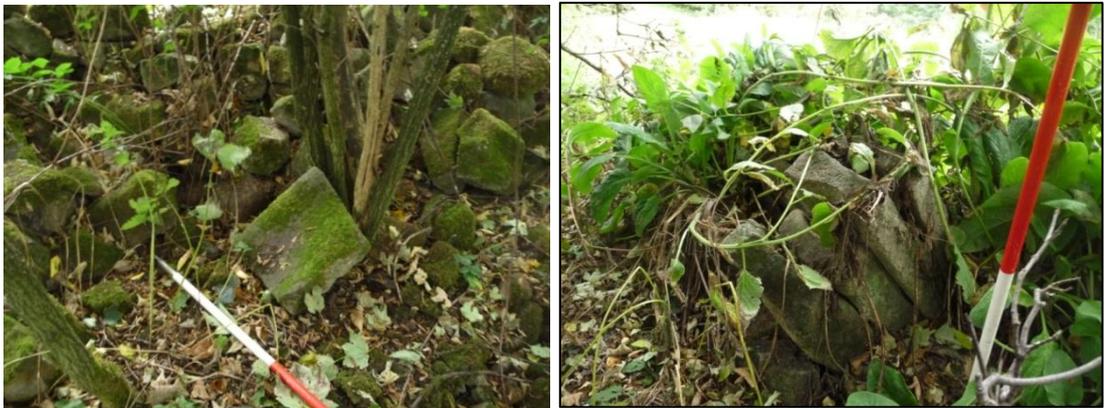
Plate 2. Possible Roman drain sections from a tumbled drystone wall north of the quarry

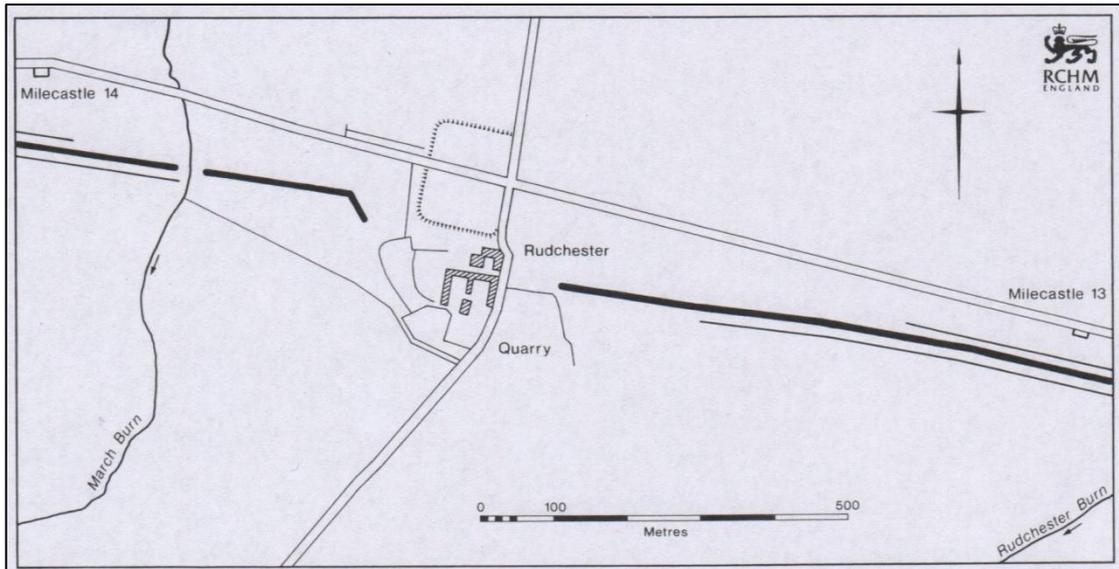
Further, the vallum immediately north of the quarry has been levelled. This might suggest that it was levelled in order to accommodate the vicus, although it is also possible that the levelling took place in association with the much later quarry development.

Figure 6. RCHME plan of the fort location. This shows how the vallum banks to the east are levelled towards Rudchester. Such levelling often took place in Roman times to create space for the extending vicus.

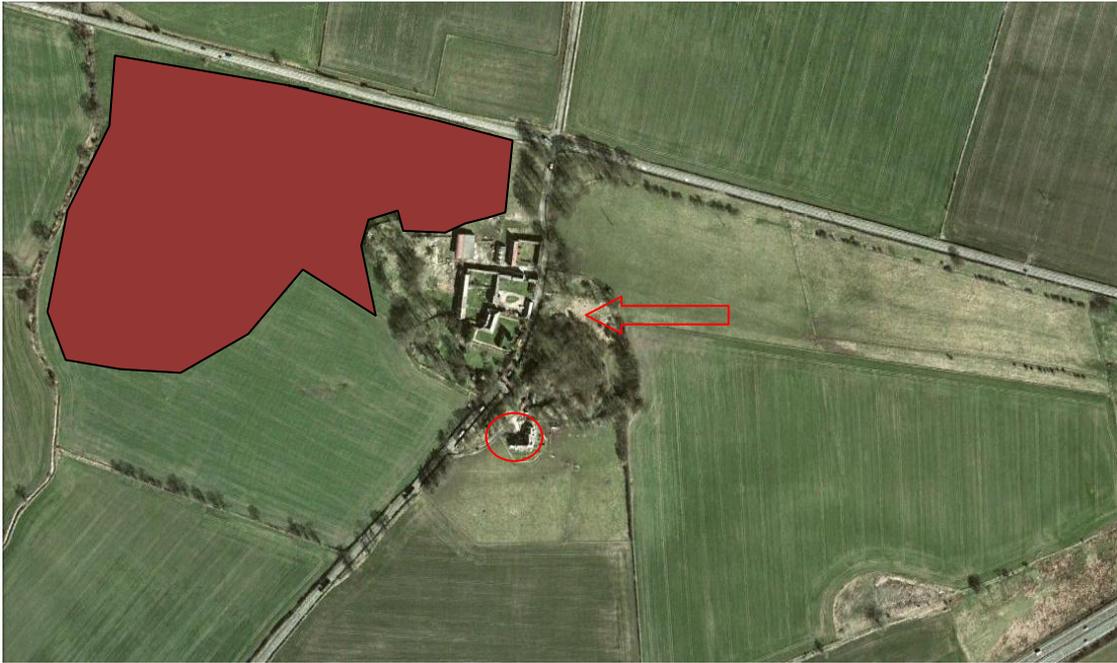
Plate 3. Reverse S-shaped selions can still be seen in this aerial photograph of 2002 which mark the layout of an open field system which pre-dates enclosure. Elsewhere, including at the development site (marked in red circle) the land has been ploughed out. The red arrow marks the location of three linear earthworks which may also be ridge and furrow that has survived the quarry operations (see plate 4 below)

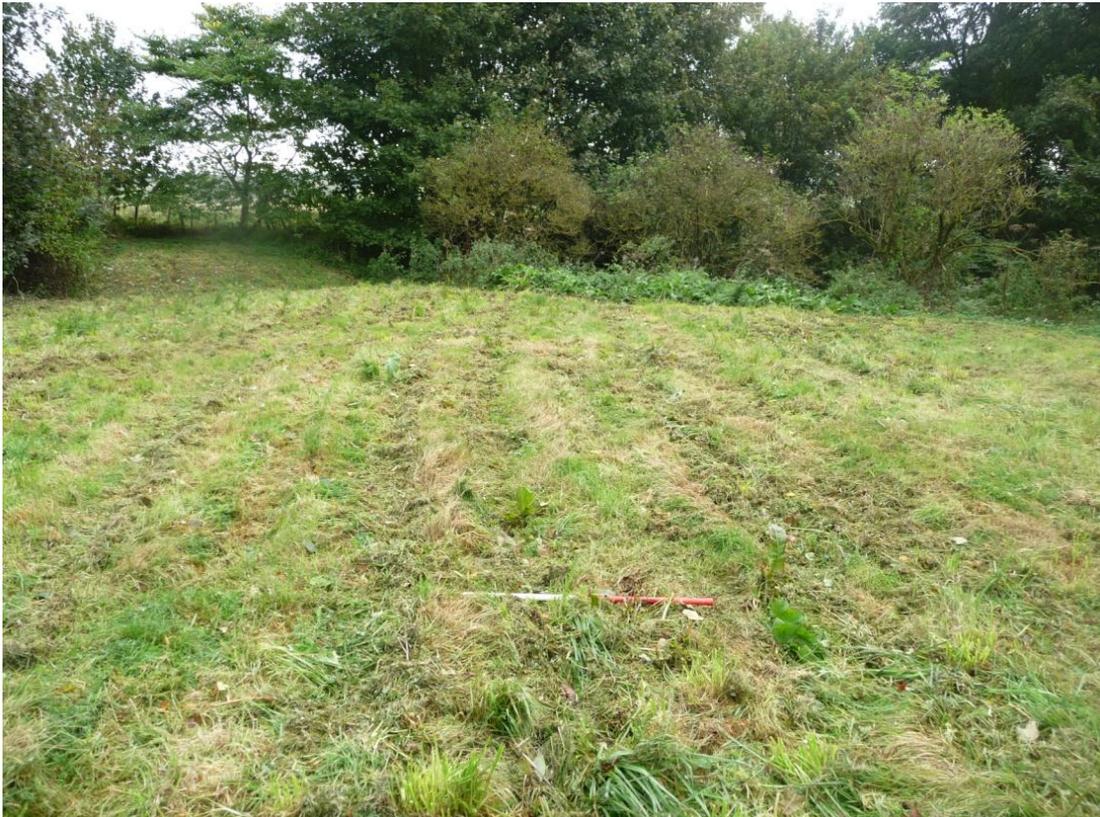
Plate 4. Three N-S running earthworks, probably medieval and post medieval ploughing running between the vallum and the quarry. The ranging pole marks the location of the nearest earthwork.

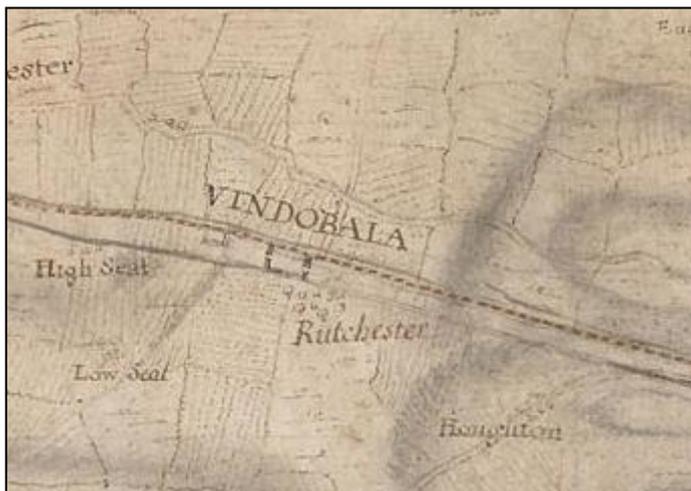
Figure 9. The Military Road Map of 1746 showing 'Rutchester' surrounded by arable fields.

In 1752 the Military Road was erected to the north of Rudchester in response to the Jacobite Rebellion of 1745. The road followed the line of the Wall and at Rudchester it was constructed directly over the Wall, using the stone as its foundations (Slater 1850, 112). The 1746 Plan of the (proposed) Military Road, was produced prior to the construction of the road. It showed the fort and its entrance points, but only a cluster of trees to the south east with no evidence for buildings. It also showed the predominantly arable field system around the fort.

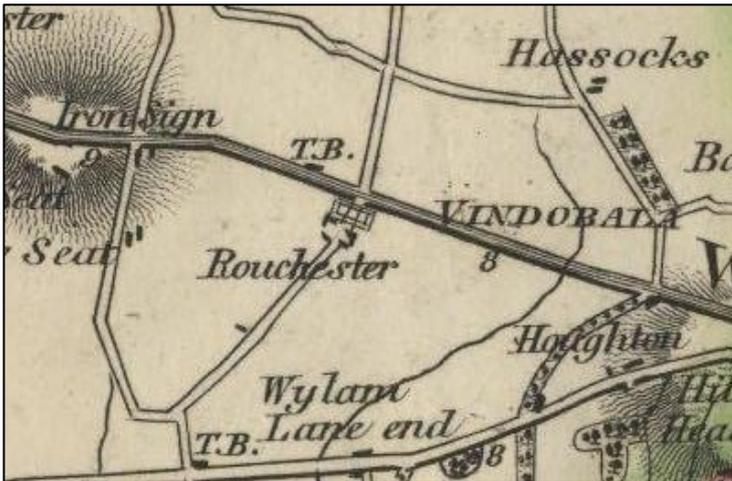
Figure 11. Fryer's map of 1820 suggesting that buildings extended on to both sides of the road. This might depict the smithy and quarry outline.

Fryer's Map of Northumberland from 1820 shows the area as it was when it passed to the James family. At that time it was referred to as 'Routchester'. The map contains little detail, while the fort has been entirely overlooked or is represented by a

large rectangle on both sides of the road (it is not clear). To the south of the Military Road, a range of buildings are set; however the lack of detail makes it difficult for any identification to be made.

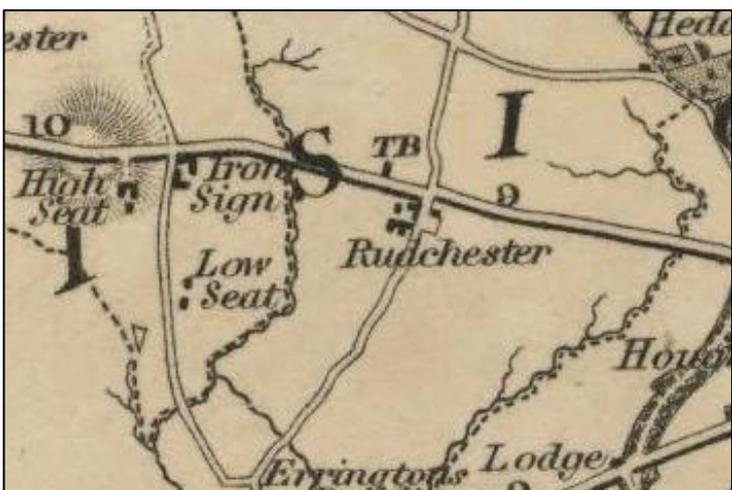
Figure 12. Greenwood's map of 1828 also suggests that a building and enclosure extended on to the east side of the road. Comparison with later maps suggests that the enclosure is the quarry

Greenwood's Map of Northumberland 1828 depicted a more inhabited settlement with a distinct cluster of buildings. The site of the fort was once again overlooked, presumably because the ravages of the 18th century no longer left anything of sufficient substance to depict. The buildings, however, now stretch to the east of the fort's site. By comparing this to the OS maps of the 1860s it is clear that the building is a smithy (sites C and D) and the enclosure shown, the boundary of the quarry.

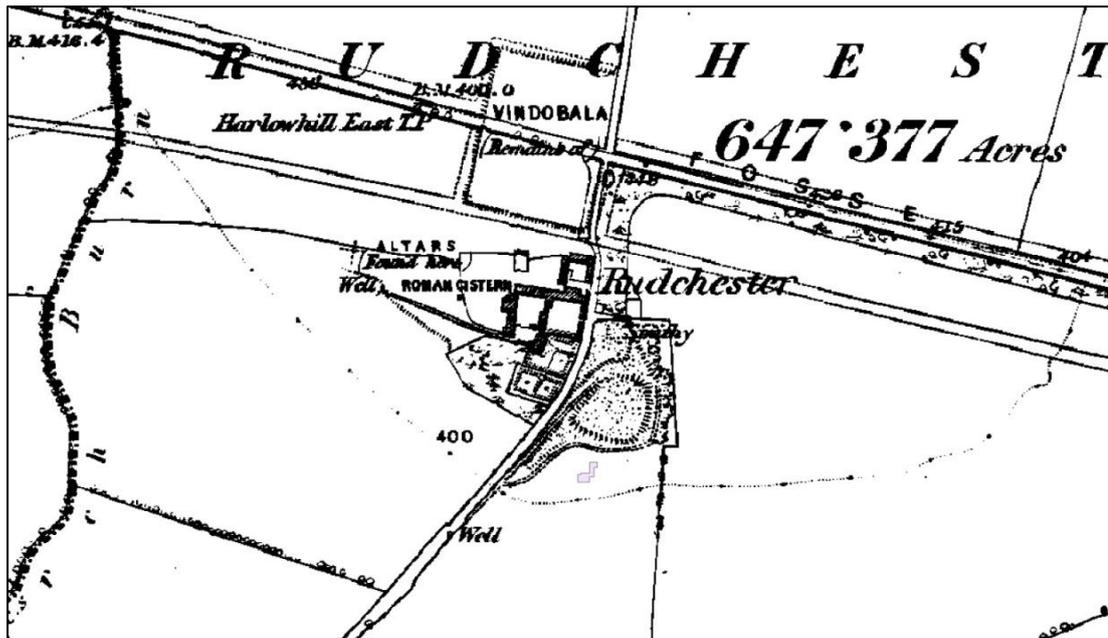
Figure 15. the 1st ed OS map (1,1250 scale) showing the extent of the quarry and the location of the smithy to the north. The current outline of Quarry House is added in lilac

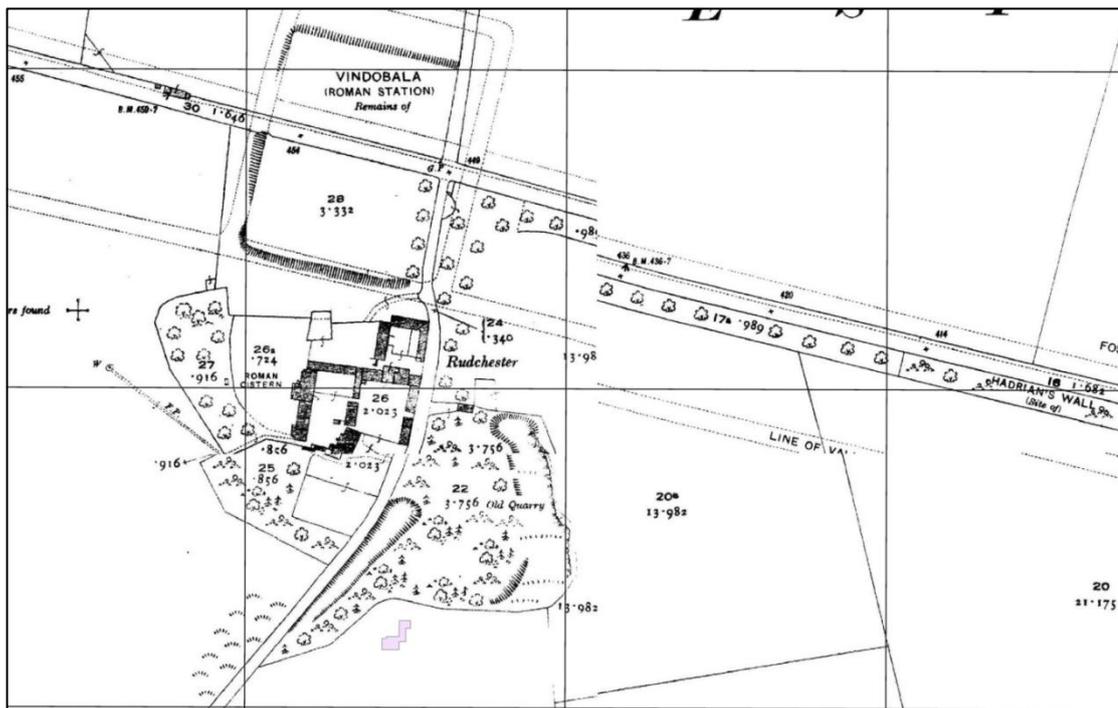
Figure 17. The 3rd edition OS map (1:1250) of 1919 showing the quarry now out of use, but the smithy is still shown. (Current outline of Quarry House has been added in lilac)

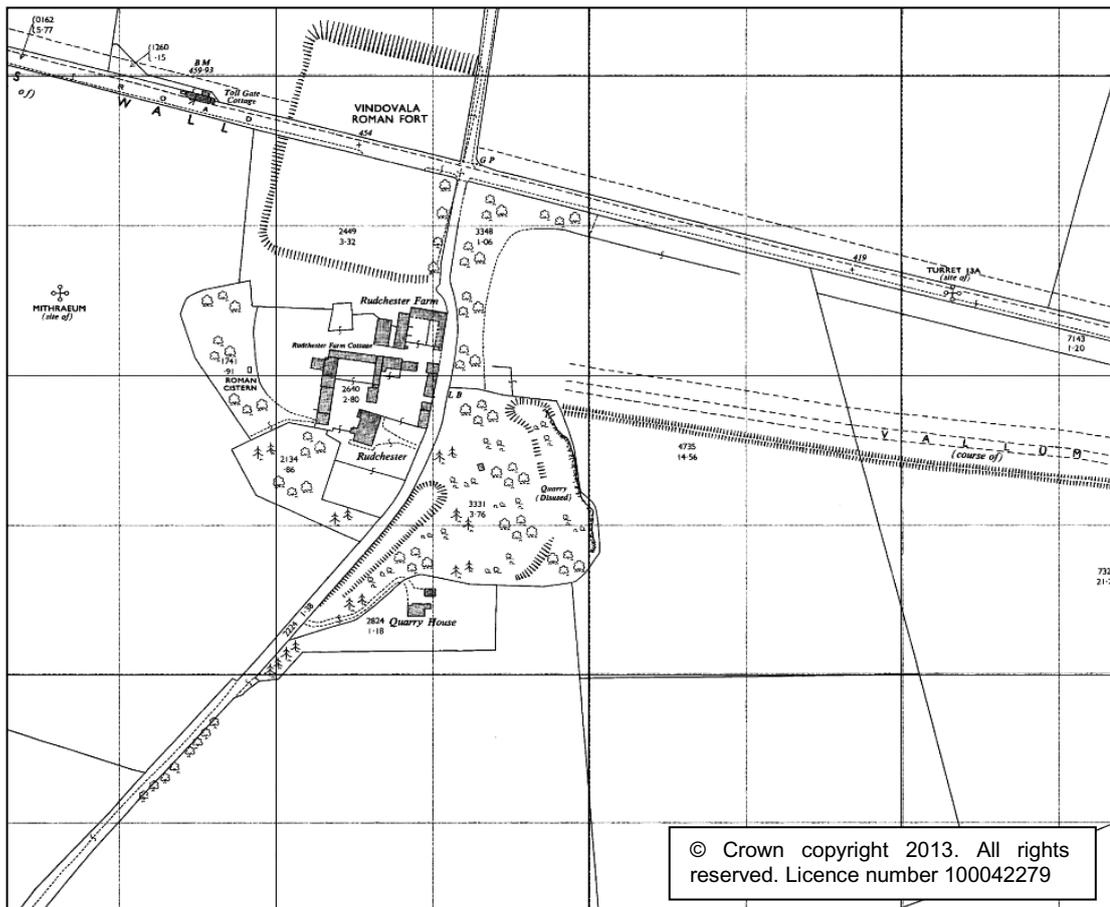
Figure 18. the OS 1963 edition 25 inch is the first map to show Quarry House utilising the original quarry drive from the south. The enclosure abutting the north side of the quarry was all that was left of the smithy. This was also shown on the earlier 1951 OS map (6 inch)

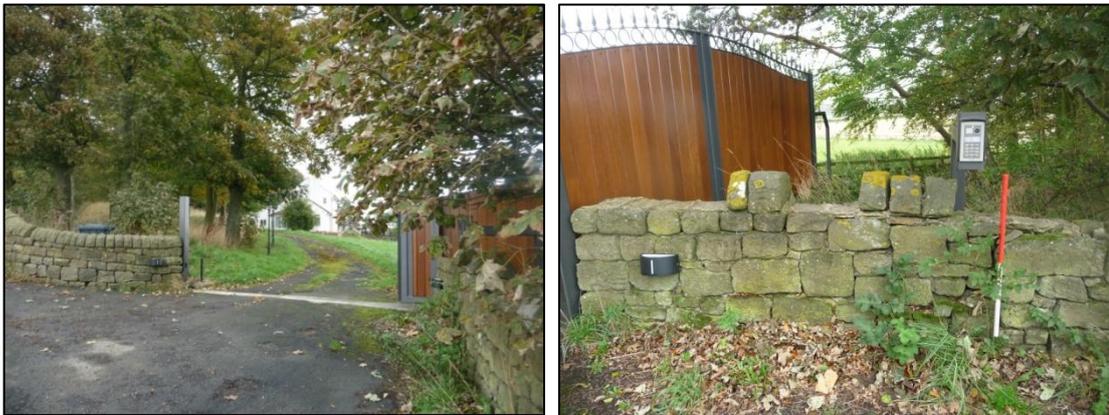
The house today is approached along a drive that has made use of the original quarry entrance. The stone walls which enclose the Quarry House site from the road are topped with rounded copes, but many of these have been removed, presumably stolen, despite being cemented into place. The copes nearest the entrance drive are modern replacements.

Plate 5. The entrance drive to Quarry House makes use of the original access into the quarry and is well shielded from the road by trees (left). The coping stones of the walling around the perimeter of the site are being stolen despite being cemented down

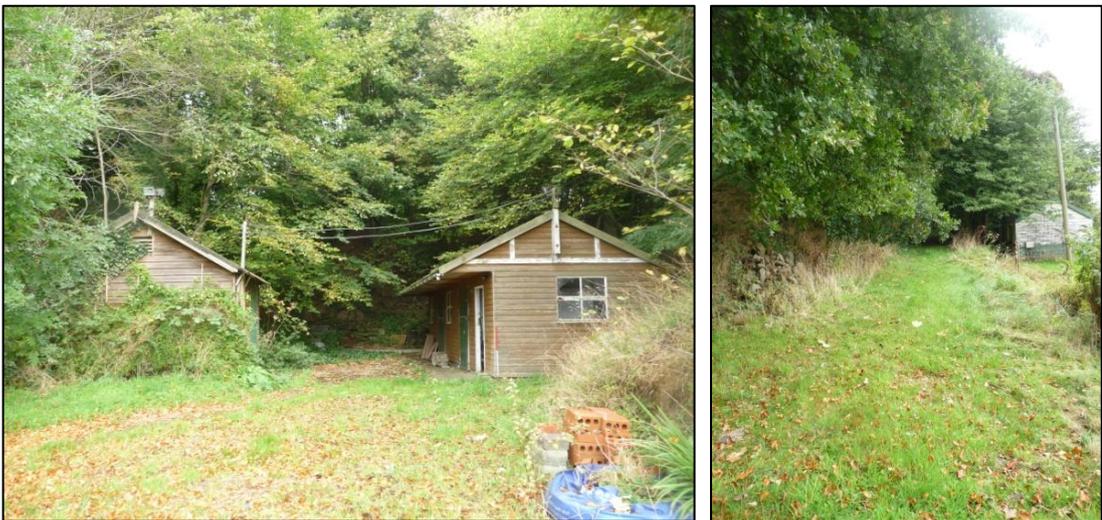
Plate 7. The backdrop to Quarry House is of dense woodland that has grown up inside the quarry. Two modern stables have been located here (left). The original entrance into the quarry continues on the north side of Quarry House into the quarry (right)

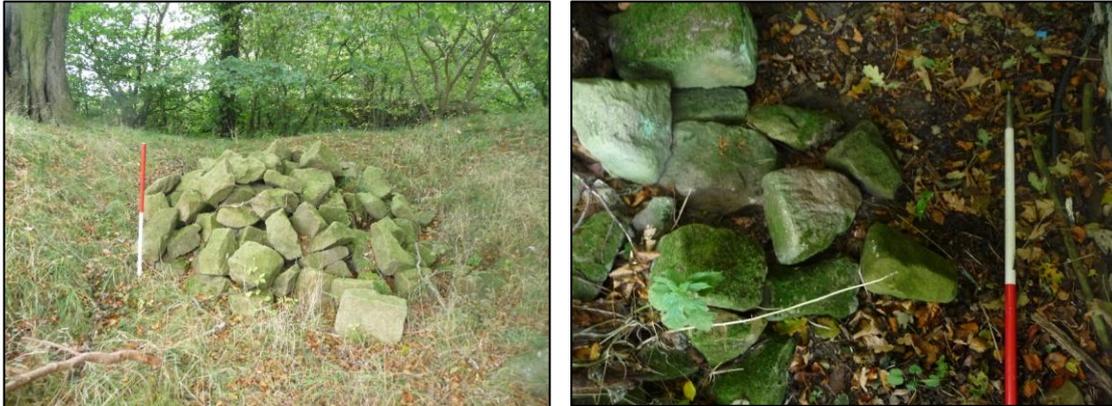
leftovers from the quarry, although some have been dressed in a style seen on Roman structures in the area (plate 8, sites M and N).

Plate 8. Discarded heaps of stones around the quarry perimeter (sites M and N)

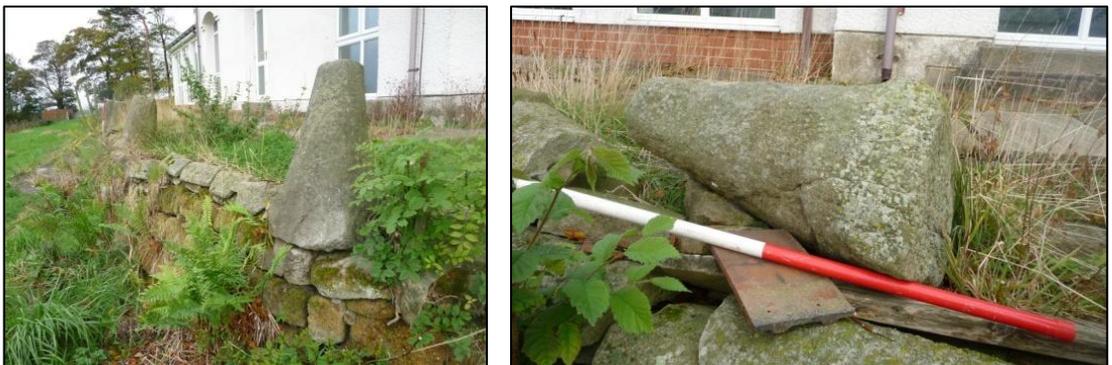
The south side of Quarry House is fronted with an unevenly surfaced patio area. This is interspersed with a number of staddle stones; a further staddle stone is used to prop open the gate near the drive entrance and another can be found in the farm courtyard across the road at Rudchester. Such staddle stones were used in medieval and post medieval times to support granaries and any other structures where there was a need to keep vermin away from the contents of the building. They were normally topped with a flat circular stone which created a mushroom shape and prevented rats and mice from climbing up the stones to reach the granary. There is not a strong tradition of such stones being used in Northumberland, but the site is adjacent to a farm which certainly included stacks and barns, but no granaries. Such stones are not known to have been used in Roman times and it is possible that they have been imported as garden ornaments from another part of the country and probably from one single granary building.

Plate 9. Staddle stones around the south facing patio at Quarry House

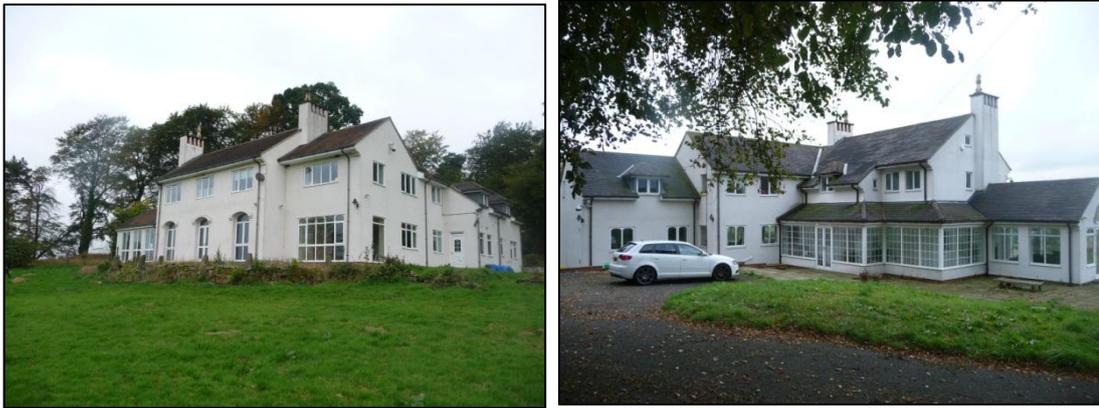
The house itself is a 1960s construction, but designed to reflect a combination of 1960s and 1920s fashions in architecture, the latter being represented by chimney detailing and arched windows. Dwarf kneelers have been used in a style often used in houses in the 1950s to 70s. The building is brick at the base, but otherwise is painted and rendered which masks any additions. The windows and doors are all modern plastic replacements and the roof is in concrete tiles.

Plate 10. The south facing elevation with wooded backdrop (left) and the rear elevation of Quarry House

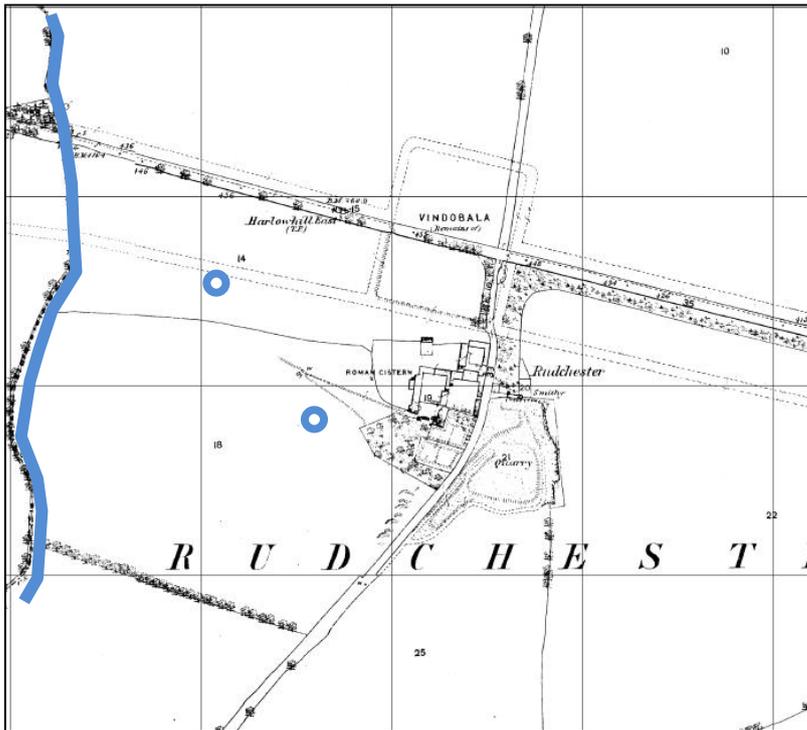
Figure 19. The 1st edition OS map showing the March Burn and other water features suggesting the flow of underground water towards the south, avoiding the Quarry House area. Water would need to be diverted to the vicus if it extended eastwards

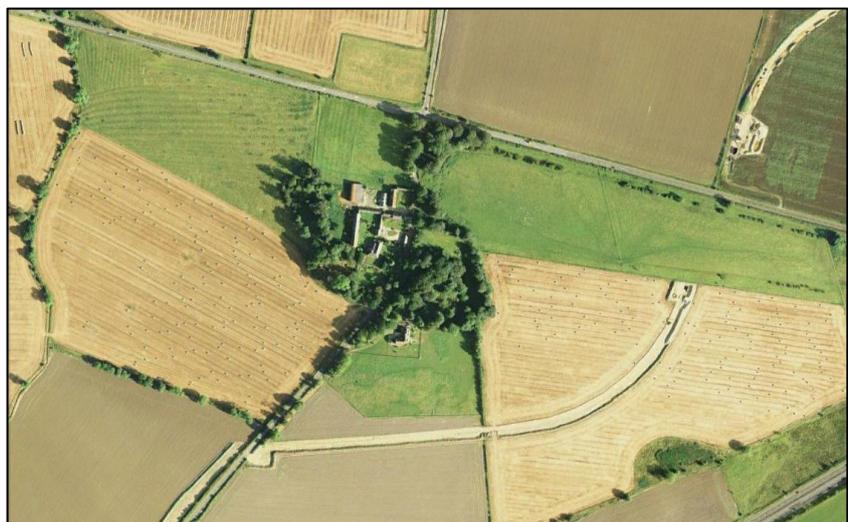
Plate 11. The extent of ploughing in 2002 and in other years suggests that any archaeological deposits in the Quarry House area will be badly truncated. Ridge and furrow only survives in the top left / west of the fort

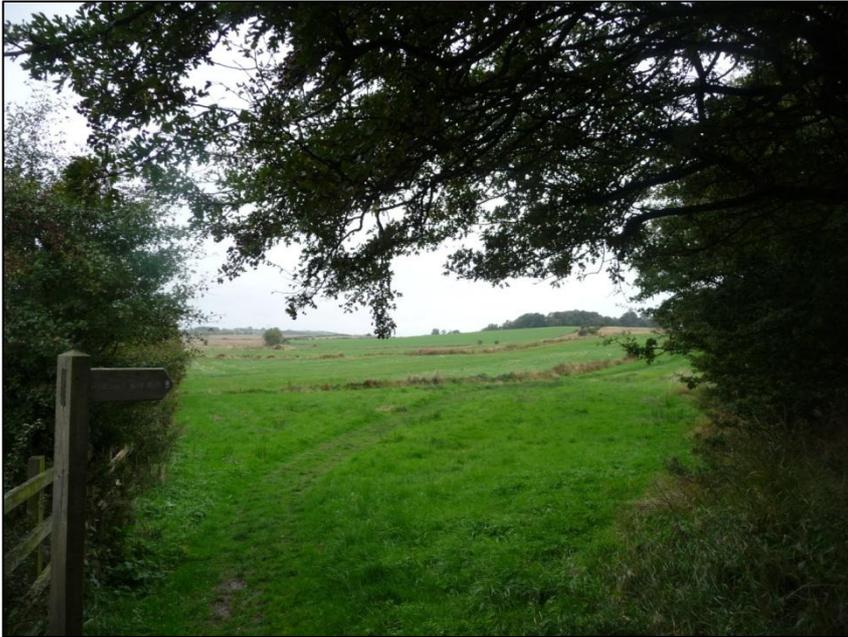
Plate 12. A view from ½ mile east on the Hadrian's Wall National Trail back towards Quarry House. Quarry House is invisible, but the woodland on the horizon is the site of the old quarry.

wall at Rudchester perhaps conforms a little less to this ideal of landscape positioning as by far its best views are southwards. The visual links between the wall and the landscape to the south have however been severed by the disused quarry which is now full of trees which prevent views between the wall and the Quarry House. This continues to be the case along the wall eastwards, where views back towards Quarry House are prevented by the quarry woodland. The ground also rises to the west and so views westwards are constrained by the hamlet of Rudchester and views from the west to Quarry House are prevented by the quarry trees; only the roofs of the farm buildings at Rudchester are visible.

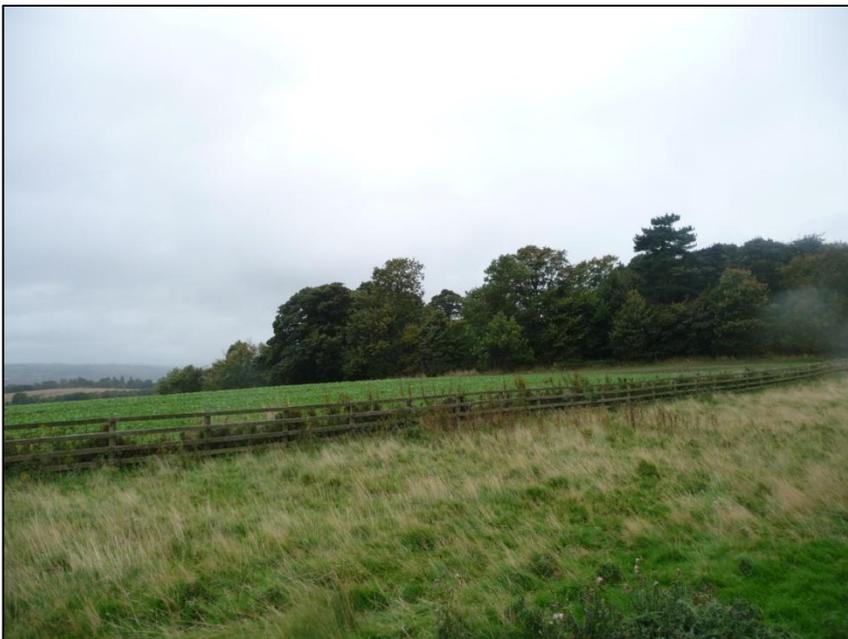
Plate 13. The view from the vallum north of Quarry House back towards Quarry House. The trees mark the site of the quarry, but Quarry House is hidden by the drop in ground levels and the tree cover.

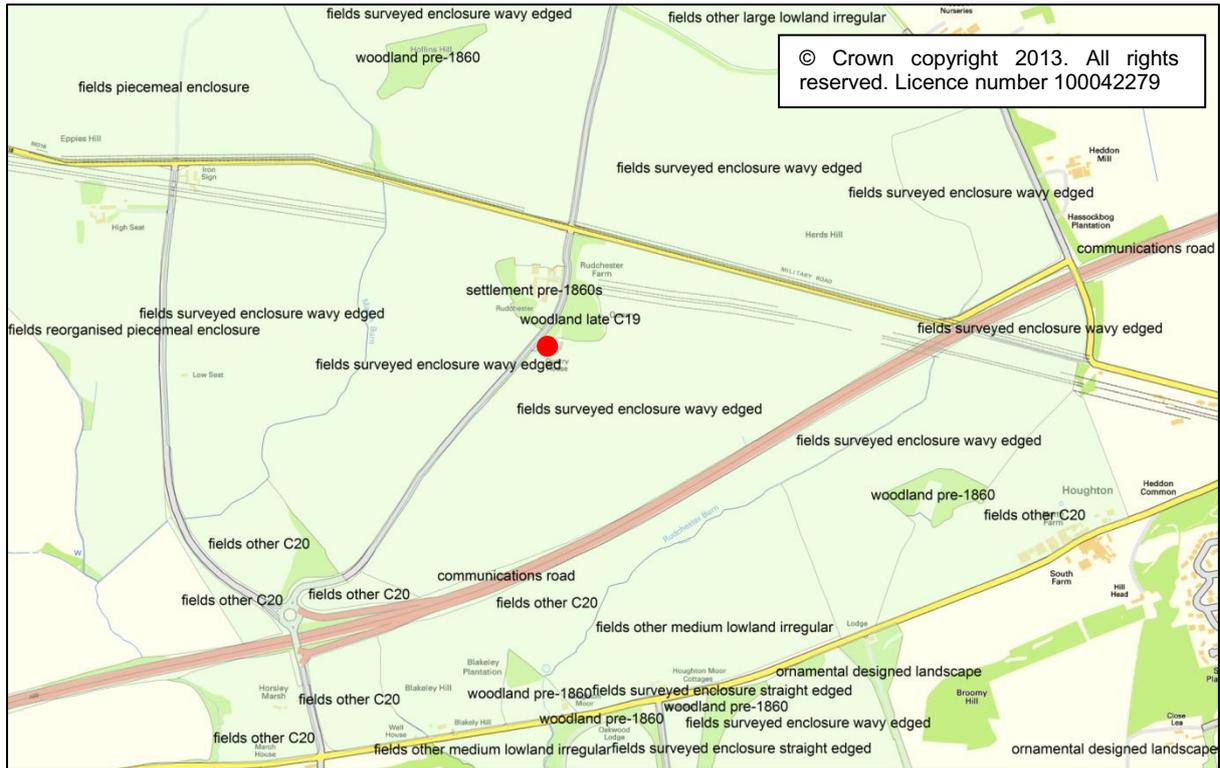
Figure 20. Historic Landscape Character as defined by Northumberland County Council

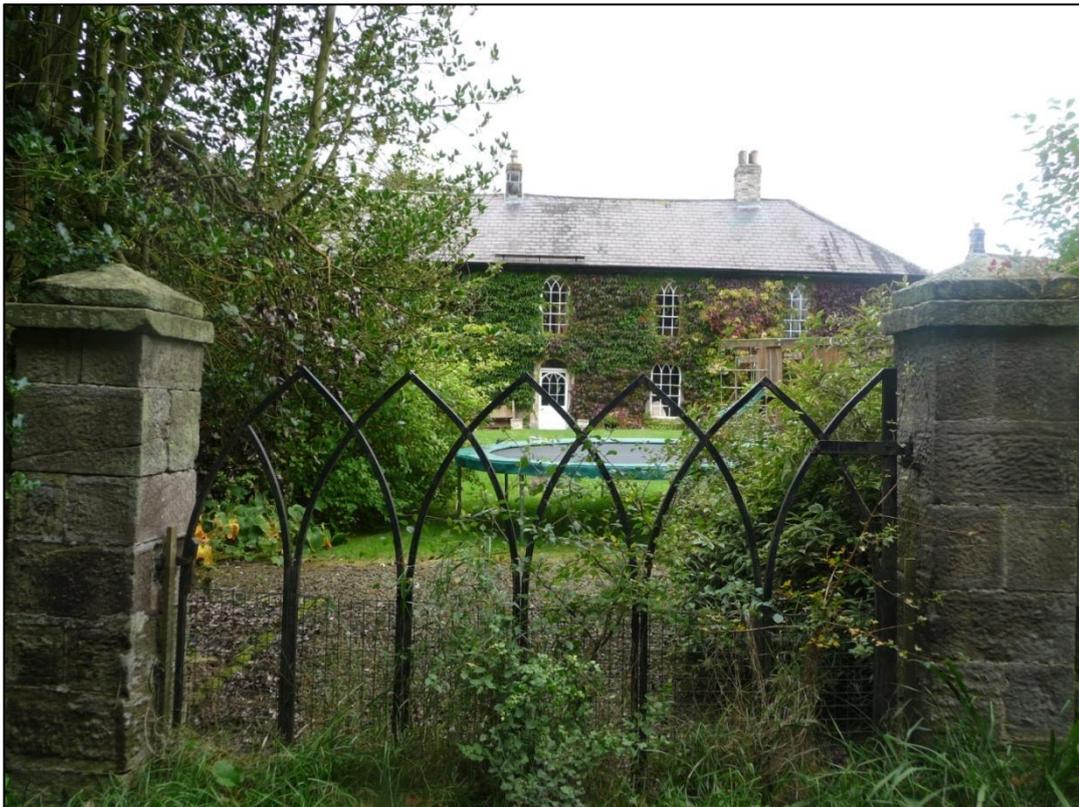
Its **considerable architectural interest** is in its form, materials and design consisting of dressed stone materials, Welsh slate hipped roof with banded ridge stack, forming an L-plan with later buildings filling the re-entrant angle. It is designed in a neo-Gothick style which is particularly evident in its Gothic tracery door and pointed arched windows with intersecting glazing bars; those on the ground floor in raised surrounds. The positioning of the Gothic windows to the approach and towards the south with the principal views are also of interest as is the sense of symmetry to the east, the gatepillars and the matching railings in a neo-Gothick style.

Plate 14. The original approach to the manor with neo-Gothick windows and doors and matching gates

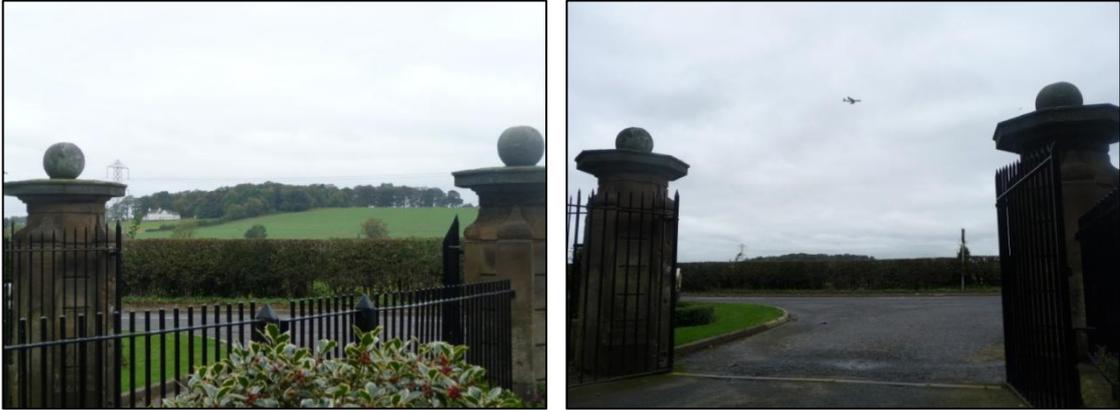
Plate 15. Left: the views from the Lodge to Quarry House and a pylon. The view is not centred and the white paintwork of the existing Quarry House makes the building more prominent in the landscape than it needs to be. Right: views from the listed gates towards Quarry House are limited by hedgerows (an aircraft is passing – it is one of the characteristics of the area that aircraft noise features through the day)

Close House is a grade II* listed building located 1.94km to the south east of Quarry House. It was built in 1779 for Calverly and Margaret Bewick. Its architectural interest is in its form, materials and design, but the building is located in a dip which shields the house from view and suggests that views towards the north (where Quarry House is located) were never part of its design and could not be valued today. However the associated Lodge and Gateway are located adjacent to the B6528, 1.02km to the south east and on ground at a higher level than Close House, but lower than Quarry House; these are listed grade II. A view is possible from the lodge and gates towards Quarry House but this is restricted because of the hedgerows and so realistically can only be obtained from the Lodge where the ground is higher. The view towards Quarry House also includes a substantial electricity pylon which is particularly obtrusive. The walls on either side of the octagonal gateposts are 6 feet high and form a serpentine boundary which does much to exclude views in to the grounds of Close House and views outside. The architecture of the boundary features are therefore more concerned with excluding the outside world than framing views towards it. The view from Close House and its Lodge and Gates towards Quarry House are therefore not considered to be significant and are not considered further here.

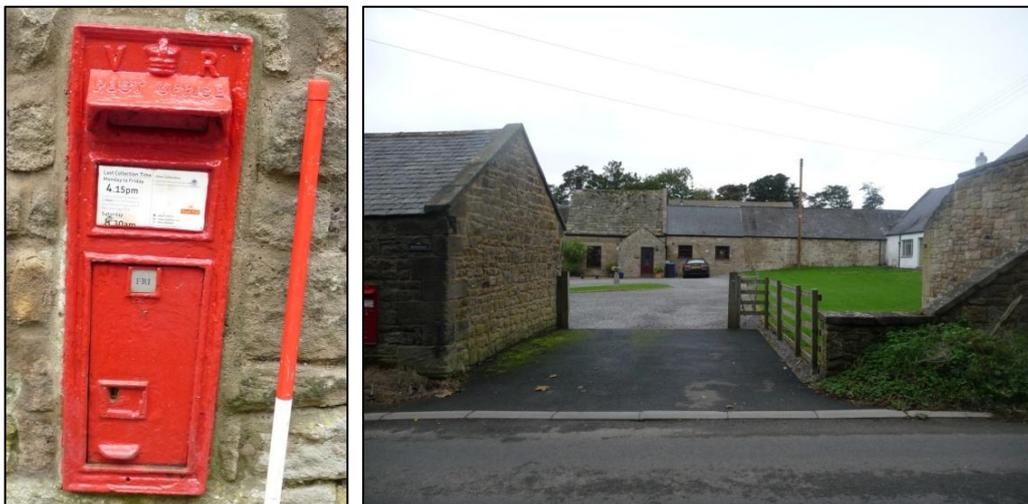
Plate 16. The Victorian post box, courtyard layout, form, use of materials at the farm are all of interest

The hamlet of Rudchester is of **some historic interest** because archival material survives in relation to its existence in the 13th century and for subsequent landholdings, layout in the 19th century and enclosure awards. The layout of the farm (HER 24707) is also of historic and architectural interest because it is associated with improvements in agricultural practices. However the buildings are also of **limited archaeological interest** because the buildings incorporate Roman masonry, but the ground beneath is likely to be of **considerable archaeological interest** as they are located on what was probably the heart of the Roman vicus. Architecturally, the buildings are of **some interest**, although this varies from building to building and part of this interest is their association with the Manor House. Some of the farm buildings have steeply pitched roofs suggesting former thatching and the plan form and use of local materials (and latterly Welsh slate) is also of interest. The strong boundary features in the form of stone walls which cut off the farm from its surroundings to the east are also of interest, but from the west, the farm is more exposed from high ground which looks down on some of its corrugated iron roofs. The Victorian post box (site Q) on the wall adjacent to the road is also of **considerable historic and architectural interest**. Such post boxes are increasingly rare and merit protection.
