APPENDIX 6: CURRENT MANAGEMENT ISSUES RELATING TO THE MONUMENT

This appendix draws heavily on a recent condition survey by Barlow Associates (2008). Their findings concur in large measure with ground observations made by those writing the CP, with conversations held with English Heritage staff and with others involved in the management of the site prior to and during the production of this CP. The Barlow Associates' report bases asset assessment on established criteria such as those used by English Heritage in Heritage at Risk (HAR) and Buildings at Risk (BAR) assessments. It prioritises the order of works and assesses compliance with existing management plans. It is anticipated that the Barlow Associates' report will form the basis of further detailed management recommendations following circulation of this Conservation Plan.

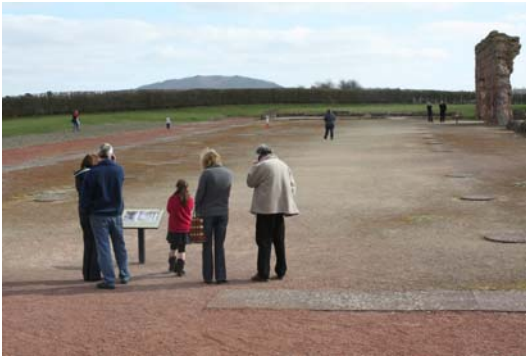
Figure 6.1: Visitors viewing the baths basilica interpretation. Note the bleeding of coloured gravels and moss growth.

- the overall degradation of interpretation caused principally by lack of routine regular maintenance and vegetation growth. As a result the coloured gravel used to mark out different rooms and paths is rapidly losing definition (Figure 6.1; contrast with Figure 6.2);

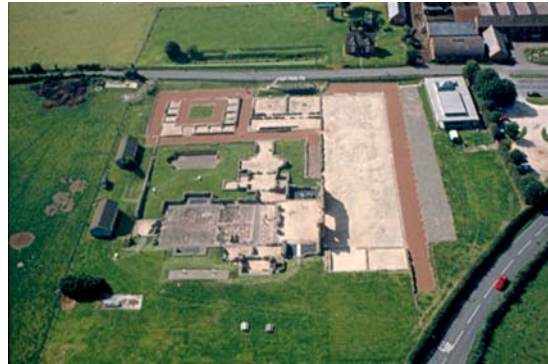
Figure 6.2: HAN119, The baths as first laid out, in 1992, demonstrating original clear delineation of colour coding.

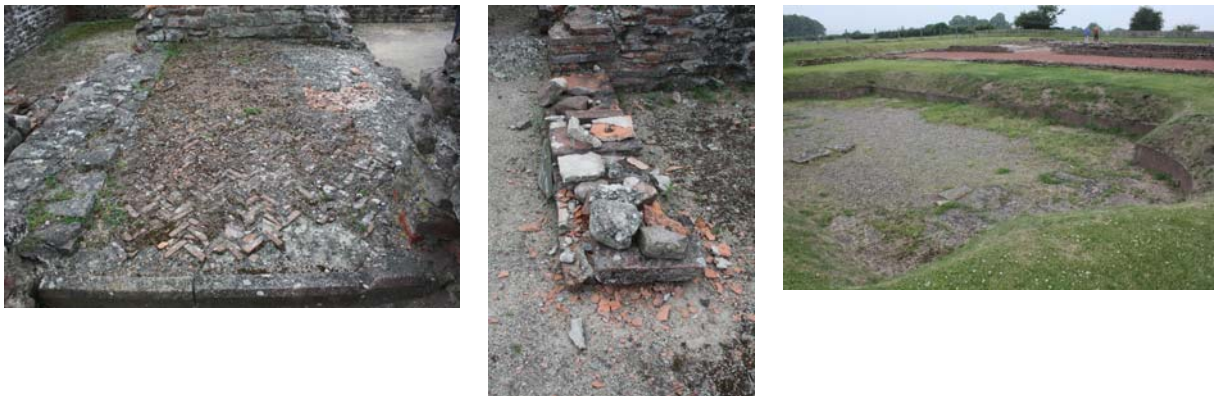
- deteriorating masonry due to footfall and freeze-thaw erosion; upper wall courses are becoming seriously depleted, exacerbated by earlier insensitive and widespread use of concrete (Figure 6.3);

- the increasing extent of animal burrowing, especially rabbits. This is severe on the west side of the *natatio* (Figure 6.3). There is rabbit and mole damage around picnic benches and display boards in the baths area. A large animal burrow, either rabbit or badger, lies in the SE corner under a group of shrubs. The extent of burrowing here is unknown but likely to be worsening. A lot of mole activity in this area too in which up-cast RB sherds and butchered bone were found. Moderate mole damage within forum ruins (west side of B 4394).

Figure 6.3: On-going damage to the monument. From left to right: decaying original herringbone floor; disintegrating east baths praefurnium wall; animal and other damage in *natatio*

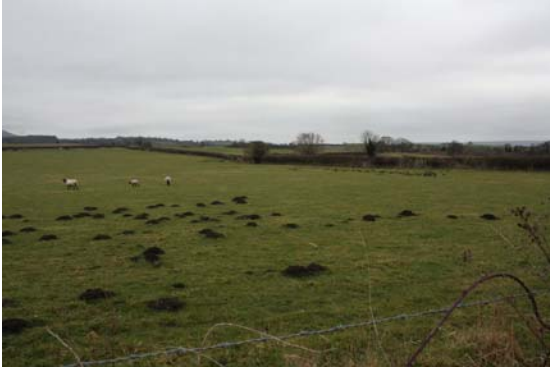
In addition to animal burrowing in the exposed ruins, there is increasing damage being caused by rabbits, moles and badgers across the site (Figure 6.4). The worst affected areas include:

Figure 6.4: Mole damage, south of the baths in HAN207.

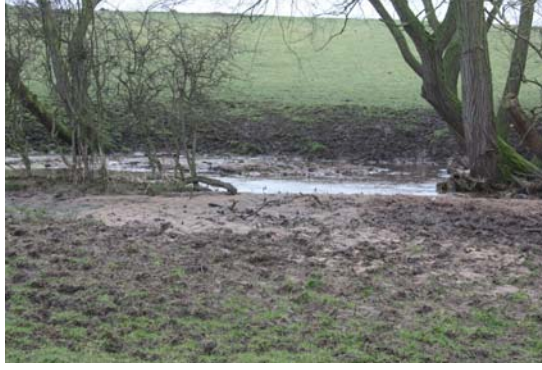
Figure 6.5: Poaching by cattle on either side of the Bell Brook in HAN200 & 203.

- 18f, 18h, 18k, 18b HAN221, 200, 201 & 212. 18h (HAN200) severe erosion along Bell Brook – erosion repairs aided by fencing needed (Figure 4.6). Metal water trough in SW corner;
- bad erosion 18h (HAN200) – along desire line footpath across field;
- 18b (HAN212) – erosion of stream banks by cattle which could be avoided if fenced and cattle were prevented from crossing stream.

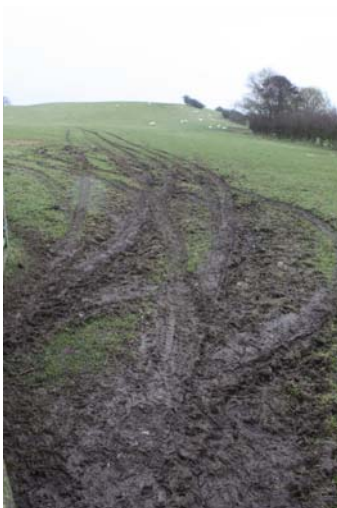
Figure 6.6: Ruts caused by farm traffic to feed stock.

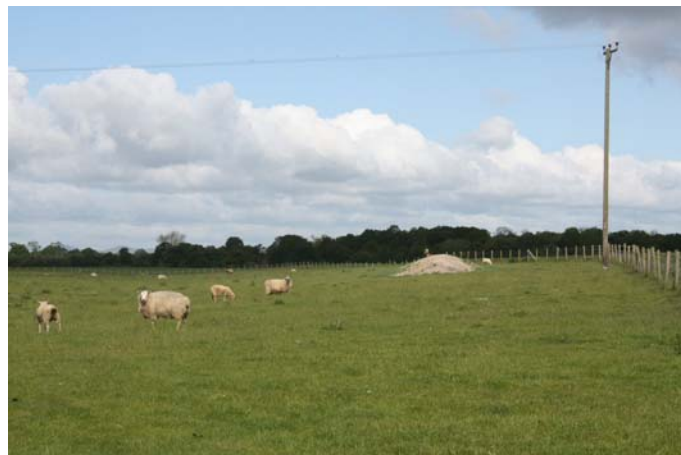
Figure 6.7: Lime dump on HAN224, adjacent to Norton Farm.

- bad in 18h (HAN200) – stone displacement over time along track HAN402 – presumed to be due to farm machinery;
- 18d HAN215 – serious deep erosion caused by vehicles tracking across field to remove piles of cut *leylandii* hedging;
- severe rutting at entrance to 18g (HAN203) (Figure 6.6);
- inappropriately sited water troughs – some leaking, e.g. one in farmyard – causing ponding. The siting of all water troughs should be reviewed;
- storage of lime on the fields for agricultural improvement 18m (HAN224) (Figure 6.7).

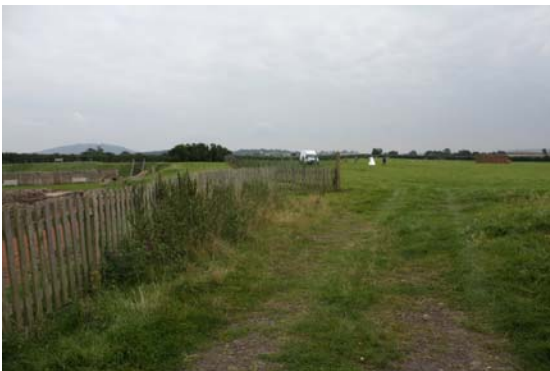
Figure 6.8: Chestnut paling and concrete-and wire fence in baths field.

- they exhibit a lack of consistency in style and materials;
- they are often visually intrusive and incongruous, e.g. the concrete post and mesh fence to S and E boundaries of baths basilica (Figure 6.8);

Ideally, properly managed hedging should be re-introduced to replace the post and wire fencing which is unsightly and jars with the sensitive landscape setting of Wroxeter. This could be undertaken gradually and could comprise post and rail fencing used in combination with hedging; the fencing would protect the hedging and could initially include sheep wire, removed at a later stage when the hedging has matured enough to provide a sheep barrier.

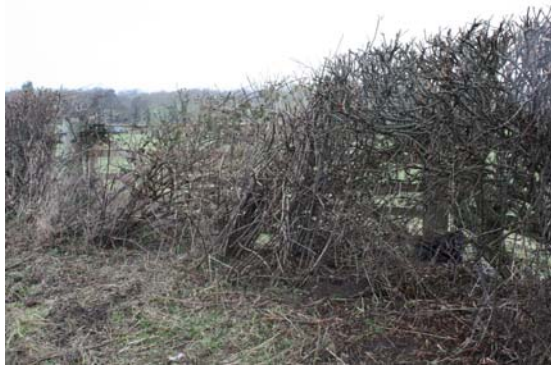
Figure 6.9: Wooden gate buried in overgrown hedge.

- many are in a deteriorating condition which imparts an air of neglect and untidiness with evidence of abandoned redundant fence posts and gates in various places (Figure 6.9);

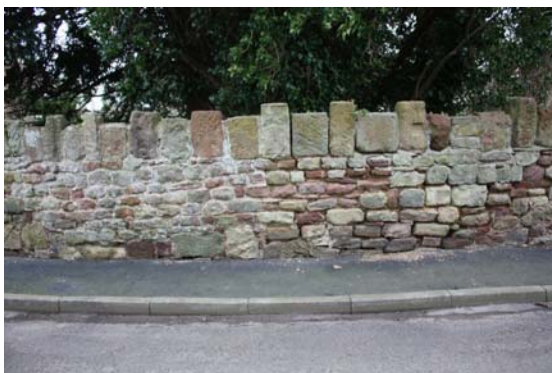
Figure 6.10: Unrecorded Roman stone HAN410 in Grange garden wall.

The stone walls on the site (HAN408, 409, 410) are archaeologically as well as historically significant; they are also aesthetically pleasing (Figures 6.10 & 11). They are

known to contain fragments of Roman masonry and may also contain earlier and later material such as Iron Age quern stones and medieval cross fragments. There has never been a thorough survey of these walls and so their full significance is not yet understood. The current state of much of the walling is generally good but long lengths are covered with ivy which in places has penetrated the mortar and set up gradual structural damage. However, much of the ivy growth is non-invasive. The stone walls were formerly managed by the Raby Estate and kept ivy-free; whether there should be wholesale ivy removal remains to be decided but this would facilitate survey if this is to be included in any management recommendations.

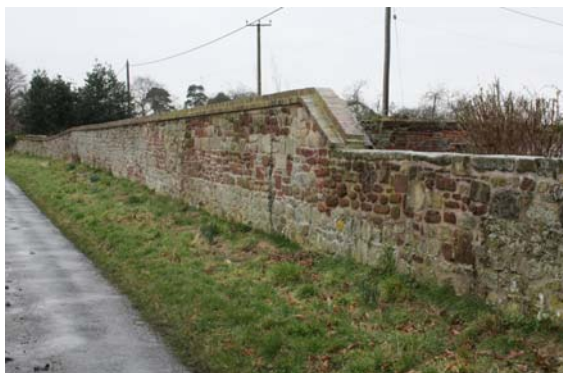
Figure 6.11; Unrecorded wall (HAN409) defining The Cottage.

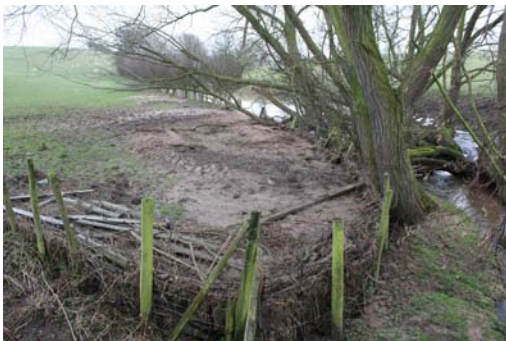
The main water courses on the site are the River Severn on the west side, the Bell Brook which runs across the northern area and a brook running along southern edge of the defined area. The main management issues with water courses are silting up and neglect of adjacent land-use (Figure 6.12).

Figure 6.12: Silts deposited in HAN203 by the Bell Brook adjacent to B4394.

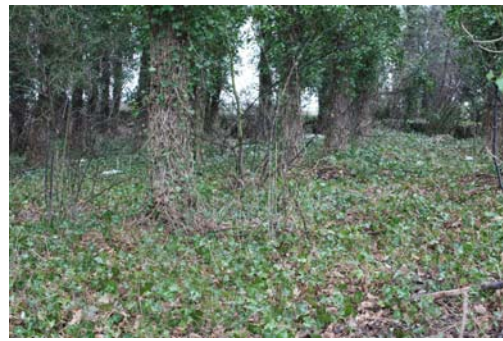
Figure 6.13: Ivy understorey in Sycamore plantation HAN216.

The future of the sycamore copse in 18j (**HAN216**) needs to be considered. To improve light penetration within the wood (Figure 6.13), the trees need to be crown lifted or the trees should be felled. They have low historical and aesthetic value but they would need to be assessed for biodiversity as they house a rookery and provide insect life for bats.

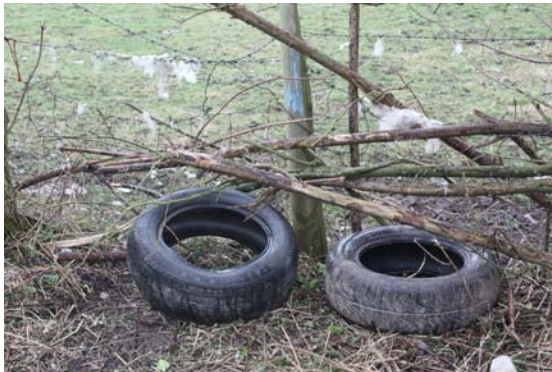
This is not particularly serious but is present in parts of the site, especially along water courses and locally around the village on some fields (Figure 6.14).

Figure 6.14: Fly tipping / fence repair adjacent to B4394.

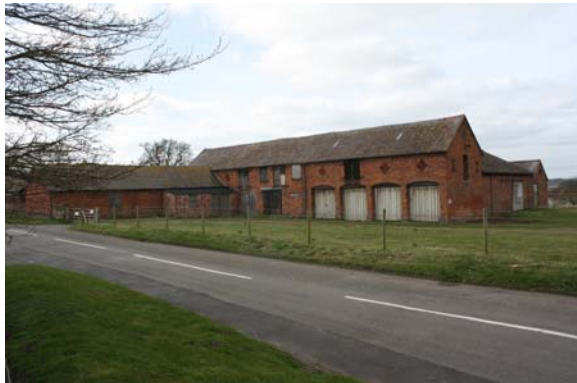
Figure 6.15: **HAN101, Wroxeter Farm and its farmyard.**

The Farm Barns buildings (**HAN101**) have been mothballed for the present until a use is decided for them. They are currently used mainly for storage by the tenant farmer. The curtilage of these buildings is extremely untidy and neglected. Redundant farm machinery, makeshift fencing and gates, hypodermic syringes and other detritus lie scattered about giving the area an uncared for appearance (Figure 6.15). Rats and mice inhabit the north west barn due to the storage of grain there. This detracts from the buildings themselves and is uncomfortably close to the visitor centre.

The buildings themselves are extremely attractive even in their present state. They have undergone detailed survey (Hislop and White 2002) and it is known that the barns

generally have only limited defects such as settlement cracks to the north east hay barn and roof damage caused by vandalism. However, the covered yard (shippen) is reported to be in poor condition with failed trusses and fixings to the tin roof of probable 1881 construction.

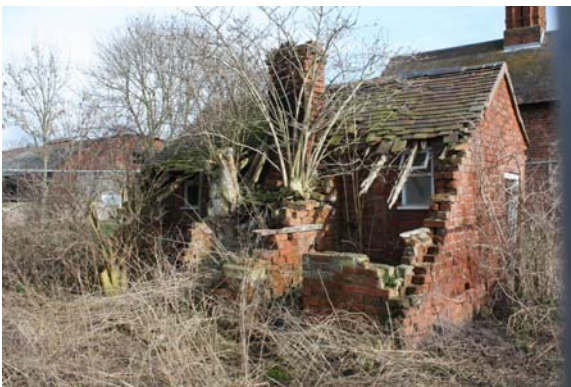
Figure 6.17: Derelict pig sties behind 1 & 2 The Ruins.

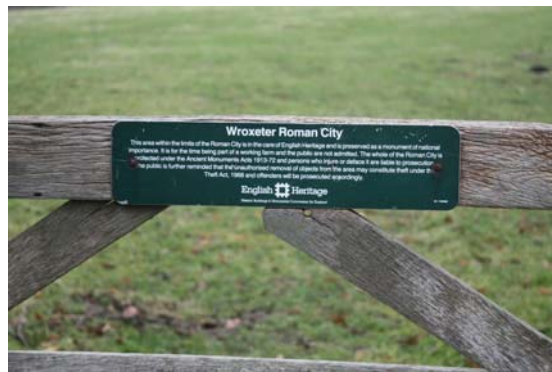
Figure 6.18: Original 1980s gate notice.

There is no consistency in the type of signage used across the site. Gates sometimes have signs warning against metal detecting within the fields that were first put up in the 1980s when English Heritage was created (Figure 6.18). On the monument there are well-maintained interpretation boards and there is a title board for the site in the car park.
