# MELROSE CREMATORIUM, SCOTTISH BORDERS

Archaeological Evaluation Data Structure Report

PROJECT 3046

TRIAL TRENCH EVALUATION DATA STRUCTURE REPORT

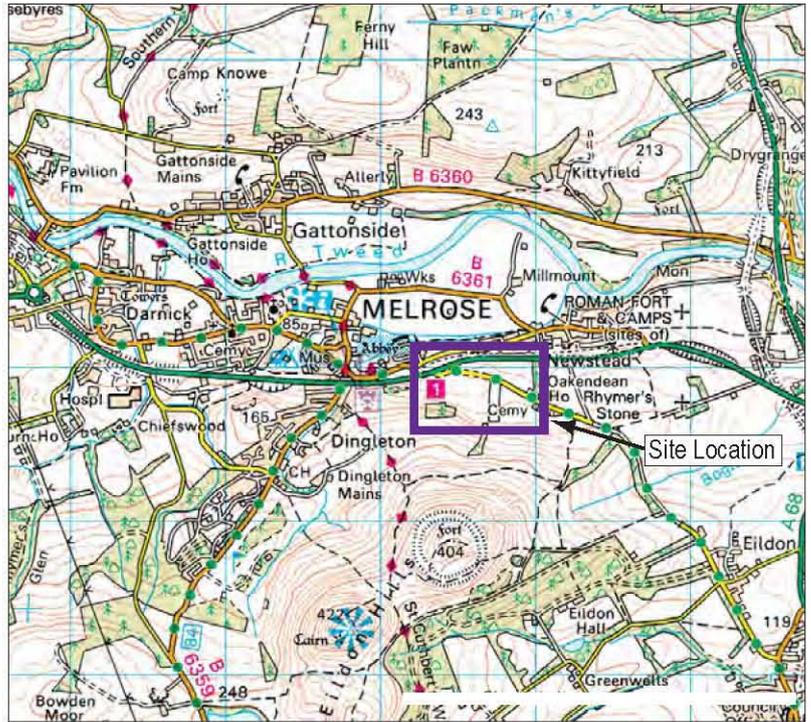
Figure 1: Site and Trench location.

- 3.1 The development area is 12,250 m<sup>2</sup> in size and is centred around NGR: NT 55624 33848, to the south-east of the turning on to the minor Eildon road off the A6091 Melrose Bypass, to the east of Melrose (Figure 1). The area evaluated comprised a gently undulating parcel of land, currently under pasture, lying at the northern foot of Eildon Hill North.

- Conduct an archaeological evaluation (Figure 1), given the proximity of known archaeological remains, to establish the presence or absence of any archaeological remains, and their character, date and extent if surviving; determine the character, extent and significance of any archaeological deposits encountered; and excavate and salvage any information possible from any significant features encountered;
- Submit a report to data structure level for agreement to Scottish Borders Council, on completion of the evaluation and any resulting excavation works if archaeology is encountered.

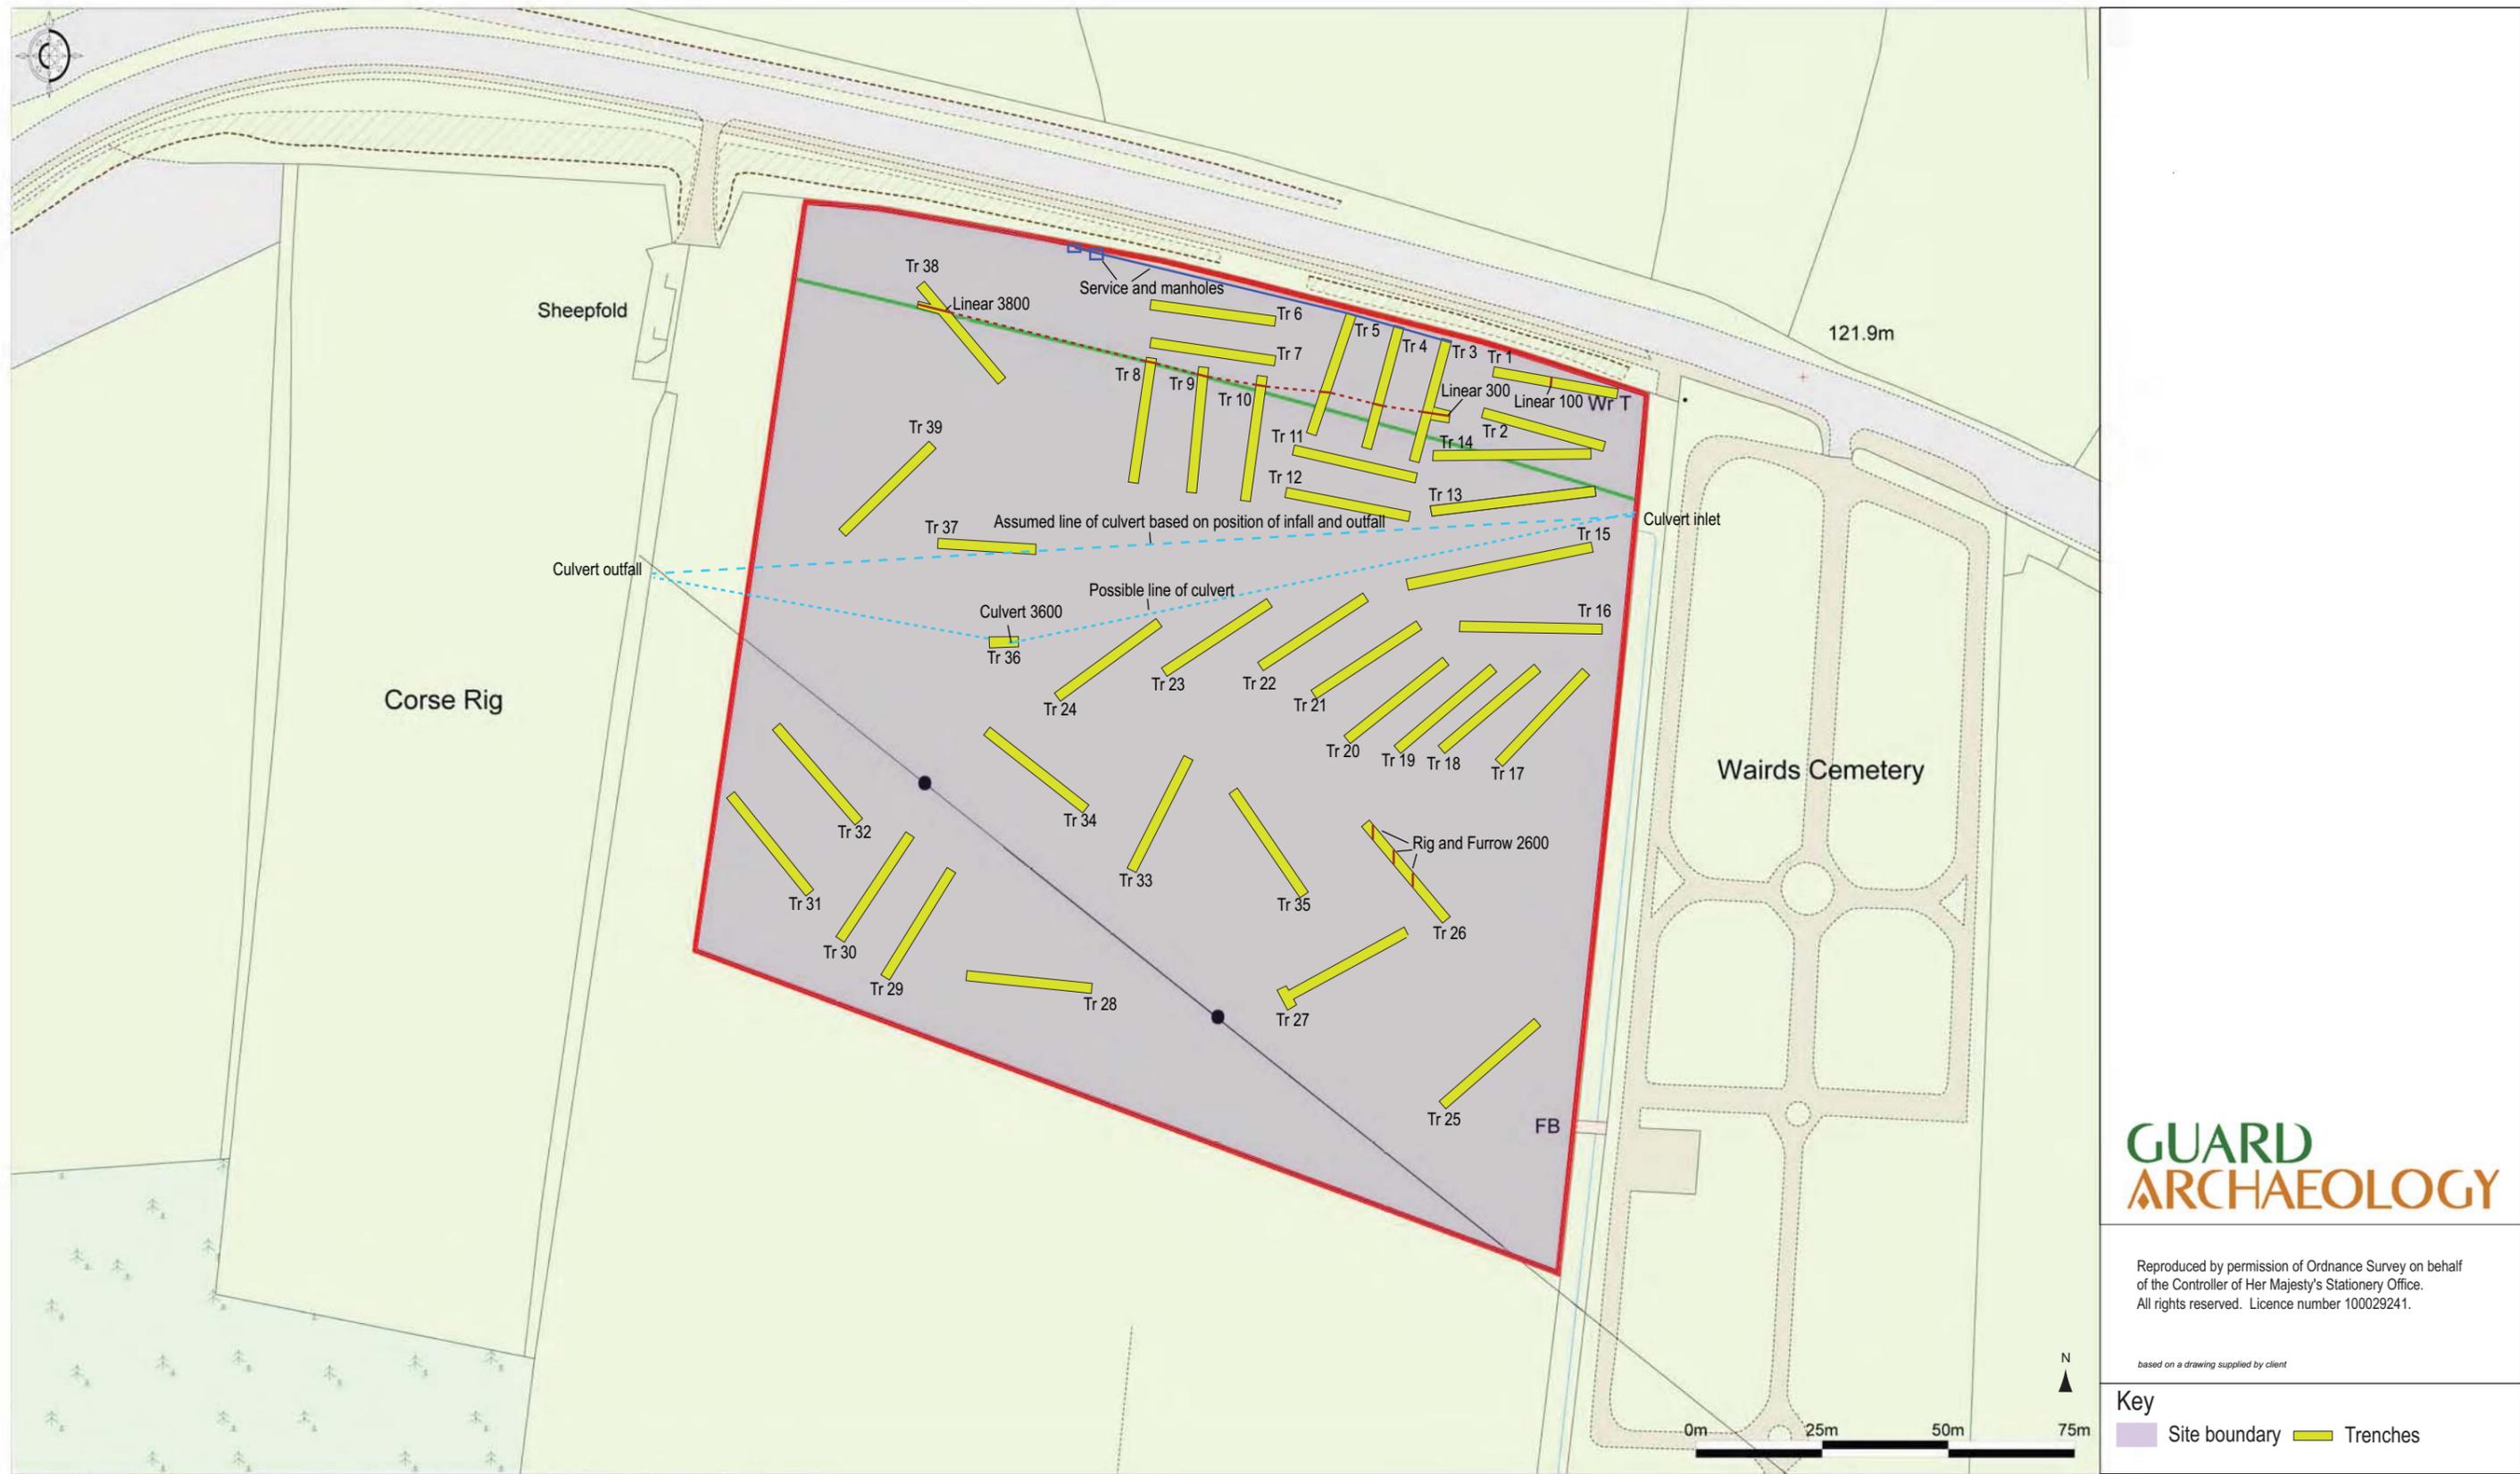
Figure 2: Location of features recorded during evaluation.

- 7.1 Thirty nine trenches were excavated, totalling 1,900 m<sup>2</sup> (Figure 2), the following text should be read in conjunction with the full trench descriptions in Appendix B and the context descriptions presented in Appendix C.

- 7.3 Two linear features were recorded (Figures 2 & 3). The first linear feature [100] was recorded in Trench 1 and was aligned north/south, and measured 0.53 m wide and 0.19 m deep. This was filled by pale reddish brown sandy clay [101] with moderate inclusions of small angular and rounded stones. The feature appeared to continue beyond the sides of the trench to the north and south but no evidence of a continuation of this feature to the south was recorded in Trench 2.

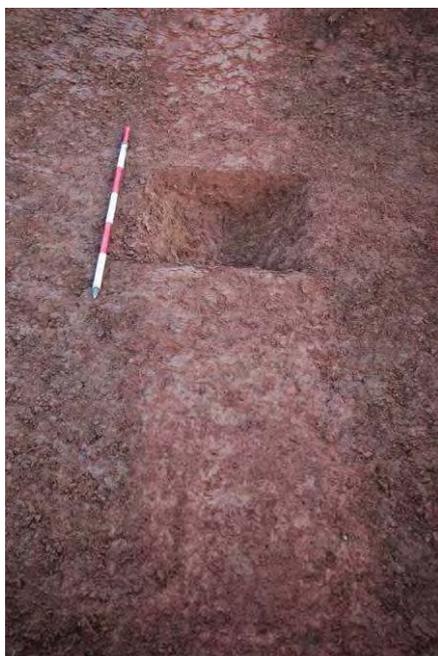
Plate 1: Linear feature [300], Trench 3 from the west

- 7.4 The second linear feature was recorded in Trench 3 [300] and was aligned east/west (Plate 1). It measured 0.75 m wide by 0.25 m deep and was filled by [301], a similar deposit to [101] filling the linear feature [100] recorded in Trench 1. This linear anomaly was recorded in plan continuing eastwards in trenches 4, 5, 8, 9 and 10. A further probable continuation of this feature was excavated in Trench 38 recorded as cut and fill [3800] and [3801] respectively, the lower edges and base of the cut were poorly defined at this juncture. No finds or other dating evidence was apparent.

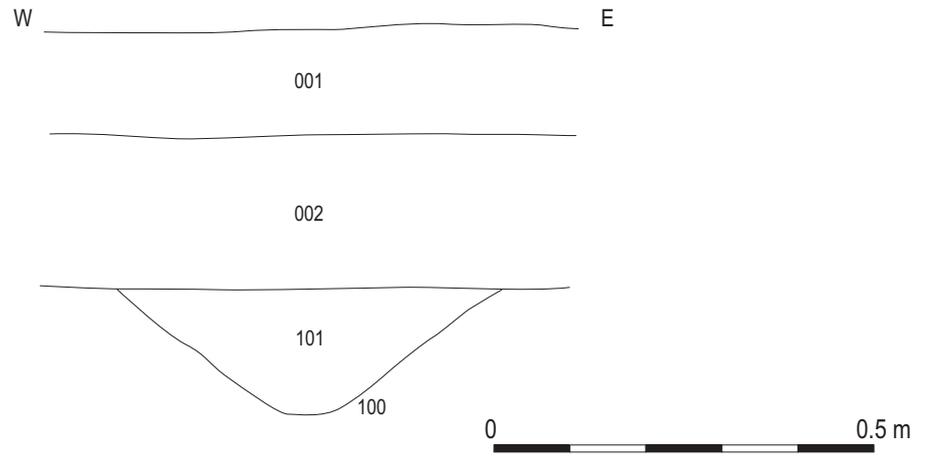
South facing section through linear feature 100, Trench 1.

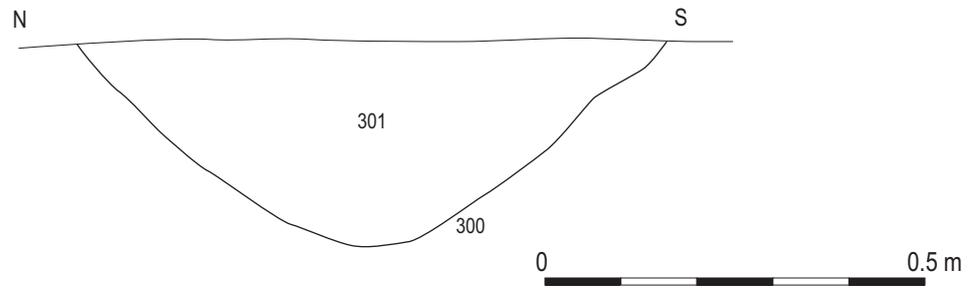
West facing section through linear feature 300, Trench 3.

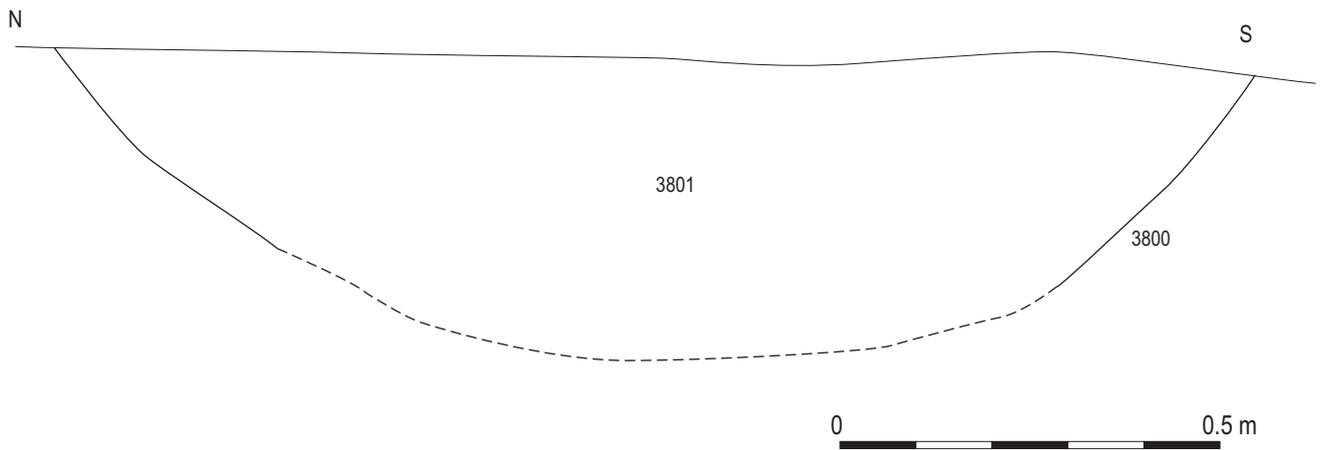
West facing section through linear feature 3800, Trench 38.

Figure 3: Sections through linear features recorded in Trenches 1, 3 and 38.

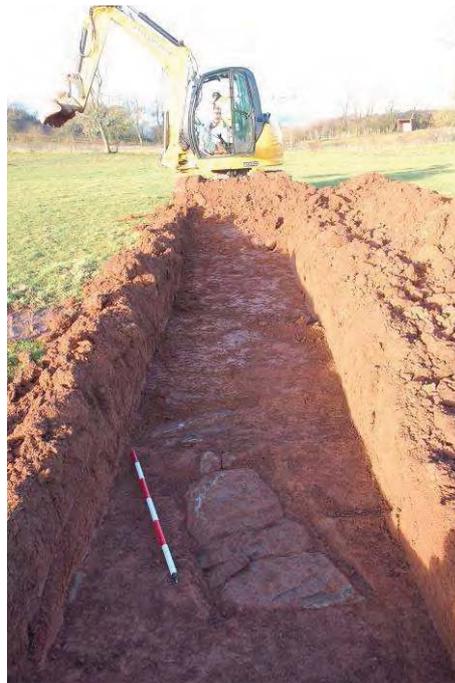
Plate 2: Culvert [3600] from the east, Trench 36

proceeded to unblock a choked inlet to a culvert fed by an open drain on the east side of the development area. The farmer indicated the culvert was roughly aligned beneath the flooded part of the development area. Subsequently the outfall of the culvert into a ceramic drain was identified on the east side of the development area and a buffer zone along the assumed route of the culvert between the infall and outfall was established by realigning the position of a number of the trenches (Figure 2). However, the capstones of a culvert [3600] were encountered in Trench 36 some distance away from the assumed course of the culvert (Plate 2). The capstones measured up to 1.62 m wide and were recorded over a distance of 5 m. A good body of water was visible flowing through the chamber of the culvert. Trench 36 was abandoned at this point and resumed as Trench 37 a good distance from the culvert.

3600	Trench 36	Structure: Large whinstone random rubble slabs laid on bed, aligned east-west form the capsones of a live culvert. Interpreted as: <b>Culvert</b>		5 visible	1.6		Culvert chamber	002
3800	Trench 38	Cut: Linear in plan, aligned east-west and continued below trench edges to the east and west. Sharp break of slope at top to moderately sloping slightly concave sides which break gently to form a broad slightly rounded base. Lower limits poorly defined. Interpreted as: <b>Linear feature</b>		5 excavated	1.62	0.38	Cuts natural 003	3801
3801	3	Fill: A moist, firm, pale reddish brown silty sandy clay with moderate inclusions of small angular and rounded stones 100 mm< Interpreted as: <b>Fill of linear feature 3800</b>				0.38	3800	002

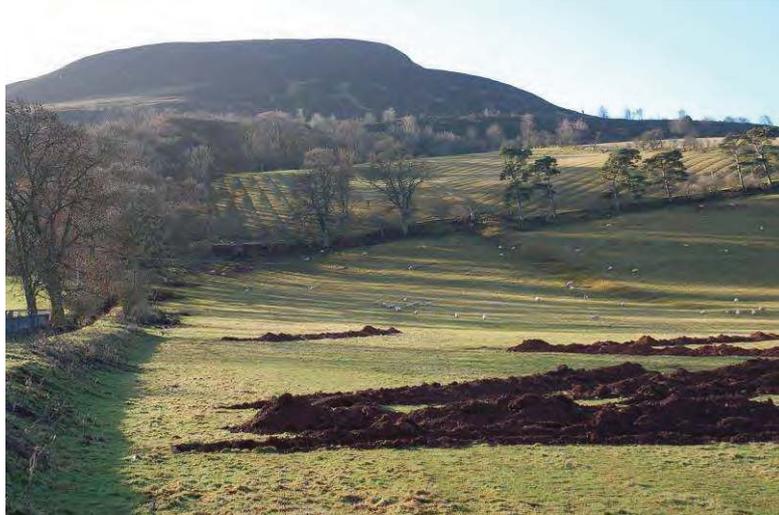
Plate 3: Rig and furrow and earthen bank to the south of development area

- 7.6 Putative cultivation furrow remnants [2600] were visible in Trench 26 (Figure 2). These occurred at 2.8 m, 9.7 m and 16 m from the northwest end of the trench and measured 3.1 m, 1.4 m and 2.1 m wide respectively. Subsequent flooding of the trench curtailed further investigation of these features. Immediately south on high ground overlooking the development area are two areas of extant Broad Rig cultivation remnants divided by an earthen bank (Plate 3). Cast on different alignments they measured 5 paces broad and were spaced around a foot apart. Trench 24 was positioned on the alignment of the earthen bank dividing the fields containing the extant Rig and Furrow and which continued into the southernmost part of the development area but no trace of this was encountered.

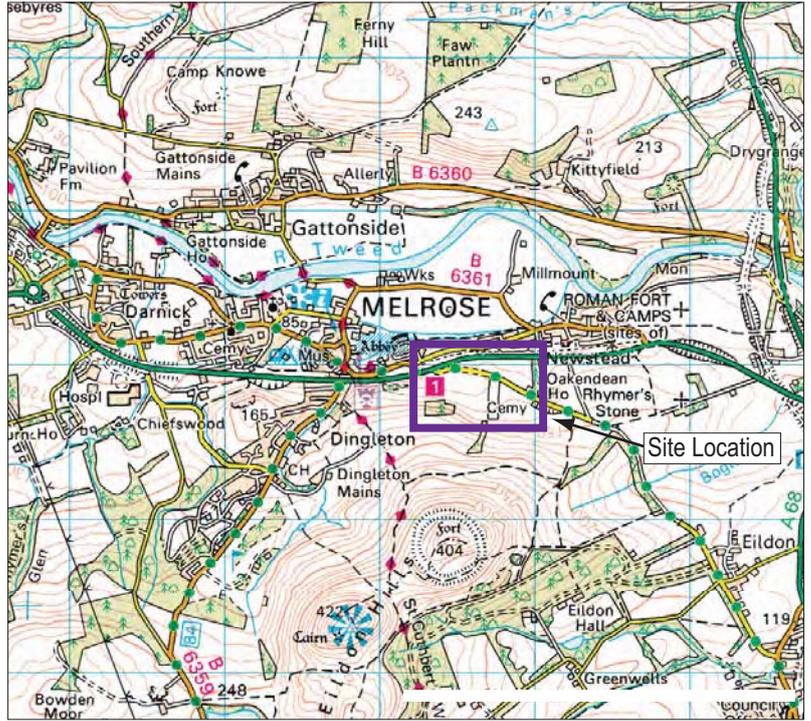
Figure 1: Site and Trench location.

The machine excavation of trenches amounting to 10% of the 59,652 m<sup>2</sup> development area, but targeted at the areas of greatest impact from the development, as specifically required by the Scottish Borders Council Archaeology Officer, will be supervised by a GUARD Archaeologist. The evaluation trenches will comprise 119 trenches (each 25 m long and 2 m wide), amounting to 5,965 m<sup>2</sup> in total (Figure 1).

The development site is 59,652 m<sup>2</sup> in size and is centred around NGR: NT 55624 33848, to the south-east of the turning on to the minor Eildon road off the A6091 Melrose Bypass, to the east of Melrose (Figure 1).

- Conduct an archaeological evaluation (Figure 1), given the proximity of known archaeological remains, to establish the presence or absence of any archaeological remains, and their character, date and extent if surviving; determine the character, extent and significance of any archaeological deposits encountered; and excavate and salvage any information possible from any significant features encountered.
- Submit a report to data structure level for agreement to Scottish Borders Council, on completion of the evaluation and any resulting excavation works if archaeology is encountered.
- Submit, if excavation works are required, an accompanying post-excavation research design (PERD) and costing alongside the data structure report, which will outline arrangements for final publication.
