SUNDERLAND

AN ARCHAEOLOGICAL ASSESSMENT & STRATEGY

- CITY OF SUNDERLAND - DEVELOPMENT & REGENERATION
- CITY OF NEWCASTLE - PLANNING AND TRANSPORTATION DIVISION
- NORTHUMBERLAND COUNTY COUNCIL - ARCHAEOLOGY & CONSERVATION
- ENGLISH HERITAGE

March 2004

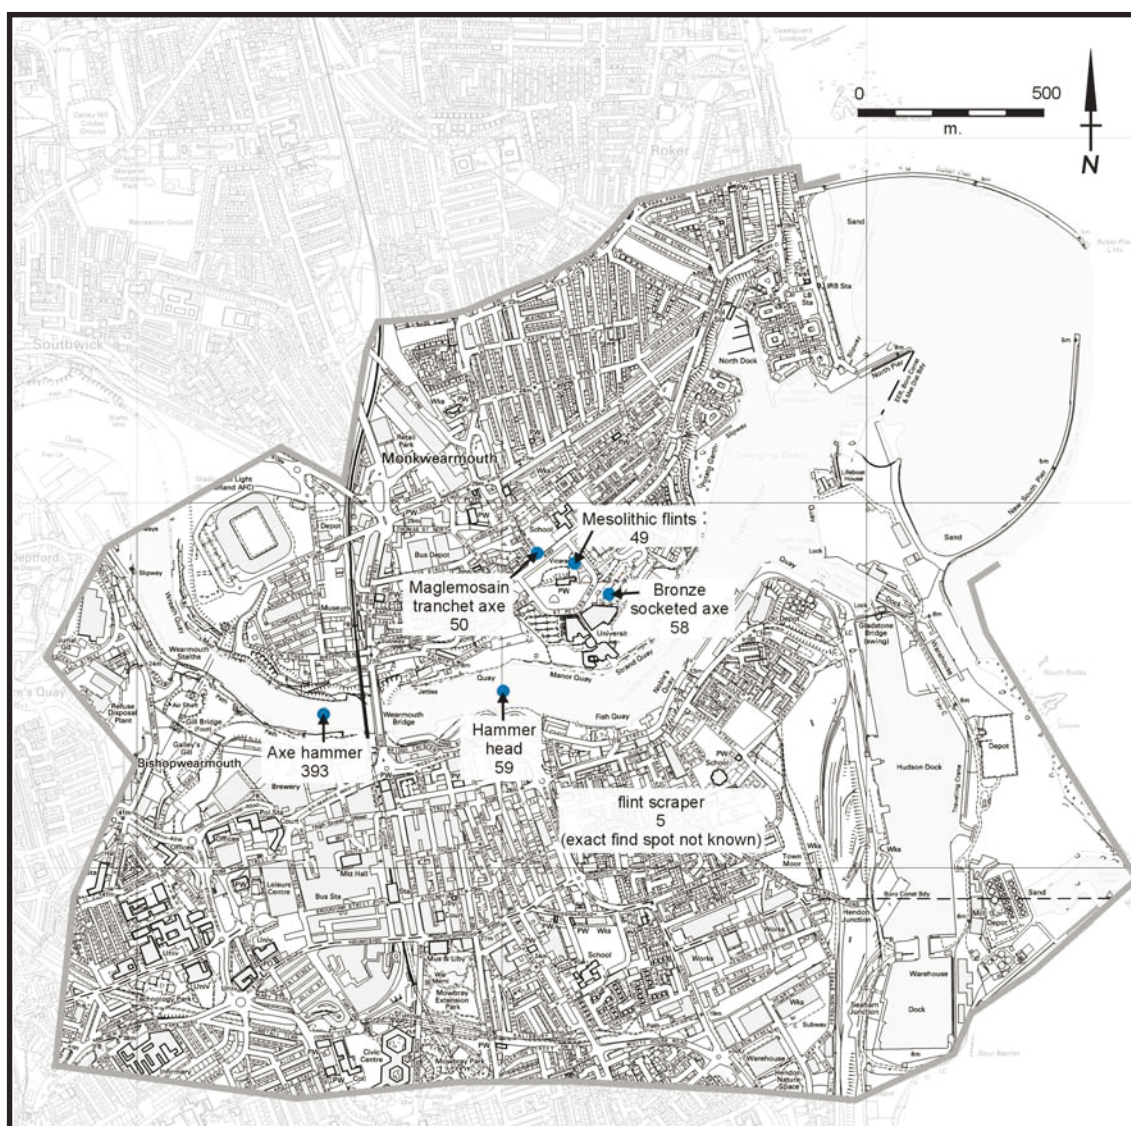
Fig 2. Prehistoric Period

Mesolithic flints (TWHER 49) have been found on at least two separate occasions south of St. Peter's Church in Monkwearmouth (Wymer, 1977, p 86). These may not represent in situ finds, and both groups of material may have derived from dumped sand used as ballast. A Maglemosian tranche axe (TWHER 50) was

found by Dodds in Church Street, c.100 - 200 yards north of St. Peter's Church, in sand 2 - 3 feet deep below cobbles, during a council landscaping project. Though Harding declares the axe came from the "basal levels of the site" (Harding, 1970), Miket suggests, that the sand may have been dumped ballast (Miket, 1984, p 91).
