**Archaeological Watching Brief
on land adjacent to
98 Etruria Vale Road
Etruria
Stoke-on-Trent
Staffordshire
NGR SJ 87395 46967**

Planning Application No: SOT/54349

Report No. 007

Cramp Sutherland Archaeological Services

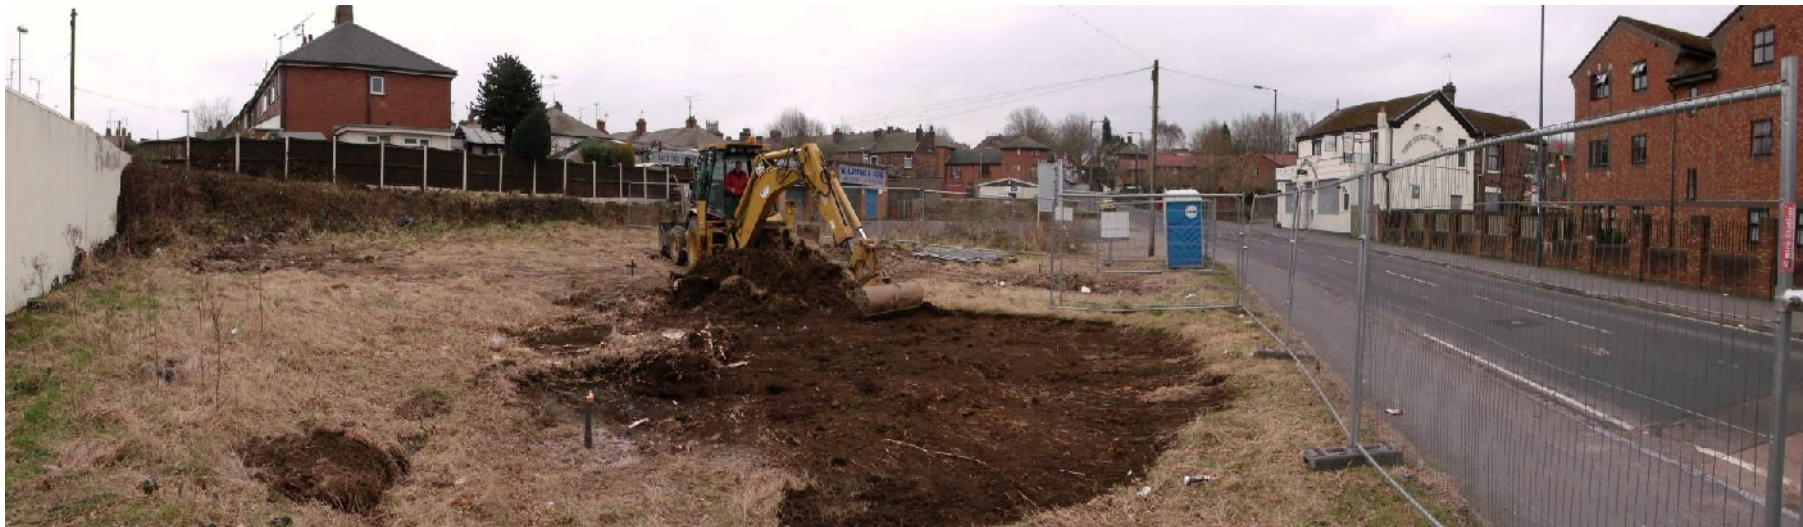
PLATE 1

Panoramic general working shot of the site during ground reduction, looking south east, with Etruria Vale Road to the right and the boundary wall of number 98 on the left.

- 2.3** The site is almost square in plan, broadly aligned NW – SE, amounting to c. 675m² of grassed over waste ground (Plate 1). The topography is flat, with a modest slope from NE – SW, lying at an average elevation of 0.96m aOD.

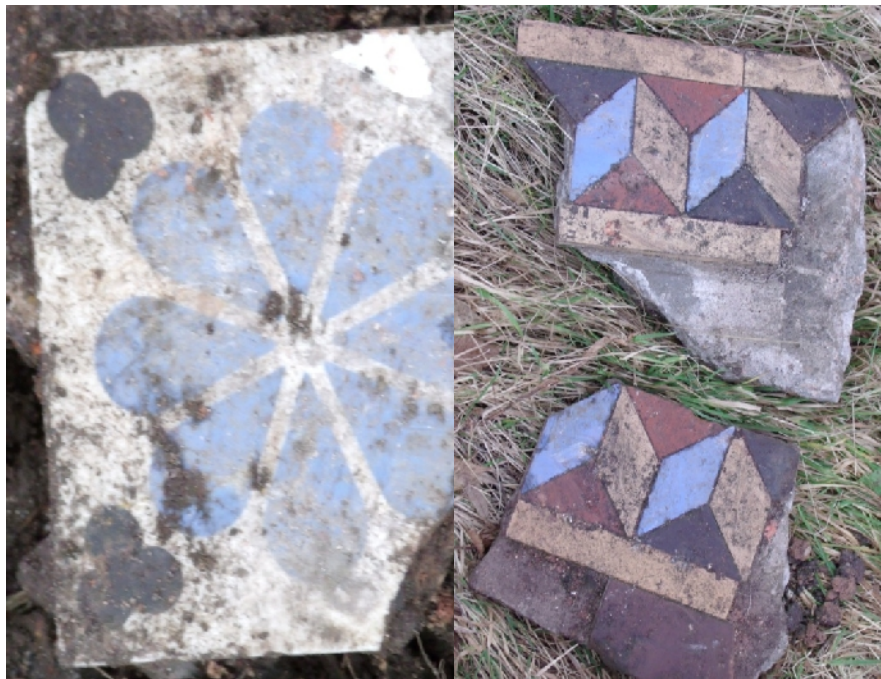
PLATE 2

Examples of wall and floor tiles recovered from TP1.

6.2.2 The cellar was filled with loose demolition rubble (**101**), c. 1.50m-thick. It mostly comprised ceramic building material (CBM), including decorated wall and floor tiles, with some fragments bearing geometric patterns (Plate 2). Removing (**101**) revealed that the two walls survived to a height of c. 1.50m. The exposed north-east face of wall (**103**) was painted with white limewash (Plate 3). The north-west face of wall (**104**) was covered with white glazed ceramic tiles.

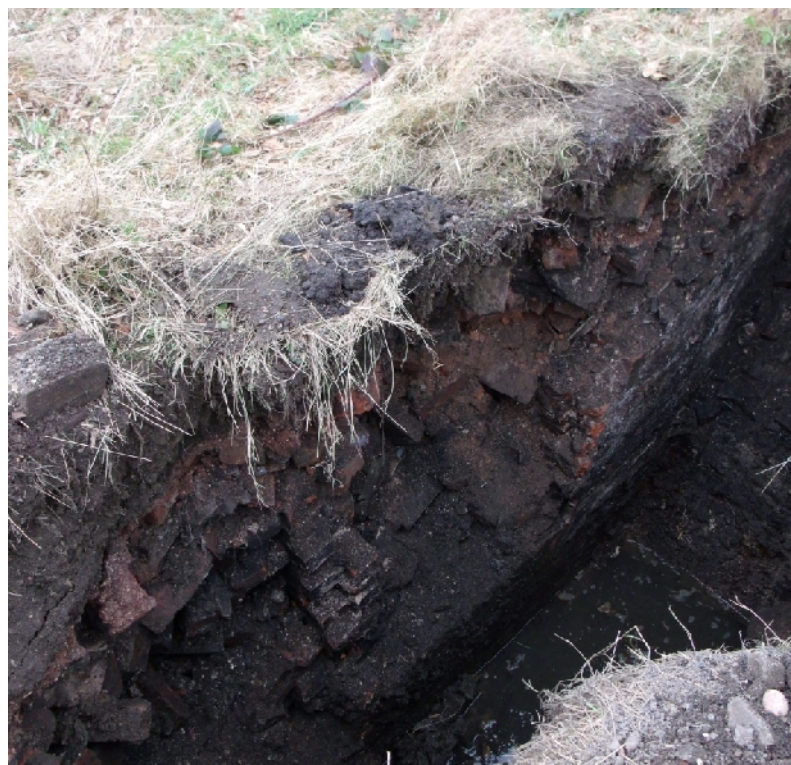
PLATE 3

TP 1 looking north west, with wall (103) bearing traces of whitewash, upper right, and wall (104) toward the centre.

6.2.1 Removal of the 0.10m-thick topsoil layer (**100**) revealed two walls forming the corner of a cellar or basement. Wall (**103**) was aligned NW – SE and extended c. 2.30m along the south-west side of the trench. At its south-east end another wall, (**104**), returned to the north east across the width of the trench.

- 7.6 The reason why most of the exposed cellar walls were lined with glazed ceramic tiles is unknown. Only one wall (103) was observed with the more usual coat of whitewash previously encountered in domestic cellars during archaeological investigations (e.g. Cramp 2013b).

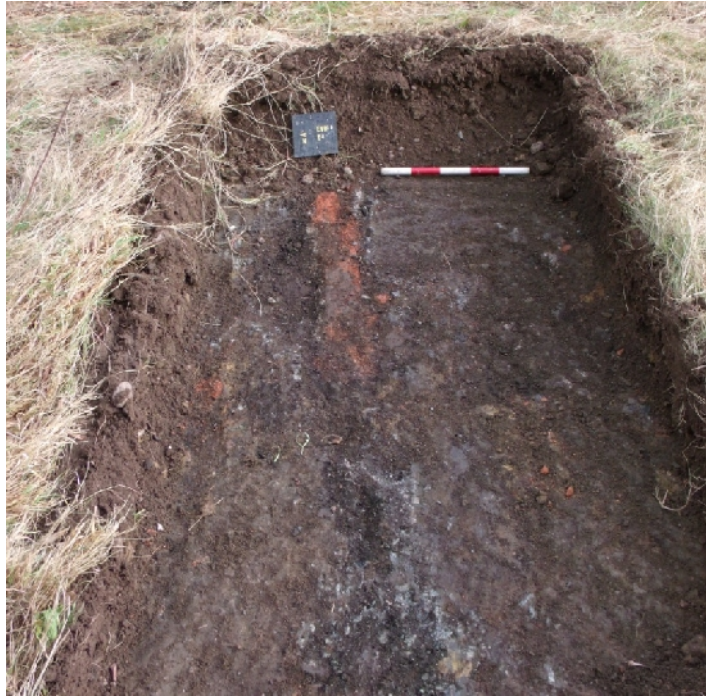
PLATE 4

TP4 looking north east, showing surface (401) either side of wall (402) (scale: 0.50m).

6.5.1 Removing the 0.30m-thick topsoil (400) revealed a single-skin, red brick wall (402) (Plate 4) dividing the pit longitudinally on a NE – SW alignment. A rough cement surface c. 0.10m thick (401) had been laid either side of the wall, directly on to an underlying layer of compact brick rubble (403), c. 1.50m-thick.

6.5.2 Removal of (403) showed that (402) survived to a height of c. 1.50m and possessed a single step footing laid on the natural clay sub-soil (406). At its north east end, (402) bonded with a single-skin wall (405), running across the width of the trench on a NW – SE alignment. These walls delineated the corners of cellars belonging to two adjoining properties, designated as Cellar 1 on the north west side of cross wall (402) and Cellar 2 to the south east.

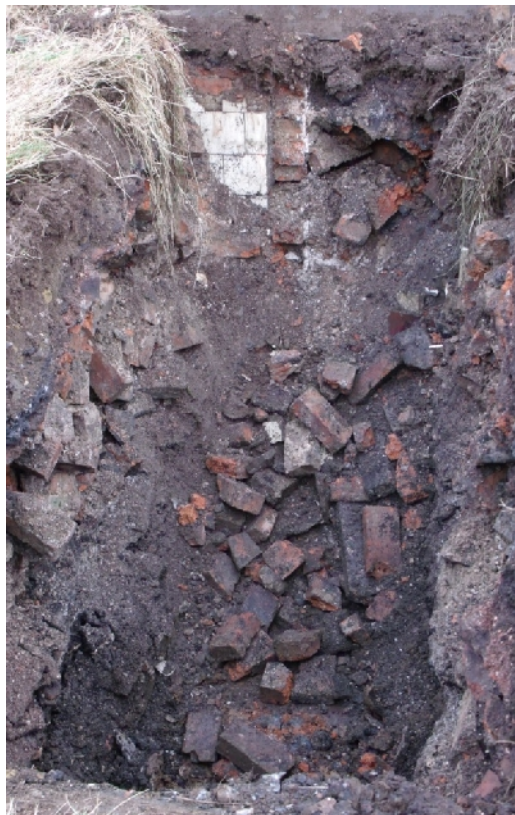
PLATE 5

TP4 under excavation, looking north east, showing tiled wall (405).

6.5.3 Both faces of (402) were dressed with white glazed tiles, which were 0.16m square. The south-west faces of wall (405) had white glazed tiles in Cellar 1 and a mix of white and dark red glazed tiles in Cellar 2 (Plate 5).

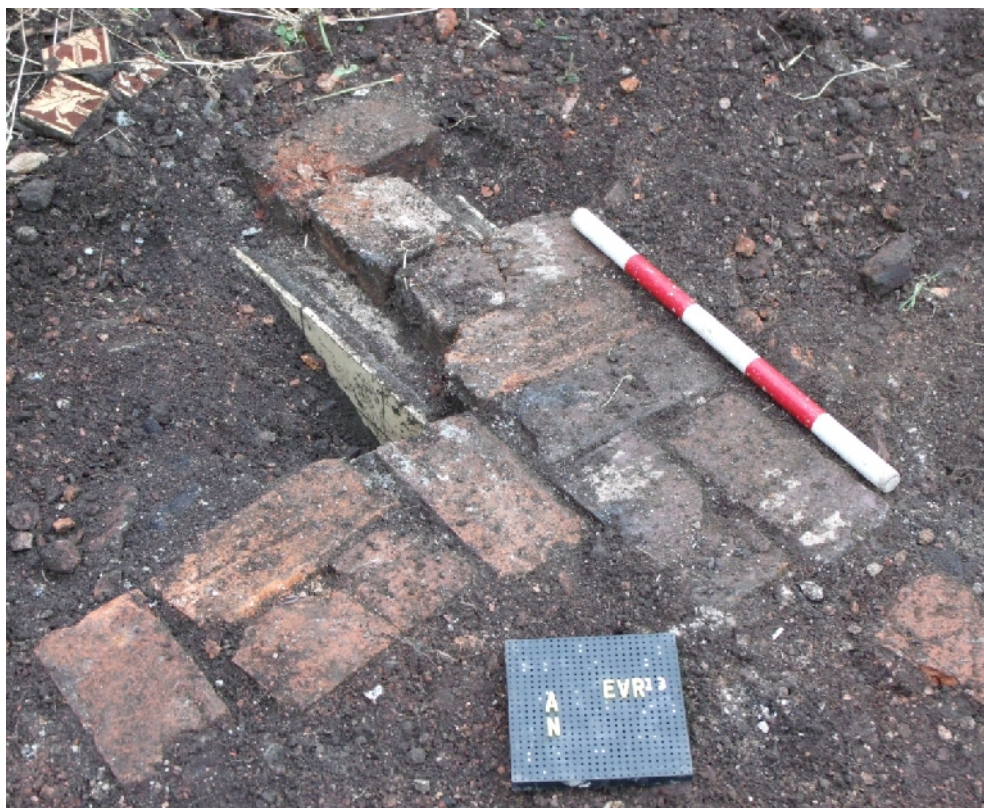
PLATE 7

Brickwork (600) looking north. Note white wall tiles (scale: 0.50m).

6.7.2 Only on the north-west side of the DA (Fig. 2) was a new feature encountered during this phase, although only the uppermost one or two courses (c. 0.15m) of the horizontally truncated top was visible. It consisted of a double-skin brick wall (**600**) measuring 0.88m NW-SE x 0.23m NE-SW, as exposed. Abutting its south-west side was another double-skin wall (**601**) (0.55m NE-SW x 0.23m NW-SE, as exposed).

6.7.3 Wall (**600**) presumably formed a divide between two cellar spaces and what was visible of the faces on both walls were covered in cream coloured, glazed ceramic tiles adhering to a 0.07m-thick bed of grey mortar (Fig. 2; Plate 7). The cellars had been backfilled with brick rubble (**602**), although some fragments of decorated encaustic floor tile were encountered in the top of the fill.
