Archaeological watching brief; Grinsdale

SPECIFICATIONS FOR A PROGRAMME OF WATCHING BRIEF INVESTIGATION TO FULFILL THE SMC CONDITIONS REGARDING S6227 & S6229 HADRIAN'S WALL AND VALLUM BETWEEN THE DISMANTLED RAILWAY SOUTH OF BOOMBY GILL AND THE FIELD BOUNDARY SOUTH EAST OF MILL BECK IN WALL MILE 68, BEAUMONT, CARLISLE, CUMBRIA AND BETWEEN THE EAST END OF DAVIDSON'S BANKS & ROAD TO GRINSDALE & VALLUM BETWEEN DAVIDSON'S BANKS & DISMANTLED RAILWAY IN WALL MILES 67 & 68, BEAUMONT, CARLISLE, CUMBRIA

INSERTION OF TELEPHONE CABLE,

GRINSDALE

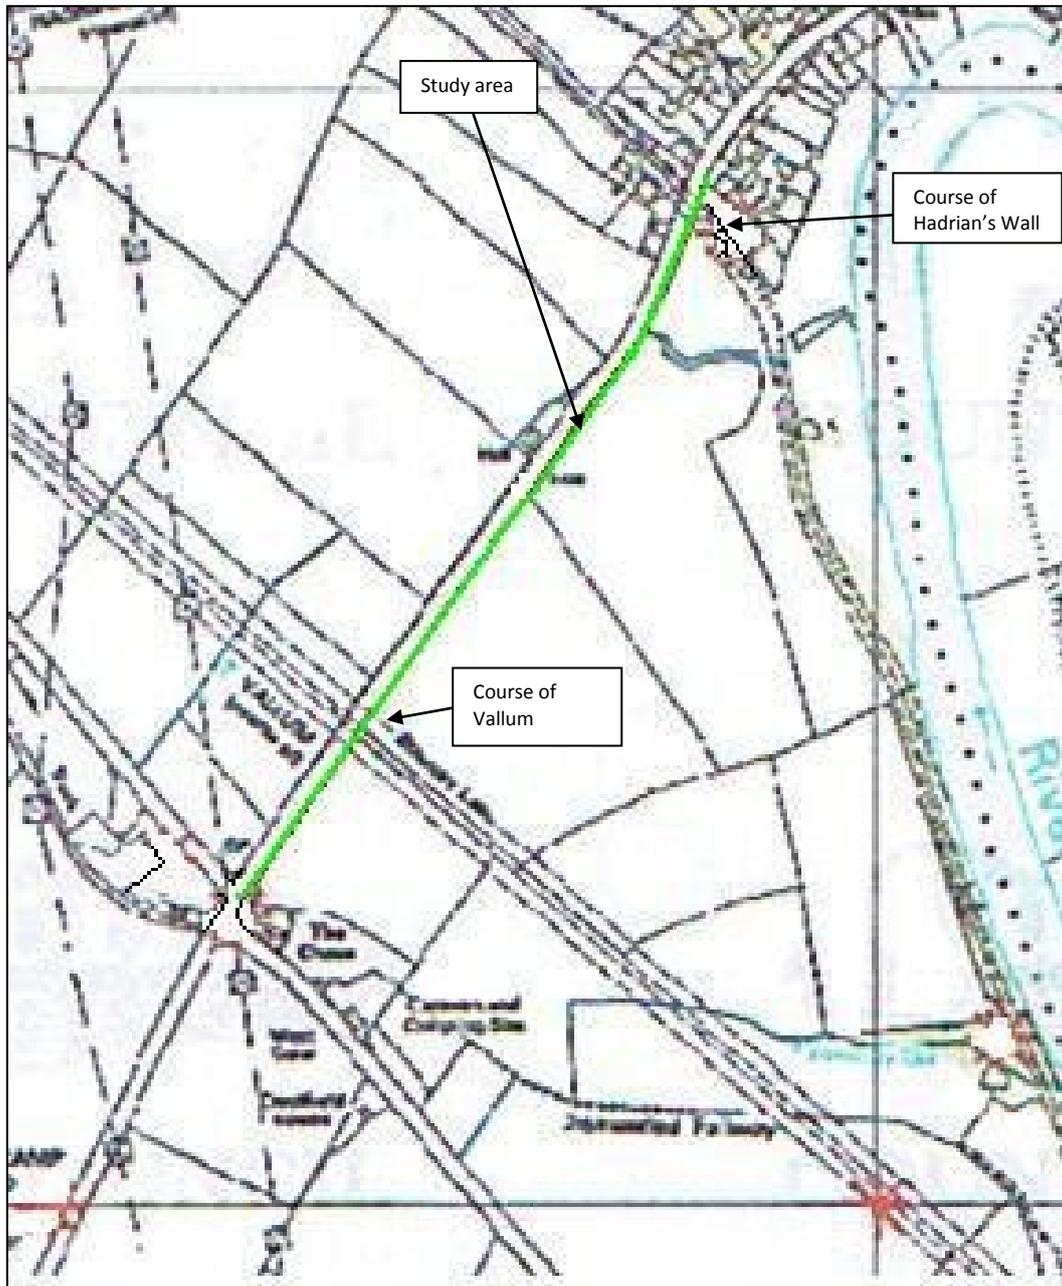
Figure 2. Location of the study area (cable trench in green outline)

Within the parish of Beaumont at approximately 16m OD, the study area (NY 36450 57300 to NY 36700 57900) runs alongside a narrow no-through road (figure 2), just off the Burgh road, that leads to the hamlet of Grinsdale. The study area remains flat with the cable lain into a furrow created by a cable plough within the glass verge on the eastern side of the lane (U1123).

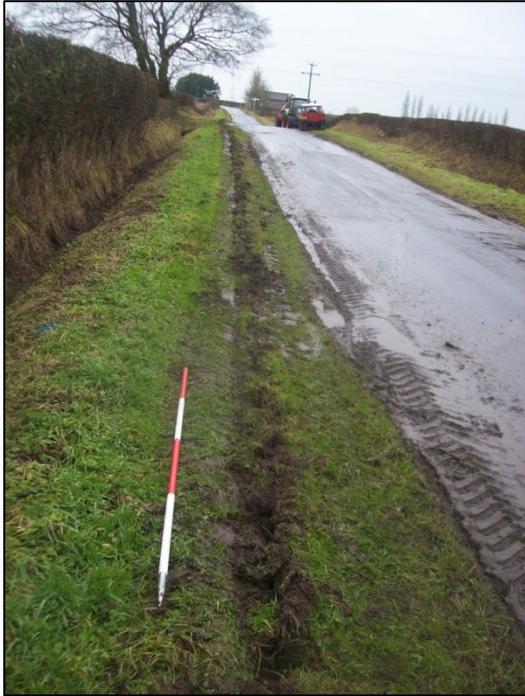
Figure 3. Trench crossing the Vallum

The course of the Vallum was crossed on 1st February 2011. The monitored action did not uncover any evidence or deposits associated with the Vallum (figure 3). Indeed, the adjacent field ditch that is periodically cleaned was significantly deeper than the depth of the newly lain cable.

The intervention that targeted the vallum was undertaken by a cable plough that self-sealed the inserted cable. However, the depth of the cable trench was so slight that it remained within topsoil. Indeed, the adjacent field ditch (figure 3) was considerably deeper; inspection of this feature following cleaning would provide superior empirical evidence.

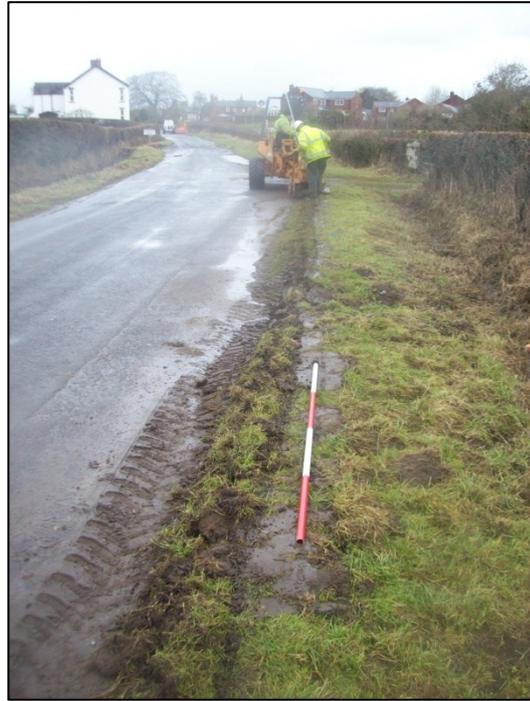
Figure 4. Trench leading to Grinsdale village

From approximately this location, ground conditions became stonier as a result of natural deposition necessitating the blade belonging to the cable plough to be raised producing a trench between 0.10m and 0.20m in depth.

The cable plough continued on the eastern grass verge (figure 4) until it met a new estate road on the southern periphery of Grinsdale. This location marked the position where Hadrian's Wall is believed to exist.

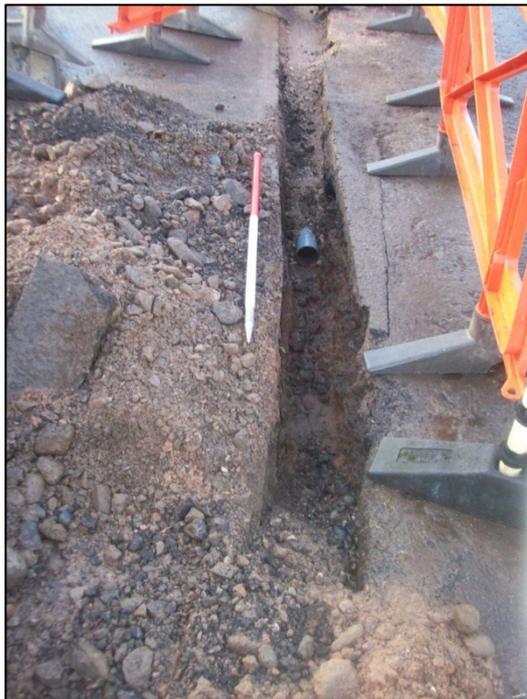
Figure 5. Machine cut trench through road

Here the new cable trench diverted onto the road and required a hand dug open cut (figure 7, green outline) between 0.15m and 0.25m in depth (figure 5). The new trench within the road partially utilised an earlier cable trench continuing onwards to an existing junction box (figure 6) opposite the gateway to Croft View (figure 7, red dot).

The open cut trench produced only clay and modern debris probably associated with the modern housing development located to the east, formerly Eden Holme Farm (figure 7). No evidence for the alignment or footprint of the Wall was encountered.

Where the trench crossed the course of the Wall (almost opposite the Hollies figure 7), modern development has created a new estate road serving the Eden Holme development, an action that would have truncated the upper part of any putative monument. Here, the new cable trench utilised an existing cable trench within the modern road make-up, a horizon that was archaeologically sterile.

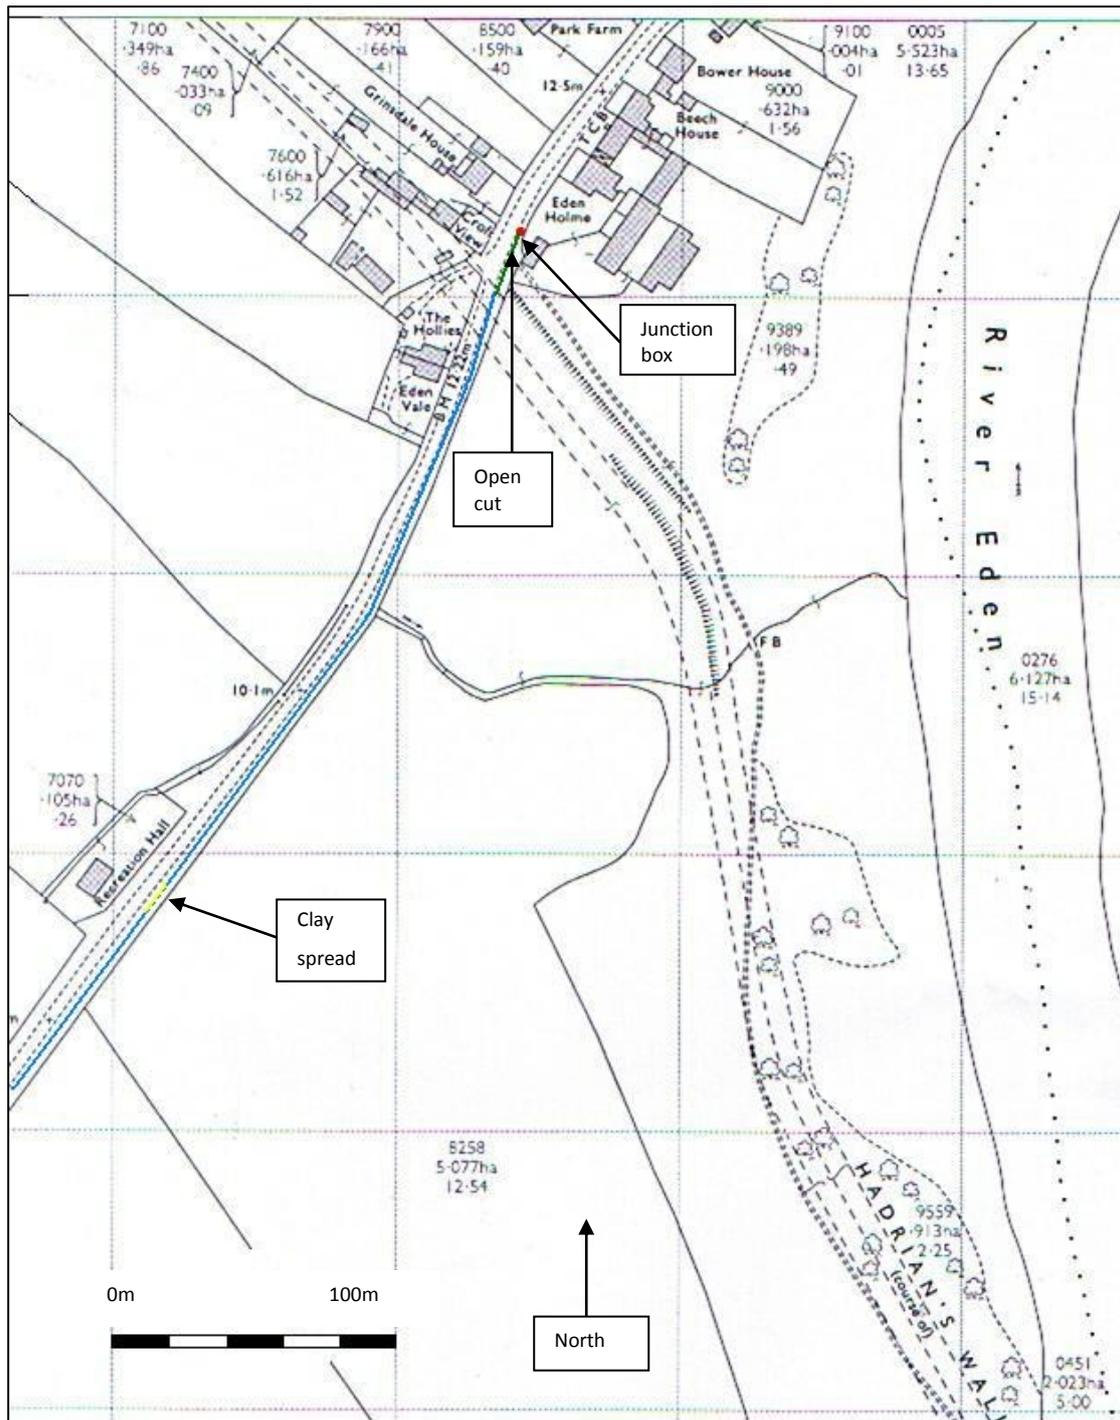
Figure 7. Location of junction box (red), open cut (green) and clay spread (yellow)
(OS Copyright, Licence no. 100044205)

Opposite Grinsdale village hall, a spread of clay approximately 7.00m in length was visible followed by a spread of brick debris (figure 7, yellow outline). No structure was visible.
