Cumbria County Council's County Historic Environment Service was consulted by Carlisle City Council regarding a planning application for the demolition of the Pink House, Little Bampton; planning application 2/2011/0133.

The study building was located at NY 27211 55208.

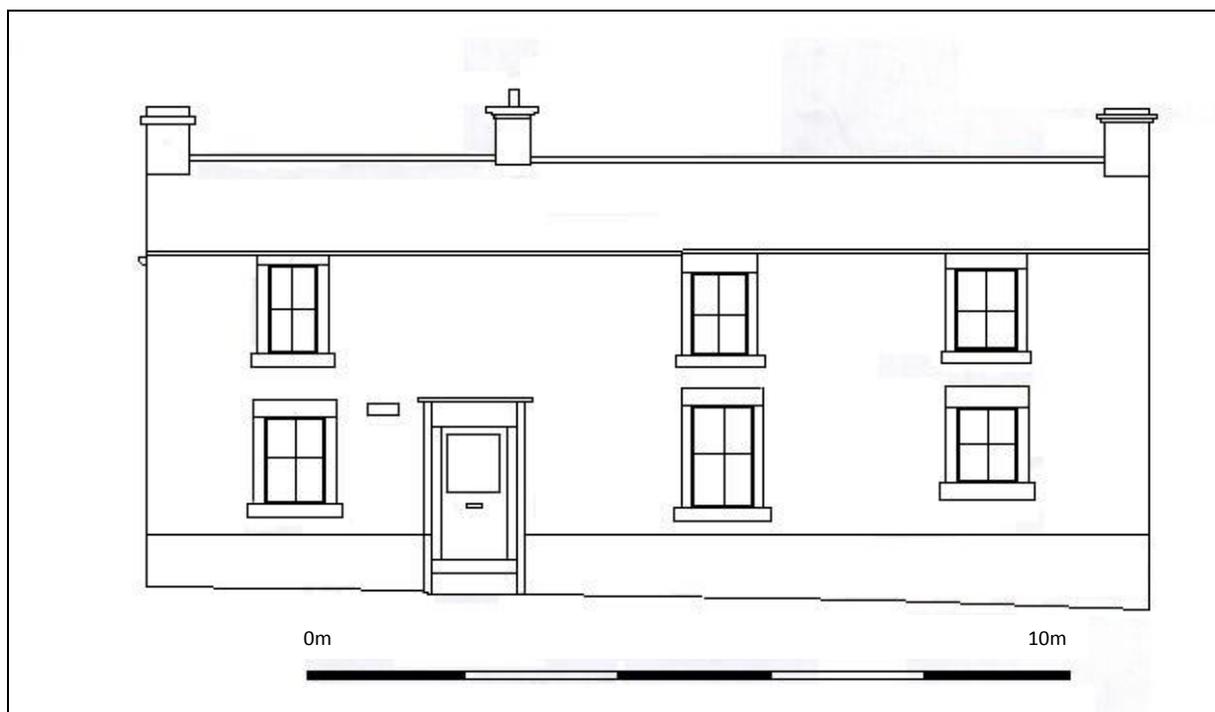
Figure 4. North elevation of the Pink House

The north elevation (figure 4) measured 13.00m in length, 5.40m in width and 4.20m to the roof extended by a further 1.30m to the ridge-line.

The building was clad in modern pebble-dash grouted into pink cement giving the property its distinctive name. At the base of the elevation was a modern, decorative grey cement render between 0.65m and 0.82m in height.

The roof was finished in slate with a stone ridge. It accommodated three brick chimneys, (the central chimney possessing a chimney pot) that all had slightly different designs suggesting that they had been constructed or repaired at various intervals.

The principal architectural devices that could be observed were the windows, all of which on the front elevation (figures 4 and 5) appeared to be square-cut mullions fashionable between 1690 and 1770 (Ibid 122-139).

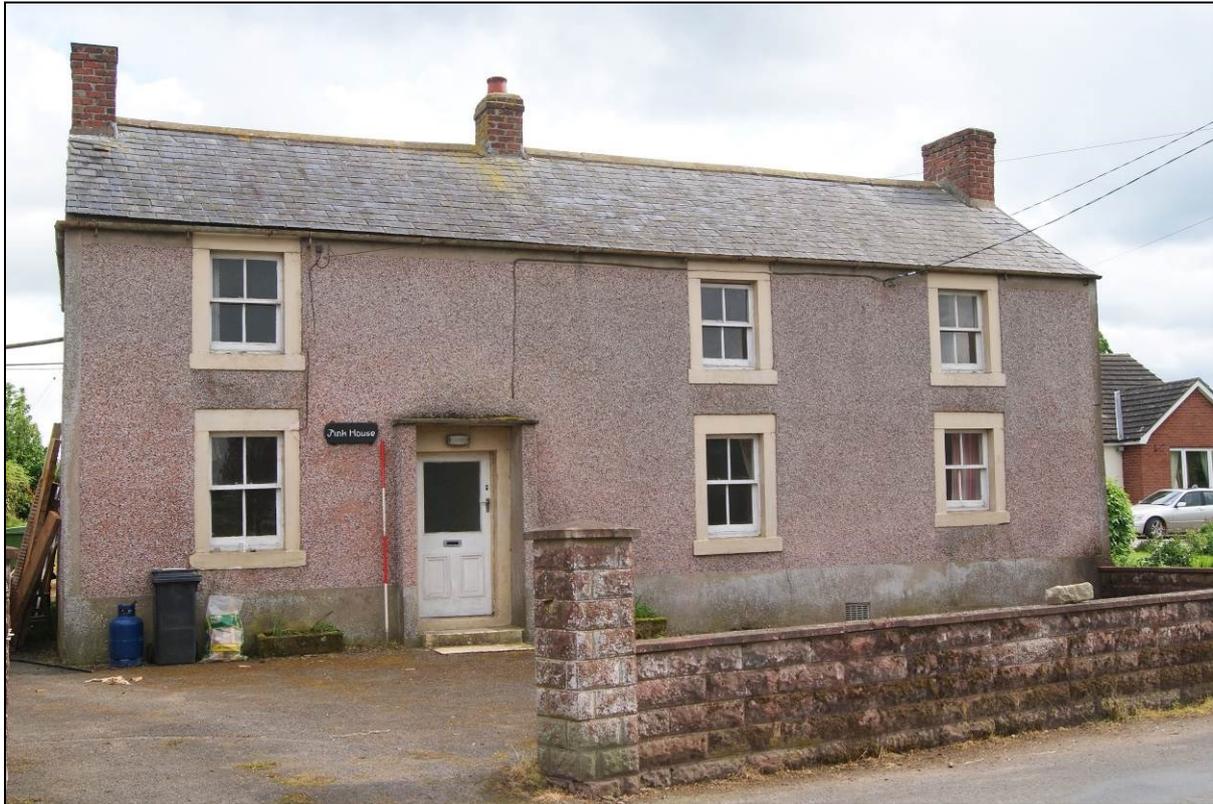
Figure 5. The Pink House, north elevation

The facade (figure 5) illustrated an arrangement of windows of broadly similar size and architectural style on two floors finished in cream masonry paint.

These windows possessed sandstone lintels, uprights and sills. The sills had uniform dimensions of 0.16m in thickness and 1.17m in length, whilst the lintels varied between 1.06-1.09m in length but were all 0.22m in thickness. The bottom central window had longer jambs (1.23m) whereas the other five windows were approximately 1.05m in length.

All the windows were four pane sash windows with timber surrounds belonging to the mid-Victorian period.

The front entrance (1.16m width x 1.181m in height) comprised of a modern, concrete hood measuring 1.24m in width and 0.04m in thickness, supported by flanking jambs 0.15m in thickness and 1.81m in height and entered via a stone step 1.16m in width and 0.13m in height. The modern door was a panelled and glazed.

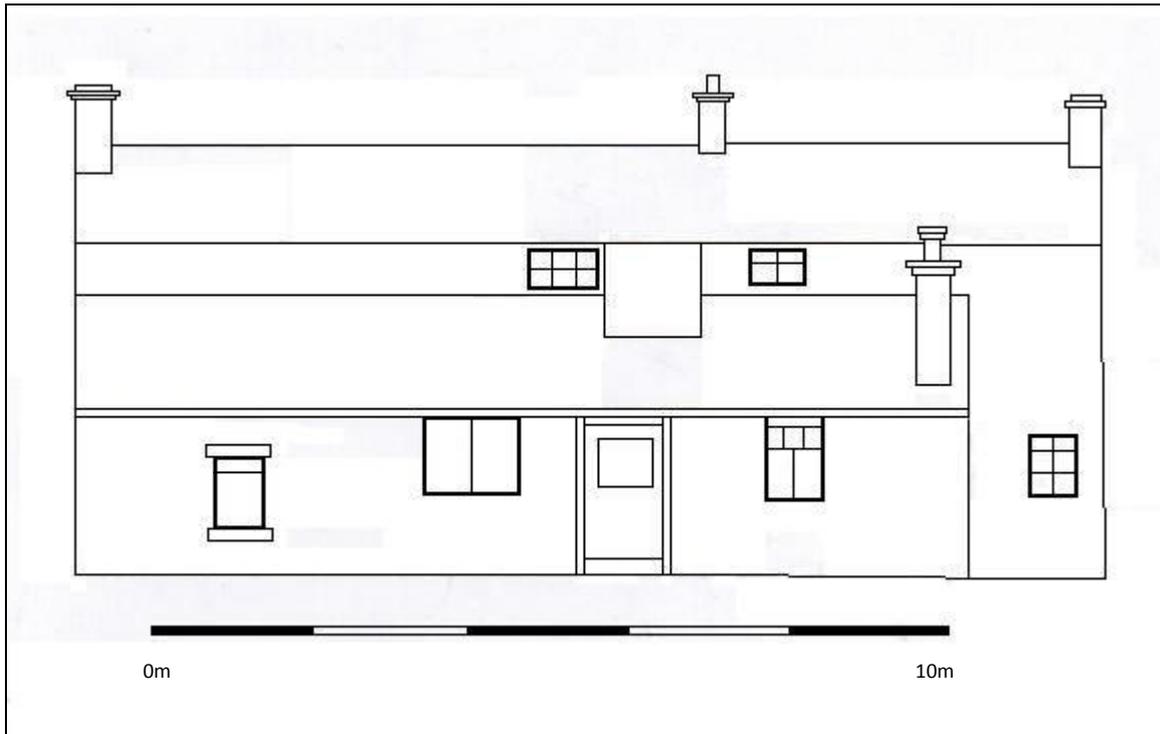
Figure 6. South elevation of the Pink House

The south elevation (figure 6) illustrated the outshut and in the background the core of the Pink House.

The outshut ground plan measured 11.20m in length and 3.25m in width, the slate roof rising from a height of 2.00m to 3.20m.

The building has been clad in pebble dash grouted into pink cement that is continued onto the partially exposed southern elevation of the Pink House with a band of grey cement render at the base.

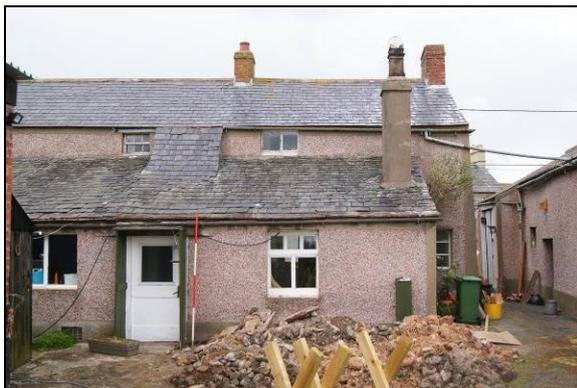
Figure 7. Looking north, the southern elevation

All the windows (figure 7) were modern conversions of earlier window jambs.

- The eastern window measured 0.74m in width and 0.95m in height and contained a five pane fixed window with wooden surround.
- The central window measured 1.22m in width and 0.93m in height and contained two panes with a modern metal surround.
- The western window measured 0.62m in width and 0.95m in height and contained two panes of opaque glass with a timber surround. A sandstone lintel measuring 0.87m x 0.13m in thickness was present as was a probable stone sill.

The doorway was a modern amendment with a crude timber porch. It contained a modern timber door 0.94m in width and 1.80m in height.

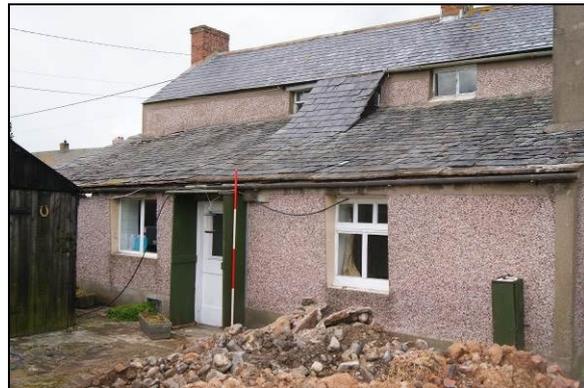
Figure 8. Southern facade looking north-west

A central slate roof (figure 8) connected the outshut roof to the roof Pink House. The purpose of this addition is not certain but shields a cupboard (discussed below).

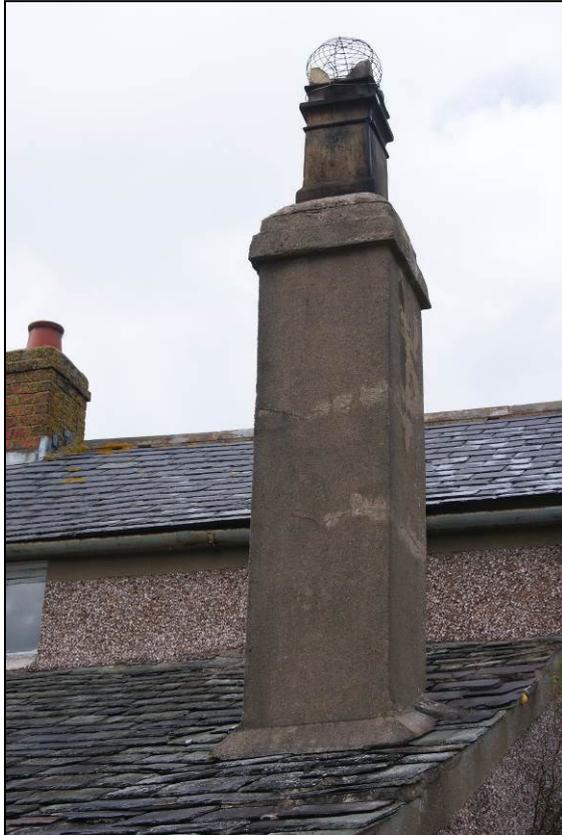
Figure 9. Chimney above the outshut

The outshut possessed a tall chimney (approximately 1.80m in height) rendered in cement with a decorated chimney pot (figure 9).

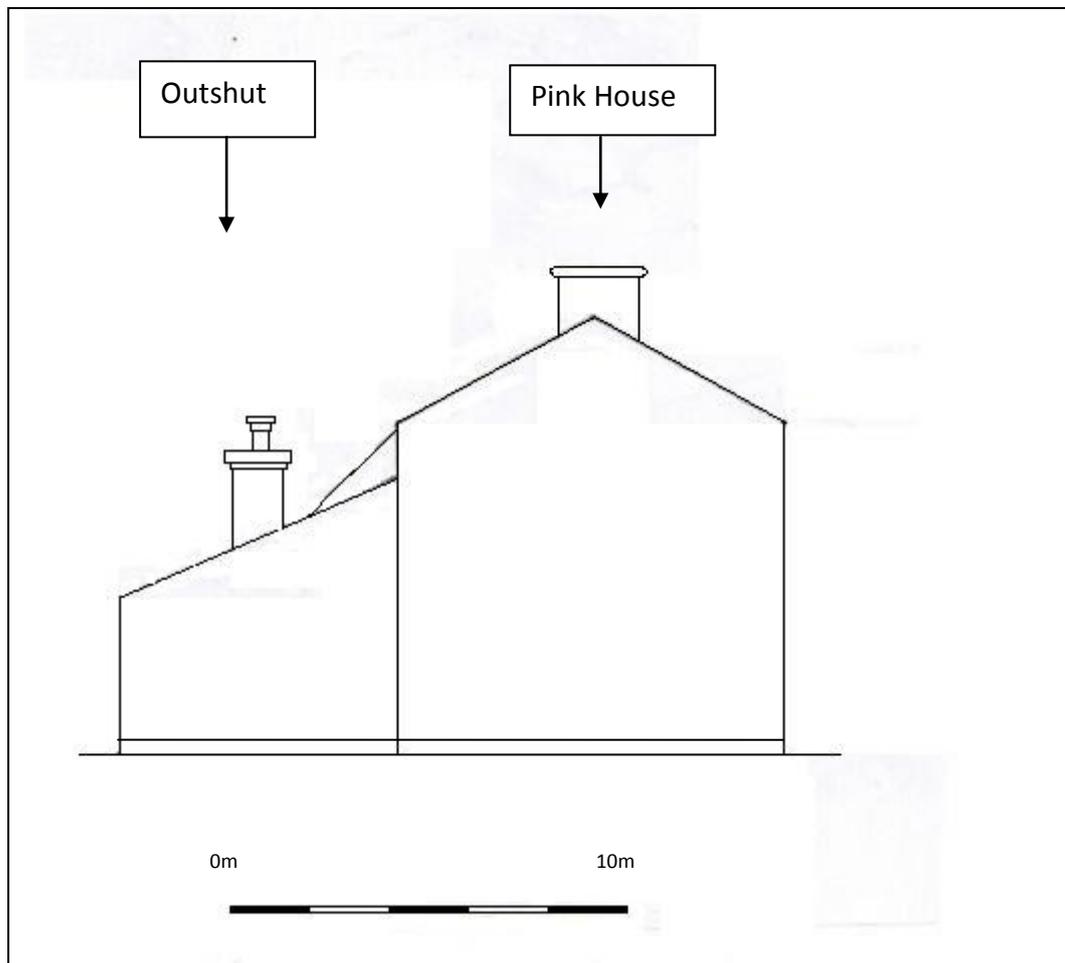
Figure 11. Eastern elevation of the outshut and Pink House

The eastern elevation (figure 11) illustrated the conjunction of the outshut (figure 10) and the Pink House. The plain elevation was clad in pebble dash grouted into pink cement with a band of plain grey cement render at the base of the wall.

There were no architectural embellishments or features illustrated within the elevation.

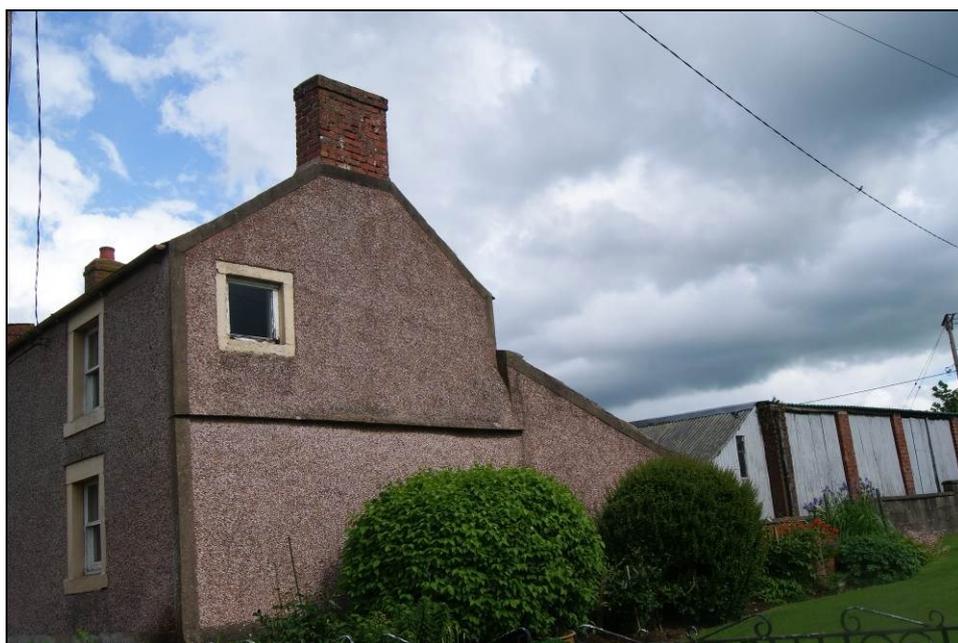
Figure 12. Western elevation of the Pink House

The western elevation (figure 12) was a generally plain elevation clad in pebble dash grouted into pink cement. A single window framed in sandstone and painted cream was visible on the first floor.

However, the elevation for the Pink House appeared to bow slightly outwards whilst the outshut demonstrated a pronounced outward kick denying a flush face to the elevation.

The interface between the ground and first floors was denoted by a slight, curving plinth that could denote the presence of a former abutting outbuilding or possibly the rebuilding or refurbishment of the upper floor

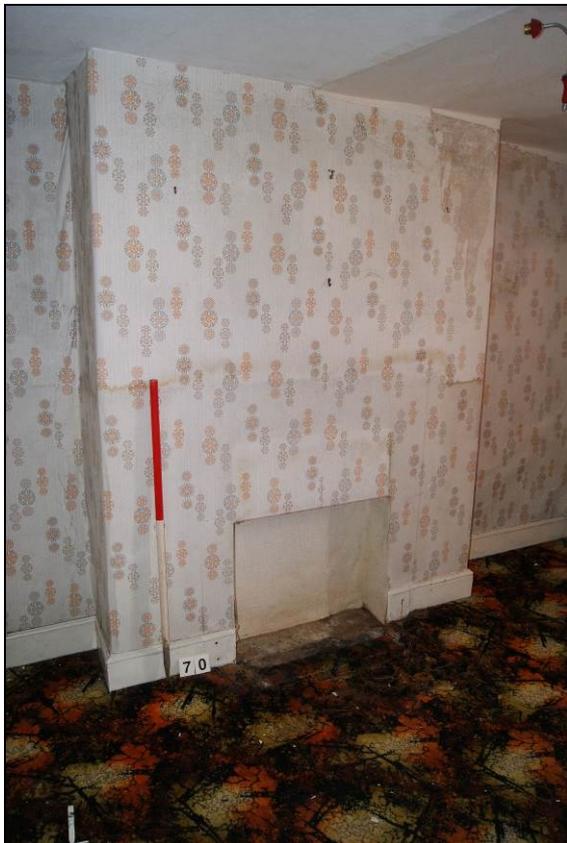
Figure 14. Fire place 70, Room 6

- A stone fireplace 70 (figure 14) with a modern opening measuring 0.73m x 0.61m in height within a firestack measuring 1.70m in width and 0.30m in depth
- South wall 71 (figure 15) displayed considerable bowing a divergence of 0.15m from base to top.
- A four pane sash window inserted on the north elevation measuring 1.05m x 1.10m in height and 0.35m in depth with a wood surround
- A modern stud eastern wall 0.10m in thickness

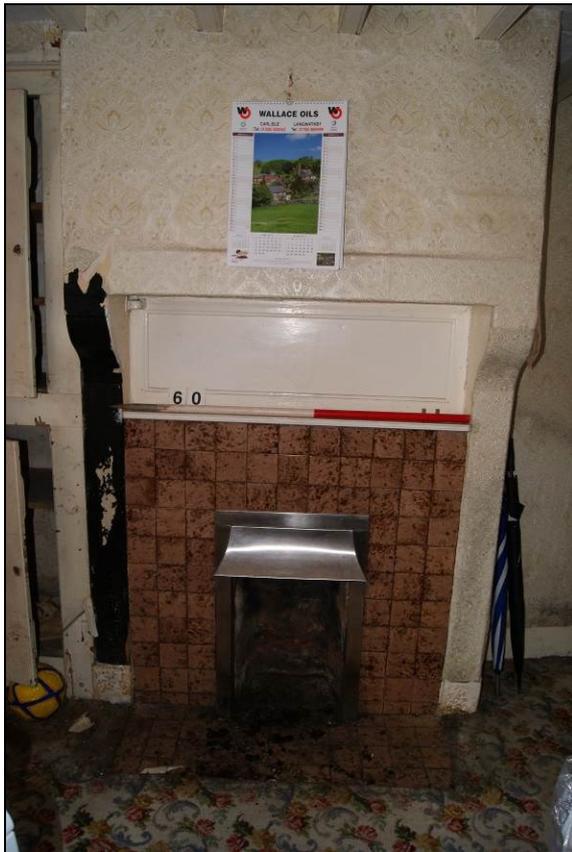
Figure 16. Fireplace 60, Room 5

- A fireplace 60 1.38m in width and 0.30m in depth obscured to the north by a modern cupboard 64. A modern fireplace (figure 16) with an opening measuring 1.12m in width

stood with the feature that had been decorated with wallpaper. The original stone fireplace had stone uprights with curved protruding supports (figure 17) and a wide stone hood that may have been decorated as relief appeared to protrude through a layer of wallpaper.

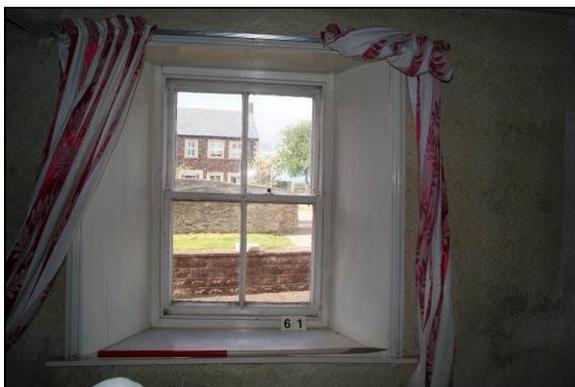
Figure 18. Sash window 61, Room 5

- A sash window (figure 18) 61 with wood surround measuring 0.80m x 1.23m in height and 0.38m in depth displaying blistered glass
- The southern wall 62 (figure 20) showed considerable bowing, continuing westwards into Room 6
- A threshold 63 (figure 19) at the south-east corner of the room illustrating two probable clay dabbins wall
- A modern timber cupboard 64 (figure 21) adjacent to fireplace 60 illustrating a bowing northern wall, probably formed from clay dabbins
- A modern timber door measuring 0.74m x 1.84m leading to Room 6

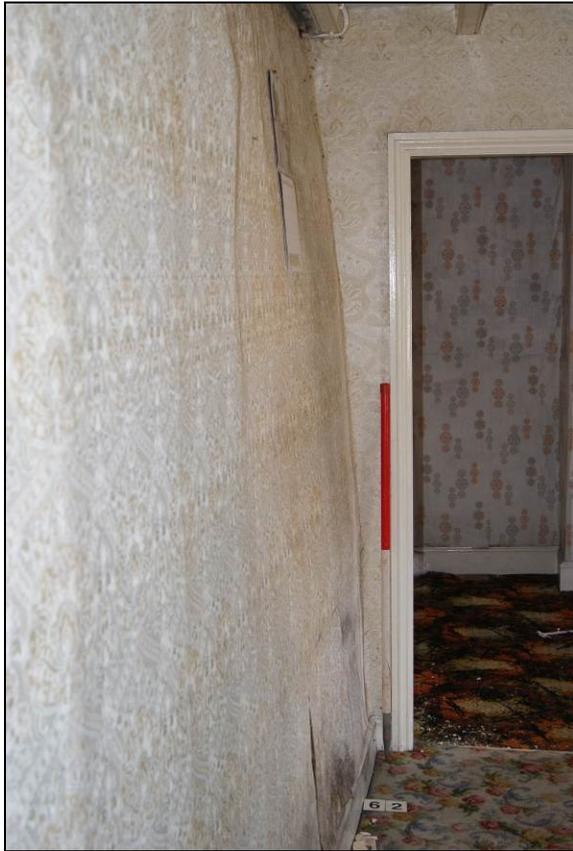
Figure 20. Bowing southern wall 62, Room 5

The bowing and unevenly surfaced external walls measured 0.60m in thickness, at their base comprising of clay dabbins wall 62. The room exhibited the following architectural elements:

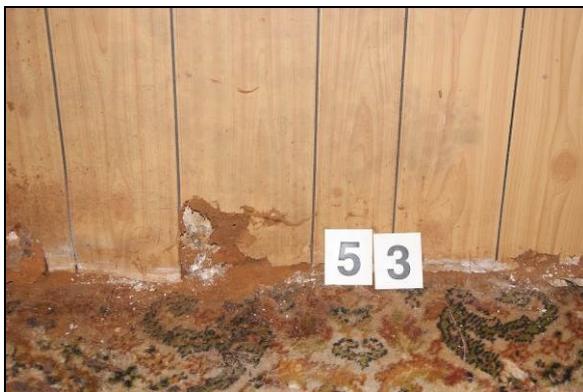
Figure 22. Clay dabbins wall 53, Room 4

The northern external wall measured 0.60m in thickness and at their base comprised of clay dabbins wall 53 (figure 22) seen through a laminated cladding. The room exhibited the following architectural elements:

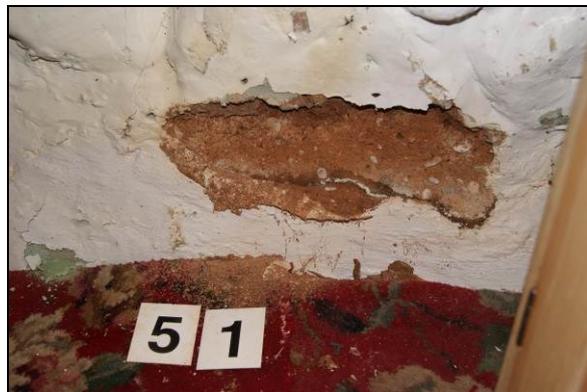
Figure 23. Clay dabbins wall 51, cupboard

The southern external wall was a white-washed clay dabbins wall 51 (figure 23) that internally measured 0.46m in width, less than the comparable northern wall 53. However, at the eastern end of the wall beside window 43, it measured 0.60m in thickness.

- Clay dabbins wall 51 (figure 23) that illustrated a probable rubble wall superstructure
- A six pane window 43 (figure 30) measuring 0.75m x 0.86m in height, with a 0.44m in depth square recess to the glass
- A fluted banister 44 (figure 31) attached to a curved handrail that formed part of a wooden stair case. Beneath the staircase, the space had been enclosed by a tongue-and-groove panel in order to form a cupboard
- The below stairs cupboard had a door 0.70m in width
- The floor was 0.06m higher than the adjacent hallway
- The stairs were 0.80m in width

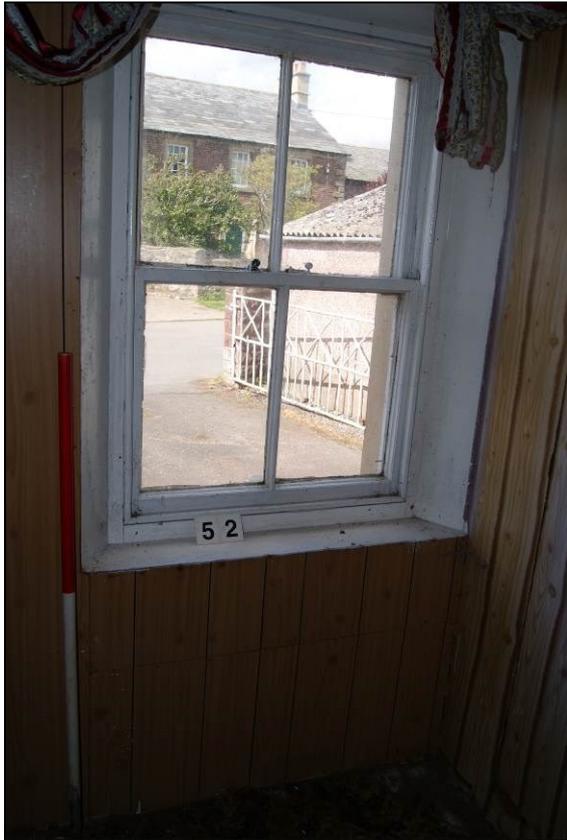
Figure 24. Window 52, Room 4

- A window 52 (figure 24) within the northern elevation measuring 1.00m x 1.20m in height housing a sash window measuring 0.75m x 1.20m
- A modern wooden frame cupboard measuring 0.60m in depth and 2.08m in width

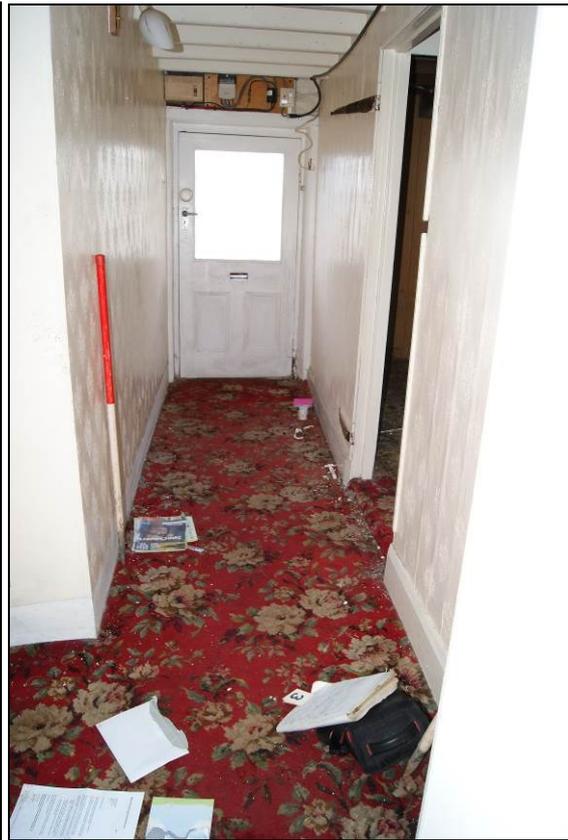
Figure 25 Hall between Rooms 4 and 5

The main hall (figure 25) measured 4.22m x 1.03m and 2.10m in height. The hall widened to 1.18m beside the eastern stud partition forming Room 4. The principal features were as follows:

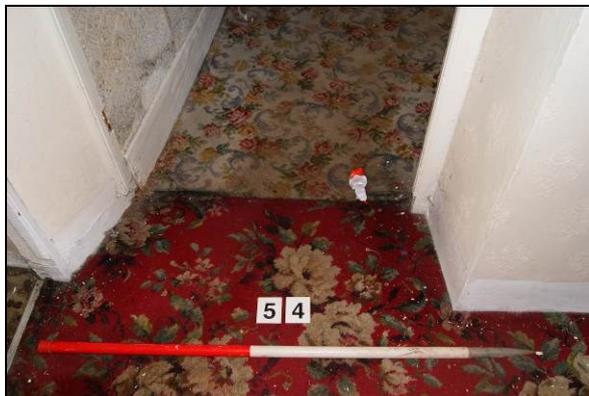
Figure 26. Threshold 54 leading to Room 5

- A threshold 54 (figure 26) leading into Room 5 denoting a rounded southern wall that became clay dabbins wall 62 and a flush partition wall formed by wall 63
- A threshold 55 (figure 27) leading into Room 7 detailing stone rubble that becomes clay dabbins wall 62
- A northern doorway measured 1.07m in width and contained a modern door measuring 0.99m x 1.88m in height
- A modern stud eastern wall 0.10m in thickness that formed Room 4

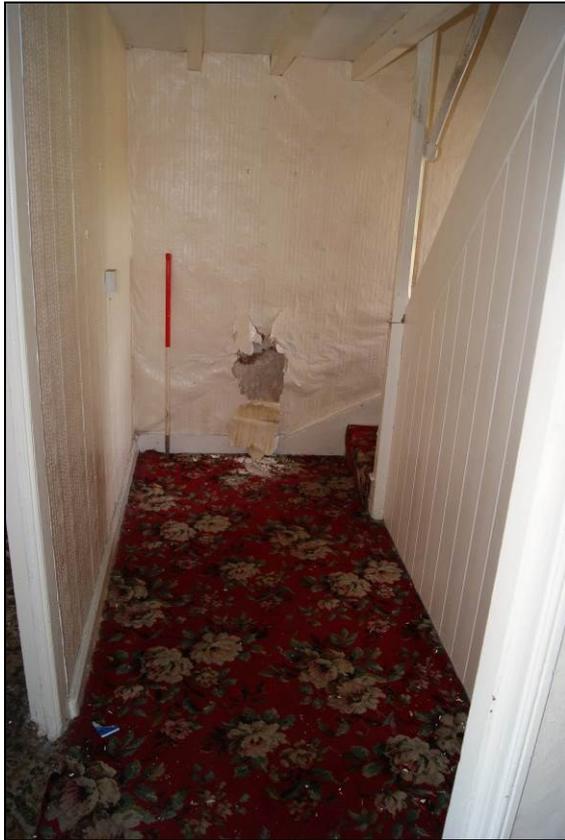
The eastern hall (figure 28) leading to the staircase was formed from a stud wall and tongue and groove cladding between Room 4 and a below-stairs cupboard. The space measured 2.90m x 0.80m.

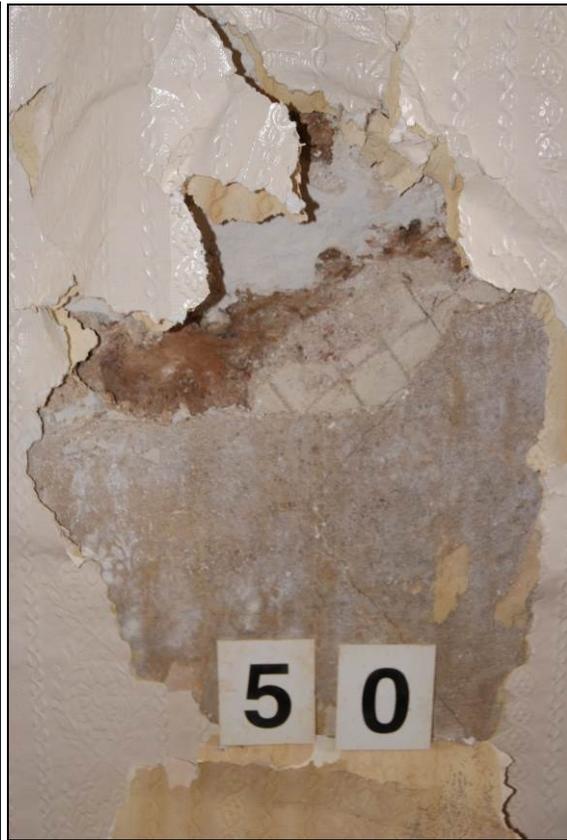
The principal feature was a northern clay dabbins wall 50 (figure 29) measuring 0.60m in thickness just visible beneath modern plaster and wallpaper.

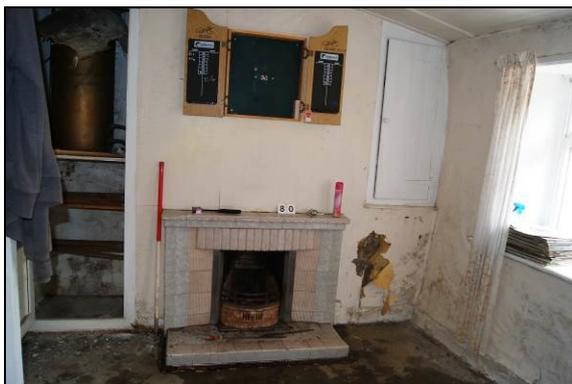
Figure 32. Fireplace 80, Room 7

- Fireplace 80 possessed a modern tiled fireplace (figure 32) measuring 1.23m in width and 0.84m in height. This feature was inserted into an earlier sandstone fireplace with a depth of 0.65m that possessed flanking cupboards to the north (0.80m x 2.26m in height) containing

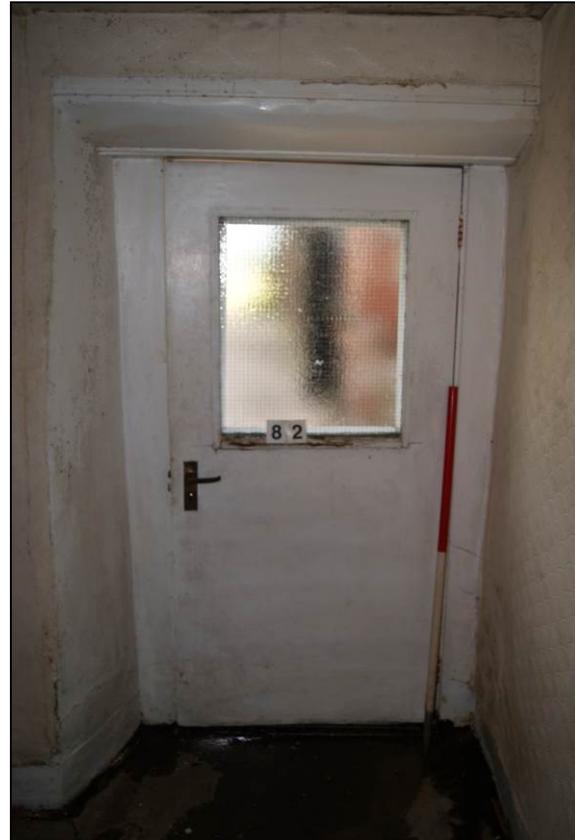
Figure 34. Doorway 81, Room 7

- A northern doorway 81 (figure 34) with a modern door. The threshold measured 2.00m in height, 0.80m in width where it entered the hall but widened to a width of 1.00m within Room 7. A partially dressed stone boulder was visible beside the west side of the door. This door probably represented the rear door to the original lay-out for the Pink House.

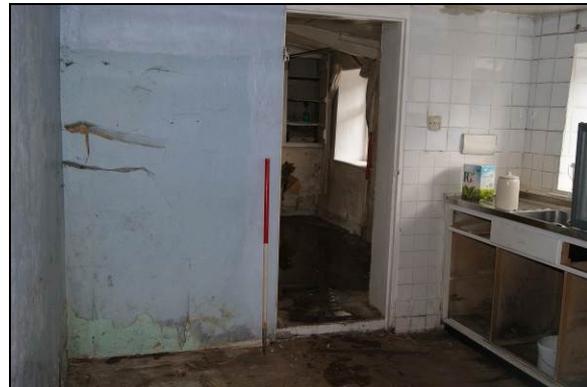
Figure 39. Kitchen

The kitchen (figure 39) measured 3.22m x 2.91m and 2.06m in height was formed between a northern clay dabbins wall 62, a possible similar southern clay dabbins wall 84, an unknown fabric wall adjacent to Room 7 and a modern stud wall beside the bathroom.

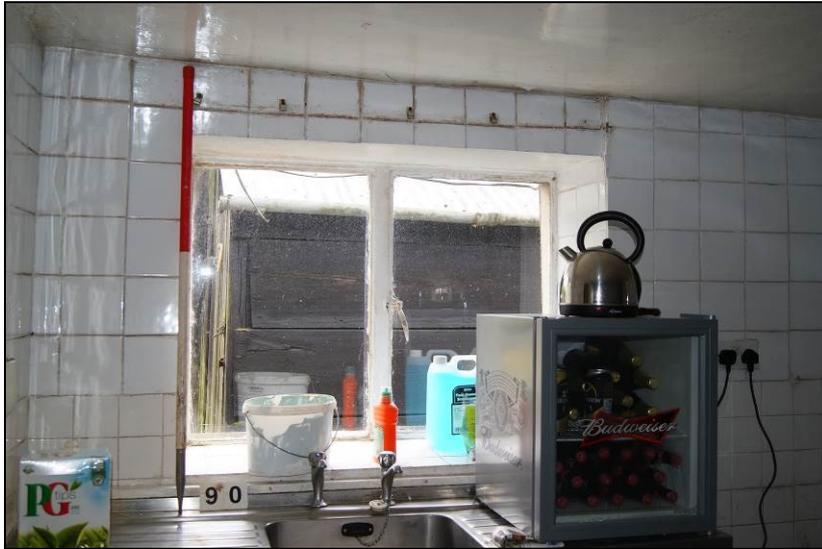
Figure 40. Window 90, kitchen

It contained a single window 90 (figure 40) measuring 1.20m in width and 0.90m in height and was 0.37m in depth, replaced by a modern metal frame.

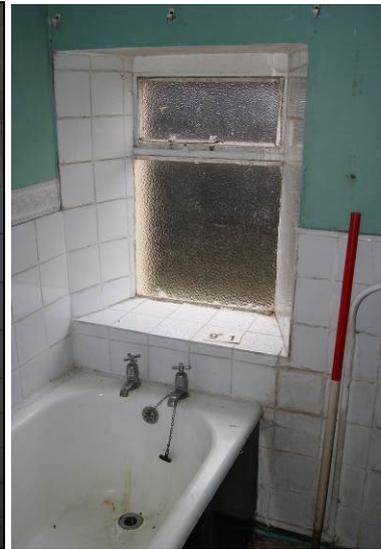
Figure 41, Window 91, Bathroom

The bathroom yielded a window 91 (figure 41) measuring 0.83m x 0.93m and was 0.33m in depth and possessed a tapered casement.

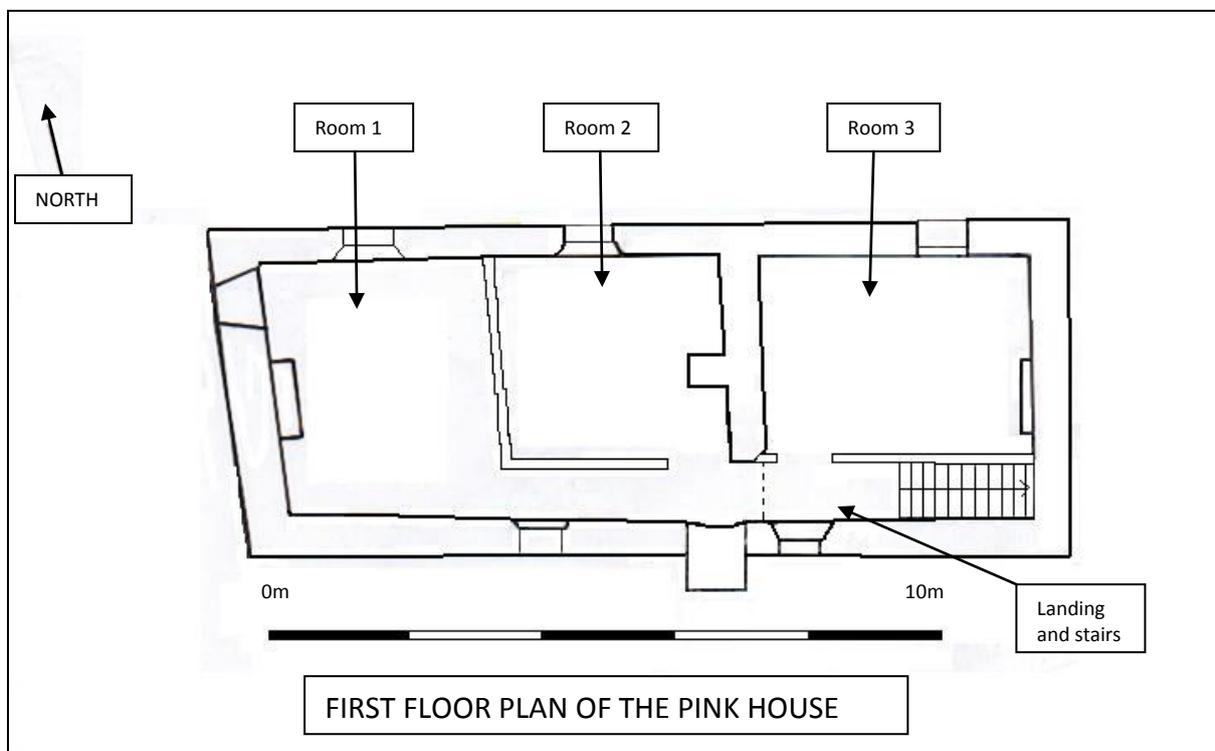
Figure 42. First floor plan, Pink House

The first floor of the Pink House (figure 42) composed of four spatial elements; Rooms 1-3 and a hallway. The structure probably comprised of a clay dabbins internal wall with the external walls a possible combination of clay dabbins and rubble core.

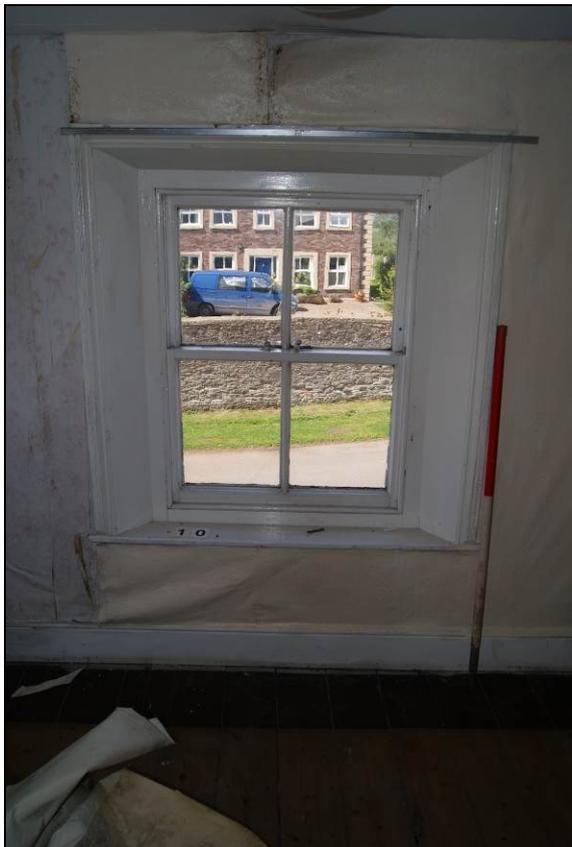
Figure 43. Window 10, Room 1

- Northern four pane sash window 10 (figure 43) measuring 1.17m x 1.20m in height of which the glazed area covered 0.73m x 0.96m.
- Western single pane window 11 (figure 44) measuring 0.60m x 0.60m that sat within a tampered casement 0.30m in depth
- Chimney breast 12 (figure 45) located on the western wall measuring 1.18m in width and 1.90m in height with a depth of 0.45m. The stack corresponded to fireplace 70 (Room 6) but it was impossible to determine whether this room possessed its own fireplace
- A modern stud wall divided Room 1 and Room 2

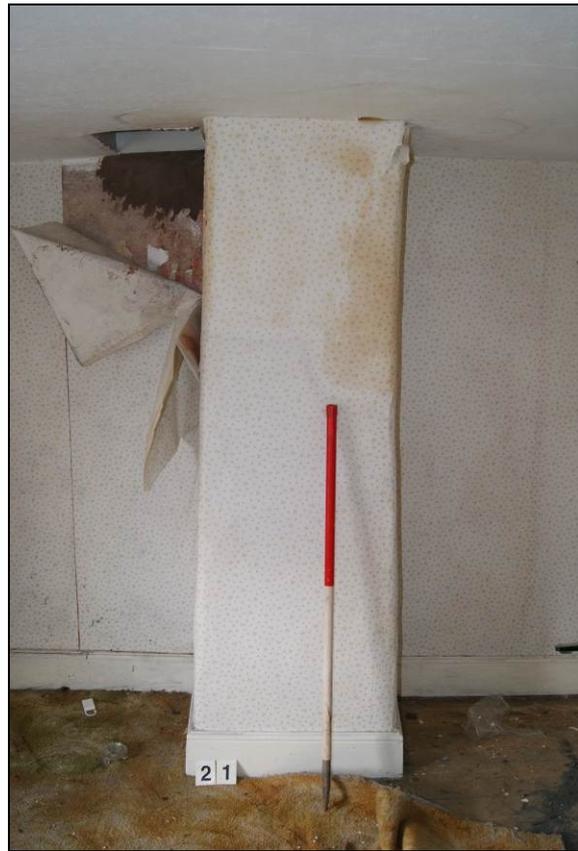
Figure 46. Chimney breast 21, Room 2

- Northern four pane sash window 20 (figure 47) measuring 0.73m x 1.02m in height within a tampered casement
- Narrow chimney breast 21 (figure 46) measuring 0.60m in width that corresponded to fireplace 60 (Room 5). No fireplace rested within the feature.

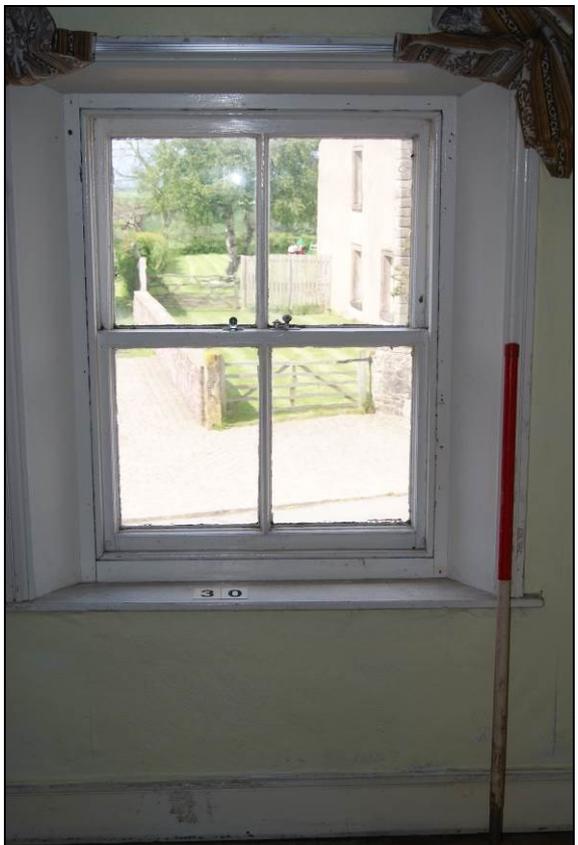
Figure 48. Window 30, Room 3

- Northern four pane sash window 30 (figure 48) measuring 0.75m x 0.97m in height within a tapered casement
- Chimney breast 31 (figure 49) measuring 2.30m before narrowing to a stack measuring 1.10m in width, 1.09m of the ground suggesting that a fireplace existed. As no extant fireplace was resident in Room 4 below, it would appear probable that this was a purpose built fireplace in order to heat the principal bedroom or chamber
- Partition wall 32 (figure 50) segregating rooms 2 and 3. This unevenly faced wall possessed a curving southern terminal with a very steep pitch rather than a vertical plane suggesting that it was a clay dabbins wall

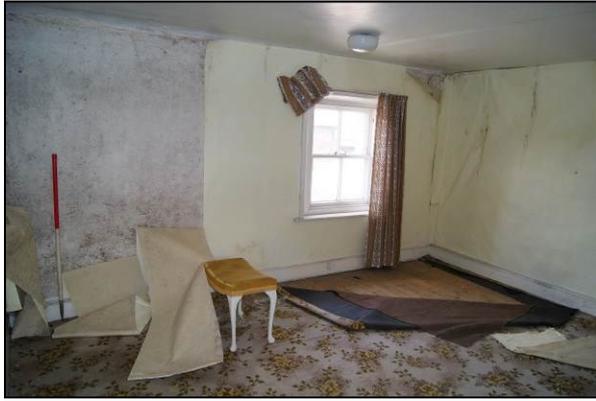
Figure 51. View of Room 3

Room 3 (figure 51) measured 4.11m x 3.29m and stood 2.09m in height formed from three walls of some antiquity and a modern stud southern wall that bordered the landing. It exhibited the following architectural elements:

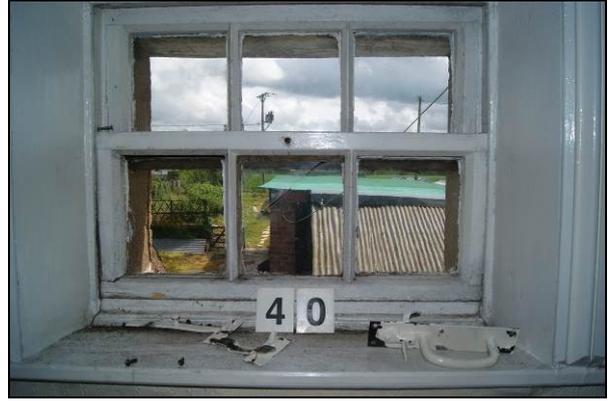
Figure 52. Window 40, Landing

- A six pane sash window 40 (figure 52) measuring 0.70m x 0.55m in height within a tapered casement
- A small sloping cupboard 41 (figure 54) that formed an adjunct to the first floor. The cupboard measured 0.93m in width and 1.73m in height comprising a slate roof attached to planking enclosed by timber cladding.
- The threshold 41 (figure 55) that formed the cupboard had a distinctive kink suggesting that the alignment of the southern external wall had been altered or reflected a lost, earlier structural element
- Modern window 42 (figure 56) measured 0.83m x 0.44m and rested within a deep casement measuring 1.09m x 0.58m. This window respected the partition wall between Rooms 2 and 3

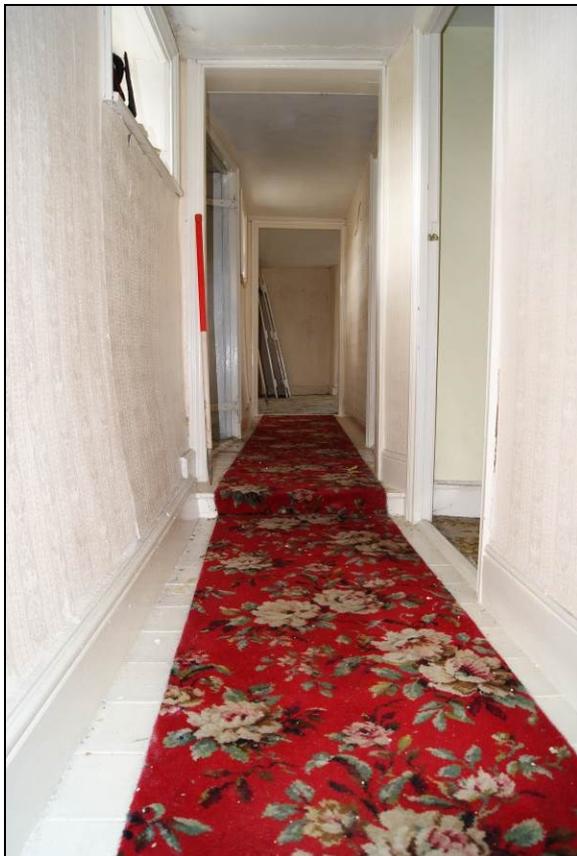
Figure 53. Landing looking west

The landing (figure 53) was formed by a modern stud wall that ran from Room 3 to Room 2, parallel to the southern external wall that appeared to slightly bow, encompassing the stairway and a small recess that had been used as a cupboard.

The landing measured 7.85m x 0.95m and stood to a height of 1.73m in height. Between Rooms 2 and 3 the landing stepped down 0.10m.

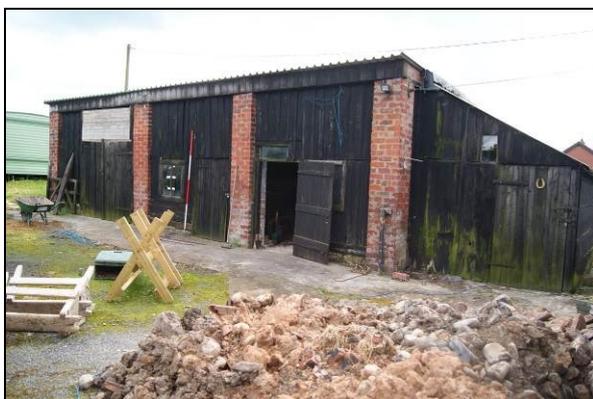
Figure 57. Eastern elevation of the outbuilding

The building consisted of four brick pillars, with on its eastern elevation (figure 57) a vertically timber planked super-structure treated with pitch or a waterproof variant.

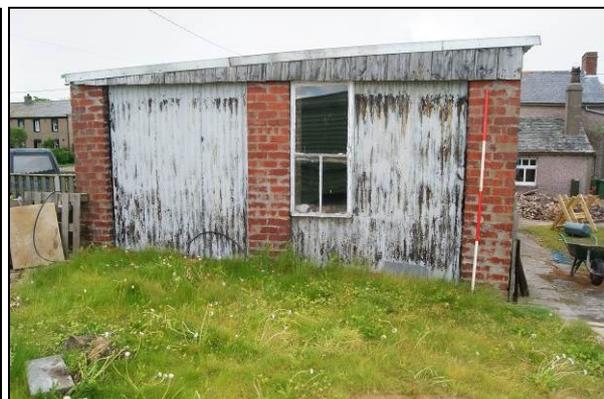
Figure 58. Southern elevation of the outbuilding

The southern elevation (figure 58) illustrated a building fabric of corrugated asbestos, the same material that formed the roof.

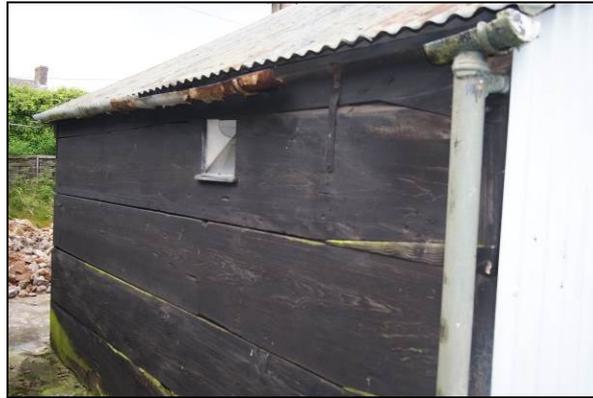
Figure 59. Northern elevation of the outbuilding

Added later, the northern lean-to (figure 59) was formed from horizontal timber planks and a corrugated metal roof.

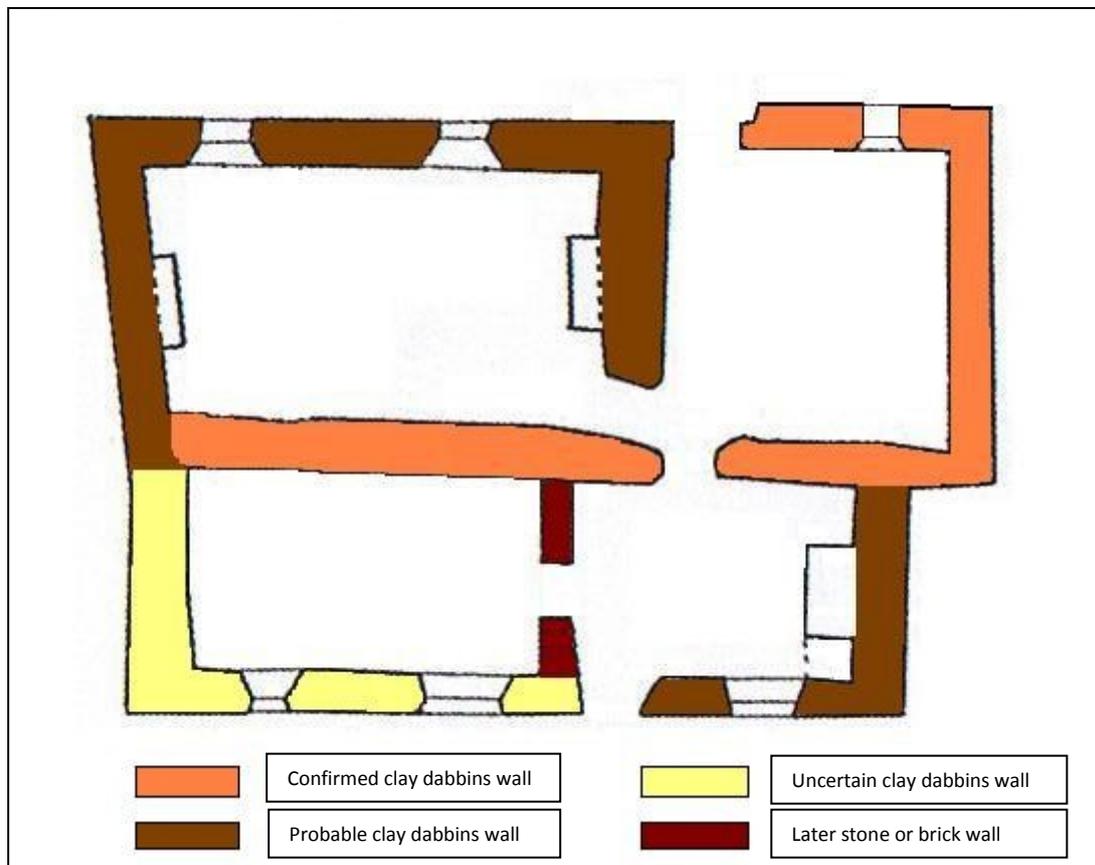
Figure 60. Lay-out and authenticity regarding the clay dabbins walls

The eastern wall and southern wall eastern limb 84 (brown outline) also appeared to be clay dabbins wall part of an outshut (cream outline) that probably post-dated the main body of the house, although no definitive structural relationship was observable.
