The study building probably served as a threshing barn built during the early to mid 19th century when farm improvements and rising agricultural incomes were developing in Cumbria.

Cumbria County Council's County Historic Environment Service was consulted by Allerdale Borough Council regarding a planning application for the conversion of a barn at Home Farm Cottage, Deanscales, near Cockermouth; Planning Application No. 2/10/0821.

Level II Building Survey Home Farm Cottages, Deanscales, Cockermouth

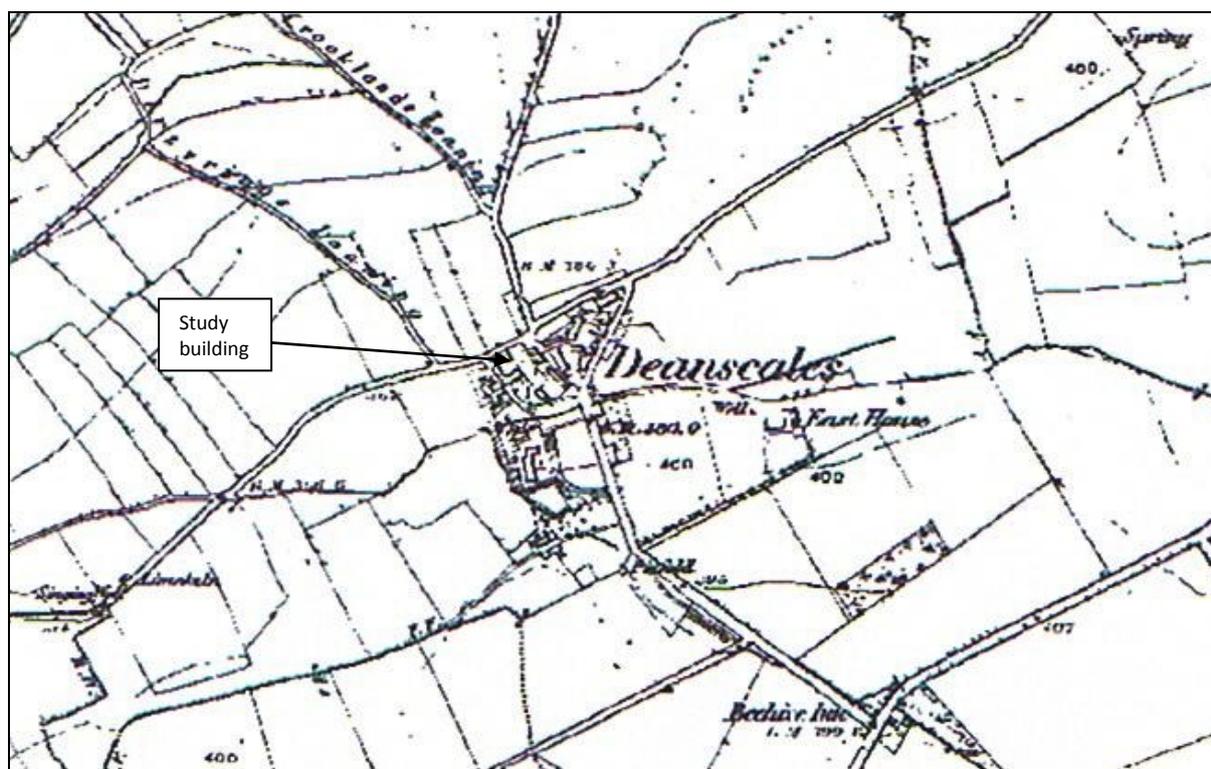
Figure 3. Ordnance Survey First Edition map of 1867

The study building is shown on the first edition Ordnance Survey map of 1867 (figure 3) and probably served as a threshing barn.

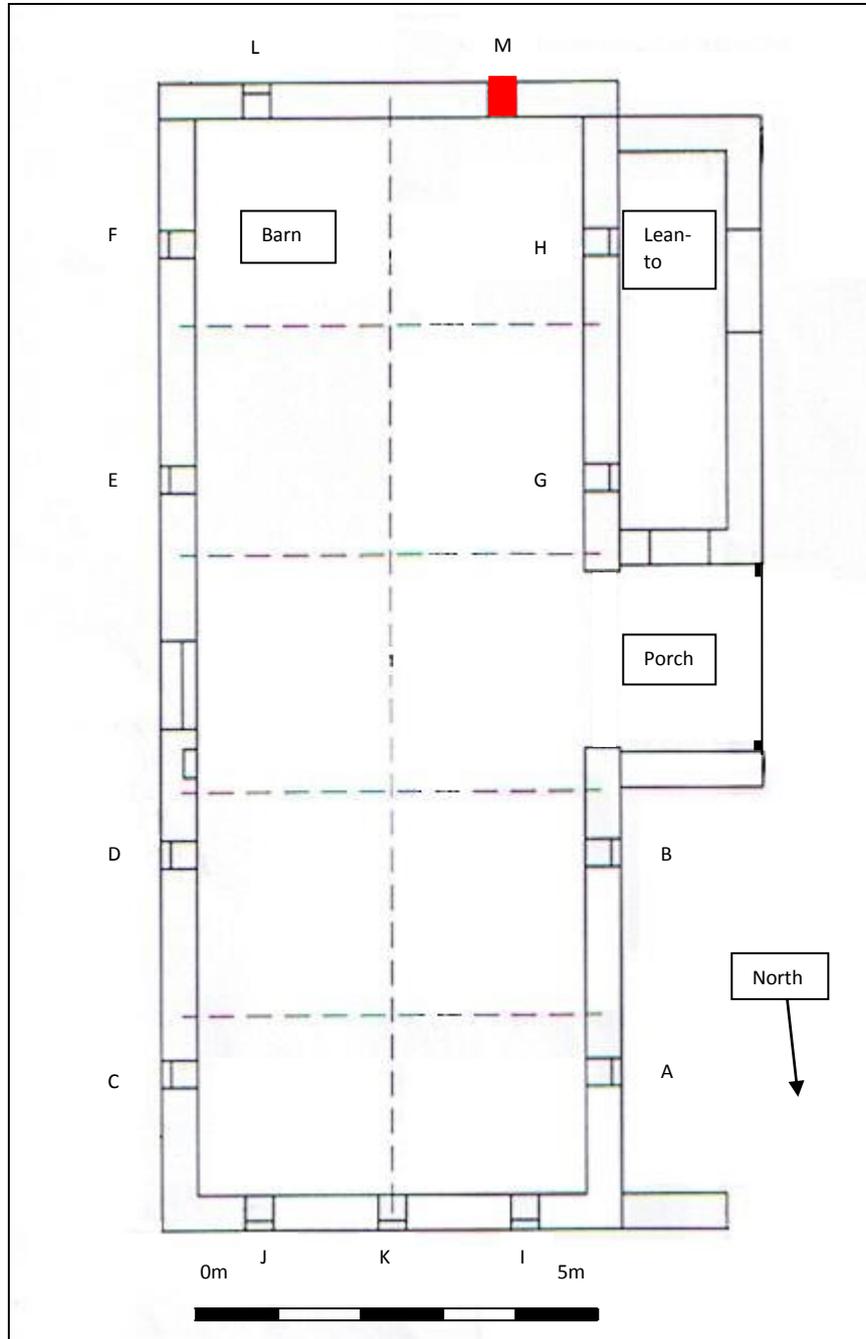
Figure 4. Ground plan of the barn

The corpus of the following report is formed from these notes and photographs. The following report describes each room within the study building (figure 4).

- On the eastern elevation were four extant air vents (C-F) measuring approximately 0.20m x 0.50m (figure 13).
- The southern gable had a single air vent (L) measuring approximately 0.20m x 0.50m, the presumed remaining air vents (M in red outline figure 4) were probably blocked (figure 9).

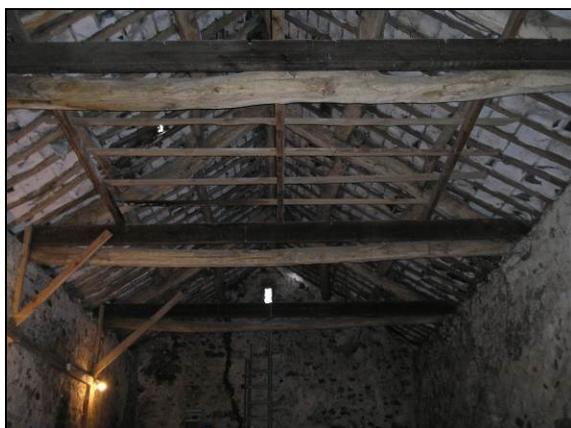
Figure 5. Roof trusses

The apex of the roof stands at a height of 5.79m with the walls standing to a height of 4.77m. The slate roof is supported by four roof trusses forming an A-frame from possible re-used timbers. The roof slats appeared to have been plastered (figure 5).

The carpentry appears to have been jointed with no evidence of iron nails or wooden pegs. However, numerous repairs have been undertaken in order to strengthen and maintain the building fabric.

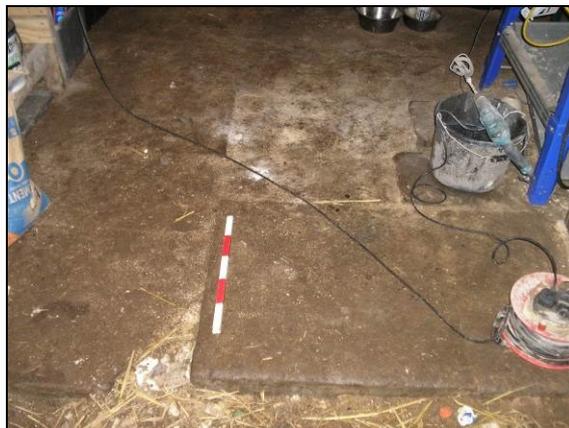
Figure 6. Flagstone floor

The floor comprised square stone flags measuring 0.75m x 0.75m and 0.07m in thickness (figure 6).

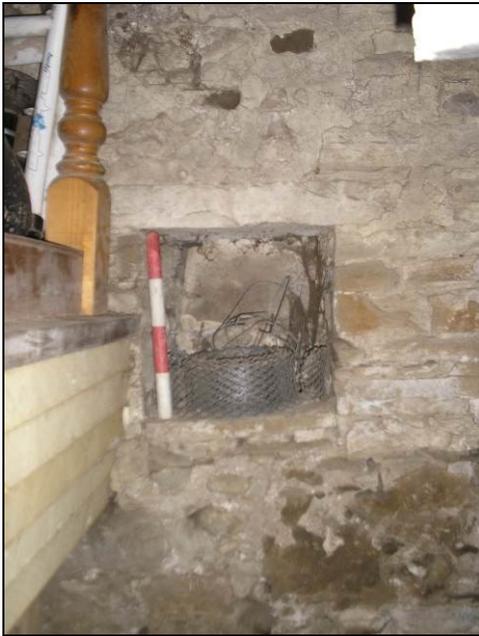
Figure 7. Niche, east elevation

- A niche on the eastern elevation 0.40m north of the eastern door, 1.30m above the ground and measuring 0.40m x 0.40m with a depth of 0.30m (figure 7).

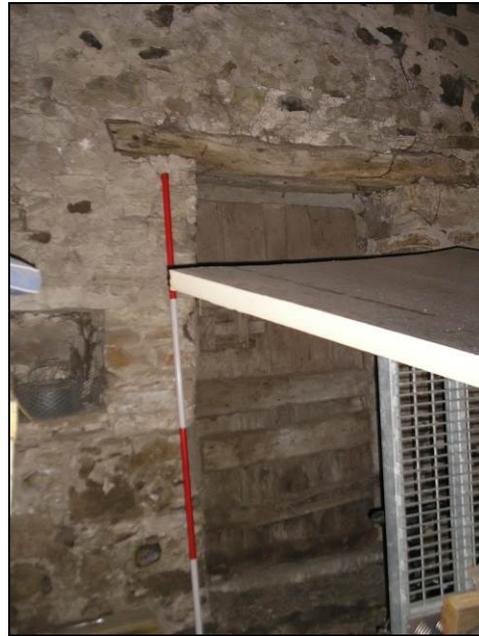
Figure 8. Wooden door, east elevation

- A timber planked door measuring 1.88m x 1.06m was located on the eastern elevation (figure 8) that probably assisted the draught for winnowing whilst threshing grain.

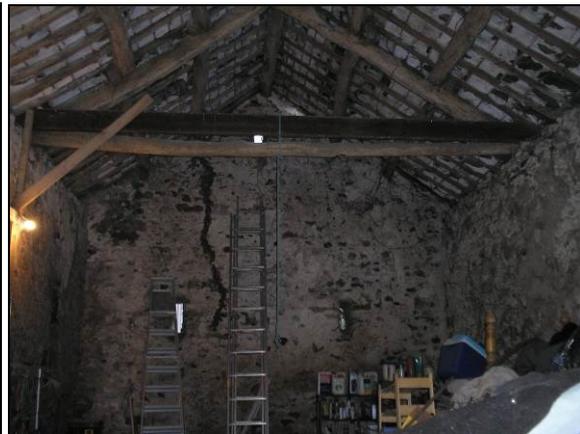
Figure 10. Interior showing northern gable end

- On the northern gable end, three air vents (I-K) measuring approximately 0.20m x 0.50m were still extant (figure 10).
- A blocked door at the south end of the western wall. An arch rose to a height of 2.30m comprising of rough hewn voussoirs. The doorway was filled by rough hewn stone with a timber lintel 0.08m in thickness introduced at a height of 2.00m. Further examination was impeded by immovable obstructions (figure 12).

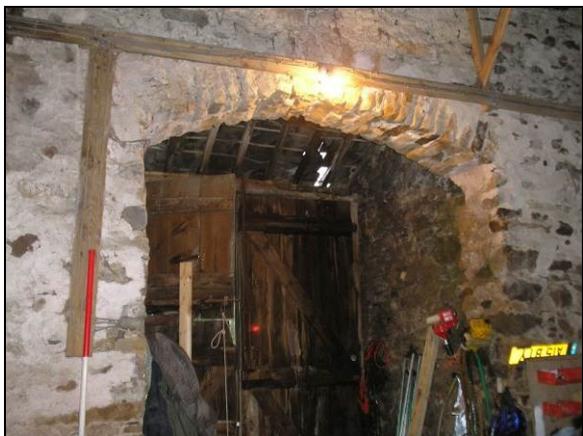
Figure 11. Western entrance

- On the west side, was the main entrance comprising a 3.30m high arch formed from coarse, rough hewn voussoirs and measuring 2.25m in width (figure 11), allowing carts to enter and providing a sufficient draught to assist winnowing whilst threshing.

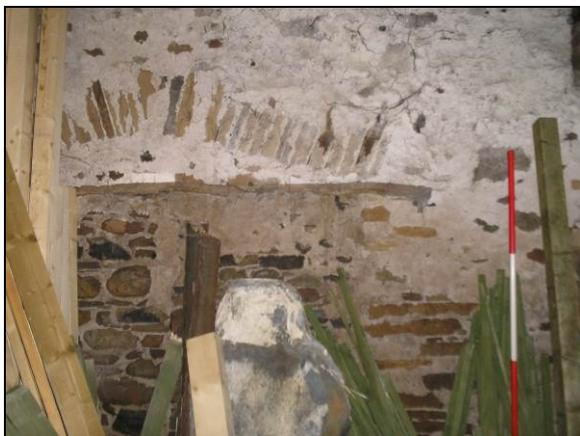
Figure 12. Blocked doorway, western elevation

A southern doorway (figure 12) was blocked and a lean-to added, measuring 1.70m in width and 6.00m in length. The additional structure was constructed from rough hewn stone forming randomly coursed, rubble stone walls. Brick repairs were later introduced above the lean-to door (figures 15 and 18).

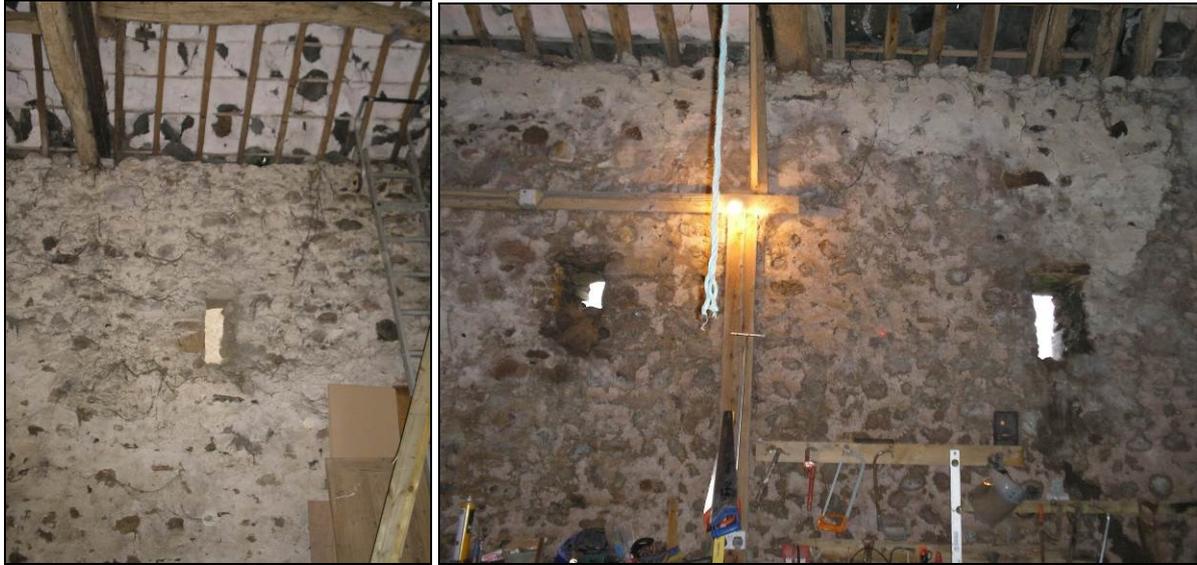
Figure 13. Air vent, east elevation Figure 14. Set of northern air vents on western elevation

- On the western elevation were four original air vents (A-D) measuring approximately 0.20m x 0.50m. The three air vents have been retained whilst the southernmost vent following the construction of the lean-to was blocked (figure 14).

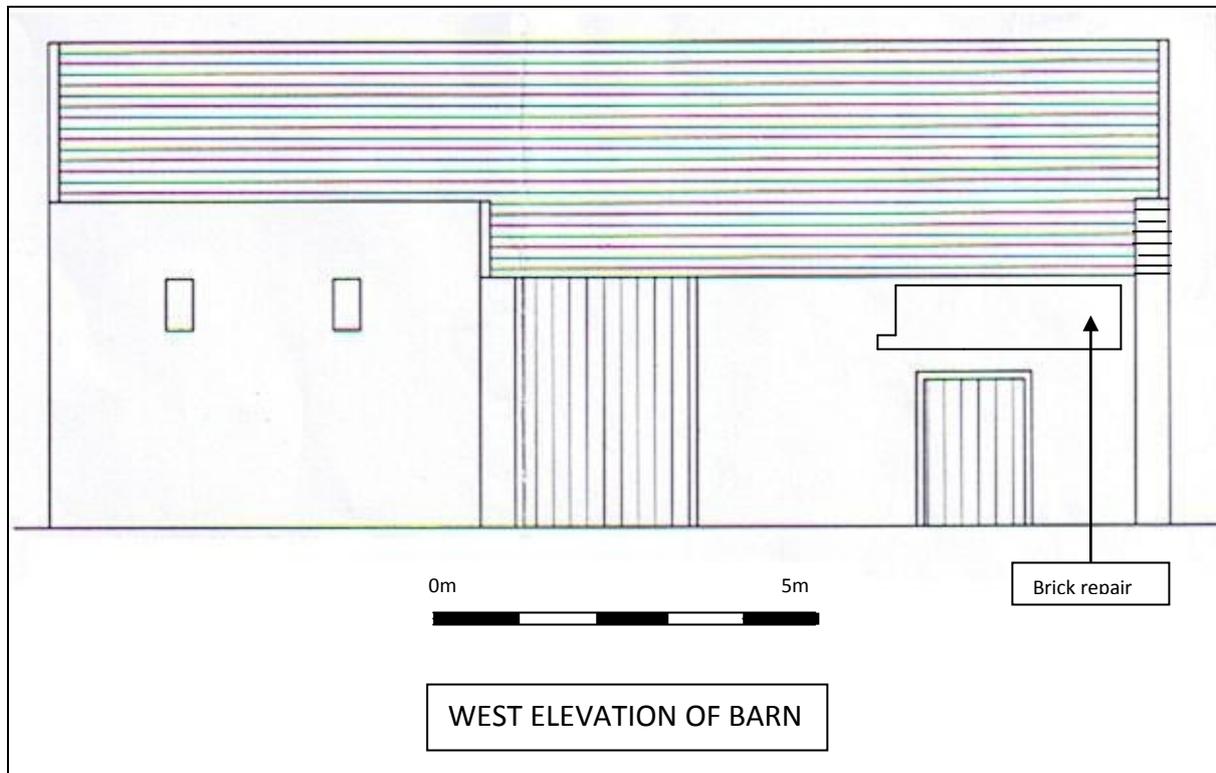
Figure 15. West elevation of the barn

The western elevation illustrated two air vents (A-B), measured 14.70m in length and stood to a height of 6.40m and illustrated a structural development (figure 15) described below.

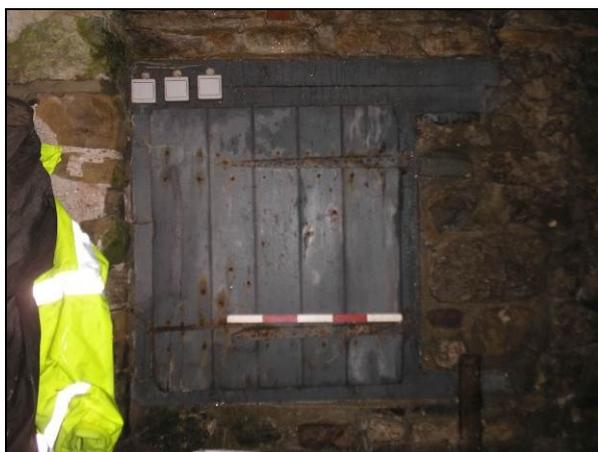
Figure 16. Hatch leading to the lean-to

The lean-to was accessed by a hatch door from the southern part of the barn (figure 16).

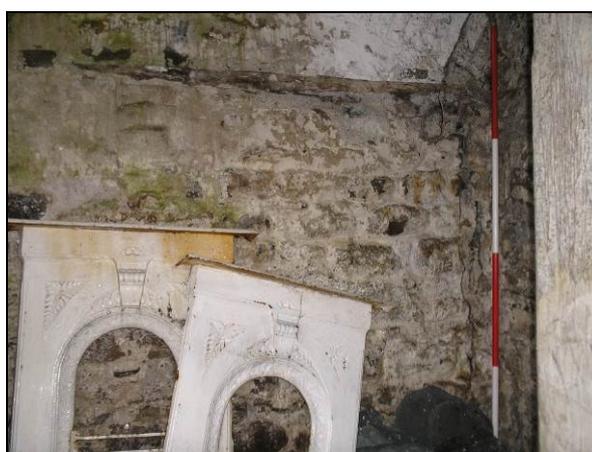
Figure 17. Internal view of the lean-to

The interior of the lean-to was whitewashed (figure 17) and had been used as a stable or cowshed as a former trough was present.

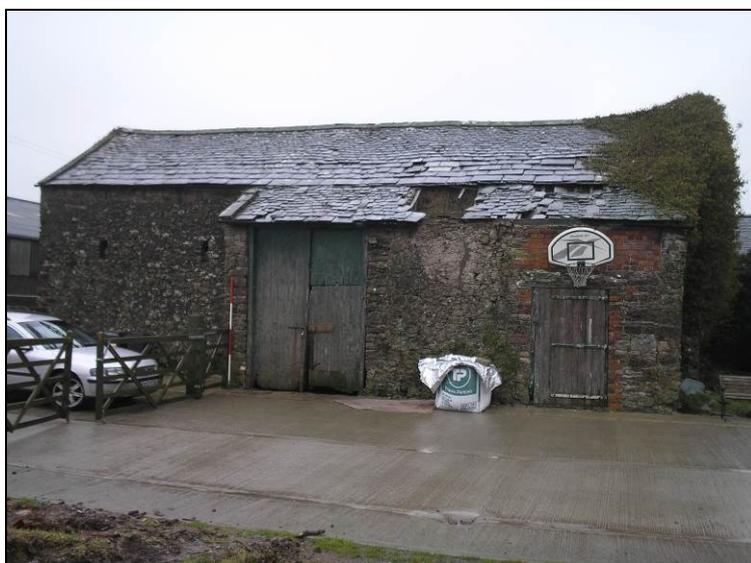
Figure 18. West elevation with lean-to and porch

Beneath a decayed timber lintel, a single timber planked door (figure 18) measuring 2.20m x 1.30m entered the lean-to from the west.

The roof for both the lean-to and porch were clad in slate whilst the roof above the lean-to was in a state of collapse.

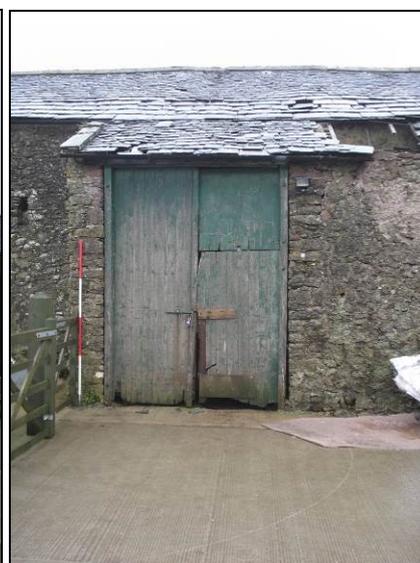
Figure 19. Porch door

A porch with a timber planked door measuring 3.30m x 2.40m adjoined the lean-to (figure 19). This was aligned with the lean-to, forming a straight face.

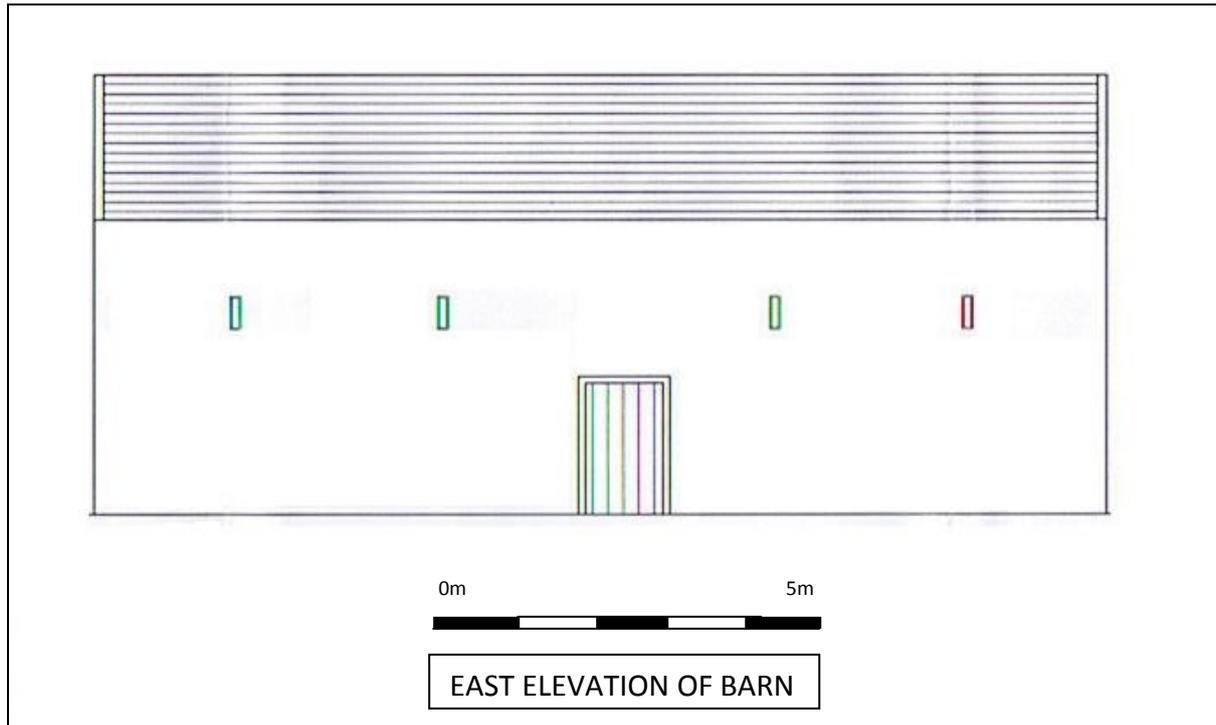
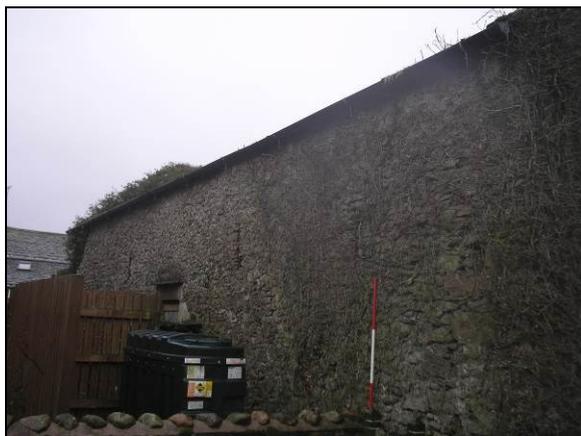
Figure 20. Eastern elevation of barn

The eastern elevation also measured 14.60m in length and stood 6.40m in height. It illustrated four extant air vents (C-F) with a central back door (figures 20 and 21) and had been left in its original rough hewn state.

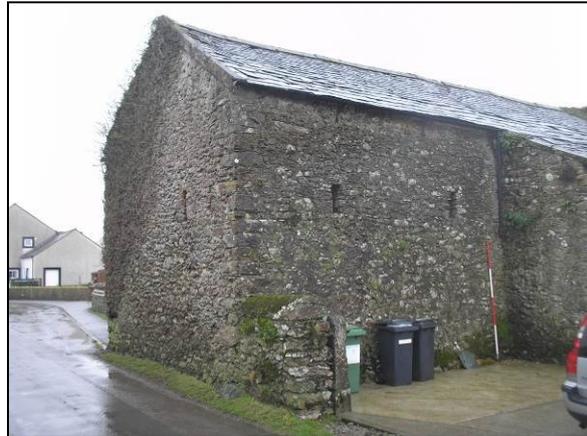
Figure 22. Exterior view of northern elevation

The northern elevation measuring 7.60m in length and 6.40m in height had also been left in a rough hewn finish (figure 22) and displayed three rectangular air vents (I-K, figures 23 and 25.)

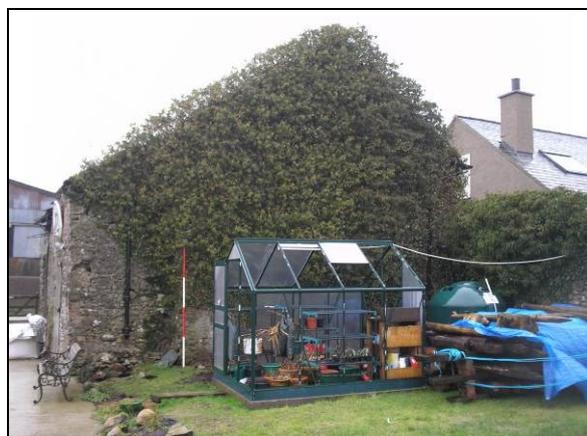
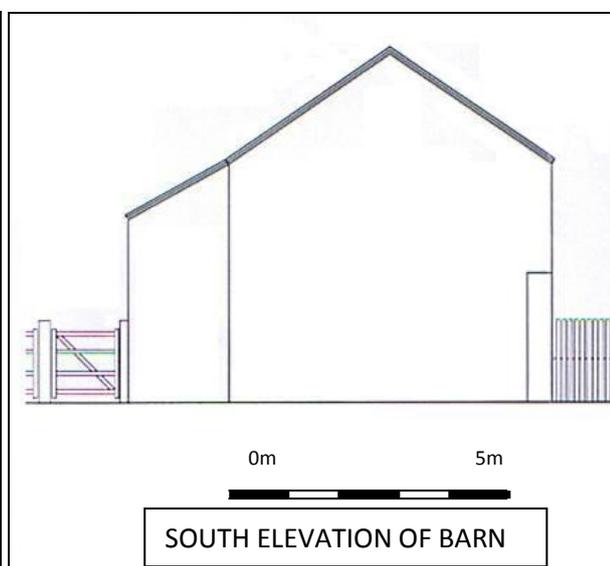
Figure 24. Exterior view of southern gable end

The southern gable end measuring 7.60m in length and 6.40m in height (figure 24) was heavily obscured by ivy but was clearly finished in rough hewn stone. The air vents (L-M) were not visible (figure 26).
