## SUMMARY

*Level II Building Survey Gelt House Farm, Hayton, Carlisle*

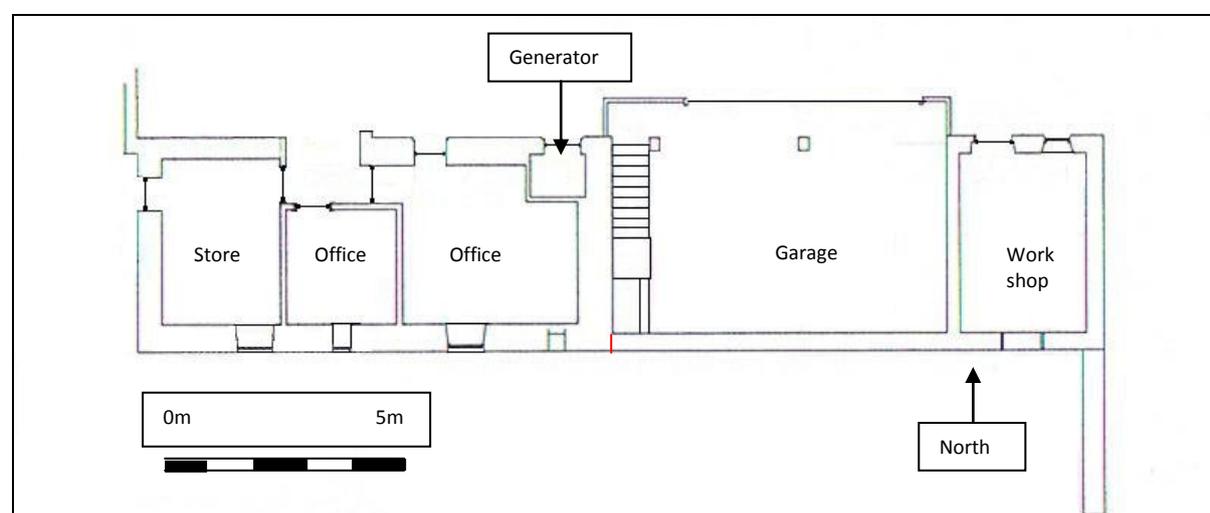
Figure 4. Ground floor plan of the study buildings

The study buildings comprised of two elements (figure 4); a barn that had been sub-divided into a store, two offices and a generator room and a workshop that had become a garage and a workshop.

The two storey study building is aligned east-west with a later two room extension to the east with both elements sharing a recent slate roof. It measured 23.00m in length and 5.00m in width.

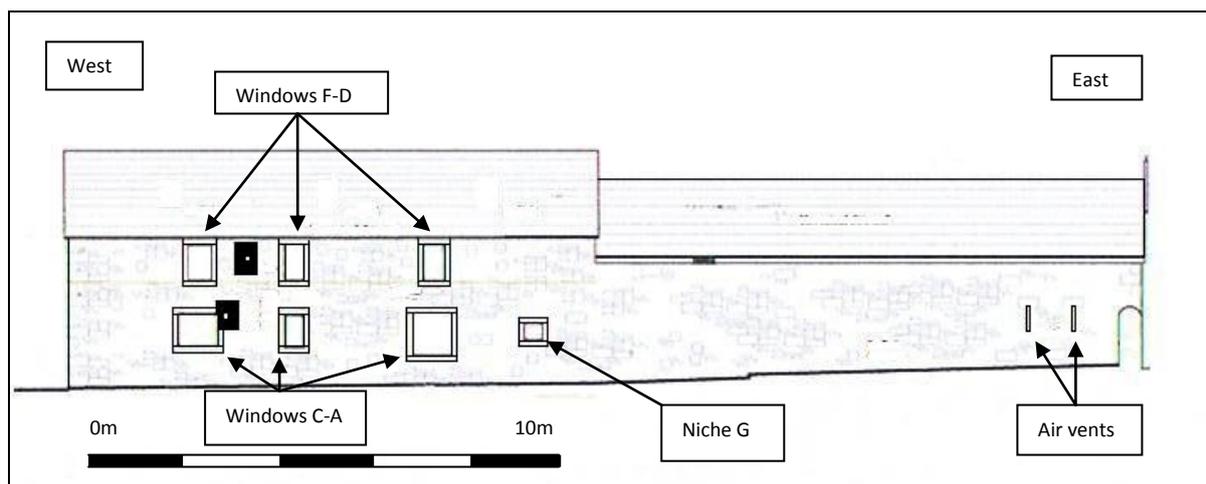
Figure 5. Southern elevation of both barn and workshop

The southern elevation illustrated both the barn and the workshop.

The roof to the barn was 0.50m higher than the workshop roof.

The walls comprised randomly coursed sandstone rubble-stone with the later workshop keyed into the earlier barn and measured 0.50m in thickness.

- Two steel reinforcing plates were inserted beside windows C and F in order to brace the barn (figures 5 and 8).

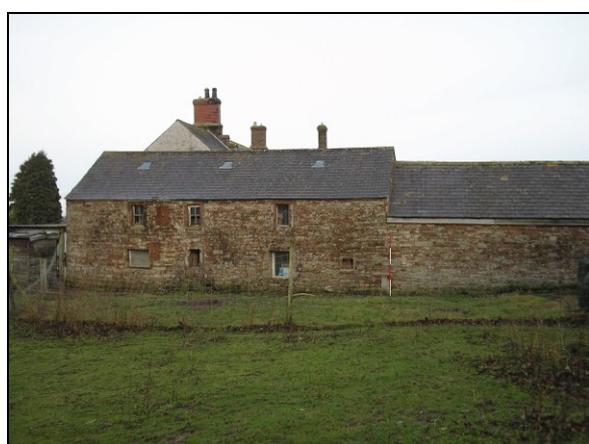
Figure 6. South elevation of barn

The details illustrated in the southern elevation (figure 5 and 6) are as follows:

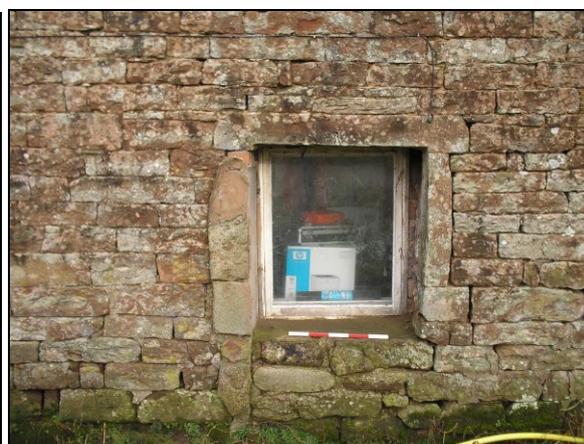
Figure 7. Window A converted from a door

- Window A measuring 0.75m x 0.90m was a probable former doorway the western sandstone jamb extending to the floor (figure 7). The window possessed a rough hewn sandstone lintel, the original window frame having been removed. The former door would have measured 1.67m x 0.98m

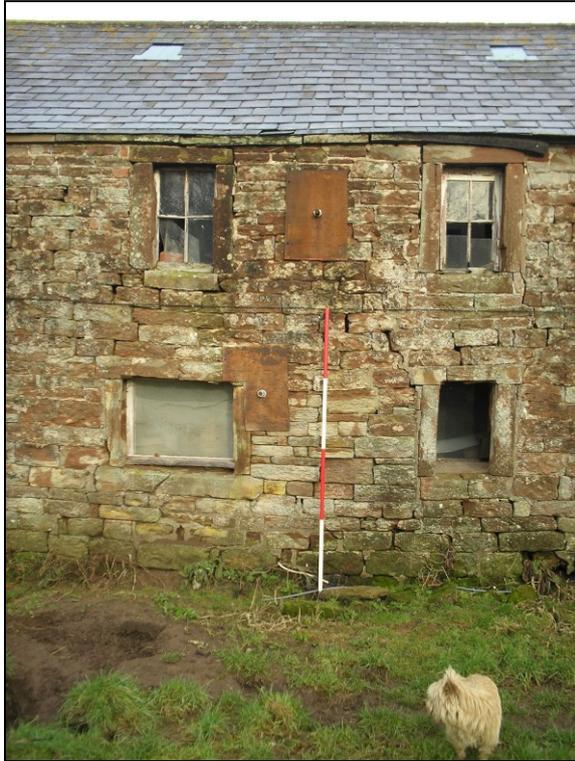
- Window B measuring 0.45m x 0.65m was a window formed from rough hewn sandstone lintel, jamb and sill (figure 8). It is currently unglazed, the frame having been removed.

- Window C measuring 0.68m x 0.82m was a window formed from rough hewn sandstone lintel, jamb and sill (figure 8). It is currently unglazed, the original frame having been removed.

- Window E measuring 0.45m x 0.73m was a window formed from rough hewn sandstone lintel, jamb and sill (figure 8). The wooden frame was still extant containing four lights.

- Window F measuring 0.45m x 0.73m was a window formed from rough hewn sandstone lintel, jamb and sill (figure 8). The wooden frame was still extant containing four lights.

Figure 8. Windows (right to left) B, C, E and F

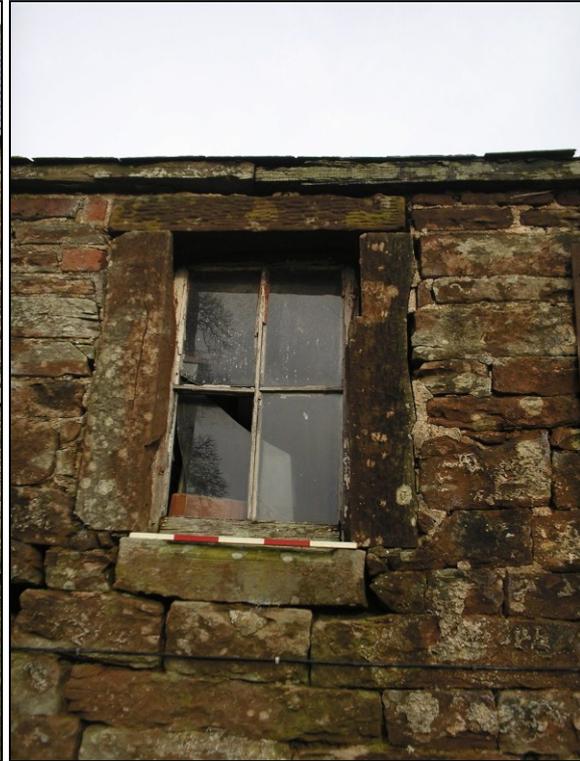
- Window D measuring 0.41m x 0.69m was a window formed from rough hewn sandstone lintel, jamb and sill (figure 9). The wooden frame was still extant containing four lights.

Figure 9. Window D

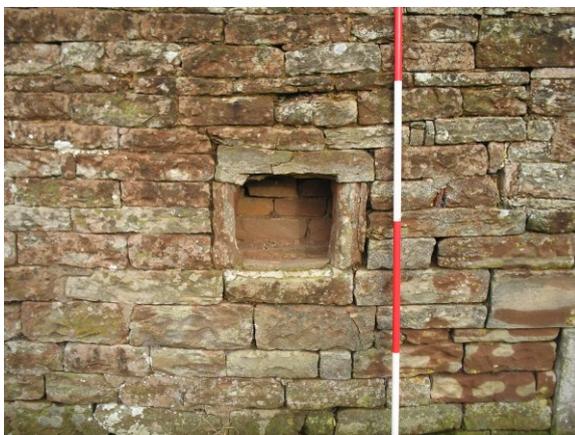
- A niche was formed from rough hewn rectangular sandstone blocks forming a former window subsequently blocked inside by brickwork (figure 10)
- Two air vents measuring 0.50m x 0.10m were built into the south elevation of the workshop that have been blocked from the inside (figure 11).

Figure 10. Niche, now a blocked window

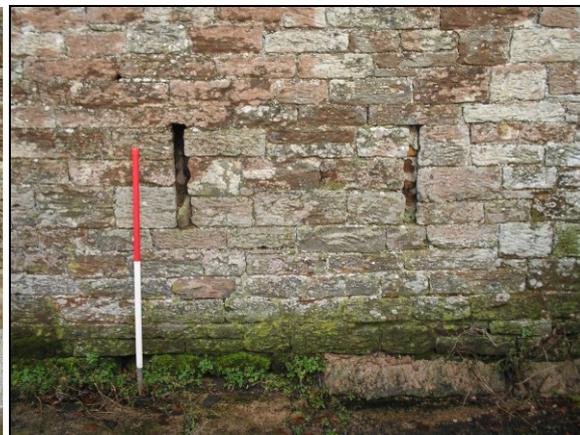
Figure 11. Air vents within the workshop

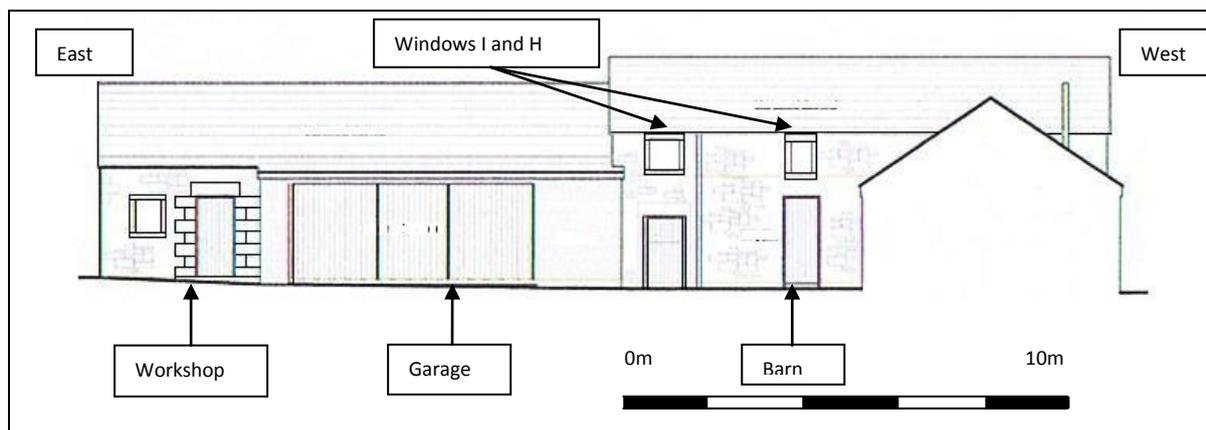
Figure 12. North elevation

The northern elevation illustrated both the barn and the workshop (figure 12).

The earlier walls for the workshop and barn comprised randomly coursed sandstone rubble-stone with the later workshop keyed into the earlier barn by brickwork.

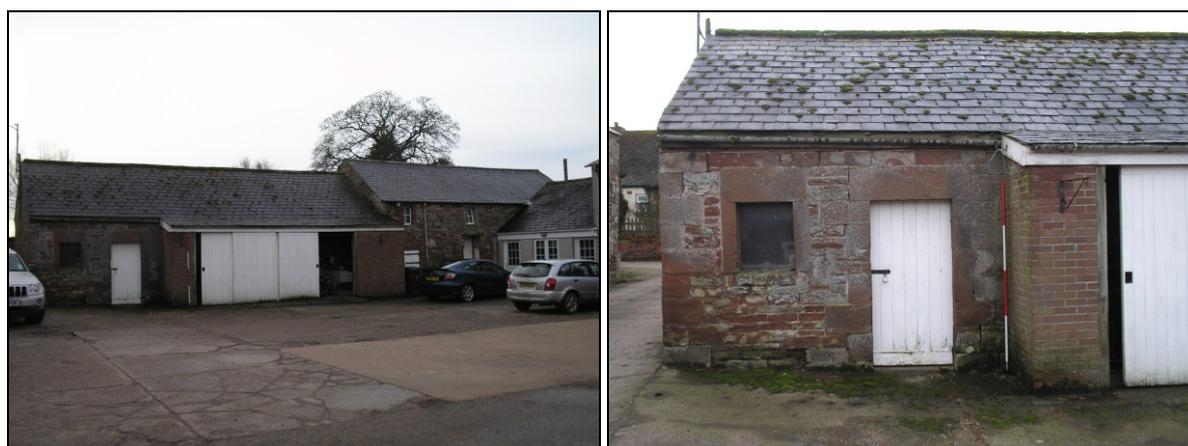
The workshop had been rebuilt when converted to a garage, the northern workshop being extended 0.70m northwards with the erection of a recent brick porch. Wooden sliding doors occupied the majority of the elevation (figure 13).

- A window made from machine-cut red sandstone forming measuring 0.60m x 0.76m formed from rough hewn sandstone lintel, jamb and sill (figure 14). The wooden window frame had been removed.
- A red sandstone door jamb complete with lintel measuring 0.88m x 1.80m (figure 14). The wooden tongue and groove door was probably not original.

Figure 13. North elevation of workshop and barn Figure 14. Window and door to workshop

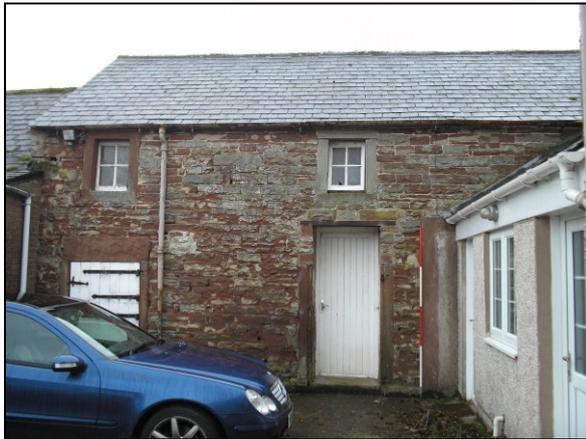
- Window H measuring 0.48m x 0.68m was an attic window formed from rough hewn sandstone lintel, jamb and sill (figure 9). The wooden frame was still extant containing four lights (figure 15).
- Window I measuring 0.56m x 0.83m was an attic window formed from rough hewn sandstone lintel, jamb and sill (figure 8). The wooden frame was still extant containing four lights (figure 15).
- The eastern door measured 0.75m x 1.50m and possessed a large red sandstone block for a lintel with a thin sandstone jamb. The wooden tongue and groove barn door possessed four iron hinges and latch (figure 15).
- The western door measured 2.00m in height and 0.80m in width and comprised of crude jambs and lintel probably a later addition introduced when the adjacent eastern door became the only ingress to the generator room (figure 15).

Figure 15. Elevation showing windows H and I

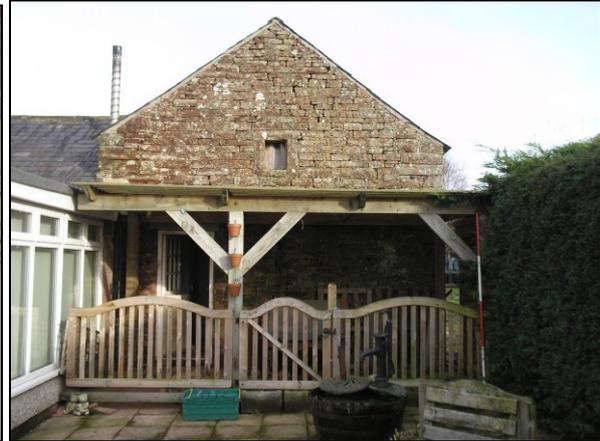
Figure 16. West elevation

The western elevation showing the barn was obscured by a wooden canopy (figure 16) but illustrated randomly coursed sandstone rubble-stone walls.

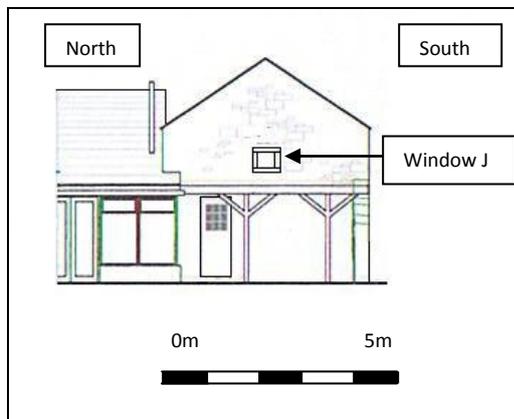
Figure 17. Detail of west elevation

An attic window (J) measured 0.60m x 0.60m and comprised of a red sandstone surround (figure 17) that was blocked with hardboard.

A ground floor door with wooden surround measured 1.80m in height and 0.75m in width, the door being a later addition (figure 17).

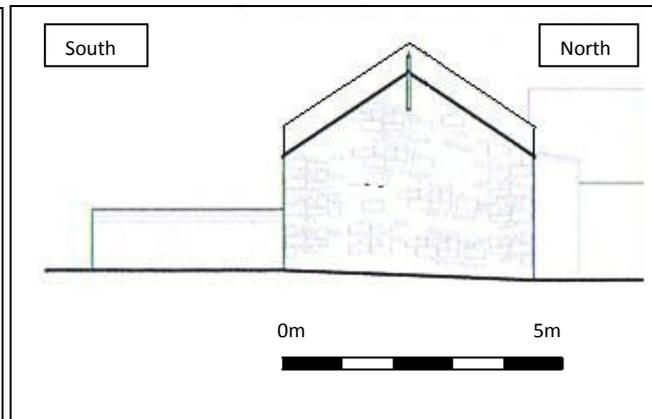
Figure 18. East elevation

Comprising of randomly coursed sandstone rubble-stone walls, the eastern elevation had been left plain (figure 18).

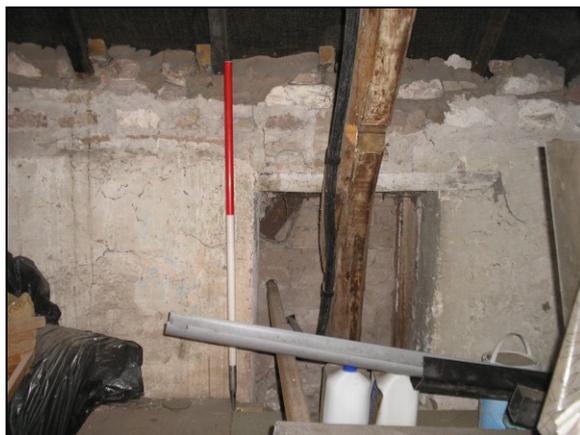
The barn was the earlier element and pre-dated the adjacent farmhouse as a window (G) measuring 0.60m x 0.80m was blocked off by the farmhouse (figure 19).

Figure 19. Blocked window G

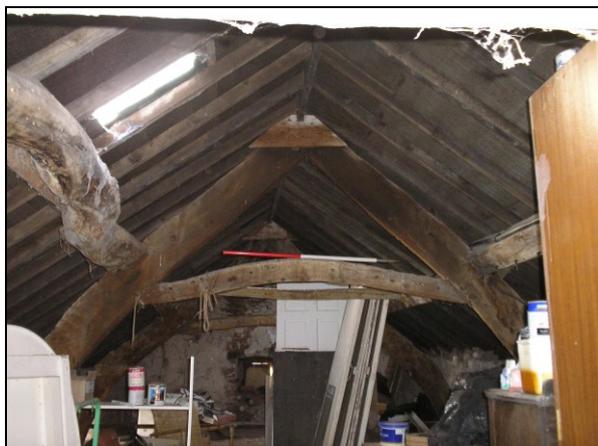
Figure 20. Eastern cruck blade within attic

The cruck blades formed A-frames (figure 20) where the two sides are made from a single piece of timber, split into two so that both sides form “mirror images” of each other. This Saxon technique was common place during the Medieval period and continued beyond that era in areas where wood was scarce and stone plentiful.

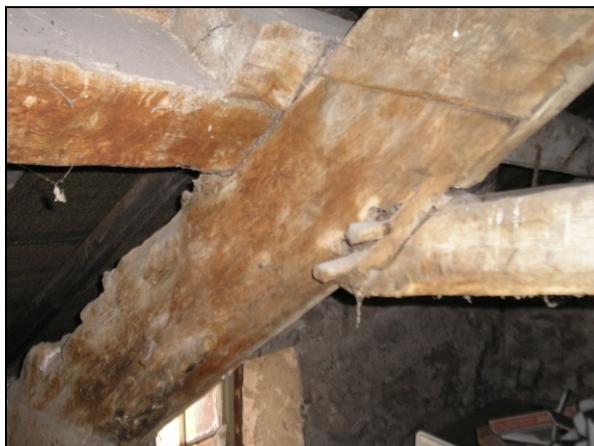
Figure 21. Detail of carpentry, eastern roof truss

The hand-made cruck blades measuring 0.25m in thickness were formed from re-used timbers (figure 23) held in place by pegs and dowels supporting a single cross-beam (figure 21). Purlins rested above the cruck blades whilst a modern roof frame had been nailed to these beams.

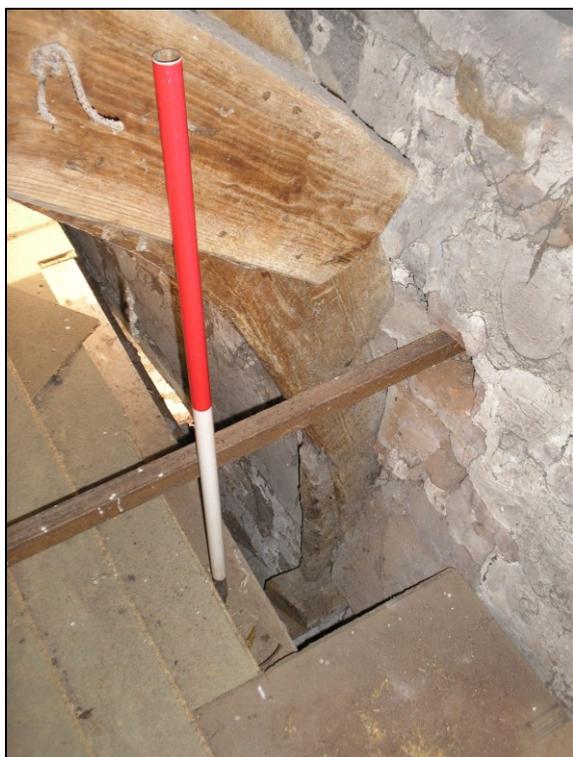
Figure 22. Northern rib of Eastern cruck blade

The eastern cruck blades (figures 22 and 23) both demonstrated that they reached to the floor and did not rest upon the shell of the building perhaps suggestive of an earlier precursor.

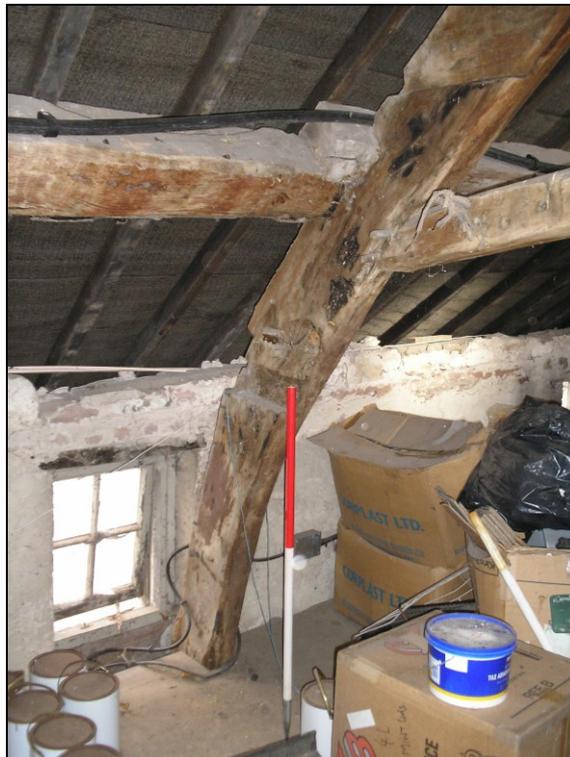
Figure 23. Southern rib of Eastern cruck blade

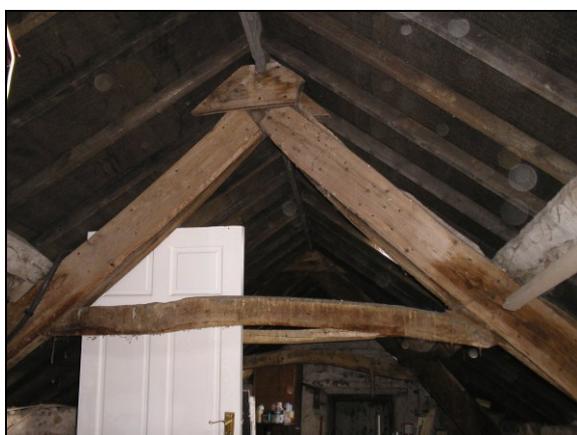
The western cruck blades had been heavily restored with modern timber replacing the upper part of the blade (figure 24)

However, there was no evidence for clay dabbins and these cruck blades and purlins are probably the result of opportune re-cycling from an earlier source and then installed when the barn was built.

Figure 24. Western cruck blades

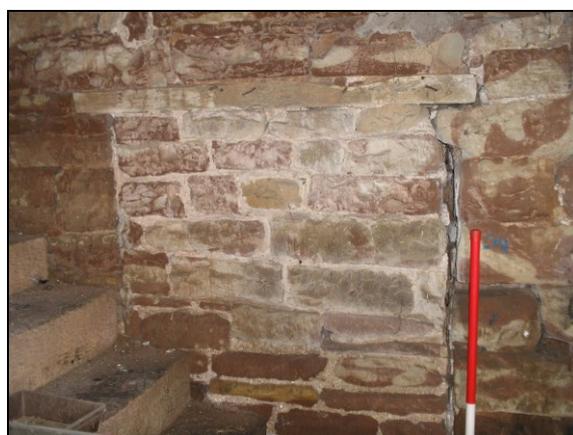
Figure 25. Blocked doorway within the garage

The attic floor for the barn was accessed from the garage via a flight of seven sandstone steps (figure 28) that blocked an earlier doorway measuring 1.40m x 1.00m (figure 25) which remained unseen within the eastern office of the barn. The steps led to a timber planked door that entered the attic (figure 27).

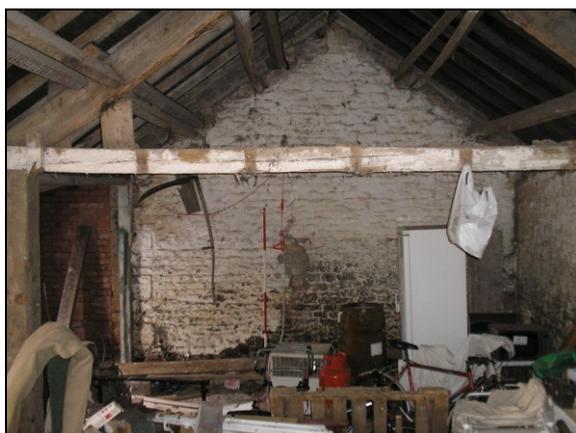
Figure 26. Eastern wall within garage

The garage walls on the eastern (figure 26) and southern elevation have been whitewashed obscuring any delicate architectural features.

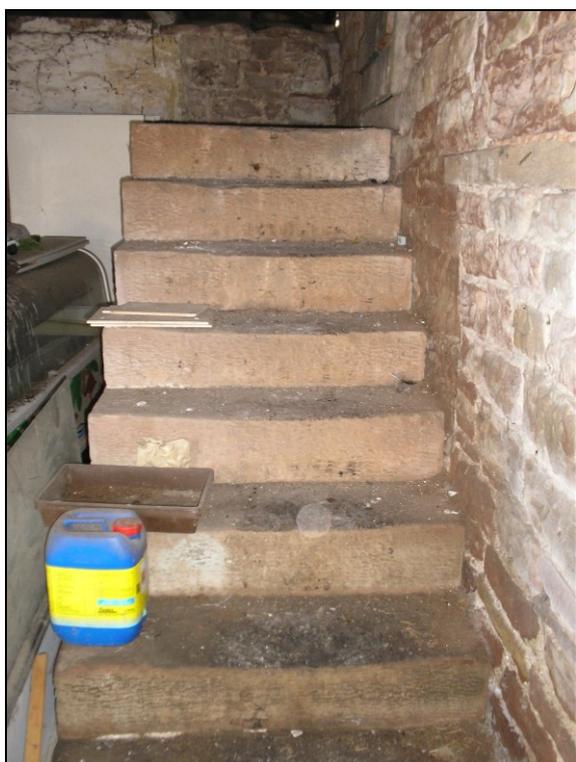
Figure 28. Steps leading to the barn attic

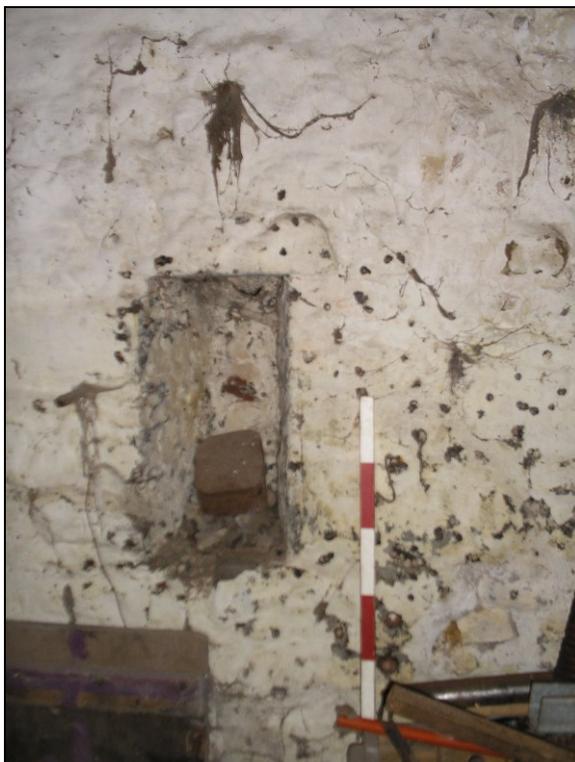
Figure 29. Blocked air vent in the workshop

The workshop was whitewashed throughout (figures 30 and 31) obscuring any delicate architectural features. However, a blocked air vent (figure 29) measuring 0.46m x 0.23m and 0.26m in depth and a possible protruding beam, beam support or stone “through” (figure 31) measuring 0.18m x 0.10m and 0.07m in thickness were observed on the western elevation.

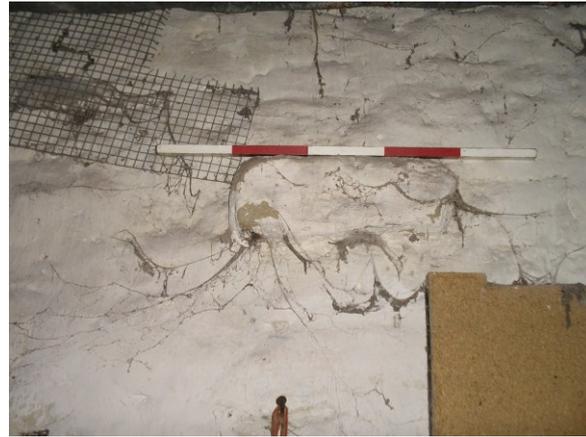
Figure 31. Protruding beam or “through”
