Post-dating Glencoe the cottage next door, the study building was a utilitarian barn, of little architectural pretension that probably dates from the mid 19th Century. A number of functional structural changes had occurred that made minor amendments to the buildings fabric.

Cumbria County Council's Historic Environment Service (CCCHES) was consulted by Allerdale Borough Council regarding a planning application for the conversion of a barn for domestic use at Glencoe, Torpenhow, (NY 1999 3964), Planning Application No. 2/10/0300.

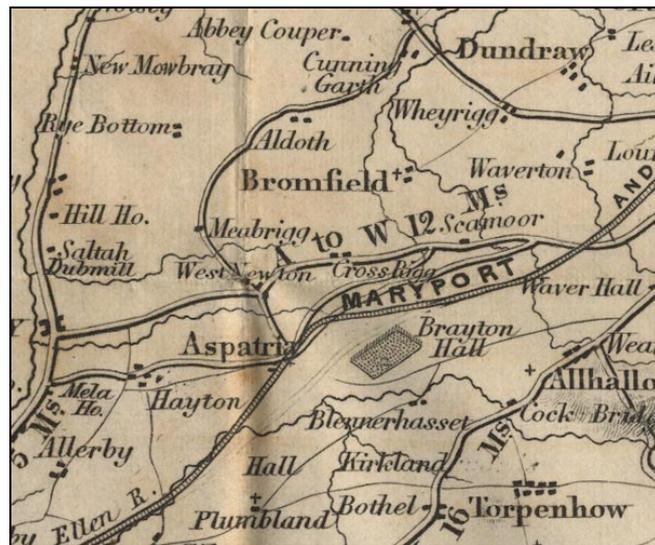
Figure 3. Ford 1839 map showing a possible building located within the study area

On the Ford 1839 map (figure 3), buildings are illustrated approximately where the study took place.

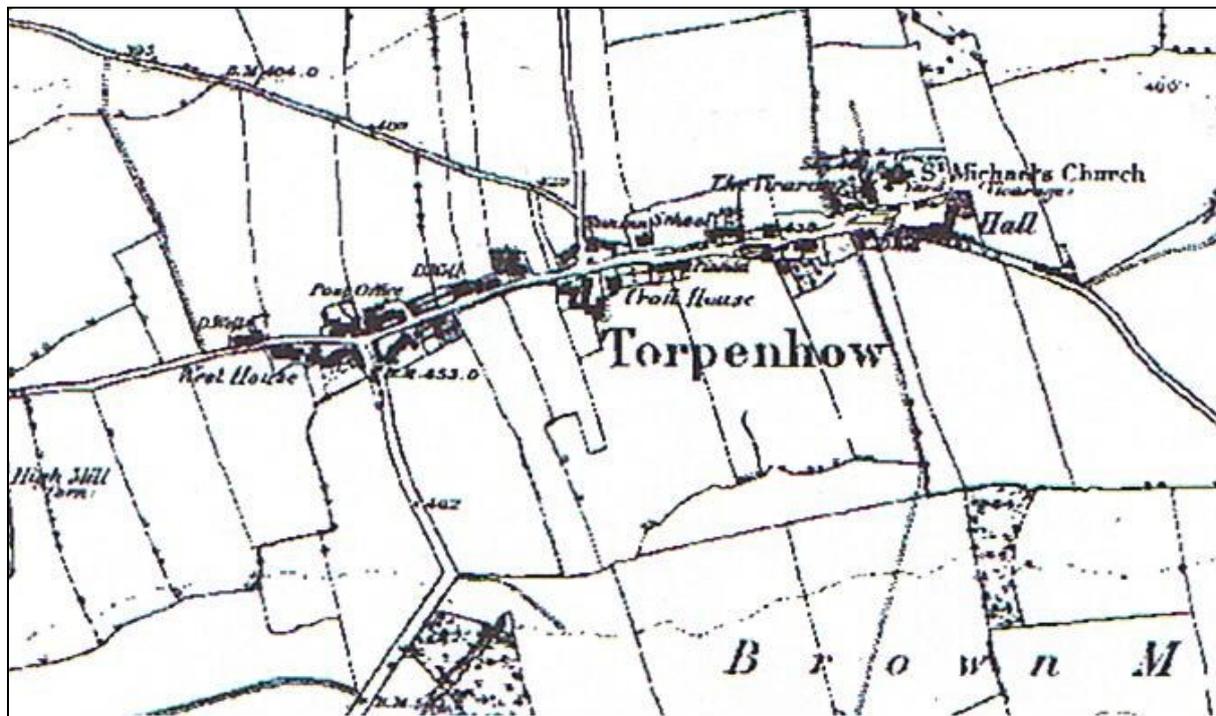
Figure 4. First Edition Ordnance Survey map 1868.

The 1868 Ordnance Survey map (figure 4), depicted the barn at Glencoe.

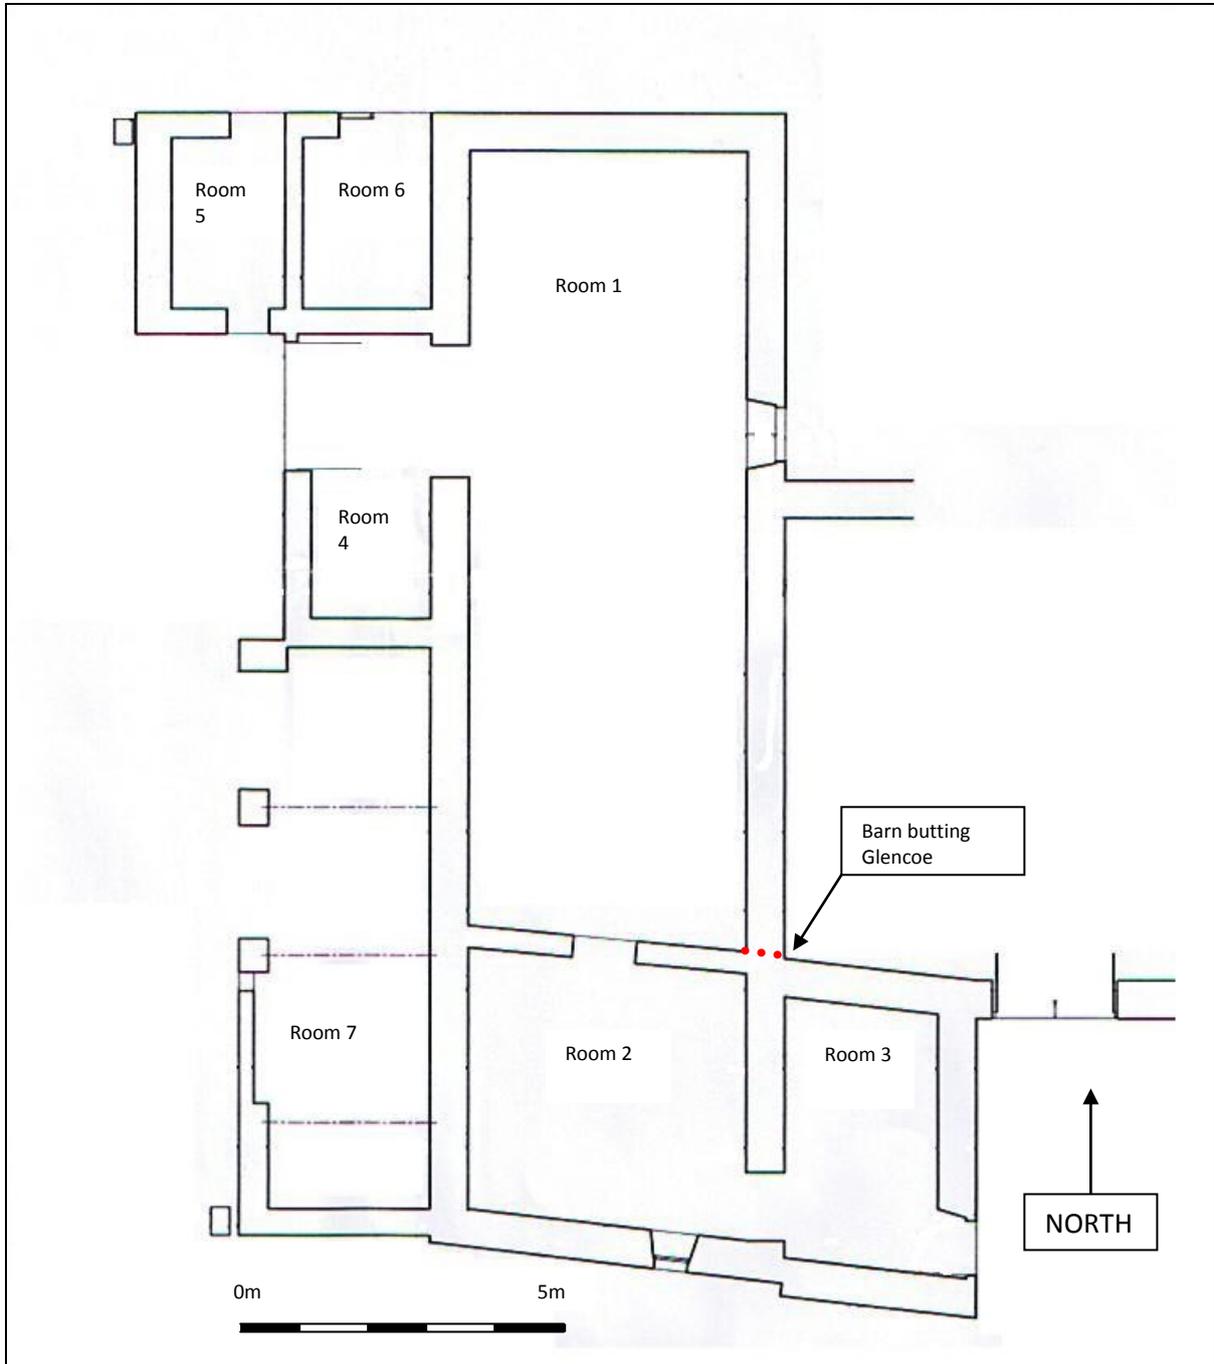
Figure 5. Plan of the study barn Glencoe, Torpenhow

The corpus of the following report is formed from these notes and photographs. The following report describes each room within the study building (figure 5).

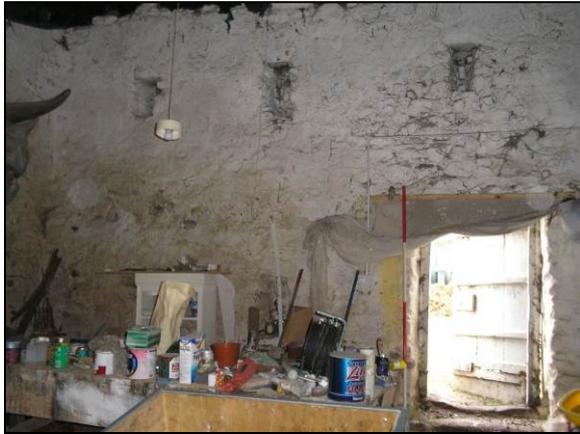
Figure 6. Eastern elevation with vents, Room 1

Four filled air vents (figure 6) of varying sizes were present on the north-eastern end of the eastern elevation approximately 3.10m above the ground.

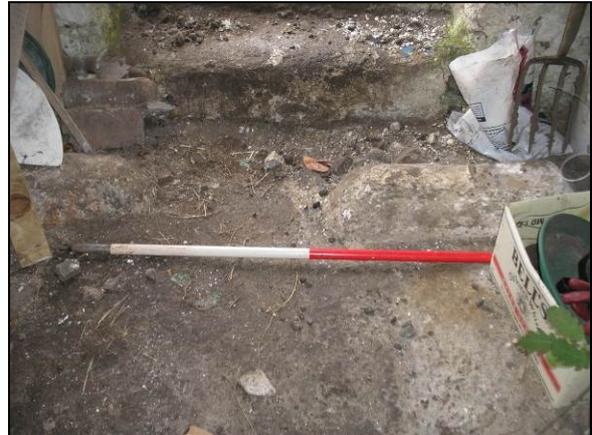
Figure 7. Stone brake near eastern door, Room 1

Beside the door were two rounded, stone plinths with flat tops measuring 0.66m x 0.26m x 0.12m in height whose function was unknown but could represent some form of brake for a cart (figure 7).

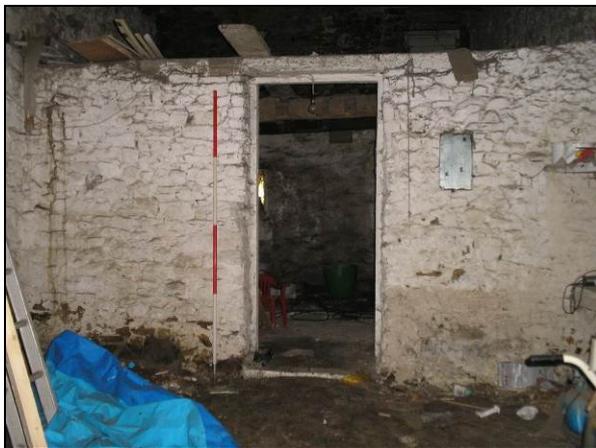
Figure 8. Southern partition, Room 1

The southern wall (figure 8) comprised a crudely coursed rubble stone wall that formed a later partition wall 4.31m in length and standing to a height of 2.20m.

A central doorway was 1.03m in width and 1.80m in height surmounted by a timber beam. The door surround was modern and machine-cut with a small step up to the threshold approach.

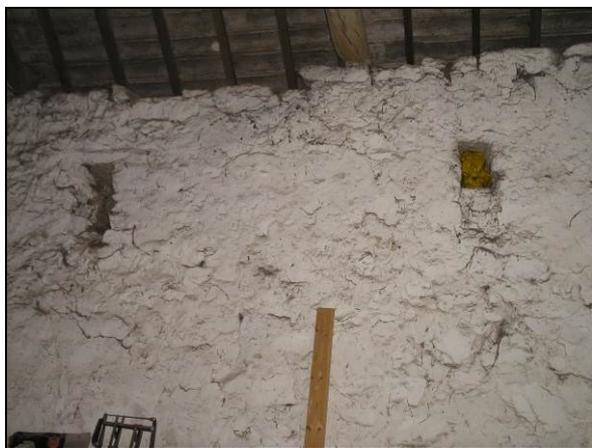
Figure 9. Western elevation, Room 1

The western elevation (figure 9), a crudely coursed stone rubble wall, possessed three filled air vents south of the original doorway and one air vent to the north. The air vents were not evenly spaced and were approximately 0.20m x 0.50m in size and approximately 2.70m above the ground.

The original doorway was 2.10m in width and 3.80m in height, built from small, sandstone blocks and comprised three hand-made but re-used timber lintels.

A timber joist from an outshut, was visible to the north of the doorway.

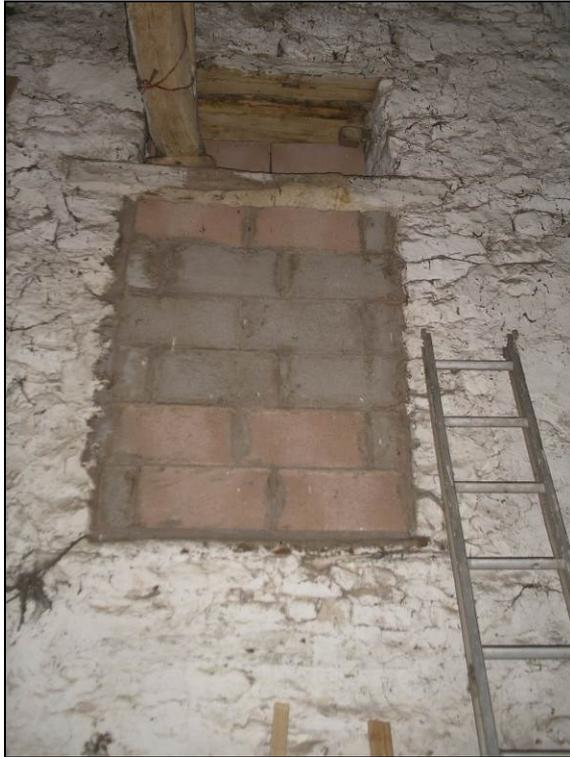
Figure 10. Filled window, Room 1

A rectangular window filled by breeze blocks (figure 10) and measuring 1.06m x 1.38m was present in the gable end of the cottage. It possessed a badly decayed timber sill and a wooden lintel above which was a rectangular recess measuring 0.50m x 1.10m that accommodated a timber roof truss.

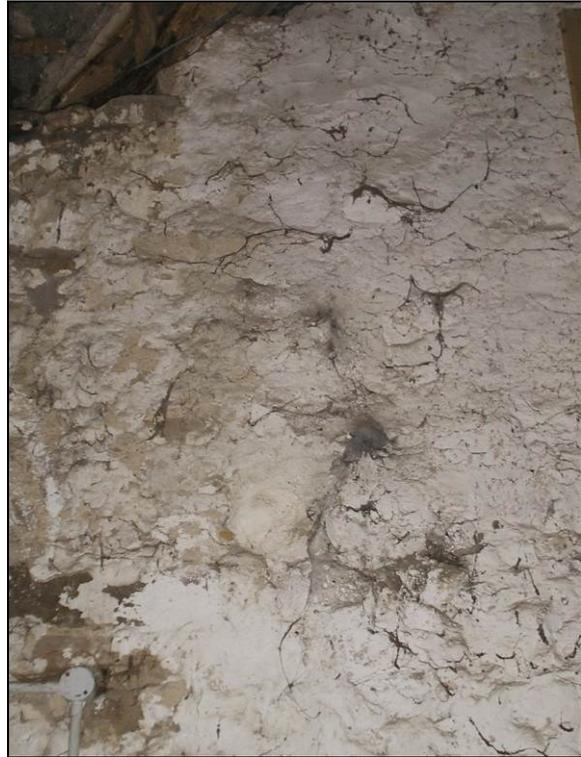
Figure 11. Outline of eastern gable from cottage

The barn fabric butted the western gable end of the cottage denoting that the barn was a later adjunct (figure 11).

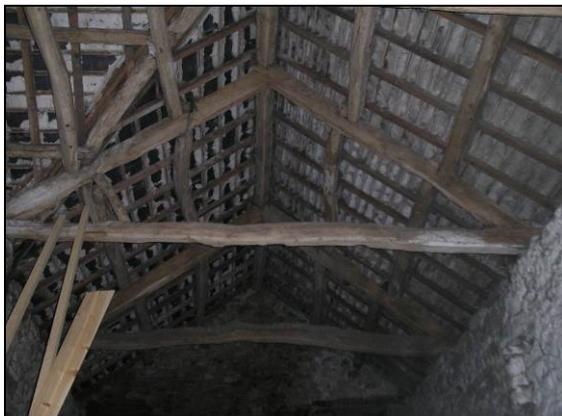
Figure 12. Roof trusses within the barn

The roof consisted of re-used timber roof trusses, supporting wooden purlins that maintained a slate roof (figure 12). A single skylight was located in the roof at the centre of the barn.

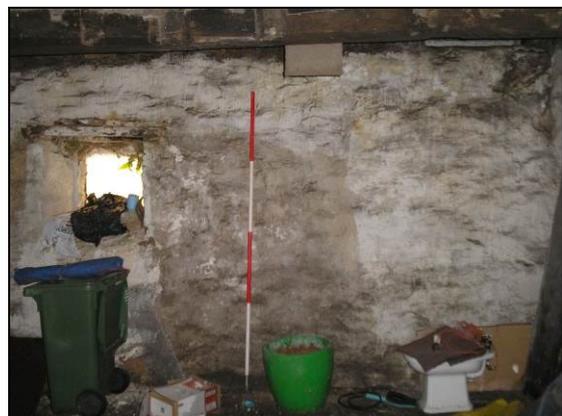
Figure 13. South elevation of Room 2

The southern elevation (figure 13) illustrated a rectangular window 0.82m from the doorway and 1.12m above the ground that measured 0.78m x 0.68m. This window narrowed to a smaller aperture on the outside wall (0.60m x 0.48m).

On the upper level, 2.20m above the ground was a modern timber, tongue-and-groove door measuring 1.80m x 1.00m beneath a timber lintel.

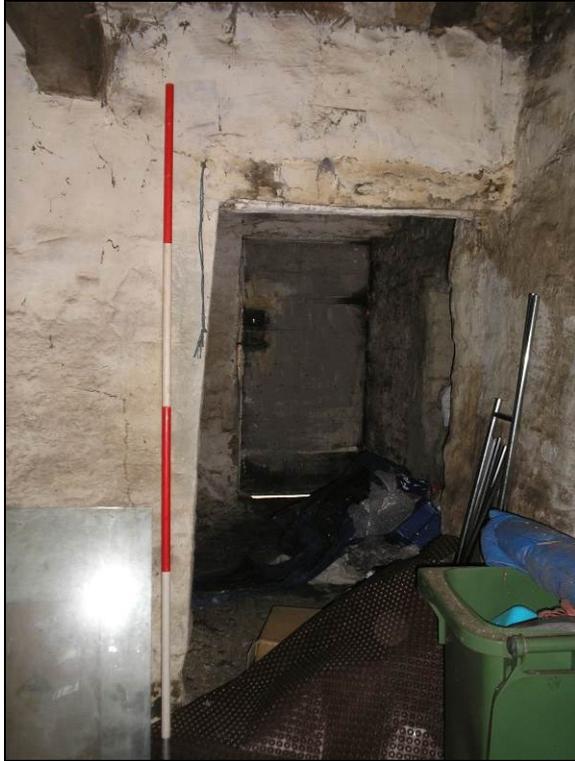
Figure 14. Doorway, Room 2

The eastern elevation maintained a doorway (figure 14) without a surround measuring 1.82m x 1.10m.

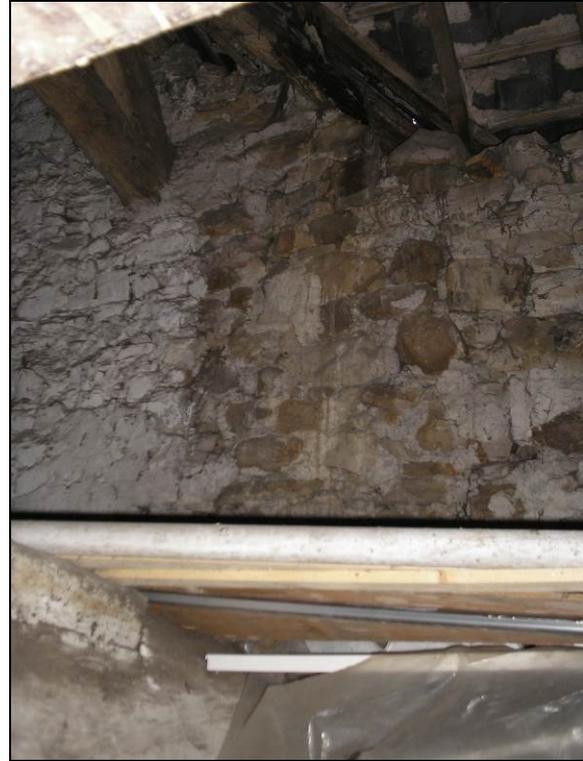
Figure 15. Conjunction of gable and Room 2

The southern part of the wall within Room 2 was observed to conjoin the original stonework for the cottage (figure 15).

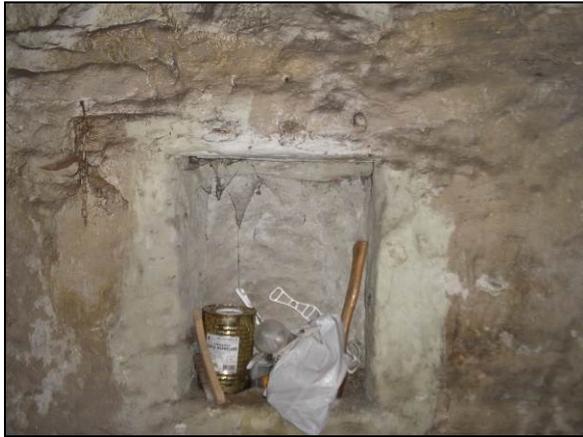
Figure 16. Blocked window, Room 3

The southern elevation possessed a filled window (figure 16) measuring 0.61m x 0.70m surmounted by a timber lintel.

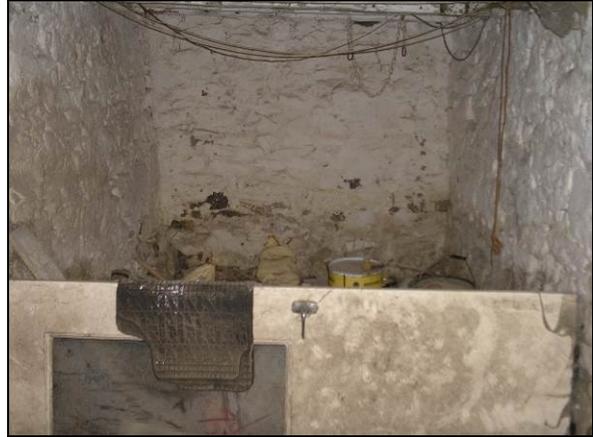
Figure 17. Interior of Room 4

The internal area for Room 4 (figure 17) measured 4.57m x 1.90m and yielded a concrete floor. The stone rubble walls of the room formed a porch to the barn.

On the south side of the room, a small modern mezzanine floor 1.68m above the ground had been added recently.

The western elevation comprised a set of 20th Century timber planked double doors measuring 2.00m x 2.50m.

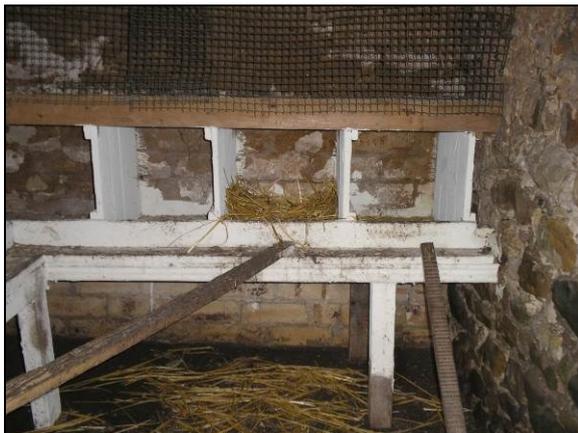
Figure 18. Interior of Room 5

Room 5 (2.70m x 1.80m) comprised of an extant chicken shed (figure 18), divided by a partition wall with an attached disused toilet and a timber door (figure 19).

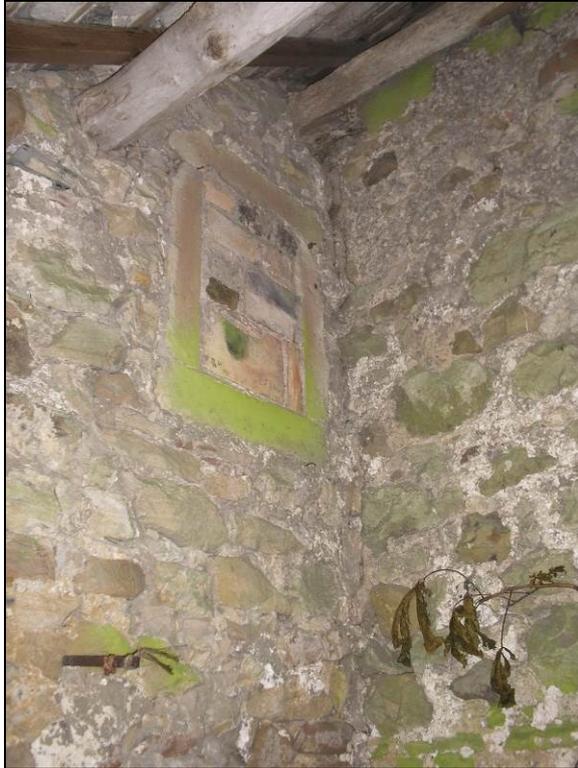
Figure 20. Filled window, Room 7

Observed on the northern elevation was a filled square window with sandstone surround (figure 20) measuring approximately 1.00m x 0.80m.

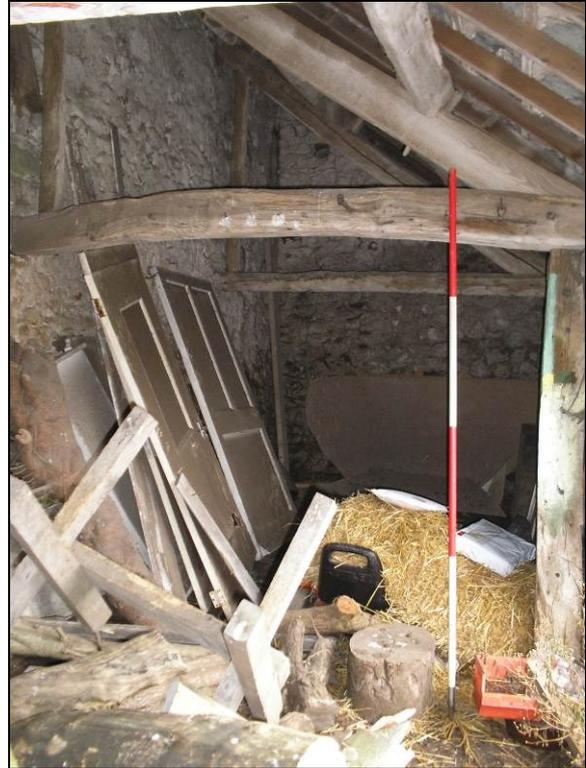
Figure 21. Interior of Room 7

The floor was cobbled with the southern elevation finished in lime-wash, the rest of the room left as bare stone (figure 21).

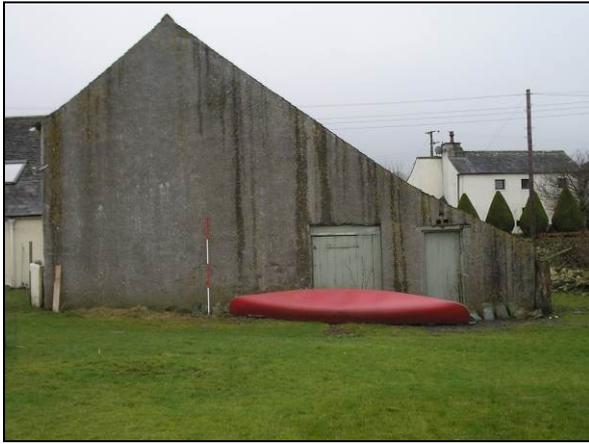
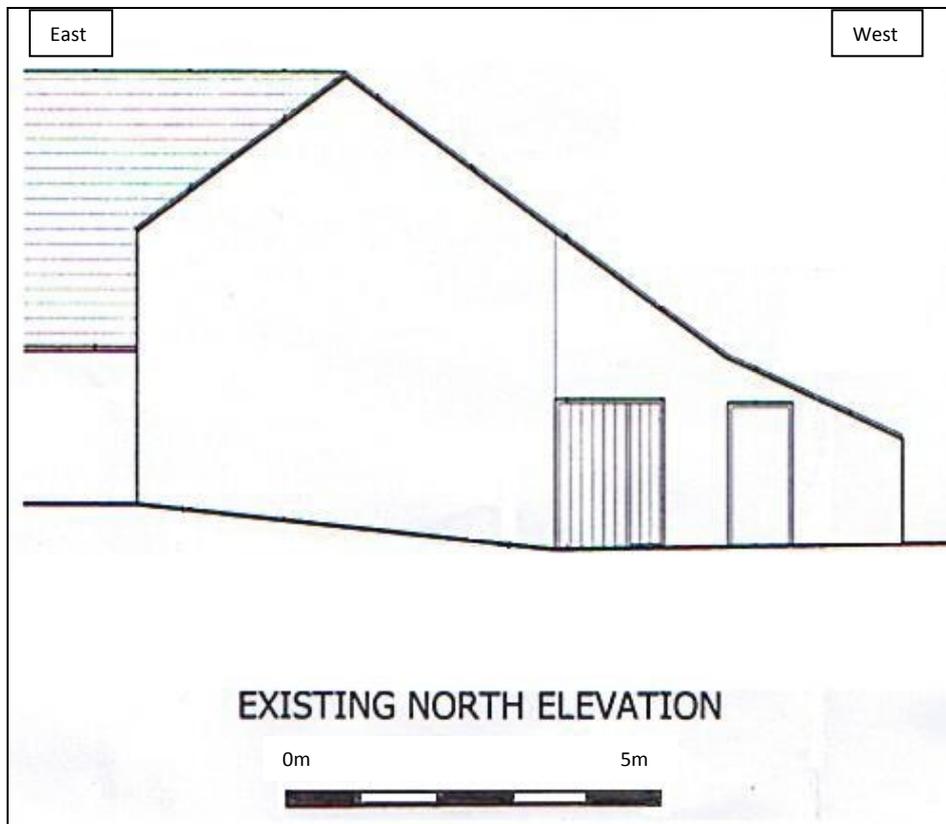
Figure 22. Northern elevation of the study barn

The northern elevation (figures 22 and 24) was finished with a pebble-dash render, concealing the interface between the barn's stonework (Room 1) and the outshut (Room 6).

The outshut possessed modern timber doors within both Rooms 5 and 6

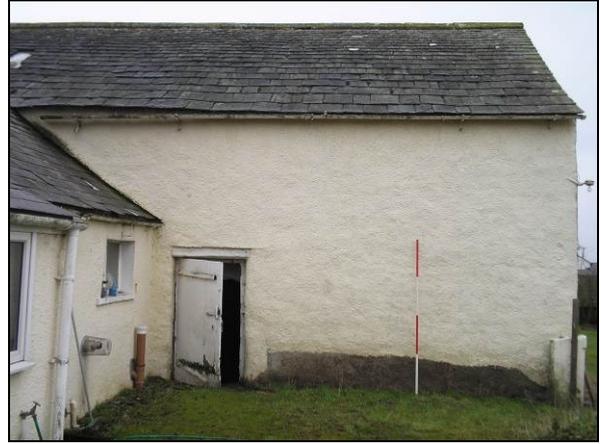
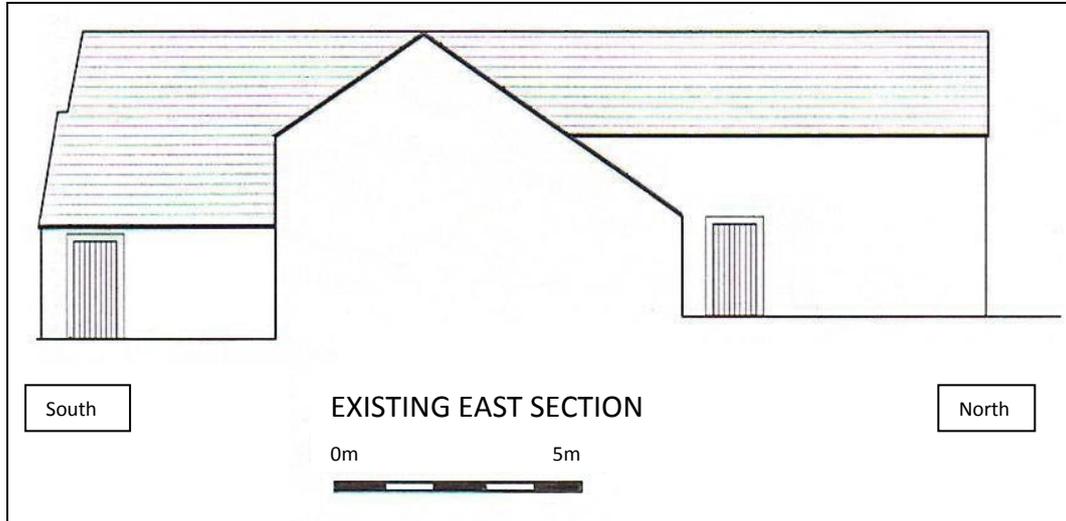
Figure 23. Eastern elevation of the study barn

The eastern elevation (figures 23 and 25) was obscured by the presence of an extant cottage, Glencoe that was structurally earlier than the barn.

The northern part of the elevation was rendered in white lime-wash obscuring any detail within the stonework. A single doorway (figure 23) housing a relatively modern door existed beside the conjunction with the cottage.

The southern part of the original barn was concealed by a later stone lean-to that formed Room 3 and finished in white masonry paint. A machine-cut sandstone surround for the doorway was also painted white.

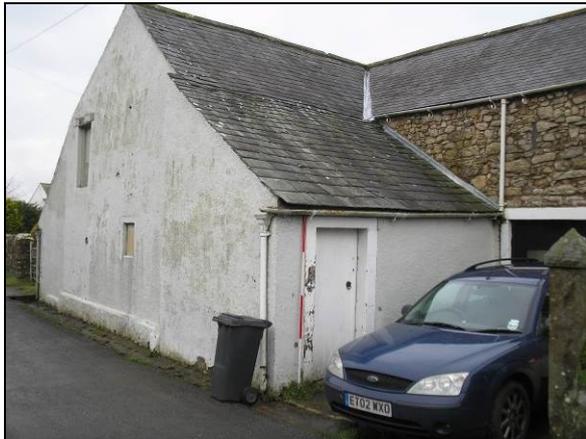
Figure 26. Eastern outside elevation of Room 3

The pitch of the roof for Room 3 (figure 26) was at a slightly different angle than the barn indicating that Room 3 was an adjunct to the barn.

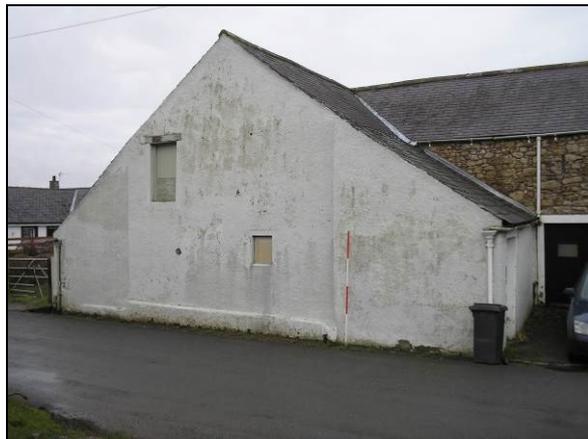
Figure 27. Southern elevation of the study barn

The southern elevation was finished in white masonry paint (figure 27). It illustrated that Room 3, to the east was a later adjunct to the study barn as was Room 7 on the western side.

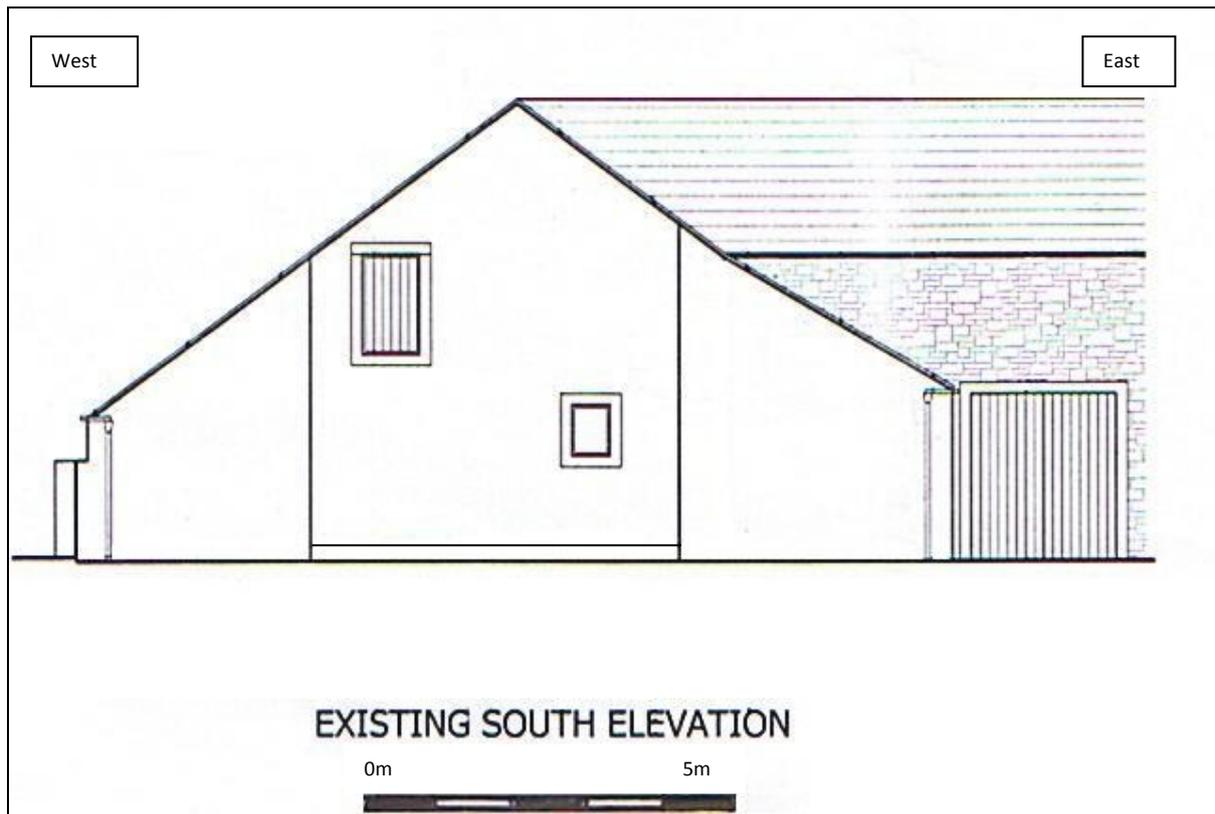
Figure 28. Drawn southern elevation of the study barn

The elevation (figure 28) incorporated a doorway on the upper level suggesting that access was via a ladder, flight of steps or a raised vehicle from the outside. A small window was also present on the ground floor.

A narrow plinth or foundation was visible at the base of the facade but it was not possible to infer whether this feature belonged to an earlier structural phase.

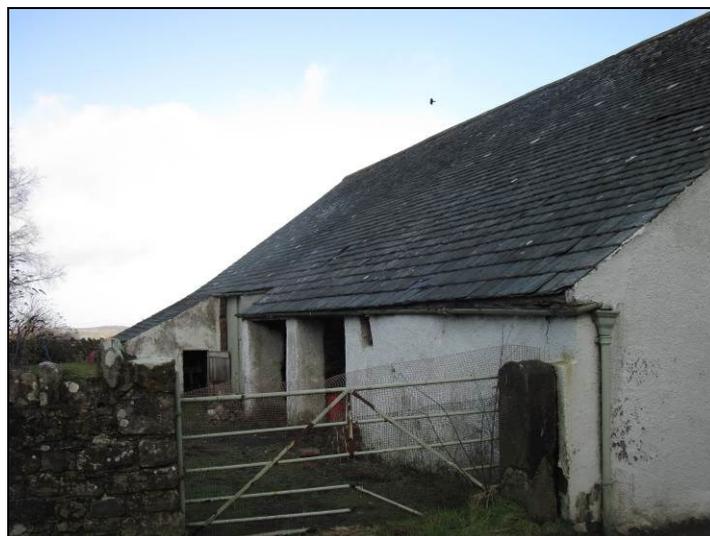
Figure 29. Drawn western elevation of the study barn

The western elevation was rendered in white masonry paint (figure 29) and obscured any architectural details. The roof appeared to be a single pitch that encompassed the original barn and the later additions, Rooms 5 and 7.

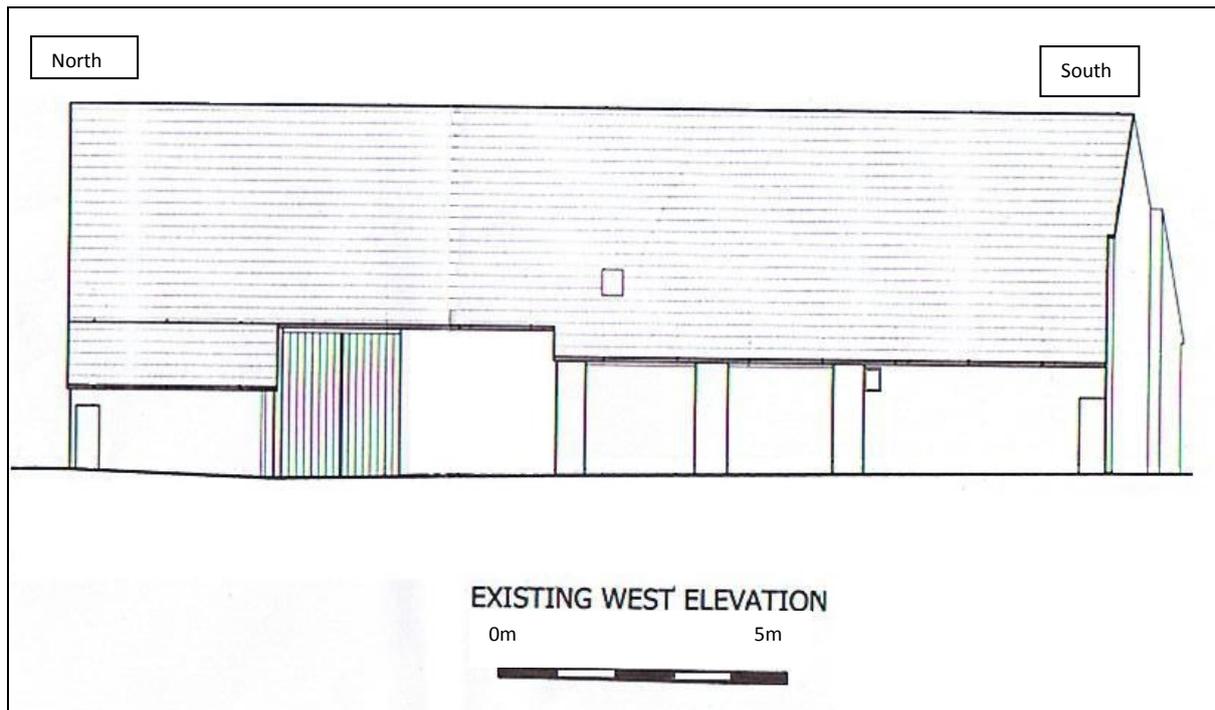
Figure 30. Western elevation showing Rooms 4, 5 and 7

Within the facade (figure 30), three relatively modern elements were illustrated:

1. Room 5, the chicken shed
2. Room 4, the porch
3. Room 7, the outside store

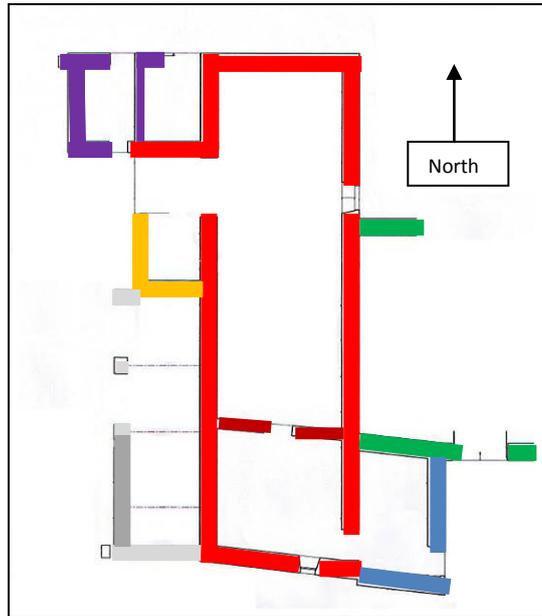
Figure 31. Glencoe Barn development; Structural phases

The probable structurally phasing (figure 31) for this study building was as follows:

- Phase 1, construction of Glencoe Cottage (green outline)
- Phase 2a, construction of the barn, Rooms 1 (red outline)
- Phase 2b, partition of the barn forming and insertion of a door, Room 2 (brown outline)
- Phase 3, widening and extension of the porch, Room 4 (yellow outline)
- Phase 4, construction of a lean-to, Room 3 (blue outline)
- Phase 5, addition of a store, Rooms 5 and 6 (violet outline)
- Phase 6a, extension of the roof to form a store, Room 7 (light grey outline)
- Phase 6b, infilling of the phase 6a facade (dark grey outline)

The study barn was structurally later than the extant cottage (Phase 1), incorporating the western gable end of Glencoe, into the eastern wall of the barn.

The original ground plan for the barn (Phase 2a) measured 18.40m x 5.40m with a main entrance on the western elevation where a small porch may have existed, then later enlarged (Phase 3).

The barn was probably constructed during the mid 19th century (Phase 2a) and then altered with the construction of a partition wall (Phase 2b) to form Rooms 1 and 2. This led to the formation of an first floor accessed via an upper door through the southern wall.

Probably, the porch was widened shortly after construction (Phase 3) with a new room (Room 4) available to the south.

Two rooms (Rooms 5 and 6) were added (Phase 5) within the northern salient between the porch (Phase 3) and the barn (Phase 1).

An open outshut (Room 7) was added (Phase 6a) within the salient between the porch (Phase 3) and the barn (Phase 1). The open facade was partially filled (Phase 6b) to enclose this space.
