The Level III building survey at Breconside Farm, Milton recorded a probable early 18th Century stone hay-loft and barn.

Cumbria County Council's Historic Environment Service (CCCHES) was consulted by Carlisle City Council regarding a planning application for the conversion of a hay barn and shed for a holiday let at Breconside Farm, Milton, Brampton, (NY 56180 60800), Planning Application No. 1/09/0116.

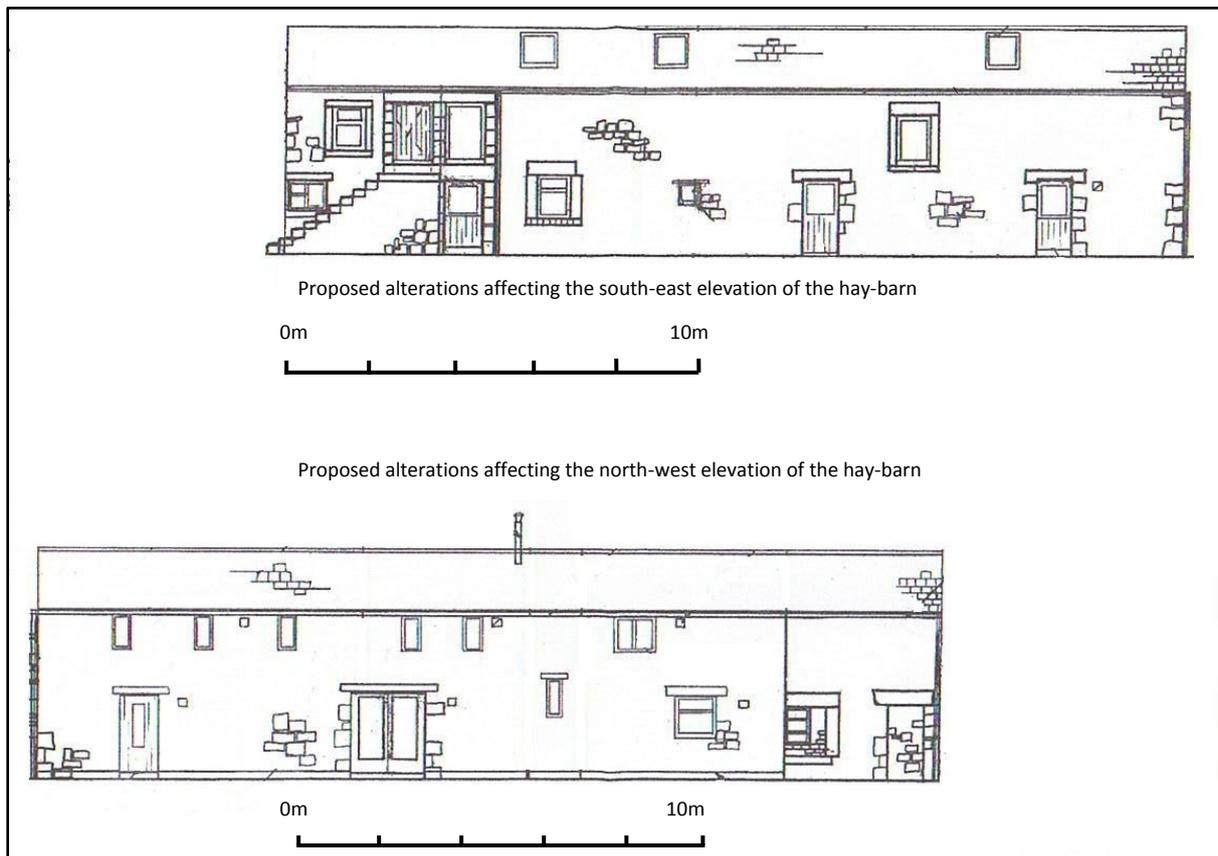
Figure 3. Proposed new building featured in the development.

The north-west elevation will have six upper windows inserted and two lower windows in addition to a set of double-doors and a single door (see figure 3).

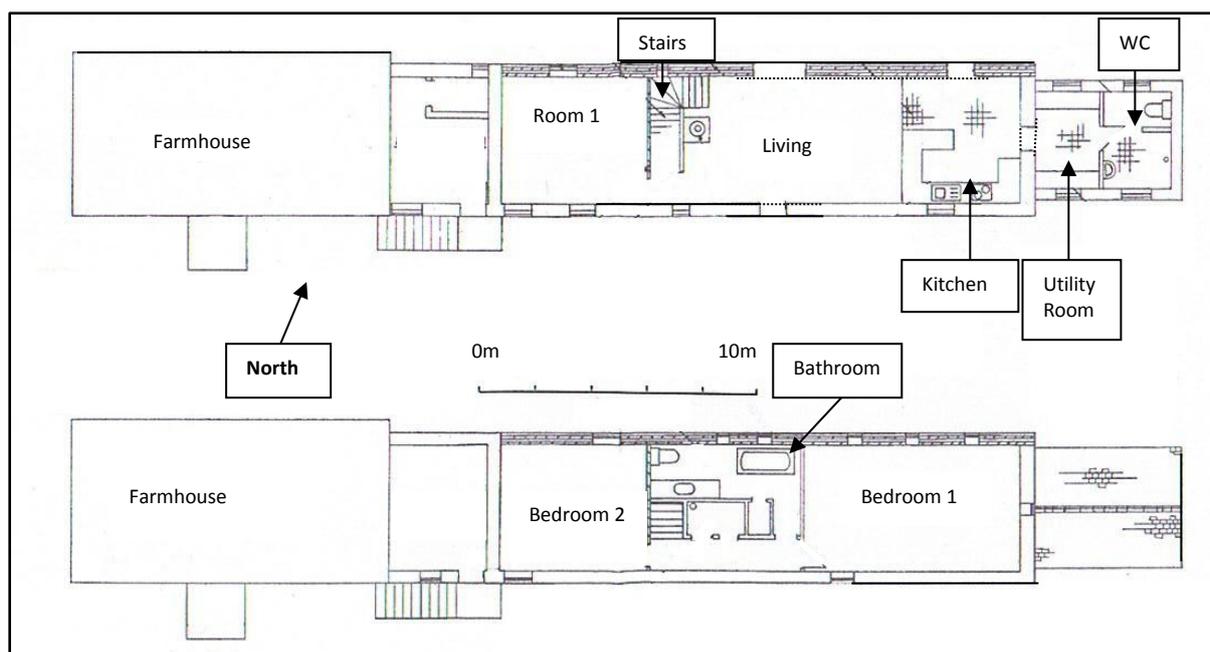
Figure 4. Ground and first floor plan of proposed development

The final internal lay-out will comprise of a ground floor living space, room and kitchen. An adjoining shed will be converted to provide a toilet with a utility room. The kitchen, utility room and toilet are to be tiled.

The first floor, accessed by a staircase at the rear, will consist of two flanking bedrooms with a central bathroom (figure 4).

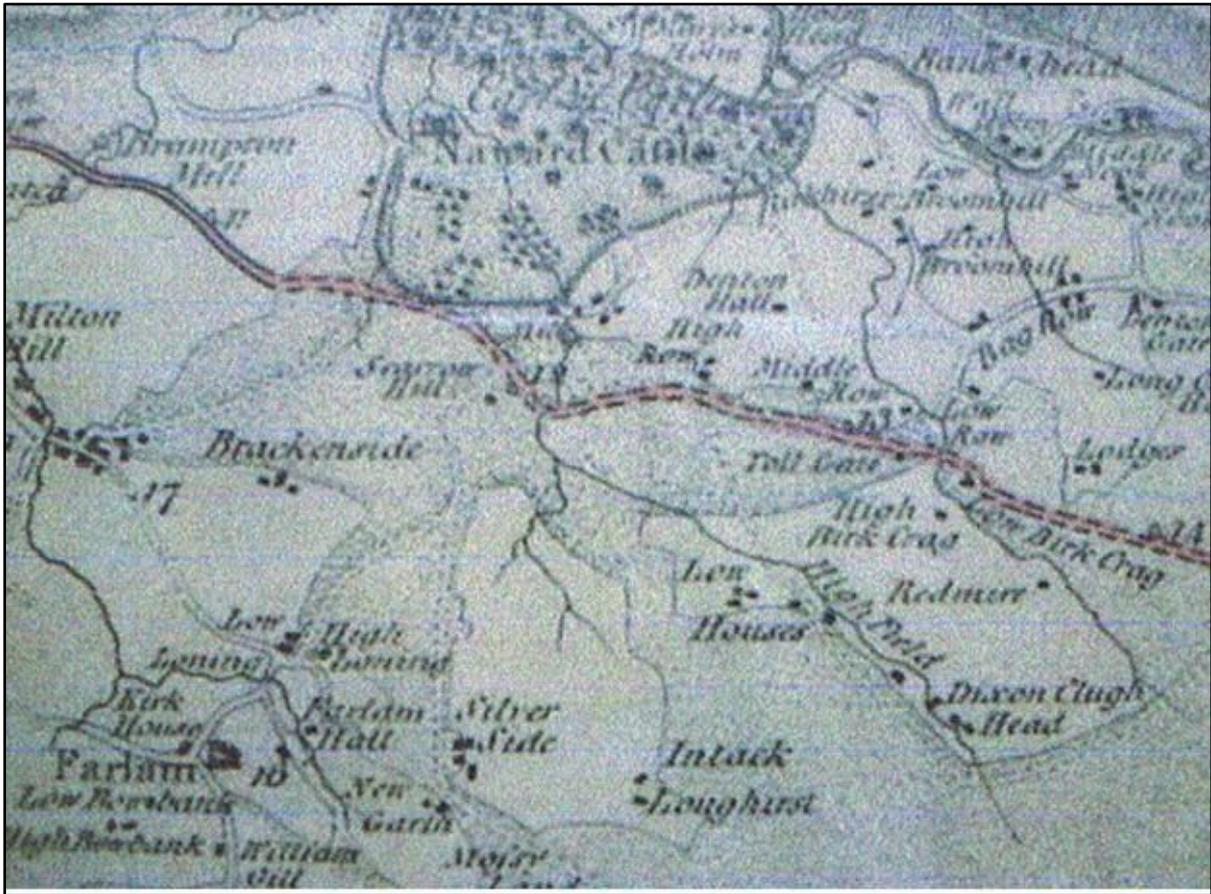
Figure 5. Hodgkinson and Donaldson’s Map of 1774 showing a group of three buildings

On the Hodgkinson and Donaldson map of 1774 (figure 5), three buildings are illustrated, a detail repeated on the 1780 enclosure map for Farlam ORE 1/79 (figure 6).

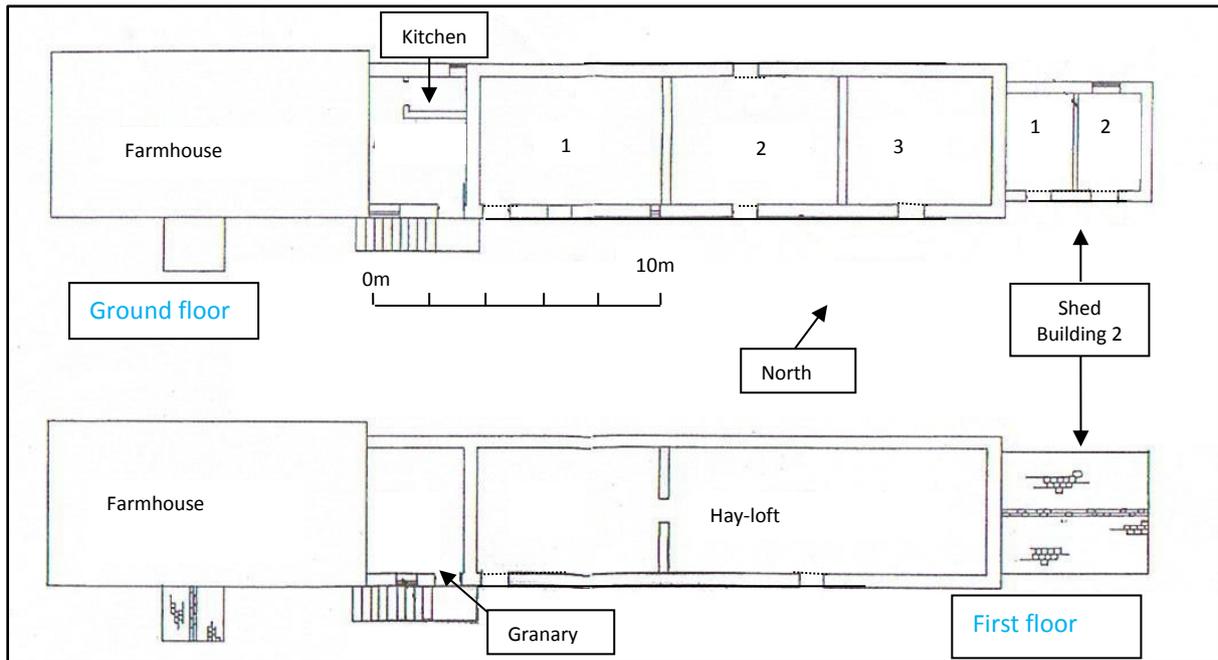
Figure 8. Location of rooms mentioned in the results section

- The hay-barn (Building 1) refers to the large stone structure adjoining the farmhouse. The hay-barn comprised of three rooms at ground level and two rooms within the hay-loft.
- The shed (Building 2) refers to the later stone building adjoining the hay-barn to the north-east. This is divided into two spaces or rooms.

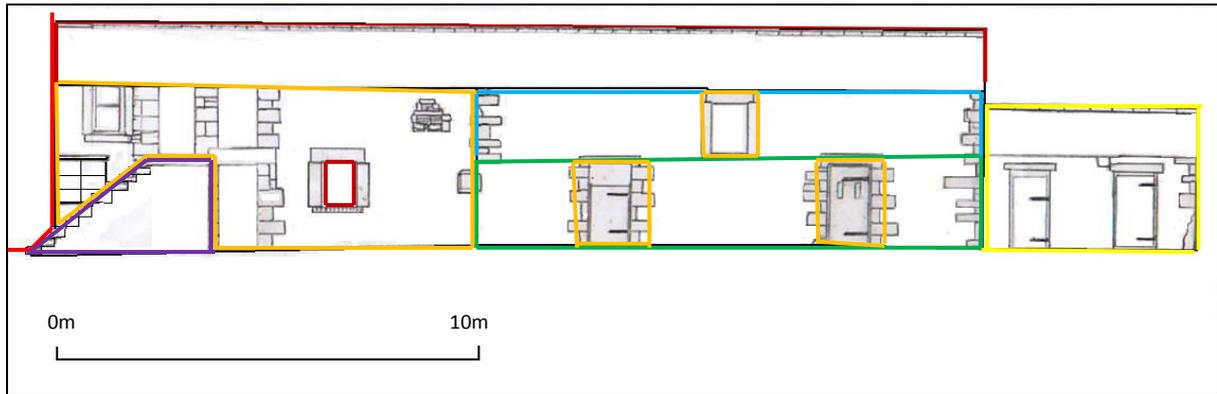
Figure 9. South eastern elevation of the study building showing seven principal construction phases

The south eastern elevation of the stone barn appears to illustrate at least seven principal structural phases that can be summarised as follows:

1. Construction of the ground floor of the hay-barn (outline in green)
2. Addition of upper floor; the hay-loft (outline in blue)
3. Addition of wing to the southwest and insertion of monumental windows and doors within the original building (outline in orange)
4. Truncation of the phase 3 wing and the construction of the farmhouse (outline in red)
5. Construction of a flight of steps (outline in purple)
6. Addition of a shed (outline in yellow)
7. Refurbishment of the roof and filled window (outline in brown)

The original structure was probably a single storey rectangular plan stone building measuring 12.00m in length, 5.27m in width and 1.95m in height. The building fabric comprises generally dressed hard yellow sandstone blocks randomly coursed to a thickness of 0.50m without windows and probably possessing a single simple opening representing a doorway on the south eastern side.

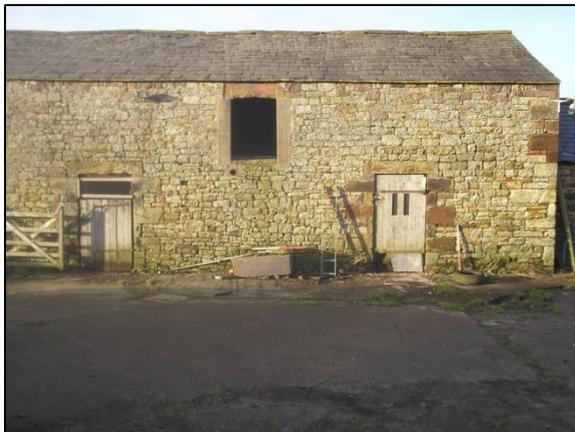
Figure 10. Eastern end of phase 1 building

At the eastern end of the building, stone quoins are represented by nine roughly dressed yellow sandstone blocks of alternate sizes between approximately 0.55m x 0.30m and 0.30m x 0.20m rising to a collective height of 1.95m (figure 10).

Only a decayed red sandstone lintel (figure 10) remained from the original window (1.30m x 1.50m), the flanking jamb replaced in concrete and the sill (0.25m in thickness) formed from rough hewn red sandstone.

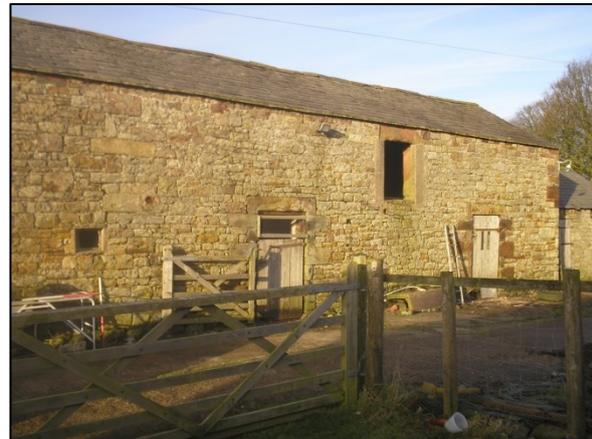
Figure 11. Western end of phase 1 building

Thereafter, the corner is enhanced by a further six red sandstone. There also appears to be a discernible in the shape and size of the wall fabric (figure 11); the lower part of the south eastern elevation possessing smaller, worn sandstone blocks with greater degree of random coursing, the upper part of the elevation greater regularity in the coursing and shape of the stone blocks. This change in style probably represents a later phase (phase 2) although this observation is not absolute proof of a structural change.

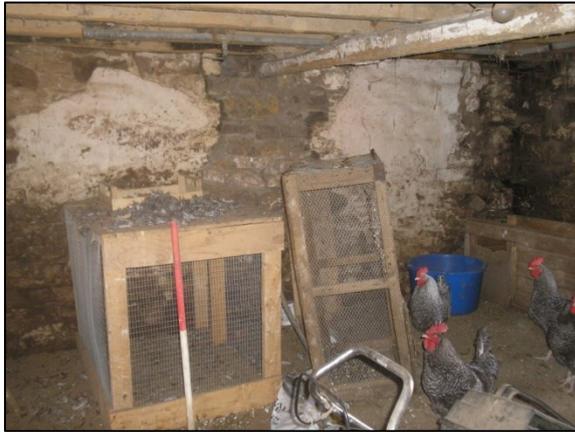
Figure 13. Room 2, now a chicken coop

Room 2 (5.58 x 4.34m x 1.70m) is currently used as a chicken coop. It possessed white-washed walls, partly rendered but with exposed stonework (figure 13). The floor was probably concrete but was heavily obscured by straw and its current use. No architectural embellishments were encountered within the room.

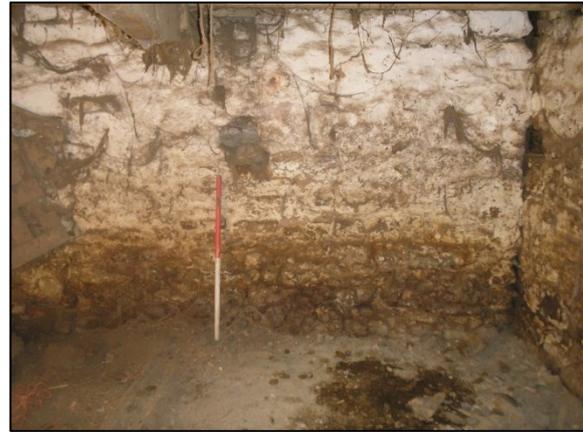
Figure 14. Room 3, now a dog kennel

Room 3 (4.96m x 4.34m x 1.70m) is currently used as a dog kennel. It possessed white-washed walls, partly rendered but with exposed stonework (figure 14). The floor appeared to be cobbled but modern use precluded closer observation. No architectural embellishments were encountered within the room.

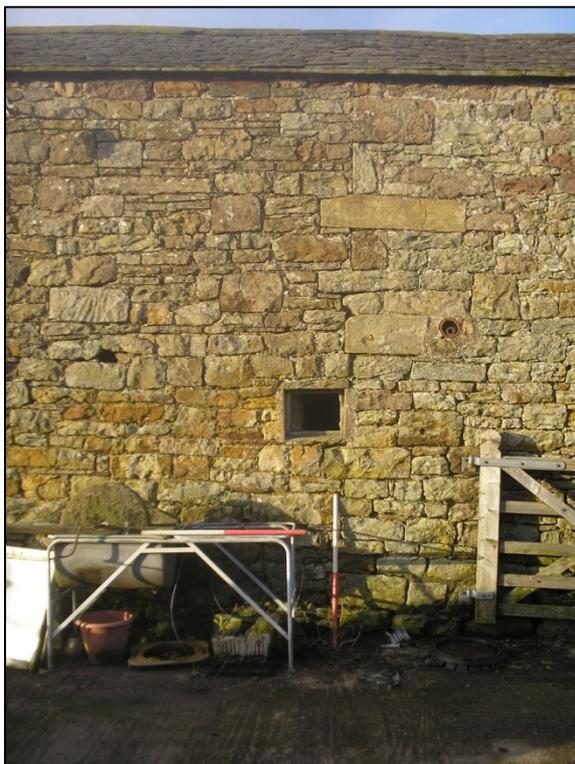
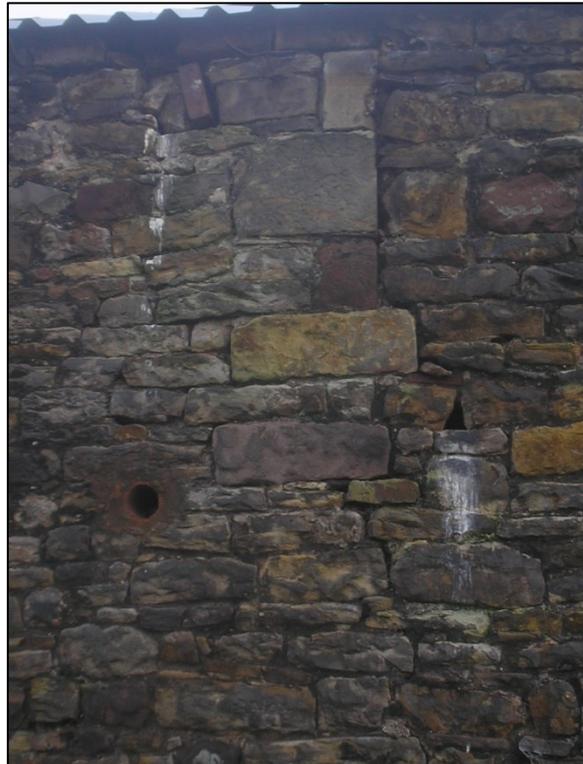
Figure 15. Wall interface south side (phases 2-3) Figure 16. Wall interface north side (phases 2-3)

The phase 2 construction enabled the original building to be raised to its current height 3.77m. The addition of a second storey was denoted by a set of six neatly dressed red sandstone quoins between 0.20-0.55m x 0.30m in size at both the eastern and western corners of the original structure. This action is illustrated in Figure 15 although at least two stones appear to have been replaced in order to key in the phase 3 extension to the west. This sequence has been repeated on the north western side of the building (figure 16).

A small extant unglazed window (0.40m x 0.35m) was present where the phase 2 and 3 stonework butted each other. The window was framed by flat red sandstone slabs but did not possess any architectural pretensions (figure 15).

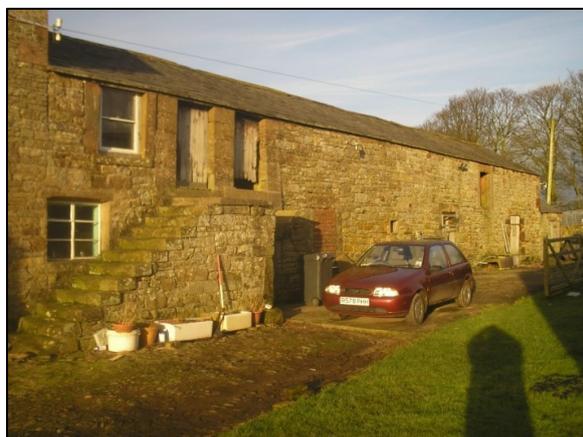
Figure 17. View of phase 3 extension

A two storey stone extension to the west of the original building measured over 10.00m in length, 5.27m in width and 3.97m in height (figure 17). The fabric consisted of a tight concordant bond of roughly hewn sandstone that appeared to include a filled or blind window (approximately 0.60m x 0.45m) towards the north-east on the first floor (figure 18)

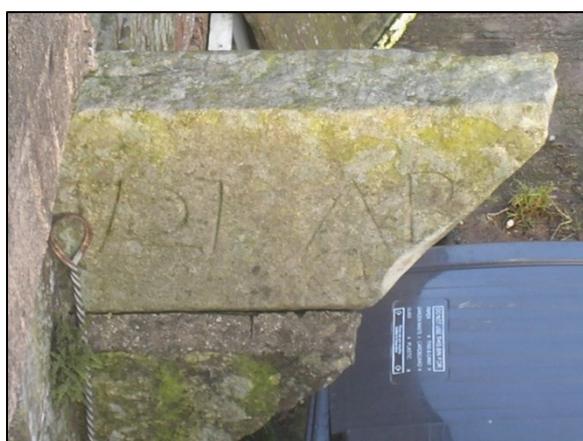
Figure 19. Date stone inscribed 1727 AB

The central element was a double doorway separated by a dressed red sandstone pier formed from blocks 0.25-0.5m x 0.30m in size. Either side of this central pier were dressed red sandstone quoins that formed four doorways measuring 1.95m in height and 0.89m in width (figure 12). A protruding date stone that formed a platform bracket for entry to the first floor was inscribed "1727 AB" (figure 19). This platform was removed following the installation of a flight of steps (phase 5), whilst an earlier lintel was replaced by a concrete beam (figure 21).

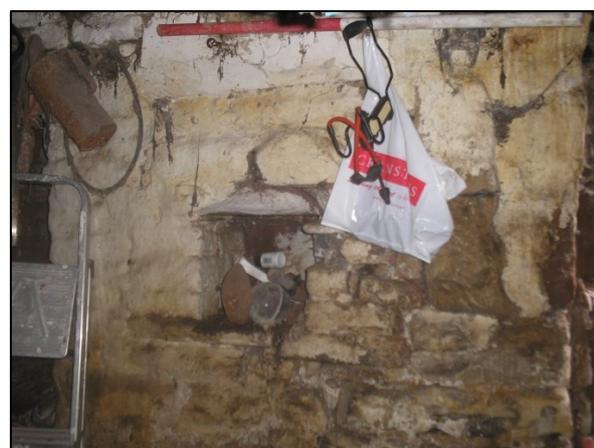
Figure 20. Niche within the stable (Room 1)

The interior of the room was partly rendered with plaster, but roughly hewn stone was extensively displayed. A single niche measuring 0.40m x 0.30m x 0.25m (figure 20) was present besides the south facing door. No other embellishments were apparent. The floor comprised of small rounded cobbles. Within the room were wooden stalls and later metal barriers confirming use as a stable (figure 22).

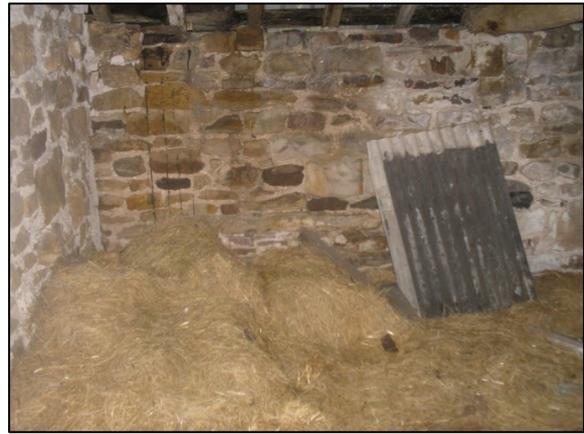
Figure 23. Hayloft within phase 3 structure

The hay-loft above the stable (Room 1) also measured 6.20m x 4.25m standing to a height of 3.00m, possessed a wooden floor and yielded partially white-washed walls with extensive roughly hewn stone exposed (figure 23). Access into the earlier building was through a stone doorway enabling the entire upper floor to become a single space whose only ingress was via the phase 3 doorway.

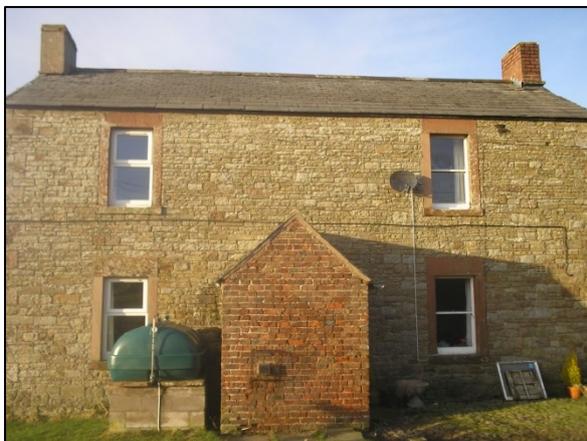
Figure 24. Phase 4 farmhouse

The construction of the extant farmhouse (11.00m x 5.75m) probably removed a length of approximately 2.90m from the adjacent phase 3 building. This double-fronted cottage of one room depth (Brunskill 2002, 90), constructed in dressed sandstone arranged in courses possesses a symmetrical frontage complementing the style of the existing embellishments established in the other two buildings (figure 24).

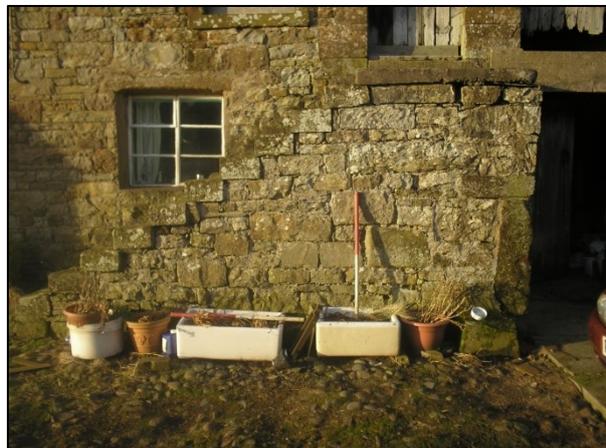
Figure 25. Phase 5 flight of steps

A flight of eleven stone steps (figure 25) was added, keying into both the farmhouse (phase 4) and the adjacent building (phase 3). These steps possessed a rectangular plan footprint measuring 4.40m in length, 1.25m in width and 2.10m in height.

These steps probably replaced an earlier flight of steps or ladder that would have conjoined with a platform subsequently removed, resting above the date stone.

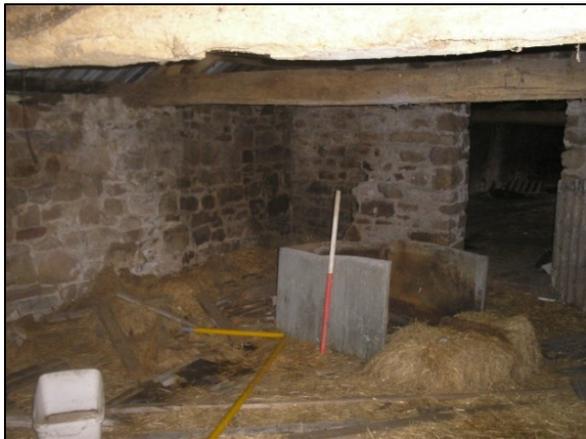
Figure 26. Re-used roof beams in hay loft

The roof is supported by wooden trusses resting on stone walls that appear to be formed from re-used timber beams that may be of some antiquity although the purlins and rafters that could be observed were modern or relatively modern.

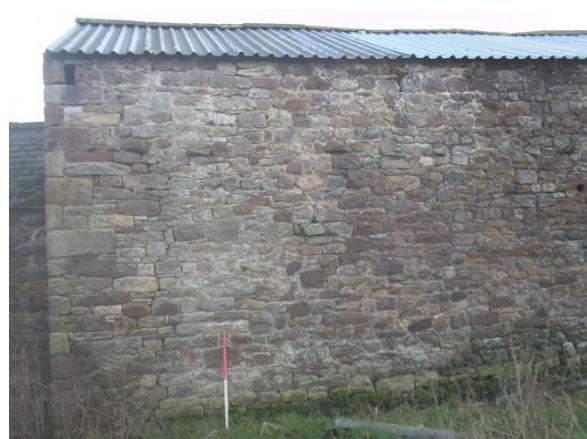
Figure 27. Study building, north-east elevation

The fabric within the north-west elevation was identical to the observations undertaken on the south-east elevation (figure 27) comprising of dressed stone quoins rising to a height of 3.80m. The interface between phases 1 and 2 was unclear.

A series of eight concordant stone “throughs” at a height of approximately 2.70m in height were inserted into the raised wall (figures 27 and 28). Possibly, these “throughs” formed a ledge for an outshot timber building subsequently lost.

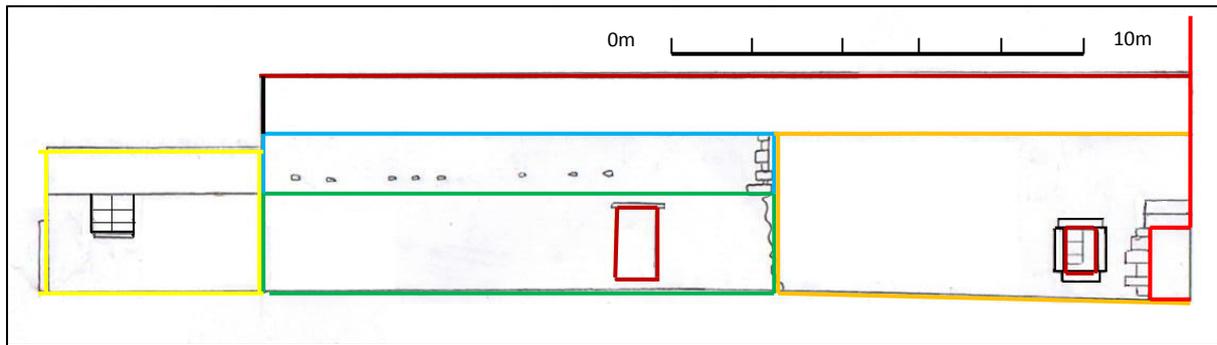
Figure 29. North western elevation of the study building showing six principal construction phases.

The north western elevation displayed six of the seven phases as illustrated on the south eastern elevation (figures 10 and 12). Phase 5, the flight of steps was not present, whilst phase 6 is discussed in section 6.3.

1. Construction of the ground floor of the hay-barn (outline in green)
2. Addition of upper floor; the hay-loft (outline in blue)
3. Addition of wing to the southwest and insertion of monumental windows and doors within the original building (outline in orange)
4. Truncation of the phase 3 wing and the construction of the farmhouse (outline in red)
5. Construction of a flight of steps (not present)
6. Addition of a shed (outline in yellow)
7. Refurbishment of the roof and filled window (outline in brown)

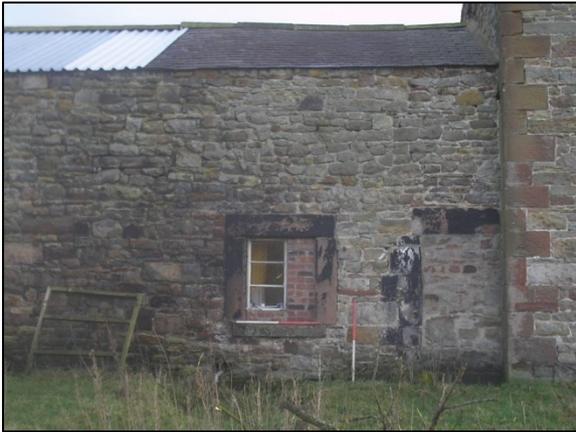
Figure 30. Window and door, phase 3

A window measuring 1.10m x 0.85m was constructed formed from a red sandstone lintel and sill (0.25m in width) with two red sandstone pillars forming the jamb. This window was partially filled with brick producing a greatly reduced glazed window.

A substantial doorway measuring 1.80m x over 0.90m outlined in dressed red sandstone was also inserted that became redundant during the construction of the farmhouse during phase 4.

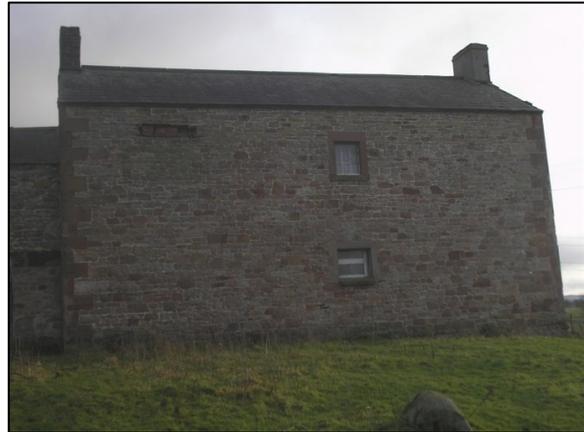
Figure 31. Rear elevation of the phase 4 farmhouse

The phase 4 farmhouse clearly truncated the phase 3 structure (figure 30). The rear of the building yielded two small windows whilst the gable end did not yield any windows or thresholds (figure 31).

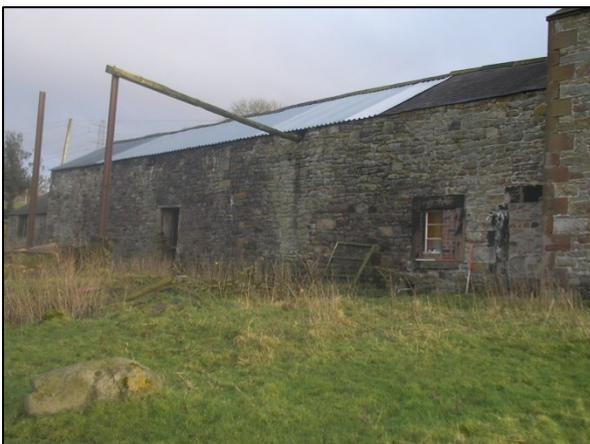
Figure 32. Remains of a Dutch barn

The skeleton frame of a modern Dutch Barn adjacent to the study building was present (figure 32) possessing a footprint of approximately 15m x 5m.

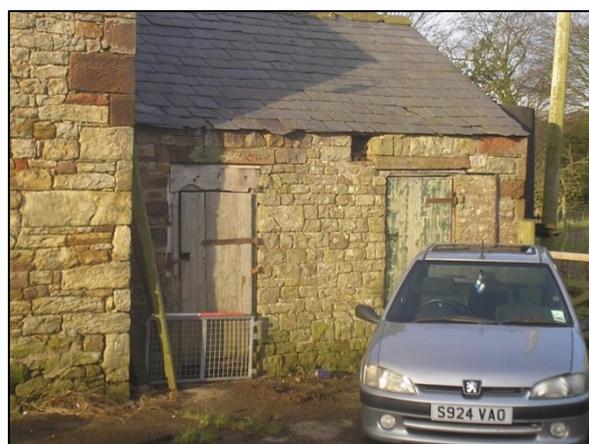
Figure 33. South eastern elevation of the shed

The south eastern elevation displayed two simple doorways (1.85m x 1.00m) that were not outlined with quoins or stone lintels and possessed planked timber doors (figure 33). The eastern end of the elevation was formed from dressed sandstone blocks the lower part subsequently removed and damaged.

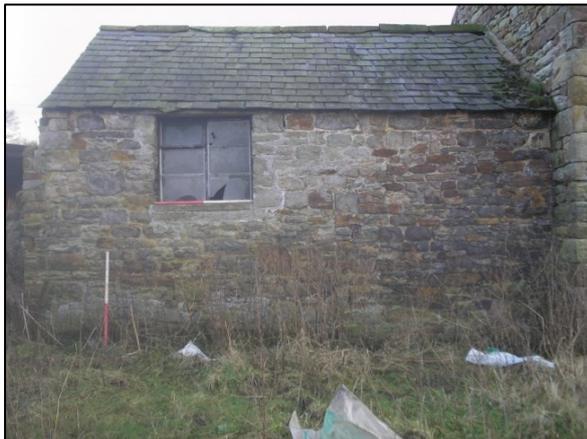
Figure 34. North western elevation of shed

The north western elevation finished in roughly hewn sandstone randomly coursed displayed a six pane window measuring 1.00m x 0.90m with a modern metal frame (figure 34).

The roof consisted of slates with a sandstone coping forming the ridge (figure 34).

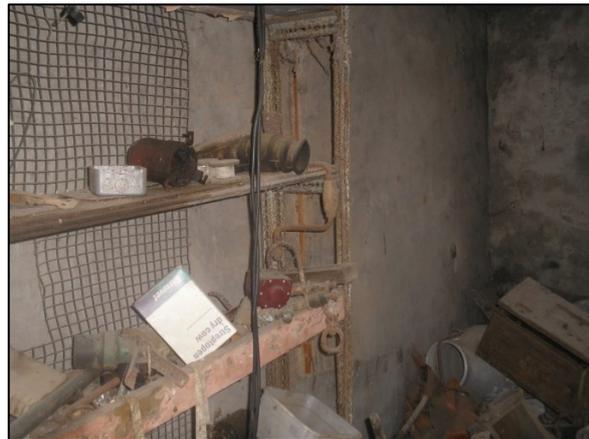
Figure 35. Interior of Room 2 within the shed

Room 2 (3.40m x 2.17m) was used as a store with access inhibited. The walls had been rendered with modern grey plaster whilst the floor was of concrete (figure 35).
