## **The Compton Project Investigations Archaeological of The Compton Family Crypt Compton Wynyates**

Preliminary Archaeological Investigations

PEL/2015/11

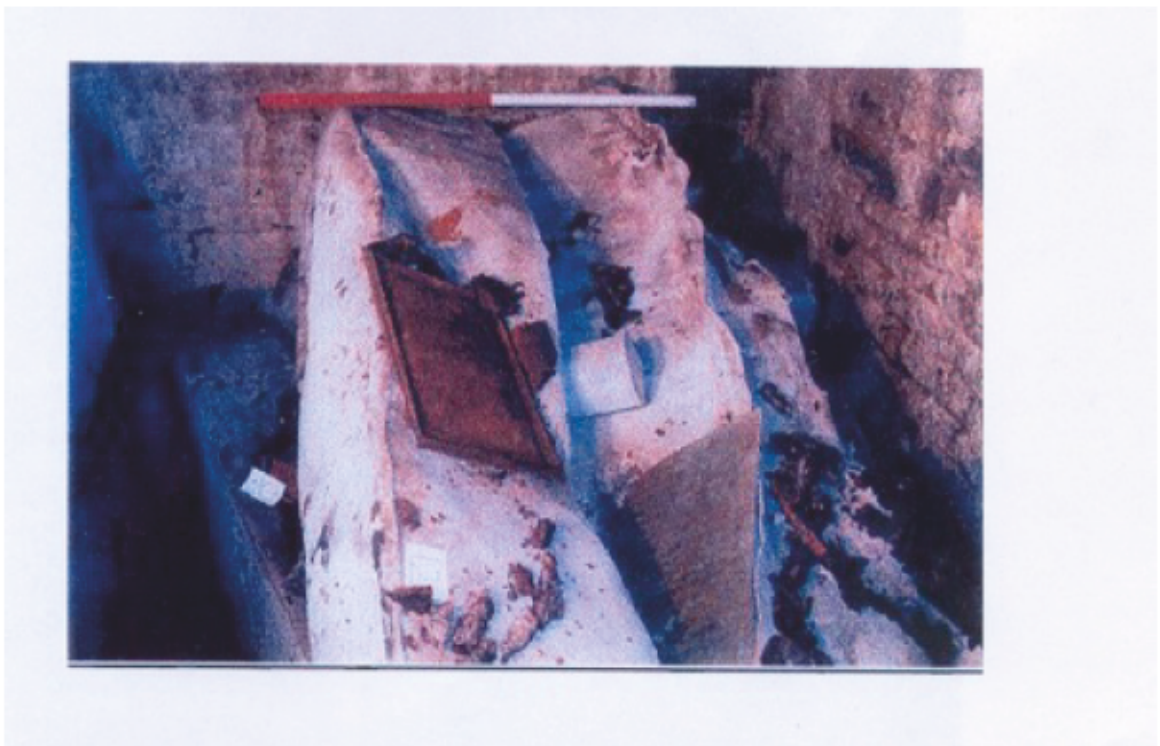
**Plate 3: Stacked Seventeenth-century coffins and viscera container.**

The inhumations were found neatly aligned along each aisle (Figure 3). In the north-west corner of the crypt at least nine lead coffins and one lead cylinder (Plate 3; burial 25) had been piled up. All the coffins in this group were found to be at least seventeenth century, possibly grouped together in a re-organisation of the crypt in the eighteenth-century.

The lead cylinder (Plate 3; burial 25) is similar to viscera containers used in France during the thirteenth century and in Britain in the fifteenth century.

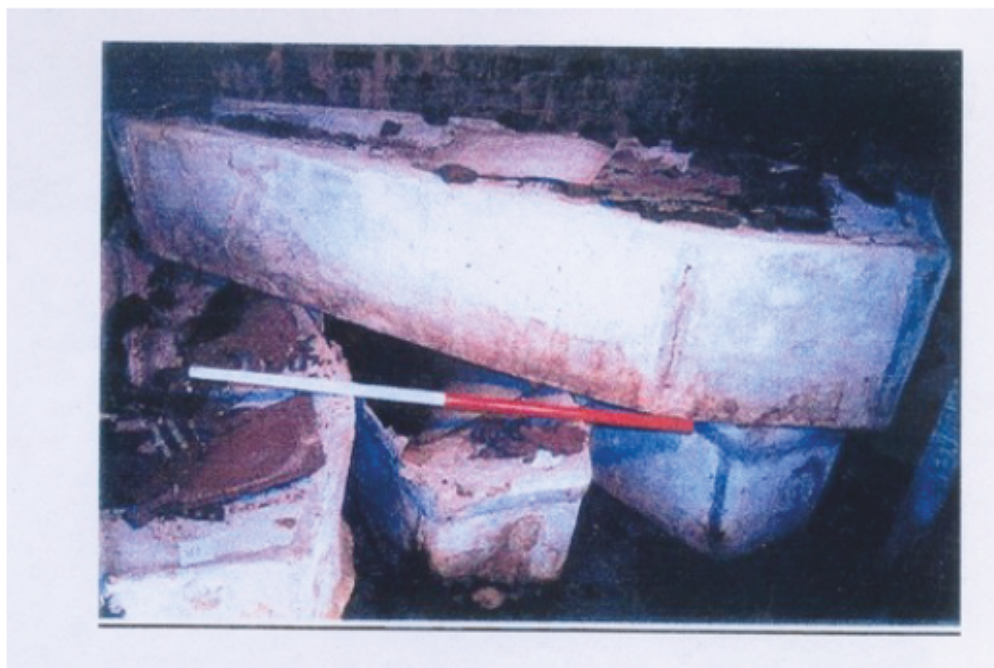
**Plate 5: Damage to three coffins caused by the weight of coffin 17**

Coffin Type: Triple-shell (?)  
Shape: Trapezodial  
Condition: Top collapsed and corner seams have split because of weight of the coffin on top (coffin 17)  
Depositum Plaque: Loose tin (?) – largely unreadable

Coffin Type: Triple-shell (?)  
Shape: Trapezodial  
Condition: Poor. Lid has collapsed through weight of coffin top (coffin 17)  
Depositum Plaque: Tin (?) –largely unreadable

The condition of the coffins varied considerably. Where they had been stacked, the lead shells were found to be crushed and split (Plate 5). Those coffins not stacked are generally in good condition, apart from general deterioration of the lead. The crypt is below the water table and has frequently been flooded over the centuries. This has caused considerable damage to the outer wooden cases.

This would maximise space and minimise damage by flooding. Opening the northern entrance would improve access to the crypt.

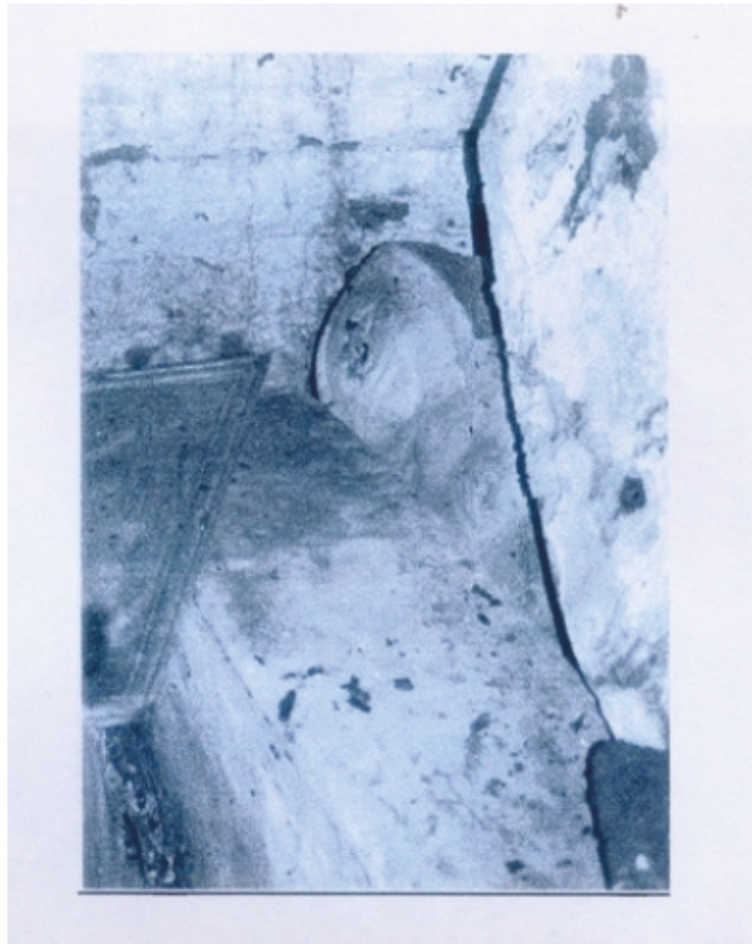
**Plate 6: Anthropoid coffin number 11**

One of these coffins is anthropoid in form (Plate 6; burial 11). This is a style fashionable from the fifteenth to seventeenth centuries.

Coffin Type:	Triple-shell (?)
Shape:	Anthropoid
Condition:	Fair, only the upper portion of coffin was visible from beneath the pile of coffins.
Depositum Plaque:	None visible
