Whaley Bridge Horse Tunnel Peak Forest Canal Derbyshire

Photographic Recording

Report No: 3043.R02

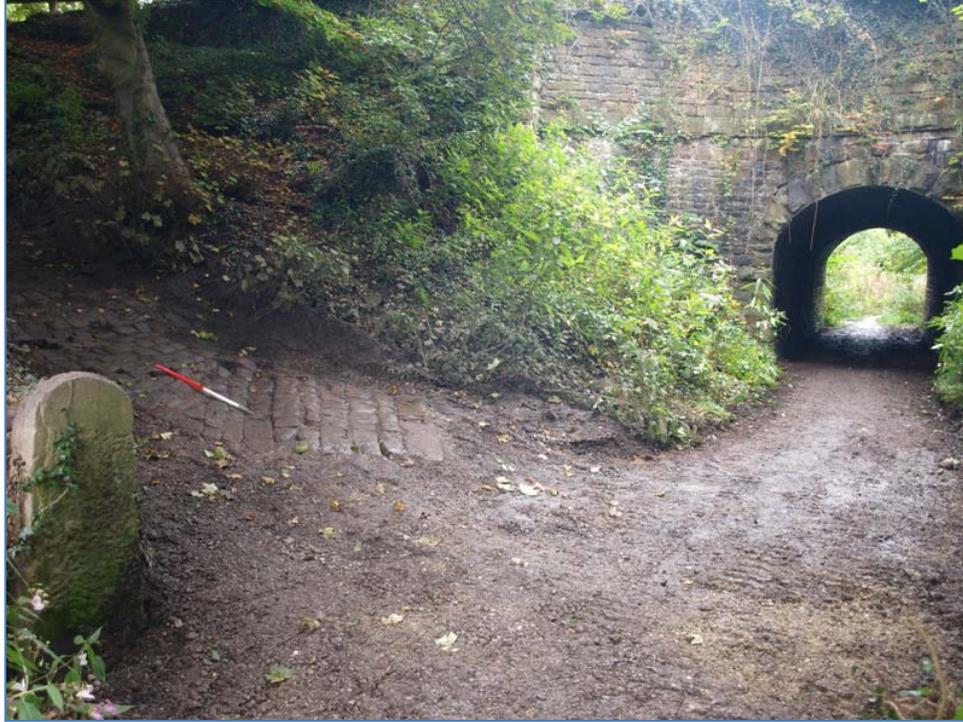
Fig. 3. Setting. View at the base of the ramp looking north, with the horse tunnel in the background, the embankment to the south of the canal to the left, and the base of the ramp in the centre-left middle ground. Scale 1m.

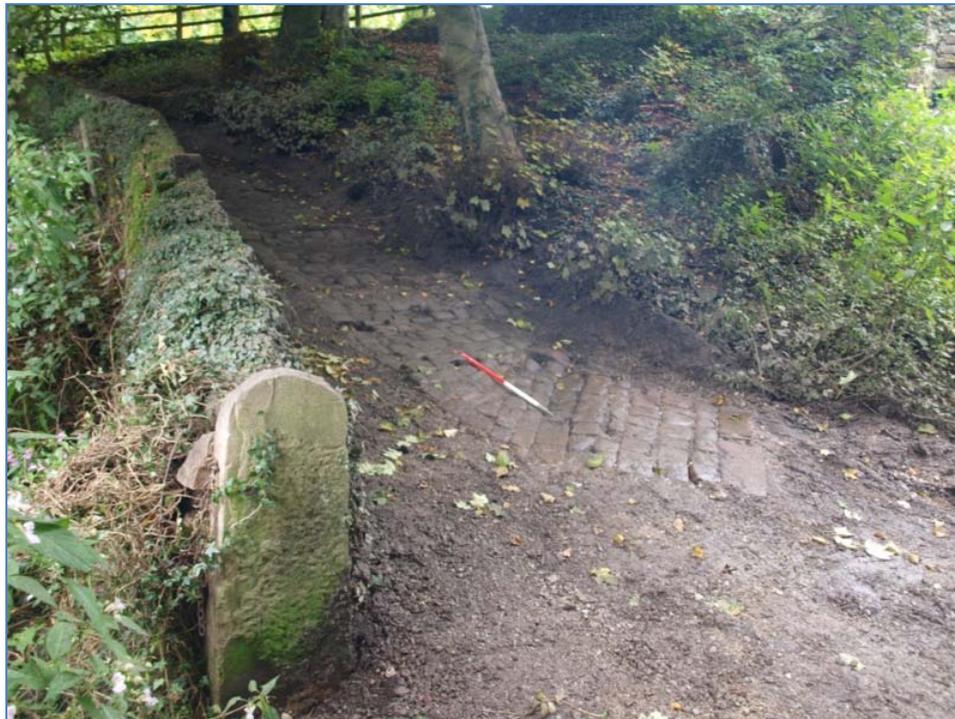
Fig. 4. Setting. View at the base of the ramp looking north-west, with the fence along the southern edge of the canal towpath visible at the top of the slope in the background. The gatepost and associated revetment wall appear to be part of the original construction of c.1796. The end of the cobbled surface is visible centre-right middle ground. Scale 1m.

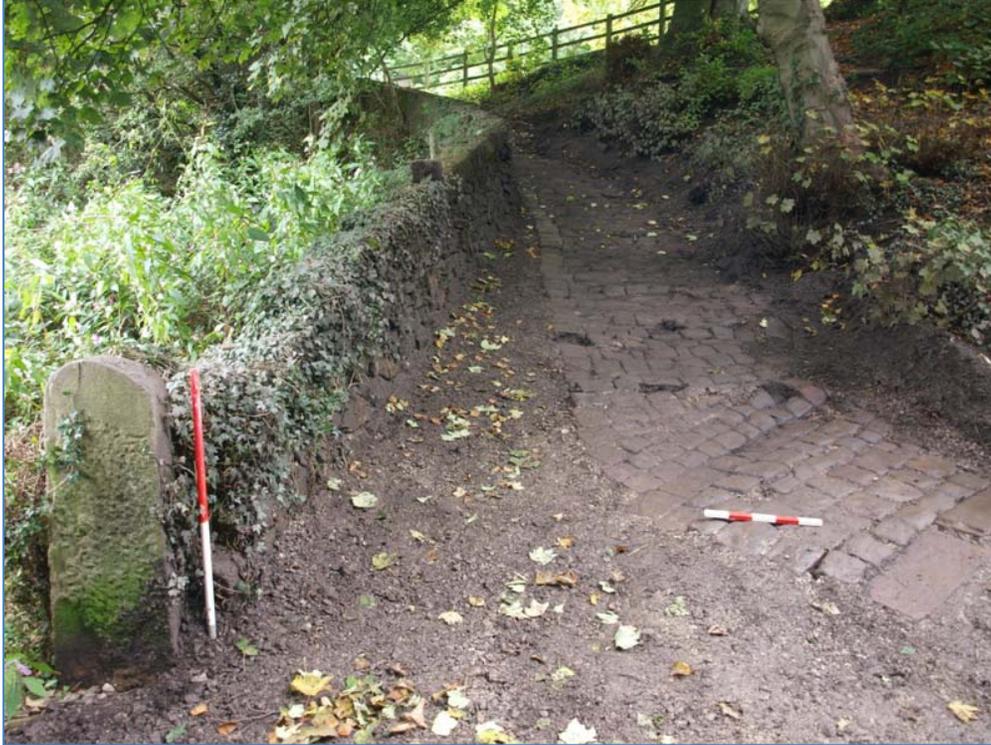
Fig. 5. Setting. View at the base of the ramp looking west. The canal towpath fence is visible in the background; the base of the ramp is at the right-hand foreground. The deviation of the southern wall is clearly evident. Scales 1m (left) and 50cm (right).

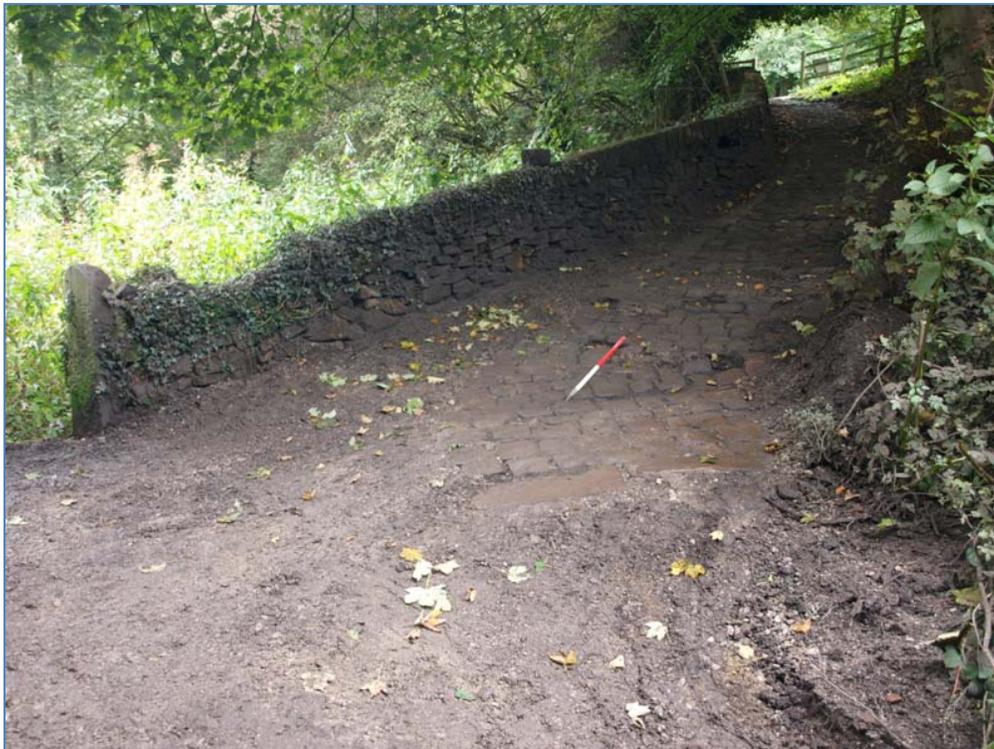
Fig. 6. Setting. View at the base of the ramp looking south-west. This shows the gatepost at the base of the revetment wall (far left) and the north elevation of the wall, as well as the base and top of the ramp. Scale 1m.

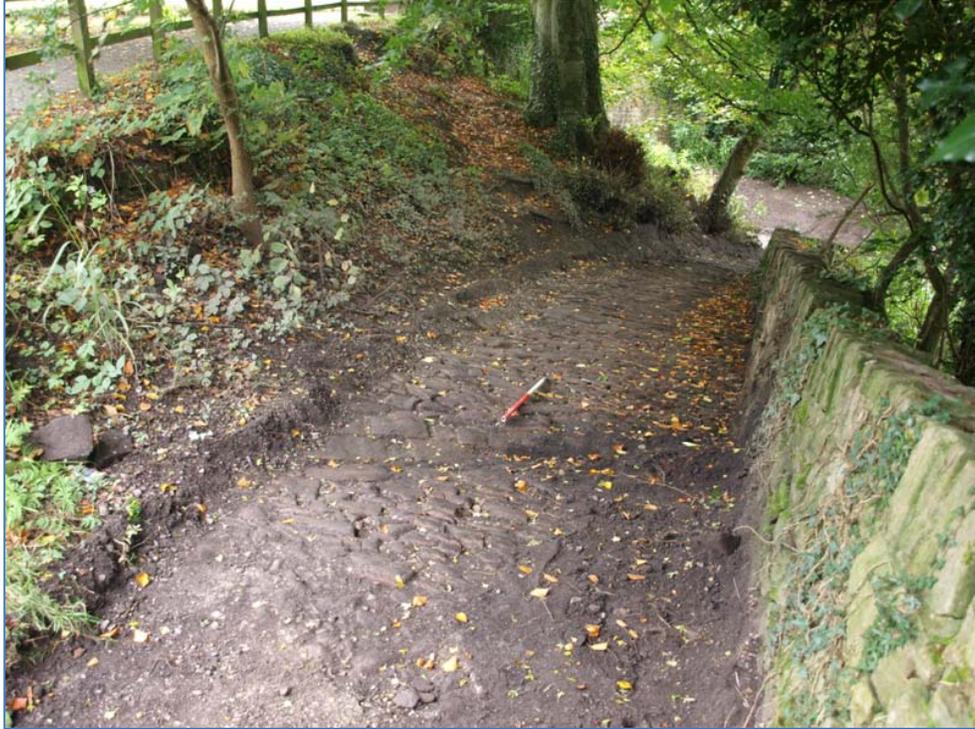
Fig 7. Setting. View at the top of the ramp, looking east. The wooden fence marking the southern edge of the towpath is visible on the left-hand side of the photograph; the revetment wall is on the right-hand side. The near end of the 1m scale is on the remains of the top drain (see also Figs. 9, 10 and 11, below).

The uppermost 2m or so of the cobbled surface was partly truncated, notably on its southern side along the retaining wall (Figs. 7, 8 and 10). There were also some patches in the lower 5m which were damaged by tree roots and other ground movement (Figs. 19, 21, 24, 31, 32, 33, 34 and 35).

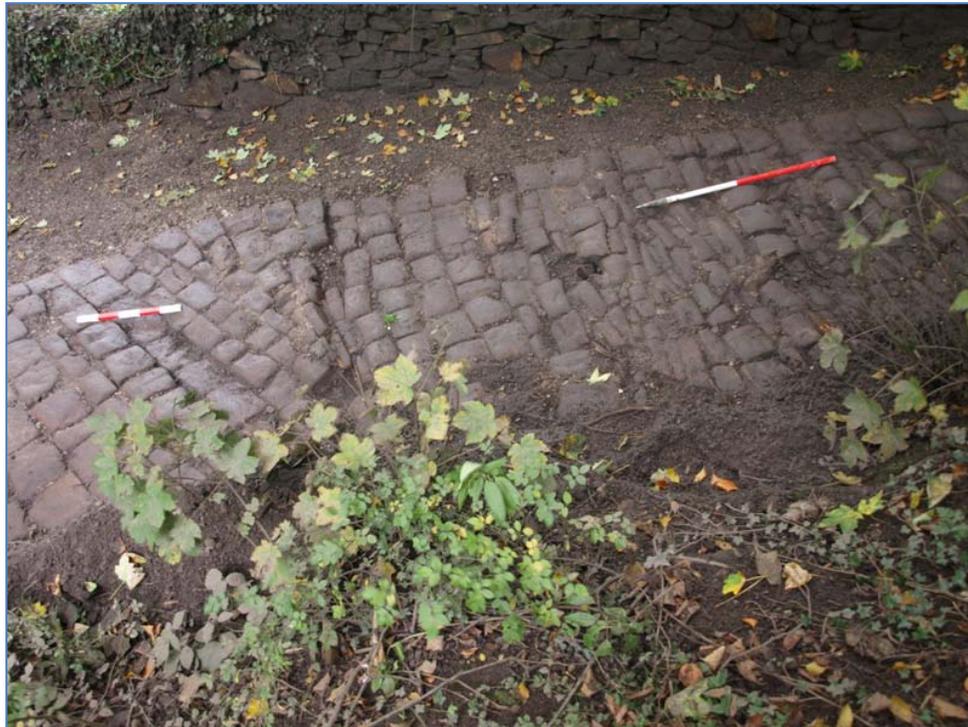
Fig. 8. View from the embankment to the south of the canal and to the north of the ramp; south is at the top of the photograph. This shows the difference in character between the lower part (left) and the upper part (right) of the ramp. See text (5.2 above) for details. Scales 50cm (left) and 1m (right).

The south ramp exhibited two distinct zones of character (Fig. 8). The lower section, comprising the first 4m or so, consisted of very regular square or rectangular sandstone setts, on average 150-200mm x 150-200mm. This was bounded at the eastern (bottom) end by two large sandstone blocks, measuring 680 x 270mm and 760 x 250mm in plan (Figs. 37 and 38). The upper section was paved with a more random selection of variously-shaped cobbles, occasionally 'brought to courses' by the insertion of a row of more regularly-shaped stones (Fig. 27). The edge of the more randomly laid upper section was, however, neatly edged with larger more regularly-shaped setts. This edging was evident both where the ramp abutted the revetment wall (Fig. 15), and where it deviated away from it (Fig. 26).

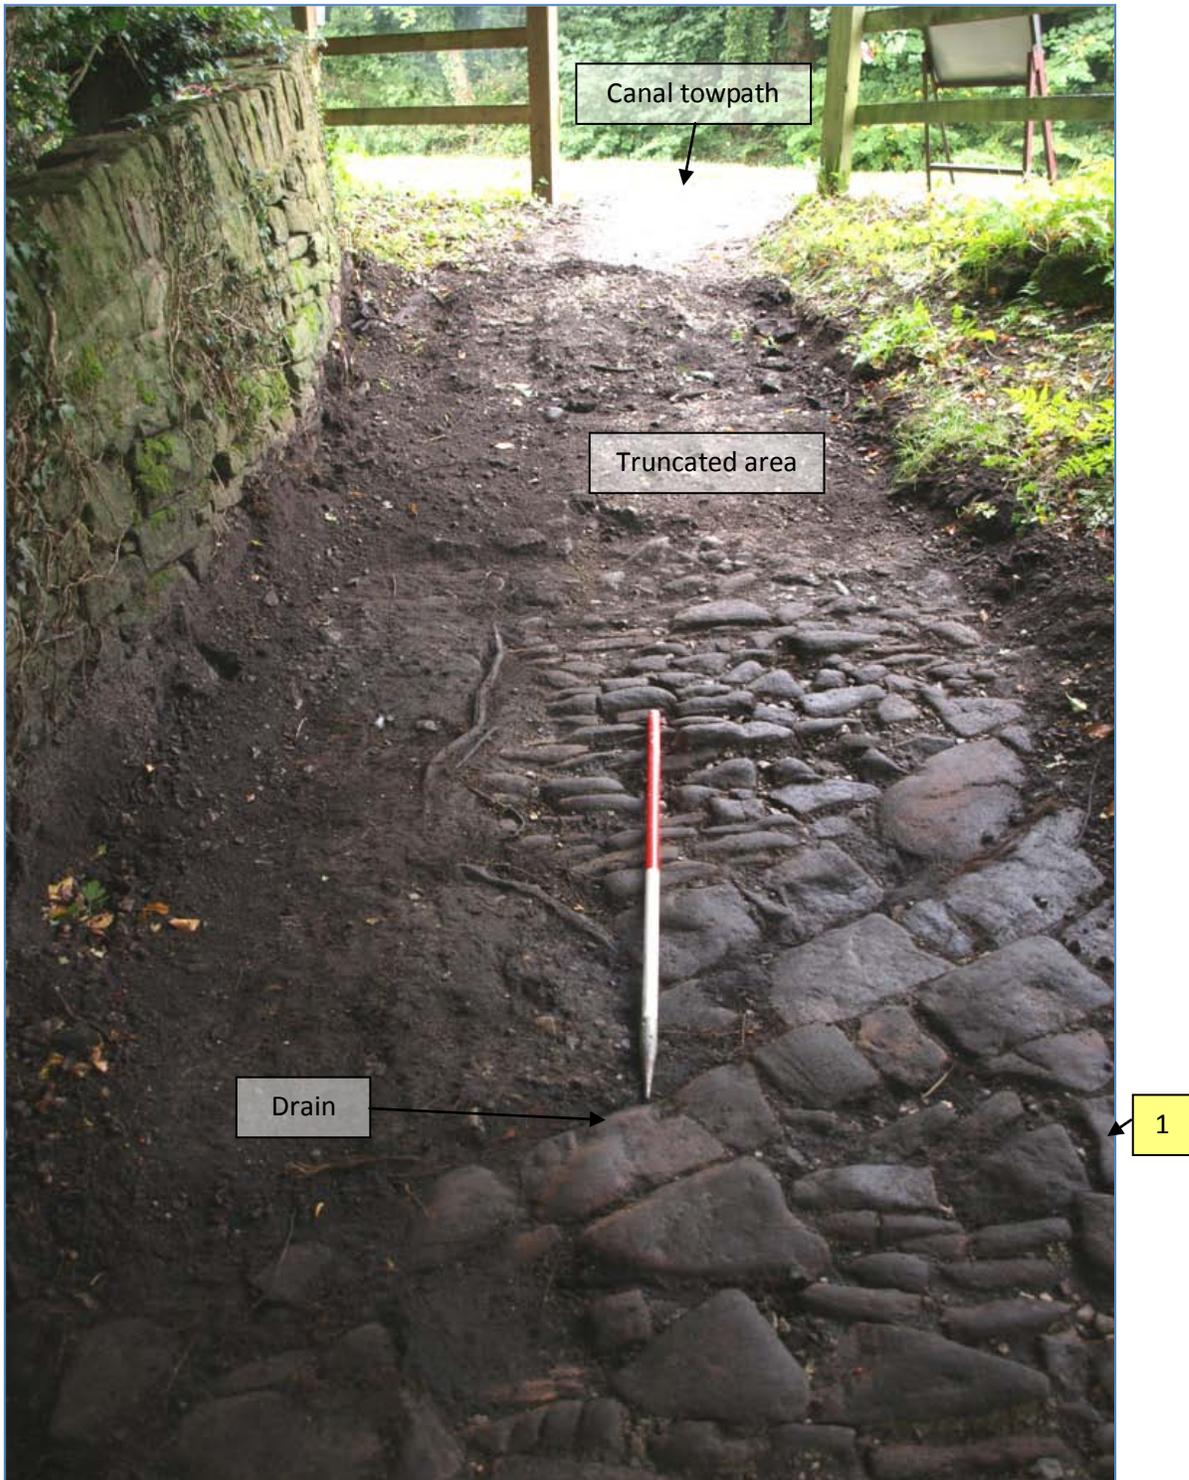
Fig. 9. Oblique view I. Looking west at the top of the ramp, showing the drain made of square setts (A), and the truncated area to the west of this (B), where the surface peters out. Stone No.1 is also visible in Figs. 10 and 11. Scale 1m.

Two drains were incorporated into the surface – one at the top using larger squared setts than the surrounding cobbles (Figs. 9, 10 and 11), and one at the bottom (Figs. 33, 34, 35 and 36).

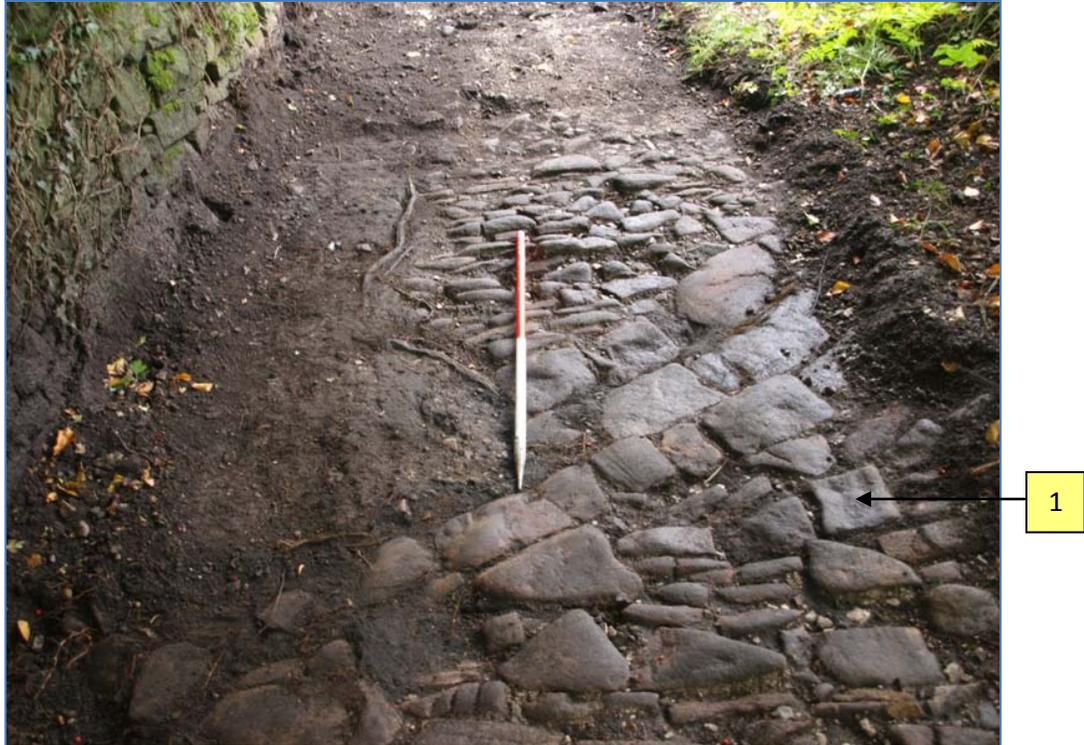
Fig. 10. Oblique view II. Looking west at the top of the ramp, showing the drain noted in Fig. 9, and the way in which the northern edge of the cobbled surface disappears under the embankment. Stone No.1 is visible in Figs. 9 and 11. Scale 1m.

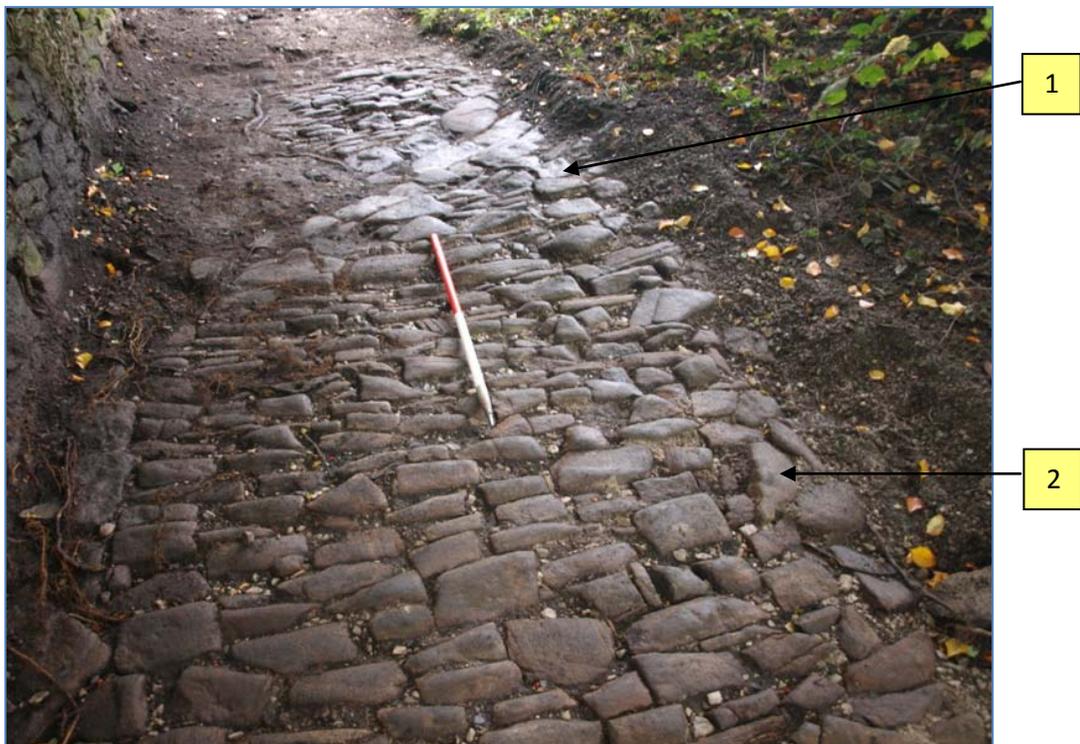
Fig. 11. Oblique view III. Looking west near the top of the ramp, with the drain noted above visible at the top of the photograph. The edging is complete from this point onwards. Stone No.1 is visible in Figs. 9 and 10; Stone No.2 is visible in Figs. 12 and 13. Scale 1m.

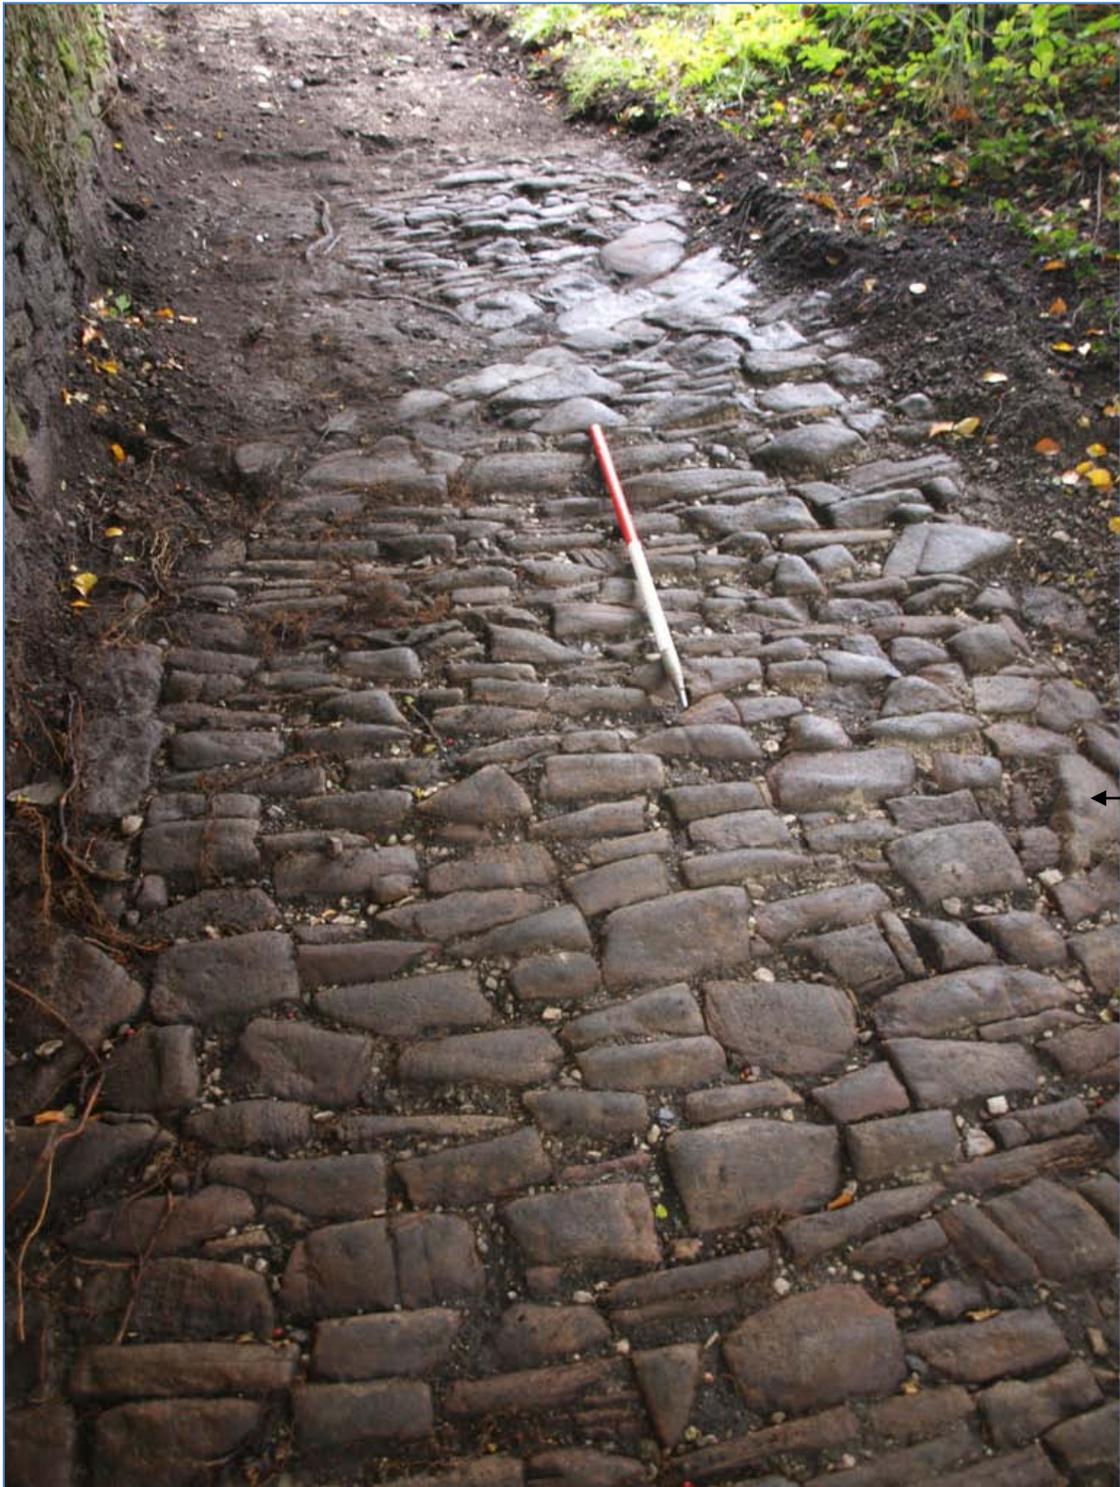
Fig. 12. Oblique view IV. Looking west near the top of the ramp. 'Levelling layers' in the cobble are evident in the immediate foreground, and at the half-metre point on the scale. Stone 2 is also visible in Figs. 11 and 13. Scale 1m.

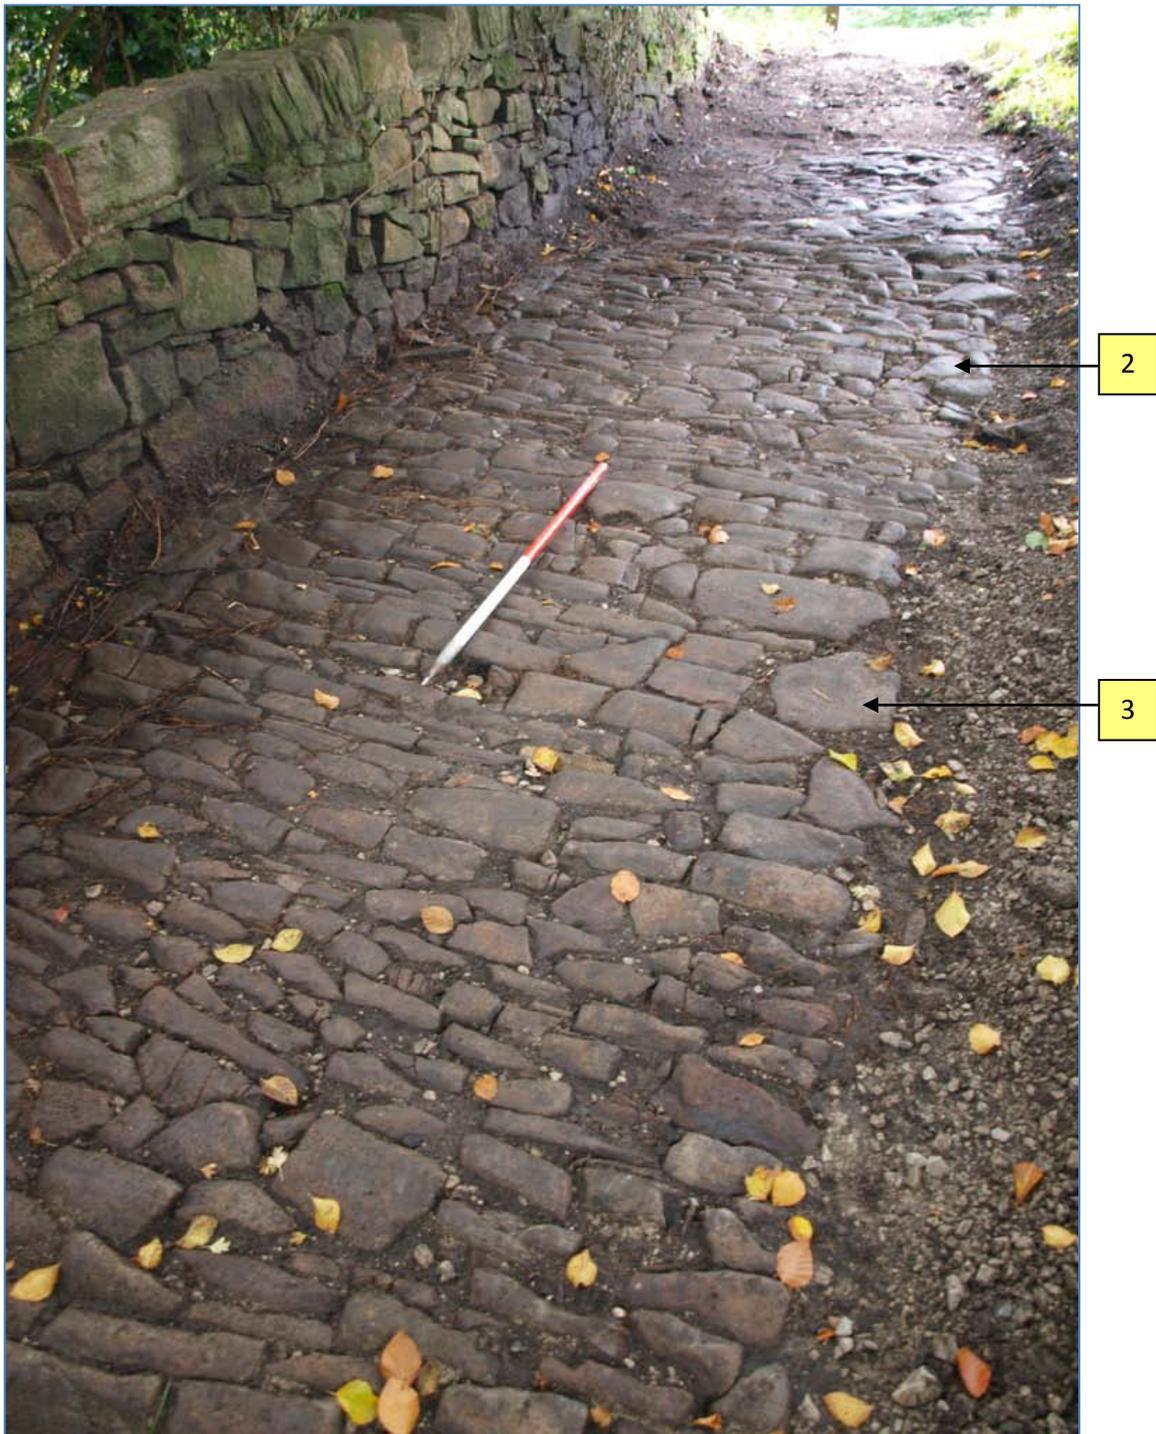
Fig. 13. Oblique view V. Looking west-south-west towards the top of the ramp. The more formal edging along the southern side (adjacent to the revetment wall) can be seen in contrast to the more random formation of the cobbled surface (see also Fig.15, overleaf). Stone 2 is visible in Figs. 11 and 12; Stone No.3 is visible in Figs. 14 and 16. Scale 1m.

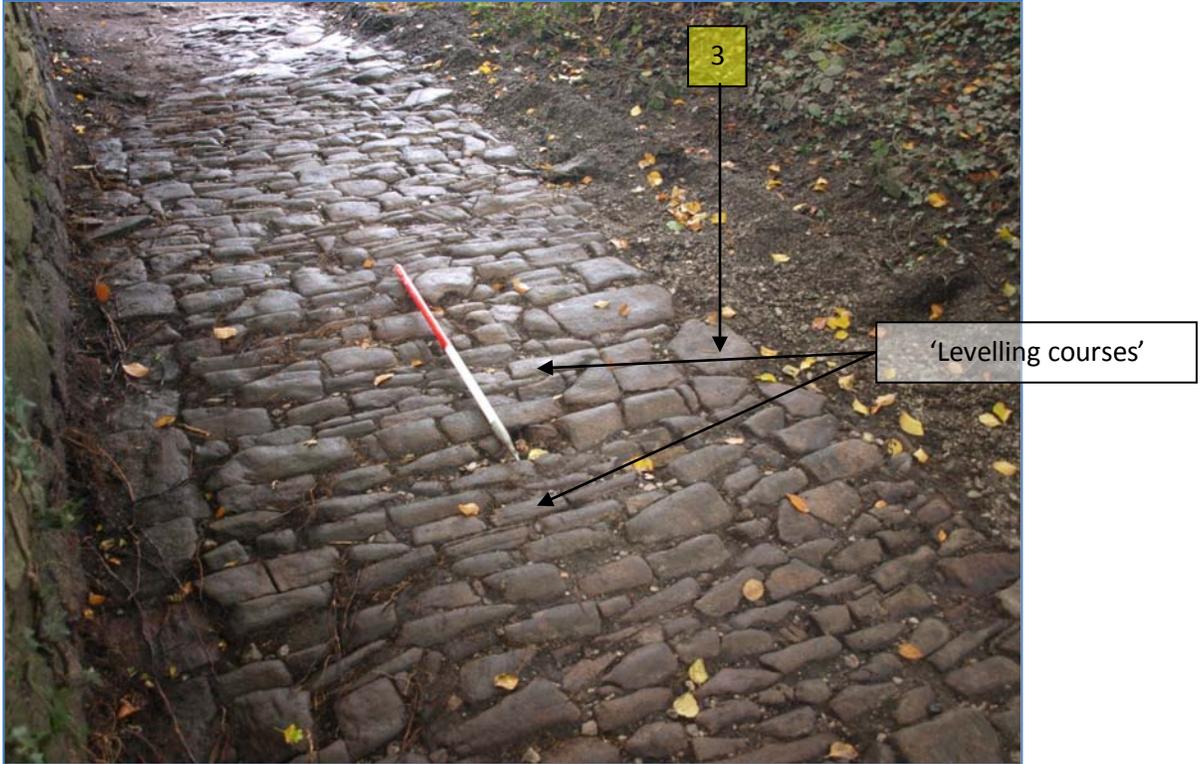
Fig. 14. Oblique view VI. Looking west towards the centre of the ramp. 'Levelling courses' are visible just this side of the scale, near the half-metre point on the scale, and also just beyond the scale. Stone No.3 is also visible in Figs. 16 and 17. Scale 1m.

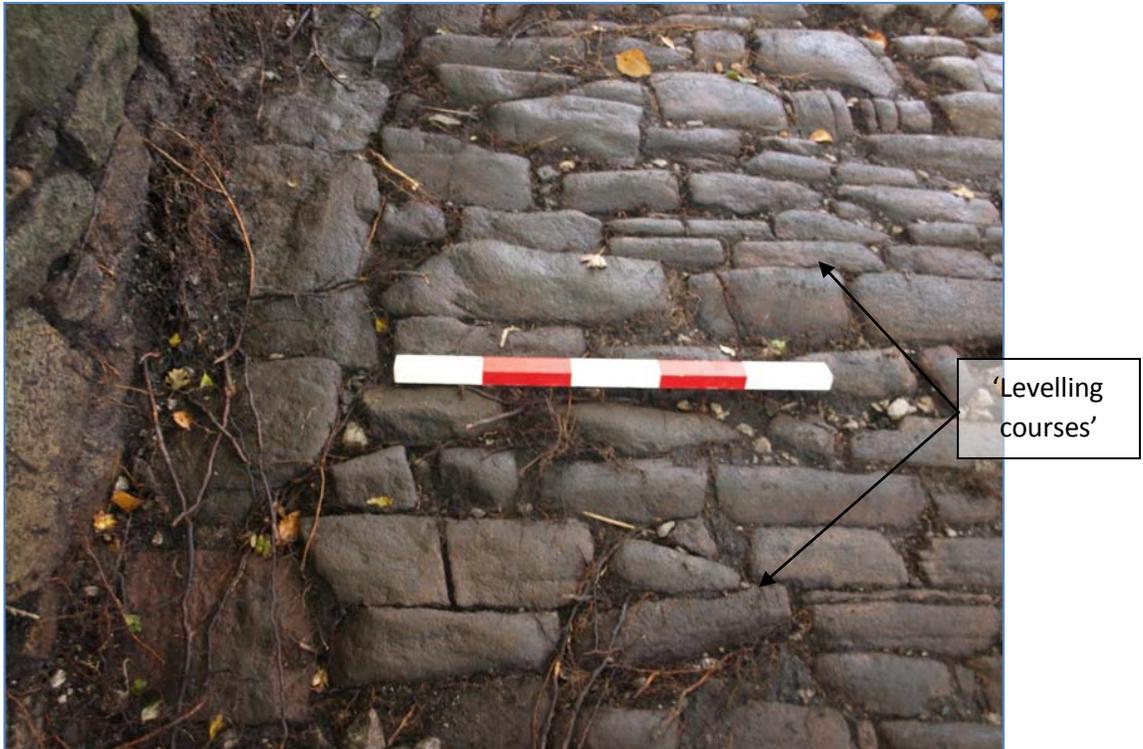
Fig. 15. Detail view I. Southern side of the ramp, showing the two 'levelling courses' indicated in Fig. 14 where they meet the edge course adjacent to the revetment wall. Scale 50cm.

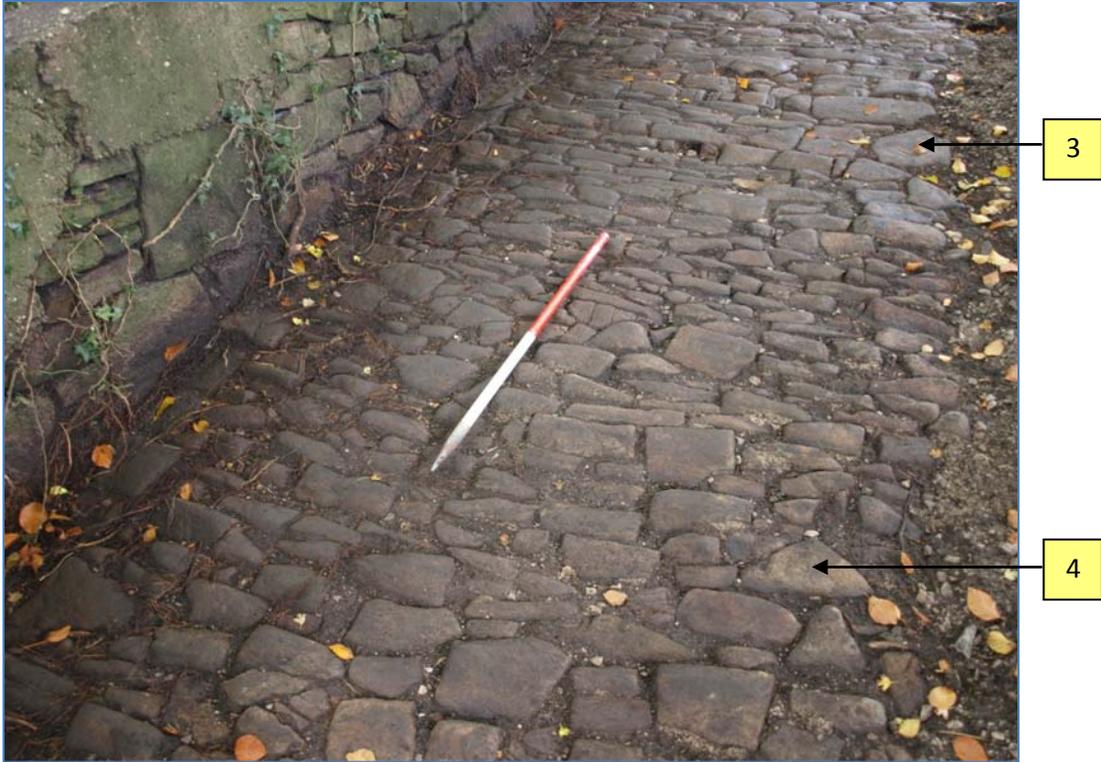
Fig. 16. Oblique view VII. Looking west-south-west from the centre of the ramp. Stone No.3 is visible in Figs. 14 and 17. Stone No.4 is also visible in Figs 17 and 18. Scale 1m.

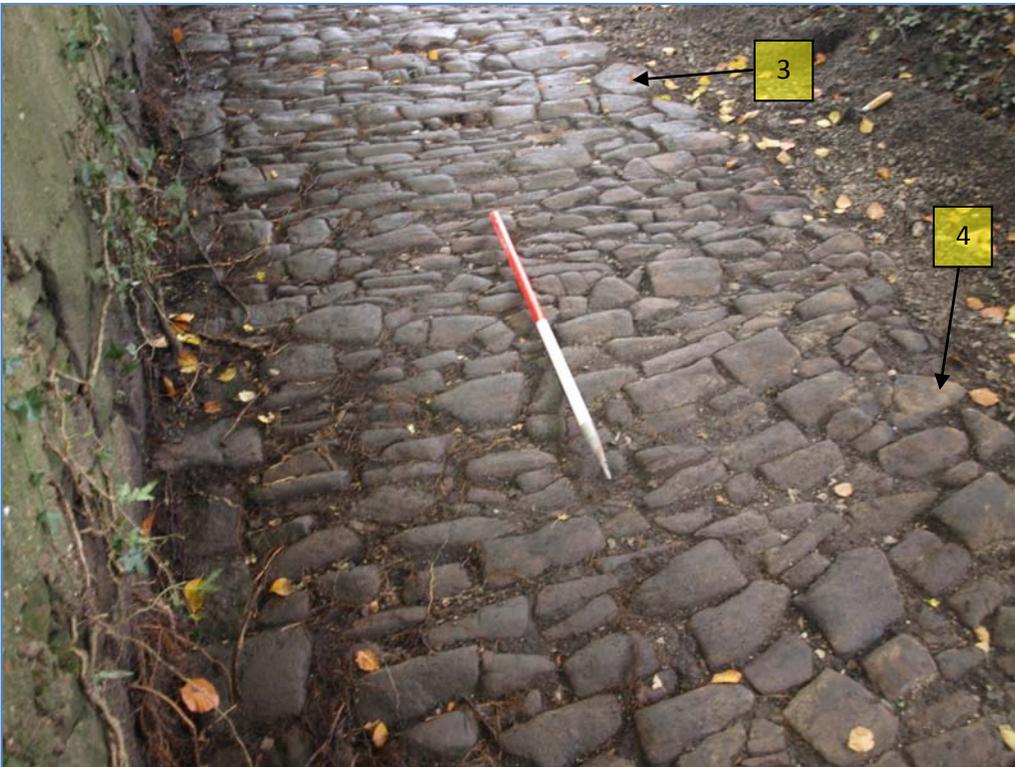
Fig. 17. Oblique view VIII. Looking west from the centre of the ramp. Stone No. 3 is visible in Figs. 14 and 16; Stone No.4 is visible in Figs 16 and 18. The cobbled surface in this area is extremely well-preserved. Scale 1m.

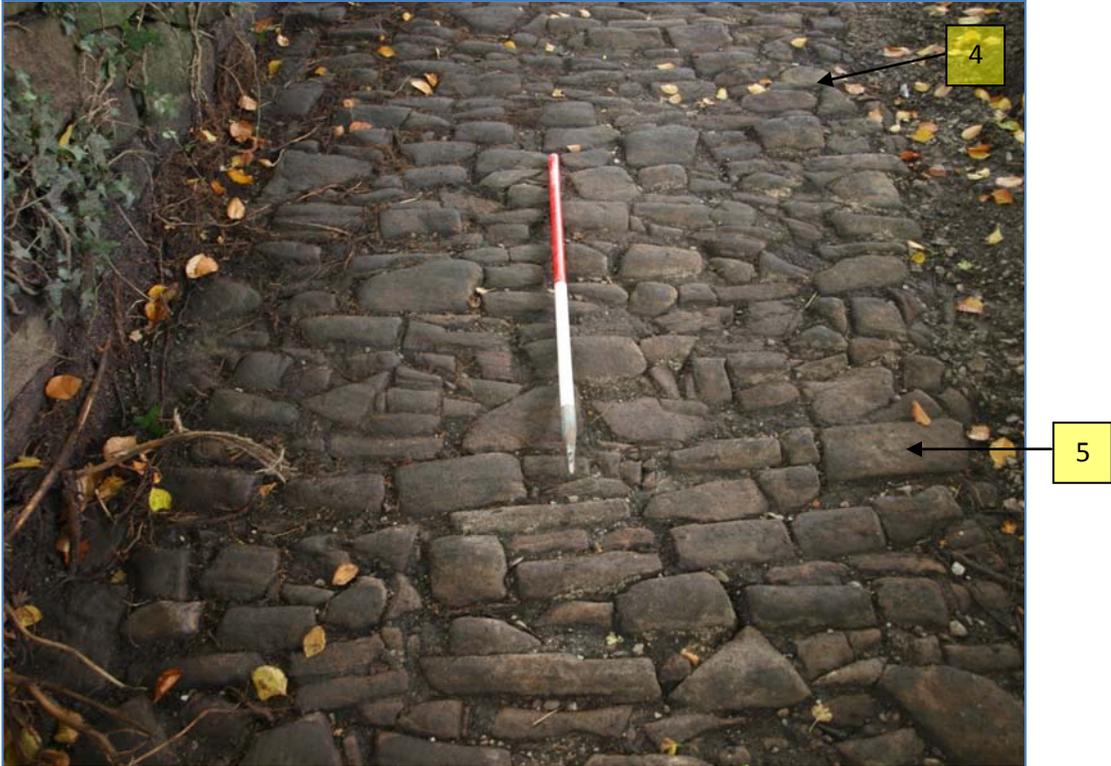
Fig. 18. Oblique view IX. Looking west from the centre of the ramp. Stone 4 is also visible in Fig. 16 and 17; Stone No.5 is visible in Figs. 19 and 20. Scale 1m.

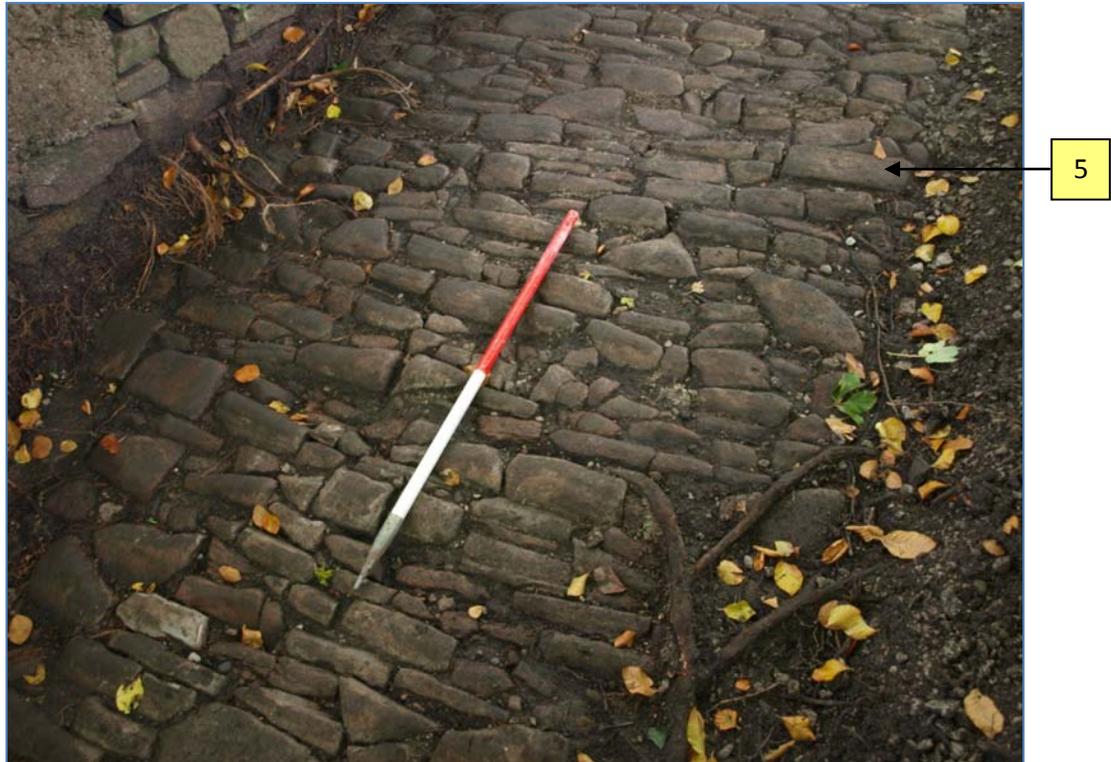
Fig. 19. Oblique view X. Looking west-south-west from the narrowest part of the ramp, just east of the mid-point. Tree-root intrusion is evident here; see also Figs. 20, 23 and 31. Stone No. 5 is also visible in Figs. 18 and 20. Scale 1m.

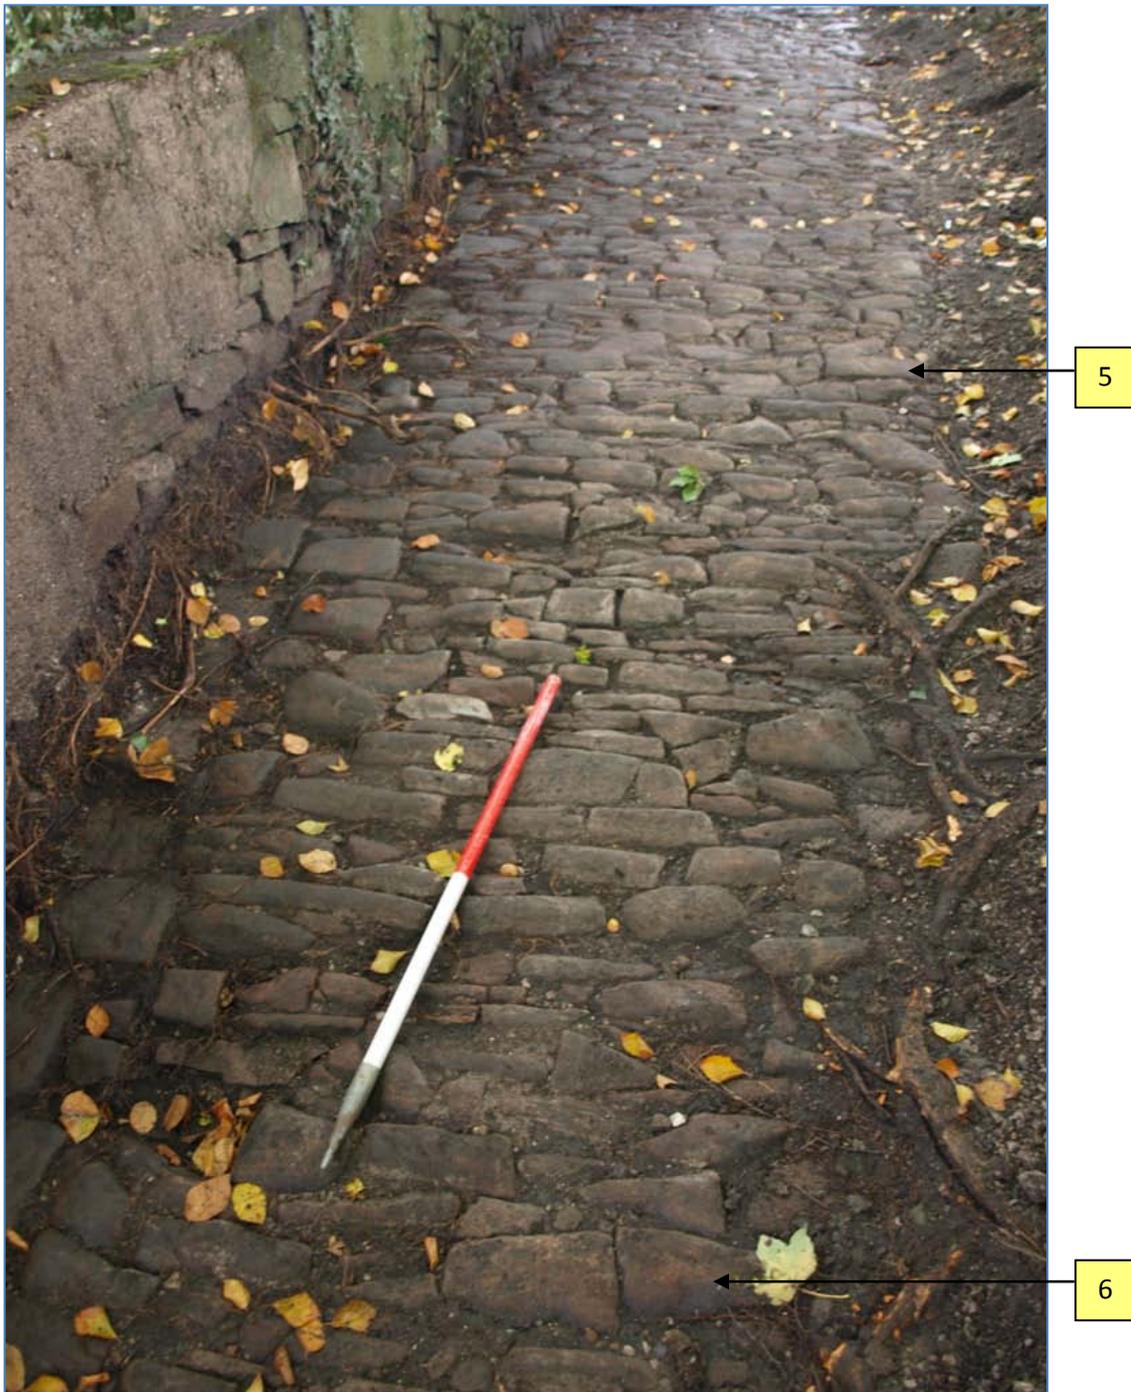
Fig. 20. Oblique view XI. Looking west from the narrow part of the ramp, just down slope from the mid-point. The tree roots on the right hand side are from a well-established beech tree which to some extent anchors the revetment between the path and the canal. However it does also significantly shade the ramp, and the roots are intrusive. The revetment wall has been rebuilt and faced with a roughcast concrete render from this point for a distance of approximately 1.8m. Stone No.5 is also visible in Figs. 18 and 19; Stone No.6 is also visible in Figs. 21, 22 and 23. Scale 1m.

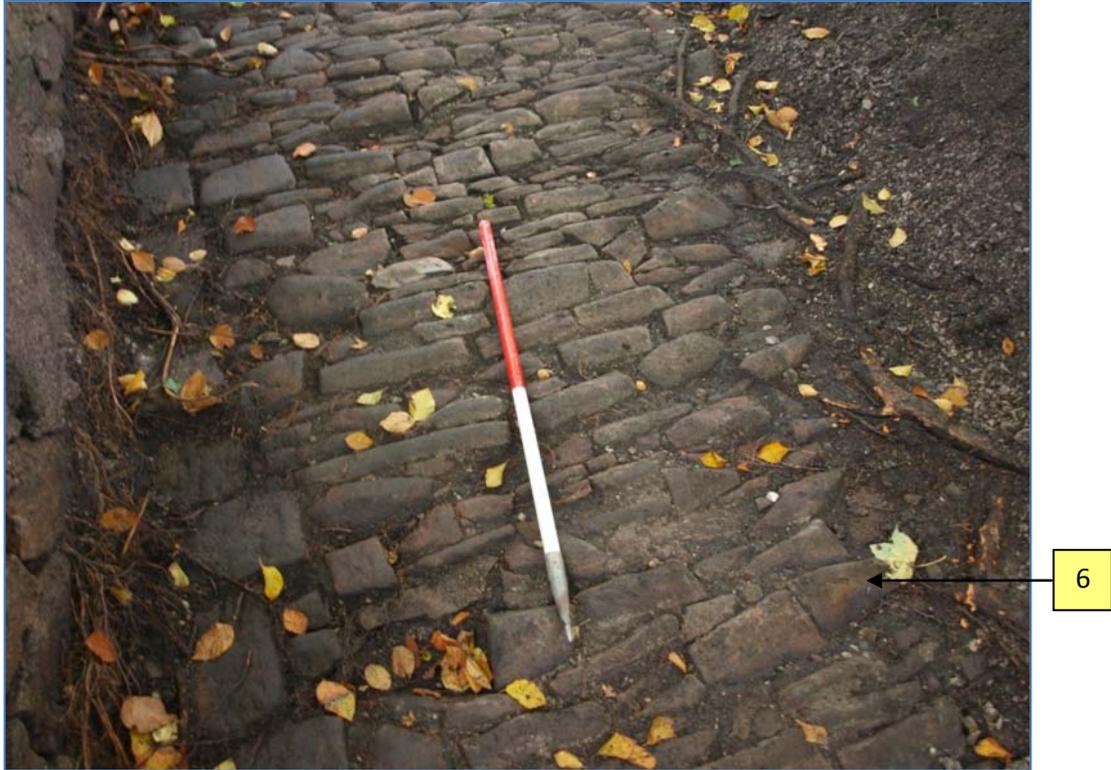
Fig. 21. Oblique view XII. Looking west from near the centre point. Stone No.6 is also visible in Figs. 20, 22 and 23. Scale 1m.

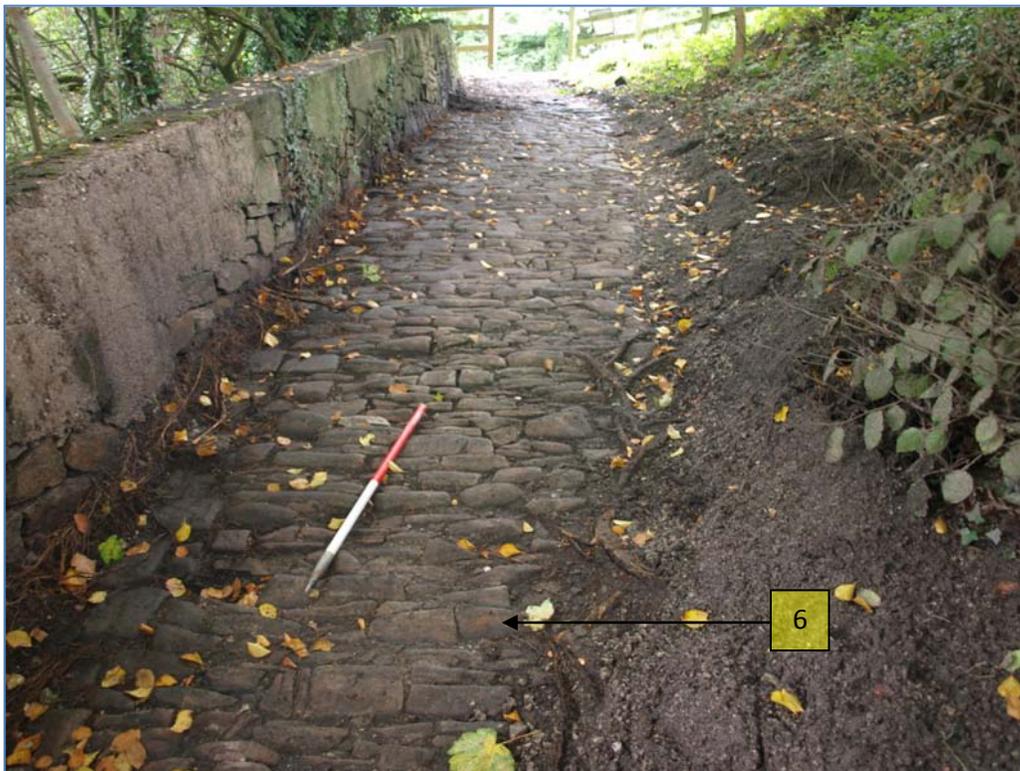
Fig. 22. Oblique view XIII. Looking west from near the centre point. The canal towpath is visible in the background. Note also the extent of cement repairs to the south revetment wall. Stone No.6 is also visible in Figs. 20, 22 and 23. Scale 1m.

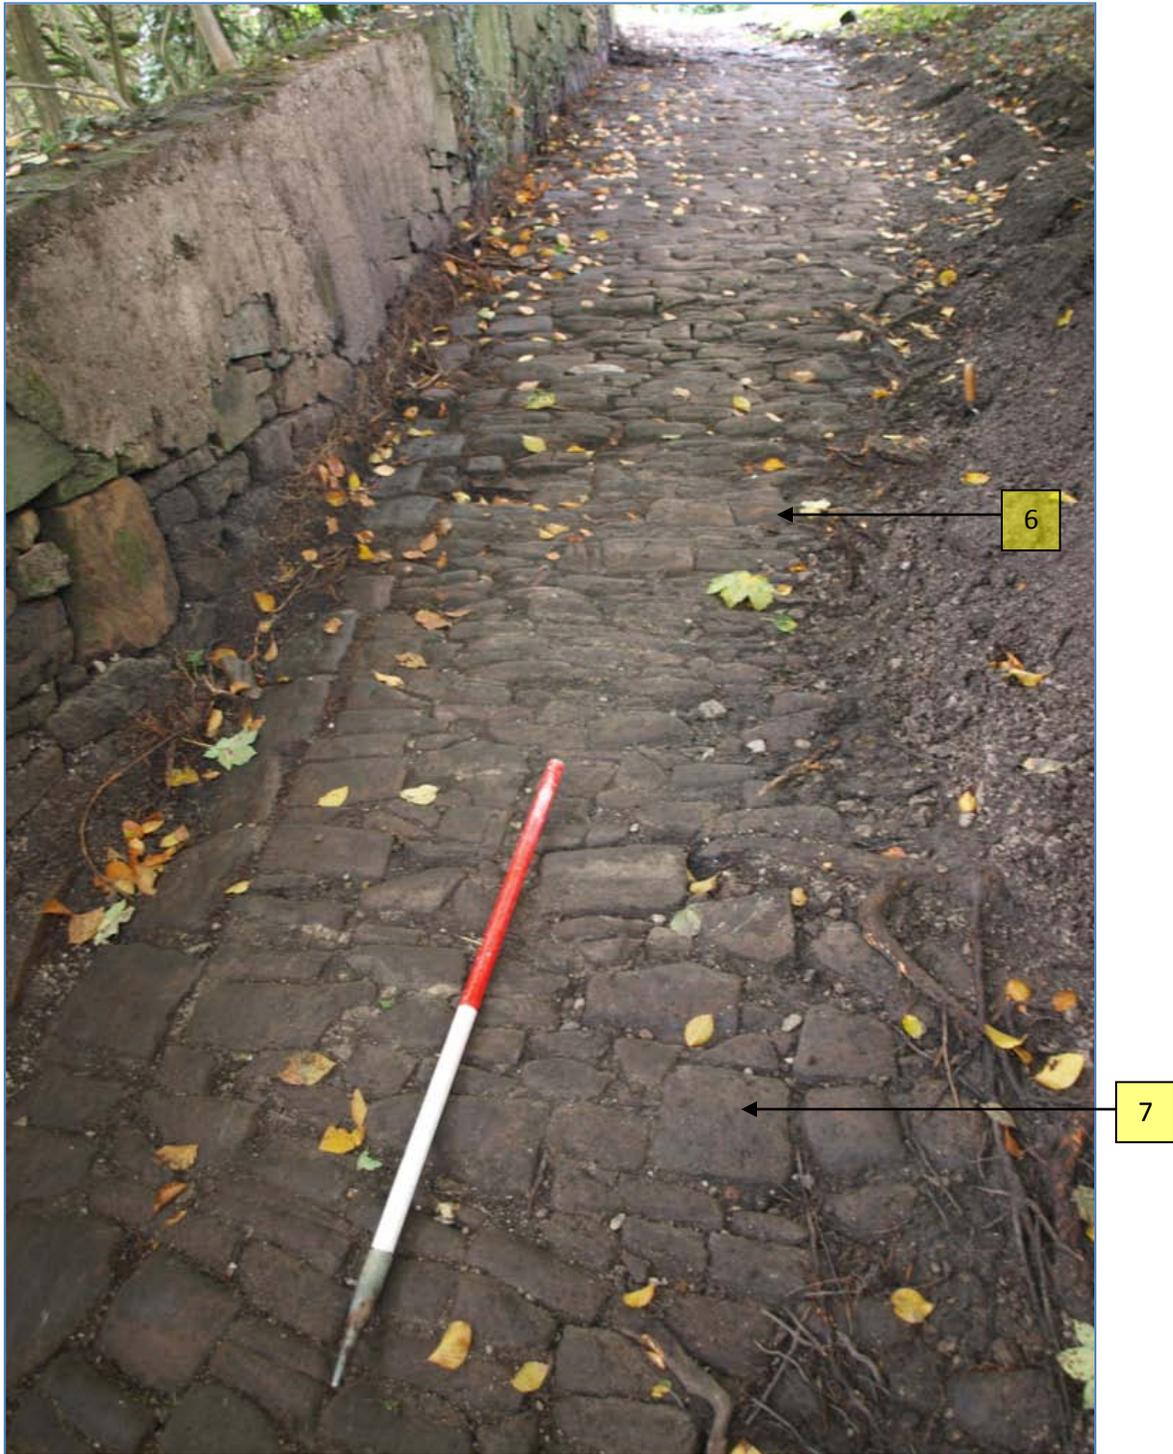
Fig. 23. Oblique view XIV. Looking west at the point where the revetment wall diverges from the cobbled surface. The continuation of the stone edging can be seen to the left of the photograph. See also Figs. 24, 25 and 26. Stone No.6 is also visible in Figs. 20, 21 and 22. Stone No.7 is also visible in Figs. 24 and 25. Scale 1m.
