Whaley Bridge Horse Tunnel Peak Forest Canal Derbyshire

Photographic Recording

Report No: 3043.R02

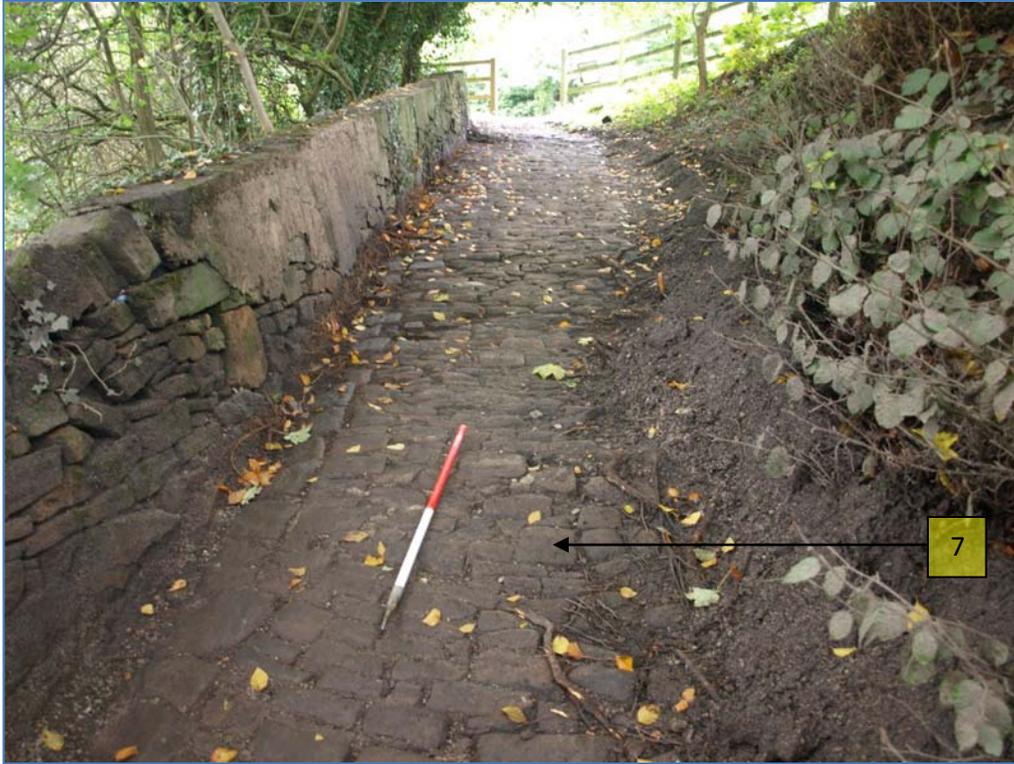
Fig. 24. Oblique view XV. Looking west near the point where the revetment wall diverges from the cobbled surface. Stone No.7 is visible in Figs. 23 and 25. Scale 1m.

The uppermost 2m or so of the cobbled surface was partly truncated, notably on its southern side along the retaining wall (Figs. 7, 8 and 10). There were also some patches in the lower 5m which were damaged by tree roots and other ground movement (Figs. 19, 21, 24, 31, 32, 33, 34 and 35).

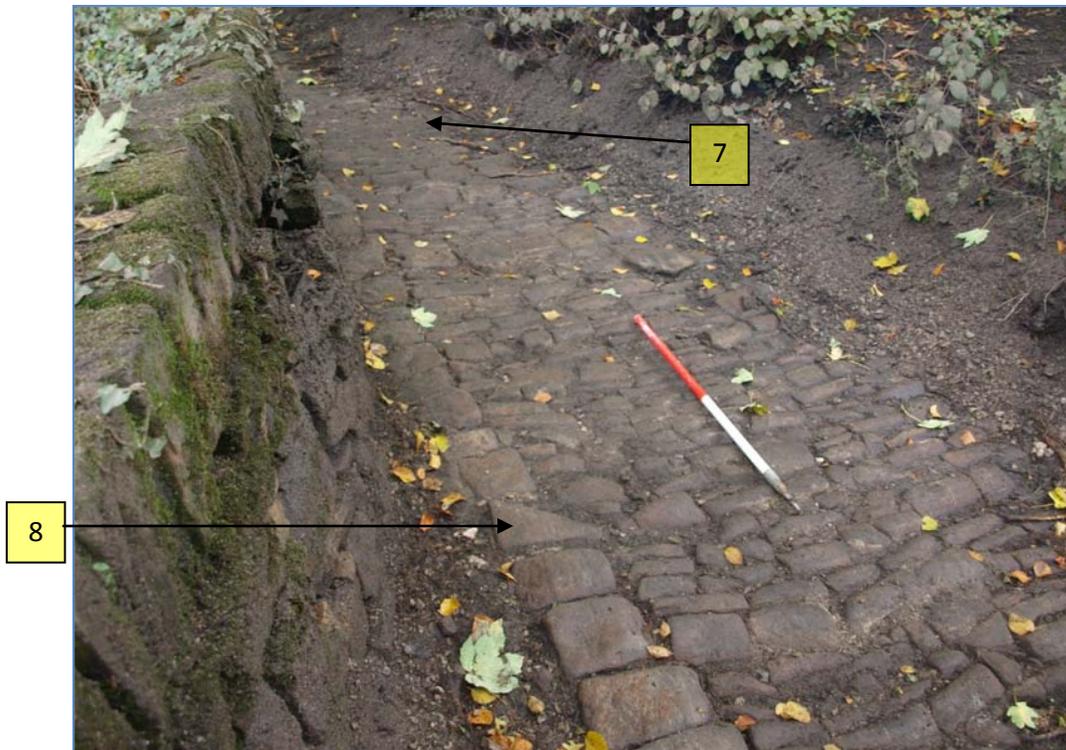
Fig. 25. Oblique view XVI. Looking north-west near the point where the revetment wall diverges from the cobbled surface. Stone No.7 is also visible in Figs. 23 and 24; Stone No.8 is also visible in Figs. 26, 28 and 29.

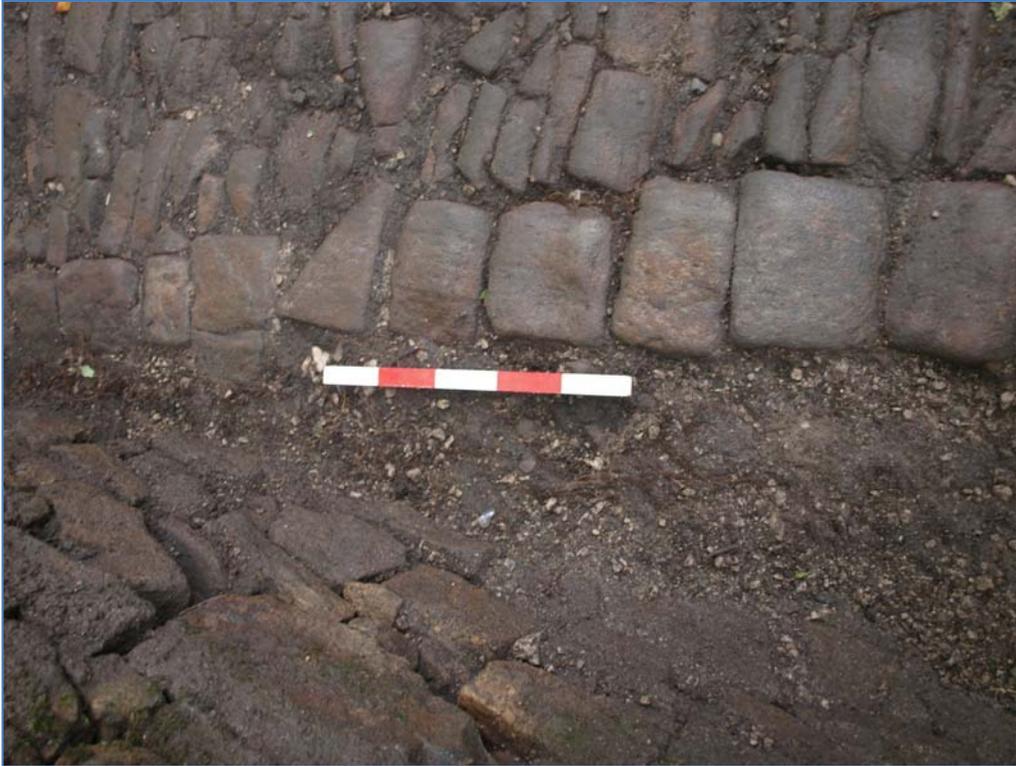
Fig. 26. Detail view II. Stone edging at the point where the wall and cobbled surface diverge. North is at the top of the photograph. Stone No.8 is evident at the left-hand end of the scale. Scale 50cm.

The south ramp exhibited two distinct zones of character (Fig. 8). The lower section, comprising the first 4m or so, consisted of very regular square or rectangular sandstone setts, on average 150-200mm x 150-200mm. This was bounded at the eastern (bottom) end by two large sandstone blocks, measuring 680 x 270mm and 760 x 250mm in plan (Figs. 37 and 38). The upper section was paved with a more random selection of variously-shaped cobbles, occasionally 'brought to courses' by the insertion of a row of more regularly-shaped stones (Fig. 27). The edge of the more randomly laid upper section was, however, neatly edged with larger more regularly-shaped setts. This edging was evident both where the ramp abutted the revetment wall (Fig. 15), and where it deviated away from it (Fig. 26).

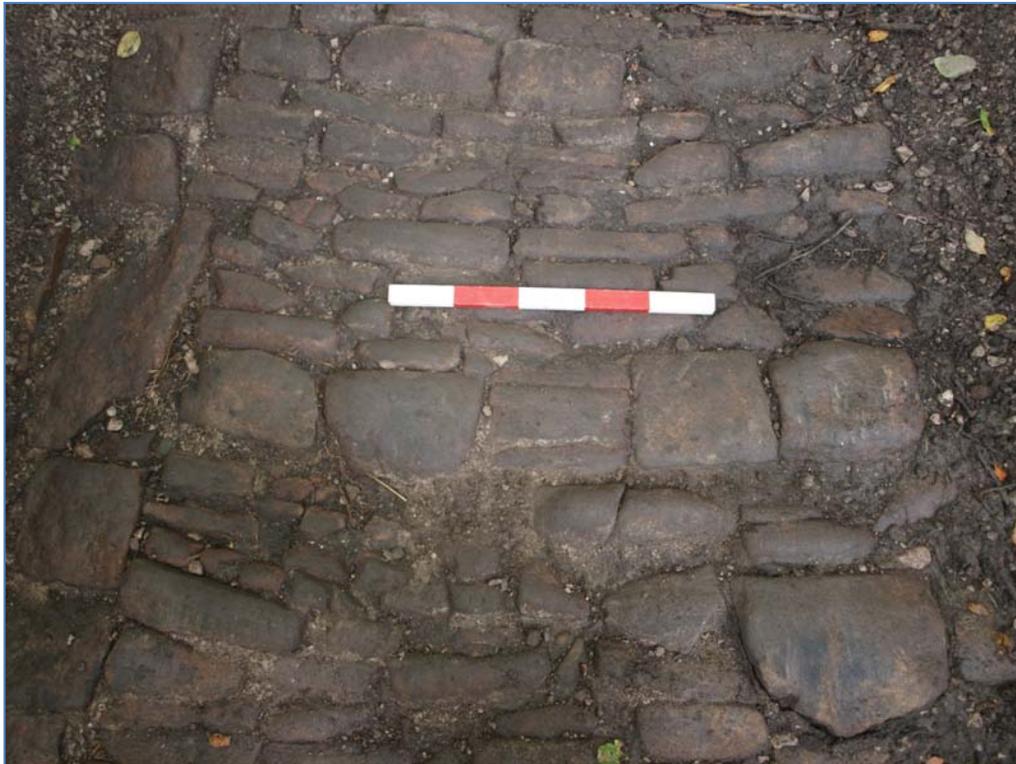
Fig. 27. Detail view III. 'Levelling course' of large blocks. The location of this is marked on Fig. 28, below. West is at the top of the photograph. Scale 50cm.

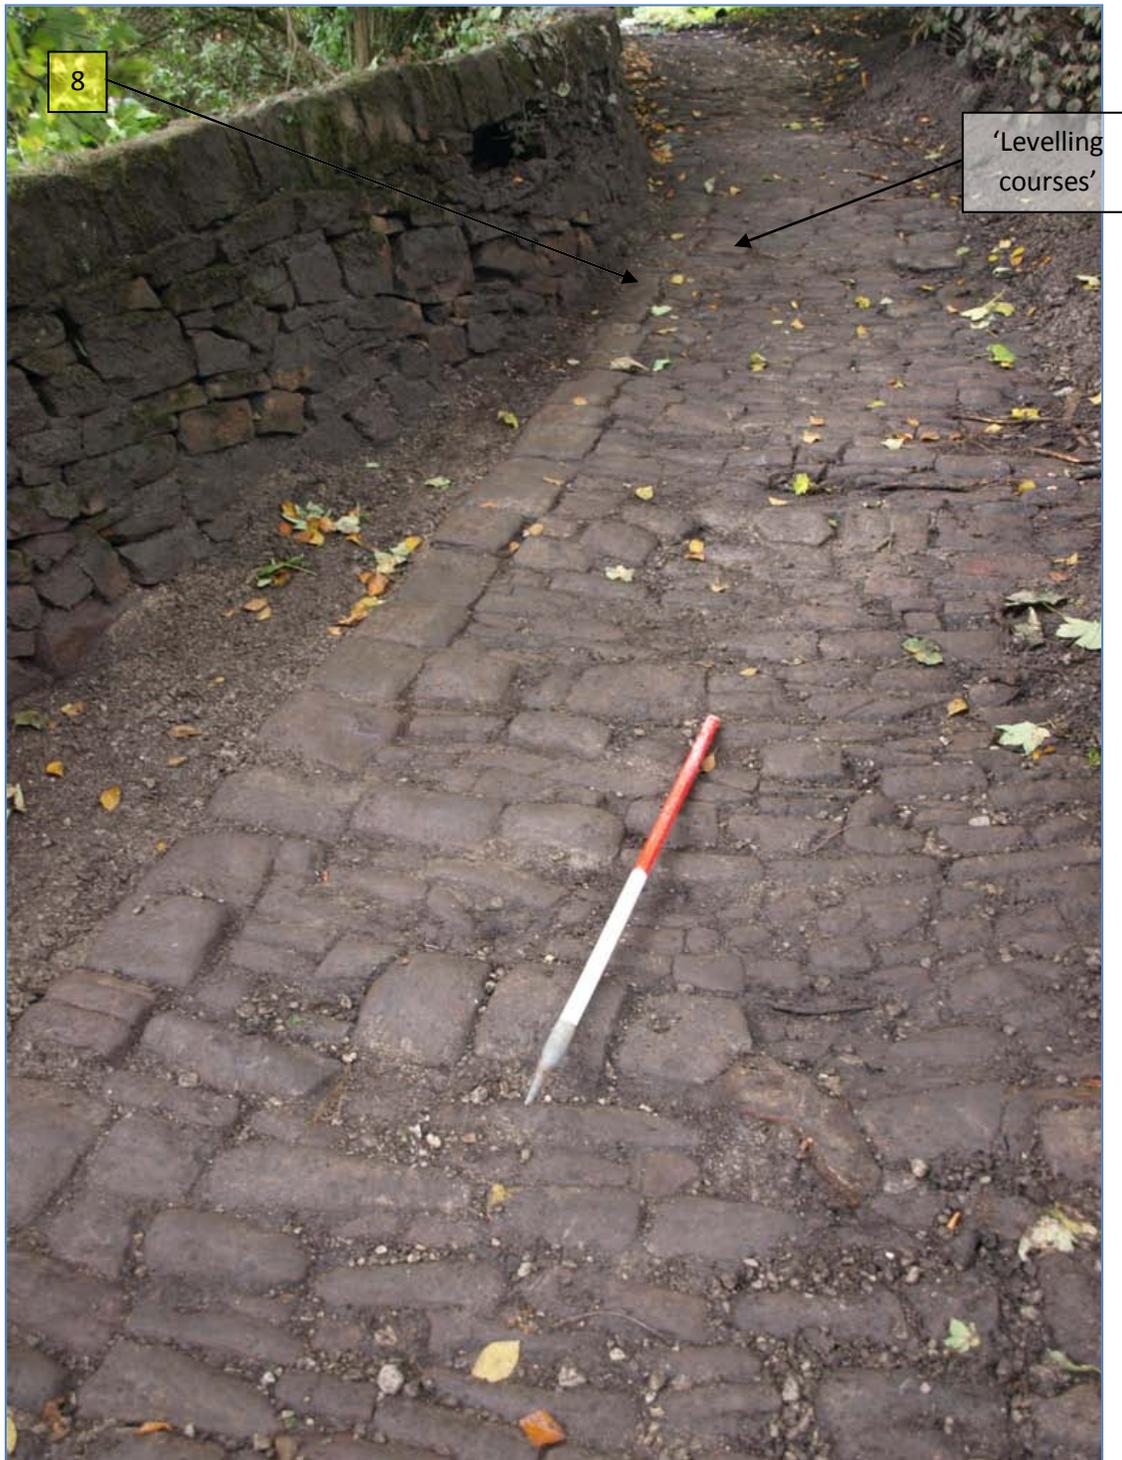
Fig. 28. Oblique view XVII. Looking west from the lower section of the ramp. Showing the divergence of the cobbled surface from the revetment wall. The 'levelling course' shown in Fig. 27 is marked. Stone No.8 is also visible in Figs. 25, 26 and 29. Scale 1m.

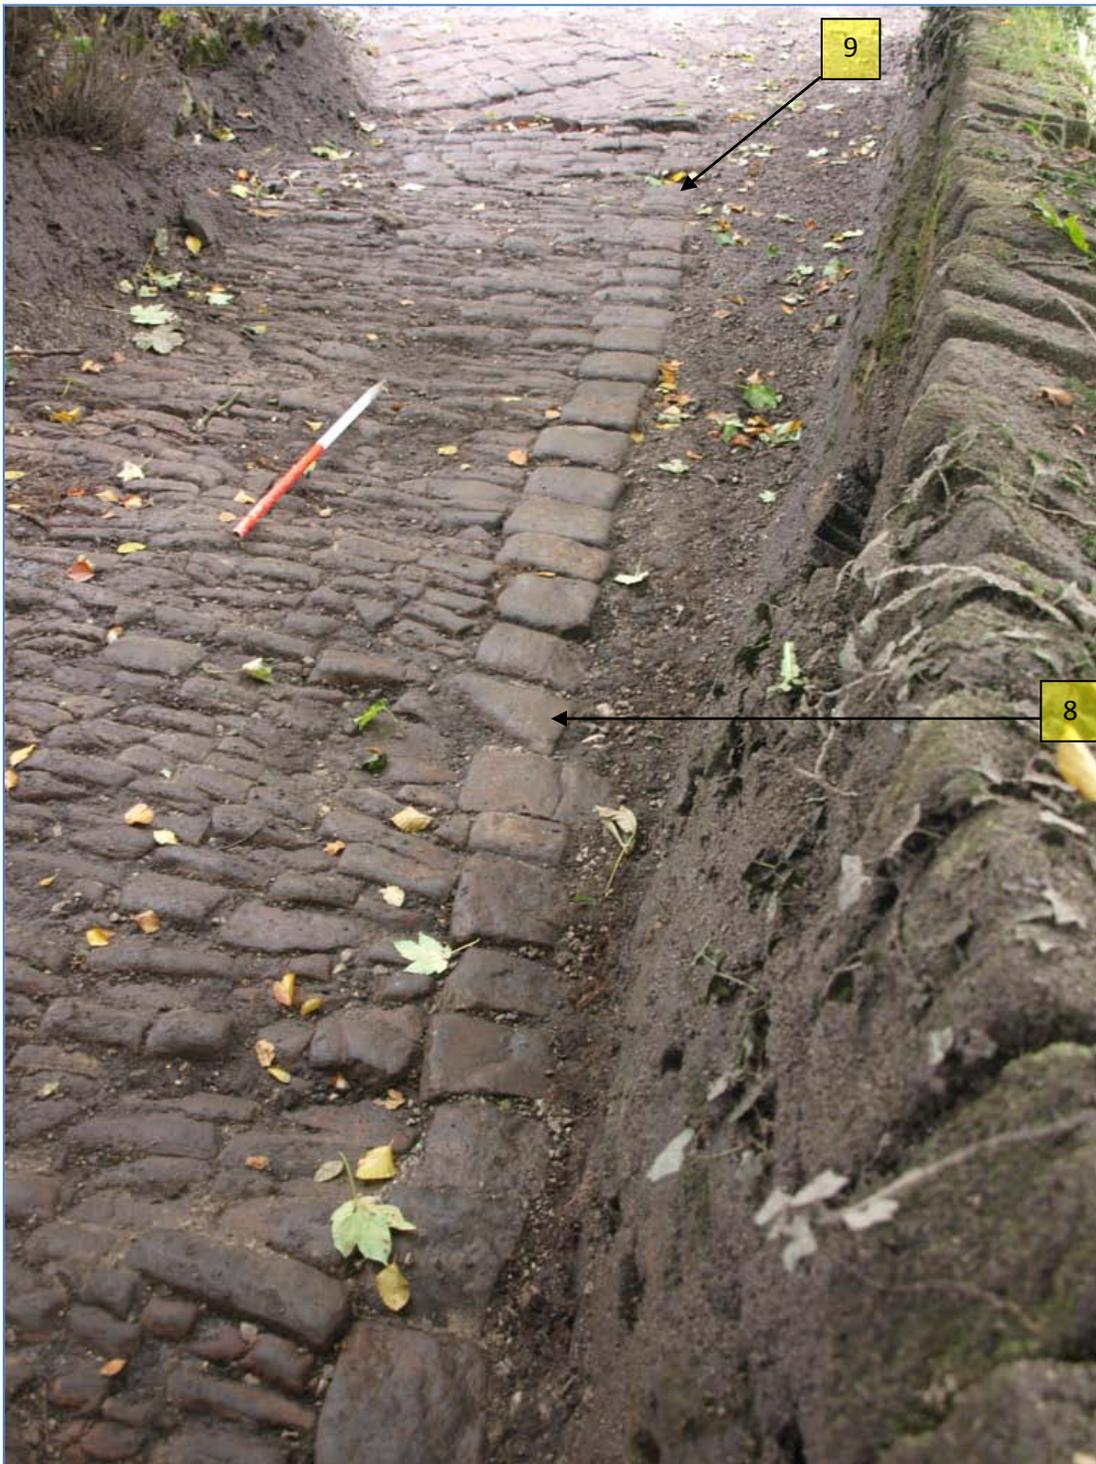
Fig. 29. Oblique view XVIII. Looking east towards the base of the ramp. This view shows the divergence of the cobbled surface from the revetment wall (right), the well-ordered stone edging to the south side of the ramp, the change in character at the base of the ramp, and the more northerly orientation of the lower part of the ramp. Stone No.8 is also visible in Figs. 25, 26 and 28. Stone No.9 is also visible in Figs. 30, 32, 33 and 34. Scale 1m.

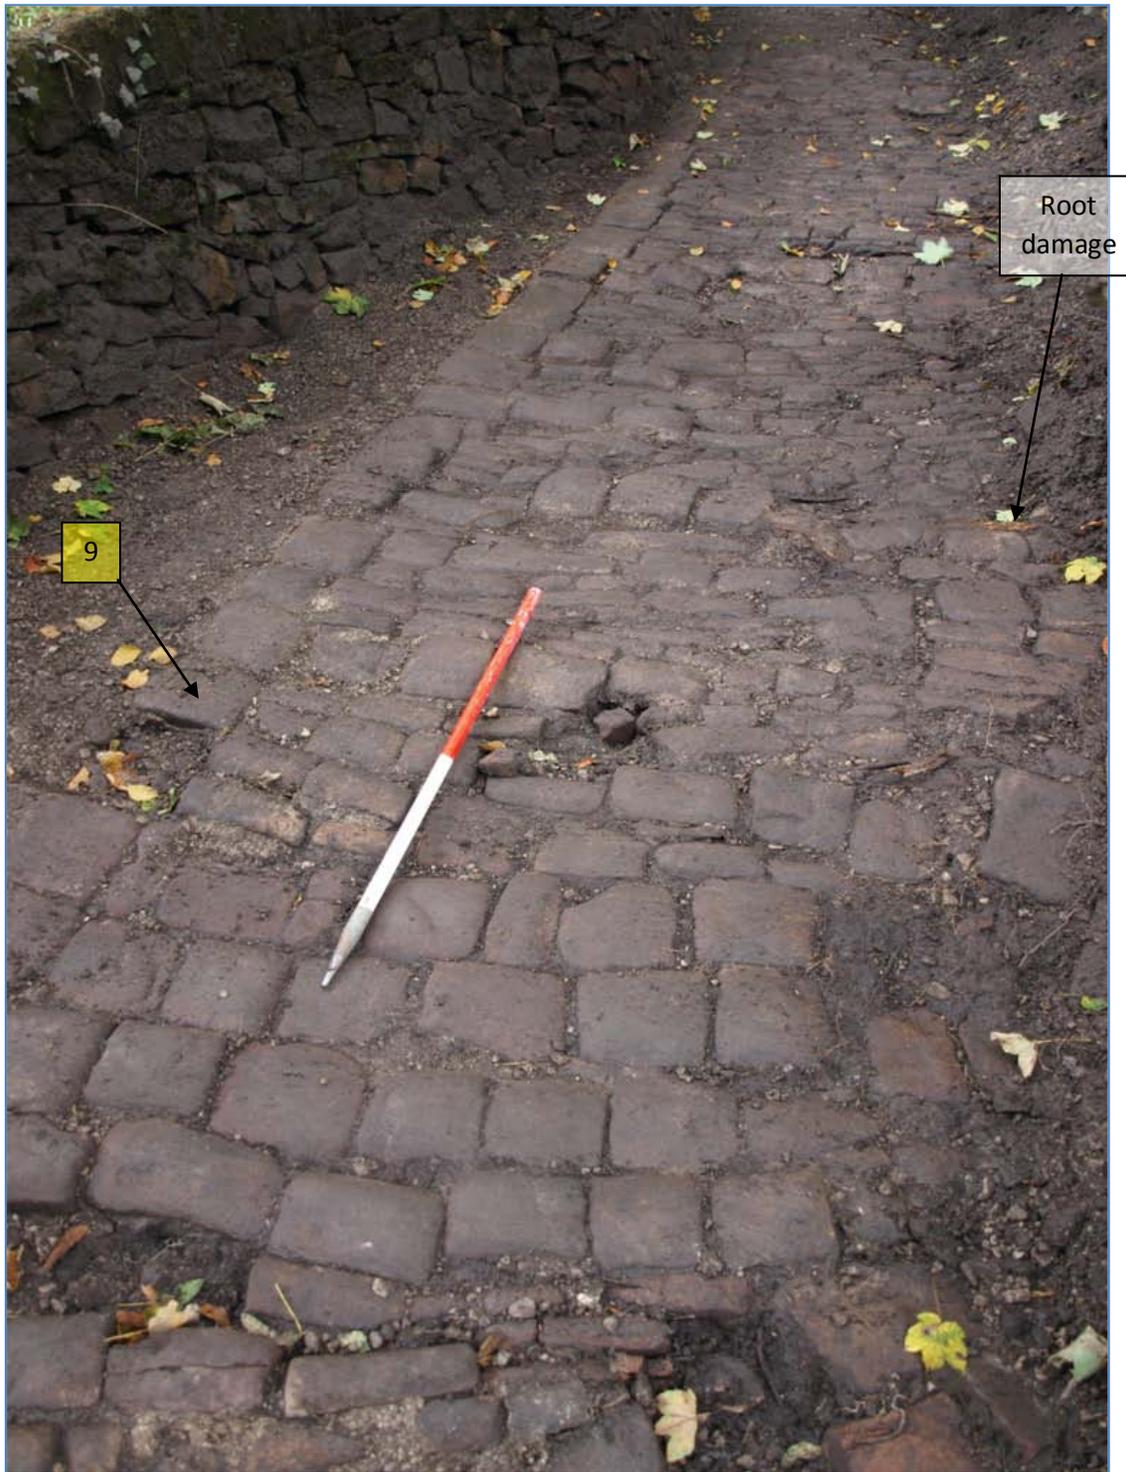
Fig. 30. Oblique view XIX. Looking west from near the base of the ramp. This shows the area of transition between the large square blocks at the base and the more random cobbles of the remainder of the ramp. The location of the root damage shown in Fig. 31 overleaf is noted. A stone block is missing from the edging just to the east of Stone No.9; at the time of survey this had been recovered and was placed on the revetment wall (see Fig. 6). Detail of this damaged area is shown in Fig. 32. Stone No.9 is also visible in Figs. 29, 32 and 33. Scale 1m.

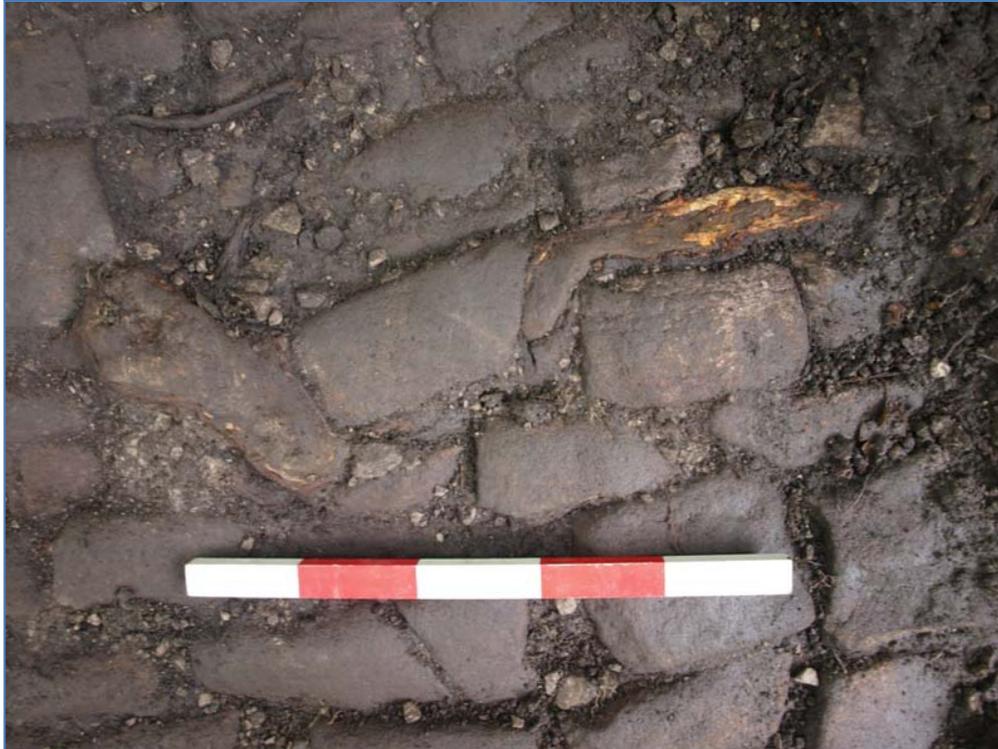
Fig. 31. Detail view IV. Root damage. The location of this is indicated in Fig. 30. North is to the right of the photograph. Scale 0.5m.

Remediation work should retain the surviving surface wherever possible, and where possible should seek to replace damaged or missing areas with material of the same character. In particular any new paving should reflect the original differences in character between upper and lower parts of the ramp.

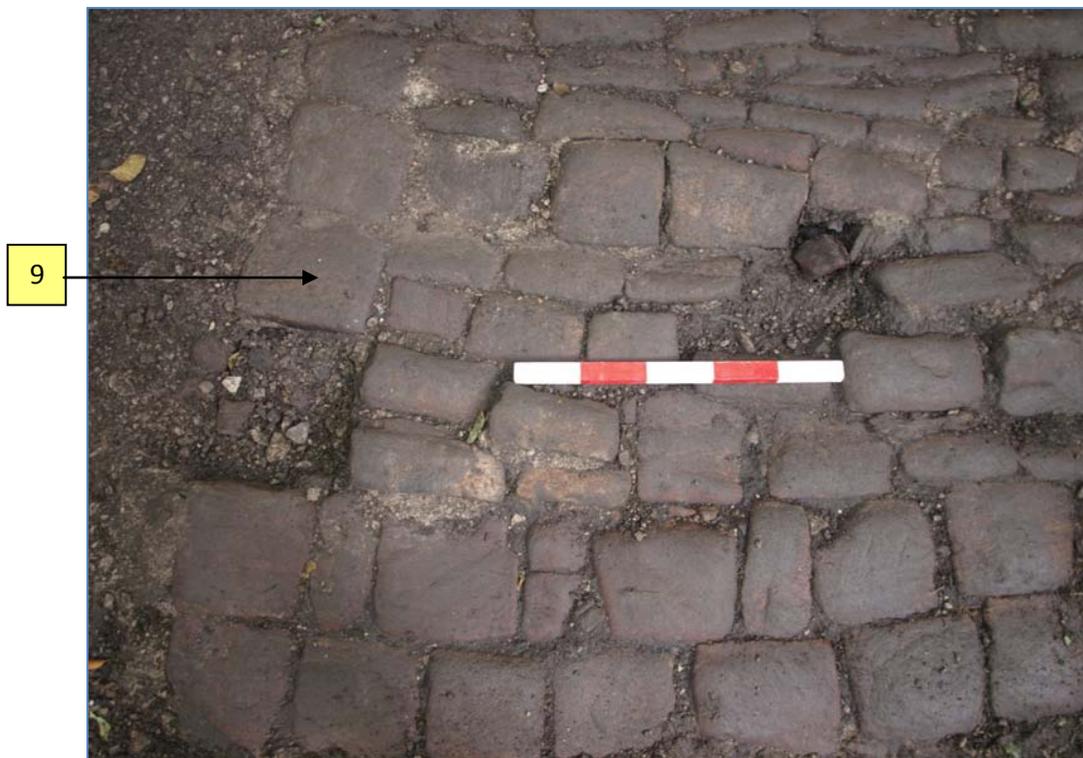
Fig. 32. Detail view V. Damage to cobbles in the lower part of the ramp. The missing edge stone is discussed in the caption for Fig. 30, above; Stone No.9 is also visible in Figs.29, 30 and 33. West is to the top of the photograph. Scale 50cm.

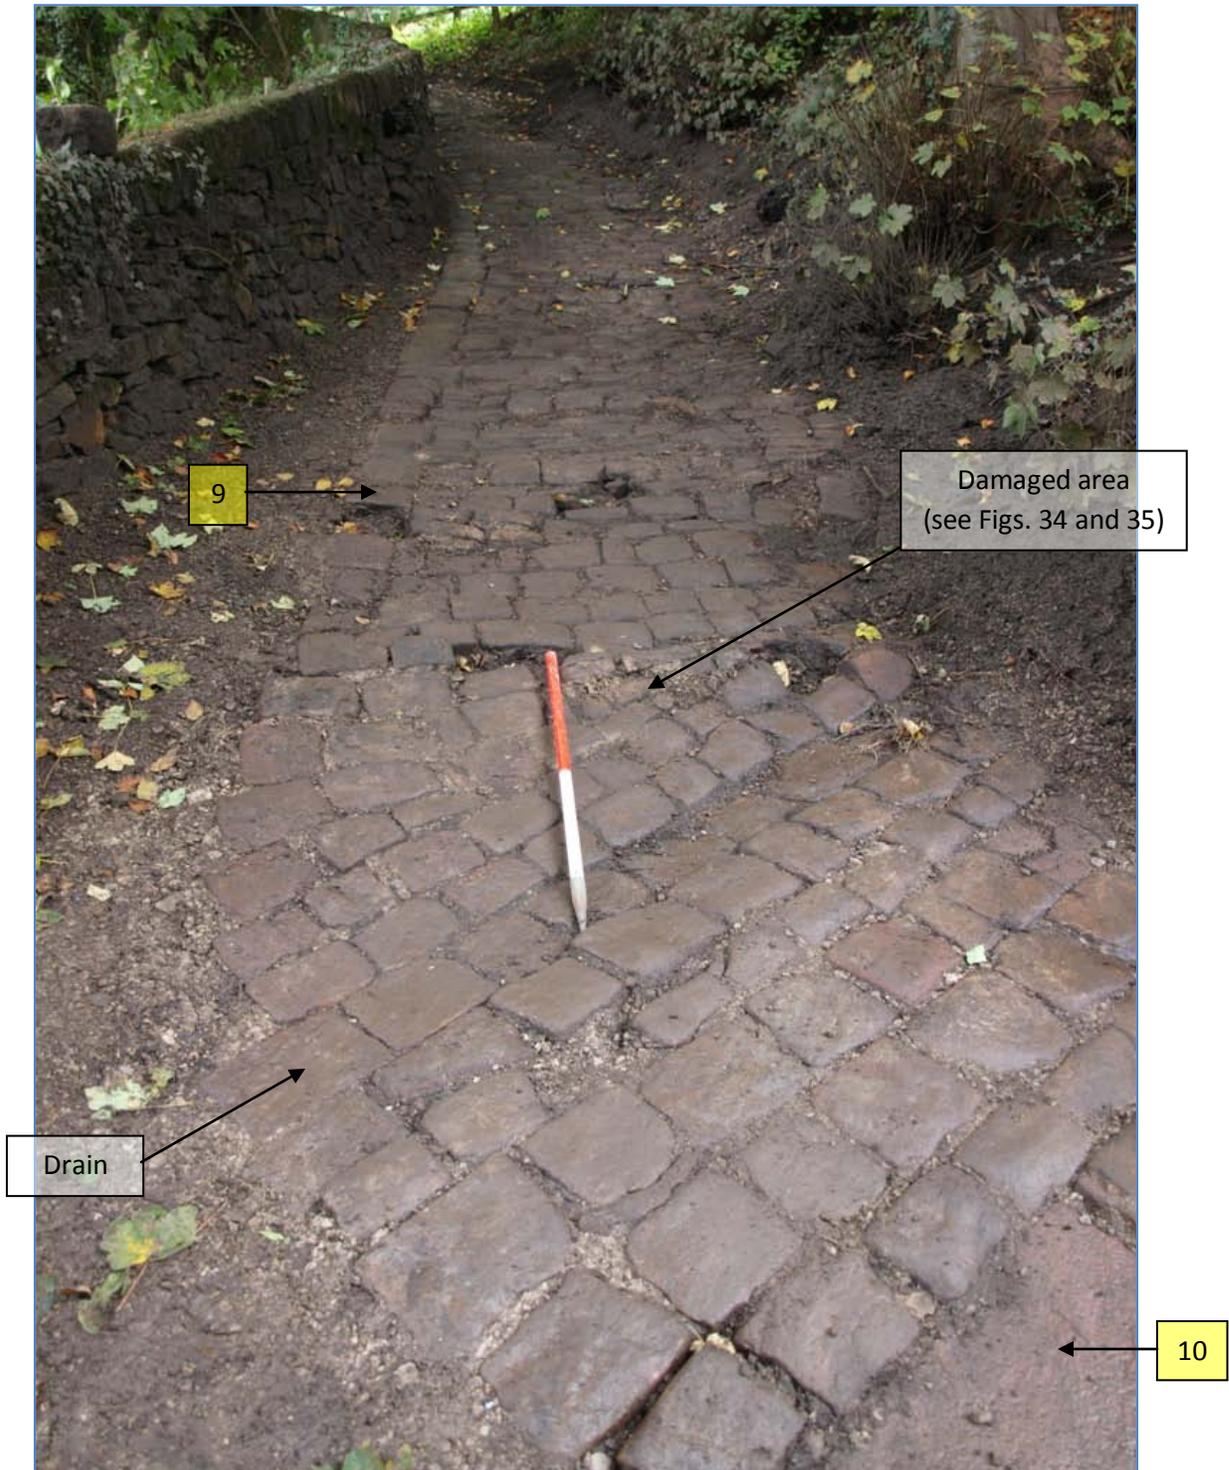
Fig. 33. Oblique view XX. Looking west from the base of the ramp, showing areas of damage noted in Figs. 32 above and 34 and 35 below. Note also the bottom drain. Stone No.9 is also visible in Figs. 29, 30 and 32 above; Stone No.10 is also visible in Figs. 37 and 38. Scale 1m.

Two drains were incorporated into the surface – one at the top using larger squared setts than the surrounding cobbles (Figs. 9, 10 and 11), and one at the bottom (Figs. 33, 34, 35 and 36).

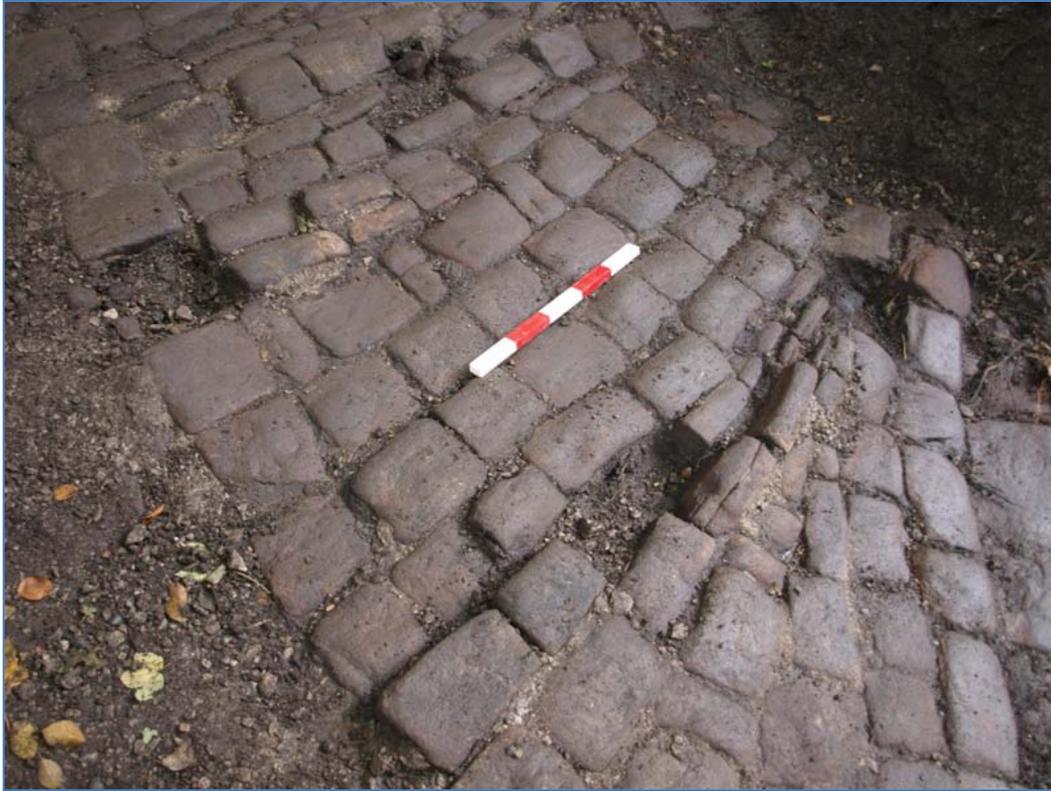
Fig. 34. Detail view VI. Damage to setts near the base of the ramp. View looking north-west. Scale 50cm.

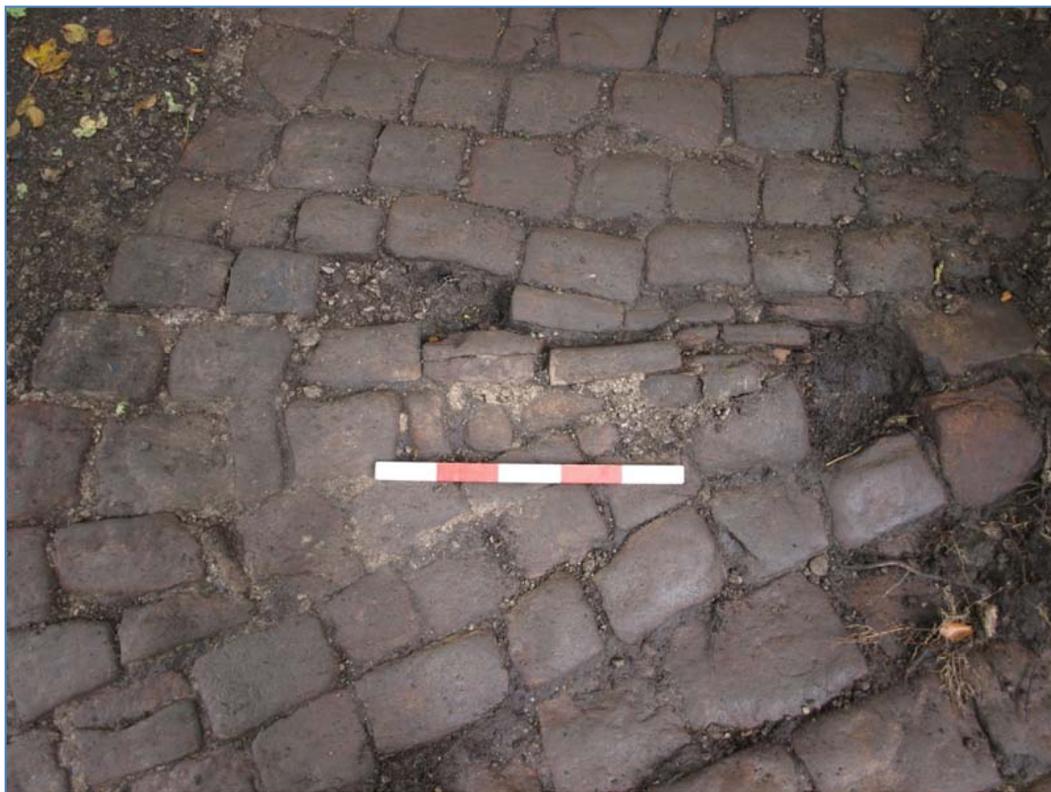
Fig. 35. Detail view VII. Damage to setts near the base of the ramp. West is at the top of the photograph. Scale 50cm.

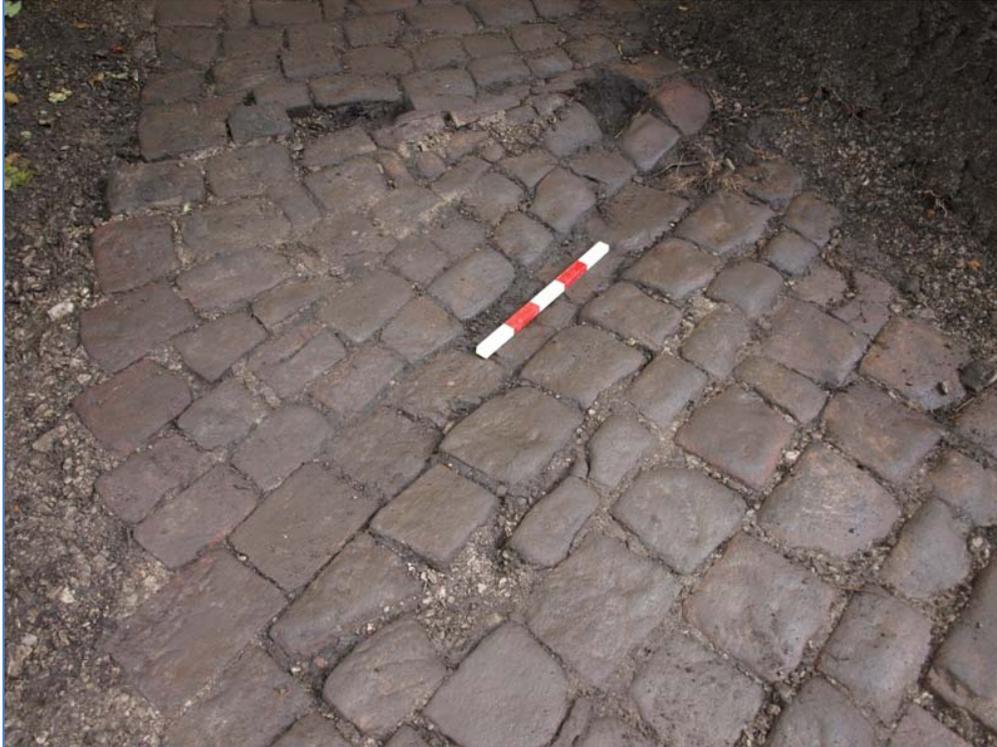
Fig. 36. Oblique view XXI. The bottom drain. View looking west-north-west, with the scale resting in the bottom of the drain. The courses of setts on either side are slightly angled to allow water to flow into the drain. Scale 50cm.

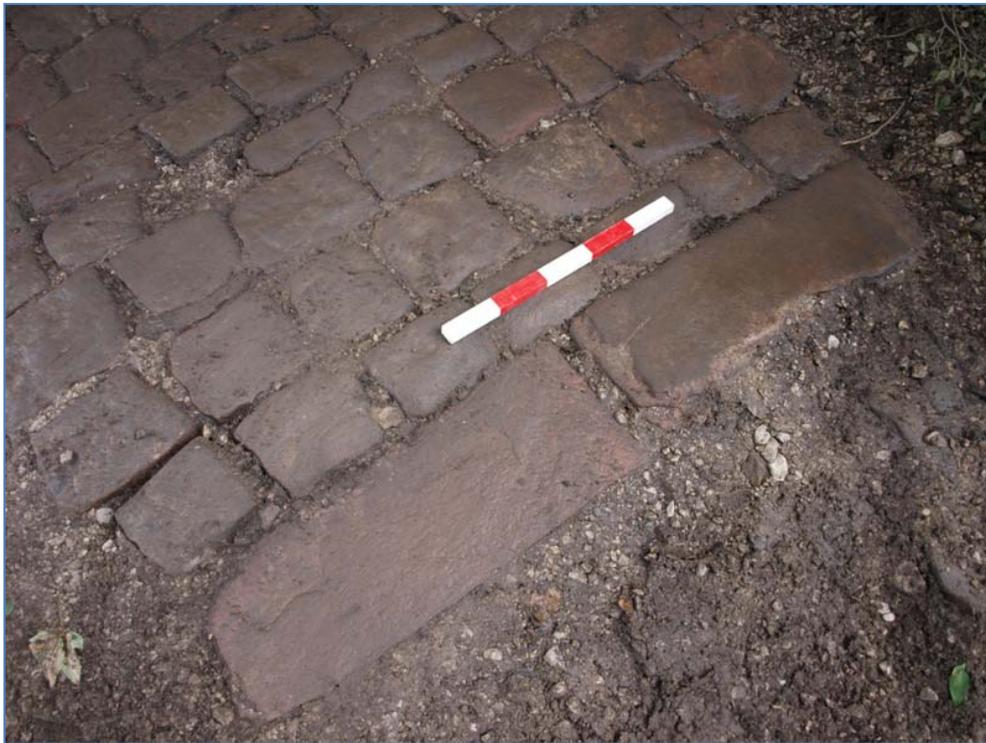
Fig. 37. Oblique view XXII. The base of the ramp showing the two extant base stones. View looking west-north-west. Stone No.10 (also visible in Figs.33 and 37) is the left-hand of the base stones. Scale 50cm.

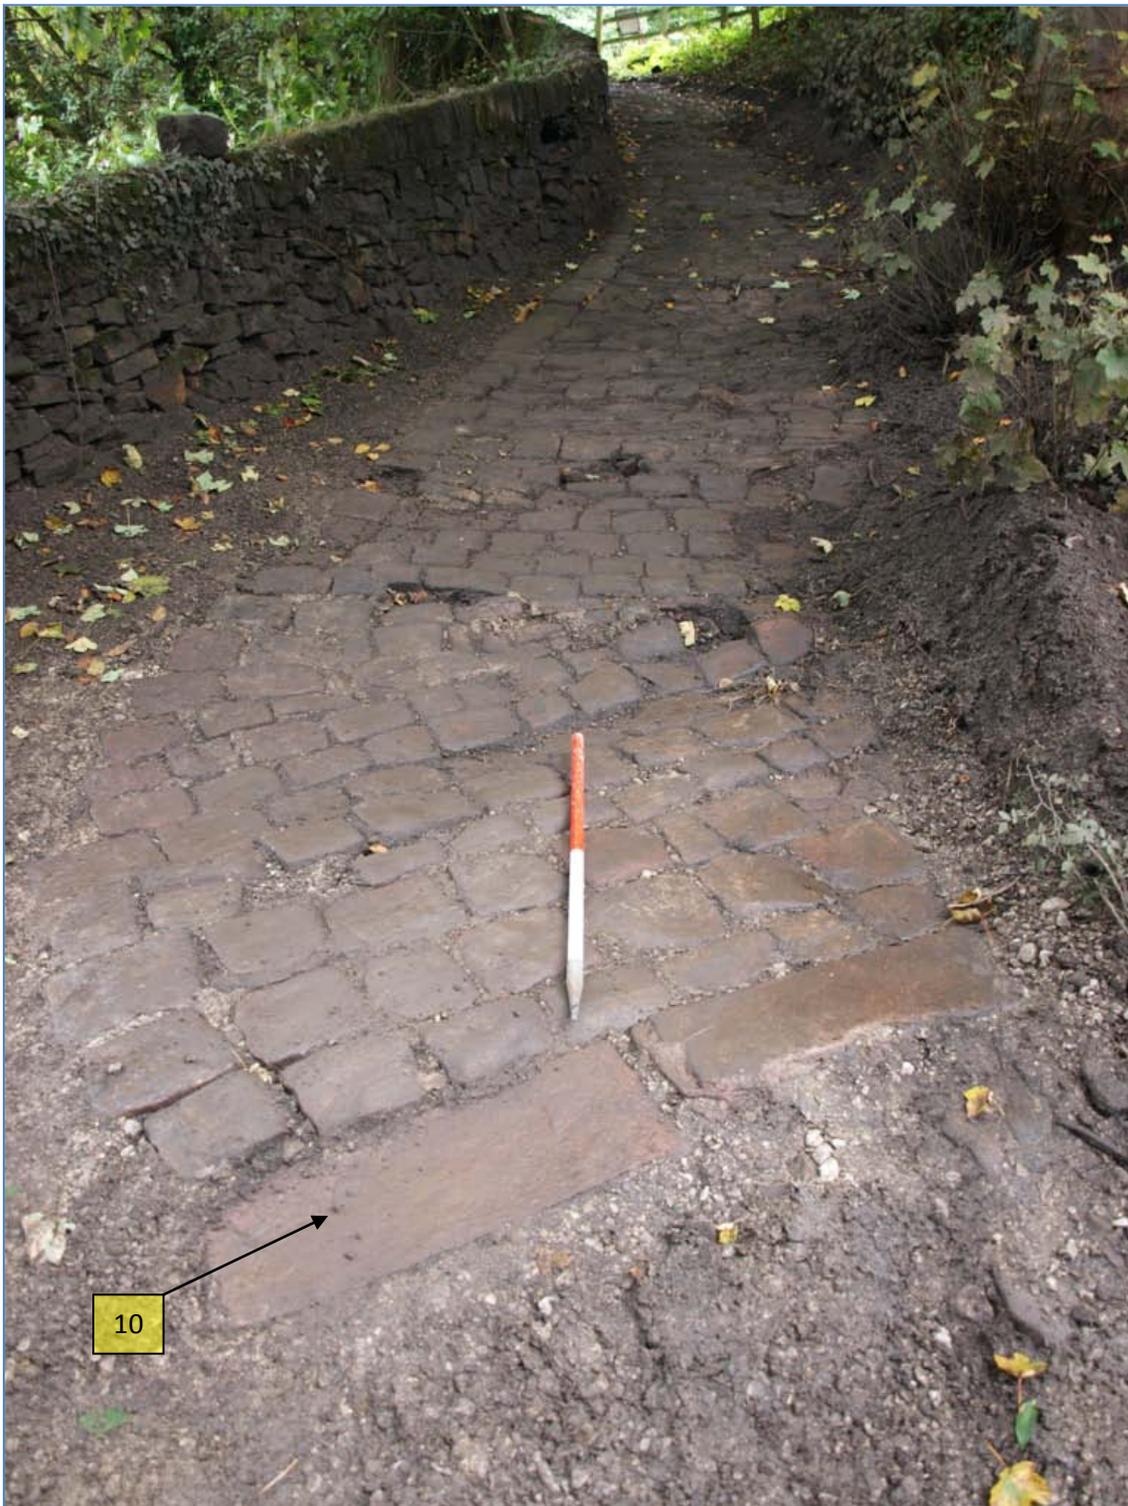
Fig. 38. Oblique view XXIII. Looking west from the base of the ramp, showing the northward curvature of the cobbled surface and its divergence from the revetment wall. Stone No.10 is also visible in Figs. 33 and 37. Scale 1m.
