Historic Building Assessment

GREAT POTHERIDGE, MERTON, DEVON

By R. W. Parker

REPORT No. 2011.01

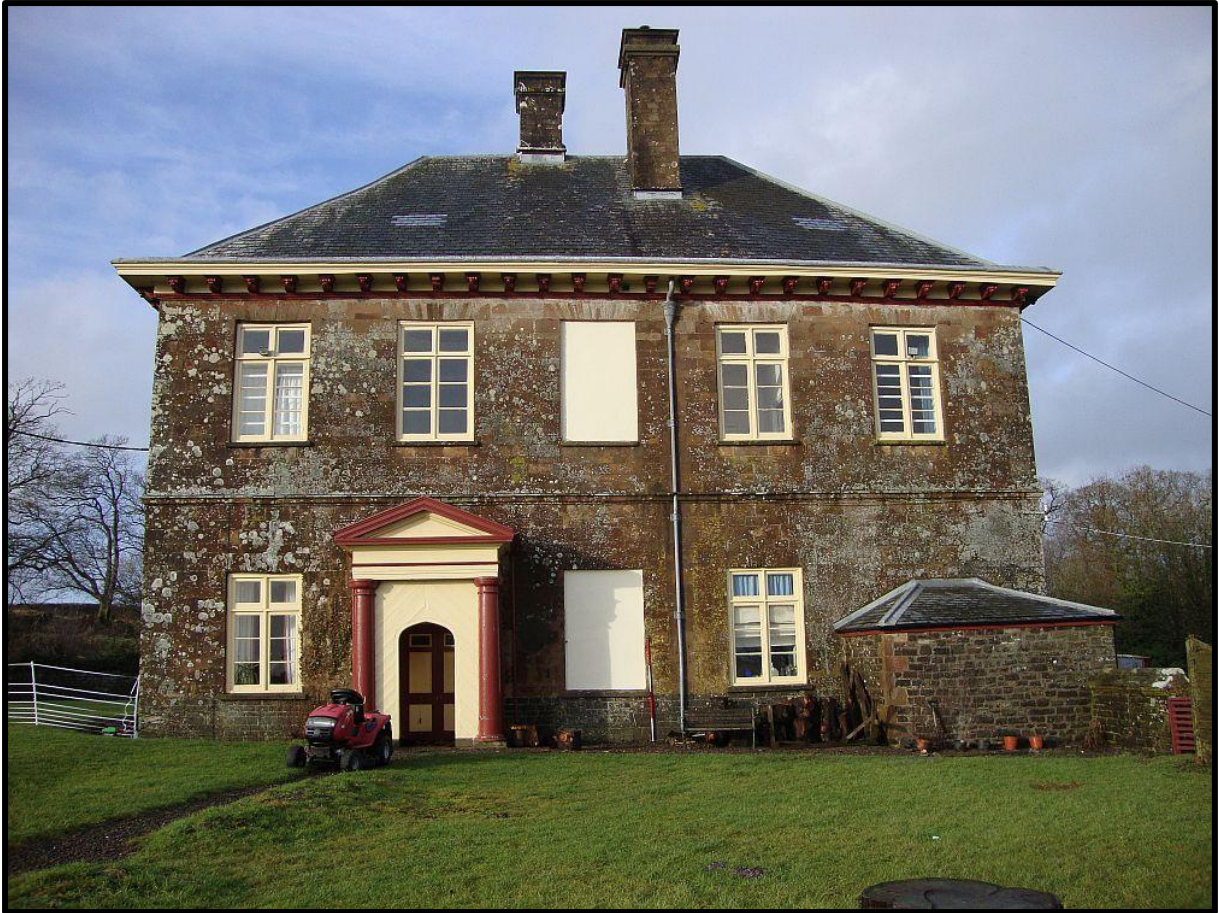
Fig. 1 The south elevation of Great Potheridge.

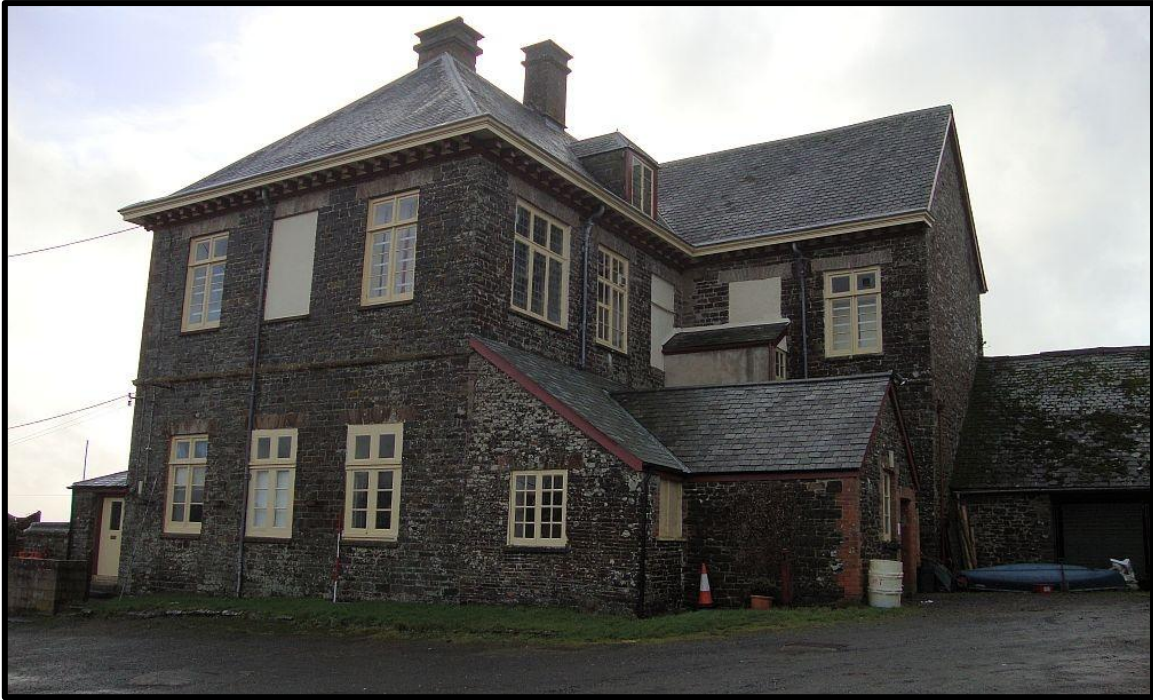
Fig. 3 View of the eastern and northern fronts of the house, looking south, showing the orderly fenestration, now partially obscured by later extensions.

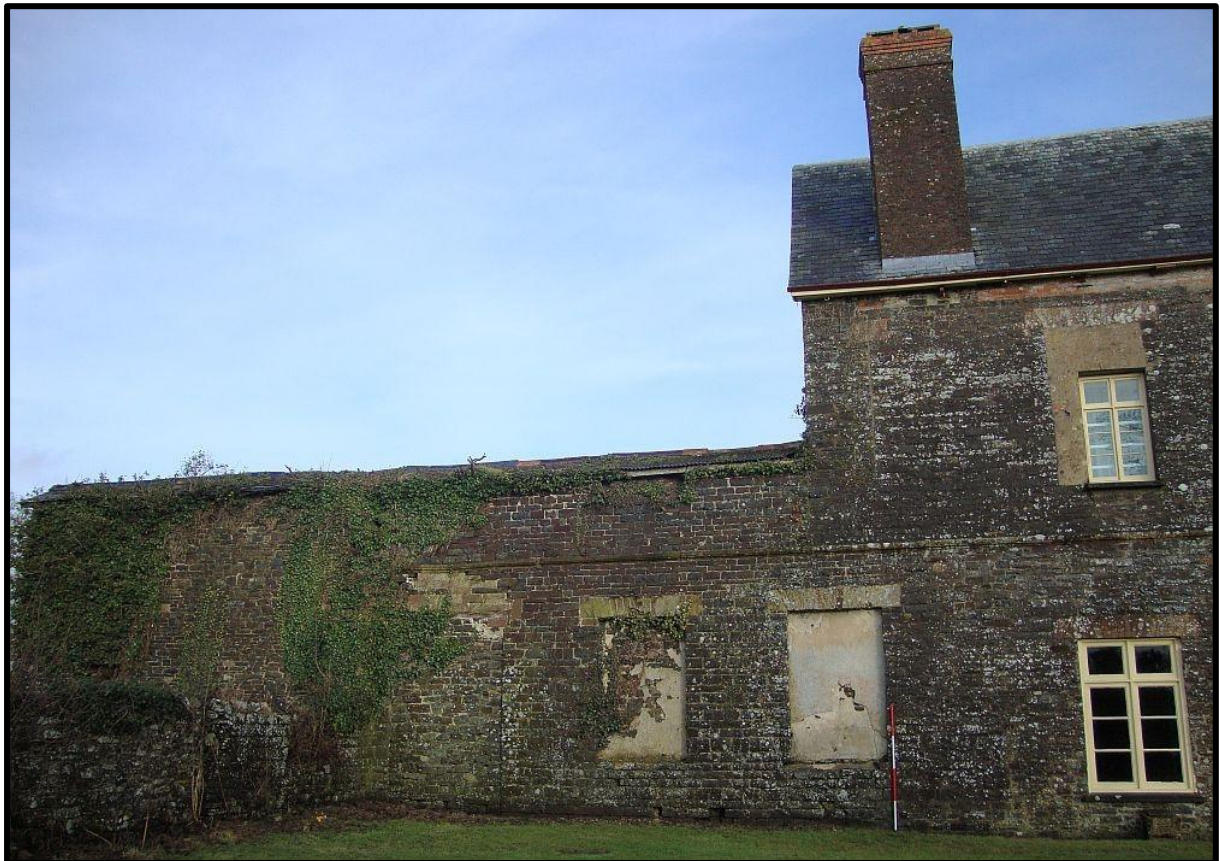
This interpretation, however, requires us to postulate even larger areas of lost fabric, including, perhaps, a north-eastern wing corresponding to the present south wing, reflecting the surviving fragment of the mansion to the north of a central, east/west axis on the line of the loggia. The house might thus have had a grand façade facing east, surrounding three sides of an eastern entrance court. The central part of the east wing might have formed the *corps de logis*, an impressive central block, with cellars, flanked on each side by lower sections of the east wing, including the present Hall, and by the projecting wings to north and south. A grander architectural treatment of this part of the eastern range may be suggested by the higher level of the surviving blocked or blind windows in its west wall (Fig. 5).

Fig. 5 Part of the west elevation showing the higher level of the windows south of the door to the loggia, perhaps suggestive of a symmetrical central block in the east range forming a *corps de logis* facing east, with a central doorway to the loggia in its rear elevation.

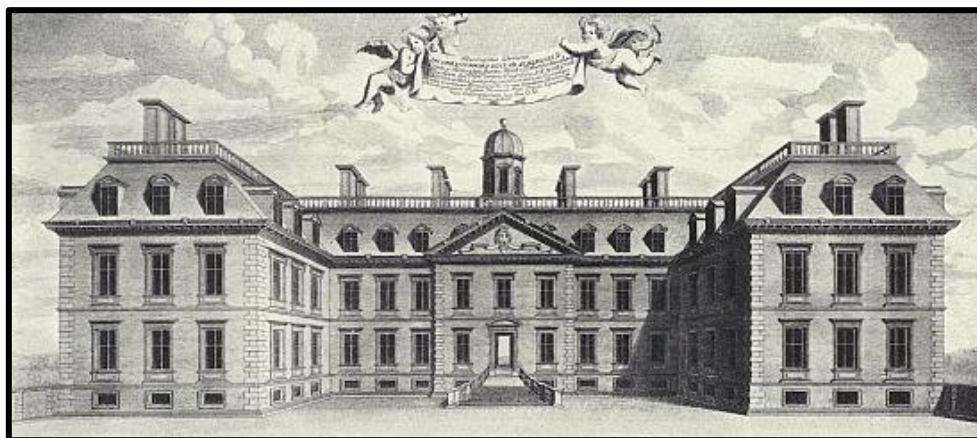
Fig. 7 Extract from an engraving of Clarendon House, Piccadilly, London, (Roger Pratt, 1664-7). This house, demolished in the 1680s, was for a period the residence of the Monk family and might have been the model for the mansion at Potheridge. Engraving by William Skillman c.1680

This interpretation would allow Potheridge the kind of formal, symmetrical façade familiar from late 17th-century classical houses such as Belton House in Lincolnshire and Stoke Edith in Herefordshire or, locally, the long-demolished Tetcott House in west Devon (Fig. 6). The model for this type of façade was Clarendon House, Piccadilly, London (Fig. 7). This highly influential, though short-lived mansion dated from 1664-7 and was regarded at the time as one of the most magnificent houses in England (Summerson 1955, 88). During the 1670s Clarendon House was occupied by the Monk family (Pye & Westcott 1993, 14) and it could well have influenced the design of the new buildings at Potheridge. Unfortunately, this very tempting conjecture is as fraught with problems as any other interpretation and could not be tested without further work, possibly including excavations, to recover the plan and layout of the house. The possibility remains that even if such an ambitious house was ever envisaged, it was never completed as intended and, until further evidence emerges, the form of the house must remain a conjecture.

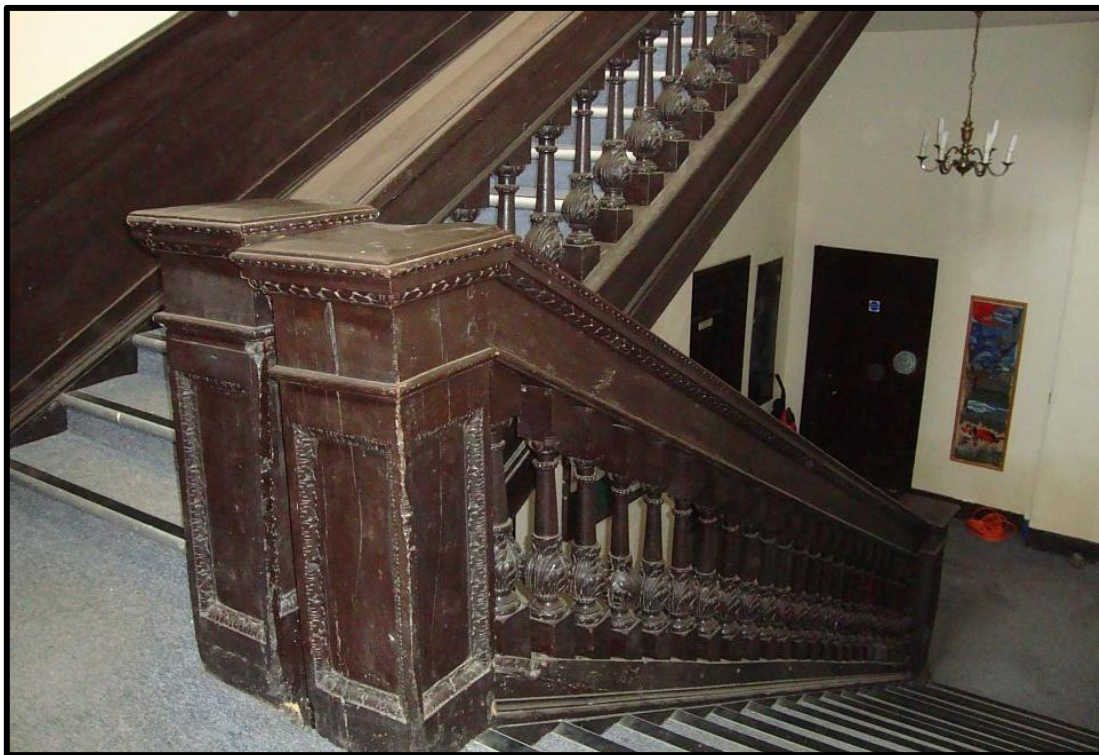
Fig. 8 Detail of the 17th-century staircase showing the high quality architectural detail and the clumsy junction of the two flights.

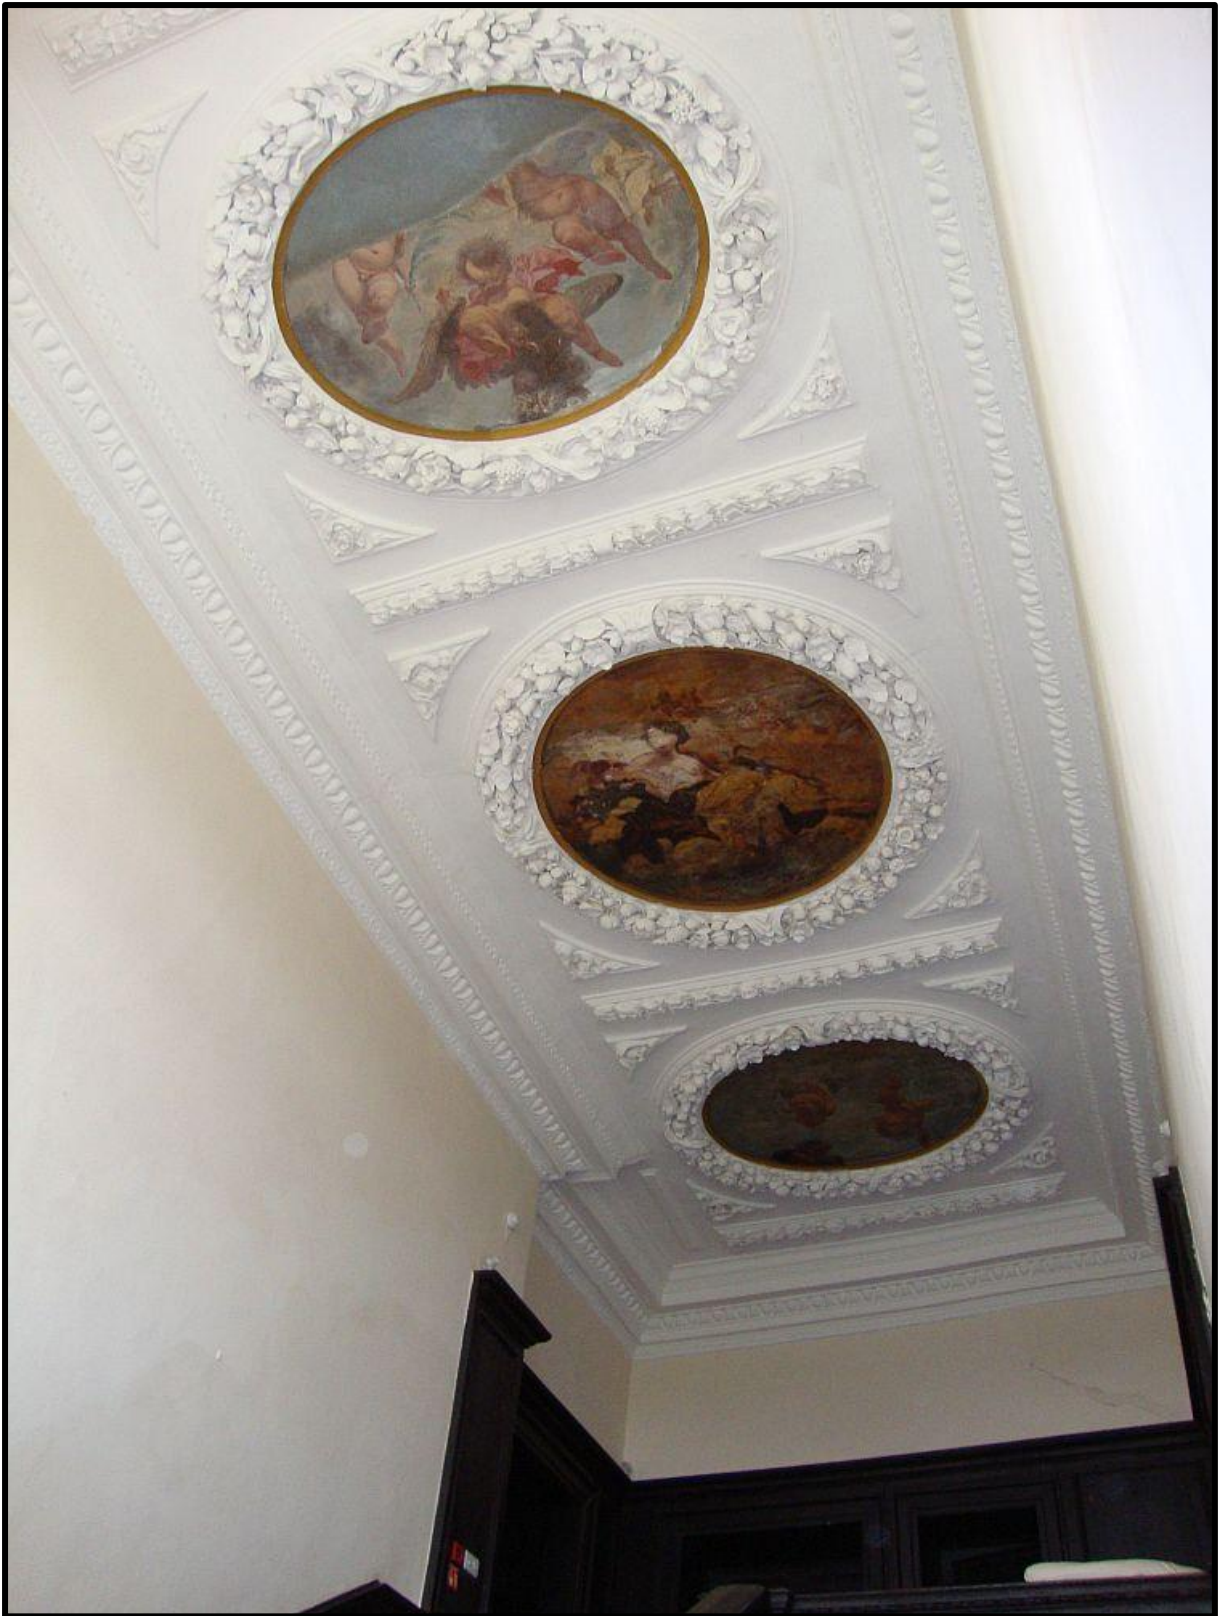
Fig. 9 View of the late 17th-century plaster ceiling above the staircase, looking north. The shape and position of the ceiling strongly suggest that the staircase is *in situ*. The alignment of the staircase and the ceiling, together with the Hall to the north, suggest a north-south axis for the house, extending to either side of a central entrance in the east wing.

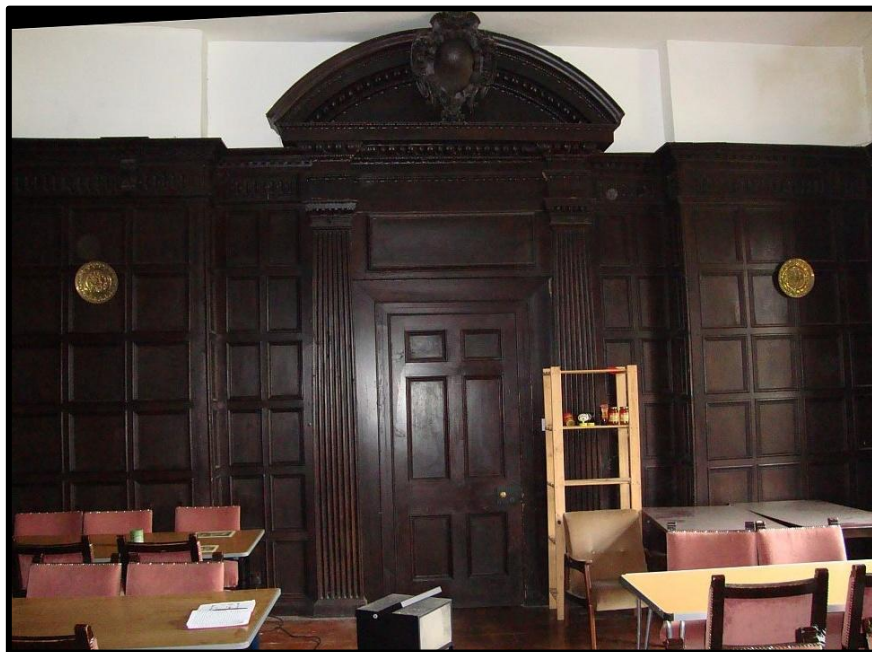
To the north of the staircase the present Hall of the house lies in the east range. The doorway from the stairs has an enormous Baroque door case crowned with a cartouche (Fig. 10). A similar door case in the opposite wall now lies against a blind wall, probably as a result of the 19th-century truncation of the east range. The enormous overmantel of this room is quite clearly reset in this position, but the extent to which the panelling is also reset is unclear. The two door cases might be *in situ* in relation to each other (though one may have been moved southwards when the present north wall was built). If the east wing was the central block of the mansion, the two opposed doorways might have defined part of a ceremonial route from an entrance hall in the centre of the east wing, through this room to the staircase, and thence to private apartments on the first floor of the south wing. A corresponding route might have lain northwards to further apartments in the (conjectural) north-east wing, if this ever existed. The east wing of the house might thus have been divided into two parts providing separate suites of apartments in each wing. Such apartments were a feature of domestic planning in formal houses of this period (Girouard 1978, 128-130; 135-136) and could either be utilised as independent sets of chambers for the use of the Duke and Duchess or, just possibly, set aside for accommodating a possible Royal visitor.

Fig. 10 Detail of the door case linking the staircase with the Hall, looking south, showing the panelling. A corresponding door case in the opposite wall, if *in situ*, would appear to confirm a north-south processional route from the main entrance in the east wing to the staircase.

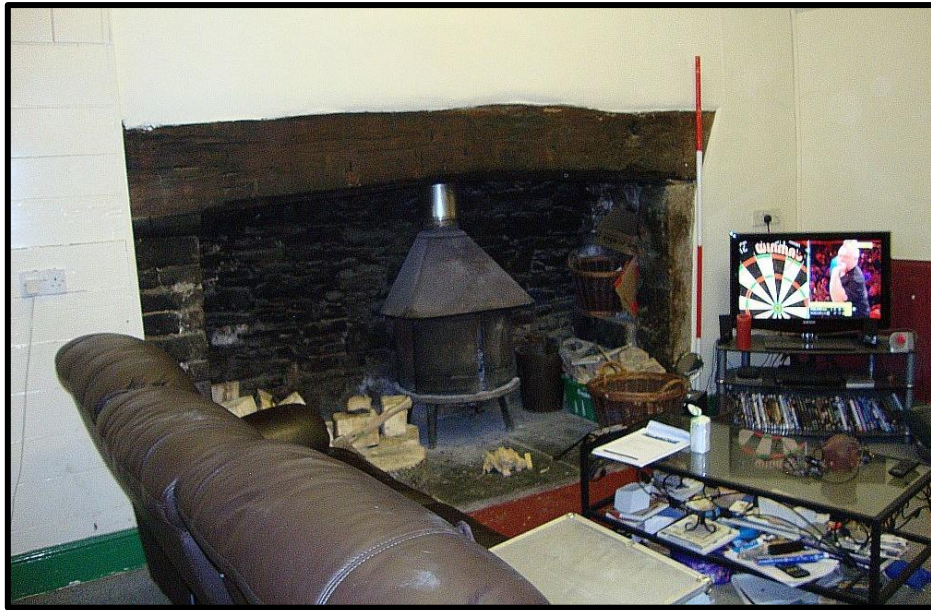
Fig. 11 Detail of the large fireplace in the present lounge, possibly the kitchen of the original house.

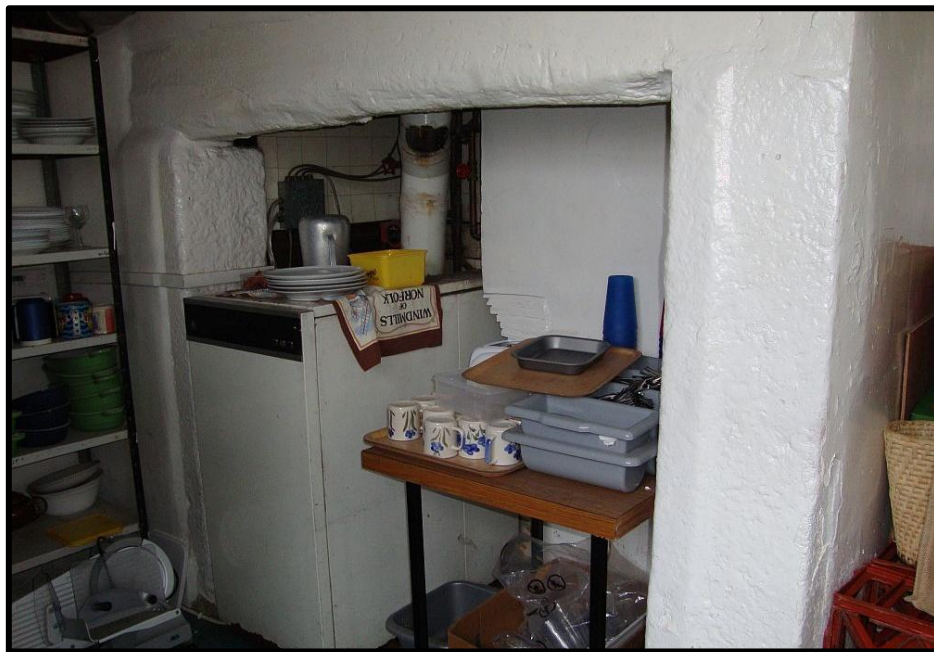
Fig. 12 Detail of the minor fireplace to the rear of that shown above, possibly serving a scullery off the original main kitchen.

The small, southern room has a medium-sized fireplace apparently constructed from reused blocks of granite and backing onto the main fireplace to the north (Fig. 12). The space is very narrow and it is possible that this fireplace is an addition, added to the rear of the earlier chimney. A large house such as this might be expected to have extensive service areas, and it is possible that the dubious appearance of the fireplace is simply the result of its being compromised by later alterations. It is evident that, although the first-floor rooms were of high status, the ground-floor rooms were probably not, and may have formed service rooms in the reduced house, if not also in the primary mansion.

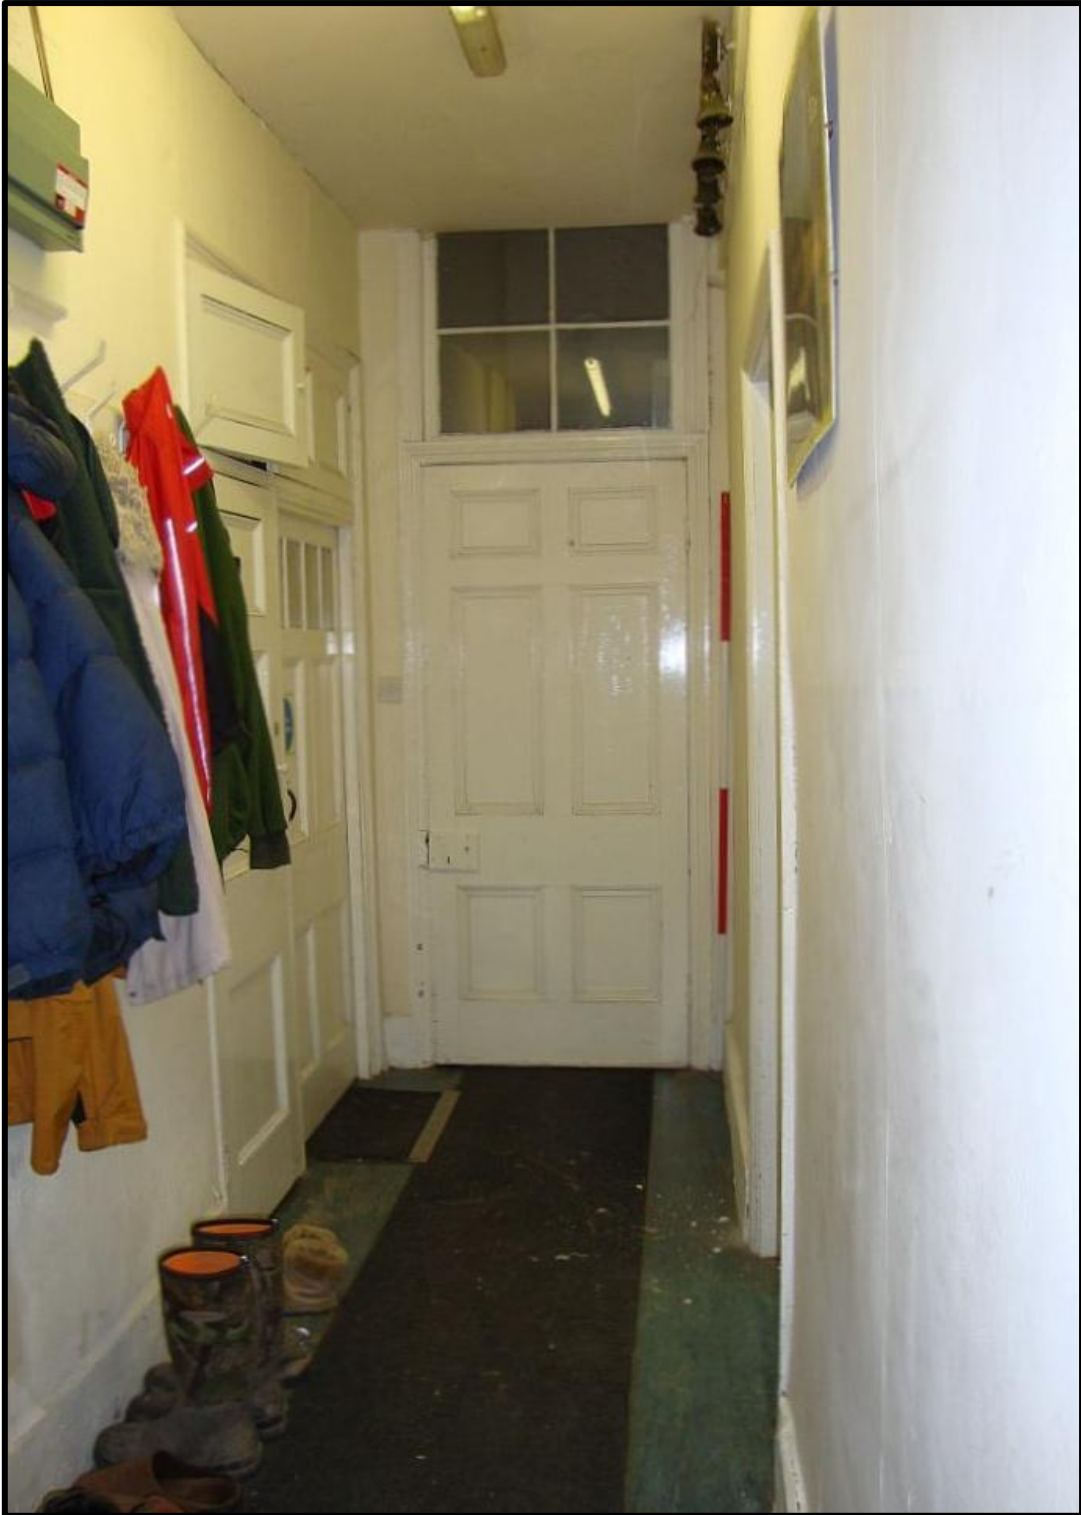
Fig. 13 View of the kitchen passage, looking east, showing the cupboards occupying a partially blocked (window) embrasure to the north (left), the 19th-century kitchen door with over light and the bells for summoning servants (top right).

The green- baize door opens upon a passage running from west to east immediately within the north wall of the south wing (Fig. 13). The north wall of this passage appears to have been one of the external walls of the house and may contain blocked window openings, now masked by plaster finishes in the corridor and in the adjacent lean-to structures added to the north front of the building.

At the eastern end of the passage the doorway piercing the wall has clearly been contrived from an earlier and larger opening, possibly a window, and it may perhaps be assumed that the three large windows visible at first-floor level corresponded with three windows in the ground floor. Evidence of such windows may be preserved behind the wall plaster and also above the ceiling of the passage, which, at 2.96 m, is 1.8m lower than the ceilings of the adjacent rooms. The presumed window opening is infilled with a curious arrangement of cupboards, all with moulded panels. The doorway infilling the opening is four-panelled, with a built in rectangular overlight. It is possible that this was originally an external door, prior to the construction of the lean-to extensions now lying against the north elevation of the house. At the east end of the passage is a six-panelled door opening into the eastern room. This has panels with planted mouldings and a delicate moulded architrave, which appears to extend above the existing ceiling in the passage. It may date from the late 18th- or early 19th century. High up on the south side of the passage, close to its eastern end are a series of four bells for summoning the servants.

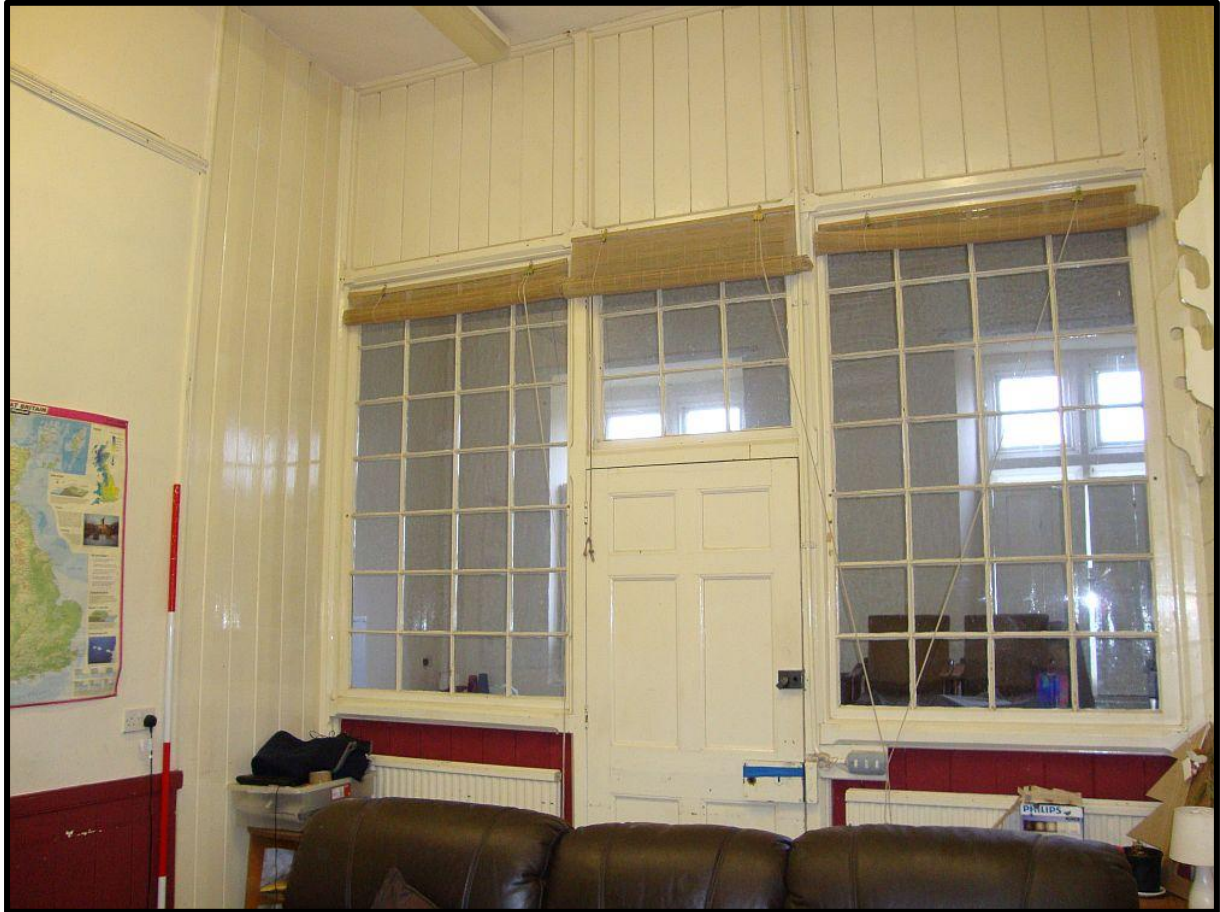
The timber screen dividing the lounge or kitchen from the eastern room protrudes into the eastern room, extending the line of the partition by about a metre (Fig. 14). The sides of the box thus formed are also constructed of tongue-and-grooved boarding. The southern side retains a series of shaped housings, probably representing a towel rail or a rack for rolling pins. The eastern side of the screen has three large panels of glazing divided by thin glazing bars into small, square panes. Two of the panels are fixed, while that over the doorway is designed to pivot open for ventilation. Both above and below the glazing are panels of tongue-and-grooved boarding. The supporting frame has chamfered stiles and rails with

stepped, hollow, run-out stops. The glazing bars have delicate mouldings of a different profile to those of the glazing bars in the adjoining overdoor.

The character of the screen, particularly the chamfering and stops, is reminiscent of late 19th- or early 20th century joinery and it is most likely that the screen was inserted to segregate areas of the kitchen for different activities in the period around 1870-1920. As the screen clearly does not incorporate any earlier material, and would also easily dismantle for storage or re-erection elsewhere, the removal of this screen to enlarge the dining area is not likely to have serious archaeological implications.

Fig. 14 The late 19th- or early 20th-century glazed kitchen screen, seen from the lounge area (the former kitchen of the house).
