Historic Buildings Assessment

**GREENALEIGH FARM,
MINEHEAD, SOMERSET**

By R. W. Parker

REPORT No. 2011.05

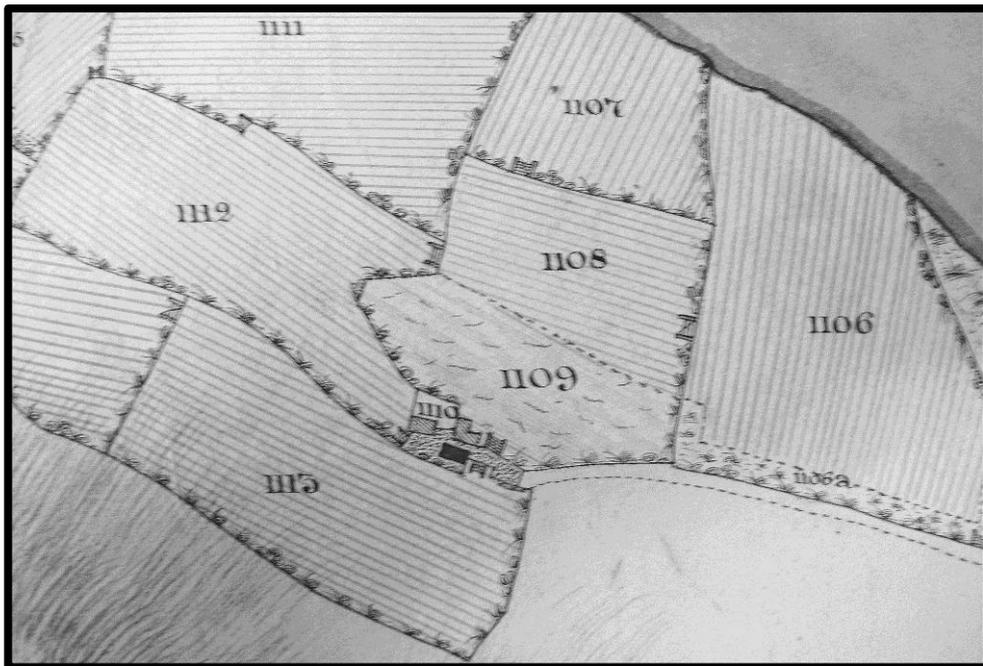
Fig. 1 Extract from 'A plan of part of the Manor of Minehead..' showing the configuration of the buildings at 'Greenlay', and some of the field names c.1800. The long range to the south may represent the farmhouse (SRO A/AOW/77/1).

Map sources also provide an useful source of information about the property and a very useful sequence from the start of the 19th century has been identified. One of the earliest maps to show the site in any detail is described as ‘A plan of part of the manor of Minehead. East Side from Bratton Manor’ this dates from c.1800 and shows the town and surrounding area, including the quay, with insets for ‘Greenlay’ and part of the manor lying on the south side of Oway Hill (SRO A/AOW/77/1). The inset (Fig. 1) shows the site as containing two, or possibly four, structures; a long range aligned from east to west, divided into three sections, which may be identified with the old farmhouse and adjacent structures, and a smaller building on a different alignment, at right angles to these. Unfortunately the functions of the buildings, residential or agricultural, is not distinguished, but it is fairly clear that the earliest buildings on the site stood on the sites of the old farmhouse and of the ruined structures to the north of this.

The earliest structure on the site of these buildings is shown upon a map of *c.*1800 as a rectangular building lying at right angles to the farmhouse range and separate from it (Fig. 1). By 1822 (Fig. 2) a further building had been added to the west of this and the original structure had either been extended or rebuilt to form an 'L'-shaped building. Later historic maps (Figs 3-4) seem to show that there was little change to the configuration of the farm buildings until the late 19th century. The 1st-edition OS map (Fig. 5) shows the situation by the mid 1880s: a large rectangular building lies to the north of the old farmhouse, linked by a long range of smaller buildings fronting a large open courtyard. At the western end of this long range was a small structure arranged at approximately 45° to the other buildings. Part of this latter structure, which perhaps might date from the mid 1860s or 1870s survives, but the rest of it has been entirely demolished and there are no clues to its possible function. By the early 20th century the original rectangular building seems to have been trebled in depth, infilling the former court with large buildings (Fig. 6). These structures presented their gables to the roadway running through the side, as can be seen in the early post card reproduced as Fig. 17, and must have been covered with a series of large parallel roofs.

These walls support the higher ground to the south of the farmyard, and were formerly associated with farm buildings aligned with and continuous with the original farmhouse, extending to the west in a long range to meet the west wall of the shed next to the piggery. The estate map of 1800 (Fig. 1) shows that there were structures in this position by the end of the 18th century, but subsequent maps (Figs 2, 3, 4) seem to imply that these had been demolished and that the site of these buildings then lay vacant until the late 19th century.

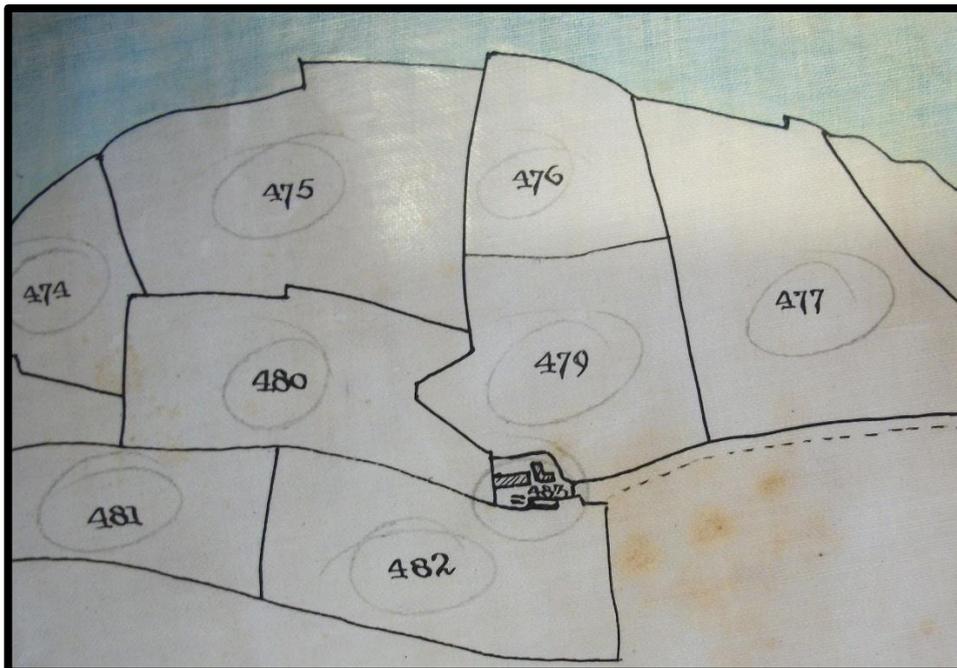
Fig. 3 Extract from the Minehead Parish Tithe Map, surveyed in 1842, showing the addition of further buildings to the complex. The 'L'-shaped building is still present and a new structure has been added to east of it (SRO D\p\m.st.m/3/2/3).

The Minehead Parish Tithe map (Fig. 3), surveyed in 1842 (SRO D\p\m.st.m/3/2/3) and a later copy of this map (Fig. 4), described as ‘A Map of the parish of Minehead in the County of Somerset in two parts, copied from W. Ponsford's Copy of the Tithe Map’ and dated the 18th of November 1864 (SRO DD\SAS/C212/MAP/97 and 98), show that there had been few alterations to the buildings since 1822. It is unlikely that this map is simply a copy of the earlier map, since it clearly incorporates some amendments: a small structure to the east of the main farmyard is shown on the tithe map, but is absent from the later map, which appears to show some alteration to the entrance to the farmyard. The building may have been erected in the 1820s or 30s, but had probably been demolished by the 1860s. Its site must lie close to the access road as it enters the farmyard, near the gate to the garden of the new farmhouse.

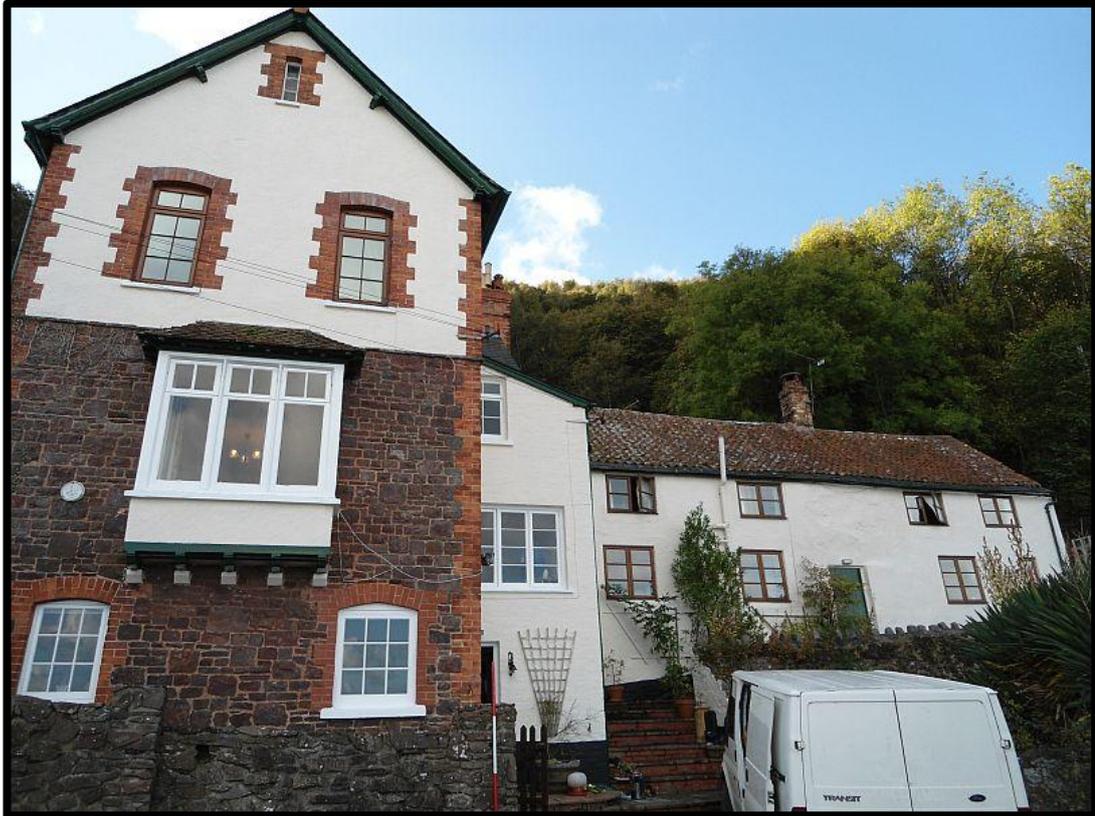
Fig. 7 General view from the north, showing the relationship and differing character of the two farmhouses.

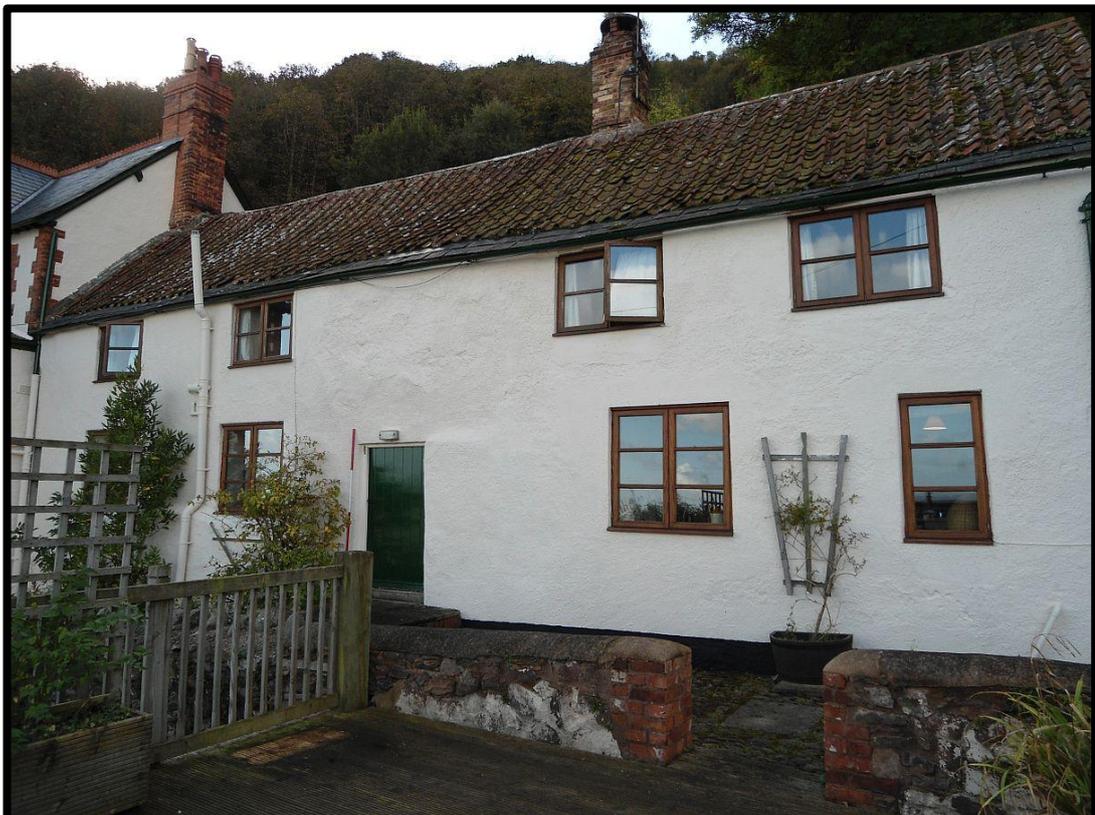
Fig. 8 The front elevation of the 'old farmhouse', showing replacement windows and the irregularities in the render suggesting alterations to the fenestration.

The house is broadly identifiable on most of the historic maps as a long range lying parallel with the hillside. It faces northwards over the Bristol Channel and is built into the hill slope almost to the height of the eaves on the south. The façade is rendered, obscuring the fabric, which appears to be of stone rubble (Fig. 8). The present external finish is presumed to be modern, though traces of patching in the render around the windows may reveal the survival in places of earlier rendered finishes. The patching of the render was presumably carried out when the existing double-glazed timber casements were substituted for earlier windows; the size and position of the windows may have been slightly altered at this time, but it seems likely that the pattern of fenestration broadly reflects the original arrangement.

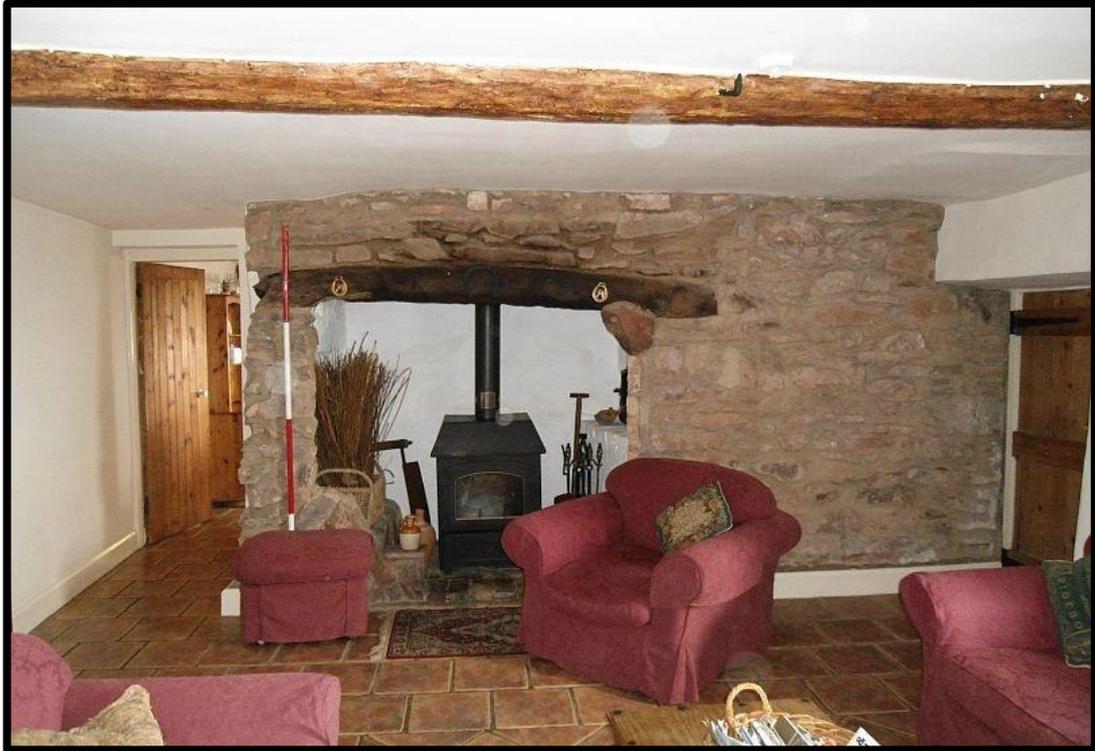
Fig. 9 View within the central room of the old farmhouse showing the plain character of the fireplace. Note the scar in the ceiling within the doorway (right) which may relate to a draught lobby.

The fireplace in the central room has a large, rather rough timber lintel without stops or decorations (Fig. 9); it may therefore have been intended to be masked by a chimneypiece. A 19th-century oven with brick jambs and vault has been added within its northern jamb. The remains of a cast-iron doorframe for the oven survive. There are also traces of a rectangular feature in the southern jamb of the fireplace which may represent a blocked recess or alcove.

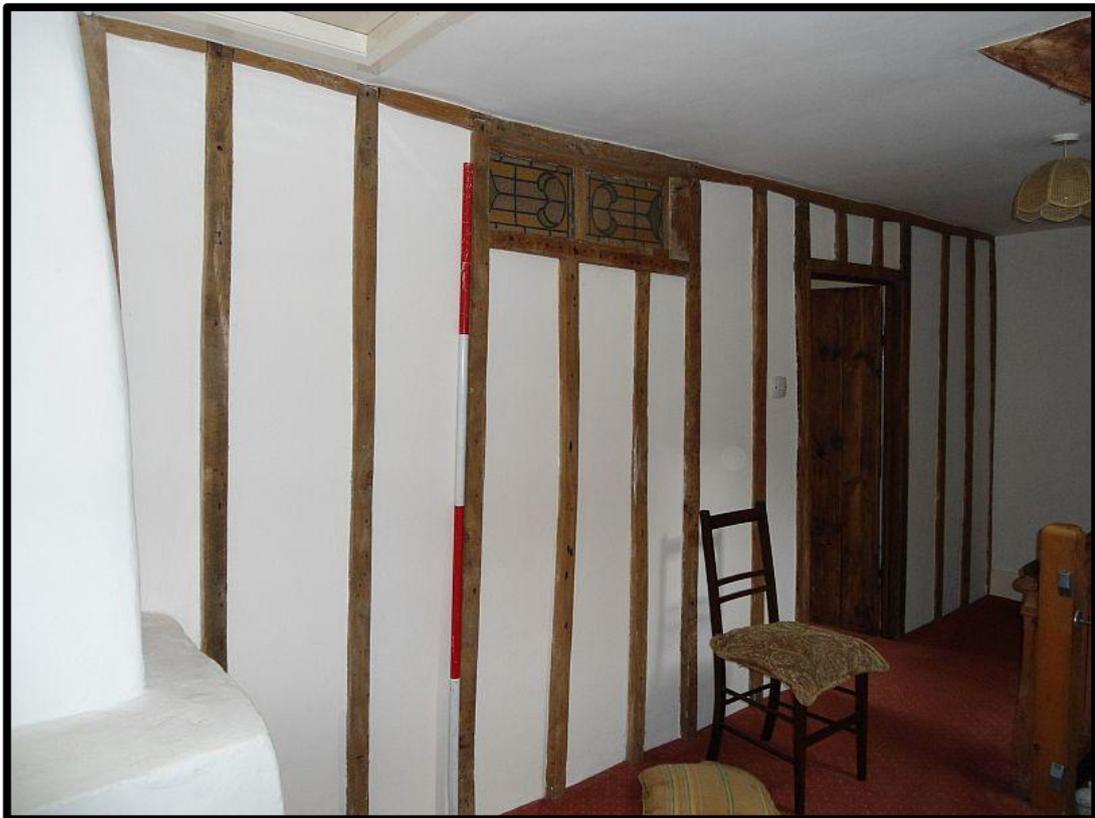
Fig. 10 detail of the construction of the partition on the first-floor landing showing typical late 17th-18th studwork, and the offset in the chimney shaft (left) which seems unrelated to the floor levels.

A stair seems likely to have risen within the area of the present landing because the partition defining the wall of the central bedroom on this floor has been set back to allow space for it. The partition is of timber-framed construction, and crosses the large projecting chimney breast serving the western chimney (Fig. 10). Although it has suffered some repair and alteration in recent years, the basic structure of the partition, with tall, narrow studs and plaster panels may be historic and could date from as early as the late 17th century. The landing continues to the east in the form of a corridor linking the old and new farmhouses and the partition between this corridor and the eastern room is likely to date from the late 19th century.

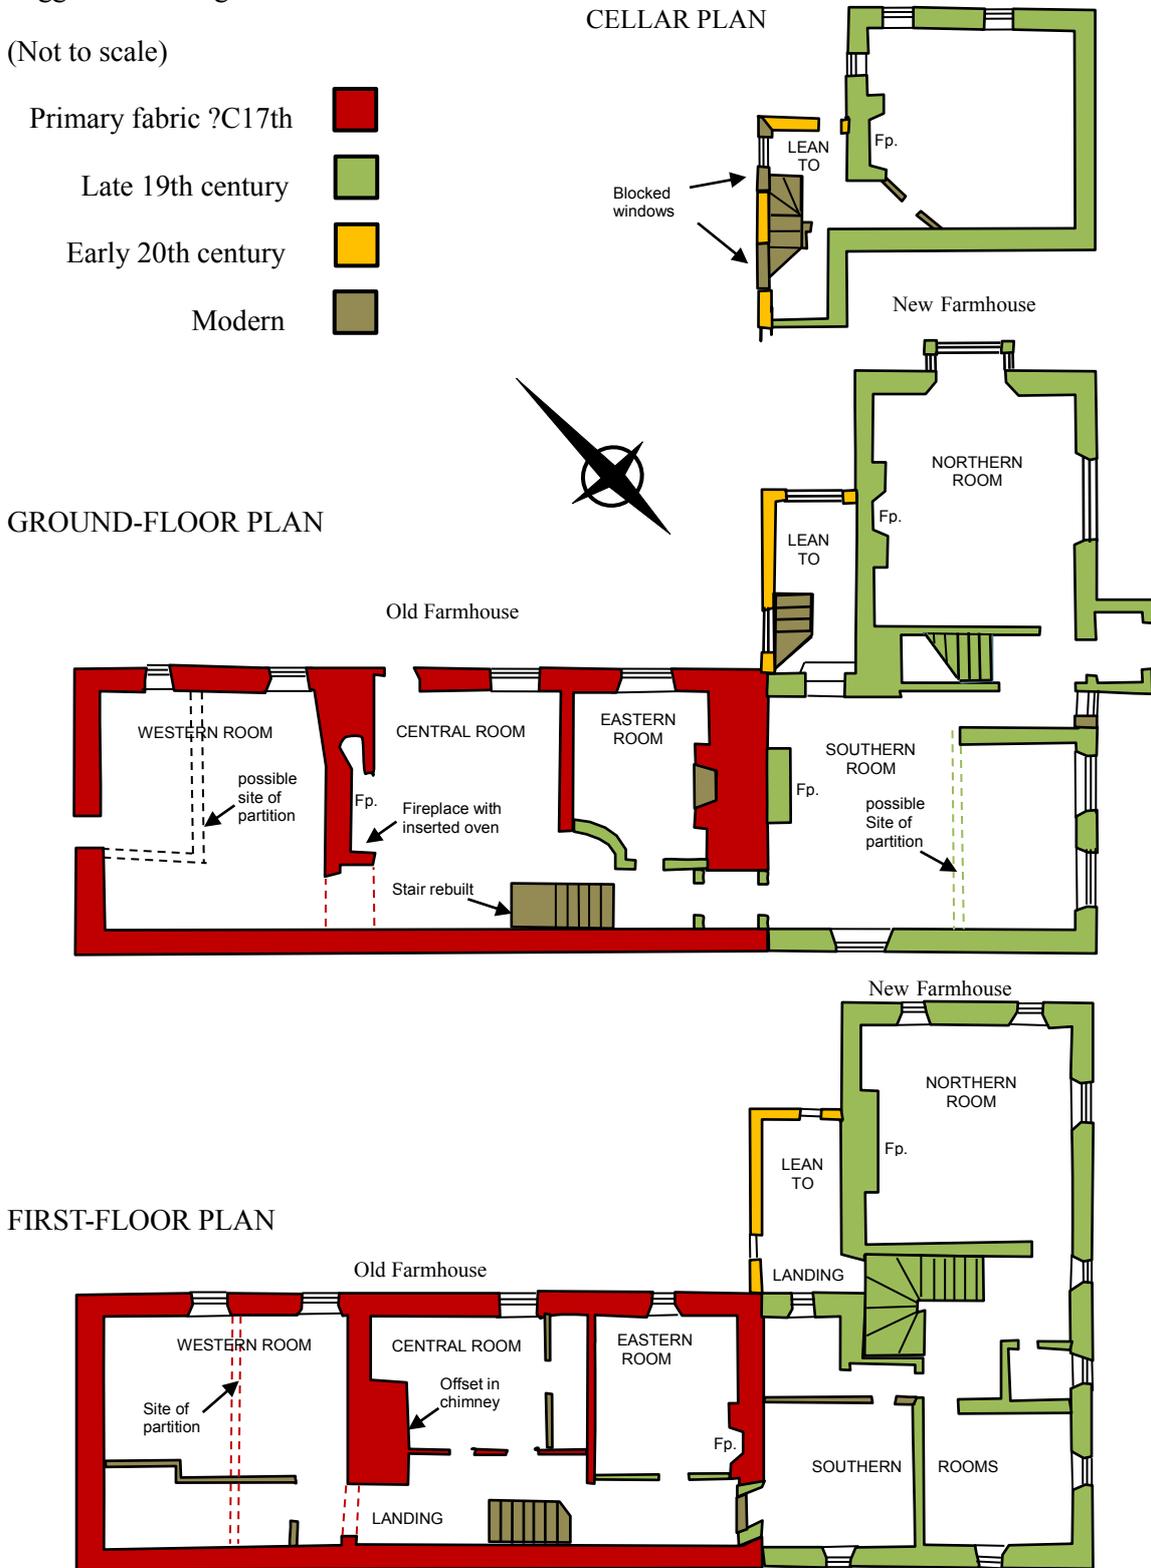
Suggested Phasing

- Primary fabric ?C17th
- Late 19th century
- Early 20th century
- Modern

Fig. 11 Plans of the farmhouse ranges showing possible phasing. Redrawn from drawings by Stags estate agents, supplied by Louise Crossman Architects (not to scale).

and this is the interpretation presented here (Fig. 11). Alternatively, the apparent absence of a first-floor fireplace and the offsets in the upper part of the main chimney shaft (which seem unrelated to the existing floor and ceiling levels) may suggest that the primary building originated as an open-hall house with a tall central volume and storeyed ends. The 'hall' may have risen into the apex of the roof or to a high ceiling suspended just below it, perhaps at the level of the offset. The fireplace is so plain that it is difficult to date confidently, but it seems unlikely to be any earlier than the mid 17th century. It is of course possible that the fireplace is itself an insertion into a much earlier building which was formerly heated by open hearths, though no evidence of smoke blackening has been noted. If the house did formerly have an open hall, the present floor structures, internal partitions and roof structure may have been added in *c.*1700 to convert it into a fully storeyed dwelling; parts of the shell of the existing building could thus be of earlier date. The western end of the farmhouse may have been an independent unit from the main accommodation in the eastern part of the building.

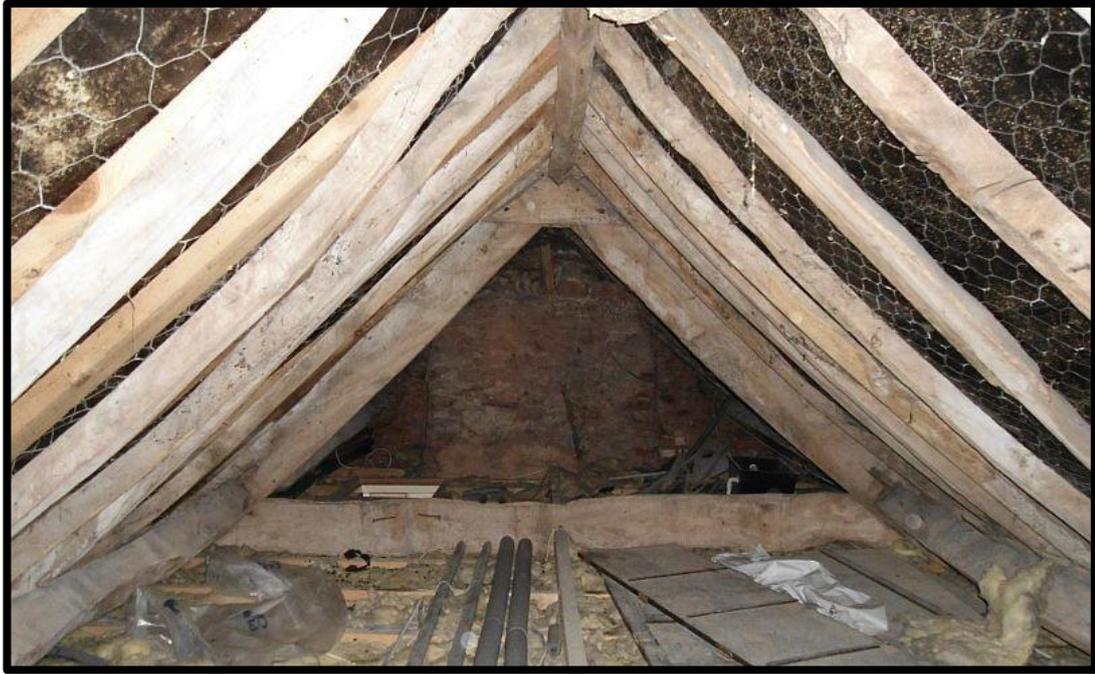
Fig. 12 View within the roof of the eastern section of the old farmhouse, looking west, showing a typical truss and the upper part of the central chimneystack.

The roofs of the old farmhouse are supported by three 'A'-frame trusses and by the stone dividing wall of the central axial chimney stack. These elements divide the roof into five bays, two of which are over the western part of the house. The trusses (Fig. 12) consist of pairs of broad principal rafters linked by applied collars, which appear to be secured by spikes or nails. The apex of each truss is concealed by a small triangular yoke applied to each side and fixed with nails and supporting a diagonally-set, square ridge tree. The purlins are staggered in each bay, with spurred and tusk-tenoned joints (Fig. 13), the tenons protruding through the blades of the principal rafters and being secured with pegs or cleats. Many of the original common rafters appear to survive, though there is much evidence of repair. There is no evidence of smoke blackening, no traces of earlier plaster above the level of the existing ceilings. All the early timbers are of a relatively light colour, with a wavy grain, and may perhaps be elm.

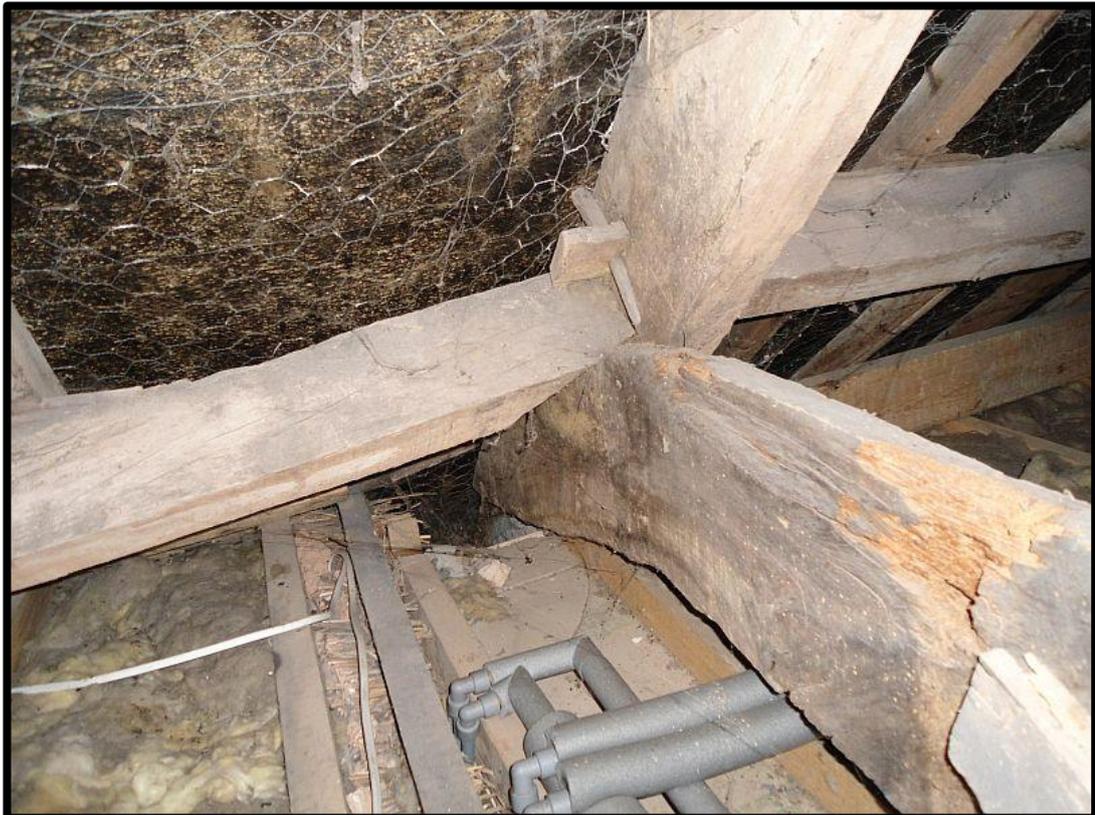
Fig. 13 Detail of the construction of the purlins and collars at their junction with the principal rafters showing typical tusk-tenons (the spurs within the joints are concealed in this assembly).

The character of the roof, with staggered purlins, tusk tenons, applied collars and roughly-squared timbers intended to be concealed by plaster ceilings, suggests a date in the late 17th- or early 18th century for the existing roof. It is possible that the whole of the old house is of the same period,

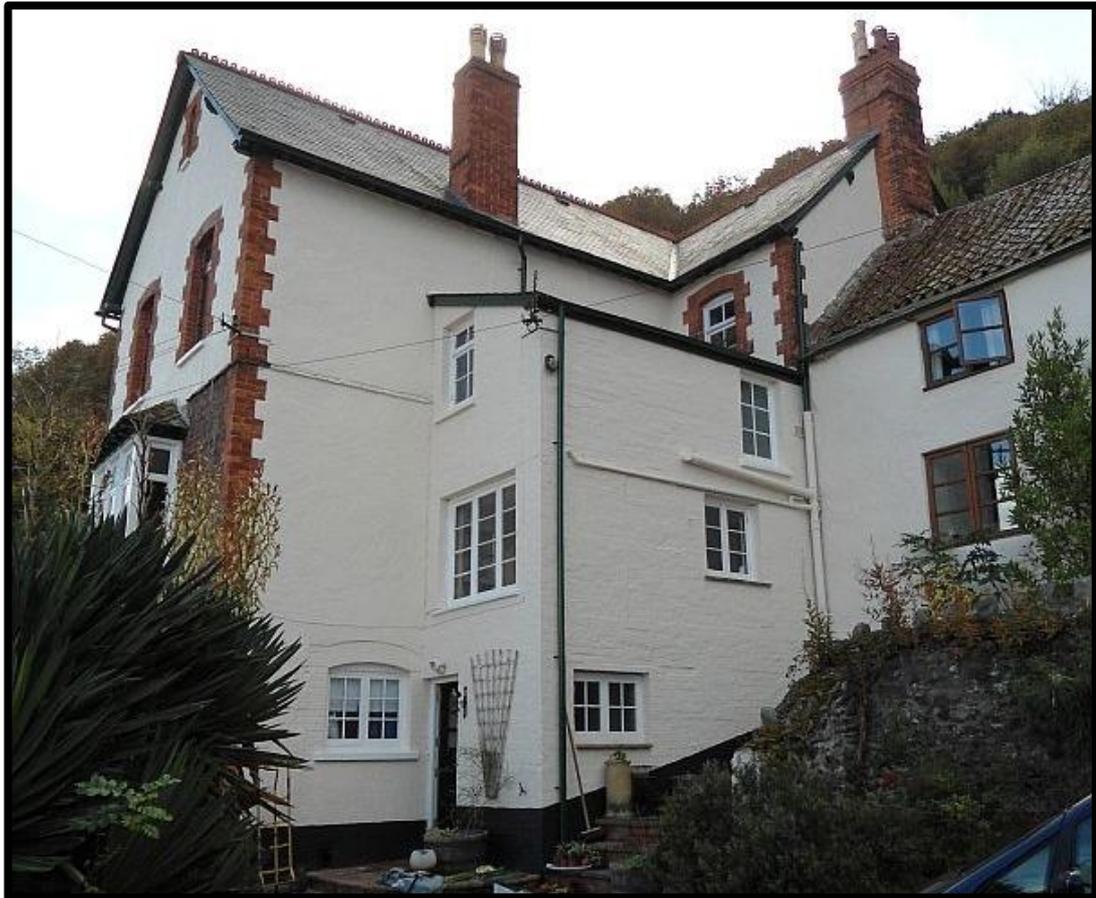
Fig. 14 General view of the new farmhouse from the west, showing the lean-to structure in the angle of the two buildings.

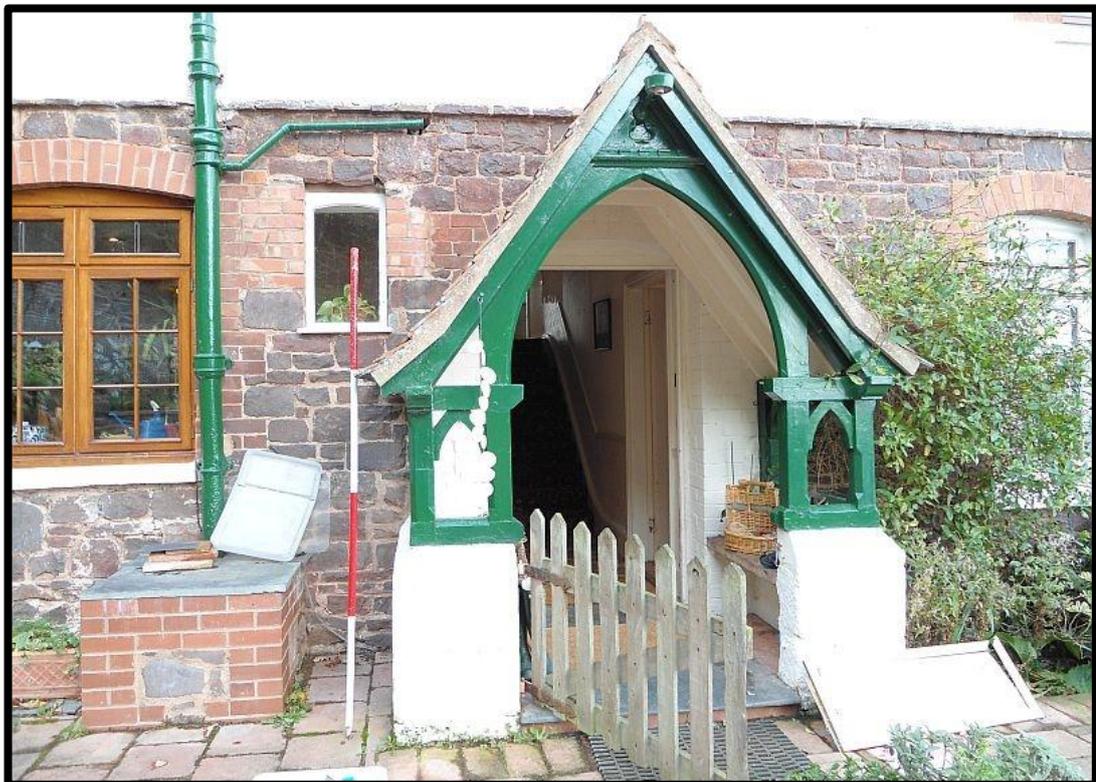
Fig. 15. Detail of the Gothic porch of the new farmhouse.

The main doorway is sheltered by a very attractive Victorian Gothic porch (Fig. 15) with a steep roof supported by a timber two-centred arch and open, arcaded sides with curved braces. There is some brattished ornament and a small trefoil in the gable. The roof is covered with plain and fish-scale tiles in alternate courses.

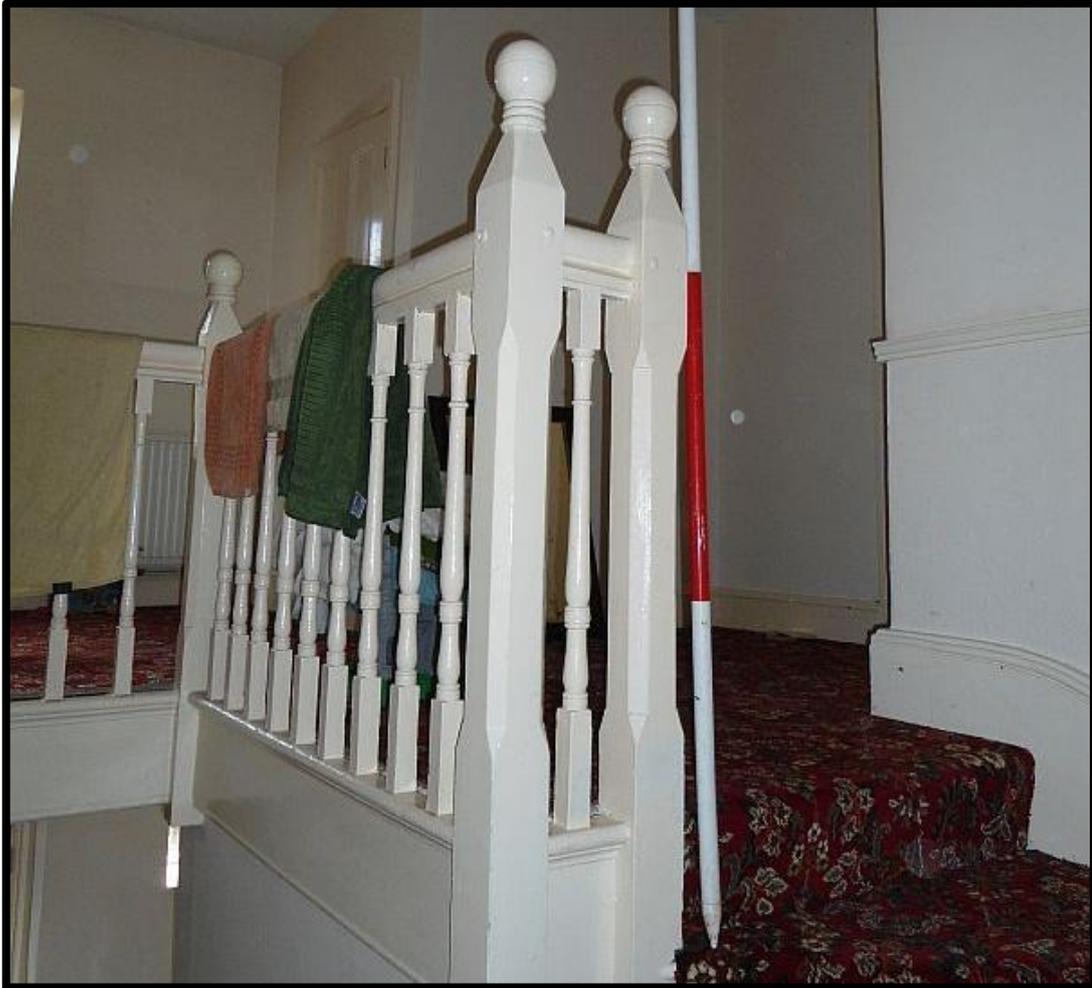
Fig. 16 Detail of the staircase in the new farmhouse showing the late 19th-century elongated chamfered newels crowned by ball finials.

The main staircase rises in a dog-leg, with winders, to first-floor level, where the landing is railed with a handsome balustrade with tall, chamfered newels crowned with ball finials and turned spindles (Fig. 16). The relationship of this staircase with the room in the lean-to structure to the east is awkward, suggesting that the lean-to is an addition.

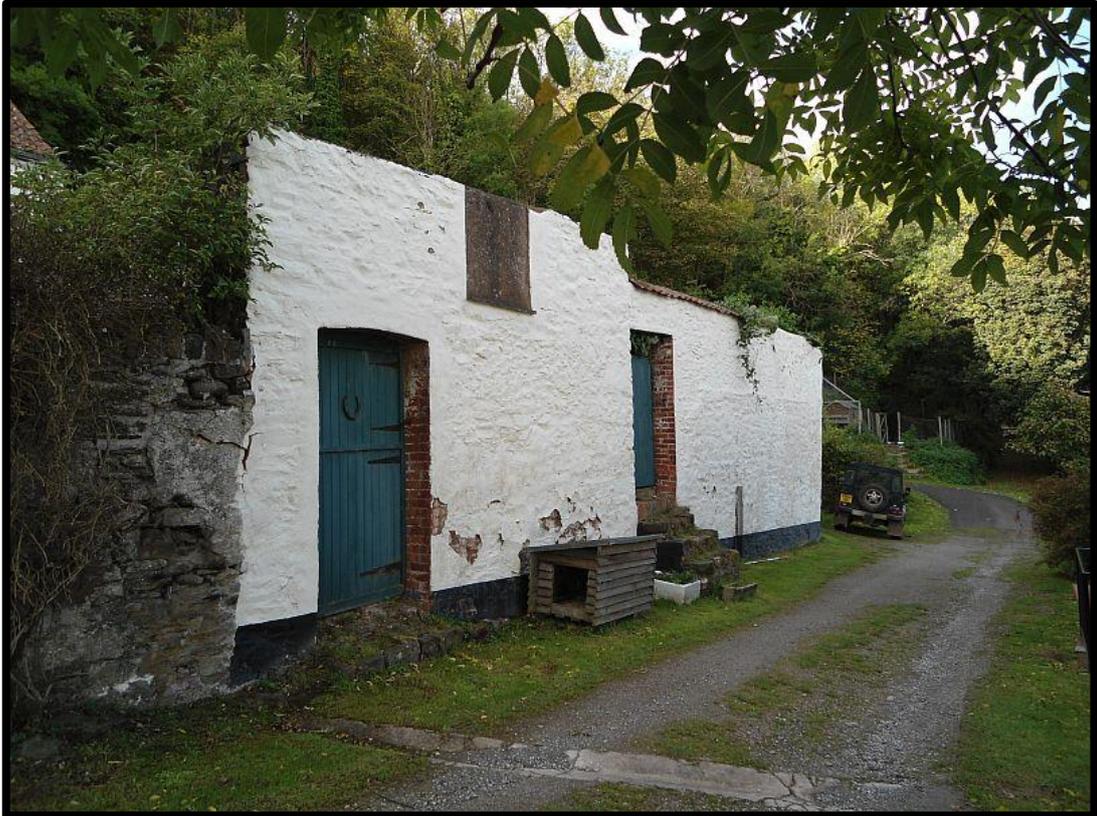
Fig 18 View of the remains of the barns to the north of the old farmhouse, showing stone construction and brick dressings to the openings.

The easternmost barn probably occupies roughly the site of the 18th-century structure, but it is uncertain whether any fabric of this early date remains. The building retained its roof until the late 20th century, but survives now only walls surrounding a parking bay. At its demolition, the building was reduced to eaves level, but the lower part of the gable still remains (Fig. 18). The walls are intact more or less to the height of the eaves and retain traces of internal plaster. The building was clearly of two storeys, since the scar of a floor level is visible. In the gable end is a doorway (now partly buried) with a timber lintel and, above this, in the centre of the gable, a loading door serving a loft. The levels within the barn appear to have been raised, which may mean that the lower levels and floor surfaces of the structure could be well preserved as buried remains. A further opening with a segmental headed arch of brick appears in the east wall, and there is a blocked opening above this. These all have jambs with brick dressings, which may point to a 19th-century date for these structures unless, the openings have been cut in to earlier fabric or enlarged. The surviving doors are all of 20th-century date.

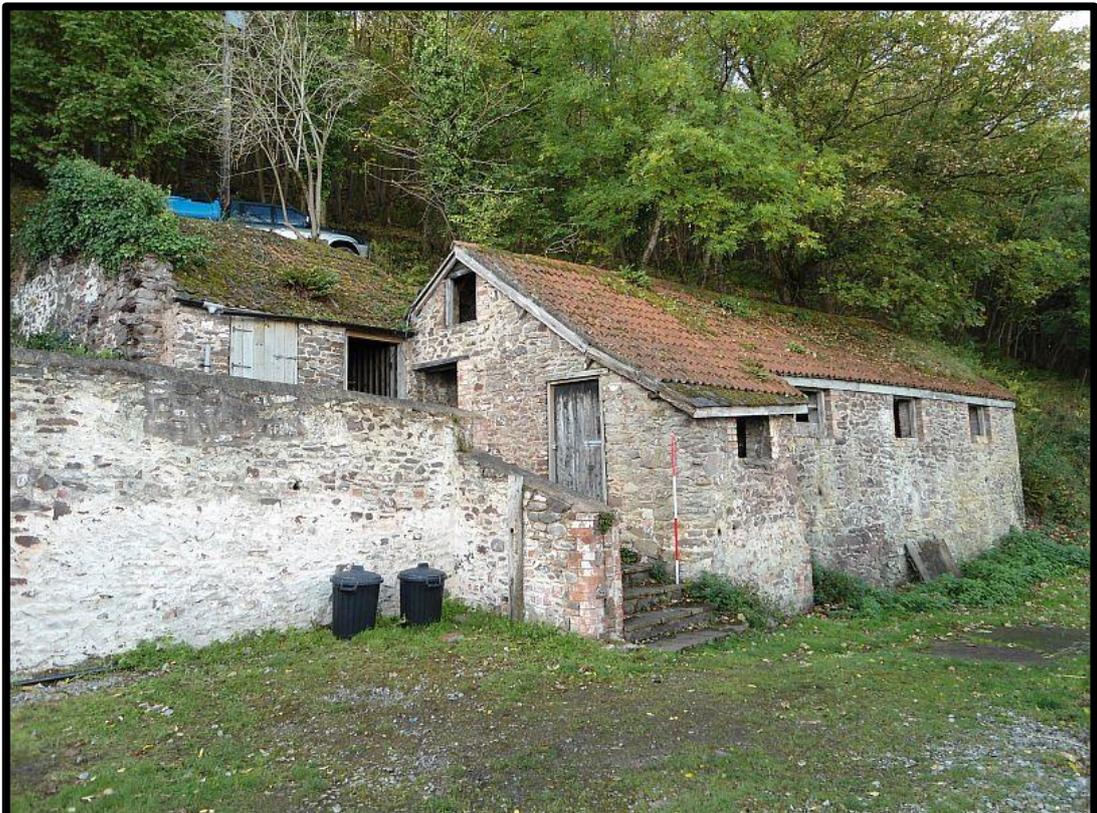
Fig 19 View of the piggery and sheds at the north-western end of the site showing the remains of revetment walls associated with demolished 19th-century farm buildings

The piggery (Fig. 19) is one of the few farm buildings left on the site which retains its roof. This building appears to have been erected in the late 19th century, between 1880 and 1900, and lies on a terrace above the presumed stockyard, and on the same level as the old farmhouse. It is a

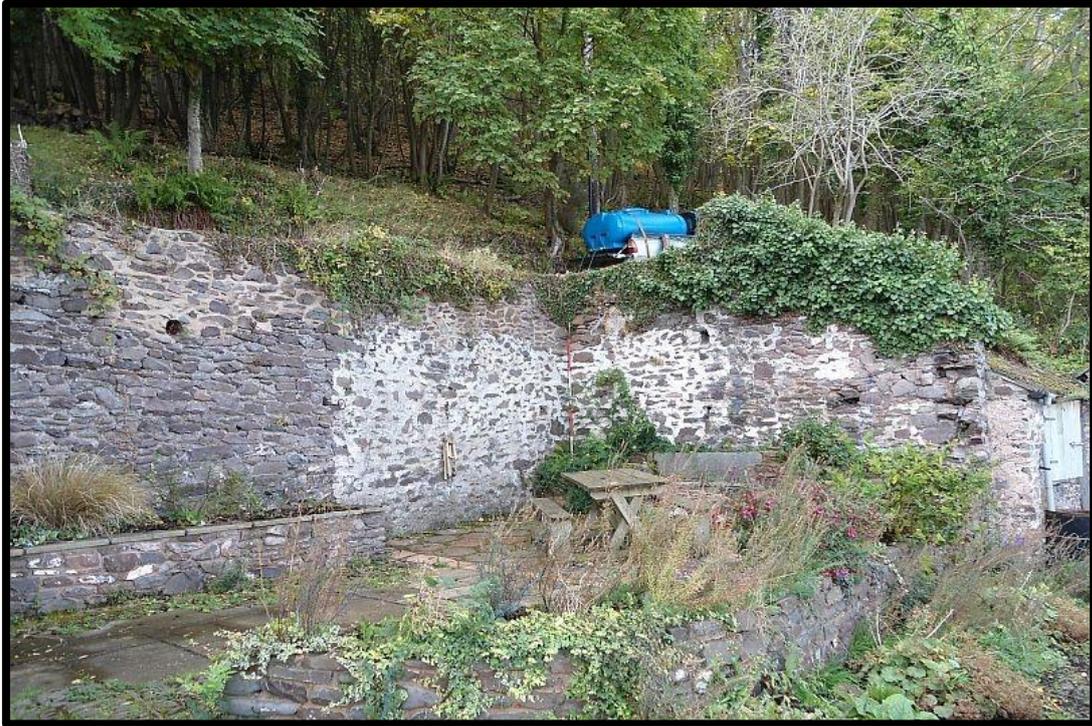
Fig. 20 View of the revetment walls to the west of the old farmhouse showing the remains of demolished farm buildings.

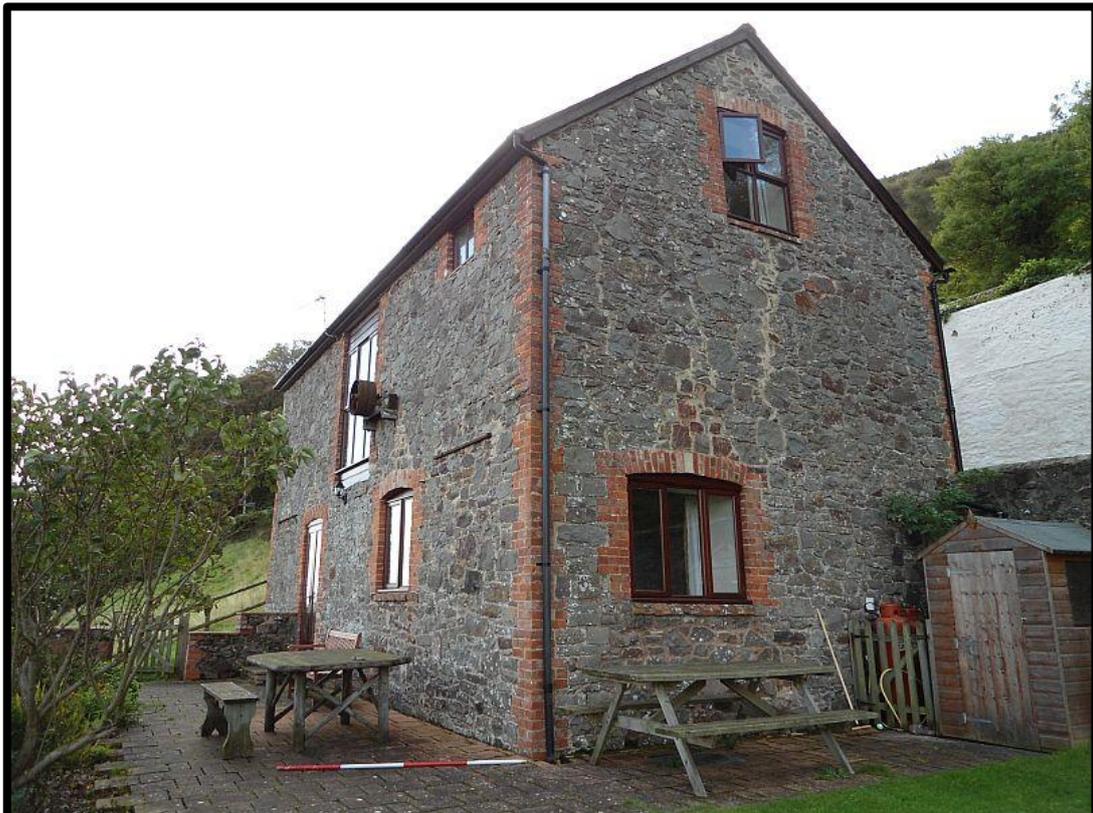
Fig. 21 View of 'Greenaleigh' Cottage, looking south east, showing the small window openings and doorway on the ground floor, the large opening and small ventilation windows in the north wall and the high-level openings in the gable.

Like the new farmhouse (with which it may be contemporary) the building (Fig. 21) is constructed of randomly-coursed rubble with red brick dressings to the openings and to the quoins, but the

rubble masonry is of lower quality and unsquared. The building has a modern slate roof and all the doorways and windows are replacements relating to the conversion of the building. The building is built into the hillside so that it is entered at first-floor level by a wide doorway opening on to the roadway passing through the site (Fig 22). This is opposed by a large doorway on the north elevation, at such a high level above the ground that it is highly unlikely to have been used for loading. On either side of this doorway are small openings which have the character of ventilators.

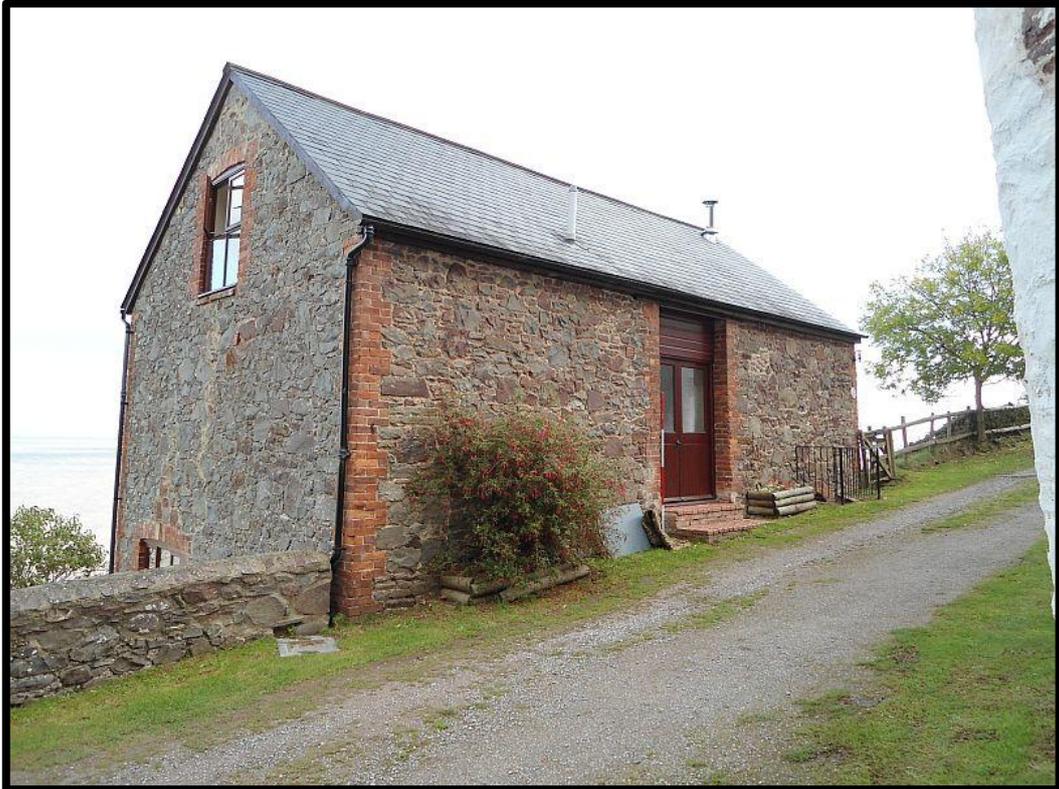
Fig. 22 View of Greenaleigh Cottage from the east, showing the large double width door in its southern elevation, opposing that on the north. These may have been used to regulate the draught for winnowing.

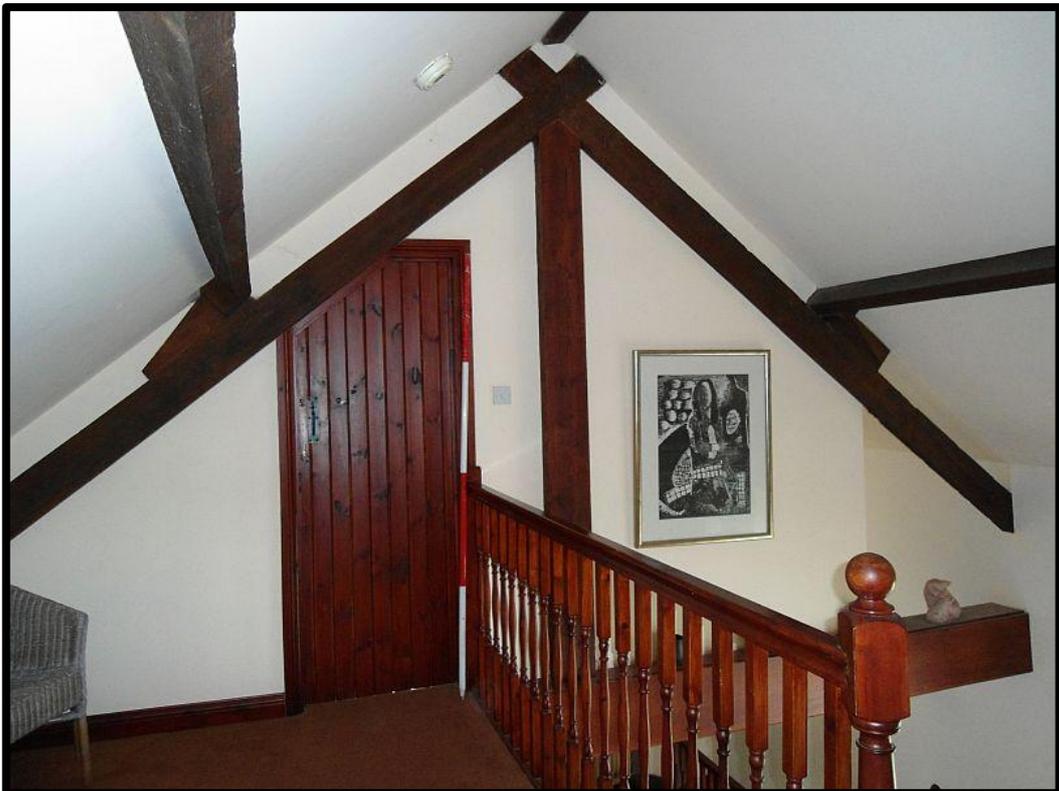
Fig. 23 View of the interior of Greenaleigh Cottage after conversion, showing the survival, though altered, of elements of the original 19th-century roof.
