## **EVALUATION TRENCHES 7,8, & 9**

### **HESLINGTON EAST, YORK**

**INTERIM EVALUATION REPORT**

**REPORT NUMBER 2008/33**

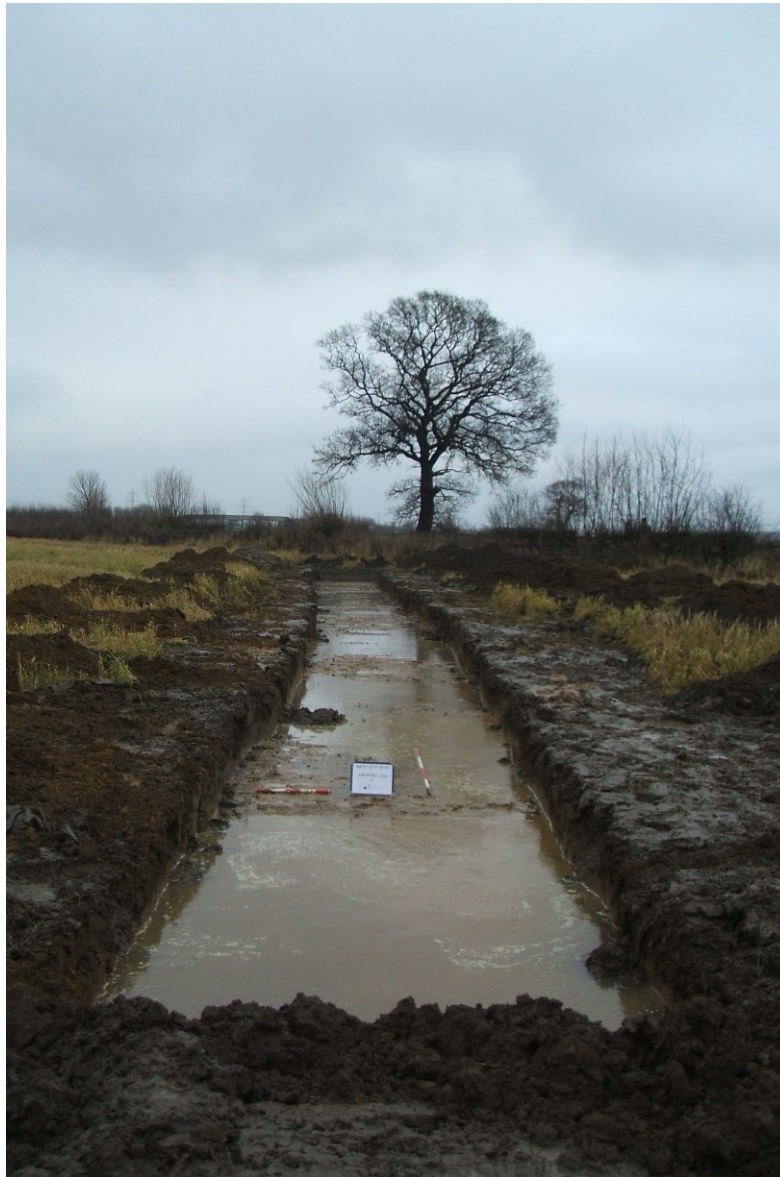
**Plate 1** *Trench 7, looking ESE*

Natural deposits of slightly plastic, mid yellowish brown clayey sand with mottled grey patches, context 17001, were encountered at the base of the trench at a depth generally around 0.32m BGL (typically around 10.85m OD). Although this trench suffered from a continuous in-rush of adjacent standing water the surface of natural deposits was exposed long enough to check for any cutting features. In order to confirm the 'natural character of 17001, parts of the trench were further reduced by around 0.10-0.15m.

Only a single feature, a post-medieval north-west – south-east aligned land-drain, 17002/17003, was seen to cut into natural deposits.

The uppermost deposit encountered in Trench 7 the extant topsoil of slightly plastic, mid grayish brown, clayey silt, context 17000.

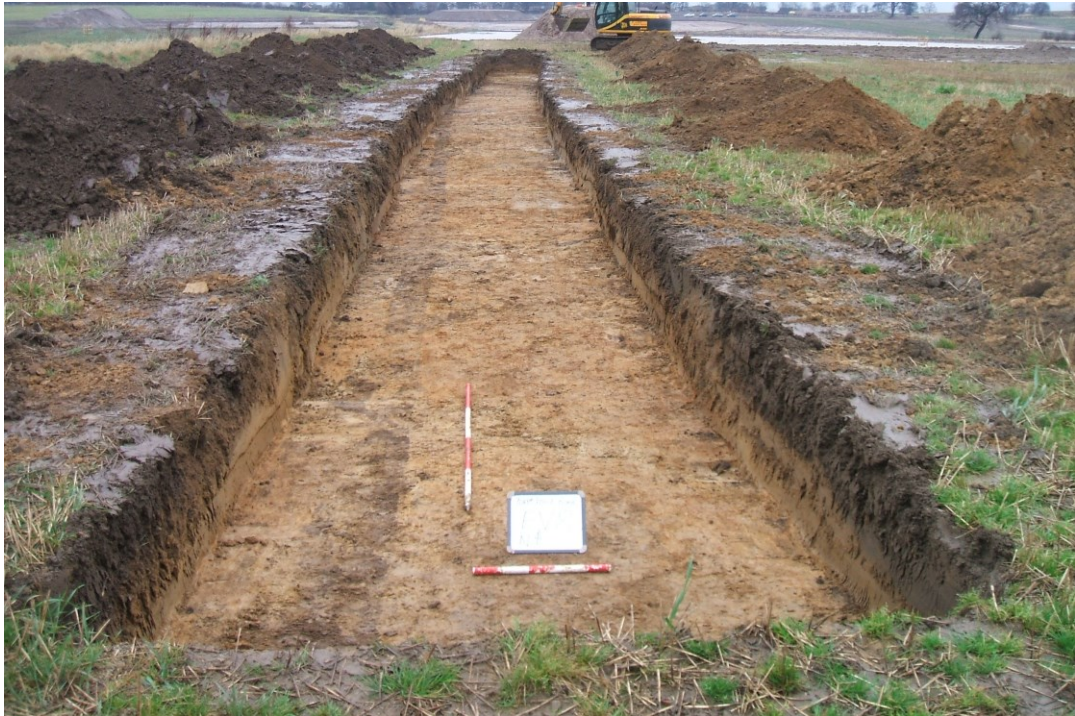
**Plate 2** *Trench 8, looking N*

Natural deposits of plastic, mid yellowish brown clayey sand containing occasional patches of gravel and reddish coloured mineralisation, context 18001, were observed at the base of the trench at a depth of around 0.30m – 0.36m BGL (typically around 10.35m OD). After cleaning, this was subsequently reduced by an additional 0.20m in order to be absolutely certain of the 'natural character of 18001.

Five features, all lumped under a single number 18003, were seen to cut into the natural deposits. These consisted of four south-west – north-east aligned field drains and a further example aligned north – south. All these field drains were of a later post-medieval date.

The uppermost deposit in Trench 8 was the extant topsoil, context 18000, composed of slightly plastic, mid grayish brown, clayey silt that was generally in the region of 0.30m deep.
