YORK ARCHAEOLOGICAL TRUST REPORT

SITE ADDRESS	University of York, Heslington East, York		
CLIENT NAME	University of York		
YAT PROJECT #	5112	YAT REPORT #	2009/94
MUSEUM ACCESSION #	YORYM 2007.6006	GRID REFERENCE	SE 6372 5077

On 22nd and 28th July 2009 J.M. McComish undertook a watching brief for York Archaeological Trust on the cutting of a number of services trenches and on the construction of a road to either side of Goodricke College, Heslington East, York (Figure 1).

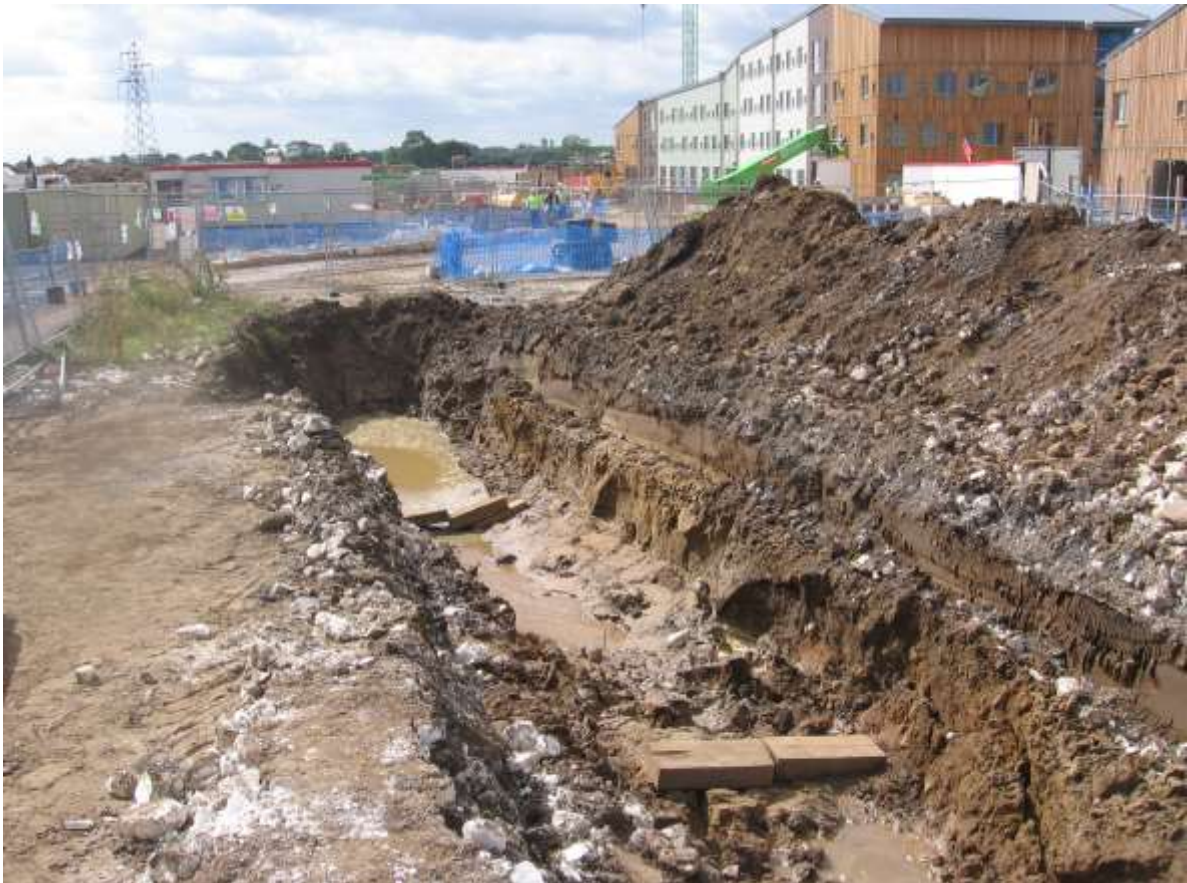
services trench. The observed portion of trench was c.38m long, 1.1m wide and 0.7-0.8m deep. Only the lowest 0.15m of deposits were of natural origin, the uppermost deposits being modern dumping associated with the present works. The natural deposits were clean light brown slightly clayey sand (Plate 1 and 2). No archaeological features were observed. The photographs are stored on IADB as photo numbers 5112-2564 to 5112-2582.

Plate 1 Services trench to the east of Goodricke College, facing south.

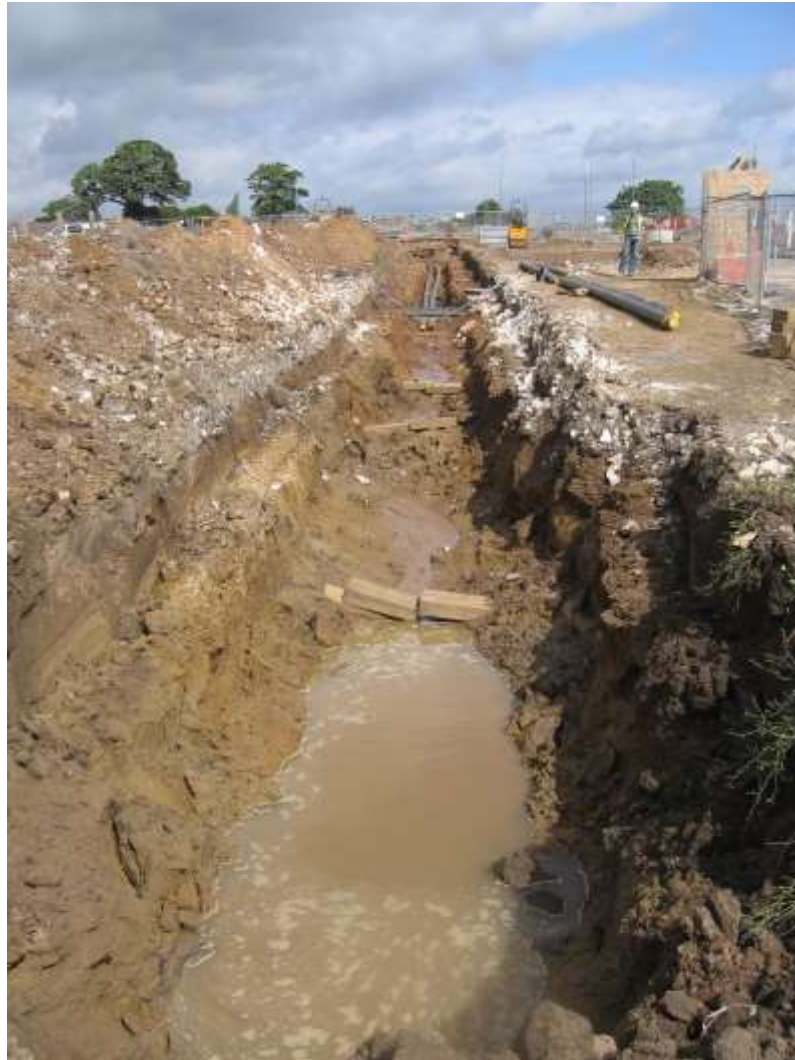
Plate 2 Services trench to the east of Goodricke College on completion, facing south.

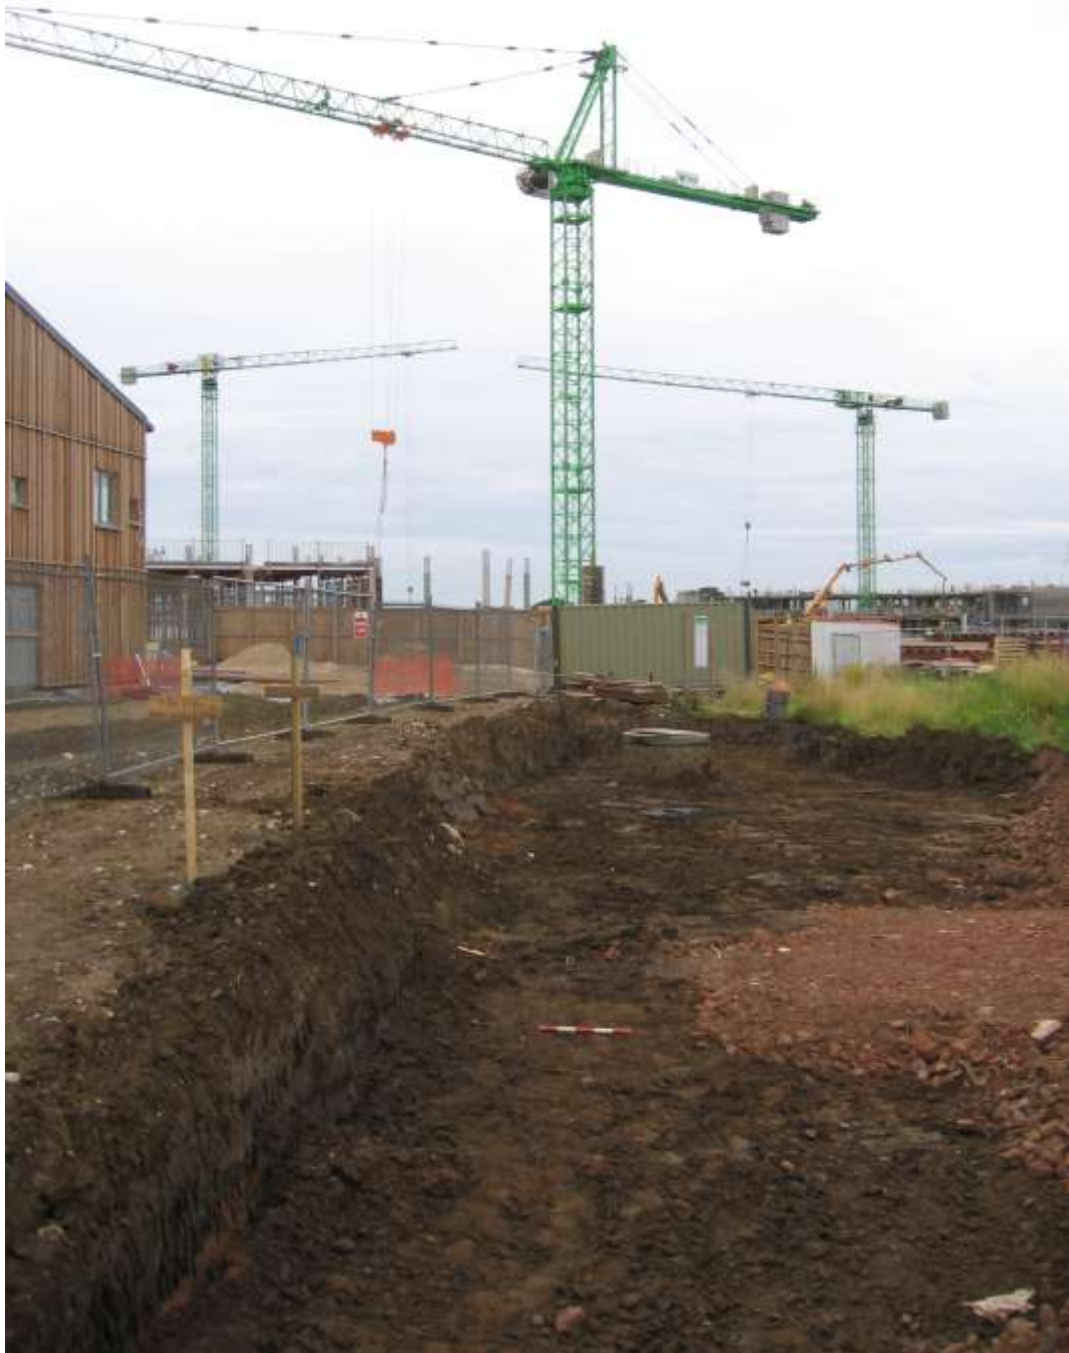
On 28th July 2009 a visit was made to observe the services corridor to the east of Goodricke College, however, since no work had been undertaken on this since the previous visit there was nothing to observe in this area. It was, however, possible to observe that an area of topsoil had been stripped on the site of the proposed road to the west of Goodricke College (Plate 3). The area concerned was c.30m long, up to 7m wide and had been stripped to a depth of between 0.6m on the western, southern and northern sides, and 1.35m on the eastern side (the eastern side had been deliberately built up by modern dumping associated with the present construction works). The stripped topsoil consisted of dark brown silty clay above natural light orange brown silty clay with no inclusions. No archaeological features were seen. The photographs are stored on IADB as photo numbers 5112-2583 to 5112-2596.

Plate 3 Stripped area to the west of Goodricke College, facing south.
