Old College Quadrangle

South Bridge, City of Edinburgh

Archaeological Evaluation: April 2010
Data Structure Report

(project AA. 1495)

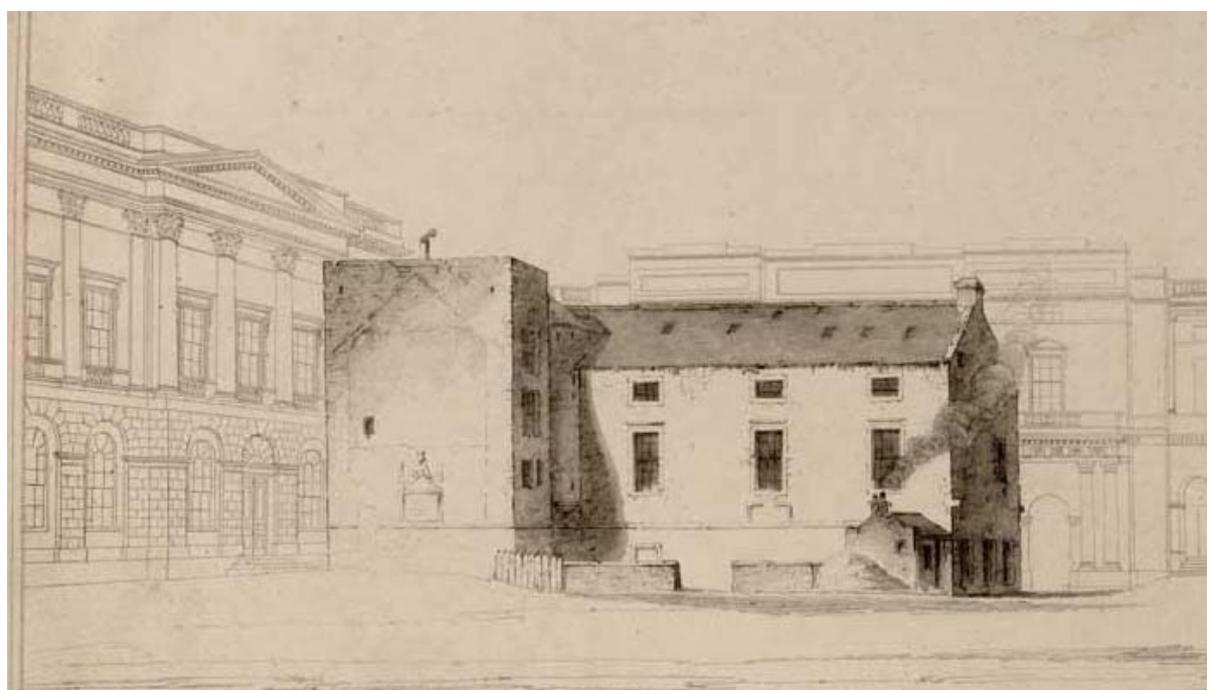
Figure 6: Sketch of the old library, with the new buildings behind. Lizars, 1823. Edinburgh University Library.

Apart from Gordon of Rothiemay's bird's eye view of 1647, the earliest detailed images of the University buildings are associated with fund-raising efforts in the early 19th century. These show how the old buildings were replaced gradually, and the contrast between their state and the neatness of the new is clear (Figures 5-6).

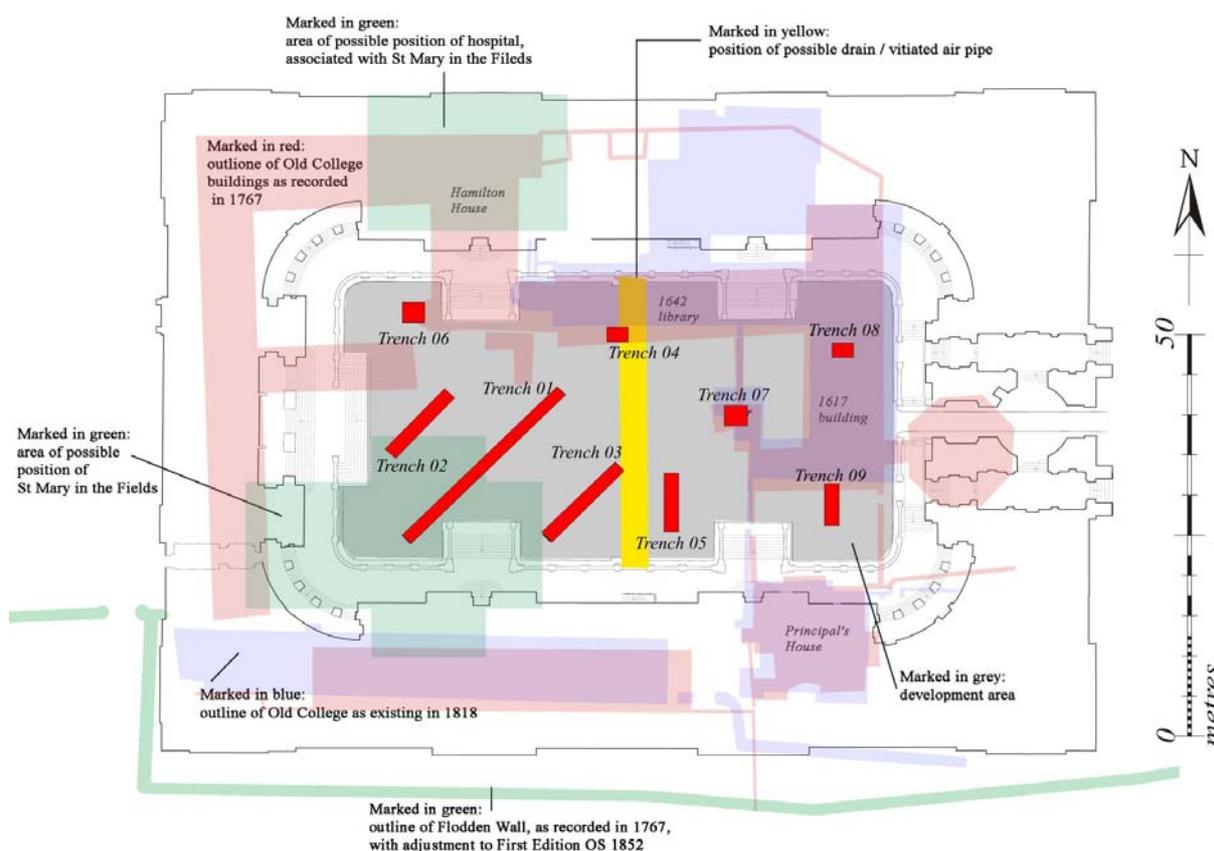
Figure 8: Location of trenches (A3 copy in Appendix F).

NOTE: Trenches are approximate positions only; the positions of historic buildings and structures are estimates from historic sources

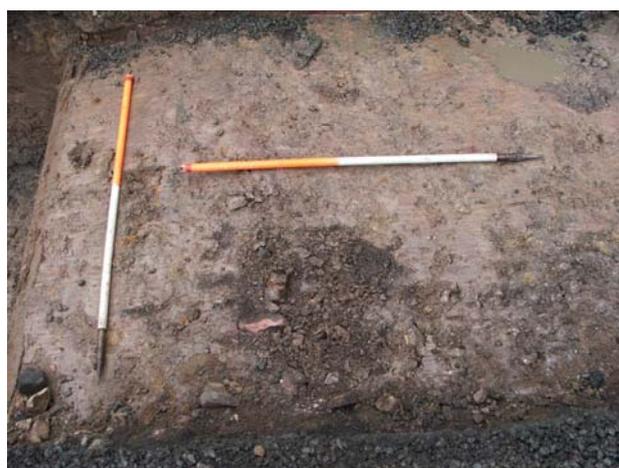
Plate 1: [3008/3006] in Trench 3 – from NW.

At 0.50m depth around 4m from the NE end of the trench a series of small sub-circular features were noted. Both (3005/3007) and (3006/3008) are cut into the natural and filled with mid brown silty clay. Another possible feature (3004) was noted adjacent to the SW of [3008], where the clay displayed a much darker grey hue.

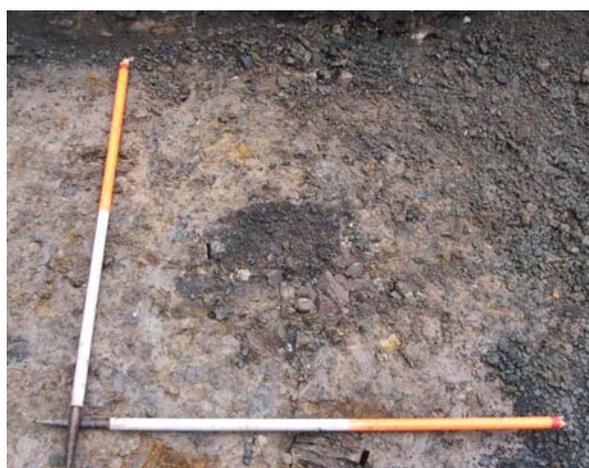
Plate 2: [5006/5004] in Trench 5 – from E.

One feature of potential archaeological significance was encountered 2.7m from the N end of Trench 5. A small, sub-circular feature 0.37m in diameter [5006/5004] was similar to those encountered in Trenches 2 and 3. Excavation revealed [5006] to be 0.18m in depth, with initially steep sides levelling off to a roughly flat base. (5004) is a mid to dark brown silty clay, firmly compacted with frequent angular stones.

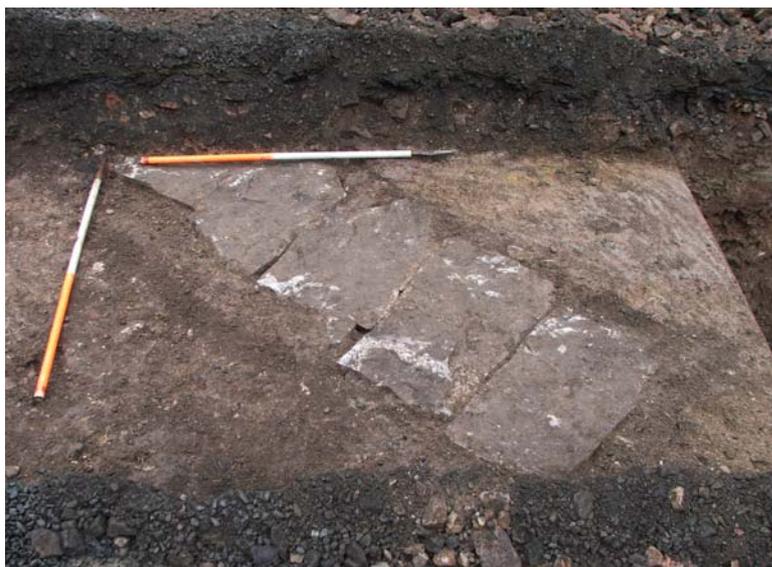
At the NE end of the trench a stone-lined 'cundy' drain was encountered on a rough W-E alignment. Situated almost 2m from the end of the trench it seems that the cut [1008] was made, the stones [1007] placed and bonded with clay (1010), before a mid brown loam (1009) was packed in the spaces between cut and the clay lining. Removal of the capping stones demonstrated the internal cavity to be 0.30m deep with a width of 0.28m. The drain was well constructed and probably still functioning and the caps were replaced prior to backfilling. It is assumed this drain connects with that uncovered on the same alignment and with similar dimensions [2006] in Trench 2.

Plate 3: Stone-lined drain [1007] from SE – Trench 1.

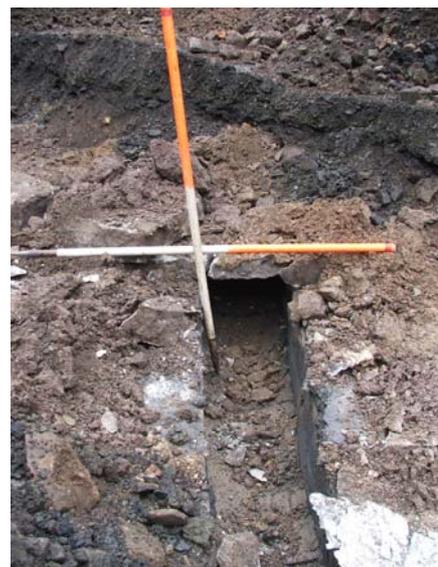
Plate 4: [1007] After removal of capping stones from E – Trench 1.

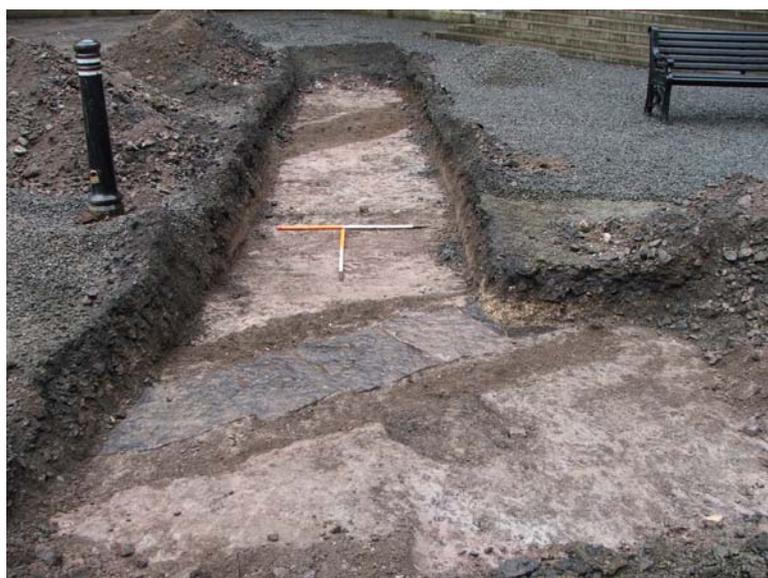
Plate 5: Post-excavation view of Trench 2 from NE with [2006] visible in the foreground and [2005] in the background.

A number of features of archaeological interest were encountered across Trench 2. 0.40m from the SW end of the trench, a linear feature [2005] of 1m width was recorded running W-E and filled by a mid brown loam (2004). A section through this feature showed a depth of 0.17m and a flat base. Glass and iron fragments were recovered from this slot.

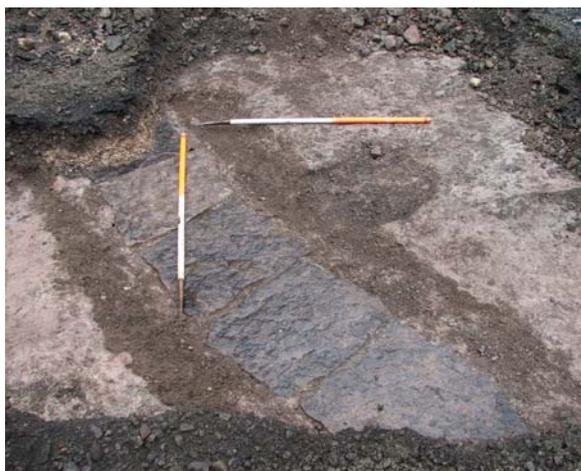
0.50m from the NW end of Trench 2 a stone-lined ‘cundy’ drain [2006] was encountered also on a rough W-E alignment. From examining the drain, it seems that the cut [2008] was made, the stones [2006] placed and bonded with clay (2009), before a mid brown loam (2007) was packed in the spaces between the cut and the clay lining. This drain may still function and was left intact. A piece of blue-pattern, glazed ceramic (18th-19th century date) and an iron object were recovered from (2009). This drain is likely to be a continuation of [1007] and associated contexts encountered in Trench 1.

Plate 6: [2006] from the SE with [2012/2010] clearly visible cutting [2008].

Two sub-circular cut features were also pinpointed adjacent to the drain [2006]. (2011/2013) lies around 0.45m to the S of [2006], protruding 0.32m from the section. (2010/2012) was initially hard against the opposite section, yet here the trench was extended slightly in order to assess the extent of this feature. It proved to be little bigger, measuring 0.64m NE-SW by 0.58m NW-SE although clearly cutting (2007/2008).

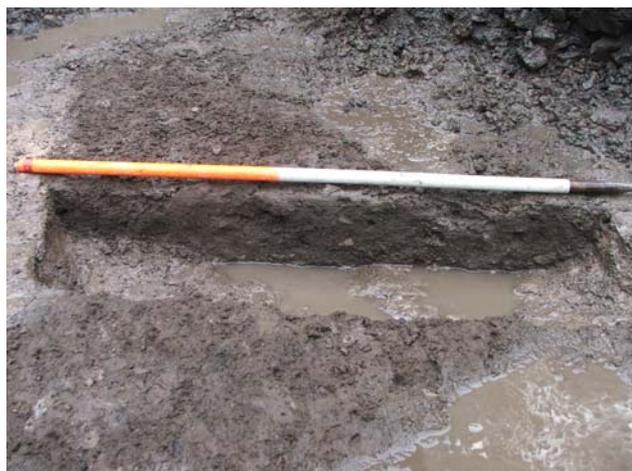
Trench 2 displayed a linear feature of mid brown silty loam orientated in a rough W-E direction. Excavation revealed this to have no great depth and uncovered a small fragment of glass from the base of the fill (2004). The function of this linear feature is unclear. The loam fill does not indicate a drainage cut and there is no evidence for it representing a robbed foundation trench. A similar linear feature, in all likelihood the same, was observed in Trench 7 at the E end of the site.

Plate 7: E facing section of [2005] revealing (2004).

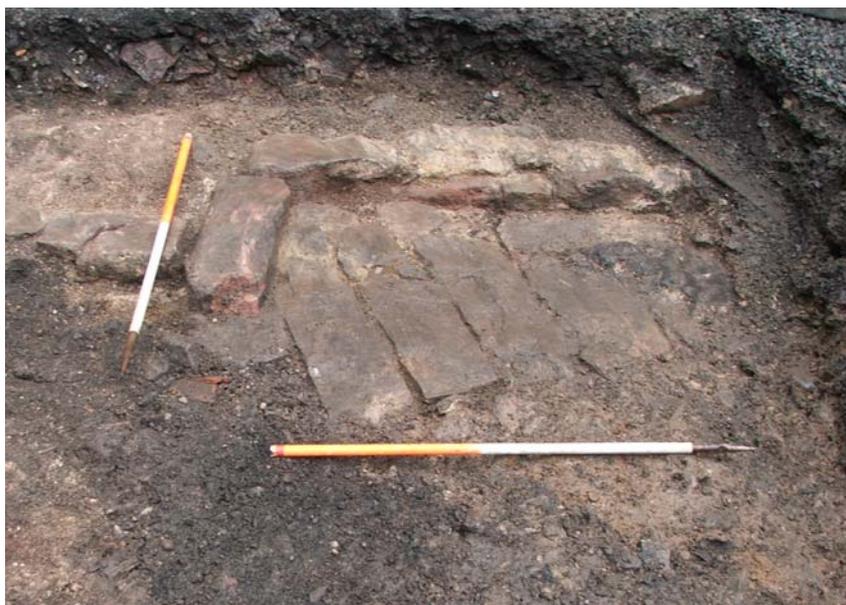
The area was covered with 0.05m of grey gravel (1001) above a 0.05-0.10m levelling layer (6001) of gritty black gravel. Stratigraphically beneath this were two layers of demolition material, with mid brown gritty hardcore of angular sandstone (6003) lying directly above a mortar-rich white sand with stone inclusions (6004). This in turn was removed to reveal a fragmentary floor surface of 0.03m fine black silt with bone inclusions (6011) lying directly on top of a disturbed red sandstone paving [6007]. This paving abutted a wall footing [6002] running roughly W-E and curving around [6007] at right angles to the W. To the SW this structure had been disturbed by the insertion of a drain [6010] while the E edge was occupied by a power cable. This structure was recorded and left *in situ*.

Plate 8: Trench 6 with structure [6002/7]- from S.

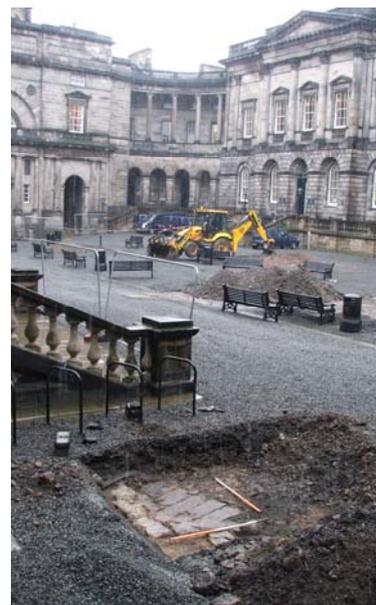
Plate 9: Location of Trench 6 - from NW.
