Douglas Coalyard

Douglas, South Lanarkshire

Archaeological Evaluation : July 2011
Data Structure Report

(project AA. 1943)

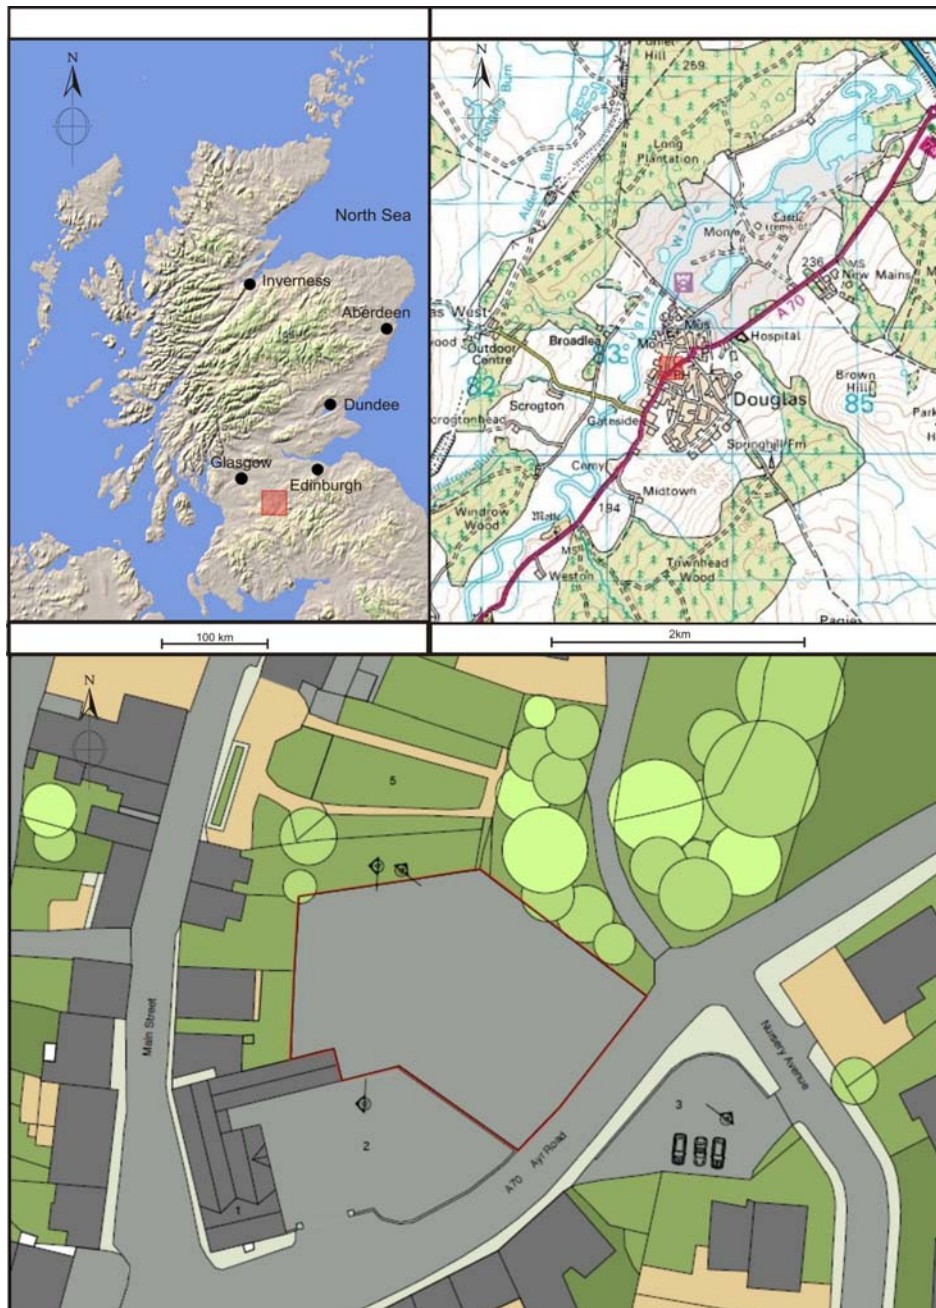
Figure 1: Site Location. Ordnance Survey © Crown copyright. All rights reserved. Licence number 1000 06772. Detailed site map provided by client with kind permission of Hugh Broughton Architects

The proposed development site lies within the modern day town of Douglas in South Lanarkshire, S of the old medieval town centre and between the fork created by Main Street to the W and Ayr Road to the S and E. The site lies within the conservation area. Centred on NS 283552 630703, the area for development consists of a parcel of derelict land with rough concrete and tarmac surfacing through which much vegetation is now protruding. This area is bounded on all sides by walls or fences and comprises roughly 1,400m² (Figure 1).

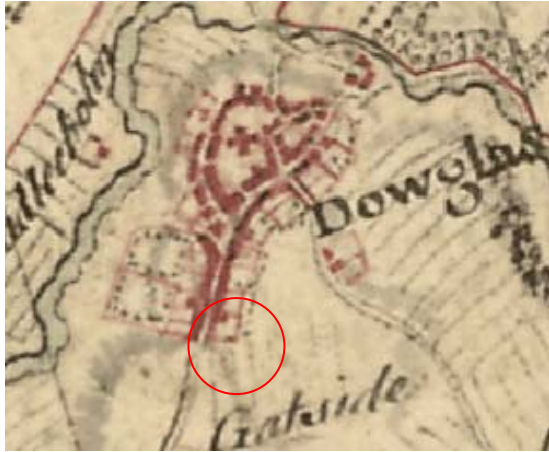
Figure 2: General Roy's map of c.1747. Rough site location indicated in red. © The British Library Board. All Rights Reserved (Roy Military Survey of Scotland)

Cartographic analysis of the area is not available in sufficient detail to identify the location of buildings and structures in the medieval period. However, the earliest map of Douglas that can allow the site to be identified with any degree of accuracy is General Roy's military map of the mid 18th century, surveyed between 1747 and 1755 (Figure 2). The map shows the general area of the proposed development site on the fringes of the village in the mid 18th century. However, it is impossible to determine its exact location, and therefore it is uncertain whether the site was occupied or developed before c1750.

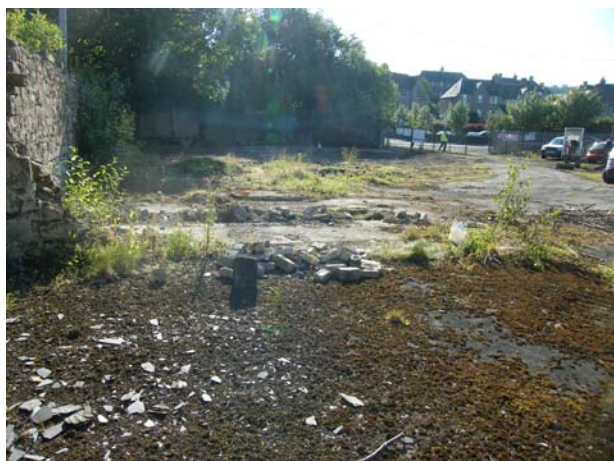
Plate 1: Pre-excavation shot looking ENE

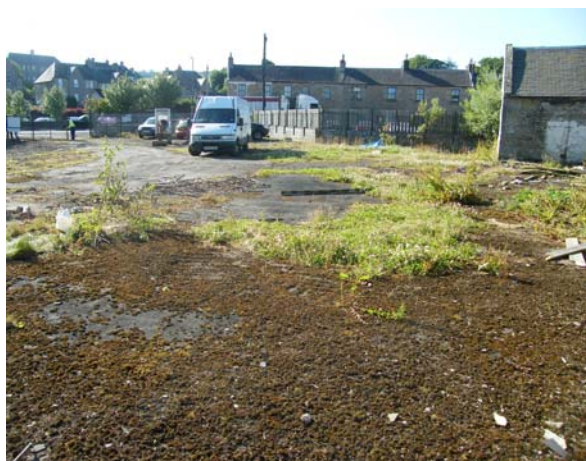
Plate 2: Pre-excavation view to SSE

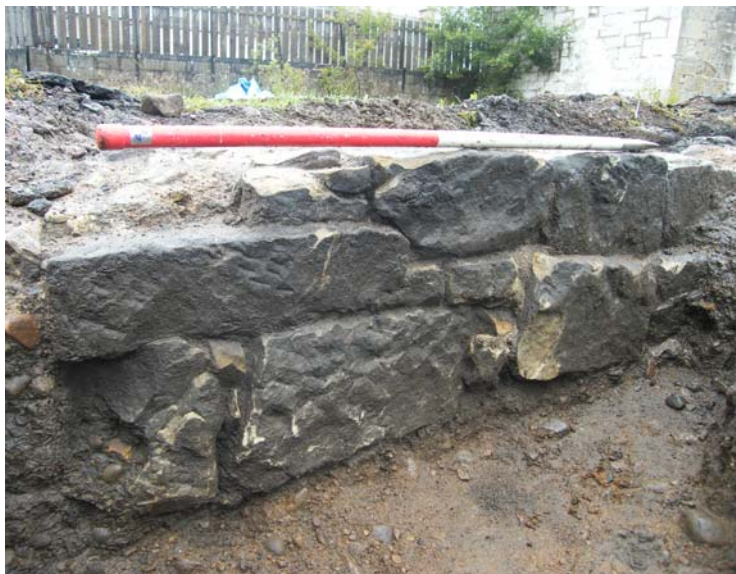
Plate 4: Oblique view looking SW to {2007} (note the tooling on the stones and clear cut shape of the large re-used stone)

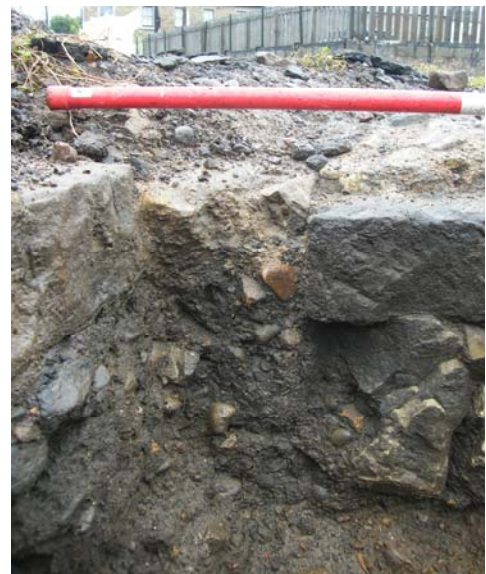
Plate 5: View looking S showing {2007} cut by [2009]

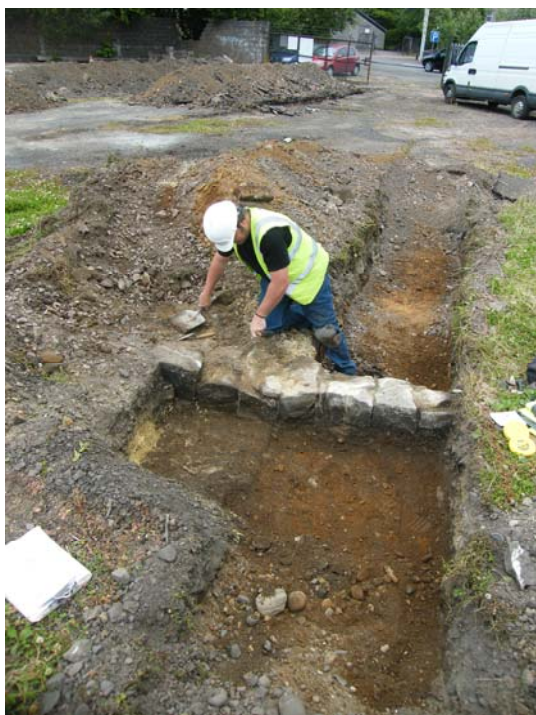
{4007} itself was not as well preserved as in Trench 2, surviving to one course of rubble stones bonded with soft, creamy lime mortar.

Plate 6: Working shot of {4007} in Trench 4 looking ESE

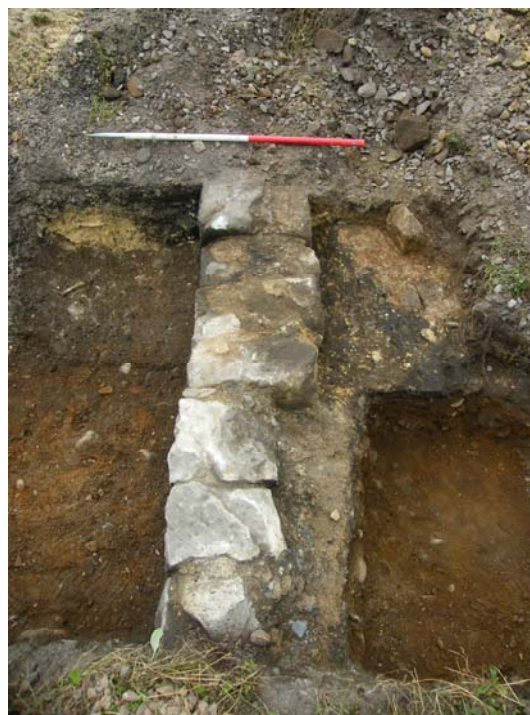
Plate 7: Post-excavation view NNE of {4007} in Trench 4

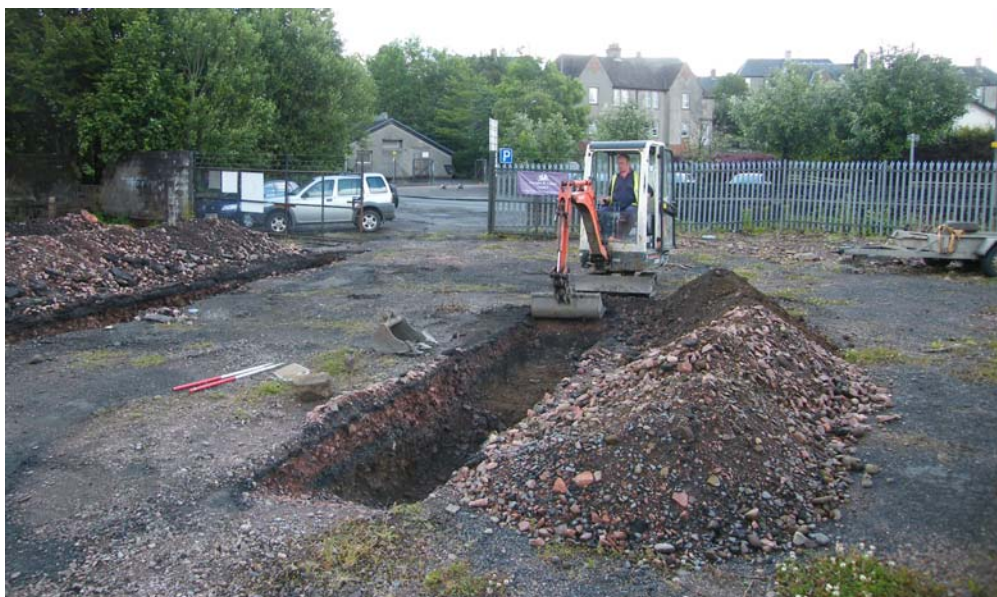
Plate 8: Working shot – opening Trench 5 looking SE

Orientated NW-SE, Trench 5 measured 13.50m, had an overall depth of 0.50m and in line with all trenches across the site, was 1m wide. No significant archaeological evidence was encountered during excavation of Trench 5.

The uppermost deposit (5001) comprised a thin layer of tarmac with a depth of 0.03-0.05m. Immediately beneath (5001), (5002) was a build up of red hardcore and rubble consisting mainly of small to medium red angular stones. This deposit was 0.30m deep and represents a large-scale dumping and levelling event in the late 20th century.

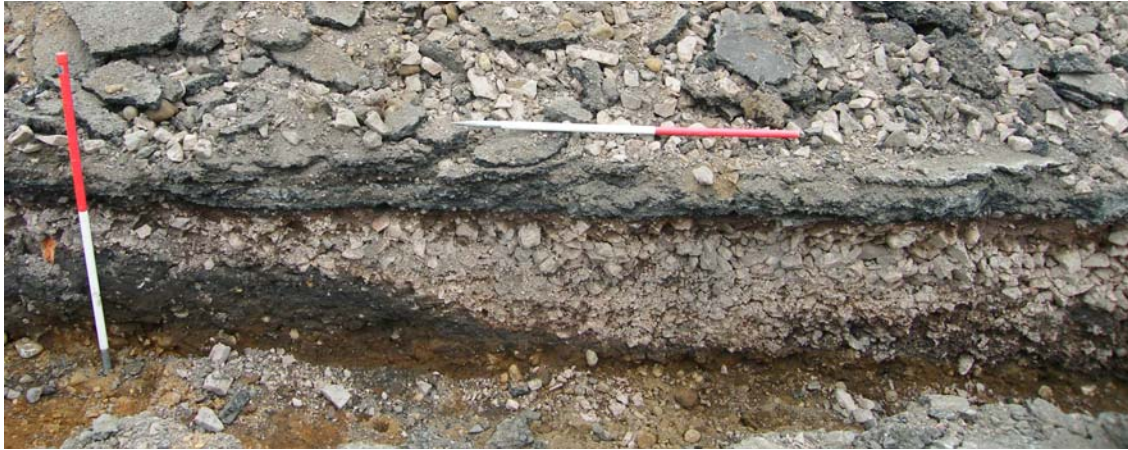
The only difference with Trench 5 worth noting in Trench 6 is the existence of [6007], a terracing cut into the old ground surface (6003) and subsoil (6004), subsequently filled by the red hardcore (6002).

Plate 9: S facing section of Trench 6 showing [6007] cutting through (6004)

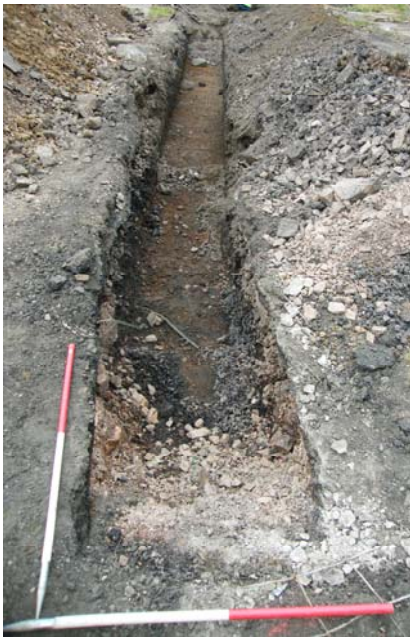
Plate 10: Post-excavation shot of Trench 7 looking WNW

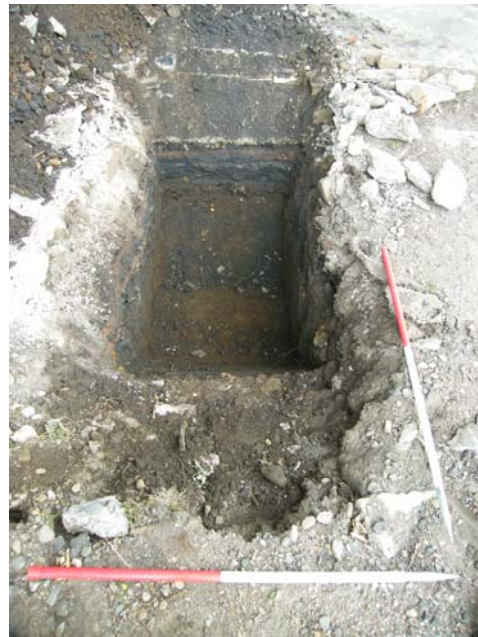
Plate 11: Post-excavation shot of Trench 8 looking ENE

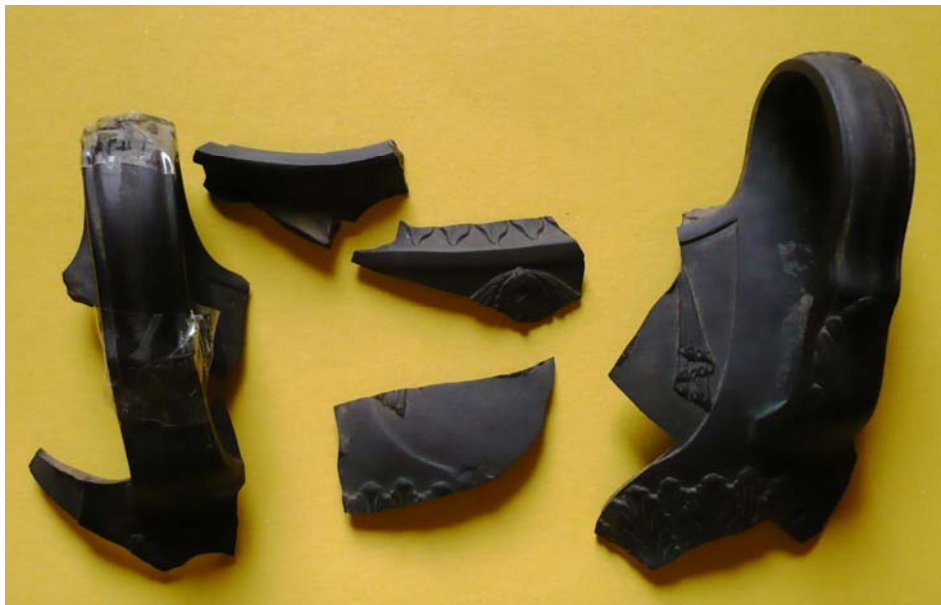
Excavation from within Trench 2, (2004), revealed six ceramic sherds (SF001) from an oval shaped Black Basalt two handled sugar dish with moulded swags and leaves, *plate 12*. The lid seating suggesting it had a cover and three of the shards conjoin giving us two complete handles and two body shards. Stylistically the pot dates from between 1790 and 1810, with the paramount clue in trying to identify a manufacturer being the distinctive handles with their lower kick and thumb piece.

Plate 12: the fragments of basalt ware sugar dish recovered from the evaluation

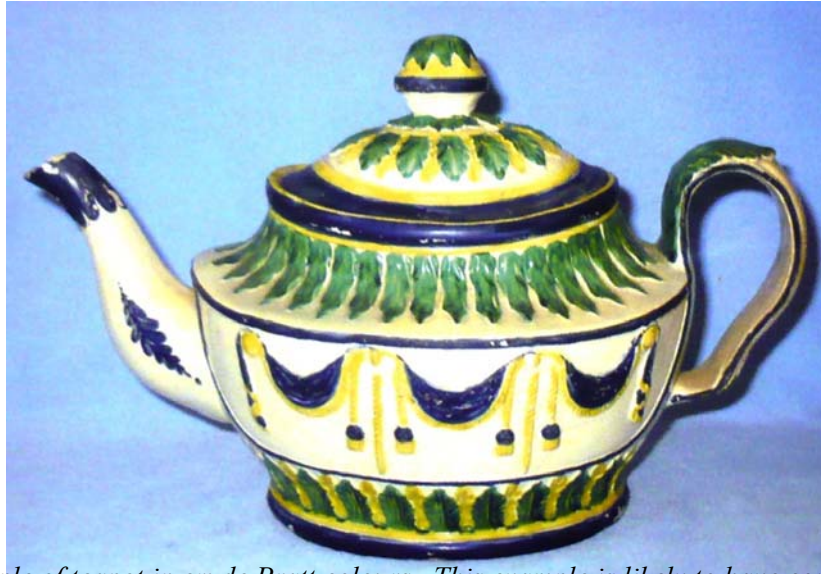
Plate 13: Example of teapot in crude Pratt colours. This example is likely to have come from the same mould as SF001

A survey of Grant's *The Makers of Black Basalt* and Diana Edward's *Black Basalt Wedgewood and Contemporary Manufactures* failed to identify a maker. However, with the knowledge that a teapot produced to go with the sugar dish would have been similar, analysis of *A Directory of British Teapots* by Berthoud & Maskell revealed an illustration of the teapot in Pratt colours.² It is in the collections of Norwich Castle Museum and was made by Elija Mayer & Son who owned the Cobden Works, High Street Hanley Staffordshire. The earthenware example illustrated below (*plate 13*) which is decorated in crude Pratt colours almost certainly came from the same mould as the teapot which went with your black basalt sugar bowl.

Godden in his *Encyclopaedia of British Porcelain Manufacturers* states that there is a possible link between marked Mayer (Elijah Mayer c. 1784 – 1834) basalt wares and a cane ware teapot in the Victoria and Albert Museum and the teapot illustrated by Berthoult & Maskell.³
