Steeple Church,
Dundee

Archaeological Evaluation: May 2011
Data Structure Report

Data Structure Report

(project AA. 0465)

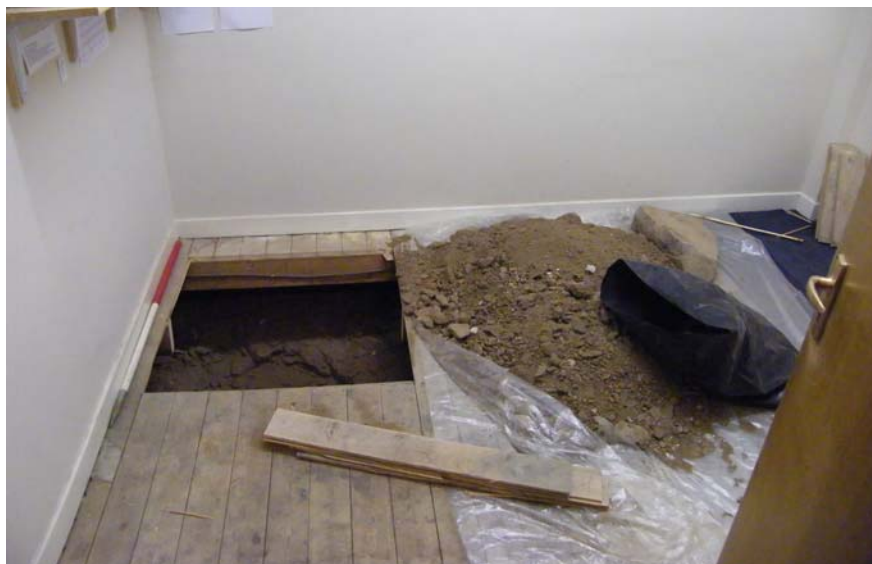
human bone. This material was carefully collated and recorded separately from that in the bag in case it represented surface spreads or depositions from earlier work and had not originated within the Trial Pit. Further human bone was subsequently recorded from the base and loose depositions on the sections of the cut.

Plate 1: Site as left by contractors

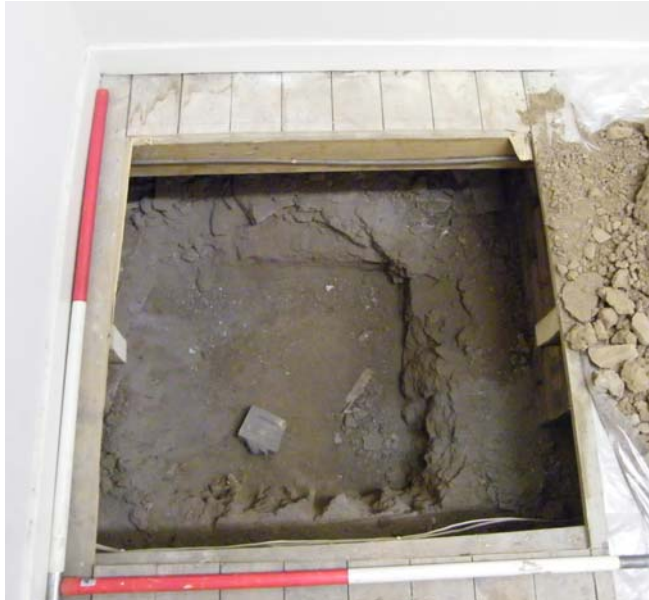
Trial Pit 2 revealed evidence for at least two disturbed inhumations, with a possible third and a further grave discernable in the NW corner of the trench.

The soil deposits were incredibly firm and dry, proving very difficult to work. The contractors had excavated the pit with a pinch bar, causing a great degree of damage to the bones recovered. Cleaning of the sections showed a number of different contexts to exist, but did not reveal clear grave cuts.

Plate 2: Post-excavation shot looking W

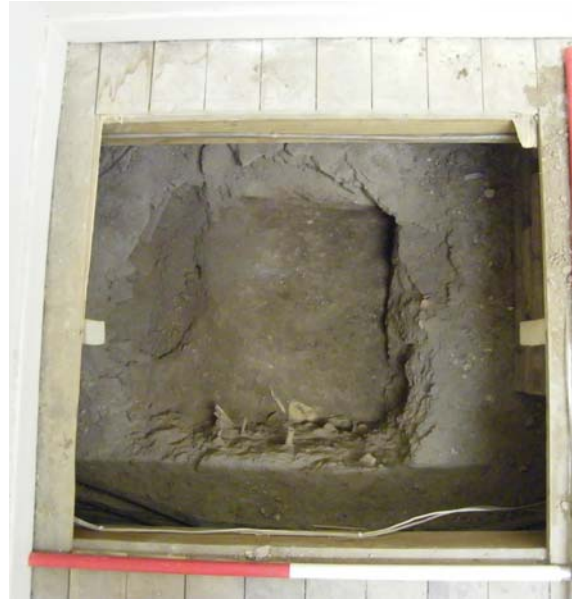
Plate 3: Post-excavation shot looking W – after cleaning and removal of loose bone fragments

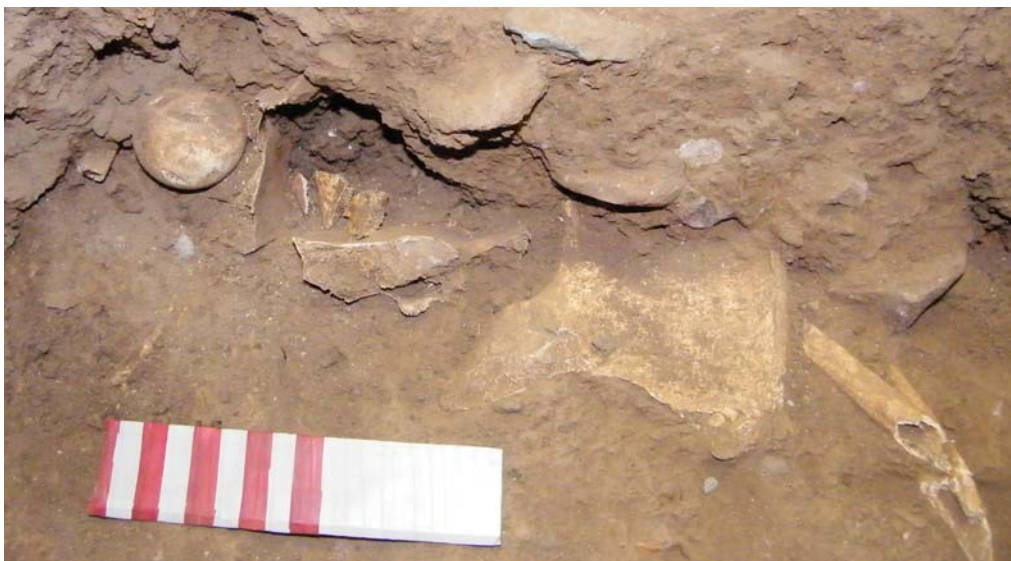
(003) is the first significant archaeological deposit encountered, although the frequency of bone and lack of obvious grave cuts make it difficult to discuss this with any certainty. It is clear that an adult inhumation lay roughly W-E across the trench, and the torso was removed by the contractor. The bones visible at the limit of excavation in the trench are clearly a pelvis, sacrum, top of a femur and broken radius – *plate 4*. The bottom half of this individual stretches E beneath the baulk.

Plate 4: Truncated pelvis in section

As the torso of the disturbed skeleton had been removed and damaged by the contractor, it is recommended that the rest of this individual be exhumed according to Historic Scotland guidelines. The remainder of the second, smaller skeleton will also be recovered. Care will be taken not to disturb any further inhumations during this process, but this cannot be guaranteed. Further investigation will also be required of the skull fragments visible in the S facing section.

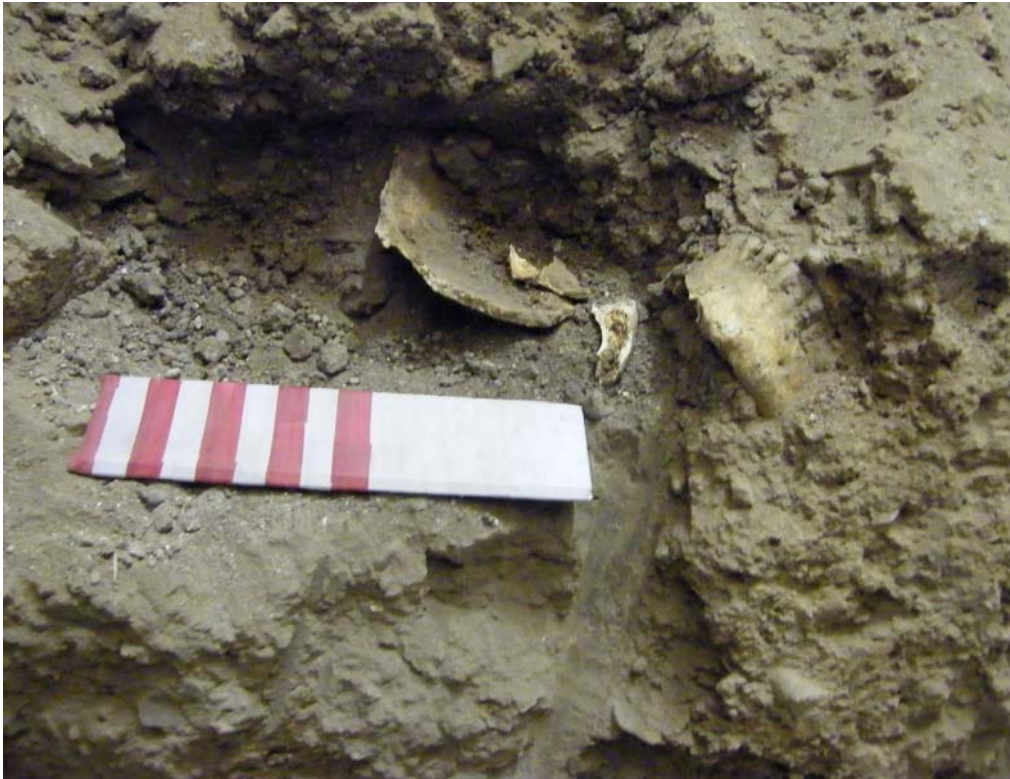
Parts of a human skull (both a fragment of cranium and mandible) are visible within (003) in the S facing section, although it is unclear if these represent charnel or an *in situ* burial (see *plate 5*).

Plate 5: Human skull fragments in S facing section of Trial Pit 2 – note the clear marks made by the pinch bar, breaking the mandible

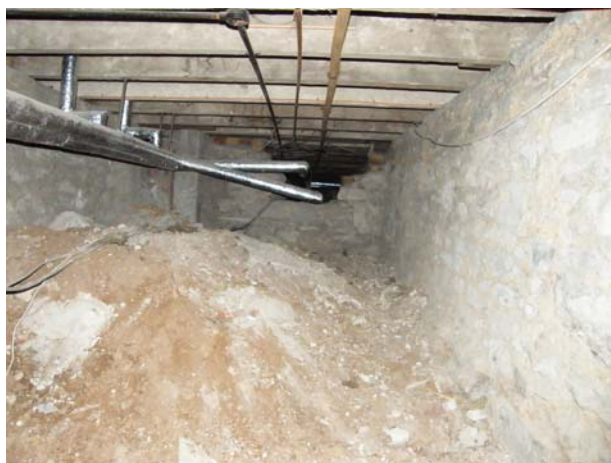
Plate 6: Mound of earth in boiler room

The boiler room itself is very cramped and claustrophobic with very poor lighting. Immediately upon inspection it became apparent there were a large number of human bones spread atop a large mound of earth at the W end of an area divided by two sleeper walls. These were recorded and a brief search of the mixed spoil heap revealed a further small to large human bones.

The spoil in the boiler room appears to be charnel-rich and it should be searched and possibly sieved if the quantity of human bone recovered merits this.

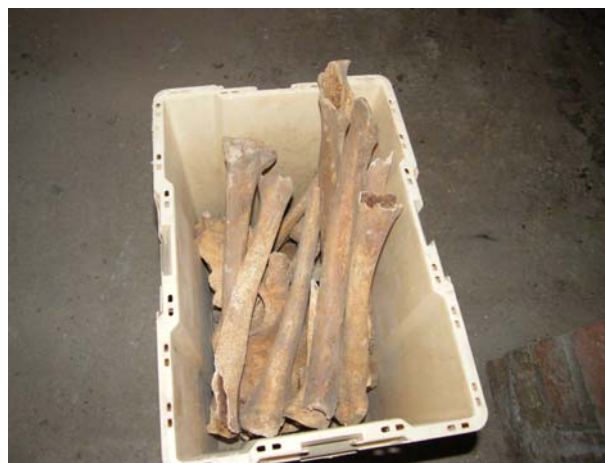
Prior to the site visit, work had been undertaken in the basement of the Church removing and replacing a boiler. It was noted by the Church that a number of long bones had been recovered in this area and as a result it was decided to investigate and photograph this room, retrieving the bones and any others that may be visible.

Plate 7: Bones recovered by Church staff from boiler room

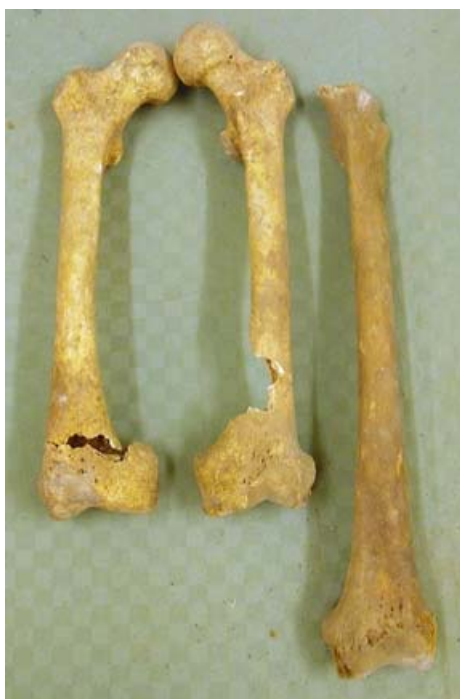
Perhaps of most interest, one individual from the Boiler Room material, represented by two femurs, part of the right tibia and perhaps one of the pelvis bones, showed the short, bowed bone-shafts and normal-sized bone ends typical of achondroplasia, the most common form of congenital dwarfism. Both knees also showed severe arthritic changes, common in the condition.

Plate 8: Achondroplastic femurs, with normal left femur (lacking head) for comparison
