Crommey Castle

Marnoch, by Aberchirder, Banffshire

Historic Building Record and Analytical Assessment

August 2011

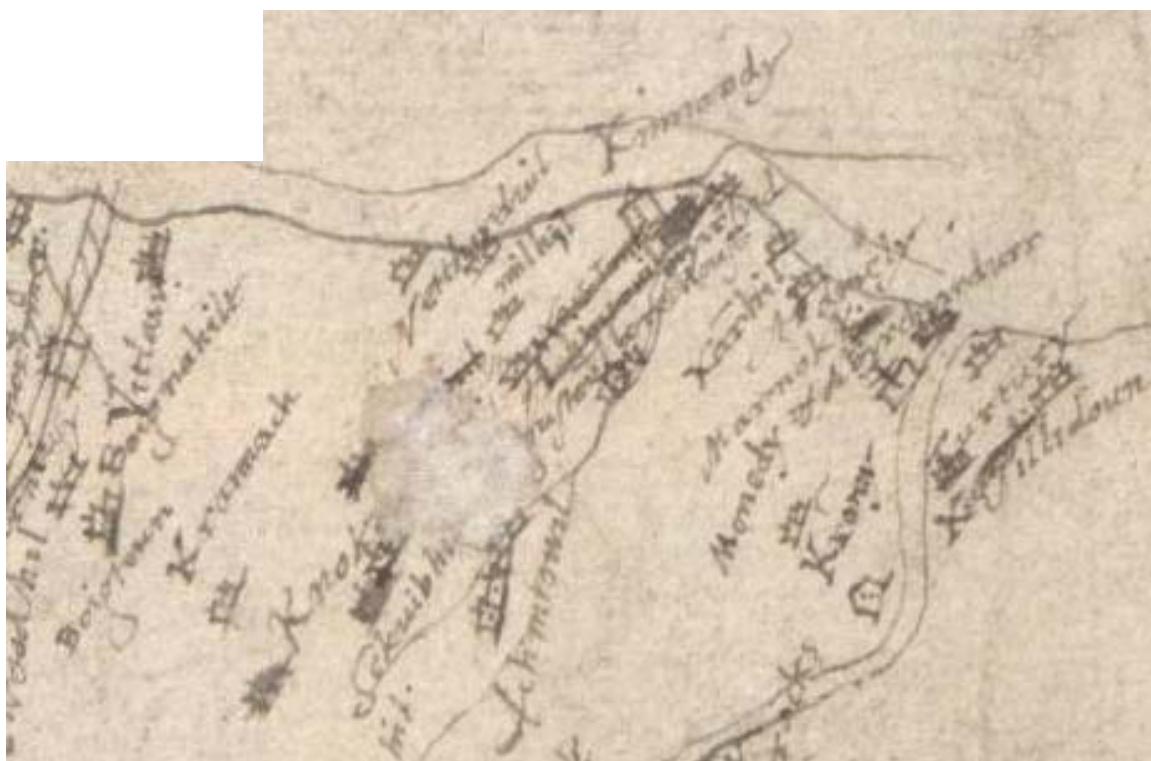
Figure 1 Detail of Timothy Pont's late 16th century manuscript map, showing the Deveron River (to the right) and settlements along its N bank (to the left), including 'Kromy' (Pont 9(1), The Coast to Banff) (NLS)

Beyond confirming the continuous presence of Crommey (spelt variously) from the late 16th century to the 19th earlier map sources provide little detail of the structures on the site with the possible exception of the later 16th century representation by Pont, *figure 1*. Here *Kromy* appears next to a diminutive sketch that perhaps represents a tower with a jamb.⁶ However its site seems clearly to lie on the E side of the Crommey Burn, and may therefore show the settlement of Old Crombie.

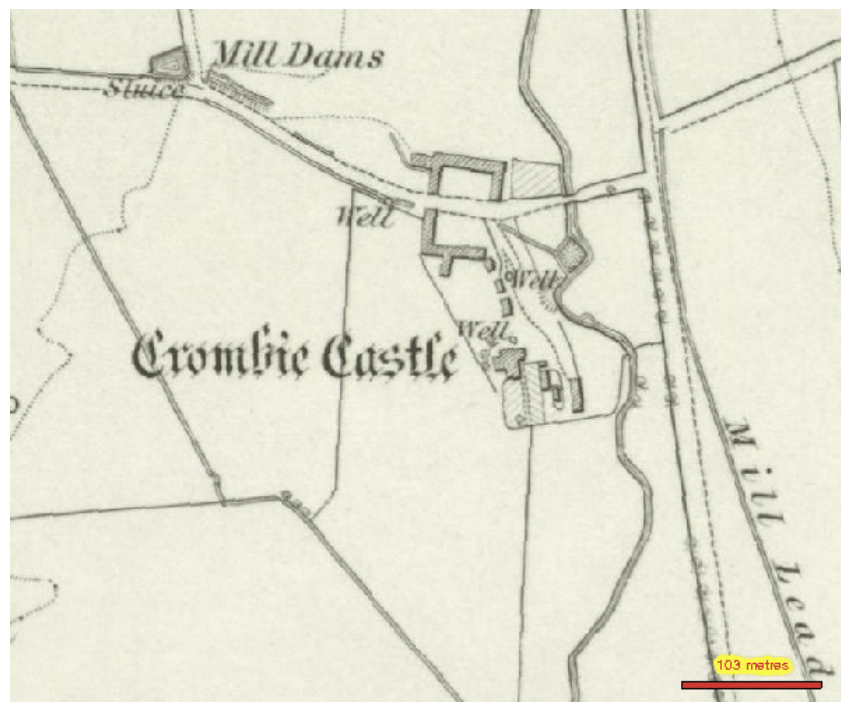
Figure 5 1st Edition Ordnance Survey, Banffshire 6 : mile sheet XV, surveyed 1867, published 1871(NLS)

Early Ordnance Survey maps provide some significant information about the evolution of the castle. The 1st Edition, surveyed in 1867, *figures 5 and 6*, shows that the S and W wings were in existence by then, as were the lean-tos against the latter and the out-shot linking the two along the SW exterior of the tower (also see discussion of the as existing plans of 1933 in the next section). A small yard or forecourt exists at the re-entrant to the early tower, an entrance on the S side of this leading to the axial garden path beyond. This arrangement remains unchanged on the 1874 OS (1:5,600) for Banffshire. However by the time of the 1904 OS (1:2,500, surveyed in 1902) the E wing is in existence – see following section.

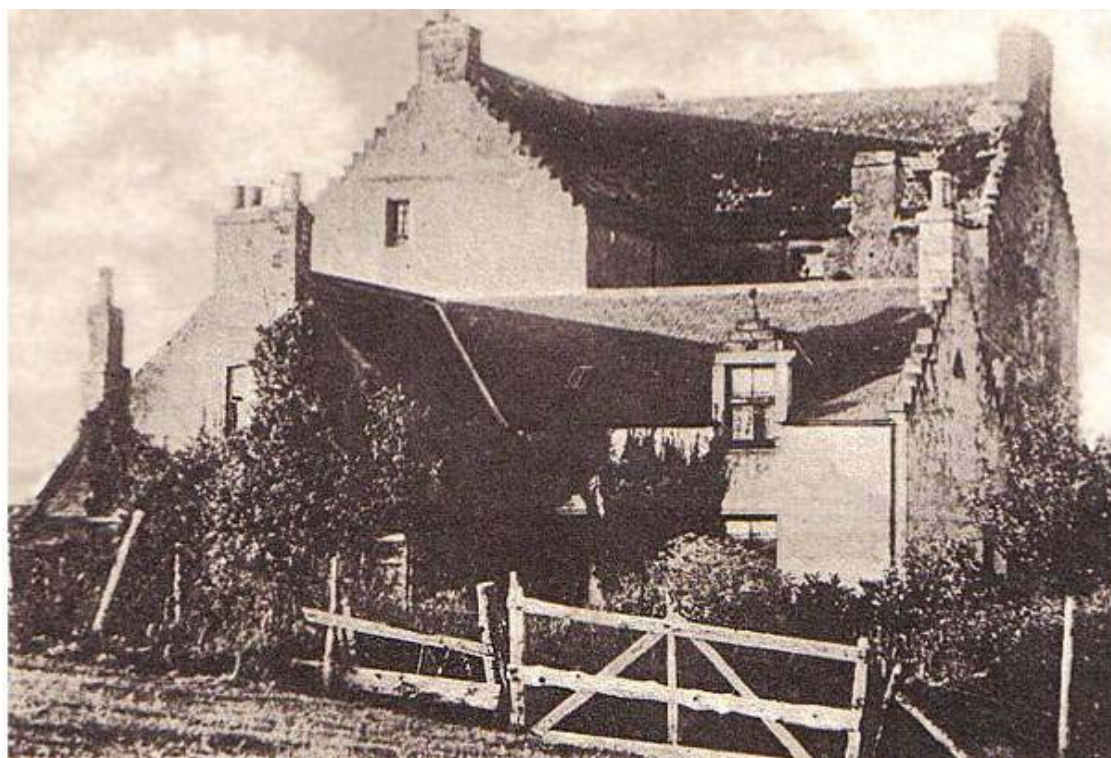
Plate 1 Early 20th century view of Crommey Castle – note the absence of bartizans; postcard post-marked '1908' (<http://www.foggieloan.co.uk/44library/picgallery/rural/pcvmcfall004.htm> - Copyright © 2002 – 2011 ADCA Aberchirder, North East Scotland)

The first historic view of Crommey appears to be a postcard, post-marked 1908, *plate 1*. This shows the structure, appearing generally much as today, from the SSE. The E wing, which is dated to c1910 in the listing description, was clearly pre-existing, not newly built even in 1908 as suggested by the mature plant growth against the S wall and loss of whitewash on the E gable (as noted above the wing also appears on the 1902/4 OS). The early tower appears to retain extensive remains of lime harl. Notable is the absence of bartizans at the angles of the S gable; the structure has much of the character of a tall laird's house.

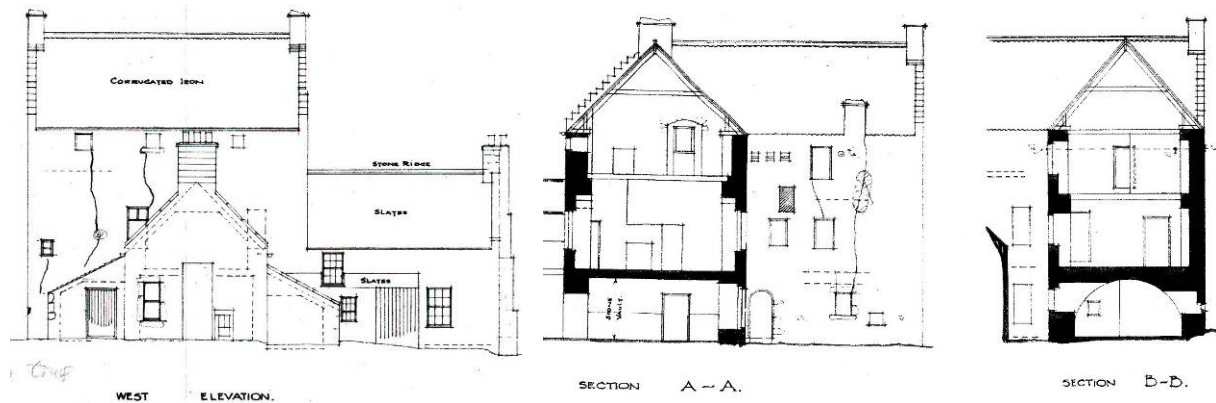
Figure 7 J Wilson Paterson – W elevation as existing in 1933, and sections showing the respective early roof structures of the principal range and E jamb (NMRS B50146-7) (Innes Family)

These drawings provide an important record of the tower in its long-un-restored state. They appear to demonstrate that the early roof structure still remained at that stage – a traditionally detailed rafter-foot assembly is illustrated for both the main range and the E jamb, see *figure 7*. However the upper surface had by then been re-roofed with corrugated iron. Elsewhere a number of existing windows and openings are shown as blocked and others as extant that are now blocked or altered. The latter include a small window lighting the intramural stair down from the hall (now blocked) and a gun-port within the N wall of the kitchen (subsequently enlarged). The existing dormers at the W wall head are shown with their lintels at eaves level.

These drawings also demonstrate that structural repair work had already been undertaken at the upper parts of the E jamb where the existing structural ties are shown as extant; it also records the considerable extent of existing structural cracking. A fireplace is shown at the N end of the hall, evidently itself secondary (and subsequently removed). A number of the entrances into the tower that are clearly secondary are shown as existing by that date; these include the two entrances from the

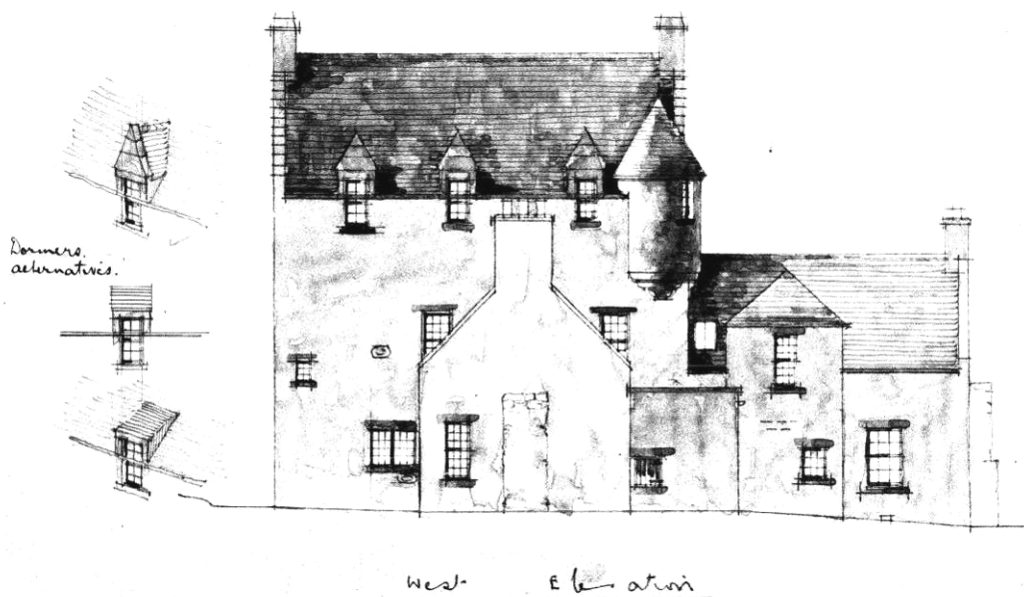
Figure 8 J Wilson Paterson – W elevation as proposed with new bartizans and pedimented dormers (NMRS B50146-7) (Innes Family)

A further drawing by Wilson Paterson, only bearing the date 1933, proposed a scheme for the restoration of the castle. This advocated the addition of bartizans to the angles of the S gable, the improvement or reinstatement of wall-head dormers (suggesting alternative details), and a series of other modifications with the intention of the reoccupation of the early tower as a fully integrated part of a new dwelling (NMRS – B50148, *Appendix A.ii*). Significantly the scheme proposed the removal of the eastwards-running wing of c1900, this in order to reinstate the former aspect of the original entrance to the tower and its visual relationship with the walled garden ground to the S upon whose principal N/S axis it lay.

Wilson Paterson's handling of the 'reinstated' external features was scholarly and well detailed (and possibly based in part on evidence then visible externally); it is reminiscent of work of Robert Lormier (cf. Dunderave Castle, Formakin), combining a good understanding of traditional Scots architectural forms and an arts-and-crafts sensibility.

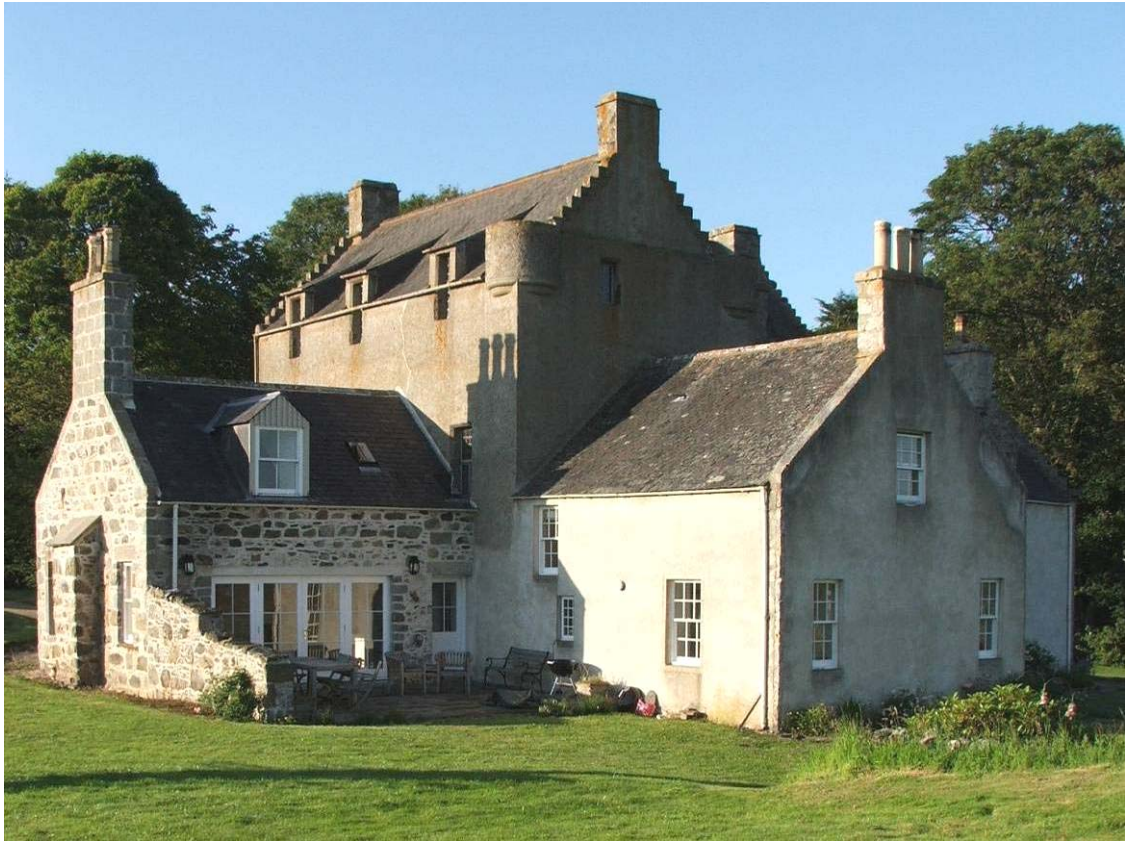
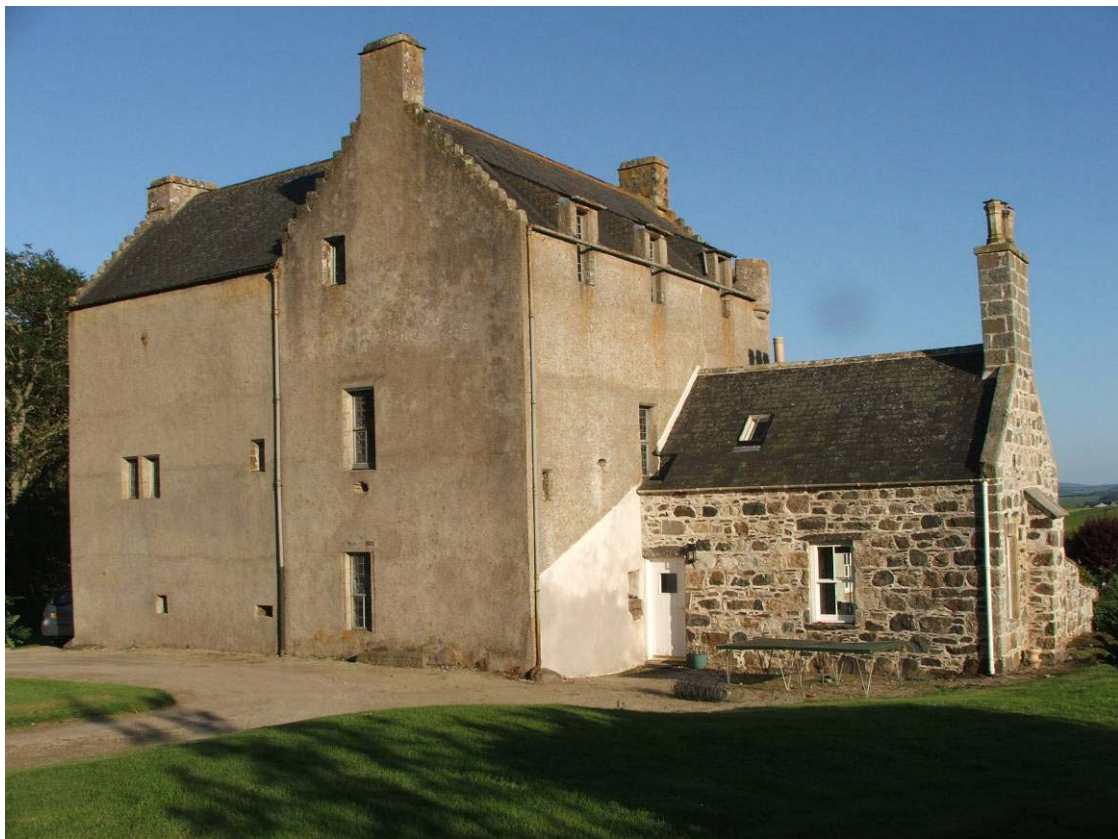
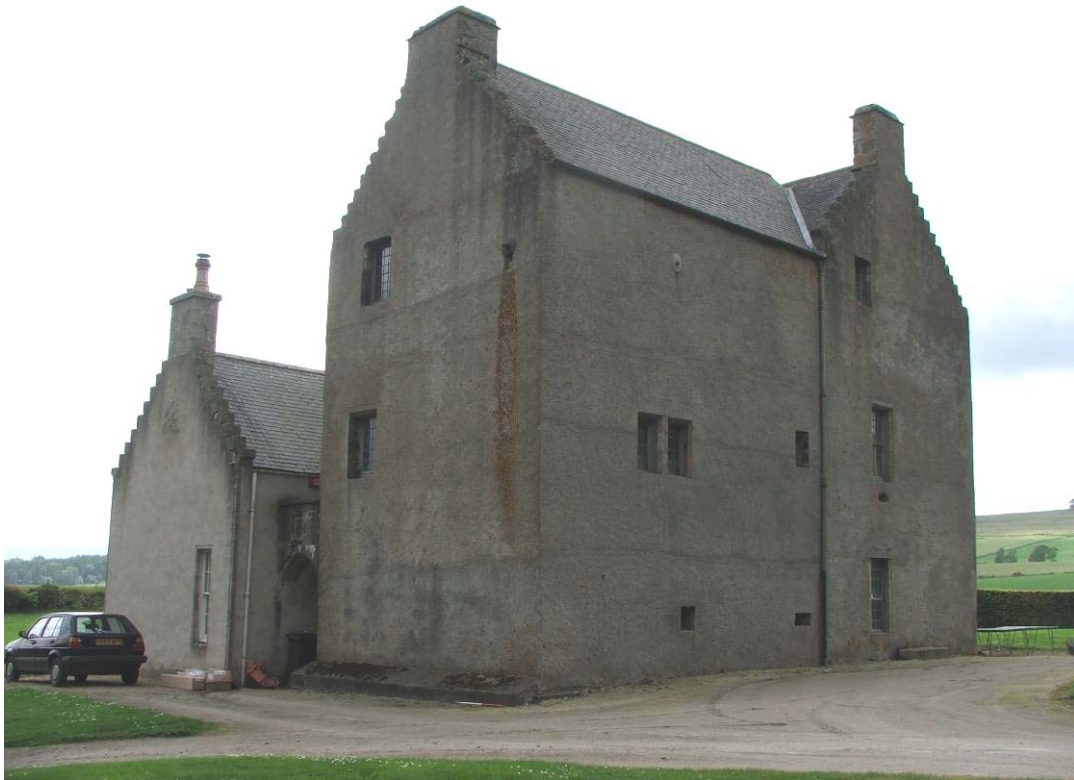
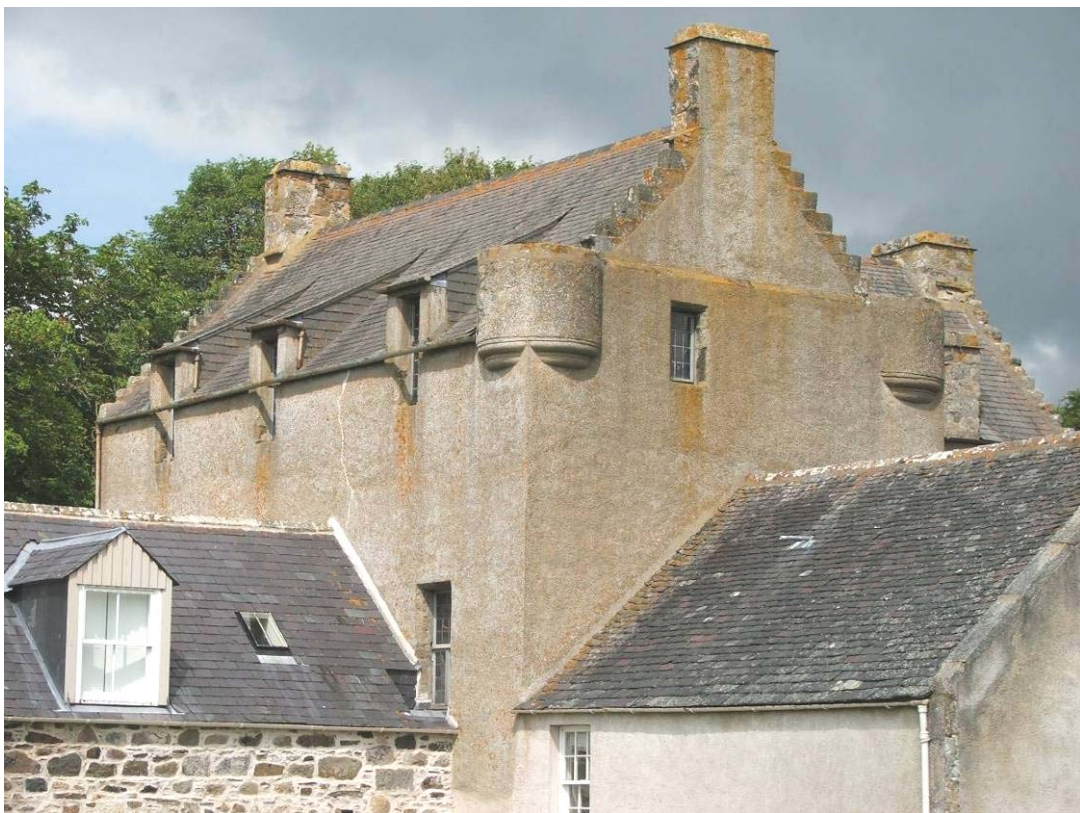
Plate 4 General view looking NE

Plate 5 General view looking SE

Plate 6 General view looking SW

Plate 7 View of the upper works of the lower, looking NE

The exterior walling of the tower-house is presently overlain by an existing coat of cementitious harl, applied in the mid 1930s, *plates 4-7*. This obscures most structural and analytical evidence for the evolutionary history of the building that might otherwise have been apparent. Overall, and before the early 20th century addition of the existing open round turrets (see *figure 5*), Crommey Castle had had the appearance of a tall 17th century laird's house rather than a structure of earlier origin and a more martial bearing. Its chimney-surmounted crow-stepped gables and simple wall-heads leant the structure a more domestic character than had evidently existed originally. However this is belied by the presence of architectural detailing lower down – the windows, narrow stair and garbidge lights, all with broad-chamfered surrounds, and, particularly, a plethora of wide-mouthed gun ports and pistol loops beneath windows (not all of these now visible externally). The gun ports are generally oval in form though one, on the N elevation, is detailed with internal reticulation, *plates 8-10*.

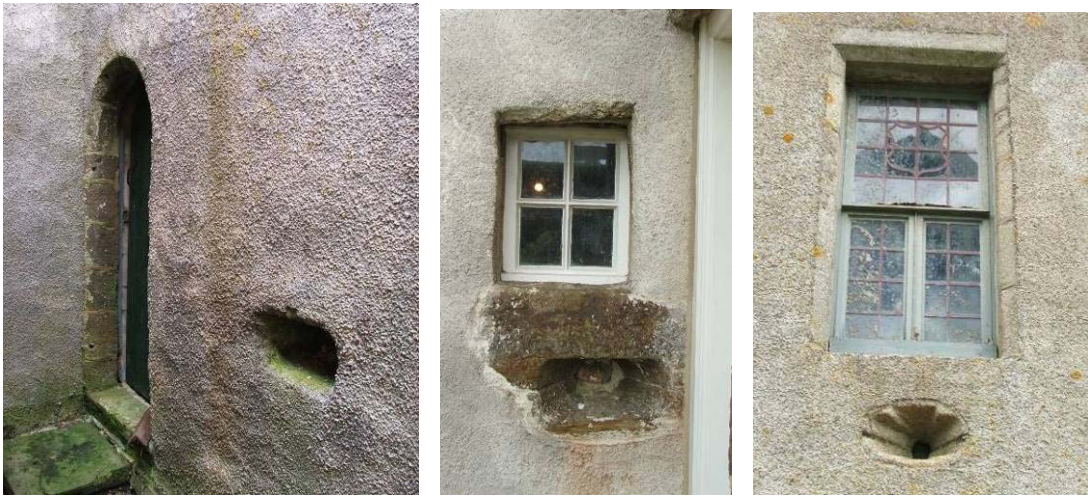
Plates 8-10 Wide-mouthed gun ports

These defensive features suggest a mid 16th century dating, as does the overall form of the building, with principal (only) entrance set tight at the re-entrant angle, this of simple detail and protected by adjacent gun-ports, *plate 8*. Also very obvious are the three corbels set a little below the present wall head above the entrance, the remains of a protective over-sailing machicolated bartizan, *plate 11*. Immediately below these corbels exists a rectangular recess; not a blocked window, this aperture may have once contained an armorial, since removed, *plate 11*.

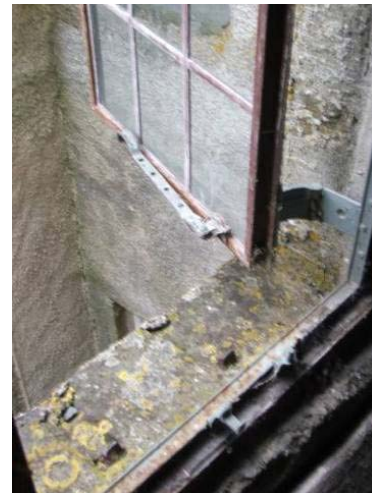
Plate 12 Remains of window grille

The majority of original windows preserve evidence in the form of rectangular seatings in their jambs, lintels and sills for stout ironwork grilles. A number of the larger windows retain glazing grooves on the upper jambs, evidence for the fixed leaded glazing above framing containing shutters below that is a typical detail for the period. One of the windows actually retains the stumps of its ironwork – a pair of vertical bars, *plate 12*.

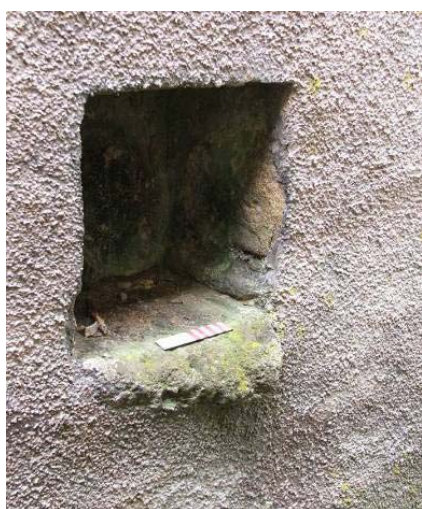
Plate 13 Recess on S-facing elevation of the E jamb

A curious feature is the aumbry-like aperture with projecting sill on the S-facing elevation of the E jamb, towards its SE angle, *plate 13*. In early garden walls features such of this nature would constitute a *bee-bole* for the keeping of a *skep* (straw beehive); however in this position the opening may have had a more profound significance.

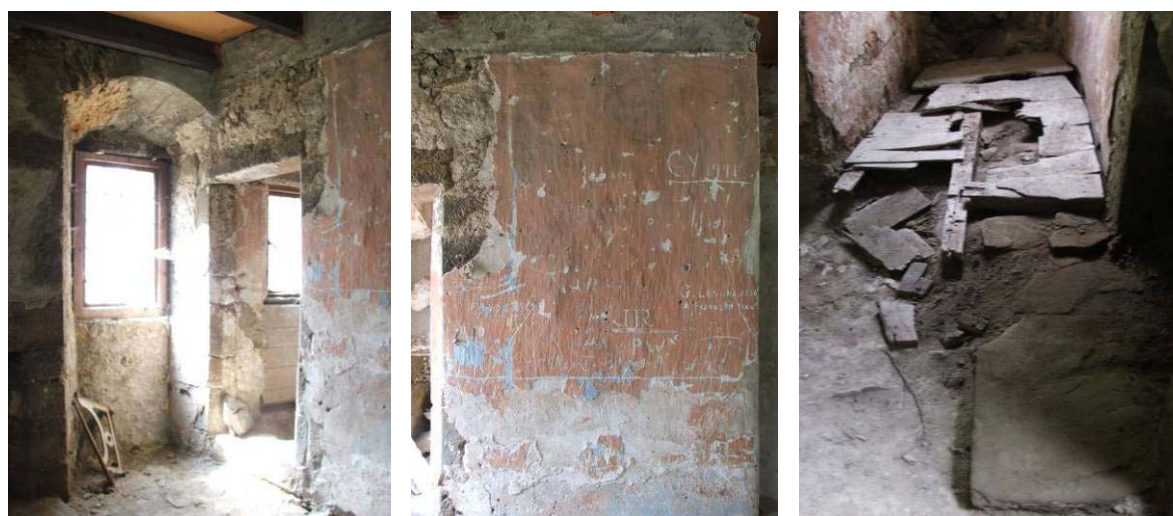
Plates 14-16 Chamber in E jamb – SW corner; paint and graffiti on W wall; early flooring and hearthstone to SE

In its un-restored state the chamber within the E jamb, and a smaller chamber that leads off it to the SW, preserve numerous early features including extensive areas of early lime wall plaster applied onto the hard. The latter retain a build-up of paint layers and, on the W wall of the main chamber, much historic graffiti, *plates 14 and 15*.

The principal features of the main chamber include a broad mural recess that occupies most of the N wall; to the W of this is an aumbry cupboard with door-frame rebate, and to the E a possible wardrobe recess, this formerly lit by a narrow light in the E wall (later blocked).

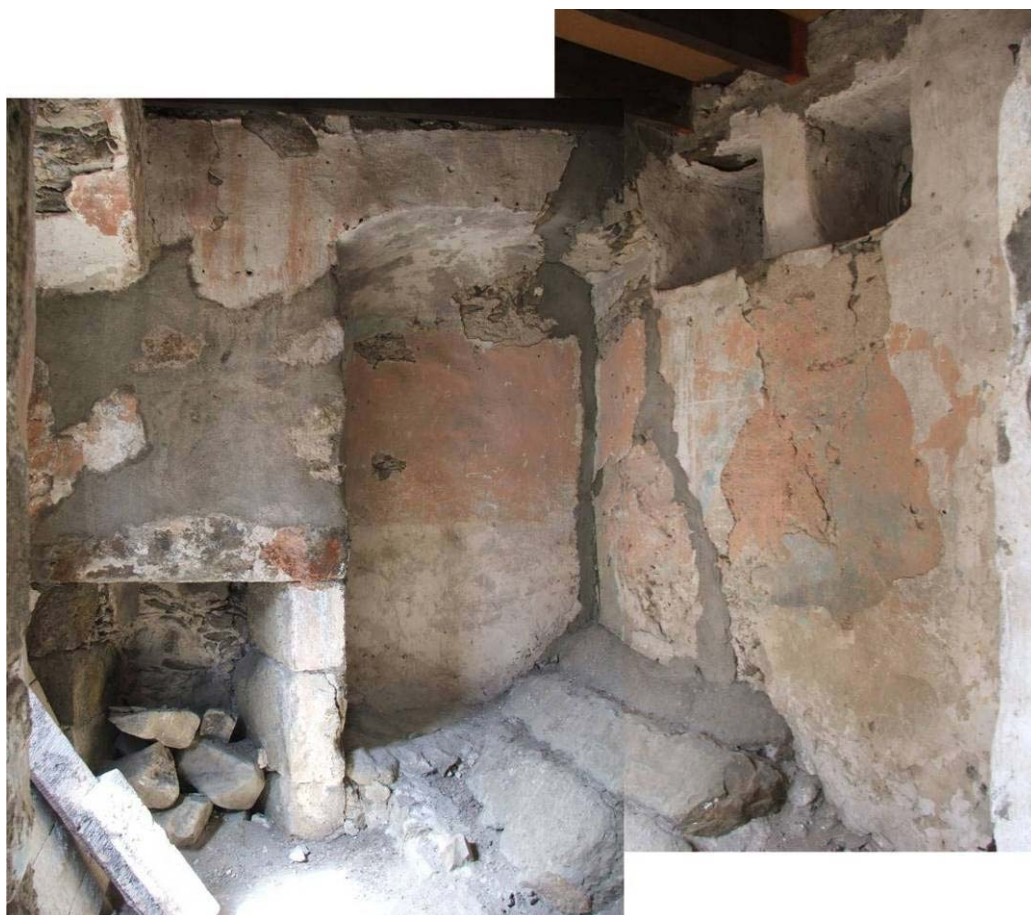
Plate 17 The inner chamber, looking W

The inner chamber lies to the SW, this lit by a broad window to the S and heated by a small fireplace at the S end of its W wall, *plate 17*. The lower parts of the NW corner of the room are intruded upon by the lintelling of the principal stair below; plaster and paint traces suggest the former presence of boxing-in in this area, likely a bed occupying the length of the N wall. Curious paired recesses occupy the upper part of the N wall.

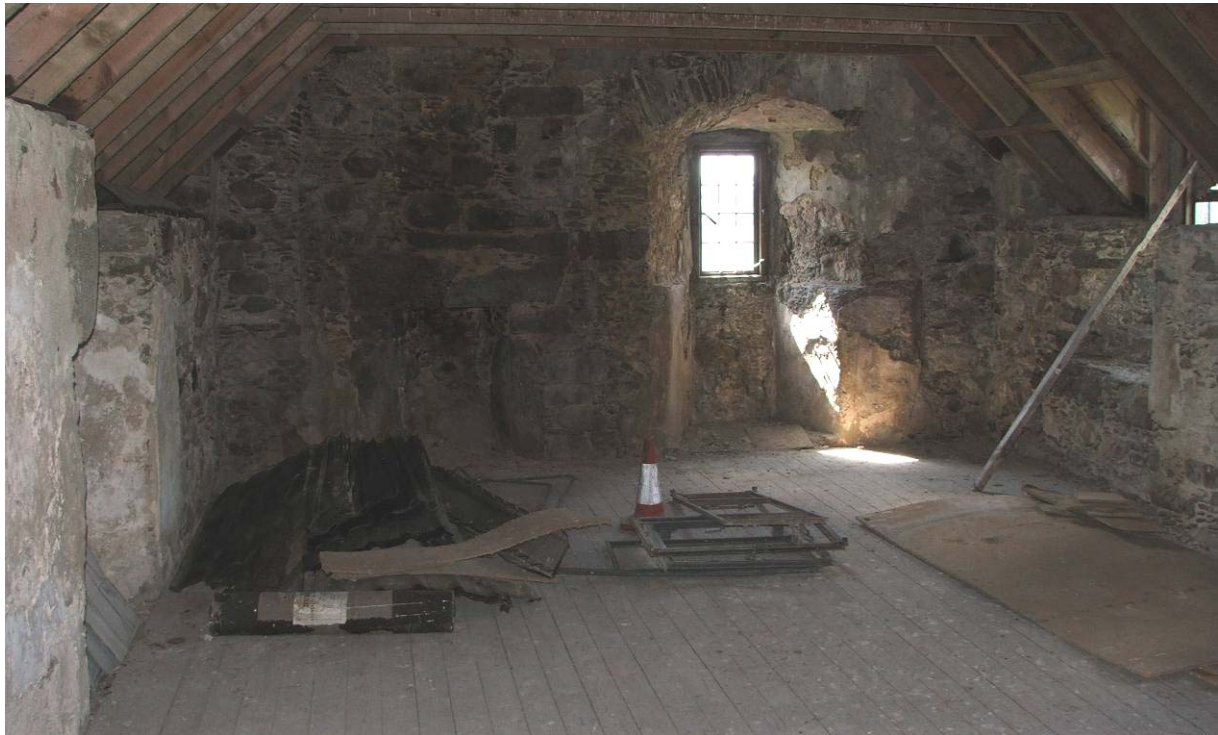
Plate 18 General view

After a few additional steps the turnpike reaches a further entrance that gives access westwards to the chambers above the hall. Now a unified interior this area had likely originally comprised two chambers as suggested by two small fireplaces, one in each gable wall and each with an adjacent large window with arched head internally. However no direct evidence for an original partition can now readily be seen. Within this area survive extensive remains of early wall plaster onto the hard. This plaster demonstrates the former presence of a number of similarly early features. At the NW, SW and SE corners of the room the plasterwork returns at an angle into the wall face, in each case likely signifying the former presence of a small chamber within a projecting roofed bartizan at the three external angles of the tower in this area.

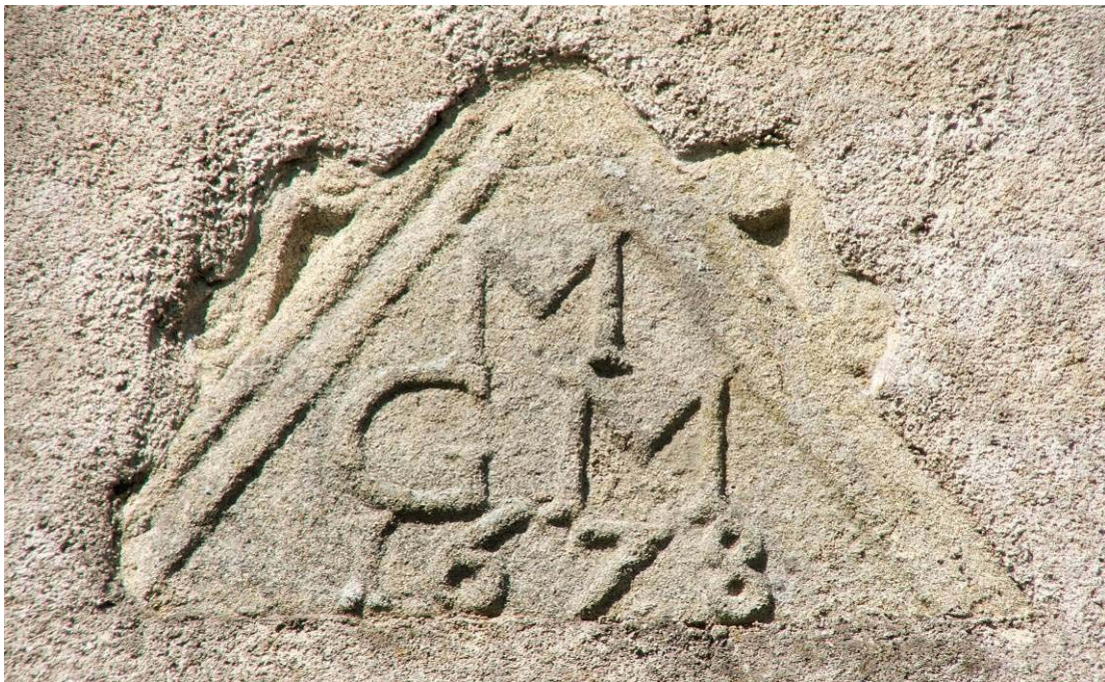
Plate 19 Detail of an ex situ dormer pediment, now within the E gable wall of the c1900 extension

Though the dormers to the W saw subsequent modification – the lintels of each were raised in the 1930s, with the jambs extended up in concrete – the northernmost retains its original lintel. Significantly this preserves angled raggles on its rear face, this demonstrating that this dormer (and presumably the others) had had small double-pitched roofs (opposed to single-pitched ‘cat-slide’ roofs); this roof form also implies the former presence of a stone dormer pediment. A single dormer pediment yet survives at Crommey, this built in to the E gable wall of the c1900 range, *plate 19*; it is very possible that this stone originated at one of the tower dormers.¹⁰ The stone bears the date 1678 and the initials MGM, the latter corresponding well to the documented proprietor of Crommey at that date, Revd. George Meldrum, who purchased the estate in 1664 (d.1692); he is referred to as *Mr George Meldrum of Crombie* on his monument in the Kirkyard of the Kirk of Aberchirder.¹¹

On the basis of this evidence it is suggested the remodelling of the upper works of Crommey Castle occurred at about this time – i.e. c1678. The remodelling would thus seem to have involved the provision of a far greater degree of fenestration for this part of the upper floor than had evidently existed hitherto. A further possibility as to why this occurred may be suggested by a fragment of plaster still adhering at the upper W side of the interior of the N gable, this abruptly terminating at a horizontal top that lies considerably below the early ceiling level, *plate 20*. It is possible this may be

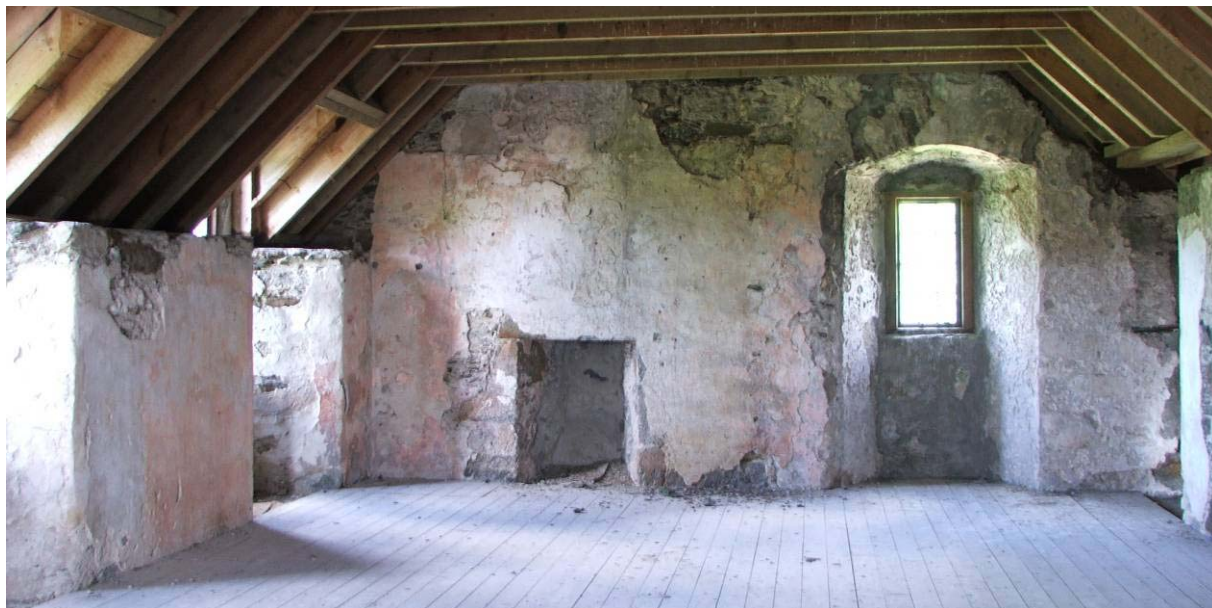
Plate 20 General view of the second floor chamber to the W, looking N. The pink-painted wall plaster defines the extent of an internal subdivision (18th century?); on the N wall this abruptly stops at a horizontal well below collar level – possible evidence for decorative plasterwork above

evidence for a missing cornice and frieze; if this area had been decorated in such an ambitious manner then it is possible that the upper level had been formed into a single high status apartment, possibly a gallery.

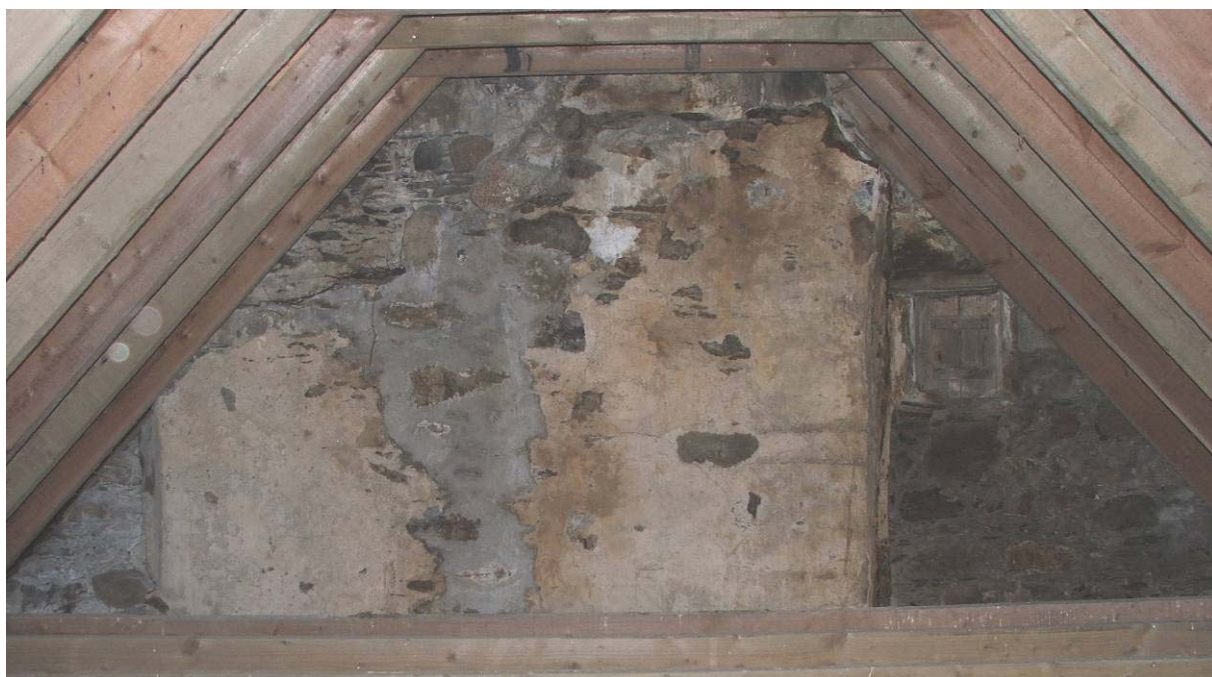
Plate 21 Interior of E gable of the E jamb, showing early plaster and returns to either side

The main evidence of the former existence of an early upper chamber within the E jamb comes from the interior of its E gable, which retains internal wall plaster, *plate 21*. On its N side this plaster returns at an angle to the NE (in a very similar fashion to the plaster returns seen in the upper chamber to the W); it seems likely that at this point there had formerly existed a further bartizan. Further S the wall plaster also returns, here angling to the SE and overlain by later masonry. Though less evidence survives here, possibly there had been yet a further bartizan at this point.
