Barrhead Road

Paisley, Renfrewshire

Archaeological Evaluation: March 2012

Data Structure Report

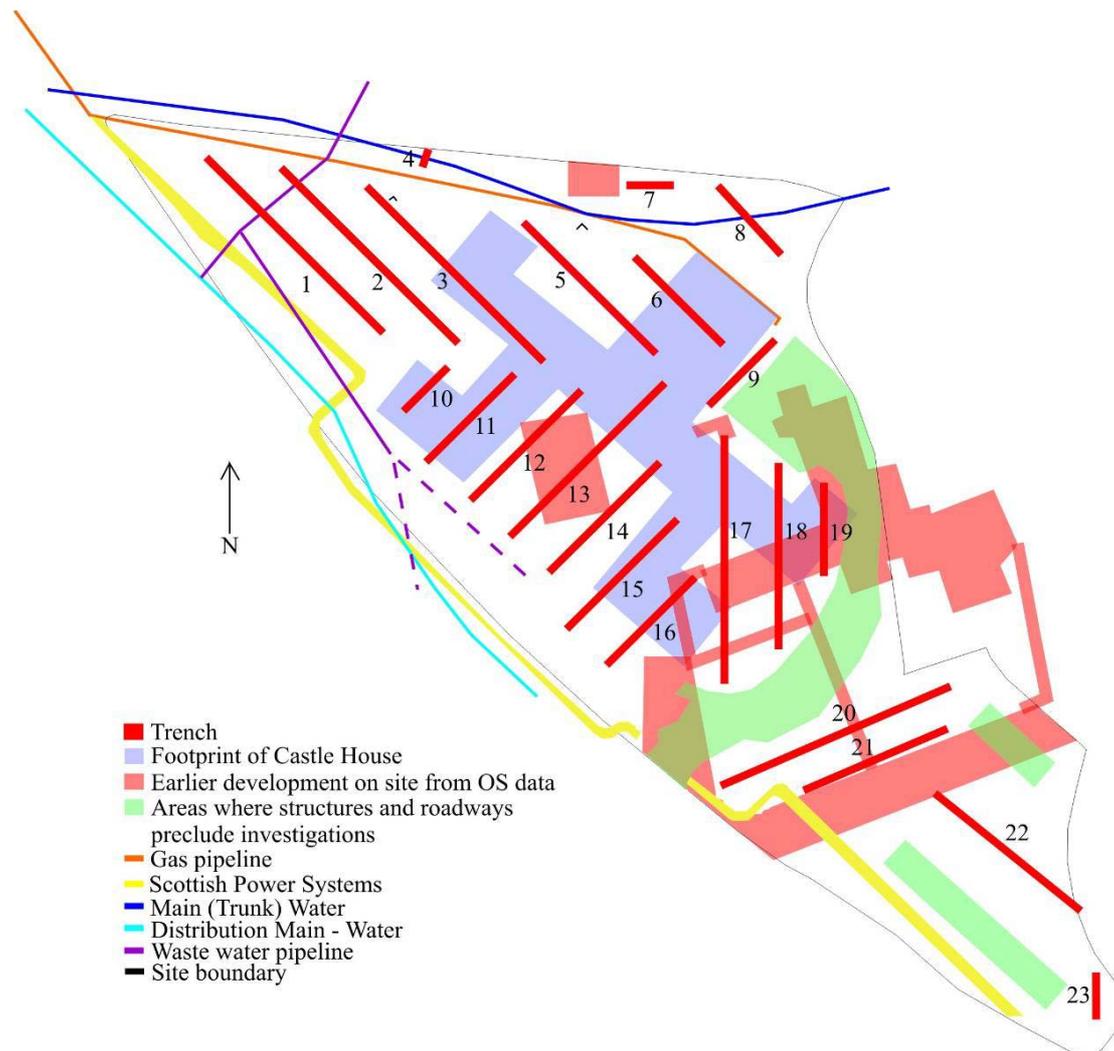
Figure 4 Proposed trench locations from WSI

Initially 23 specifically placed linear trenches were planned (*figure 4*), providing good spatial coverage across the site and ensuring areas that had shown no signs of development from the cartographic evidence were investigated. It was felt these areas could feasibly hold pockets of earlier survival. The trench plan as proposed accounted for 6.86% of the total development area, assuming the use of a 1.2m wide bucket of a mechanical excavator for the excavation of the trenches. This

indicative trench plan could be adjusted depending upon the archaeological remains encountered and logistics on the ground, as long as a good spatial coverage of archaeological evaluation was provided across the site to test for the preservation of archaeological remains to be affected by development.

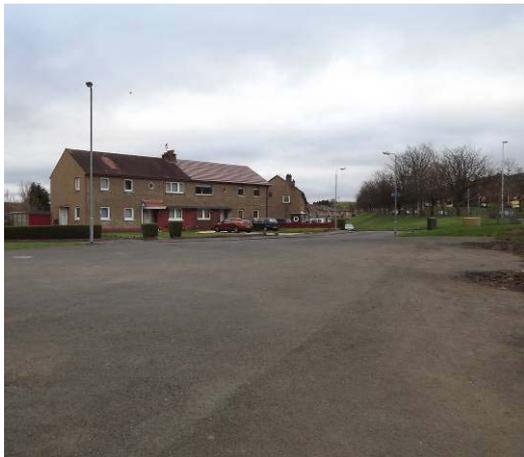
Plate 1 Pre-excavation view of the SE of site looking E across the road surface (1001) (Photograph 001)

Contrary to initial misgivings, excavations of the road surface atop Trench 1 did not prove to be problematic and 0.10m of tar macadam were subsequently removed along with a small quantity of mixed stone bottoming material. This deposit was recorded as (1001). (1001) was laid directly atop a surface of 19th and early 20th century bricks of local origin, each laid flat in a relatively unorganised manner to a depth of c.0.10m, or one brick deep (*plate 2*). Recorded as (1002), it is unclear whether this brick surface comprises hard-standing or levelling for (1001), or is indeed a pre-existing surface in itself. The mixed nature of the bricks and the unorganised nature with which they are laid suggests the former, although some evidence of concrete bonding may indicate an established road surface. Regardless of the function of (1002), it is clear this represents some form of rough surface constructed in the early 20th century, perhaps associated with the farm complex that developed around Blackhall Manor.

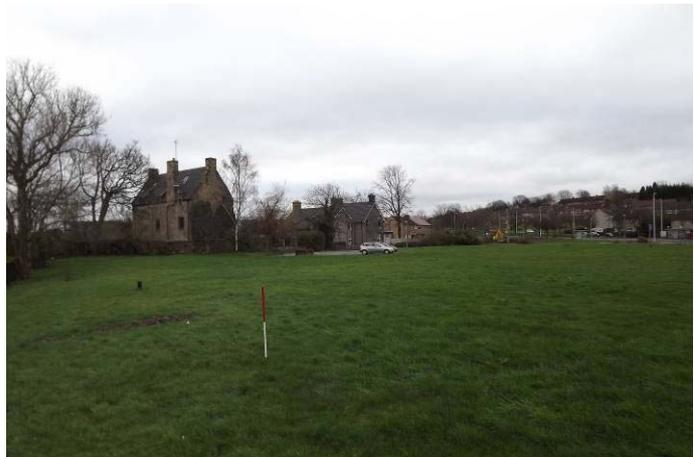
Plate 2 Pre-excavation view ESE across the main area of the site towards Blackhall Manor (Photograph 015)

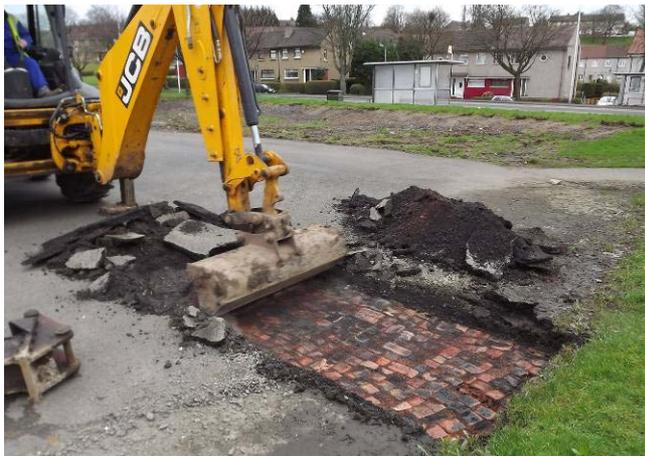
Plate 3 Mid-excavation shot showing brick floor (1002) as revealed (Photograph 004)

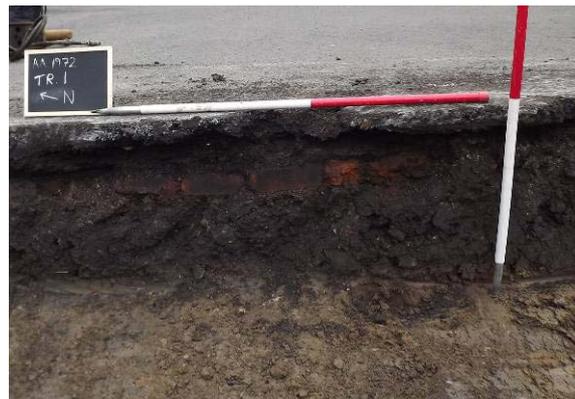
Plate 4 NW facing section of Trench 1 (Photograph 027)

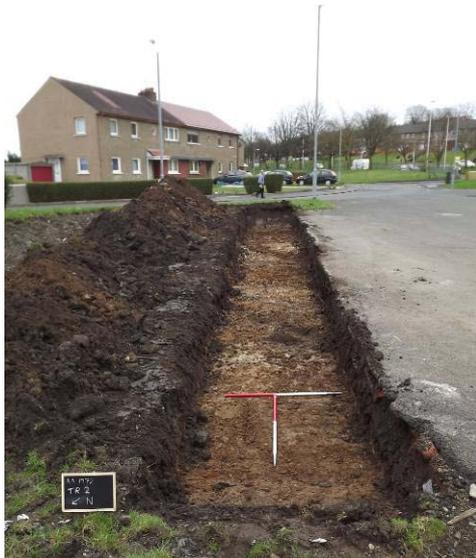
Trench 2 proved to be of minimal archaeological interest. The upper deposit (2001) was found to be a loosely compact dark to mid dark brown organic loam, abundant in small to medium angular stones and modern detritus. This had a depth of 0.30-0.35m and sat directly atop the natural subsoil (2005). As in Trench 1, this comprised silt clay, banded and mottled from orange brown to yellow/white brown. It was clear that the garage foundations had been wholly grubbed out with a toothed bucket during demolition, with the uppermost area of (2005) showing signs of disturbance. However, the trench was relatively shallow and there was no evidence these foundations had penetrated (2005) to any significant degree. If any archaeological features had existed, they may have survived the ‘grubbing out’ process providing they weren’t ephemeral in nature. The fact that no archaeological activity was recorded indicates a lack of archaeological activity in this area.

Plate 5 Post-excavation view of Trench 2 looking SE (Photograph 025)

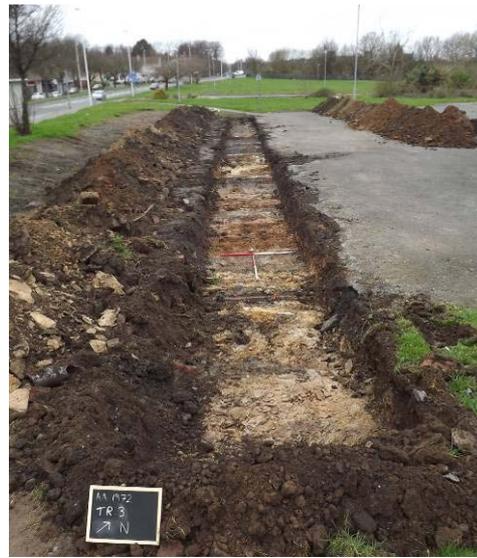
Plate 6 Post-excavation view of Trench 3 looking NW (Photograph 029)

The notable difference between trenches 2 and 3 is the survival of the garage foundations in Trench 3. As in Trench 2 it was clear that the buildings had been demolished using a toothed bucket, but 9 NW-SE aligned concrete foundations showed that the same standards of removal had not been reached during the demolition of the southern garages.

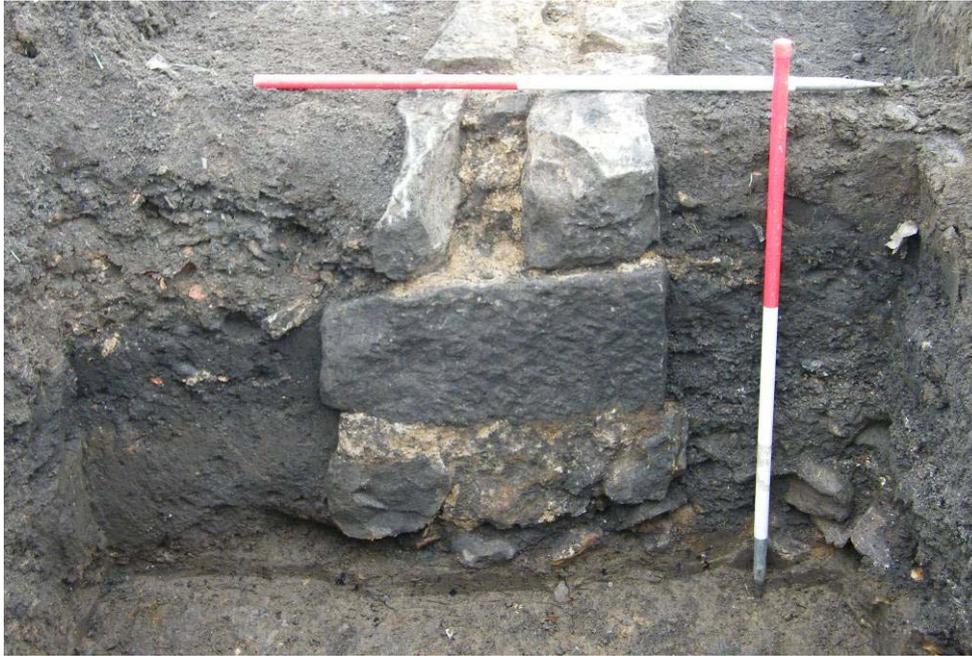
Plate 7 NE facing section of Trench 4 showing {4008} (Photograph 070)

The SE side of {4008} contained (4004), a possible old ground surface abutting against the base, whilst the deposits to the NW consisted of road make-up (4003) and subsequent layers of road surface (4002). These deposits on the SE side of {4008} were characterised across the majority of Trench 4.

Both sides of {4008} also showed evidence for the decay and collapse of the wall and the roadway with (4009) recorded as a topsoil deposit of dark brown slightly gritty soil with charcoal and cinder inclusions alongside frequent mortar fragment inclusions. This was interpreted as surfaces being neglected and grassing over prior to the deposition of the landscaping material (4010).

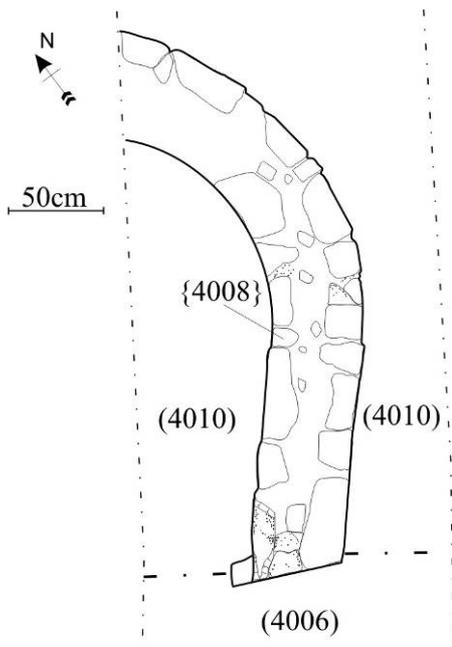
Figure 6 Plan of {4008} reproduced at 1:40 (Drawing 002)

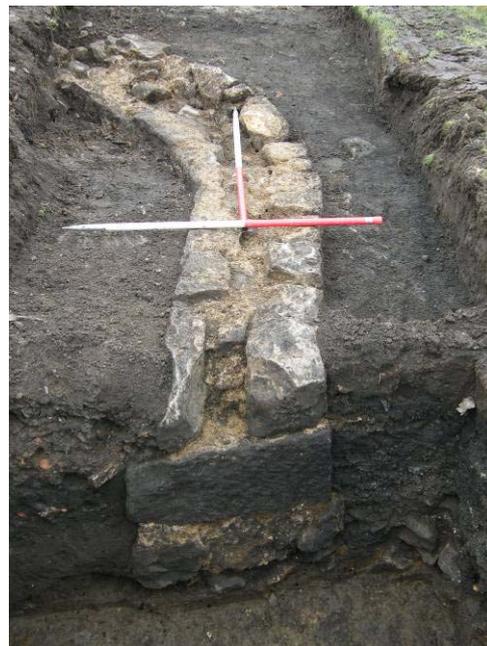
Plate 8 View NE across {4008} (Photograph 081)

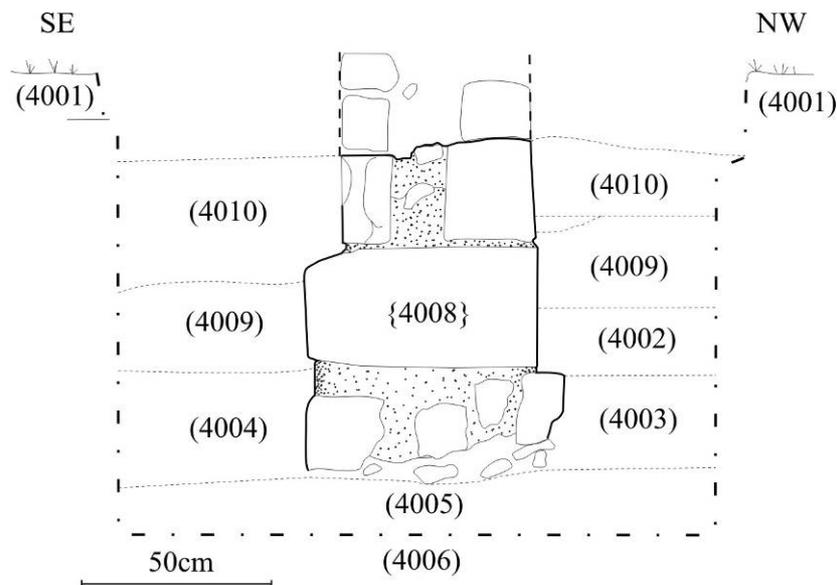
Figure 7 NE facing section of {4008} in Trench 4 reproduced at 1:20 (Drawing 001)

Wall {4008} is clearly placed on the alignment of an earlier, but secondary entrance to the Blackhall House and associated farm complex (figure 8) as seen on the 2nd edition as surveyed in 1896 and subsequent OS maps until at least 1947.

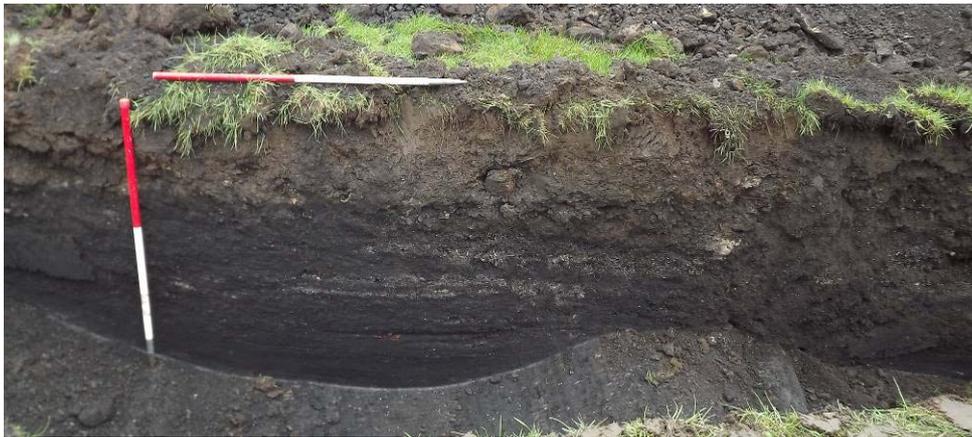
Plate 9 E facing section at the S end of Trench 5 upon termination of excavation. Note the water main to the right of the picture and the very firm build up of cinder deposits (Photograph 046)

The heavily compact nature of (5004) as well as the banded nature of the deposit and make-up of the industrial soils, suggests (5004) had formed some sort of industrial compound or had undergone a major landscaping event, perhaps linked to the development of the railway to the N.

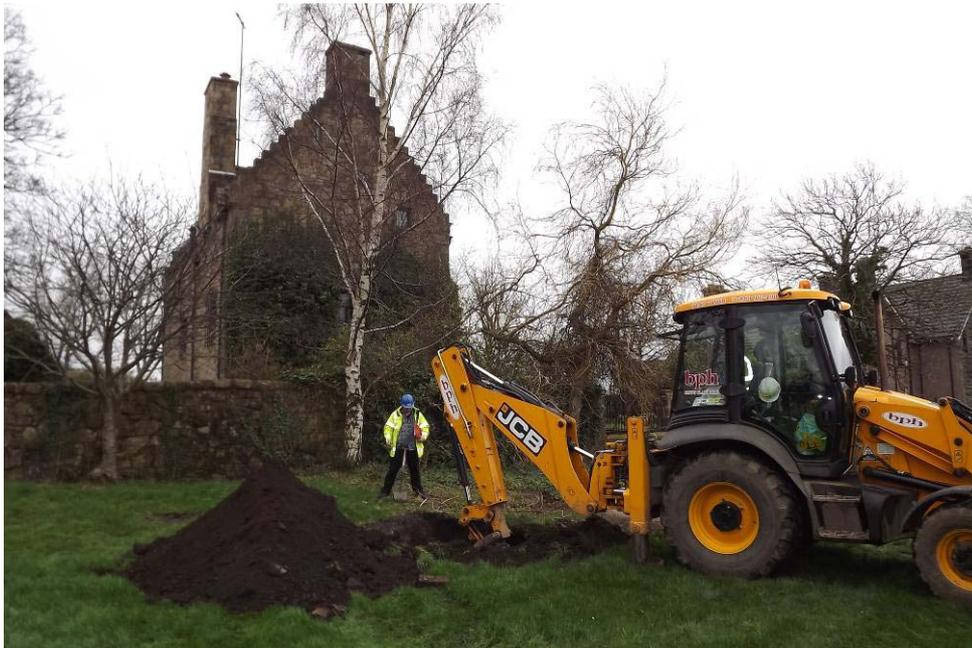
Plate 10 Working shot showing the opening of Trench 7 - looking E (Photograph 051)

Orientated NE-SW, Trench 7 was located on the site of the proposed Trench 9 at the end of the existing access roadway and in close proximity to Blackhall House. Running parallel with the end of the roadway, Trench 7 also lay just outwith the footprint of the demolished Castle House and could investigate the impact of the foundations and their subsequent removal on the underlying subsoil and indeed whether archaeological features survived on the sliver of undeveloped ground.

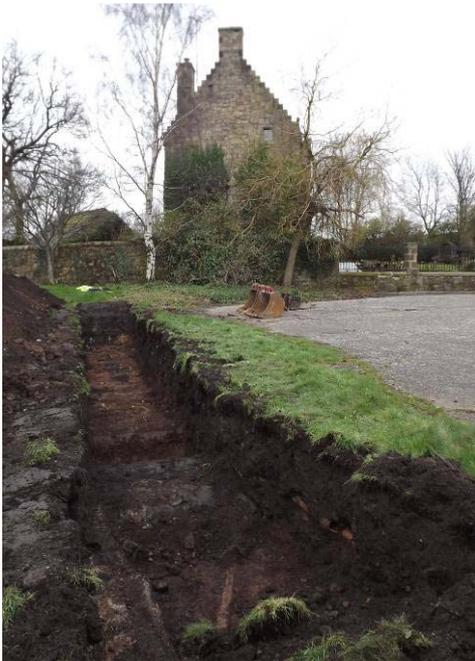
Plate 11 Working shot – view ENE across Trench 7 towards Blackhall House – note drainage (7007) and wall {7005} in bottom left of trench (Photograph 066)

However, at the SW end of Trench 7 the foundations of Castle House became visible running along the edge of the trench. Along with associated destruction debris, this modern wall was assigned context {7005}, sitting within possible cut [7006]. Excavation continued adjacent to {7005} in order to assess the depth of the disruption, but was ceased at a depth of 2.2m upon the discovery of the drainage network for Blackhall House. Aligned roughly W-E, this network was recorded as (7007).

Trench 7 revealed no archaeological features, but demonstrated the impact of Castle House on the site. The foundations at the end of the Trench were demonstrated to be deep and intrusive, deeply cut into the natural subsoil. The demolition of the building also clearly resulted in significant disruption to a depth of >1m, with much of the major building debris being dug out and removed. The existence of the drainage network (7007) was unexpected and unrecorded, demonstrating further human interference across the site and the need for caution during excavations.

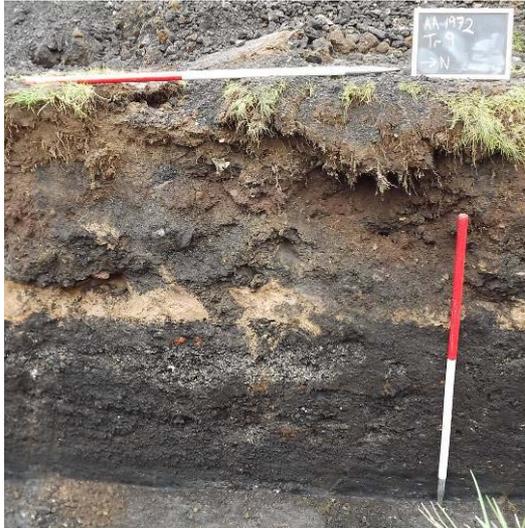
Plate 13 E facing section of Trench 9 showing (9005). Note depth not realised in section (Photograph 111)

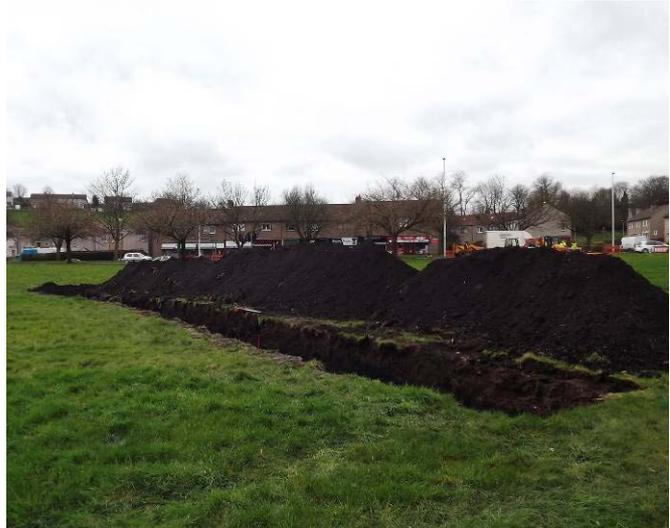
Plate 14 Location shot of Trench 9 looking SW (Photograph 117)

The depth of Trench 9 and proximity of water main and drainage pipe made it impossible to adequately assess the natural subsoil. The banded deposit (9002) has clearly undergone a major series of compaction and levelling and must certainly be associated with industrial activity in the 19th or 20th centuries. Whether this deposit filled an undulation in the natural topography or was put in place post-grubbing out of another feature is unclear. All that can be confirmed is that (9002) survives to a great depth and is located directly above the natural subsoil.

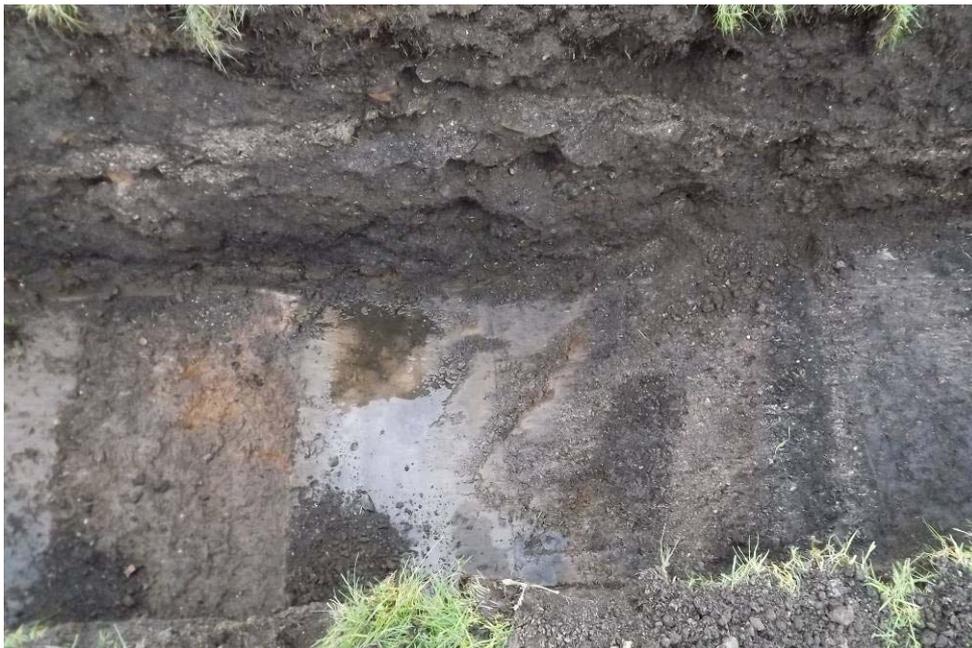
Plate 15 Scars from a toothed bucket during demolition of Castle House. Note at this point, Trench 11 was deemed to deep to enter (Photograph 132)

A combination landscaping and demolition ensured no archaeological material was recorded from Trench 11. The evidence of deep excavation by a toothed bucket on the footprint of Castle House makes it unlikely any archaeological material could survive across the majority of the building, despite the significant build up of material over the centre and N of the site.

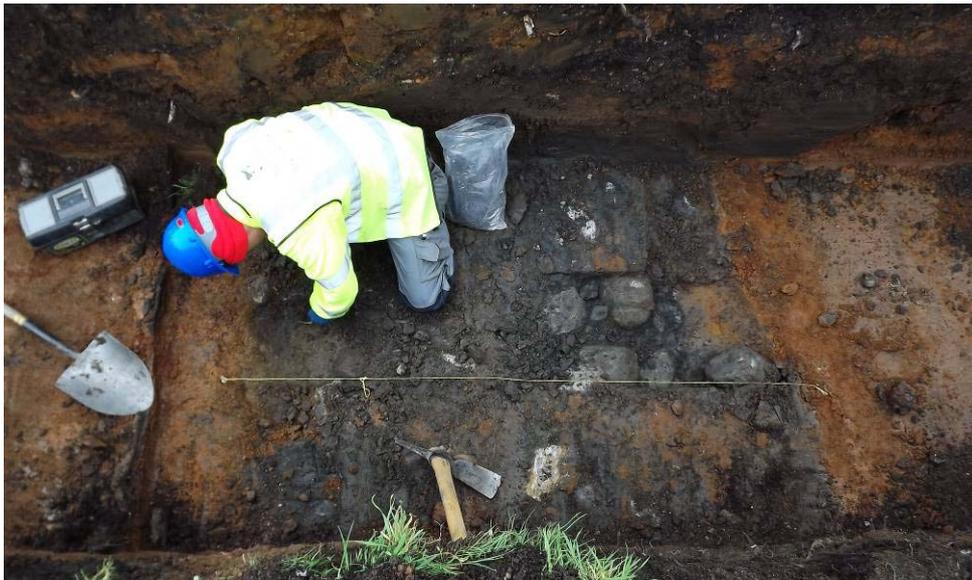
(12002) lay directly atop the natural subsoil (12003), a mid orange to light brown clay silt. However, 7m from the NE end of Trench 12, a clear linear was noted running NW-SE across the trench with a diameter of c.1.75m. Unfortunately the discovery was made at the very end of the day with Trench 12 requiring to be backfilled. An investigation of (12004/12005] revealed a shallow trench with a stony bottom, however no finds were recovered before Trench 12 was backfilled.

Plate 16 Working shot removing (12004) in Trench 12 (Photograph 143)

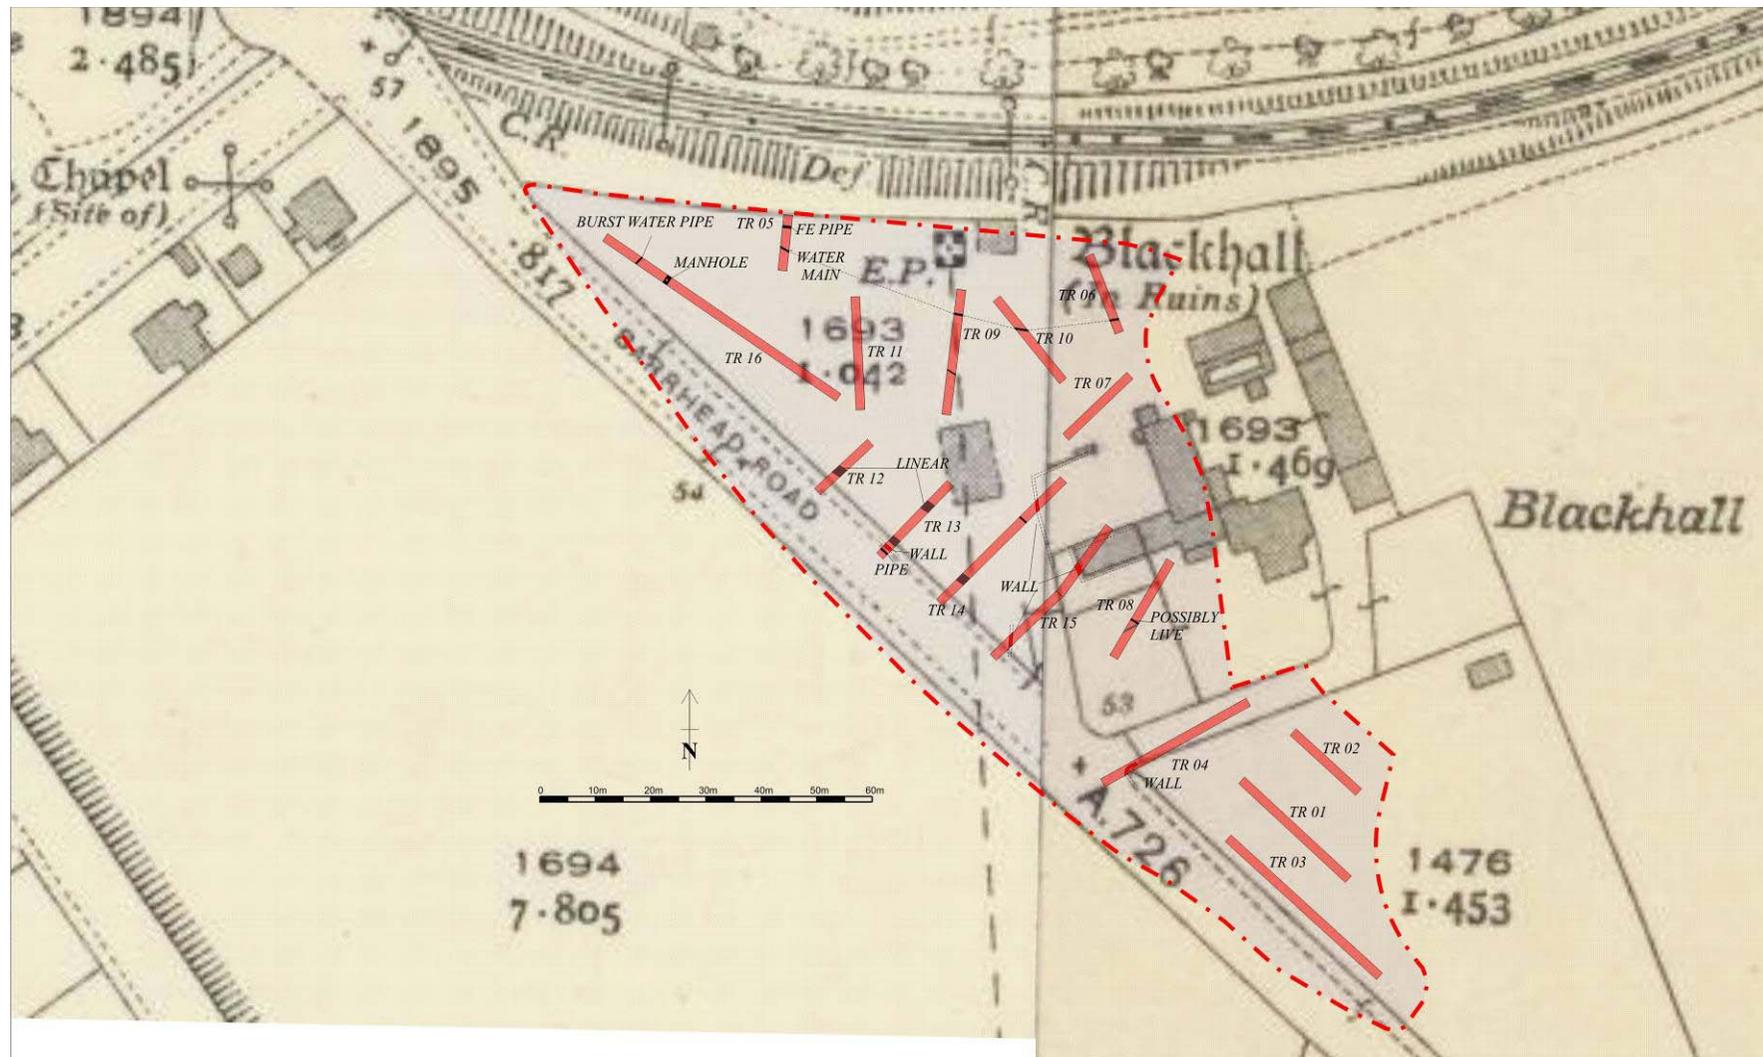
Figure 8 1939-47 Ordnance Survey map (over two sheets) with the Trench plan overlaid. Note the alignment of recorded walls in the trenches with features and buildings readily visible. (NLS)

The alignment of {13009} indicates that this was the original boundary of the property and farm associated with Blackhall House as seen on the OS maps (figure 8). At some point post-1947 Barrhead Road was re-aligned slightly SW and the entrance to the farm complex as recorded in Trench 4, was altered to the current setup. The wall recorded in Trench 13 shows this original boundary and will probably be synonymous with {4008} in Trench 4.

From assessment of the OS data, {14005} in all likelihood represents the perimeter of the courtyard formed in the corner to the NW of the farm buildings (figure 8) and constructed after the 1st edition was surveyed in 1858, but before the publication of the 2nd edition in 1895. The alignment is correct and style of build can be accepted as of 19th century date, not of sufficient scale to act as a retaining wall. As seen in plate 22, {14005} consists of sandstone rubble bonded with creamy lime mortar, faced to both the W and E.

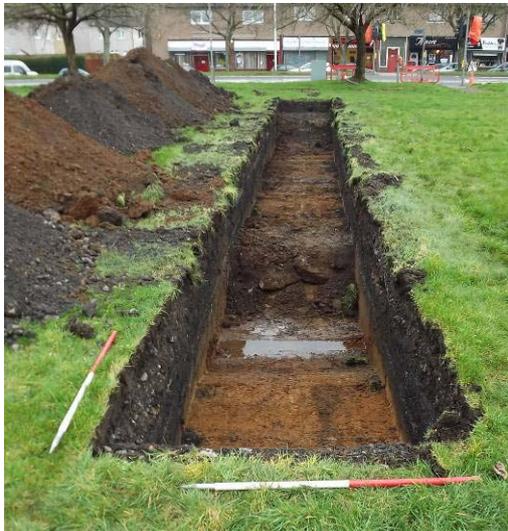
Removal of the turf and topsoil (13001) revealed a 0.3m deep deposit of hardcore at the NE half of the Trench, with a high concentration of small rounded stones (13002). This is likely to be hard-standing associated with the demolition of Castle House and lay directly atop 0.65m of firmly compact banded black brown gritty silt and cinders (13003) as seen elsewhere across site. Beneath (13003), the original subsoil (13004) survived to a depth of 0.40m above the undisturbed natural (13005).

Plate 17 Post-excavation view of Trench 13 looking SW prior to excavation of features (Photograph 151)

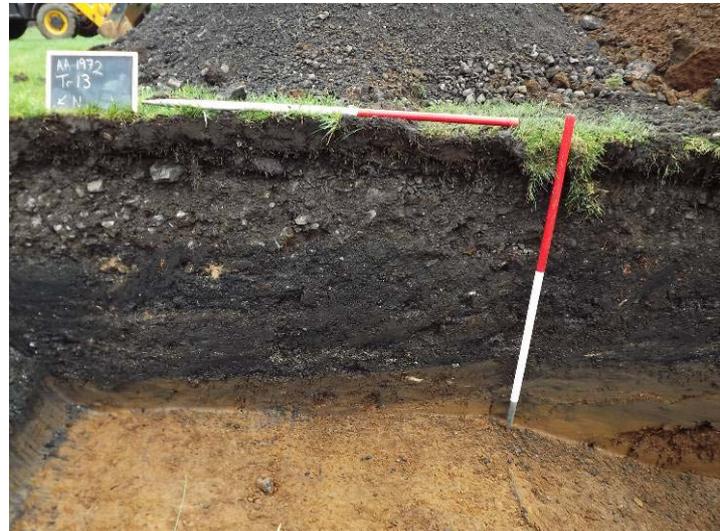
Plate 18 NW facing section of Trench 13 (Photograph 154)

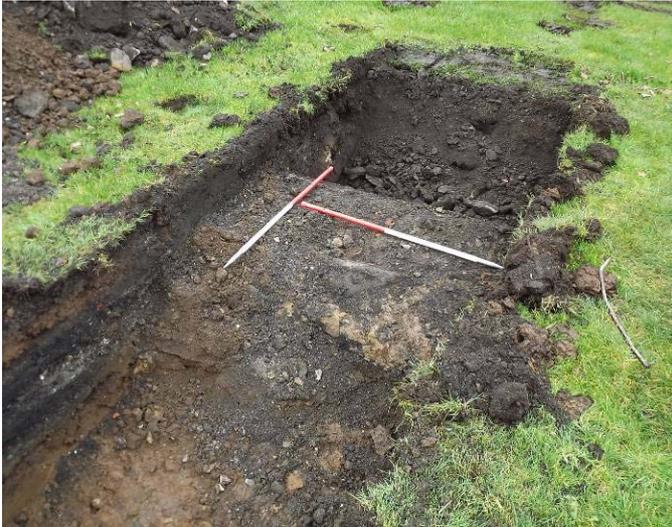
*Plate 19 Pre-excavation view of {13009}
(Photograph 159)*

Excavation of {13009} revealed a NW-SE aligned wall of lime bonded, roughly squared white sandstone blocks. The wall survived to c.0.6m, or three courses, one of which was at foundation level and was cut into the original subsoil (13004). Like {4008}, {13009} appeared to have a rubble core and a width of c.0.50m.

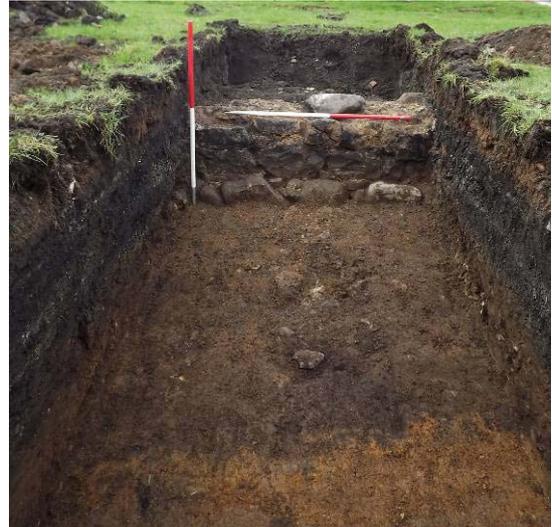
*Plate 20 Mid-excavation view showing
(13012) in immediate foreground beneath
overburden of (13004) and {13009} in the
background. (Photograph 168)*

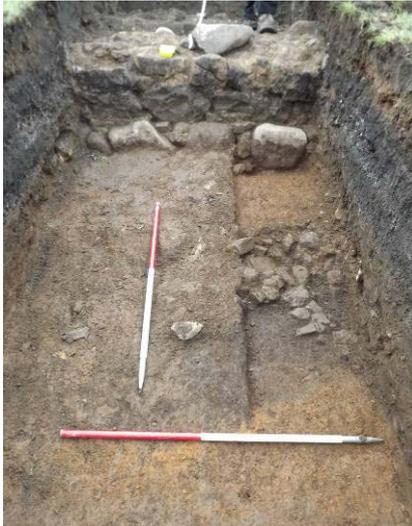
Plate 20 View NE across [13011/13012] and {13009} (Photograph 189)

No direct relationship was discernable between {13009} and linear [13011], despite initial interpretations. The overburden (13004) made it appear the linear ran directly adjacent to the wall, but excavation proved this actually sat some 0.6m NE of {13009}, although on the same alignment. Removal of (13012) revealed the linear to have the same character as (12004/12005], with the base filled with rounded stones. The function of [13011] remains unclear, and while it was thought this may be a geological feature, the alignment of the feature alongside the wall indicated a more archaeological purpose. A slot placed across (13012) uncovered a number of geographically separated sherds of 19th century glass, showing the ditch to be (in all likelihood) man-made. The cut itself had shallow sides and a roughly flat base, with a width of <1.26m.

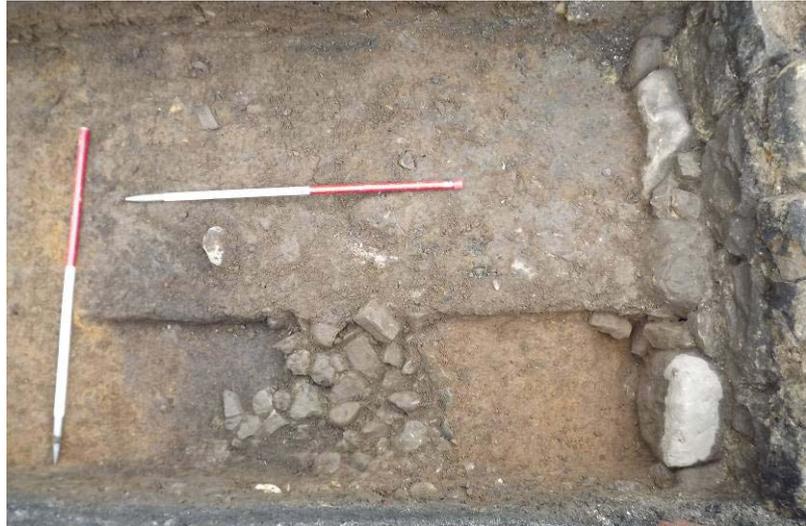
Plate 21 Post-excavation view looking SE of [13011/13012] (Photograph 191)

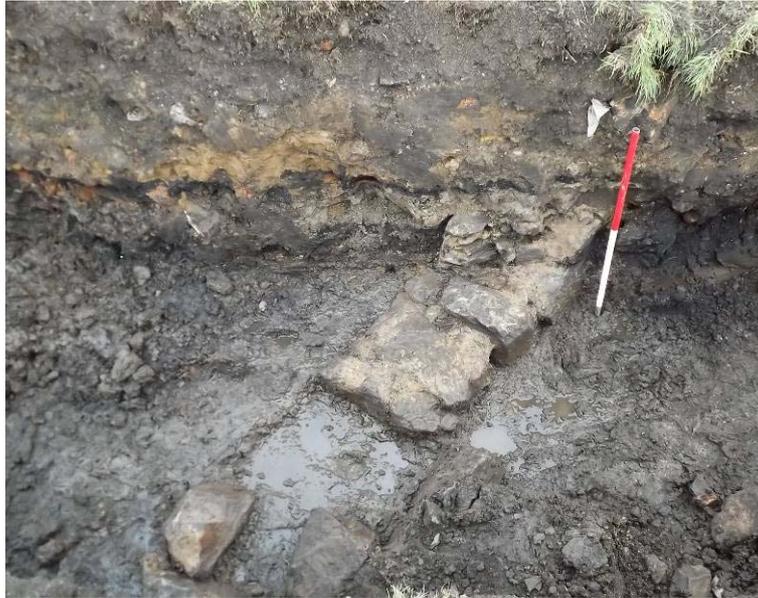
Plate 22 View westwards over {14005} (Photograph 181)

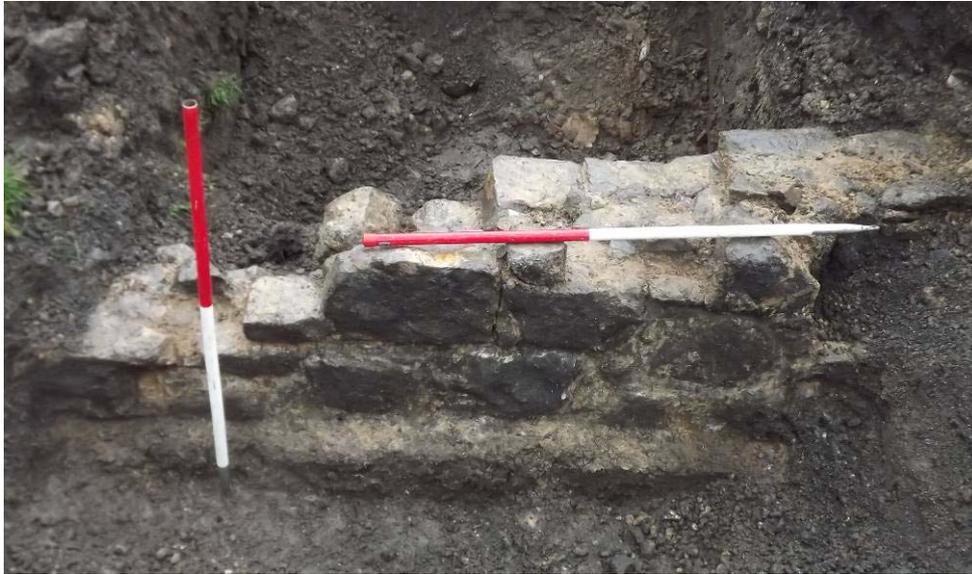
Plate 23 NE facing elevation of {15005} (Photograph 199)

In Trench 15a NW-SE aligned, well-faced lime bonded masonry wall {15005} with nearly three courses surviving and a rubble core (*plates 23 and 24*). This wall aligns roughly with a small turn-off from the road visible from the 2nd edition onwards. Unroofed, and seemingly walled on three sides, it must be presumed this was some form of area where carts or vehicles were set, possibly for loading or storage. The placement is not certain, but it seems clear {15005} formed some form of boundary wall.

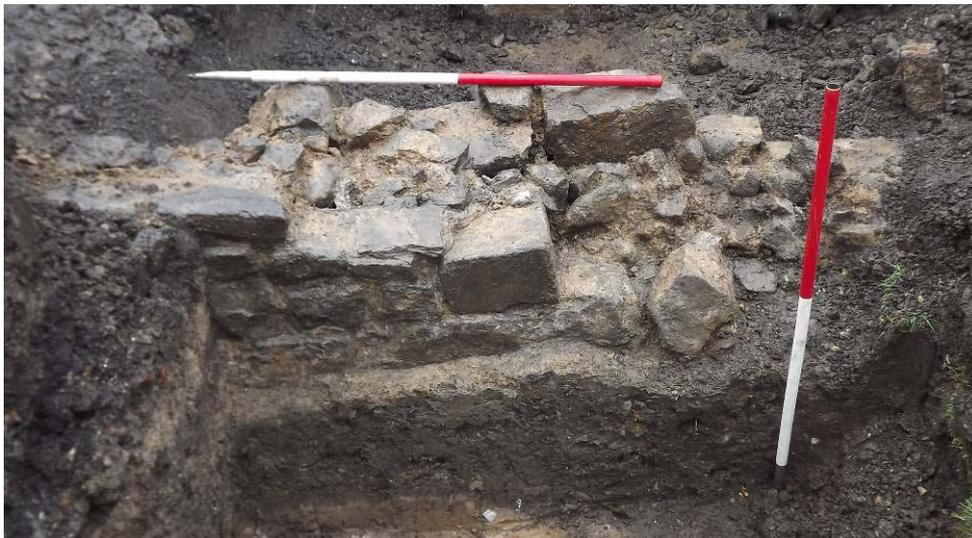
Plate 24 SW facing elevation of {15005}

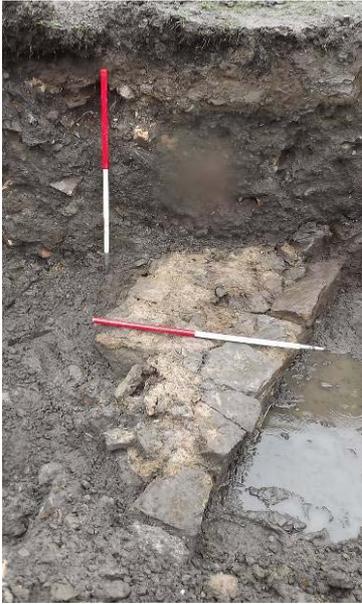
Plate 25 Post-excitation view of {15007} looking SE (Photograph 219)

In Trench 15b, wall {15007} is arguably significantly more interesting. N-S aligned {15007} is constructed from irregular and sub-angular stones, roughly faced to both the W and E with a rubble core bonded by creamy brown lime mortar. {15007} clearly corresponds with the W gable of the farm building constructed between 1858 and 1895 and measures a huge c.0.90m in width. The build is significantly different from the nice facings of {15005} and the other masonry encountered on site. {15007} had clearly been damaged in its visible NE corner by a 20th century down pipe from Castle House, and no dating material was recovered from around the wall. In lieu of further information, it must be assumed {15007} represents the vestiges of the W gable of the farm structure, with the width possibly explained by the presence of a fireplace and flue not recorded in Trench 15.

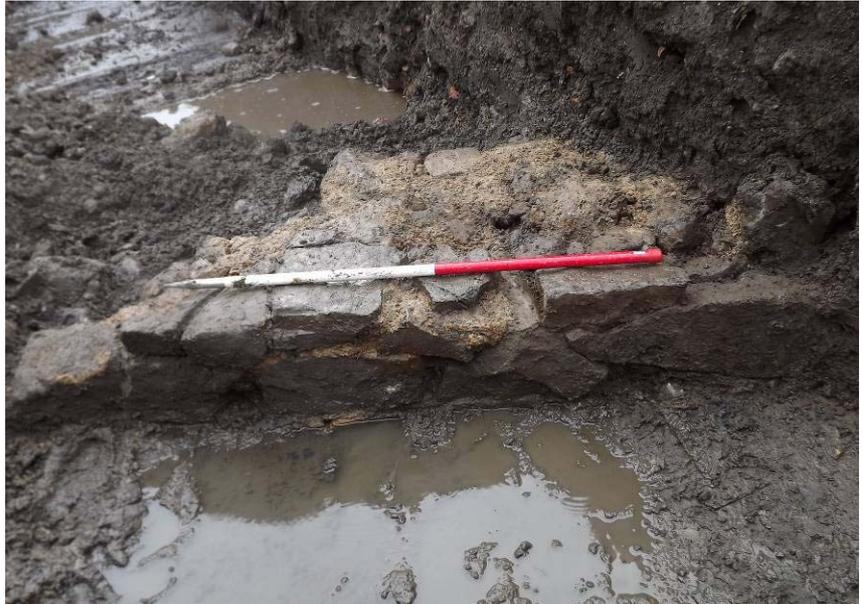
Plate 26 Post-excitation view of {15007} looking E. Note the difficult weather conditions (Photograph 224)

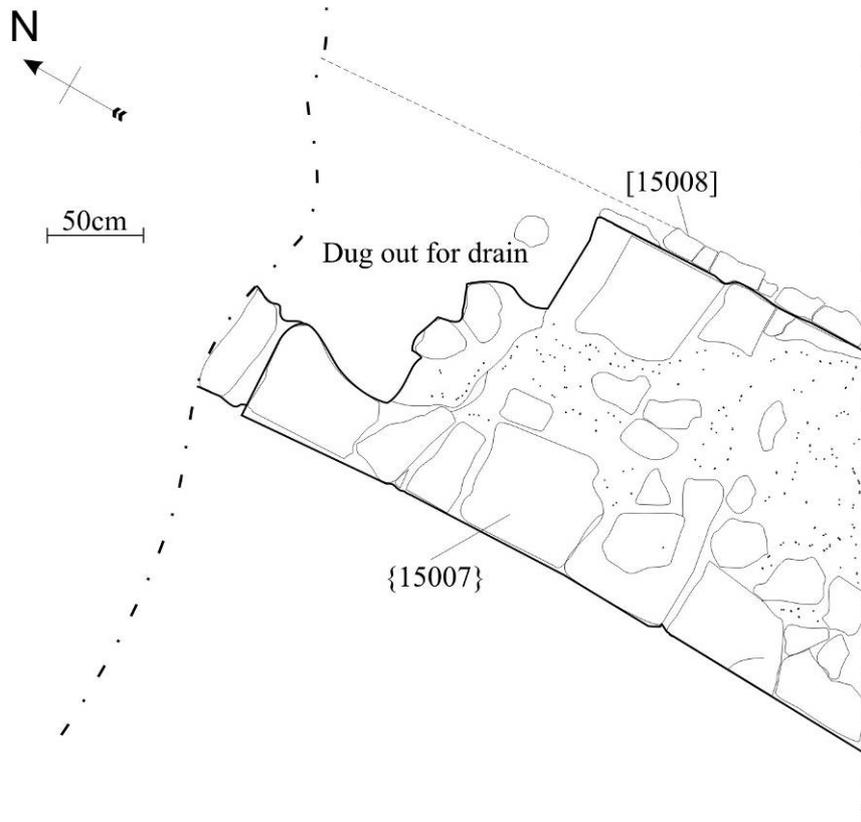
Figure 9 Post-excitation view of {15007} in Trench 15b (Drawing 007)

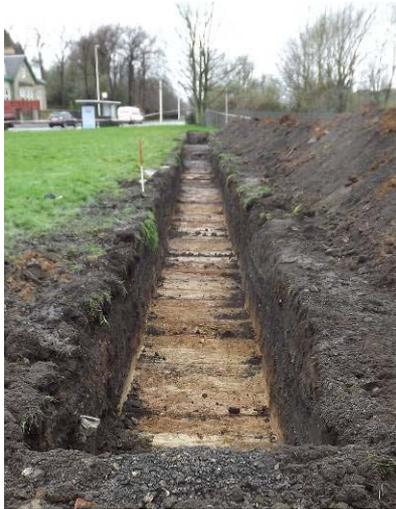
Trench 16 contained no surprises from an archaeological point of view, although an unforeseen and unrecorded water pipe was encountered and the depth of the cinder landscaping was not as deep as seen elsewhere. Here the cinder deposit (16002) was 1m deep, with the banding clearly visible (plate 28). Beneath the cinders, (16003) in all likelihood represented the vestiges of the old ground subsoil, covered by the subsequent build-up of industrial material. This lay directly atop the orange brown silty clay, undisturbed natural encountered across the trench with the exception of a series of defunct W-E aligned red ceramic field drains (16005). The natural was encountered at a depth of 1.2-1.4m SE-NW.

Plate 27 Post-excavation view of Trench 16 looking NW (Photograph 232)

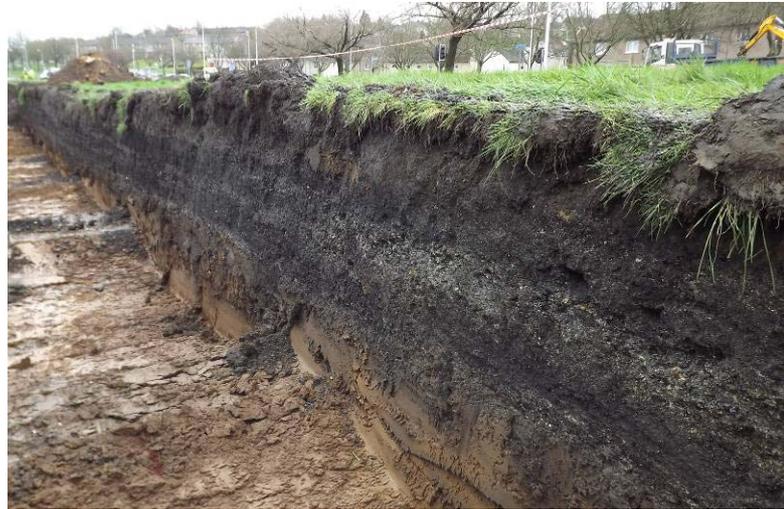
Plate 28 Post-excavation view of trench 16 looking SSE across NE facing section (Photograph 239)

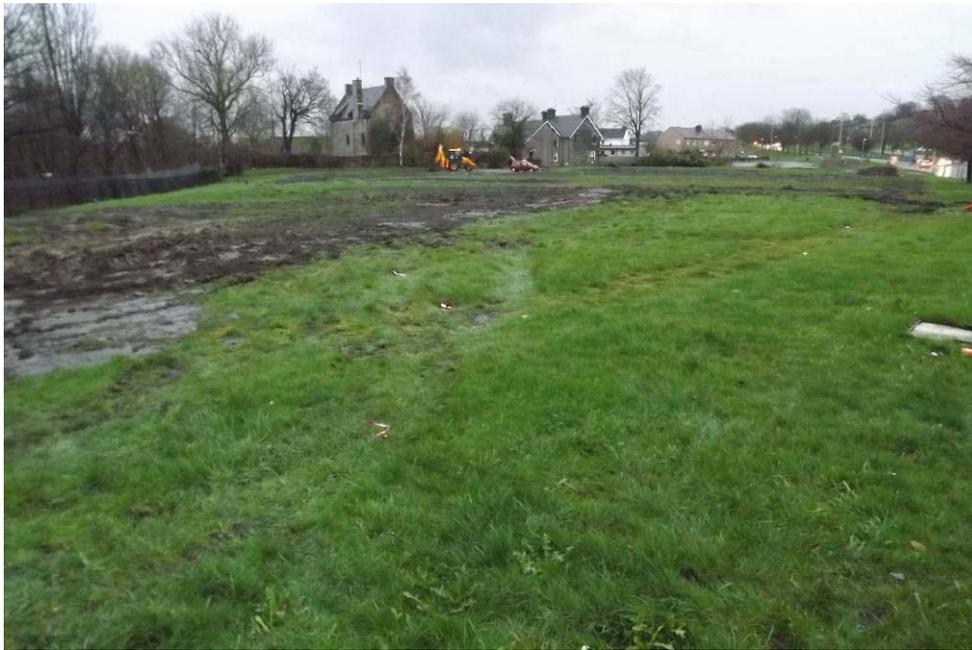
Plate 29 Site on a very rainy 16/03/12 post-reinstatement of trenches (Photograph 243)
