Davie Cooper Centre, Great Western Road

Clydebank, West Dunbartonshire

Archaeological Evaluation: June 2012
Data Structure Report

(project AA. 1981)

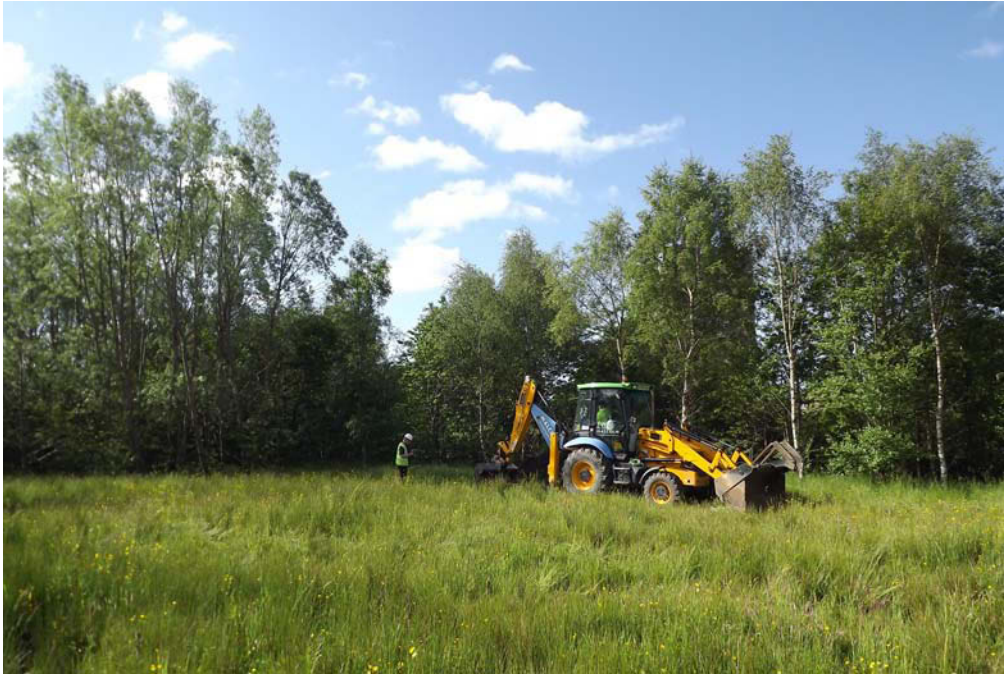
Plate 1 Monitoring the opening of Trench 1 (Photograph 004)

Trenches were excavated using a JCB 3CX mechanical excavator fitted with a 1.6m toothless ditching bucket. All trenches were opened under the direct supervision of a qualified archaeologist (*plate 1*). The site could clearly be divided into two areas in terms of results and depth of deposits. The more raised SE area proved to contain large and deep deposits of made ground characterised by demolition rubble and modern detritus. In sharp contrast, the remainder of the trenches revealed predominantly shallow deposits of topsoil atop undisturbed natural subsoil. In all trenches the level of the natural subsoil was reached, however in localised areas of the SE of the site, this proved to be located at a depth of >3.5m and was not seen across the whole trench. In such deep areas test pits were excavated within the trench to the natural subsoil. All archaeological material and features were investigated and recorded to Addyman Archaeology and Institute for Archaeologists (*IfA*) recording standards.

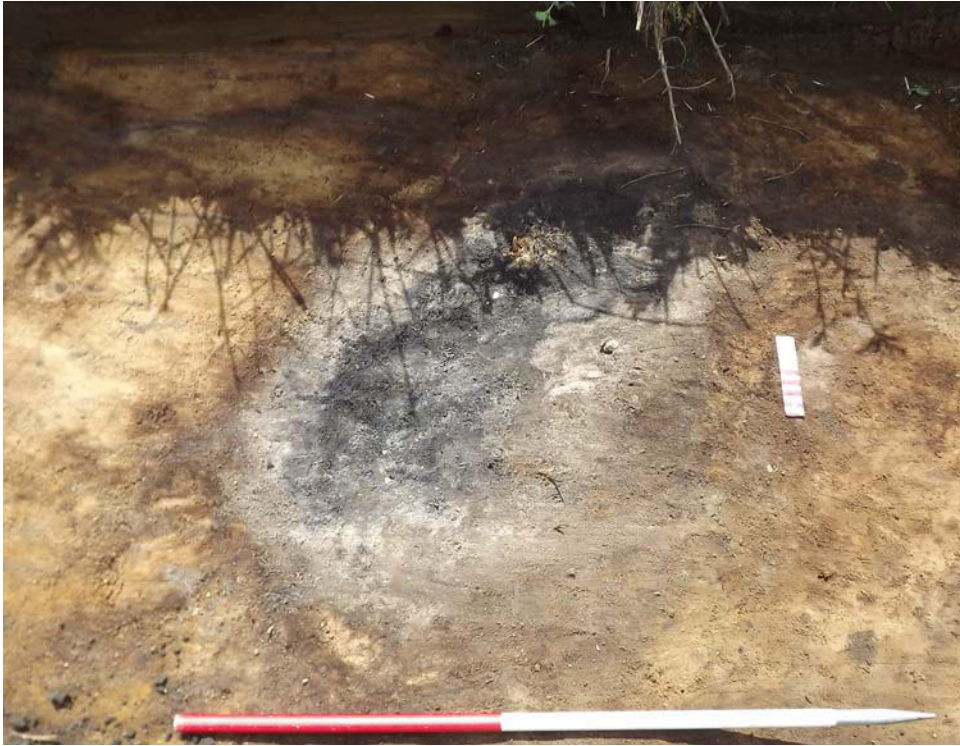
One of these features in particular appeared more substantial. This was hand-excavated and half-sectioned as appropriate. Recorded as [208], the irregular and undulating 'cut' had gently sloping sides and was filled by both (207) and (206). (206) filled the majority of [208] and comprised firmly compact dark black brown silty sand with flecks of degraded white sandstone. (206) lay atop (207), the primary fill of [208]. (207) comprised fine white sand with a hint of brown and no inclusions.

Plate 2 Pre-excitation view of (206) (Photograph 028)

[208] was initially interpreted as a pit with evidence of burning in the interior. However, no signs of charcoal were present and the firm nature of (206) did not sit true with this interpretation. Likewise (207) did not look or feel like heat affected sand and subsequent excavation across the site revealed a number of ephemeral stains in the natural subsoil which were clearly geological, many still containing black sandstone blocks degrading in the sand. In light of these subsequent investigations it became clear that [208] was a geological feature and of no archaeological interest.

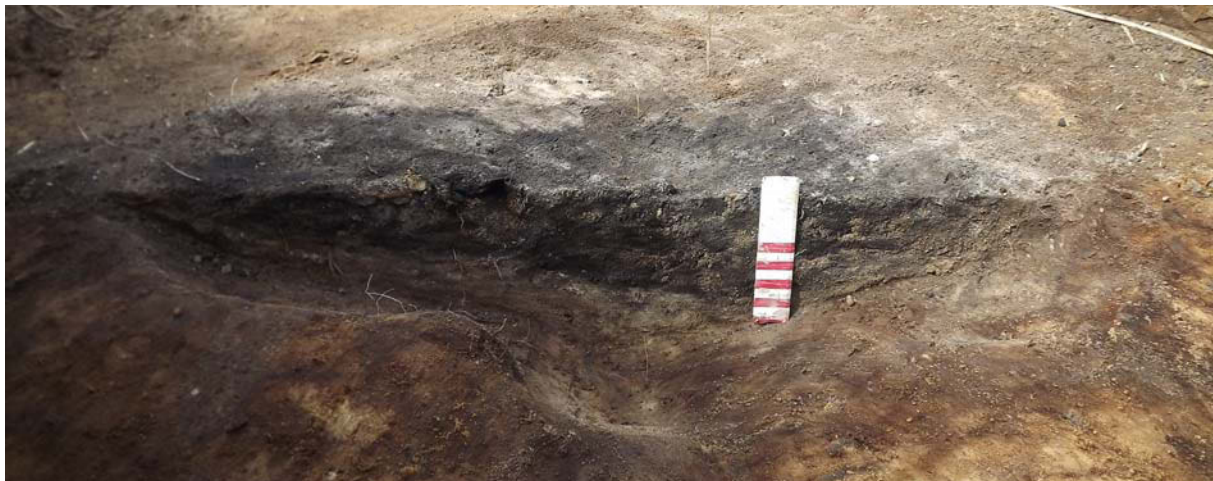
Plate 3 S-facing section of [208] showing (206) and (207)

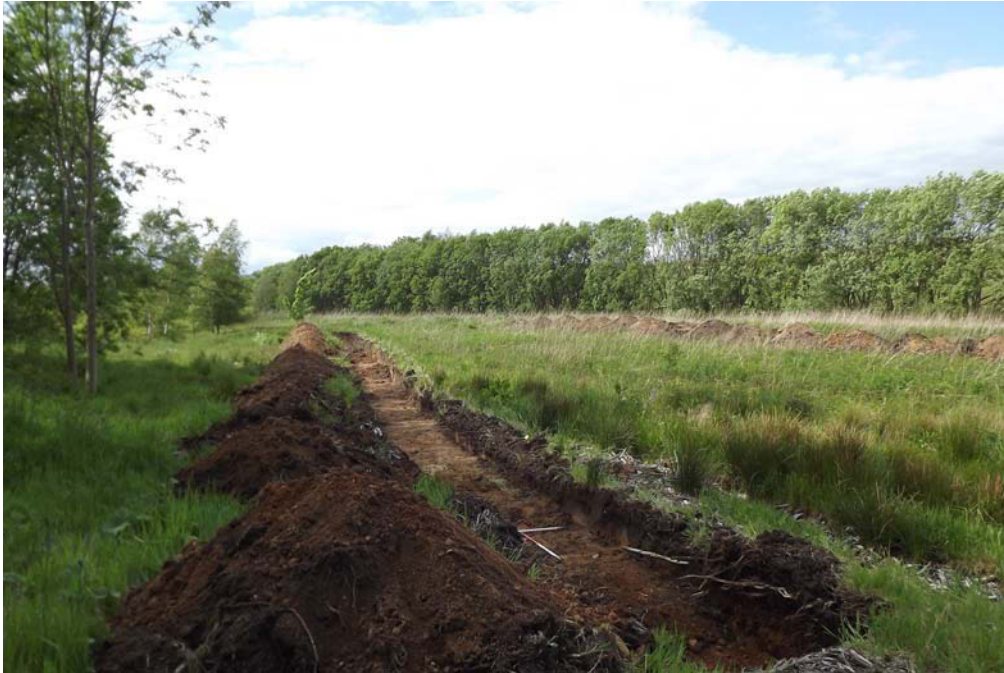
As with Trench 1, difficulties pinpointing the NW boundary of the site meant that only 28m of Trench 2 lay within the site's limits.

Plate 4 General view of Trench 2 and 3 looking N (Photograph 048)

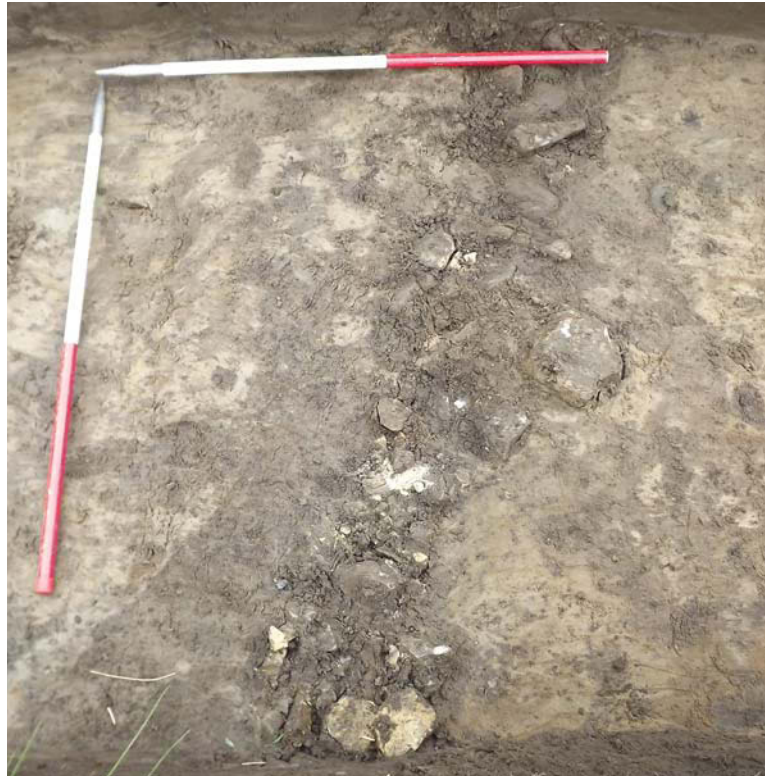
The topsoil became deeper as excavation continued NE, although no archaeological features save a further N-S aligned stone-filled field drain (plate 5) were noted. Excavation through this feature revealed 19th century ceramic sherds. These were not retained.

Plate 5 Pre-excavation view of stone-lined drain (505) (Photograph 067)

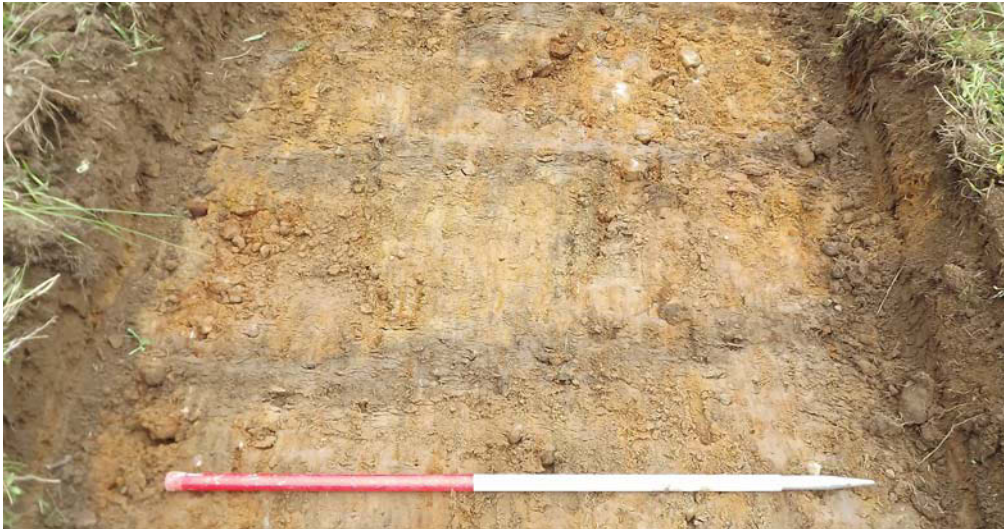
Cut within (902), two faintly discernible linears were apparent running NW-SE across the bed of the trench. With all the appearance of plough scars, both linears were hand-excavated in and recorded. Both linears (903) and (904) had near vertical sides with a near flat base, but were found to contain deposits of what was essentially topsoil. Whilst clearly limited in what they can tell us, these plough scars demonstrate previously recorded cultivation to have occurred on site, although as to what date it is impossible to confirm. The ephemeral nature of the plough scars indicates this was not deep ploughing and may indicate cultivation of some antiquity.

Plate 6 Possible ard marks (903) and (904) within Trench 9 (Photograph 080)

Plough scars in Trench 13 illustrated a previously unrecorded phase of cultivation in the area. The almost complete lack of ceramics of any age recovered from the topsoil tentatively points to this cultivation pre-dating the medieval period whereafter ceramics often made their way to cultivated land through land improvement and spreading of nightsoil. The scars had the appearance of ard marks, possibly prehistoric in date, although unsealed and seemingly filled with topsoil. The ephemeral nature of the plough scars and the lack of further evidence in other trenches means that any such conclusions however, must remain tentative at best.

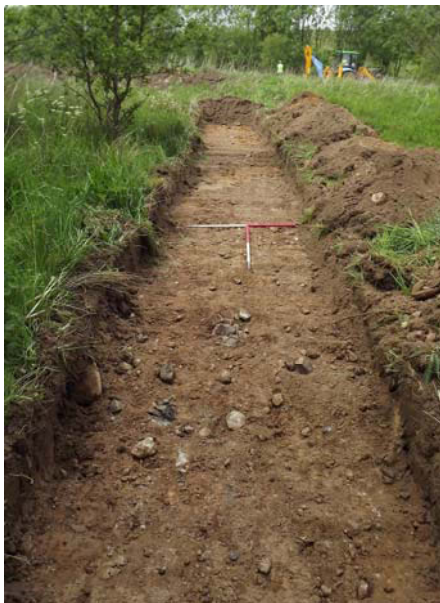
Trench 10 was excavated on a NW-SE alignment immediately adjacent to tree cover in the E edge of the site. Topsoil was revealed to 0.2m in depth and whilst the natural subsoil was much stonier and clearly different, no archaeological features were revealed within.

Plate 7 Post-excitation view of Trench 10 looking NW (Photograph 082)

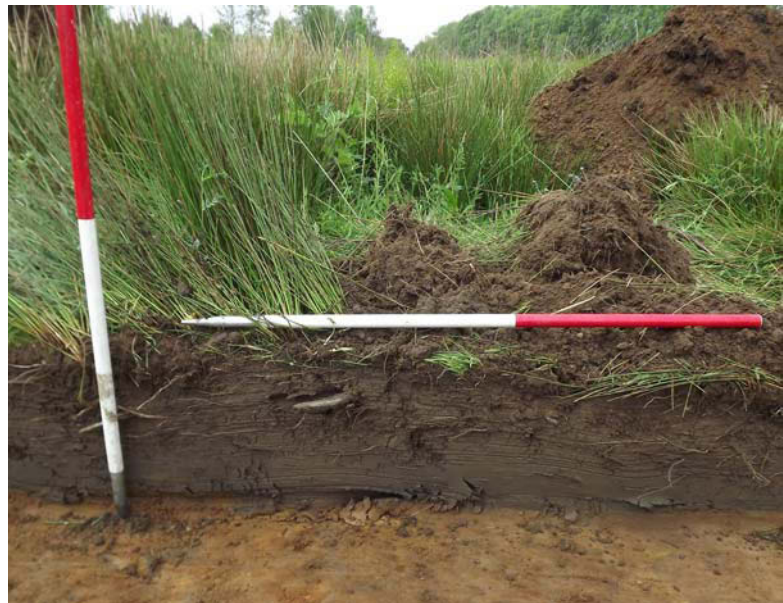
Plate 8 SW facing section of Trench 16 (Photograph 110)

Trench 16 ran for 34.3m NE-SW and was placed in order to straddle the raised area known to contain deep deposits of made-ground and the rest of the site where it was clear that no real stratigraphy existed. It was hoped Trench 16 would ascertain if the deposits of demolition debris noted in Trench 1 were in actual fact the infill of the 1930s sand quarry in which the Bronze Age Cemetery was uncovered, or indeed a large dump of later material placed upon the subsoil.

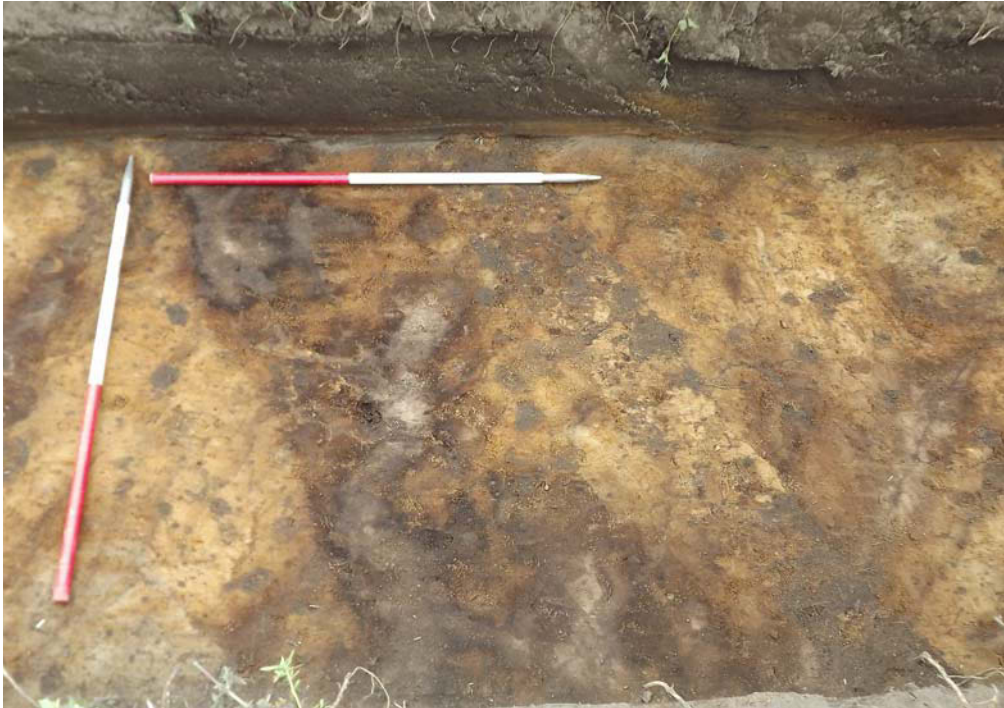
Lying on a similar NE-SW alignment, the topsoil in Trench 13 comprised mid to dark brown silty sand with a depth of 0.6-0.7m. Removal of the topsoil revealed a linear running WNW-ESE, seemingly the same as (1203) recorded in Trench 12. Here this was recorded as a feature (1303).

Initially (1303) appeared much larger than (1203), although subsequent investigation showed the darker material to the W to be ephemeral, with no distinct edge or base (see *plate 9*). This seemed distinctly non-archaeological, although the alignment suggests some form of intervention contemporary with (1303). Repeated excavation into (1303) confirmed the findings in Trench 12 and showed the cut to have vertical sides for a depth of c.0.4m. At the base of the cut a red ceramic field drain was evident. The depth and vertical edges of (1303) suggest a machine cut trench and it may be that the darker material to the W may represent disrupted ground from the tracks of the machine or compressed spoil from excavation of the drainage channel.

Plate 9 Linear (1303) within Trench 13 looking NE. Note the linear to the right of the picture. The darker material to the left proved to be non-archaeological, despite the parallel to (1303) alignment suggesting otherwise. Also note the large number of burrows across the whole of the area (Photograph 094)

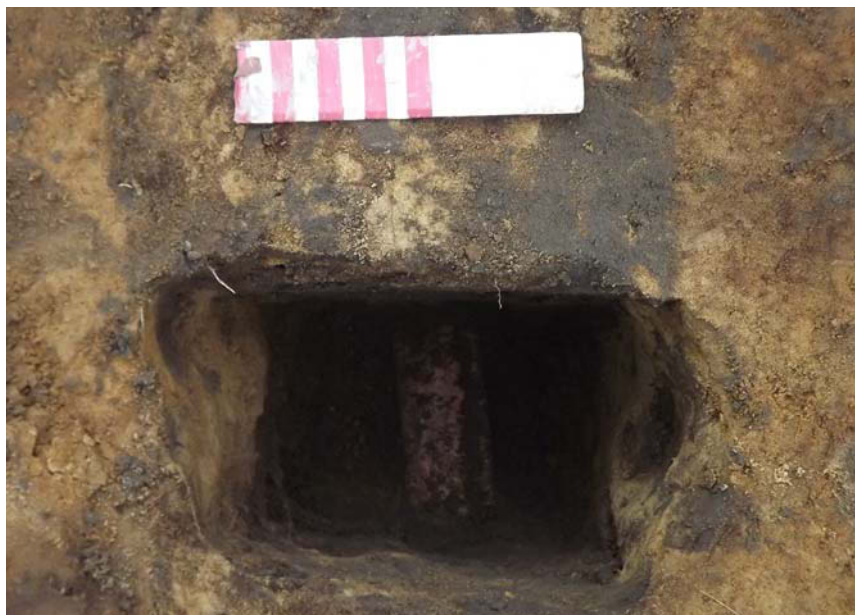
Plate 10 Red ceramic field drain (1303) (Photograph 097)

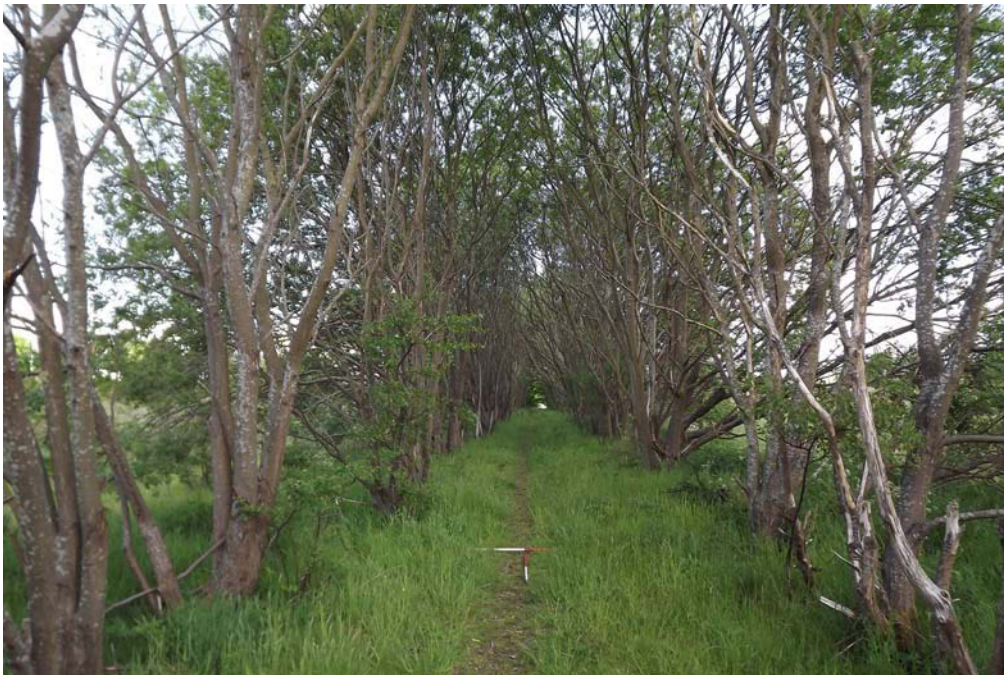
The site boundary does not match the existing field and land boundaries and slightly impinges upon a second field to the N. The N limits of the main excavation area are marked by an irregular line of trees sweeping in a south-easterly direction. The map regression undertaken as part of the Written Scheme of Investigation identified this tree line to correspond with an old road pre-dating the construction of Great Western Road in the 1930s. Still a popular path for walkers and horses, this road still exists, lined by a series of mature trees on either side (*plate 11*). Trench 15 was planned to assess the small parcel of land within the site boundary and located to the N of the old road.

Plate 11 The old roadway to the N of the site (Photograph 012)

Despite the proximity to the roadway, Trench 15 proved void of any archaeological features with around 0.7m of topsoil removed directly onto undisturbed natural subsoil. The roadway was shown to be constructed of compact ash, coal and clinker placed directly onto the topsoil, which in turn had accumulated to a degree over the top of the road in the years since its abandonment.

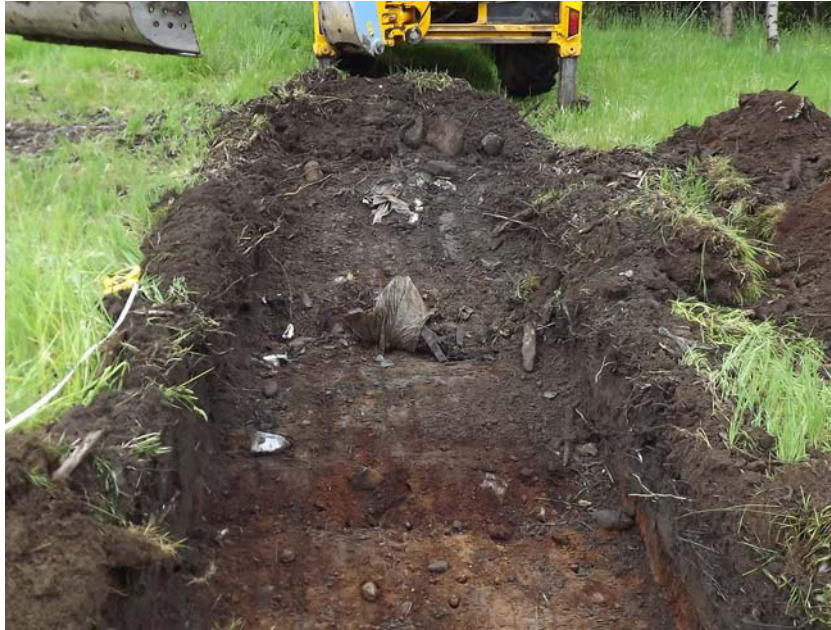
Trench 16 revealed no archaeological features, although it did uncover the edge of the modern dumped deposit. This did not indicate the demolition debris and modern detritus to be the fill of the quarry, but showed it to sit directly atop the undisturbed natural subsoil. This does not conclusively say the material does not represent the fill of the Knappers Quarry, however, it seems likely that this comprises a series of dumps, all placed directly atop the existing ground surface.

Plate 12 Working shot looking SW. Demolition rubble (1603) sitting directly atop (1602). (Photograph 101)

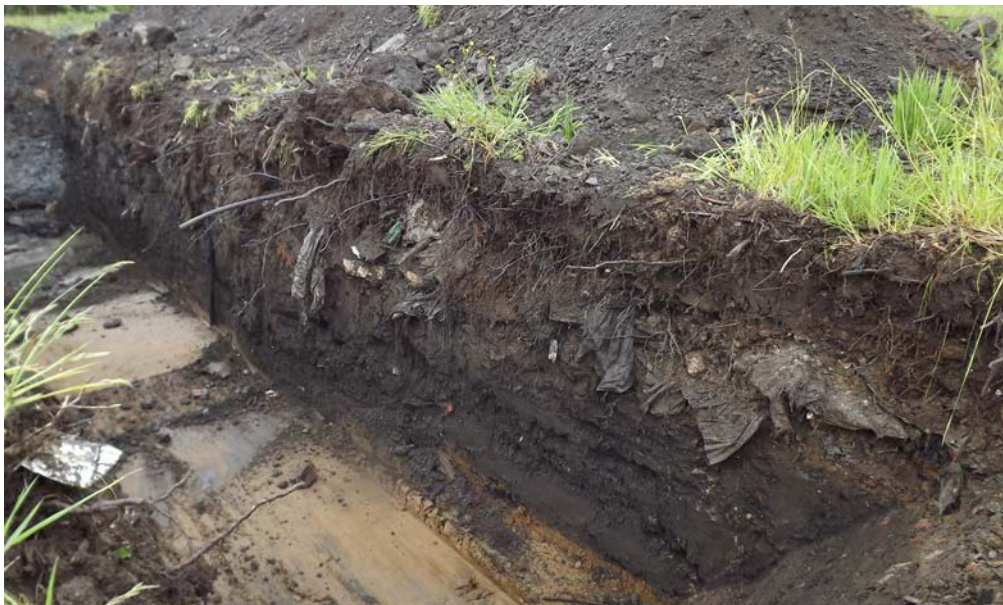
Aligned WNW-ESE along the edge of the raised area, Trench 17 measured 16.6m and had an eventual depth of c.2.5m. As within Trench 1 it was clear that a series of large and very mixed deposits of demolition rubble survived across this area of the site. The natural subsoil was encountered at a depth of 2.5m and Trench 17 was excavated to this level along the entire length. However, as excavation continued towards the ESE, a large volume of dirty water trapped within a layer of debris dominated by modern waste, began to flood the trench, making it impossible to view the natural subsoil unobstructed. Trench 17 was abandoned at this stage as of limited archaeological value.

Plate 13 NE facing section of Trench 17 (Photograph 117)

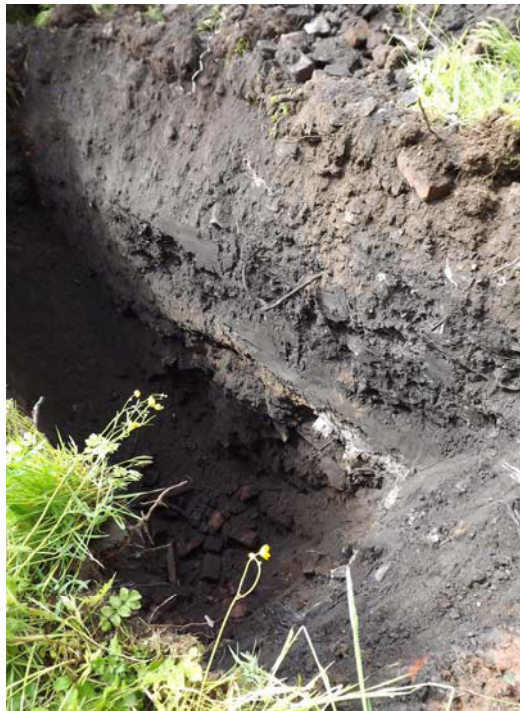
The last of the trenches excavated on site, Trench 21, was placed as far E as the tree cover would allow, running SE-NW for 7m. Essentially a Trial Pit to confirm the continuing presence of the deep and mixed demolition deposits, the natural subsoil was revealed at a depth of 3.1m.

Plate 14 SW facing section of Trench 21 (Photograph 142)

It is currently unclear whether construction can take place atop the loose and heterogeneous dumped material in the SE of the site. Should this be stripped away prior to development, a case could be made for monitoring such work due to the proximity of this area to the Knappers Cemetery and the difficulty assessing the subsoil in the evaluation due to the depth of deposits. However, due to the lack of any archaeological material encountered during the evaluation in the main area of the site, Addyman Archaeology recommend that no further archaeological mitigation is required on the proposed site of the Davie Cooper Centre.
