# Kirkhope Tower

*Ettrickbridge, Scottish Borders*

*Archaeological Evaluation: August – September 2012*

### Data Structure Report

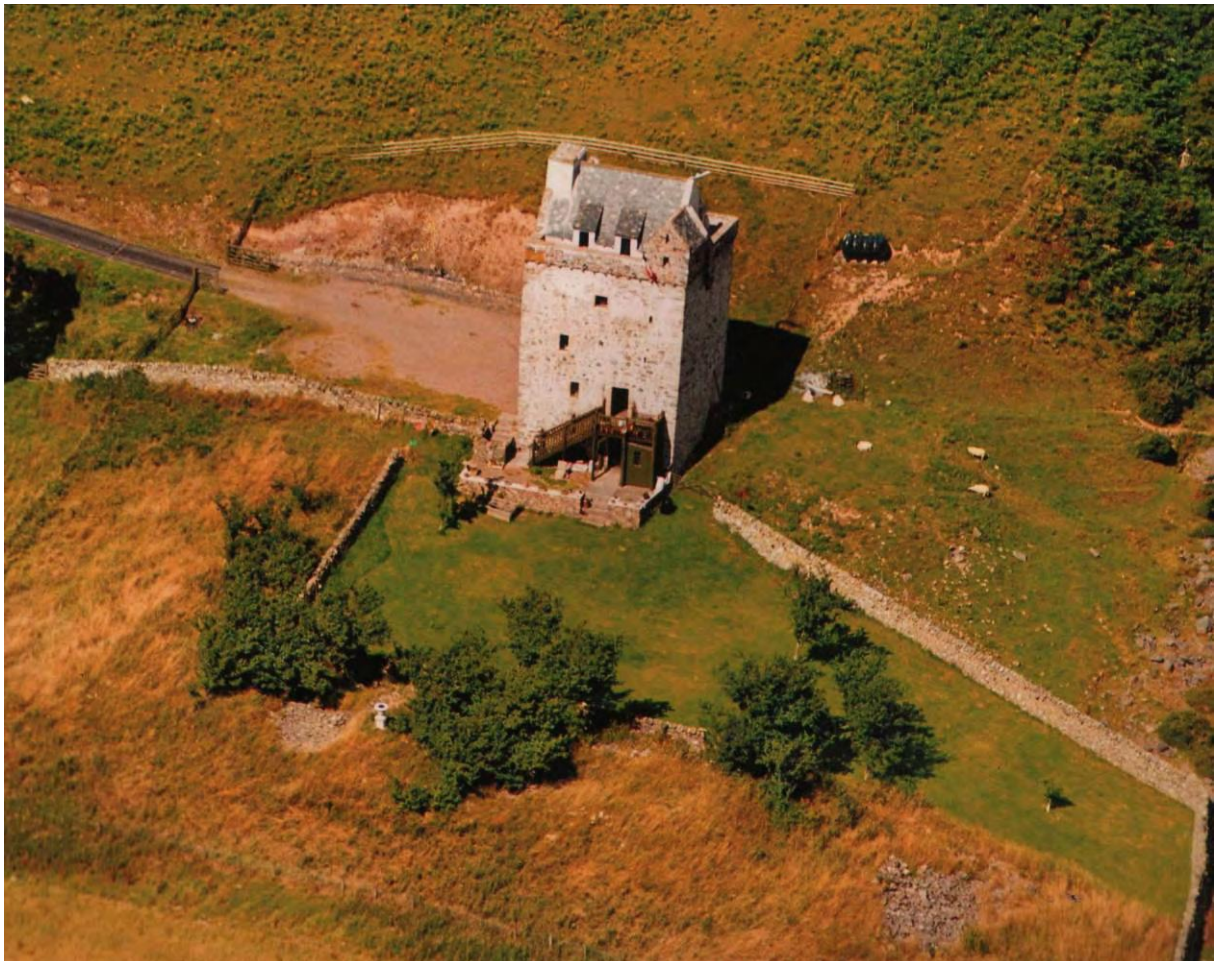
*Plate 1 Aerial view of Kirkhope Tower post-restoration (Peter Clarke)*

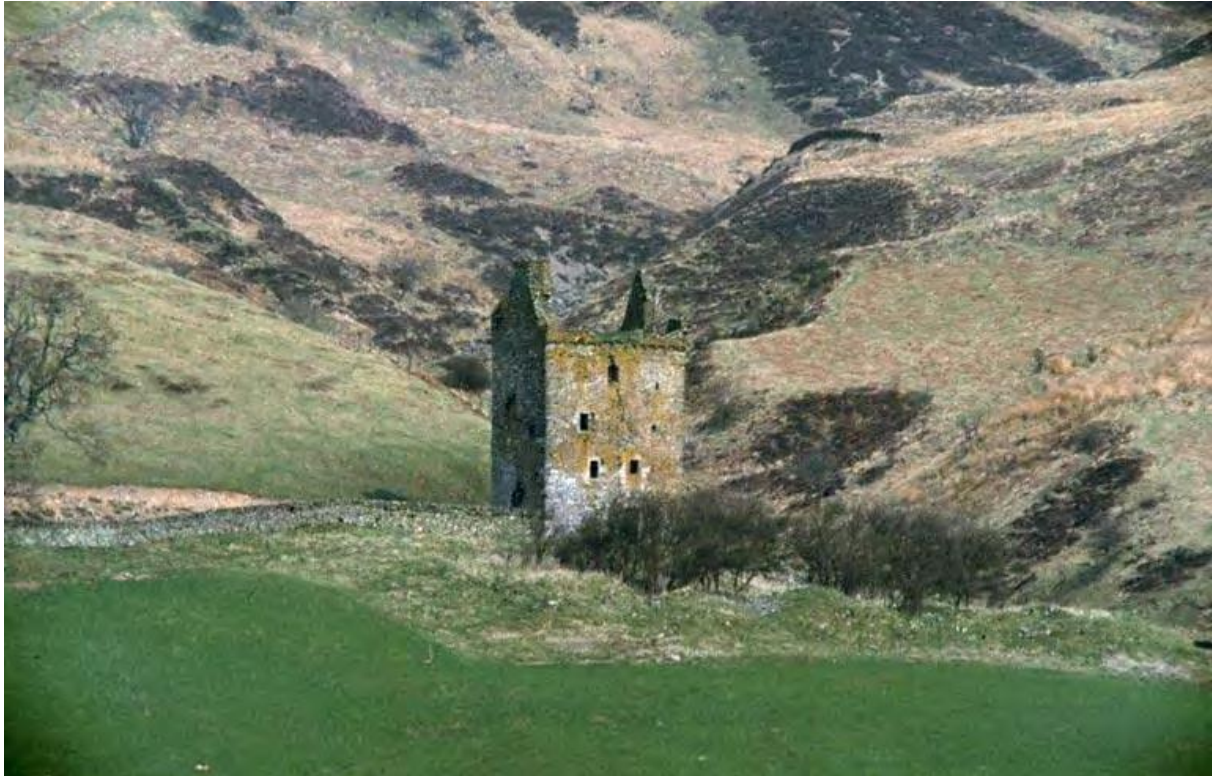
*Plate 2 Kirkhope Tower from the S prior to restoration. ©RCAHMS 000-000-339-465. Licensor [www.rcahms.gov.uk](http://www.rcahms.gov.uk)*

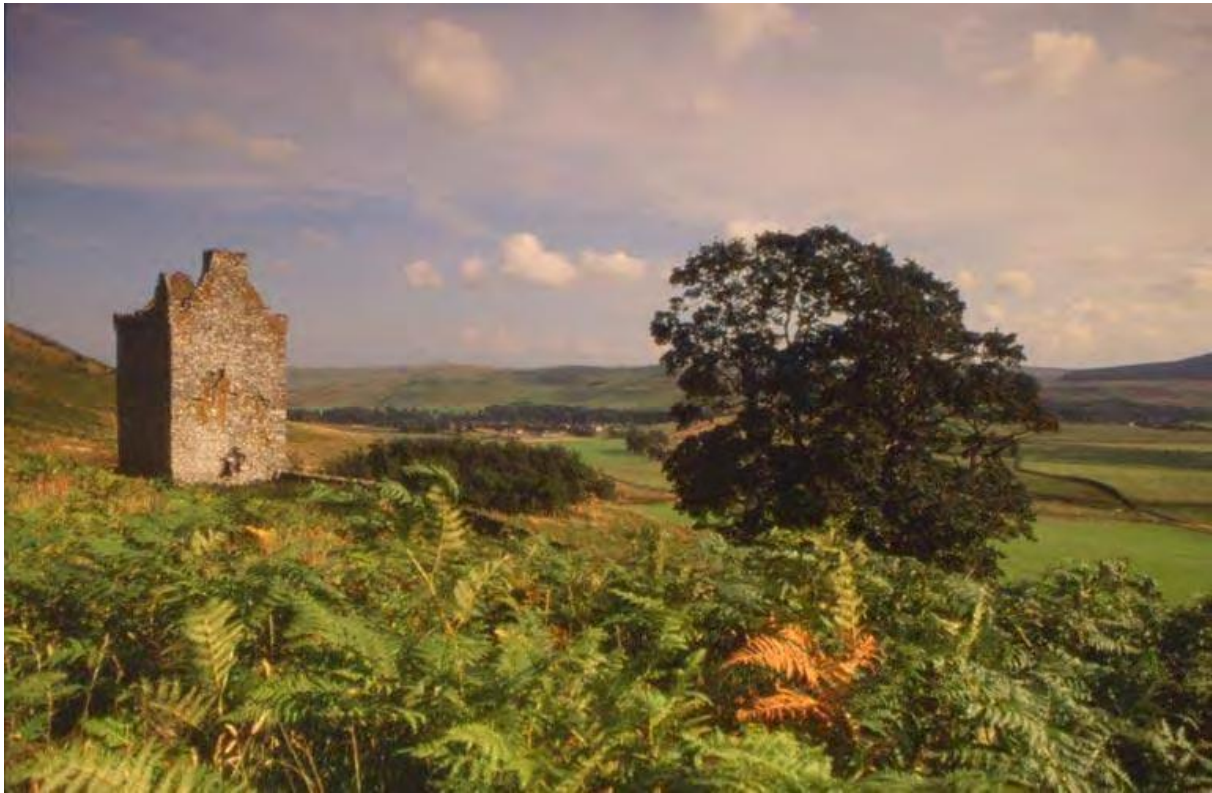
*Plate 3 Kirkhope Tower from the NW prior to restoration. ©RCAHMS 000-000-132-578-C. Licensor [www.rcahms.gov.uk](http://www.rcahms.gov.uk)*

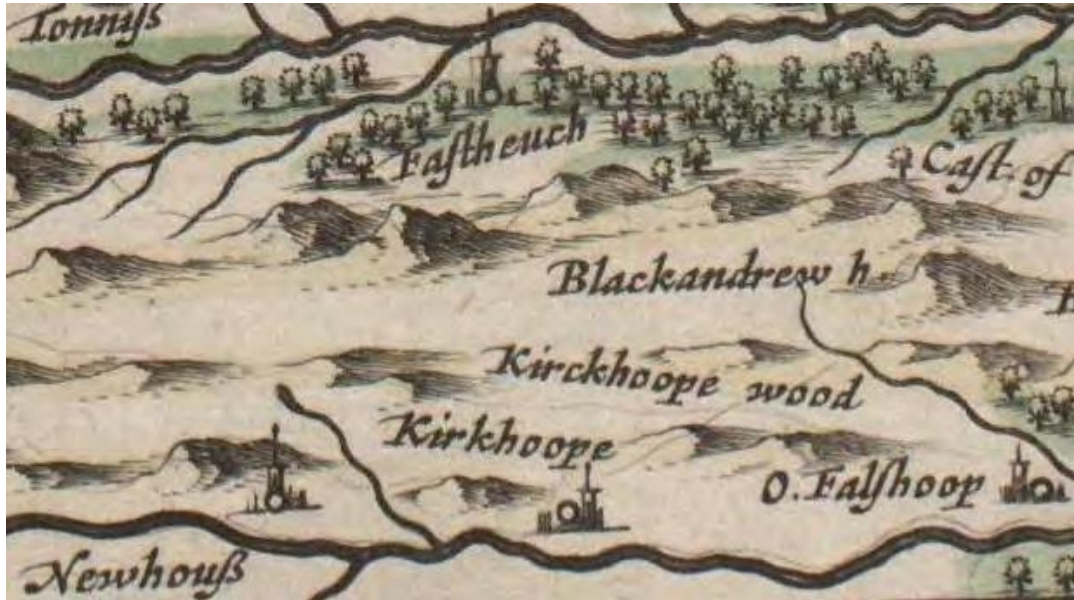
Figure 2 Extract from Joan Blaeu’s *Atlas of Scotland* published in 1654 showing an idealised view of ‘Kirkhoope’. This is potentially the earliest depiction of Kirkhope Tower (NLS)

Joan Blaeu’s *Atlas of Scotland* was published in 1654 and provides the first potential view of Kirkhope Tower in the cartographic resource. The map is by no means ideal, and the actual depiction of ‘Kirkhoope’ is idealised and can provide no information as to the appearance of the site. It is also debatable whether the idealised view depicted is actually the tower house itself, or indeed a farmstead or hamlet also known as Kirkhope and recorded immediately to the W of the tower on later maps and today known as ‘Old Kirkhope’.

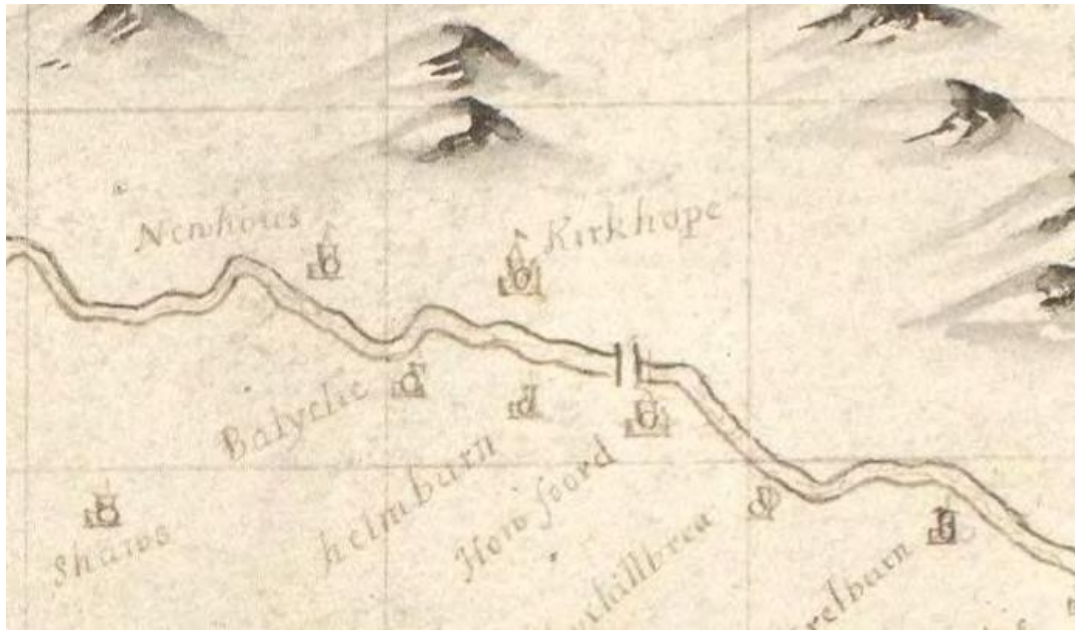
*Figure 3 Extract from John Adair's manuscript The Sherifdome of Etrik Forest showing the depiction of 'Kirkhope'. Note the small sketch is larger than the majority of those in the surrounding area (NLS)*

The discussion of Bleau's map can also be mirrored in the only other 17<sup>th</sup> century map to portray 'Kirkhope', that of John Adair in his manuscript plan *The Sherifdome of Etrik Forest*, from c.1688. This too depicts a view that provides little information as to the size, status and plan of Kirkhope Tower. There also remains the possibility that the designation and placement of 'Kirkhope' may relate to 'Old Kirkhope'. However it may be significant that Adair's depiction of 'Kirkhope' is larger than the majority of the surrounding sites he records, and this may reflect its status, described a mere 39 years earlier in 1649 as 'one of the principal houses in Selkirkshire'.<sup>47</sup> To draw any such conclusions as to the style and layout of Kirkhope Tower from Adair's small sketch must however be considered tentative at best.

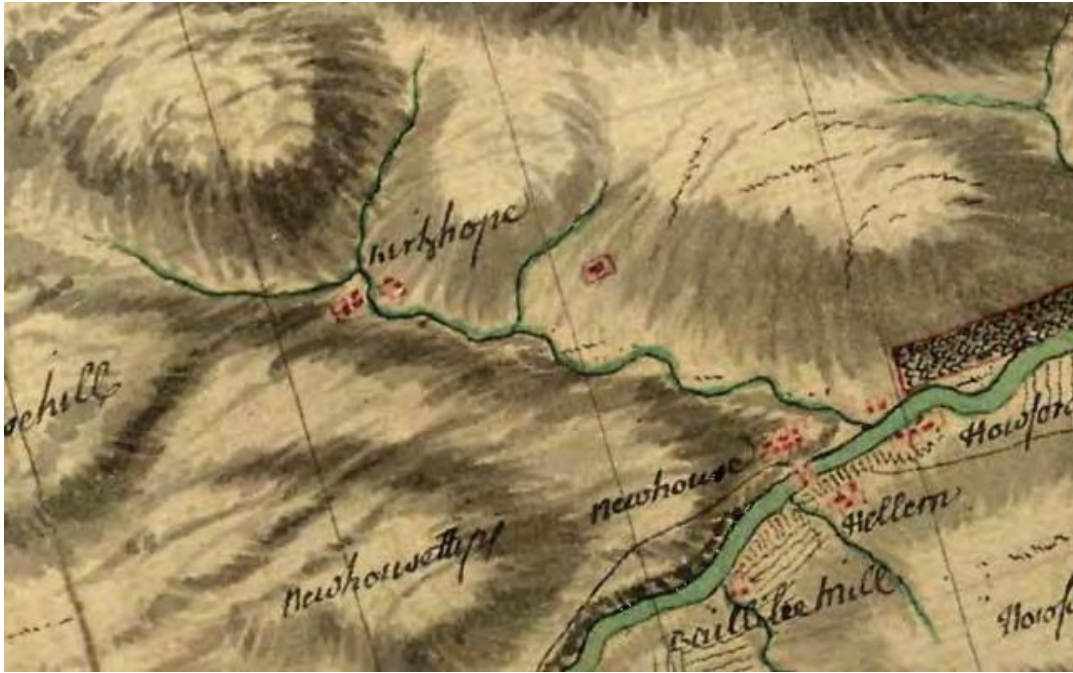
Figure 4 Extract from William Roy's Military Survey of Scotland of 1747-1755 with 'Kirkhope' clearly marked. Yet note the enclosed building set back from the watercourse to the E (NLS)

Following the delineation of Adair's map, the next cartographic depiction of Kirkhope Tower is William Roy's *Military Survey of Scotland* (Figure 4) conducted between 1747 and 1755. Here for the first time the Kirkhope Tower site is differentiated from the later (existing) farm settlement of 'Old Kirkhope', with the tower depicted further to the E as a larger red rectangle within a surrounding enclosure but without annotation. It seems likely the earlier maps indeed show the tower site, which had perhaps been superseded by 'Old Kirkhope' by the publication of William Roy's map. The presence of the enclosure surrounding the Tower means it would be difficult to argue this had lain in a ruinous condition and was never re-occupied following the sacking of 1543 if it remained substantial enough to be recorded by Roy in the mid 18<sup>th</sup> century. This evidence appears to corroborate that of the historical analysis, which suggests Kirkhope continued to be occupied and extensively used post-1543.

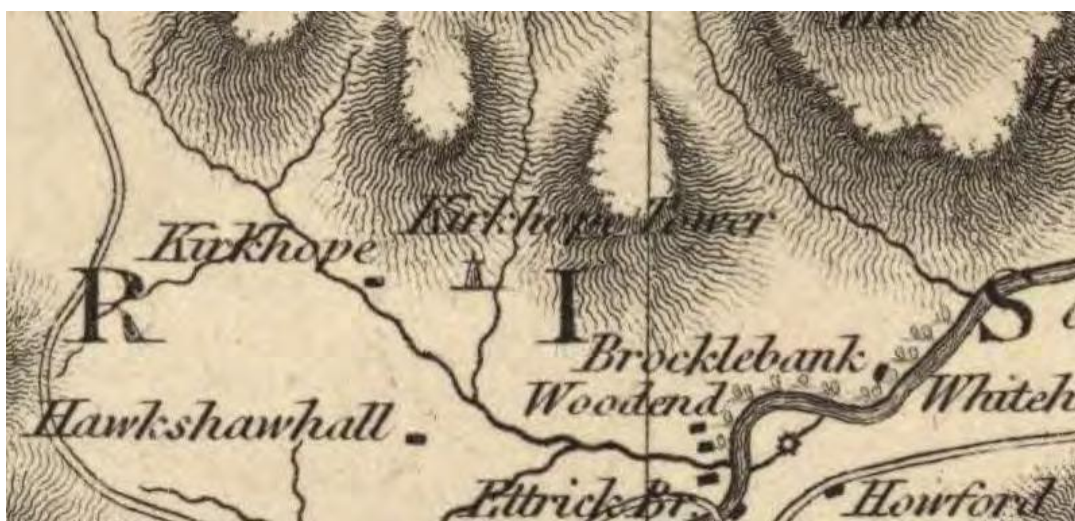
Figure 5 Kirkhope and Kirkhope Tower from John Thomson's Atlas of Scotland produced in 1832 (NLS)

'Kirkhope Tower' is first specifically named on John Thomson's map of 1832 (*Figure 5*) where it is recorded E of 'Kirkhope'.

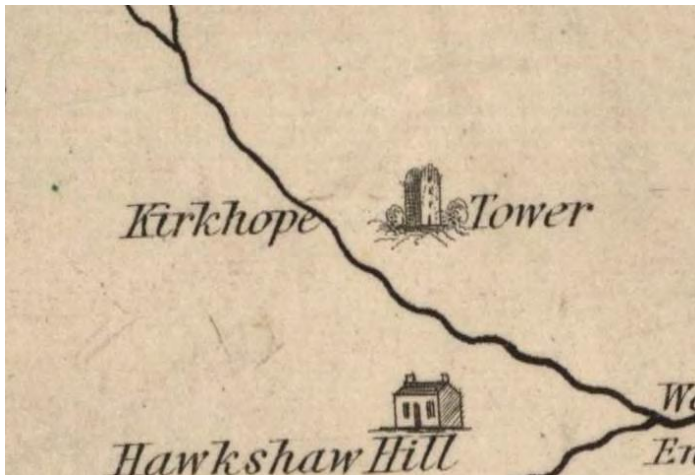
*Figure 6 Kirkhope Tower as depicted on Thomas Mitchell's map of 1851 (NLS)*

Thomas Mitchell's *Map of the County of Selkirk and District of Melrose* produced in 1851 provides the first possible apparent depiction of *Kirkhope Tower* as it appeared at the time. As seen in *Figure 6*, the vignette representing the tower appears to be Kirkhope itself and although there is little further to note on the map, the tower itself is depicted with land rolling away below its main entrance, and shown without indication of surrounding courtyard structures. The tower also appears to be roofless, which may not actually have been the case – as later sources reveal, see below; nonetheless the depiction certainly suggests dereliction.

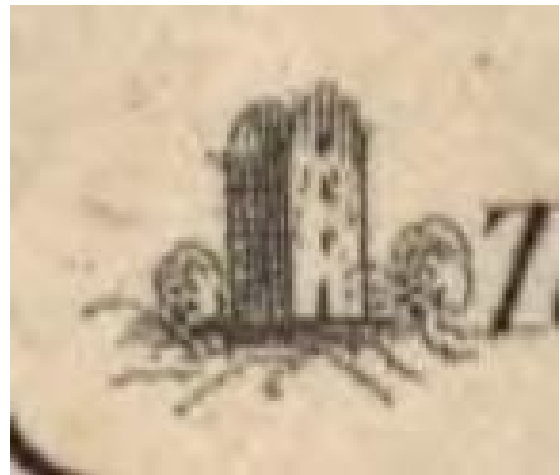
*Figure 7 Detailed view of the depiction of Kirkhope Tower. This seems to be the first accurate depiction of the tower (NLS)*

Closer scrutiny suggests it unlikely this is an actual representation of Kirkhope Tower rather it is indicative as the elevation containing the vertically aligned windows and entrance (which could only be the existing S elevation) is incorrectly shown in relation to the gables. Both the layout and number of these openings is incorrect and at Kirkhope Tower the roof is aligned W-E and not N-S as would be indicated by the gable arising above the openings on Mitchell's sketch. It must be assumed then that Mitchell was unfamiliar with Kirkhope Tower when he drew his map, or indeed was not sufficiently aware of the Tower to draw it accurately from memory.

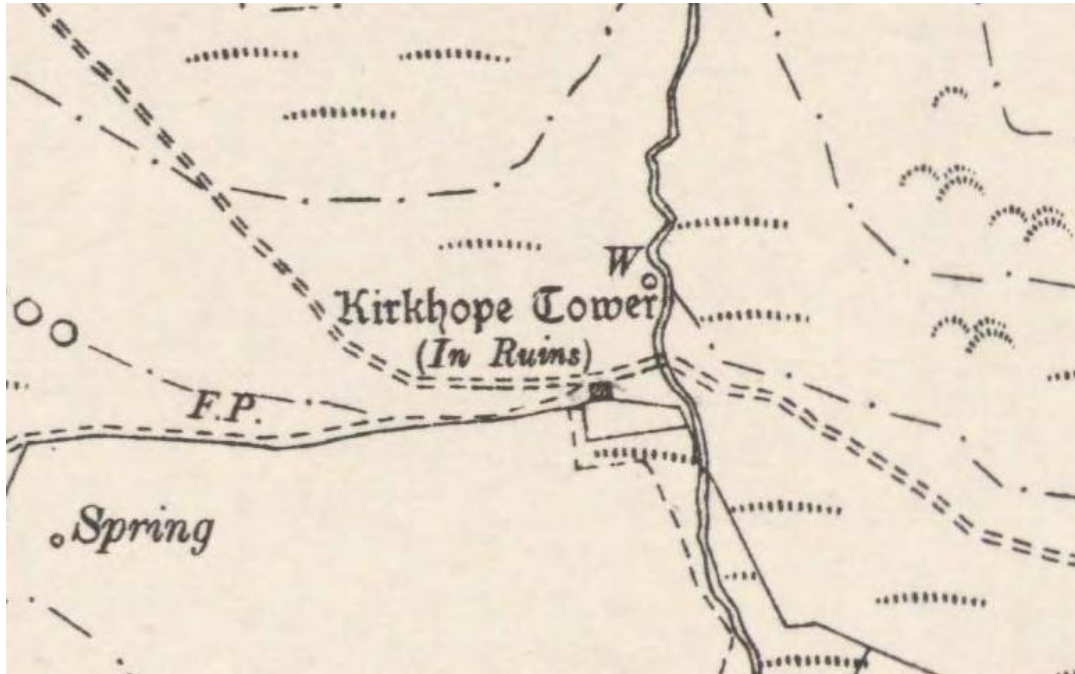
Figure 10 Extract from the 6 inch to 1 mile OS map of 1900, surveyed in 1897 (NLS)

Subsequent editions of the Ordnance Survey map series provide little further new information relating to Kirkhope Tower, but it is worth noting that the 2<sup>nd</sup> edition 6 inch to 1 mile OS map surveyed in 1897 and published in 1900, records Kirkhope Tower to be ‘in ruins’ (see *Figure 10*). No detail is visible for the buildings to the S of the tower, perhaps suggesting these have become increasingly overgrown and less clearly visible in the intervening period between the production of the 1<sup>st</sup> and 2<sup>nd</sup> editions.

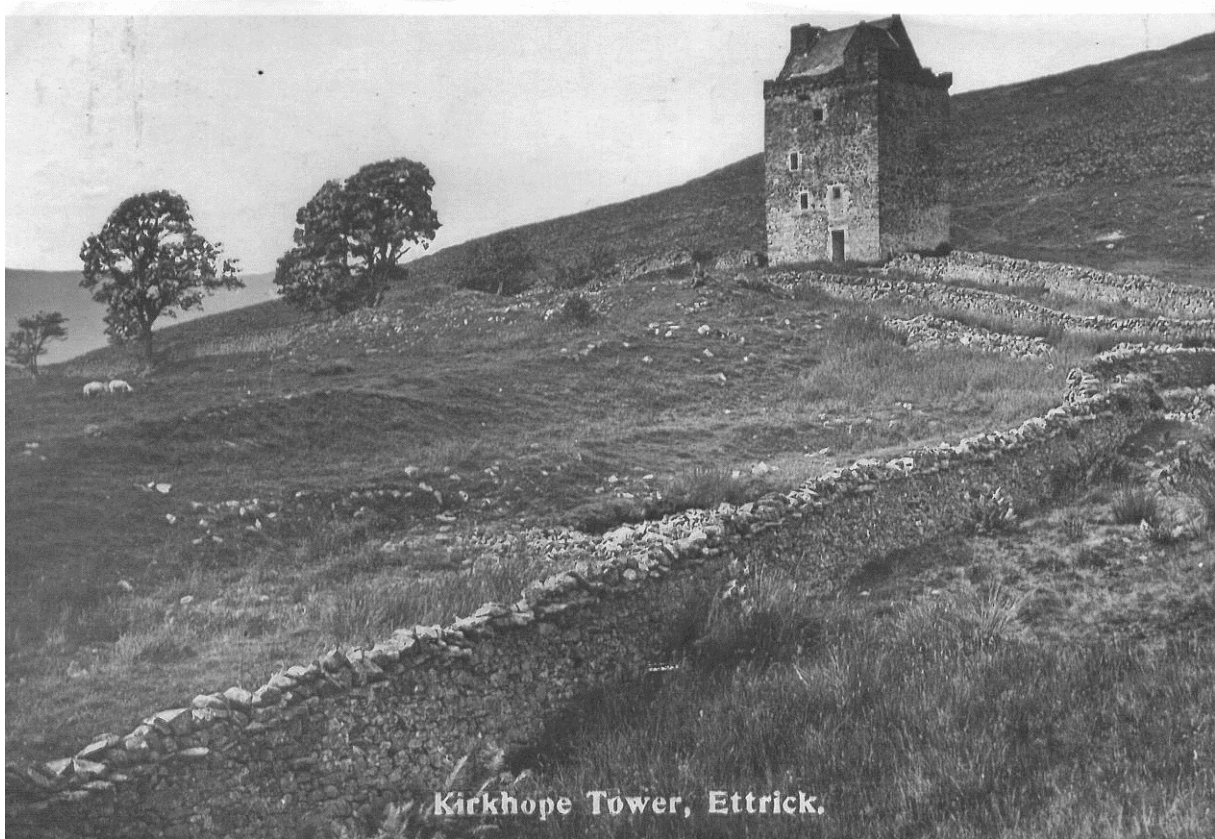
*Plate 4 Dramatic early view of Kirkhope Tower from a postcard of unknown date. Note the Tower is roofed while the vegetation cover in the barmkin is minimal (supplied by Peter Clarke)*

A number of photographic images exist prior to the restoration in the early 1990s. The earliest is a postcard (in the possession of the client) that shows the Tower surviving intact (*Plate 4*), still roofed and surrounded by the indications of the ruined barmkin much as it exists today. The date of this image is unknown, but pre-dates 1930 when a series of images (incl. *Plate 5* and *Plate 6*) show the Tower as a roofless shell.

Of these images, only *Plate 4* reveals any possible traces of earlier features, possibly obscured by the 1990s restoration. In this image, the remnants of a small structure can be discerned abutting the W facing gable. The location of these remains correspond in part to those noted on the 1<sup>st</sup> edition OS map of 1865 (*Figure 9*), although the date and function of this structure is unclear it appears to have been a small ancillary range or shed and likely relates to the later years of occupation at the site. None of the early pictures reveal any further structural details which can assist in assigning a reliable date to the present structure.

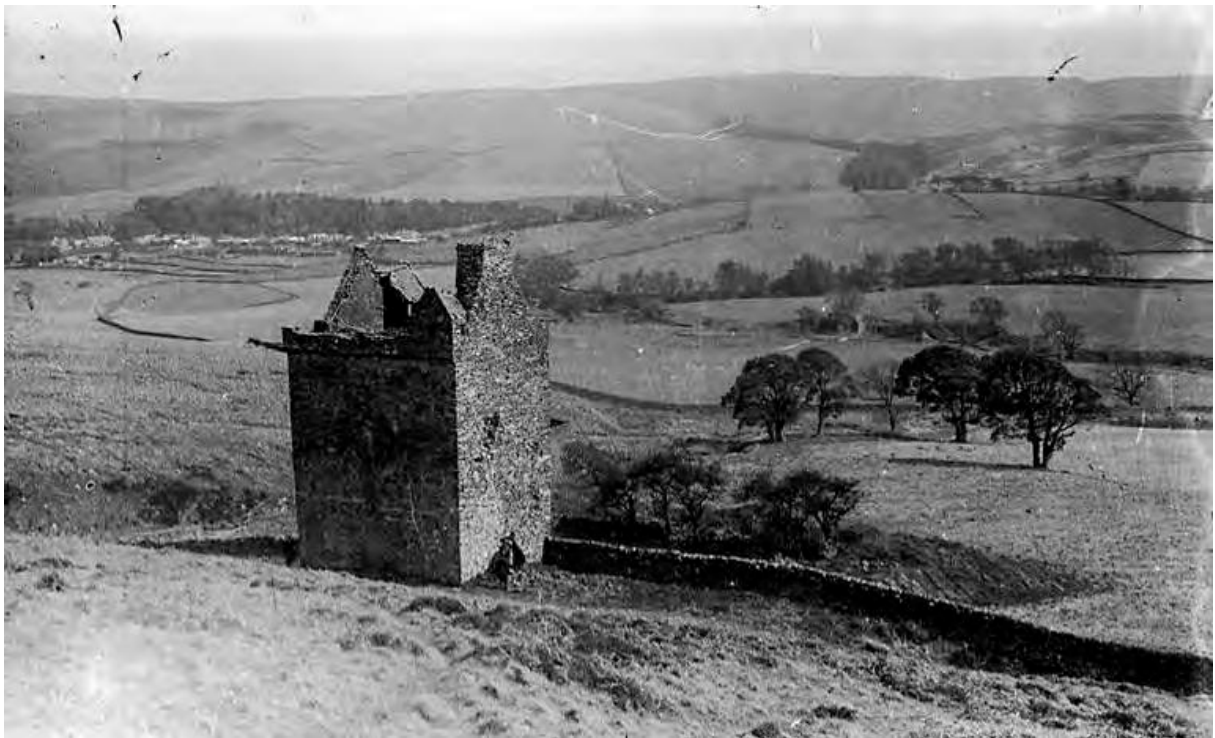
*Plate 5 Looking SE towards Kirkhope Tower in an image from 1930. The structure is now roofless, although note the presence of a possible small structure abutting the tower on the W facing elevation.*

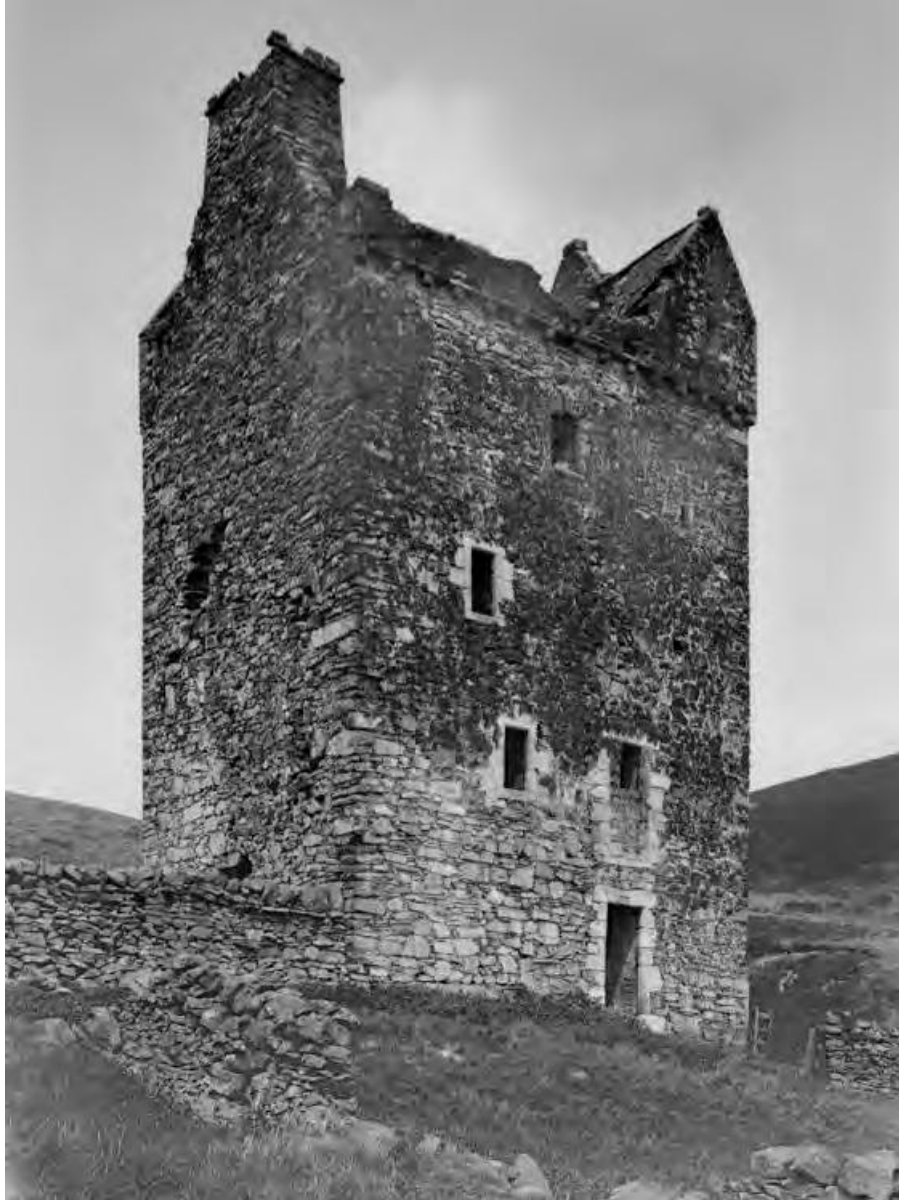
*Plate 6 Looking NE towards Kirkhope Tower in an image from 1930. The fabric of the building is essentially intact although the roof has fallen in. Note the blocked up doorway on the second floor.*

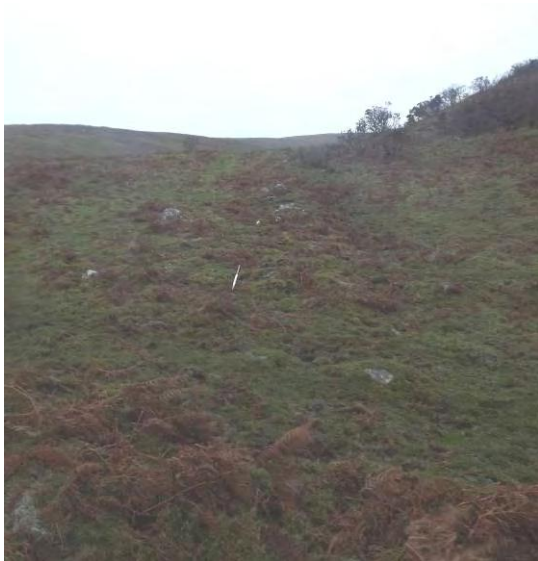
*Plate 8 Large N-S linear to the E of the Tower Burn as photographed in bad light during the topographic survey*

To the E of Tower Burn, three irregular linear banks (*Plate 8* and *Plate 9*) were recorded on an area of gently sloping ground overlooking the valley below. None of these form a clear and complete visible compound, but each has at least three sides visible whilst they do not appear to be in any set or organised manner. These may be long disused field boundaries, possibly associated with the occupation of the Tower nearby.

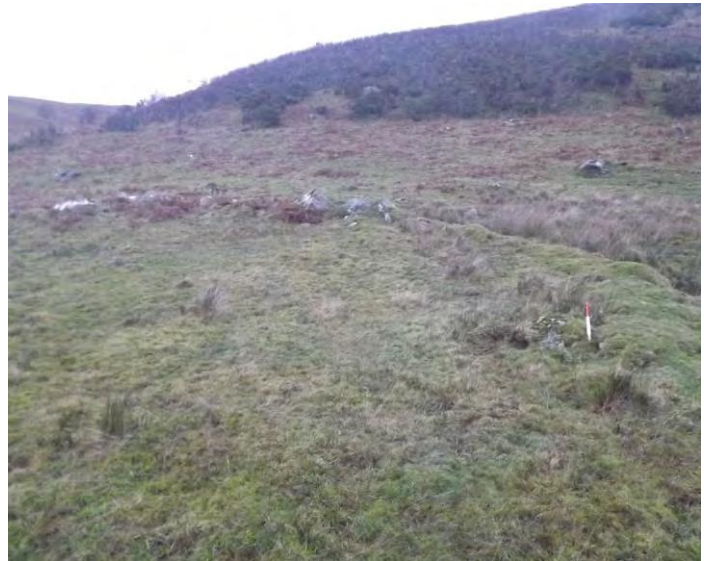
*Plate 9 A clear linear bank to the E of the Tower Burn as photographed during the topographic and walkover survey*

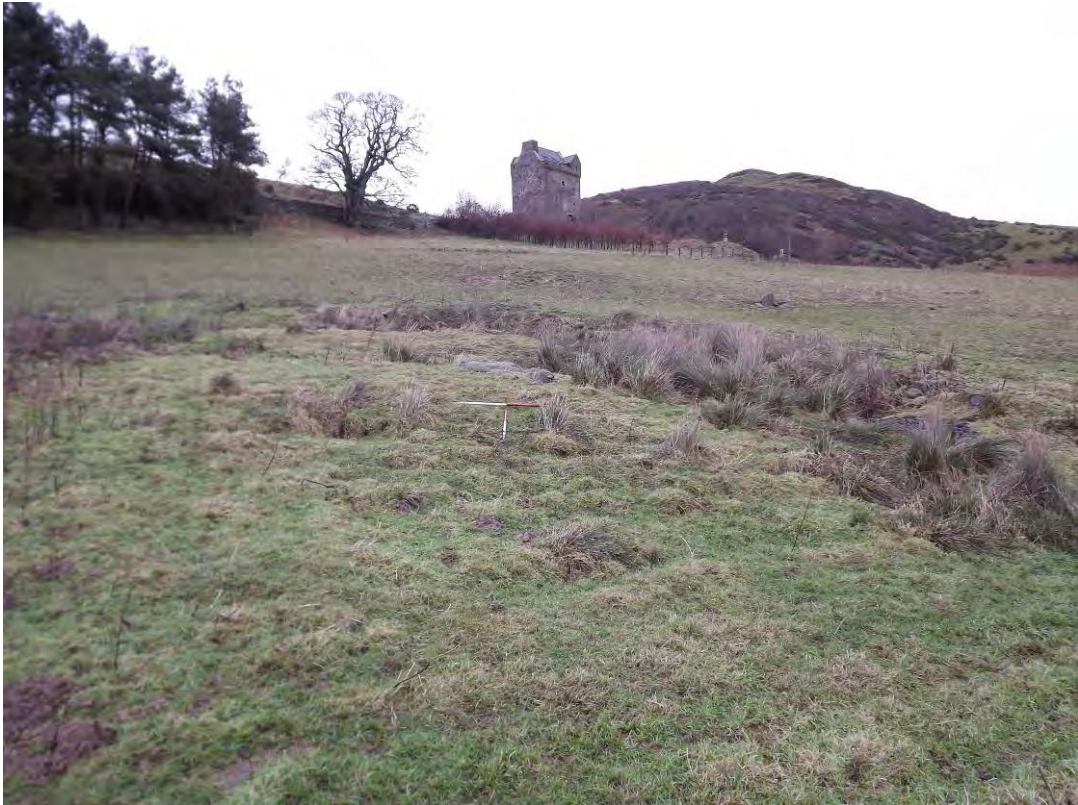
*Plate 10 Area A looking NE towards the castle as photographed during the topographic survey*

The feature recorded as Area A from the aerial photographs was assessed on the ground during the topographic walkover survey and whilst the function and nature of this remains unclear, the interpretation as an area of marshy ground with accumulated field clearance does seem applicable.

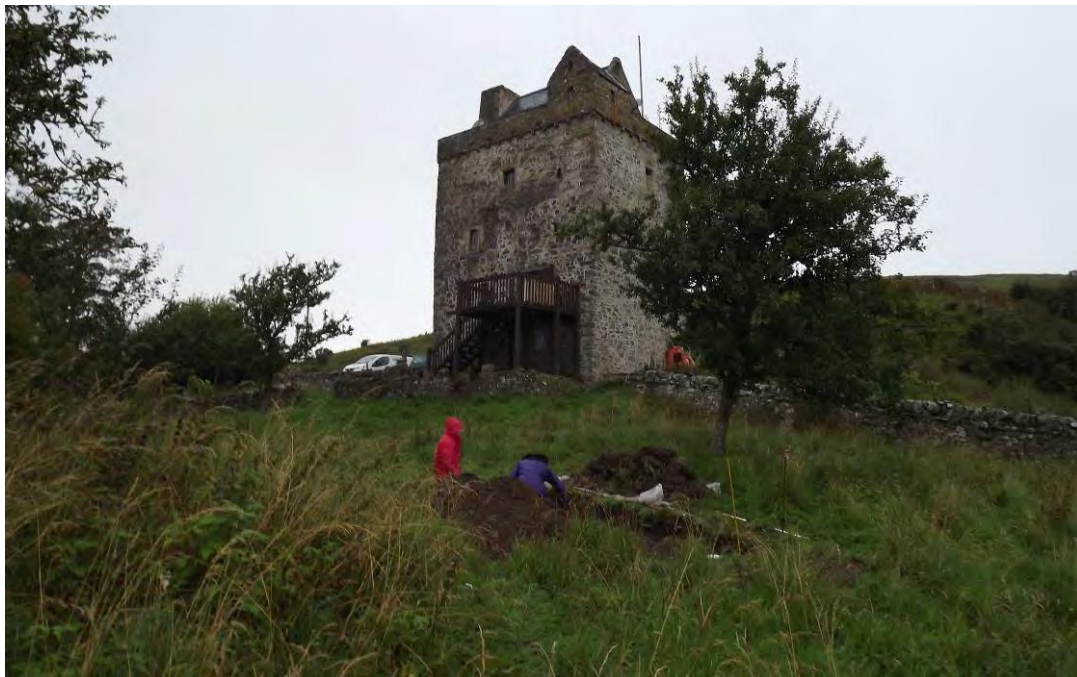
*Plate 11 Working shot looking NW and showing the location of Trench 1 (Photograph 088)*

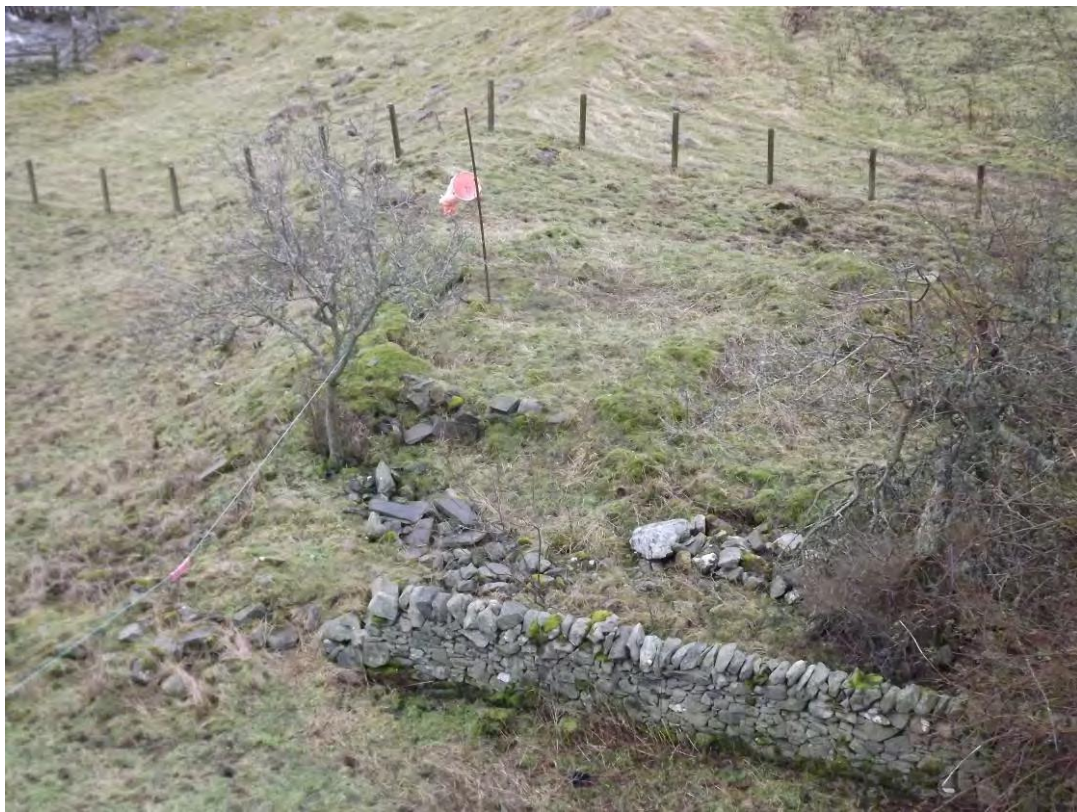
*Plate 12 View of the SE of corner of the 'barmkin' as taken from the Tower. Note Trench 2 was placed within the corners of the upstanding walls below the wind sock.*

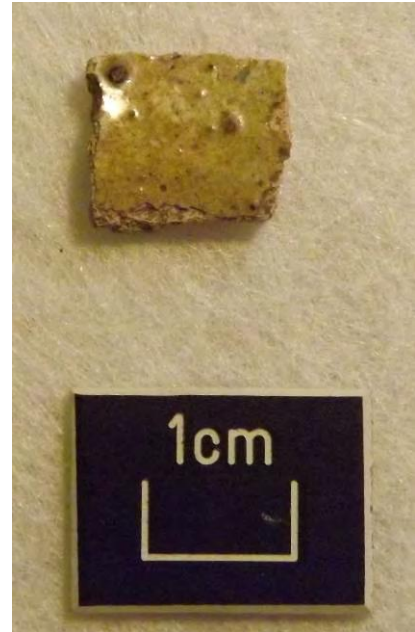
*Plate 14 SF003. The only  
medieval artefact from the  
excavation*

The vegetation growth and topsoil in Trench 2 was very tough and time-consuming to remove. The earlier excavation had been left open and had filled up with organic material to a significant degree. Removal of the accumulated turf and topsoil (201) revealed one small body sherd of medieval ceramic (SF003 - *Plate 14*), possibly of 14-15<sup>th</sup> century date, from a thin-walled vessel with a yellow-green lead glaze internally and externally. This small fragment may have been re-deposited by the earlier excavations in this area.

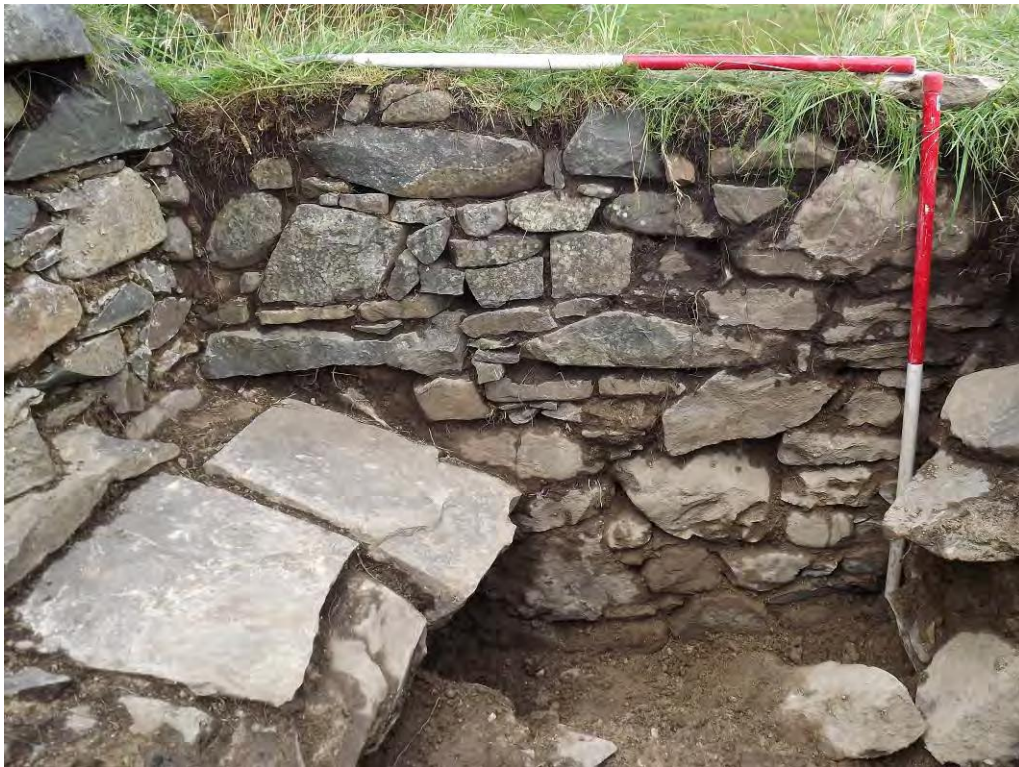
Plate 15 W facing elevation of {208} (Photograph 121)

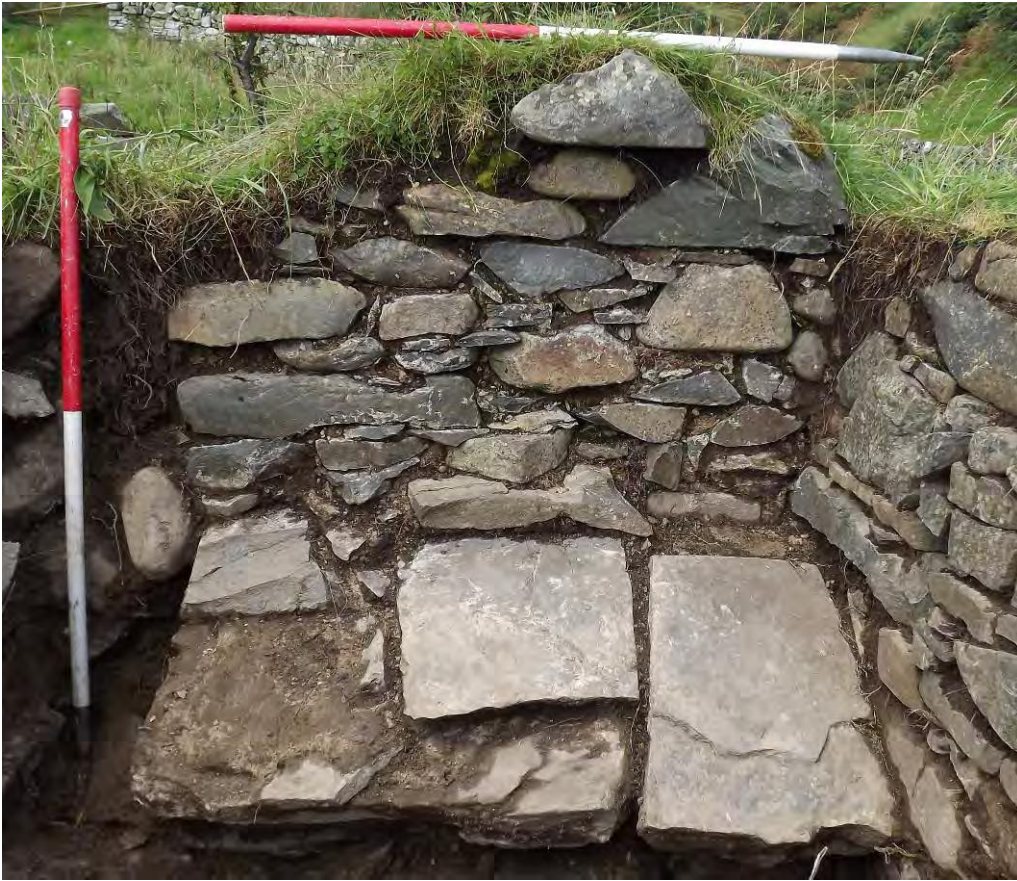
*Plate 16 S facing elevation of {208} with {209} at the base. Note the break, or possible opening in {208} to the left of the picture (Photograph 122)*

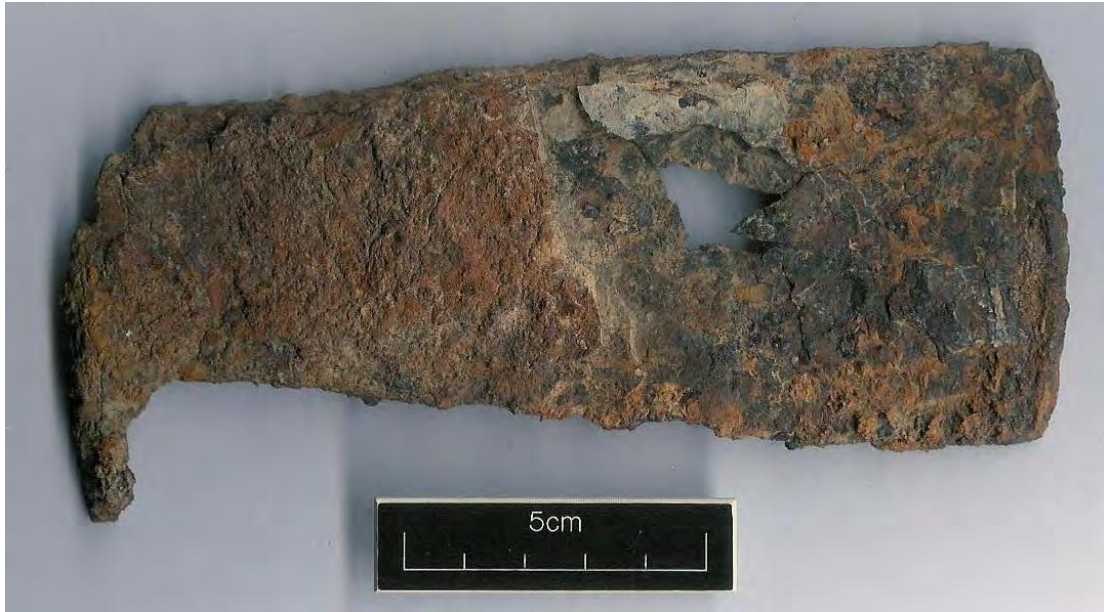
*Plate 17 Obverse of SF010*

Three fragments of ceramic (SF009) were recovered from (205), all of 19<sup>th</sup> century date. Of these a white stem from a pipe is marked 'T. WHITE & CO.' on one side and '...NS. CUTTY PIPE' on the (Plate 34). Thomas White & Co. of Edinburgh, a most prolific manufacturer, made pipes between 1823 and 1876. A further small-find, SF010, was a degraded Fe object recovered from (206), a flat panel, irregular in shape, splaying towards the end (Plate 17 and Plate 18).

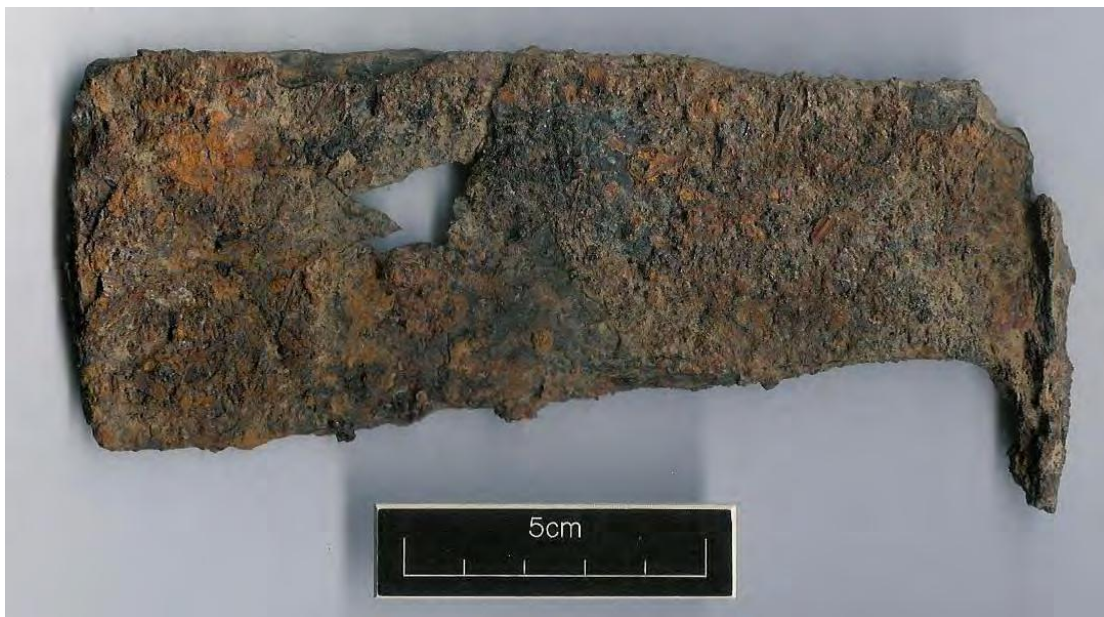
*Plate 18 Reverse of SF010*

The function of SF010 is unclear. It may be the head of some tool or implement, but may alternatively be structural, perhaps a *pintle*.

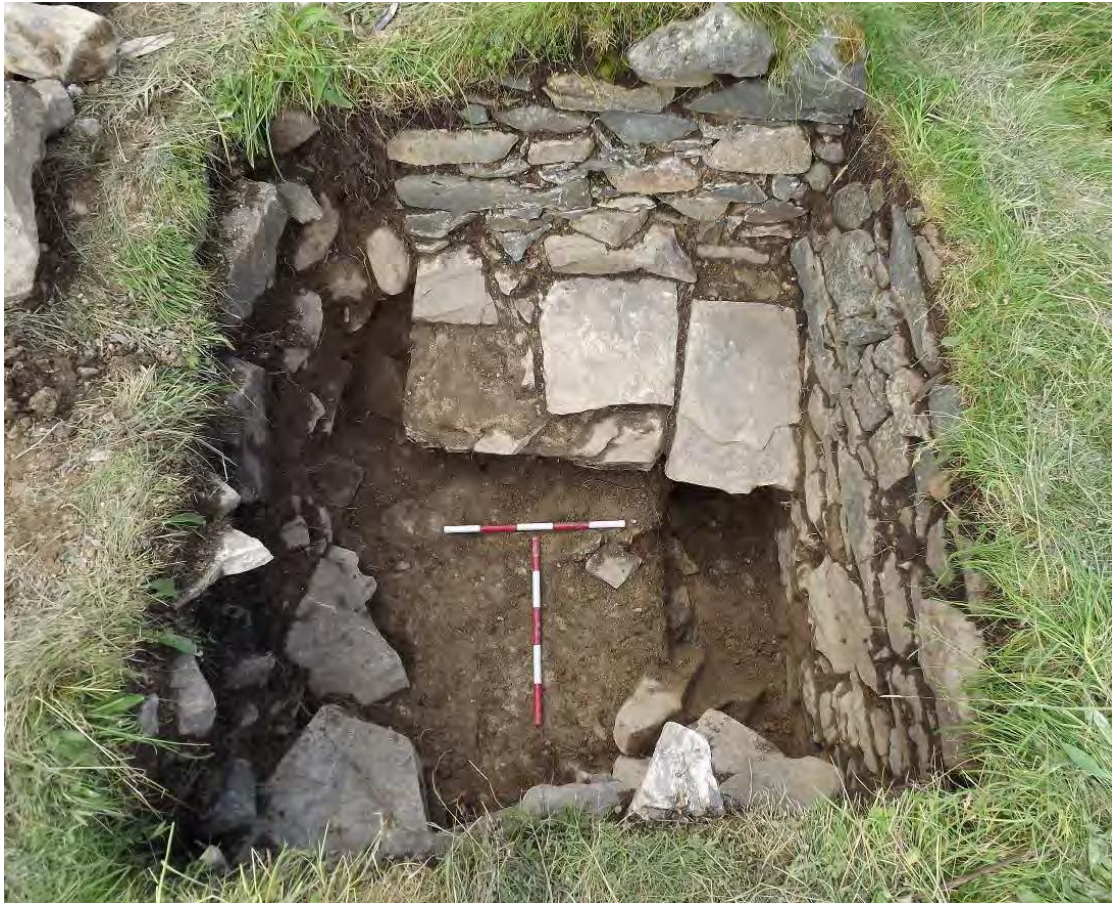
Plate 19 Post-excavation view of Trench 2 looking N (Photograph 119)

the S facing elevation of {208}, and sloping down from it at a pronounced angle. The easternmost slab abutted the E wall of {208}. Only a fragment of the western slab remained but its socket was still evident. From the curved profile and pronounced overhang of its S side (running down into the underlying (206) rubble fill), and its inclined top, it was evident the feature had formed a springing of an arched feature, probably a vault.

However the masonry baulk, and the {208} masonry of the N wall generally, terminated at a vertical face on its W side - neither continued into the E facing section of Trench 2, but stopped some c.0.45m short of the section. It seems likely that there had been an opening – an entrance or window - within the N wall at this point. Such a feature might have interrupted the ceiling of a vaulted cellar in this fashion.

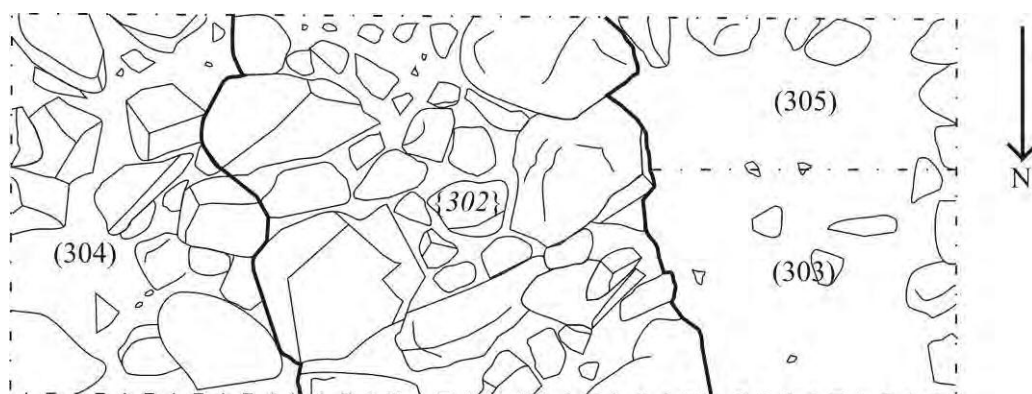
*Figure 18 Post-excavation plan of Trench 3. Reproduced at 1:20*

Removal of turf and topsoil (301) immediately revealed a significant volume of stones and the alignment of a large NNW-SSE orientated wall {302}. This was of dry-stone construction, built of medium to large angular field-stone boulders and smaller stones packed between the gaps. The *in situ* structure of the wall survived to only one course in height; its overall width was about 1.0m. The W facing elevation was well-defined while the eastern side had seen some tumble and slippage. The ground dropped significantly from here towards the burn to the east, and this side may have been further masked by a build-up of surrounding material.

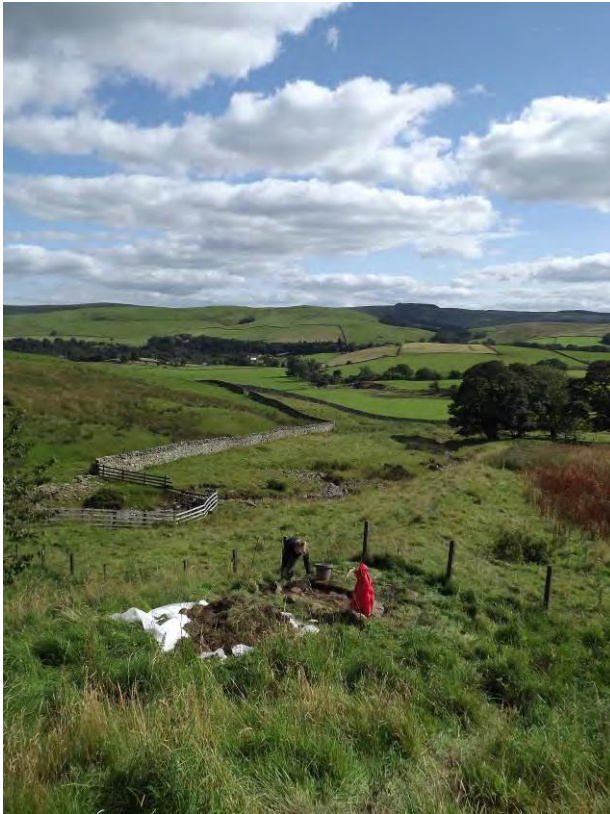
Plate 20 Working shot showing the location of Trench 3 (Photograph 110)

It is unclear to what extent archaeological remains of significance may continue outwith the limits of the Scheduled Monument and specifically into the area between the barmkin and the burn. Trench 3 was placed in order to gain some idea of the archaeological potential of this wider area. Specifically it targeted one of the visible features crossing this area, a substantial boundary structure. This ran from adjacent to the SE corner of the barmkin's south range in a NNW-SSE, located above the bank of the burn. It was hoped to ascertain whether this feature was of particular archaeological interest and how it may have related to the ruins associated with the tower. Trench 3 was positioned across the line of the feature. East-west aligned, the trench measured 2.50m by 1m; it achieved a final depth of around 0.40m.

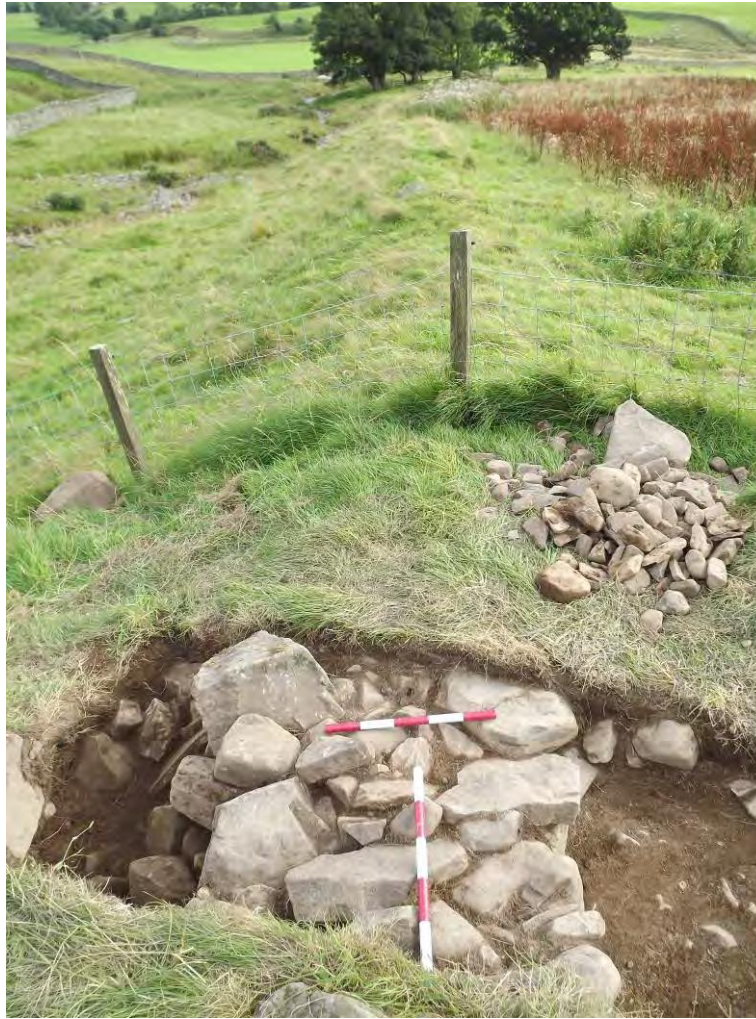
*Plate 22 Post-excavation view along the line of {302} looking SSE (Photograph 155)*
