# Kirkhope Tower

*Ettrickbridge, Scottish Borders*

*Archaeological Evaluation: August – September 2012*

### Data Structure Report

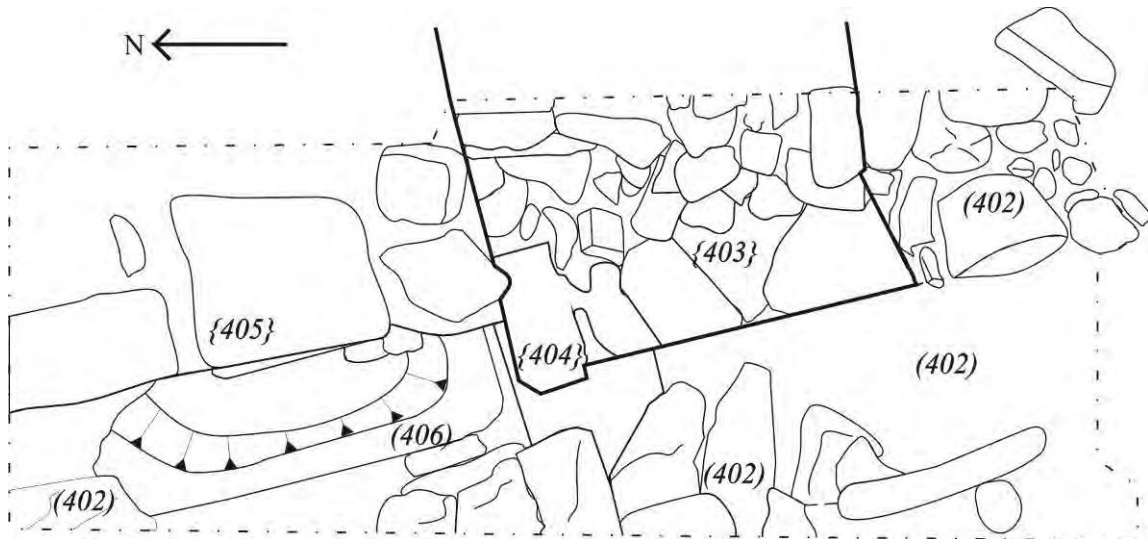
Figure 19 Post-excavation plan of Trench 4. Reproduced at 1:20

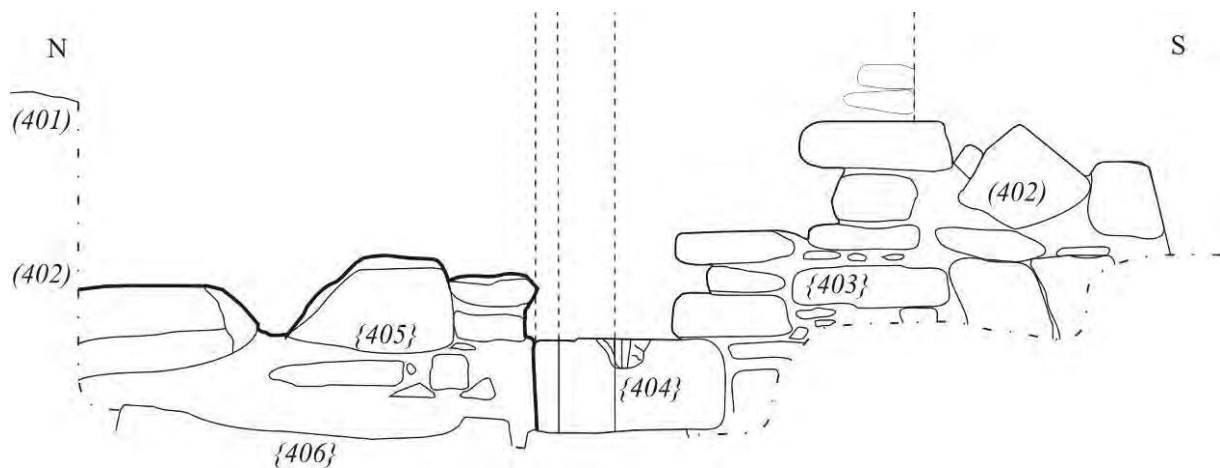
Figure 20 Profile across Trench 4 showing features. Reproduced at 1:20

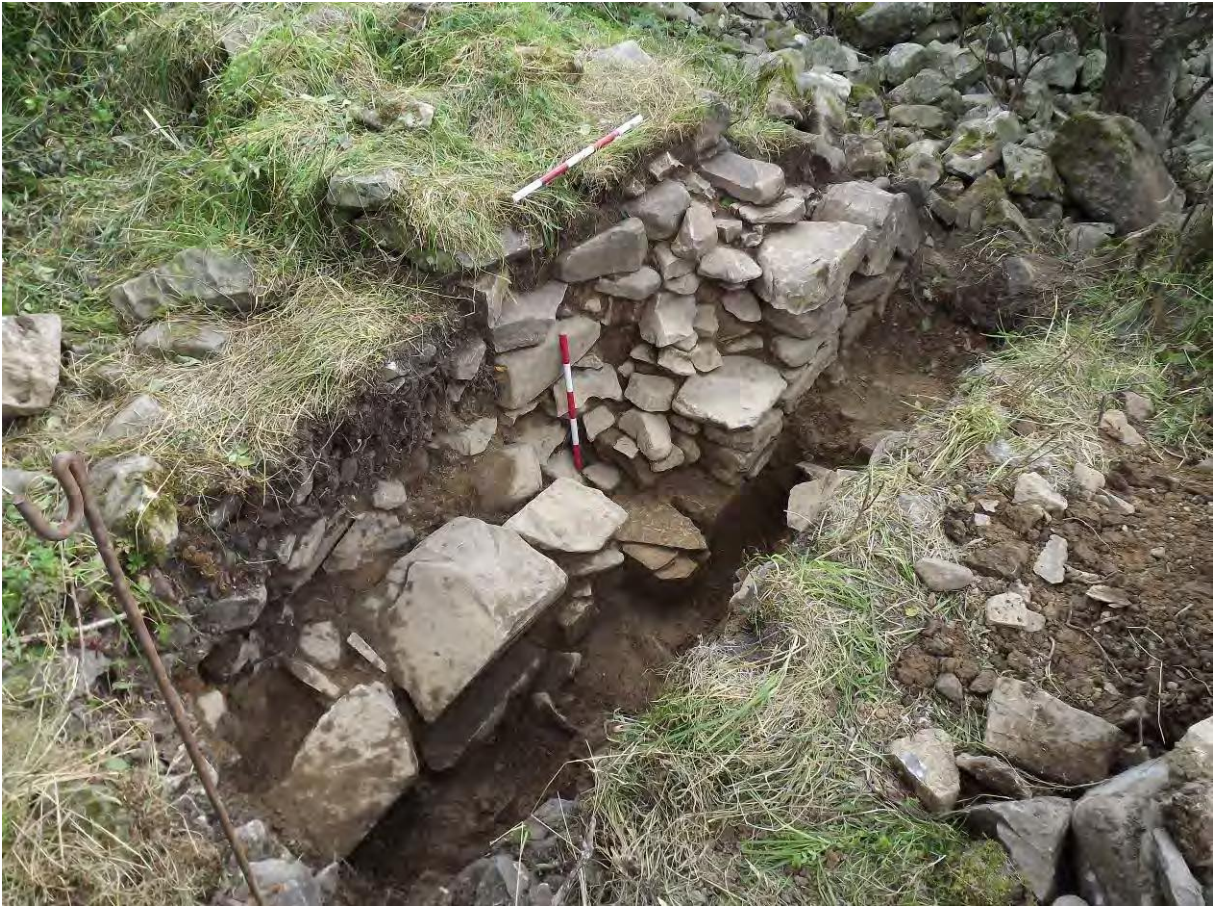
*Plate 23 Mid-excavation view looking SW across Trench 4. Note {405} running N-S in the bottom of the trench and abutting the chamfered door stone {404} (Photograph 178)*

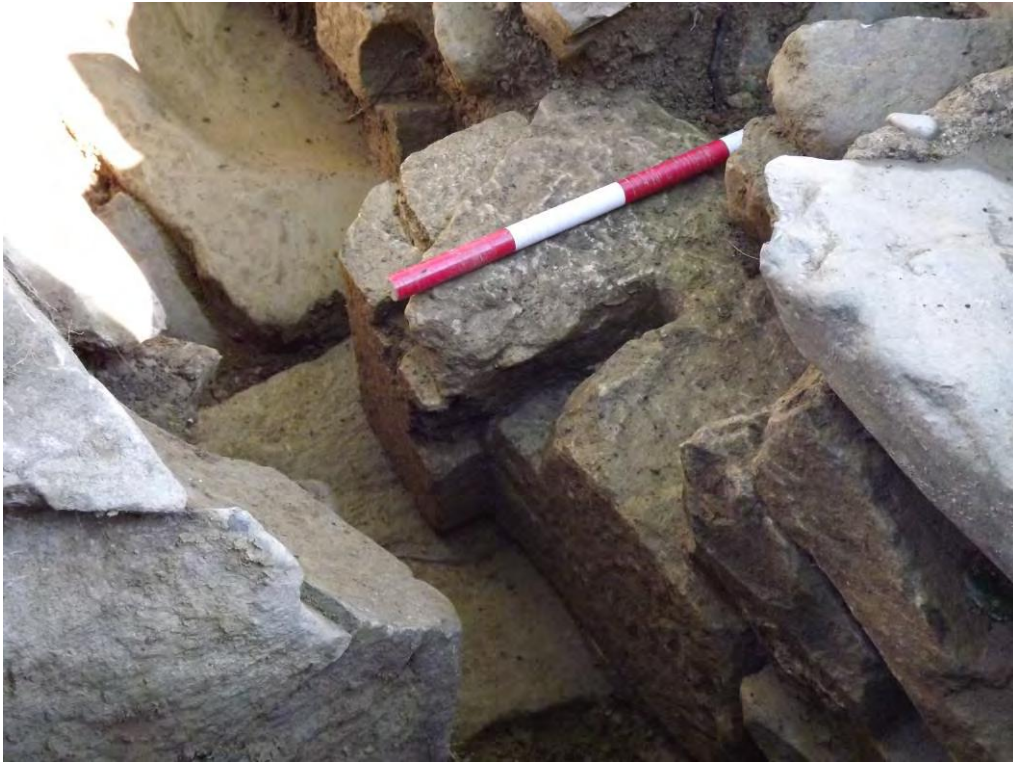
*Plate 24 Detail of chamfered stone {404} showing socket for a lower door pintle (Photograph 231)*

The wall alignment visible at the surface running W-E across the site and straddled by Trench 4 was not clearly definable during the initial stages of the excavation; however it was soon revealed, running for some 0.60m before terminating at a vertical face and, apparently, returning to the S. This wall {403} was lime mortar-bonded, faced externally and with a rubble core. Its NW angle was found to be much reduced/robbed. However at its base this angle retained a solitary dressing of cut sandstone, detailed with a chamfer and rebate within. It also preserved an iron-stained socket for a door pintle. This stone proved to be the lowest surviving jamb stone of an entrance, it sat directly atop a large W-E aligned threshold stone (Plate 24). Together these features were recorded as {404}.

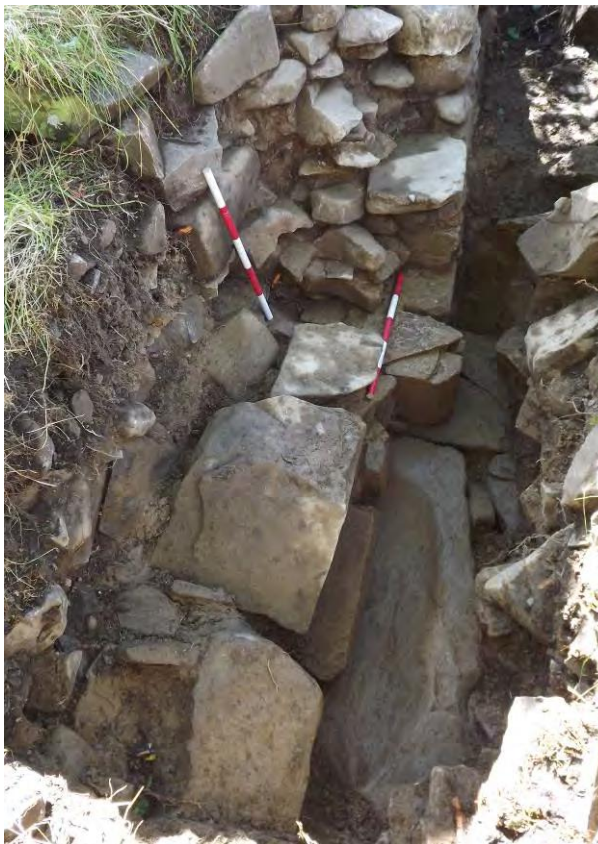
*Plate 25 Looking SSE across {405} to the robbed corner of {403} and {404}. Note the possible cobbled surface (406) with large hollowed stone 'trough' (Photograph 225)*

The roots in Trench 4 were shown to be deep and intrusive although little apparent damage was being caused to the lime bonded masonry by those recorded, *plate 25*.

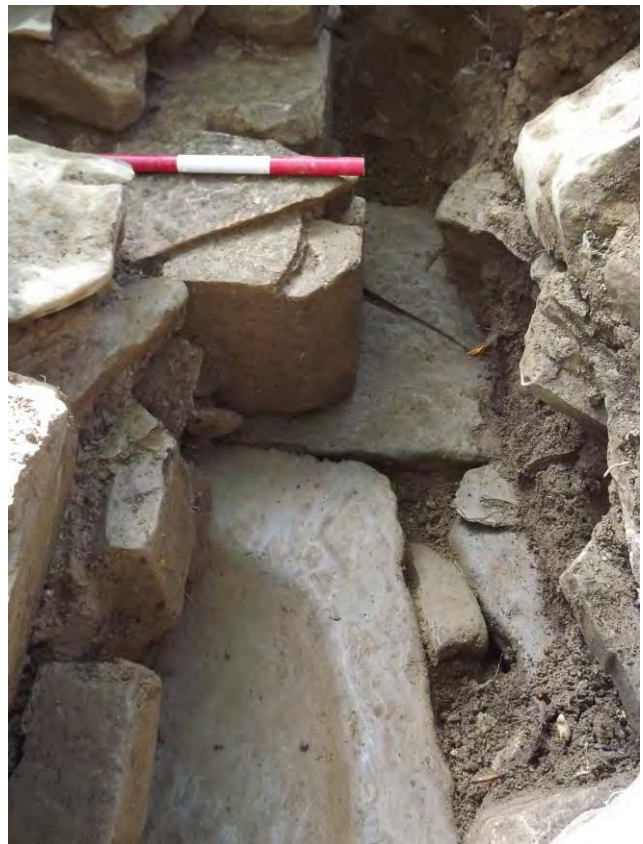
*Plate 26 Detail of worked chamfer {404} and surface (406) (Photograph 229)*

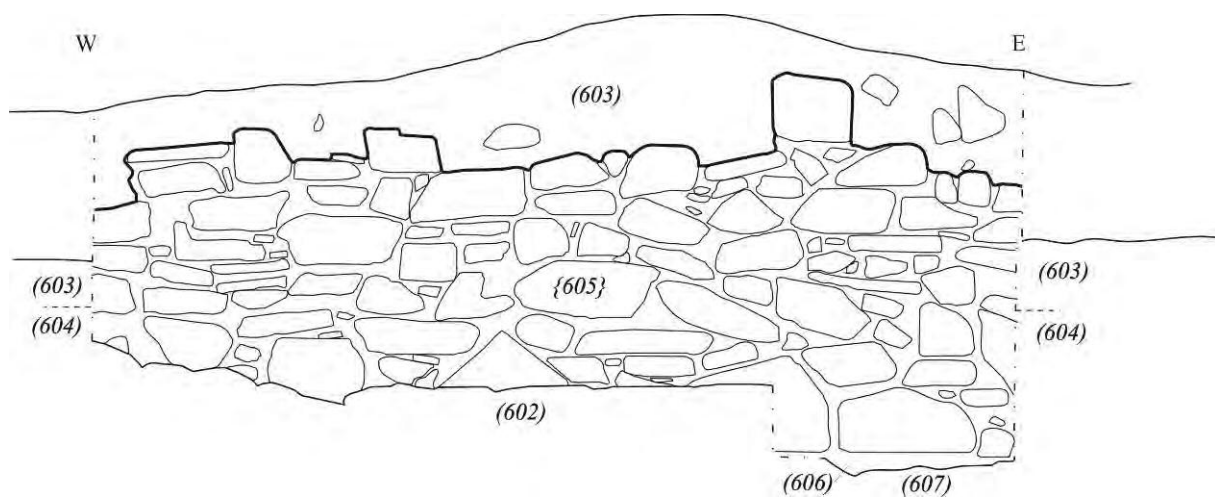
Figure 21 Scale drawing of the S facing section/elevation of Trench 6. Reproduced at 1:20.

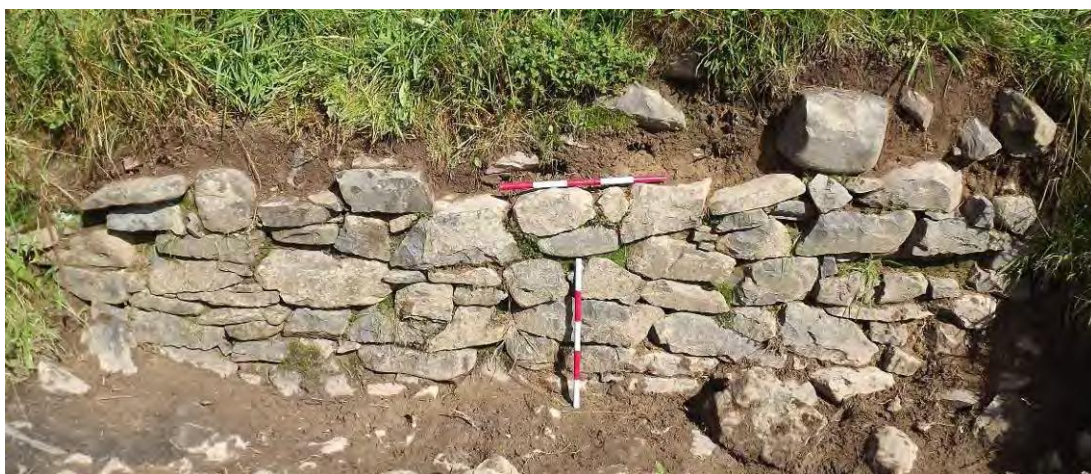
Plate 28 S facing elevation of {605} (Photograph 029)

Below (604), a very disturbed layer of humic silt was visible and recorded as (606). 0.05-0.10m deep, (606) included numerous small rubble stones pressed within, although the relationship with upstanding wall {605} was not clear. {605} was constructed from sub-rectangular whin boulders bonded with clay. The foundation course consisted of much larger stones which were in turn placed directly upon the natural subsoil (607).

The excavation of Trench 6 showed that the earlier investigation had not gone deep enough to reveal the foundation structure of the upstanding wall. (604) was clearly a deposit of demolition and collapse and removal of this showed the upstanding {605} walling to be built directly atop the natural subsoil; no evidence existed for a foundation trench. It seems likely that prior to constructing the rear wall of the range, an attempt was made to rectify the issues caused by the sloping nature of the site and a terrace was dug into the slope. The S wall of the range was then constructed upon the southern edge of the terrace.

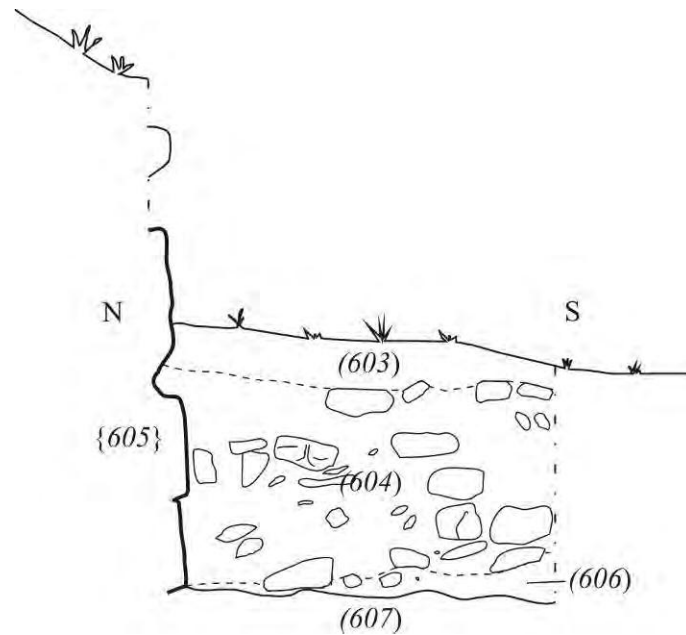
Figure 22 W facing section/elevation of Trench 6. Reproduced at 1:20.

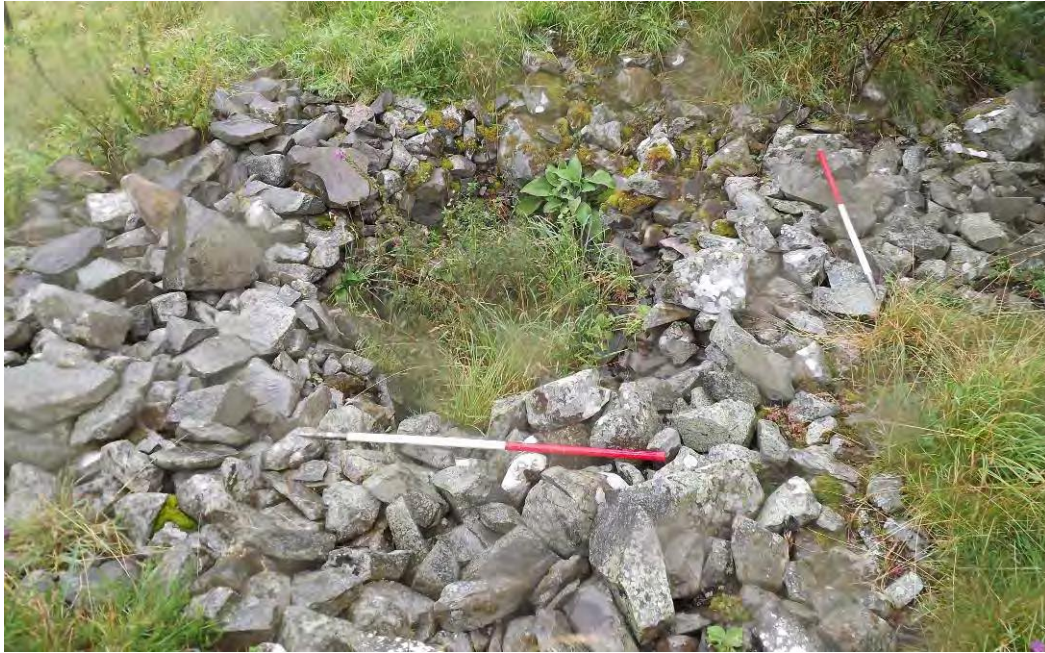
*Plate 29 Pre-excavation view of Trench 7 looking SW and showing the earlier investigation  
(Photograph 015)*

The placement of Trench 7 was dictated by the presence of an earlier investigation that had taken place towards the western end of the S range. This earlier investigation seemed to have been excavated through an area dominated by loose demolition rubble, though many of the stones spread around the surface of this area were undoubtedly spoil from this earlier excavation.

The intended purpose of re-excavating at this point was to assess whether this earlier investigation had caused damage to the buried remains of the range and, hopefully, to recover further details of its construction. It was also hoped to assess the depth of potentially damaging root intrusion.

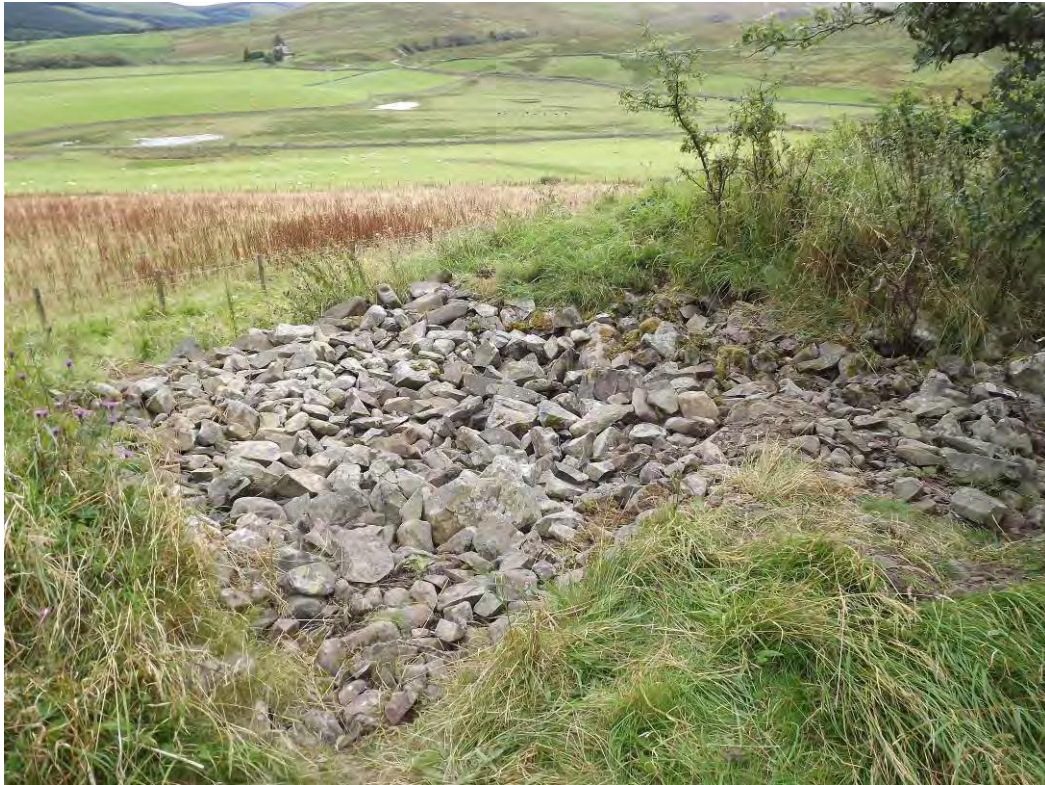
*Plate 30 Post-excavation view of Trench 7 (Photograph 247)*

Subsequently Trench 7 measured c.1.5m<sup>2</sup>, although the edges and sections of the Trench were very difficult to maintain as they consisted almost wholly of small to large angular stones and were prone to tumble. The final depth of Trench 7 was c.1.20m, this was <0.50m deeper than the original excavation after removal of the covering vegetation.

The accumulated vegetation and detritus built up since the earlier investigation occurred was removed and the edges of the trench cleaned. This revealed no features of note and indicated the earlier investigation had been placed in an arbitrary location and had been abandoned with no significant archaeological features noted.

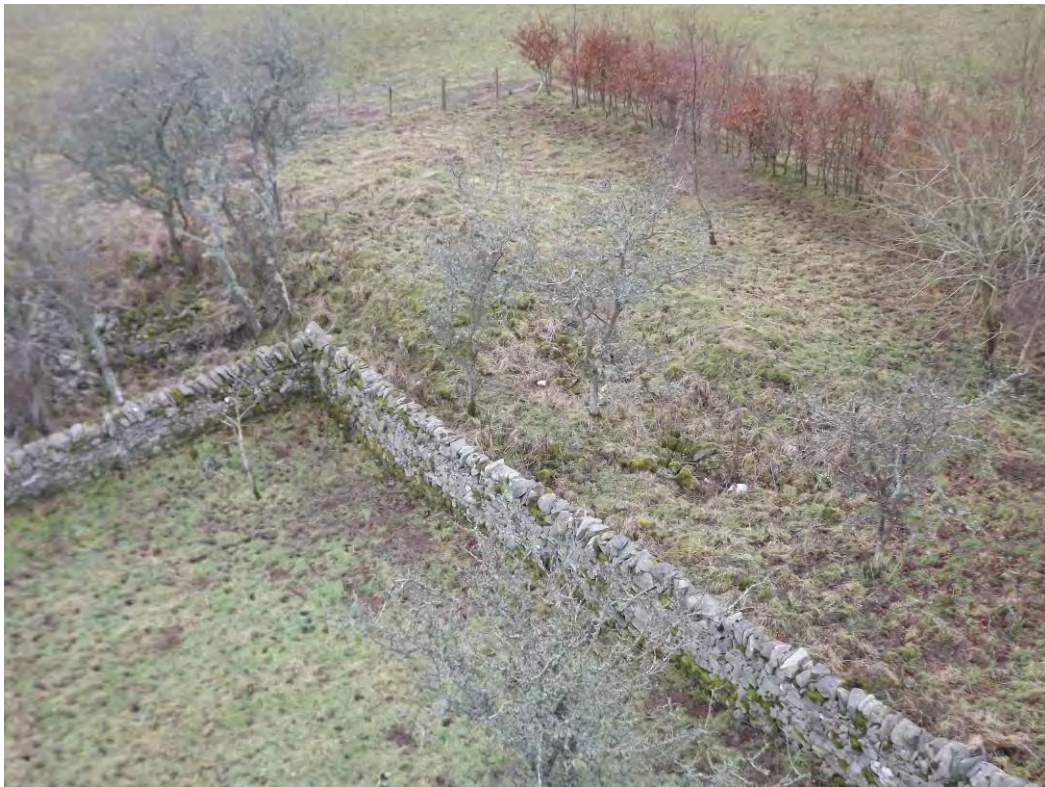
*Plate 31 View looking SW from Kirkhope Tower across the W range of the ruined barmkin. Note Trench 8 was placed N of the two trees in the centre of the image*

Trench 8 was intended to confirm details of the W perimeter of the courtyard complex, sampling internal and external ground levels and providing further information as to the character, function and survival of this, presumably a range of ancillary chambers, and whether occupation deposits survived within. The proximity of the upstanding dry-stone field wall to the immediate E of the trench meant it was unlikely that a substantial portion of the courtyard interior would be revealed, although it was hoped that some indication as to the make-up of this would be uncovered. Trench 8 measured 4m W-E by 1m N-S and was excavated to a maximum final depth of <1.20m.

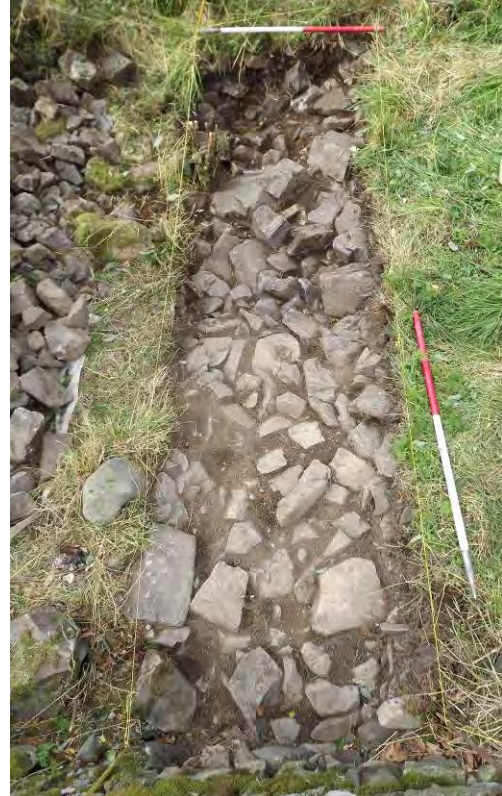
*Plate 33 Mid-excavation view of Trench 8 post-removal of (801) (Photograph 208)*

(802) was revealed beneath (801), consisting almost wholly of large angular stones with a very small proportion of a mid to dark brown sandy silt matrix – similar to the overlying topsoil; this deposit was around 0.25m deep. (802) was removed slowly and systematically in order to identify any visible walls or features within, yet none were located at this stage.

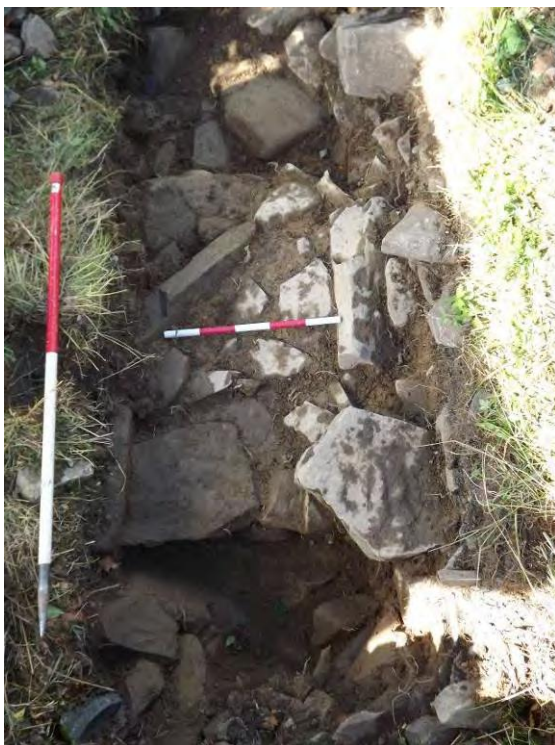
Plate 35 Post-excavation view looking vertical and to the W towards wall {804} (Photograph 233)

However, as suggested by the topography of the site, removal of (802) revealed a large N-S aligned wall {804} (Figure 23) at the eastern end of the Trench. The surrounding (803) was interpreted as the first *in situ* demolition deposit and contained a high percentage of small to large angular boulders set within very firmly compact pale brown silty clay – likely *ex situ* wall bonding material. The volume of these stones made defining the faces of the {804} walling problematic. With the continuing removal of (803) the E face was fully defined, showing the walling at this point to survive to at least three courses.

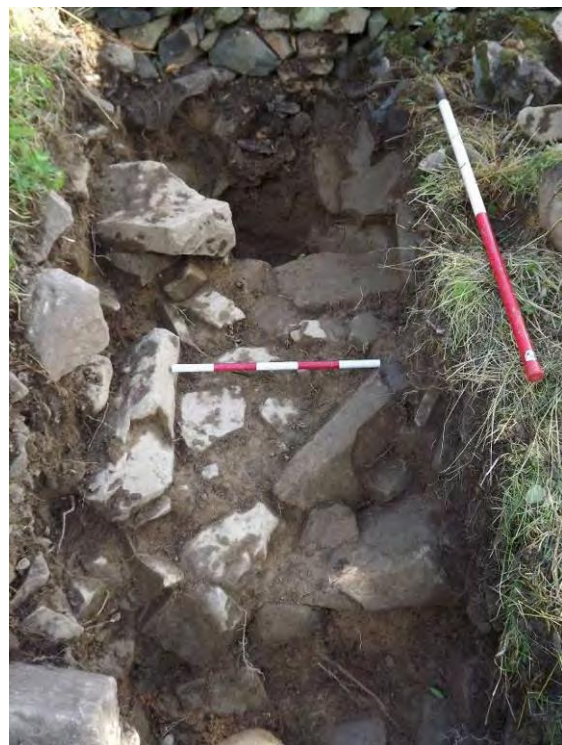
Plate 36 Looking E across the problematic face of {804} (Photograph 234)

Locating the western face of the walling proved more problematic and, although an apparent face was partly defined it is possible this had seen some disturbance. However this apparent face did correspond to sections of the same walling still visible at the surface nearby, this confirming the wall thickness to have been around 1m in width. When this dimension was plotted against {804} one large stone protruding from the southern baulk seemed to be in the correct alignment and location to be part of the W face, Plate 37. The undisturbed walling clearly retained areas of clay bonding.

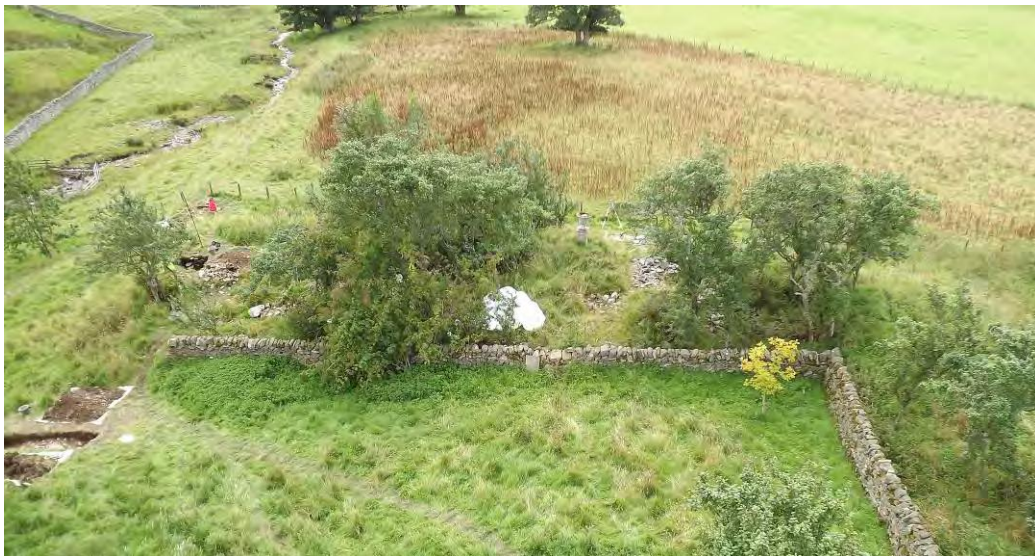
Plate 38 View S across the scheduled area from the battlements of Kirkhope Tower (Photograph 099)

The site is currently heavily overgrown (Plate 38 and Plate 39) with a 'lawn' area of long grass bordered by a perimeter of wild grasses, scrub and trees of varying ages to the S and W. At the southern side in particular a number of mature blackthorn and/or sloe trees proliferate. Located within the southern range of the barmkin, and in immediate proximity to clear wall alignments, these trees were of particular concern regarding any impact on the buried archaeological remains.

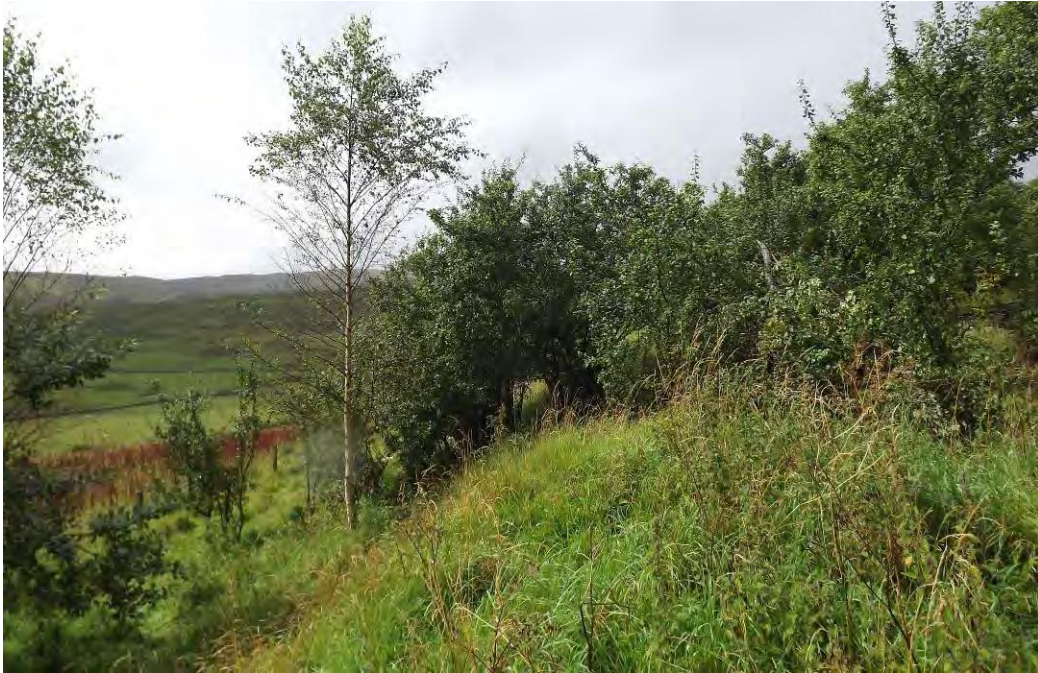
*Plate 39 Looking W across the S wall of the 'barmkin' compound (Photograph 069)*

This was especially true in the area of Trench 4, where there exists a thicket of five or six blackthorn trees. In addition, the visible wall alignments around Trench 4 showed these trees to be located adjacent to *in situ* archaeological remains and within the footprint of the S range.

However, although excavation of Trench 4 revealed significant root intrusion throughout the collapsed rubble infill, this was confined to the upper c.0.30m of the trench, where the leaf litter and humic soil was richest and most conducive to promoting the growth of the roots. The depth and density of the rubble collapse served to protect any underlying archaeological deposits from damage caused by bioturbation.

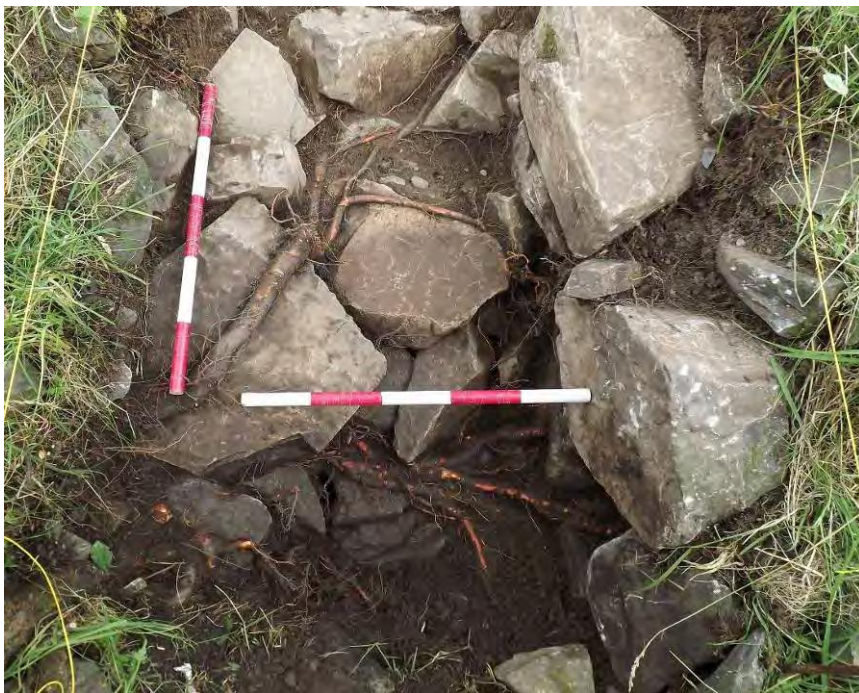
*Plate 40 Evidence of root intrusion within Trench 4 (Photograph 135)*

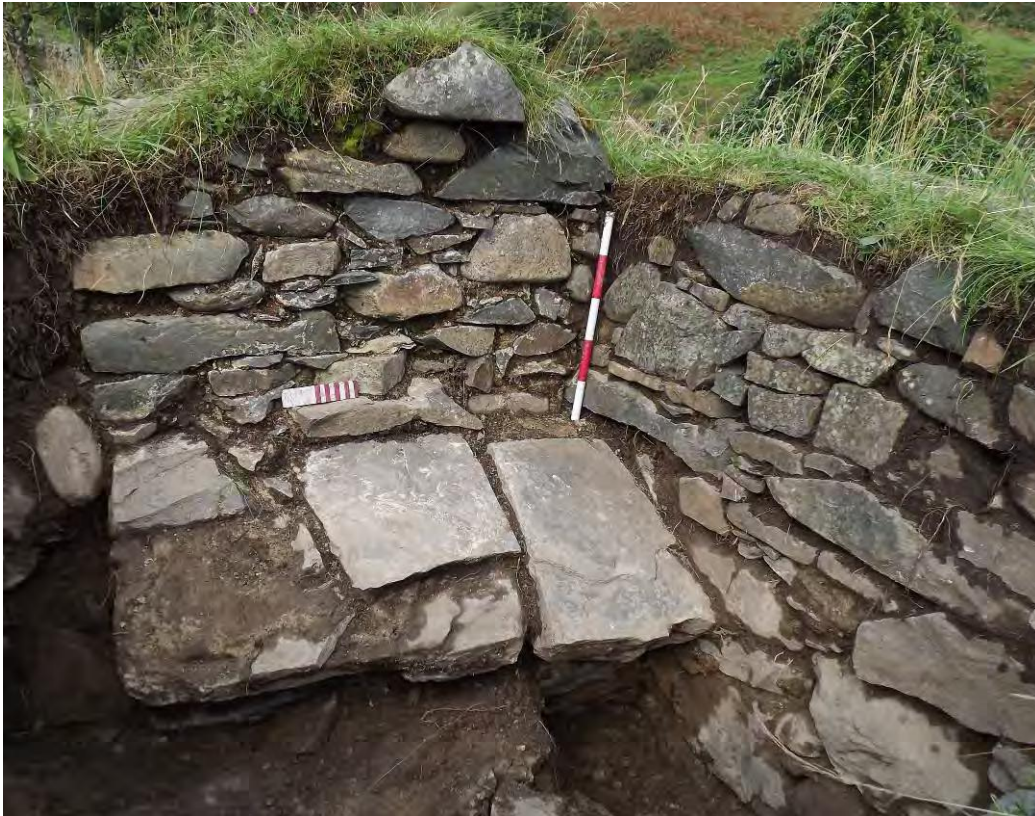
*Plate 41 S and W facing elevations of Trench 2 showing condition of {208} (Photograph 130)*

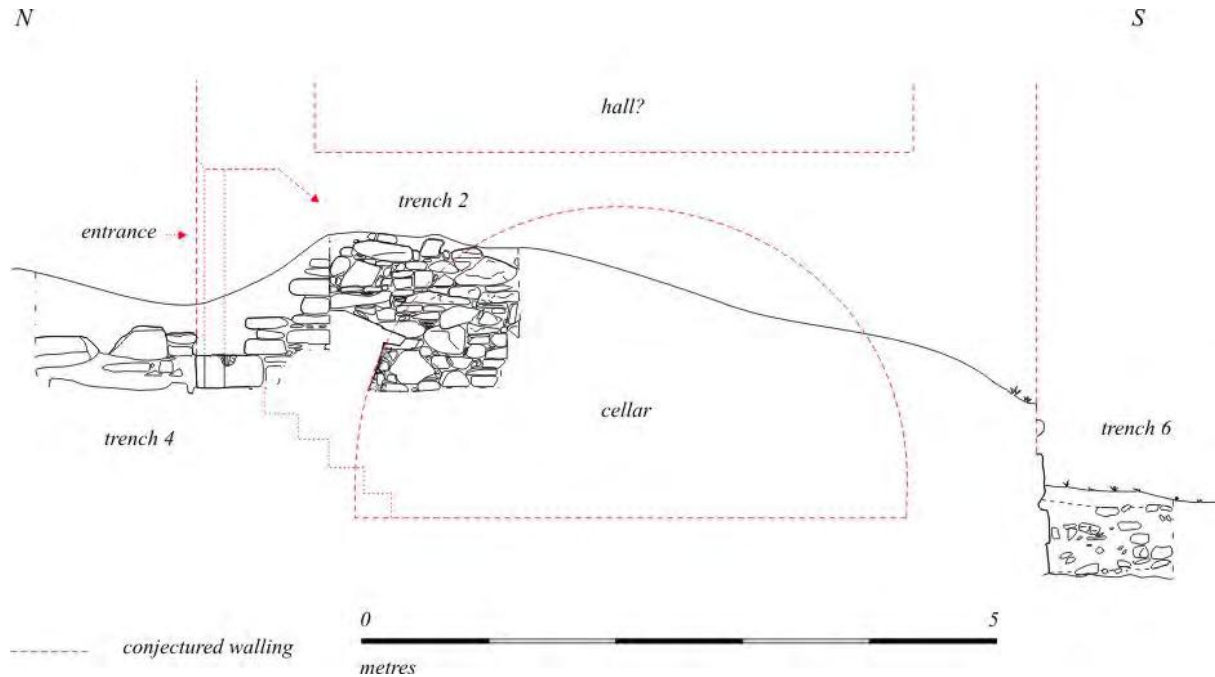
Figure 24 Composite north-south section across the south range combining the evidence revealed in trenches 2, 4 and 6, and showing projected walling of superstructure.

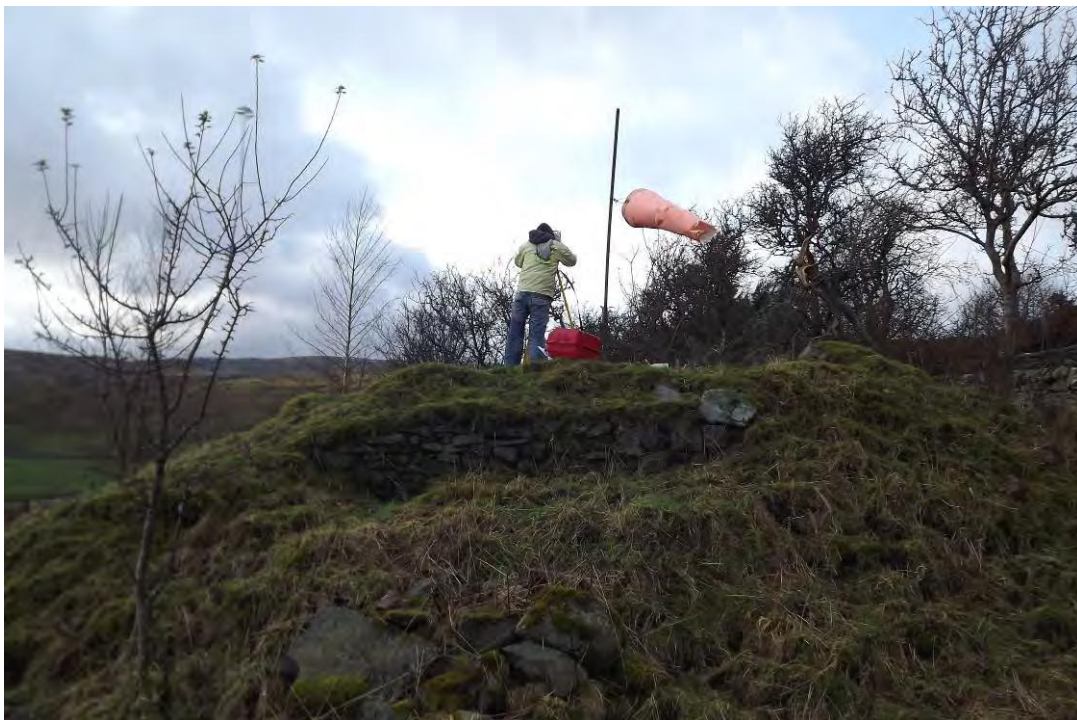
*Plate 1 Rubble scarped back from the SE corner of the ‘barmkin’*

The topographic survey of the site revealed a number of apparent past investigations of the site, in the area within the S range of the ‘barmkin’. It is also clear that some volume of soil and rubble has been scarped back from the E facing external elevation in the SE corner of the compound and possibly also the S wall.

These small investigations seem not to have been backfilled, leaving wall faces and possibly features exposed and, possibly, in danger of further degradation.

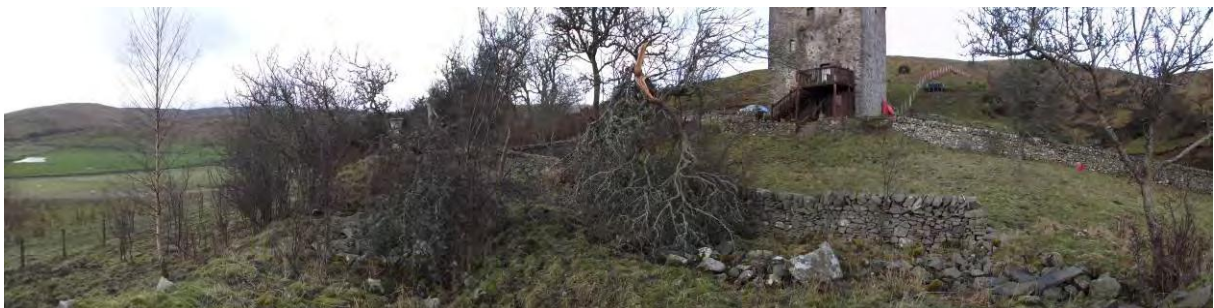
*Plate 6 Panoramic view looking NW across the courtyard S of Kirkhope Tower. Note the heavy tree / scrub cover in the S range*

As can be seen from Plates 6, 7 and 8, tree and vegetation cover across the Scheduled Monument is extensive and intrusive. Trees are tending to grow adjacent to upstanding walls and foundations, and as the trees mature, there is significant potential for the roots of these to disrupt and damage the archaeological remains. This is especially concerning as the visible walls of the 'barmkin' appear to be of clay bonded construction.

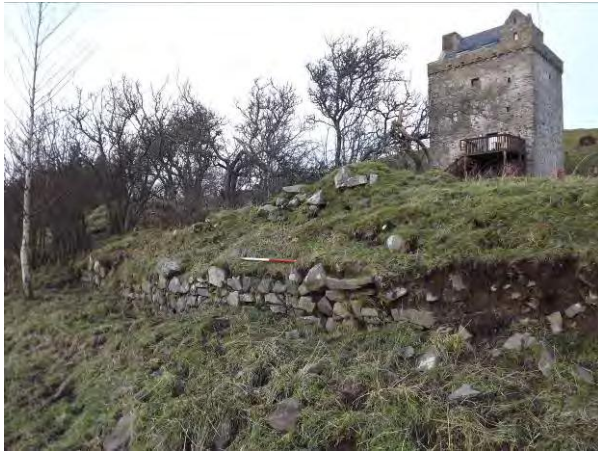
*Plate 7 View looking NW towards Kirkhope Tower, showing extent of vegetation cover and the cleared face of the southern wall. Note the damage to the wall in the foreground.*

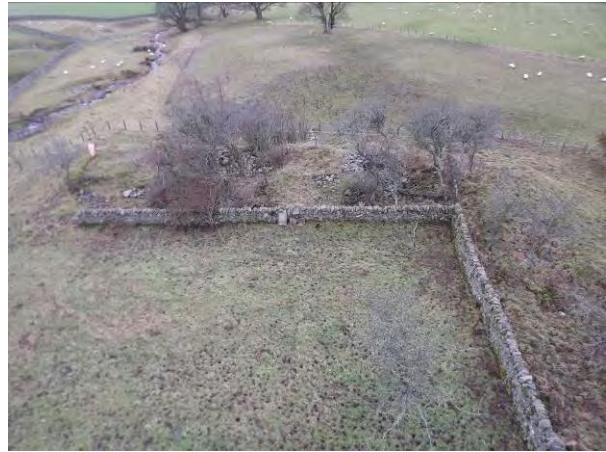
*Plate 8 View looking S from Kirkhope Tower showing tree and vegetation cover within the S range*

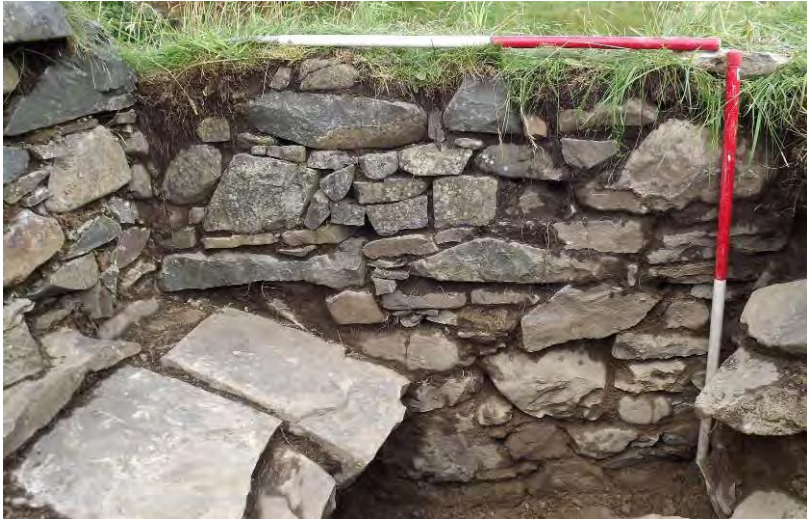
Good	<p>Upstanding walls of split whinstone with no obvious signs of bonding.</p> <p>Some small sections of walling survive above ground but these show minimal indication of weathering and are generally protected by overlying turf.</p> <p>Re-instatement of Trench 2 allowed earth to be placed against these upstanding areas of walling, further protecting them from the elements.</p>
209

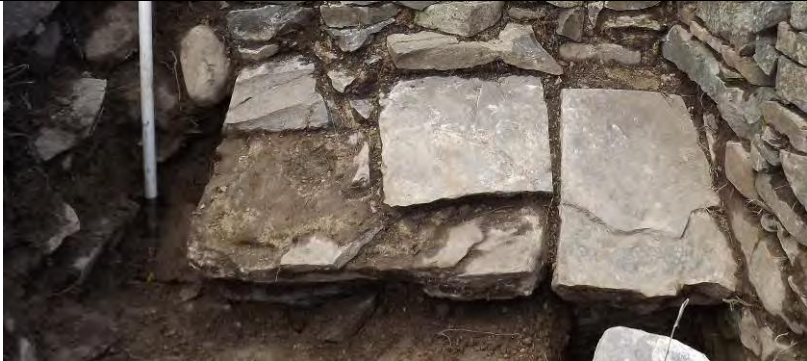
Excellent	<p>Mortar bonded arch springing constructed as part of {208}.</p> <p>Very firmly bonded.</p>

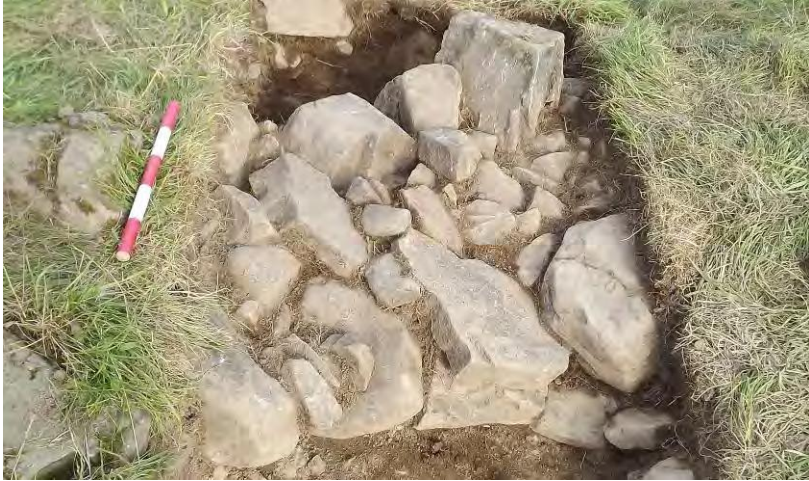
302

Good	<p>Large drystone wall of irregular boulders.</p> <p>One course surviving protected by a layer of turf and vegetation (primarily grass).</p> <p>Stable/</p>
403

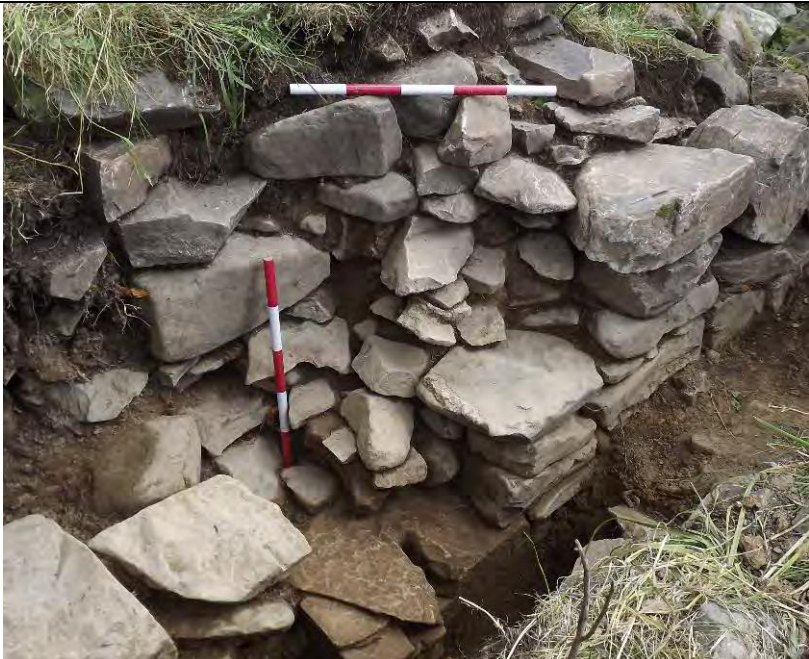
Excellent	<p>Substantial wall of lime bonded rubble stone.</p> <p>Alignment clearly visible above ground, yet very little stonework visible. Wall capped by a protective turf and vegetation layer.</p>

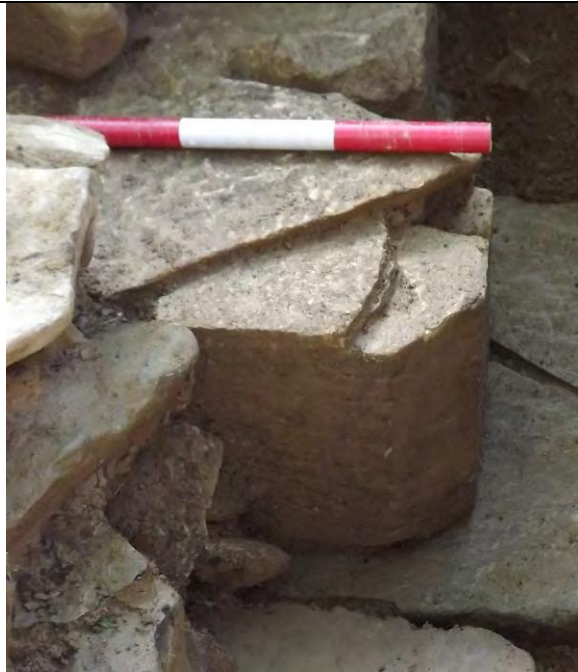
404

Excellent	<p>Carved sandstone block with chamfer and socket for bottom pintle of door.</p> <p>Bottom carved jamb stone of entranceway. Protected by significant rubble and demolition build up and in no danger of removal or deterioration.</p>

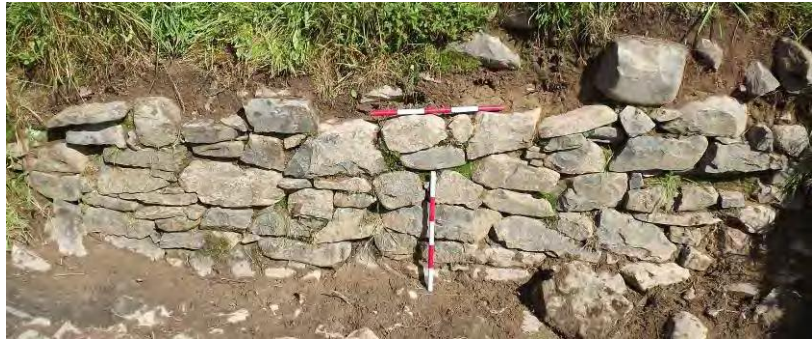
Good	<p>W-E aligned upstanding wall of clay bonded sub-rectangular whin boulders.</p> <p>This is the only area of walling on the site significantly exposed to the elements by historic excavation and topography. There is also potential for pressure upon the wall from the rubble build up behind. Despite this {605} appears in good condition with little obvious signs of deterioration.</p>
804

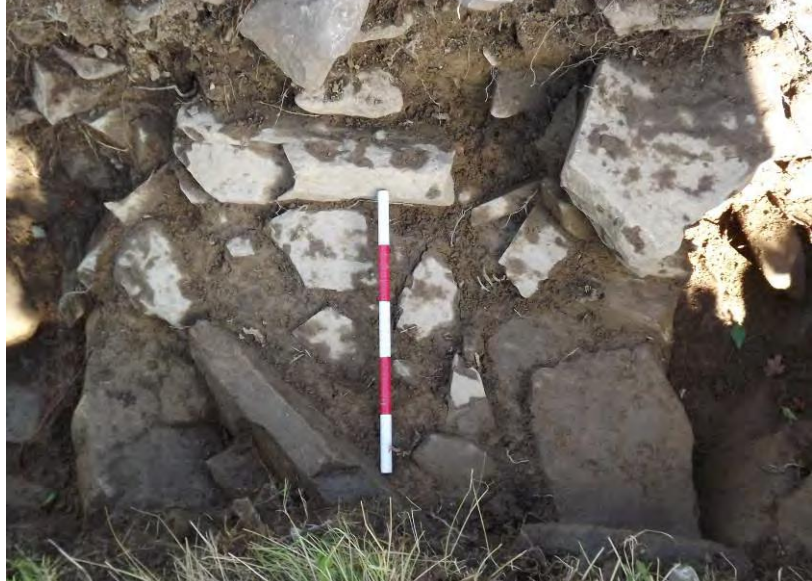
Excellent	<p>N-S aligned clay bonded masonry wall.</p> <p>Bonding material is strong and the main body of the wall protected by a build up of rubble and vegetation.</p>
