# Ninebanks Tower

*Ninebanks, Northumberland*

Historic Building Survey: Data Structure Report

North Pennines AONB Partnership

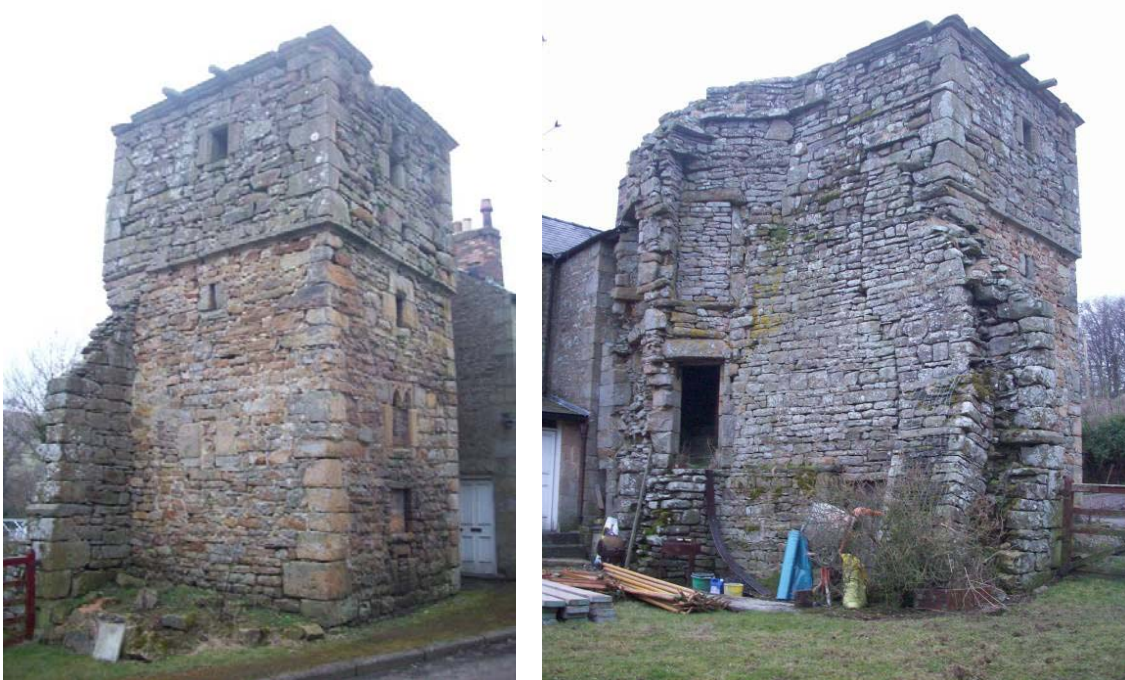
Ninebanks Tower consists of the major surviving fragment of a once-extensive mansion house that may originally have been of semi-fortified character (*plates 1* and *2*). Centred on NY 78204 53201, the fragment consists of a single tower, approximately square in plan and of three stories that appears to have projected from the SE angle of the former building. At its own NW angle the tower contains a stone turnpike stair that rises to parapet level.

*Plates 1 and 2: General views of the exterior of the tower from SE and SW*

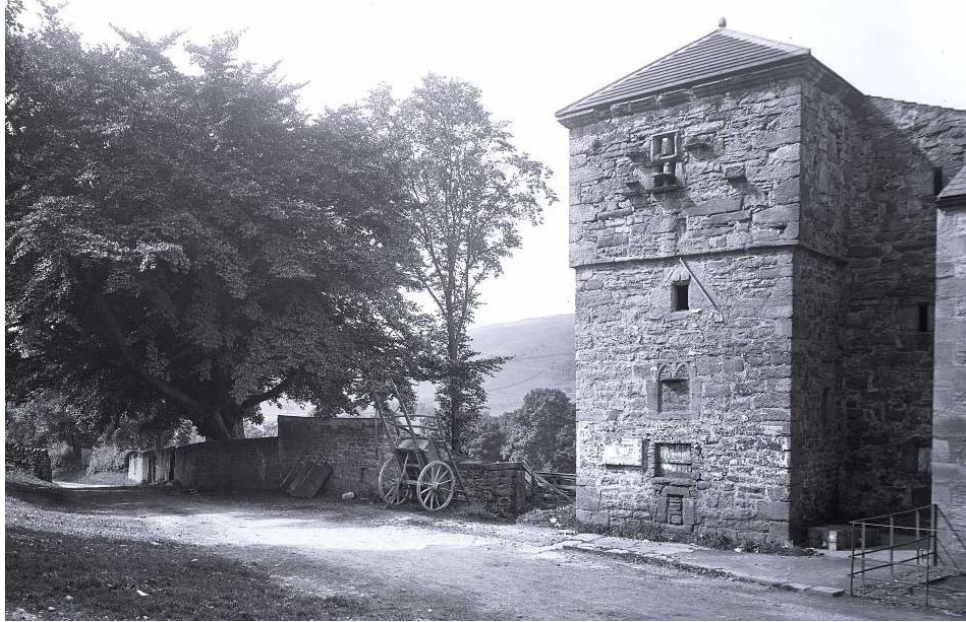
One other early source was a photograph of later 19<sup>th</sup> century or early 20<sup>th</sup> century date, taken from the NE and showing the N and E sides of the tower, *plate 3*. The principal interest of this image is that at that stage the tower was surmounted by a slated roof of low pyramidal profile, evidently of comparatively recent date when the photograph was taken. Otherwise the tower seems to be much as it is today.

*Plate 3 Detail from early photograph showing Ninebanks tower roofed.  
(courtesy of the National Record Office – NRO 1876-F-3429)*

All that can be surmised regarding the date of this image is that it was taken after c.1867 as the buildings present today to the N of the tower were constructed between the production of the First Edition OS map in that year (*figure 2*), and the Second Revision in 1897 (*figure 3*).

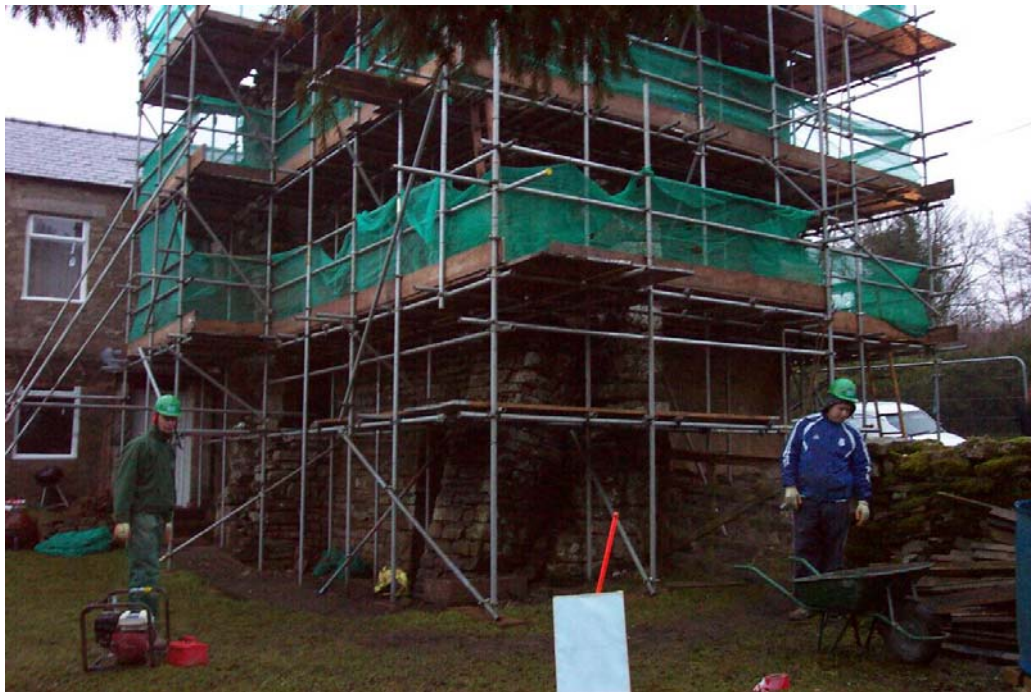
Survey work on site benefited from scaffolding access during the on-going repair works, *plate 4*. Site survey was undertaken by Kenneth Macfadyen on 25/01/09, 26/03/09 and 13/05/09. The existing rectified photographic survey proved to be of limited accuracy once the resulting drawing set was re-checked on site. Some attempt was made to remedy the distortion through correction on site (see individual notes on drawings).

*Plate 4 View of consolidation work on site from the SW*

The conservation repairs to the tower were generally restricted to localised re-pointing. More extensive works, requiring an archaeological monitoring presence, included the clearance of debris from within the tower interior (particularly to identify significant carved stones or early architectural materials that may have fallen within), and the repair and re-bedding of the dressings at the existing wall head of the tower.

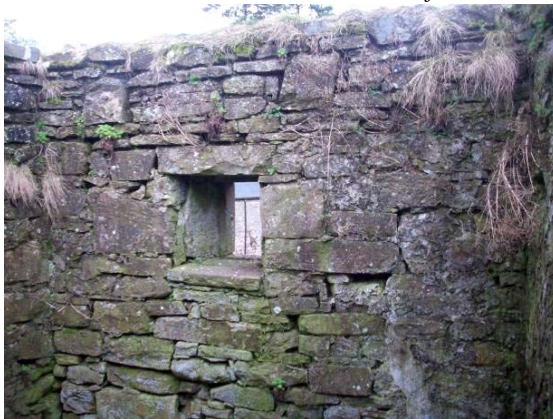
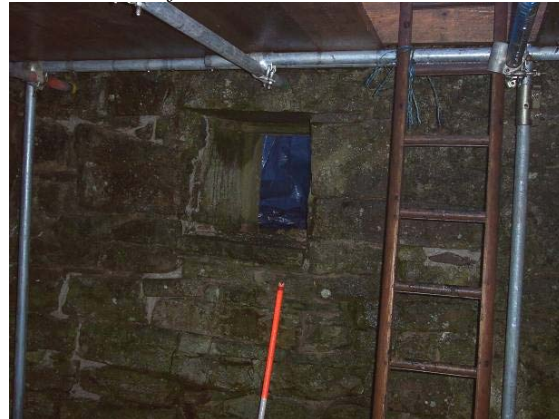
*Plates 5 and 6 View of upper window in S elevation from within, before and after consolidation*

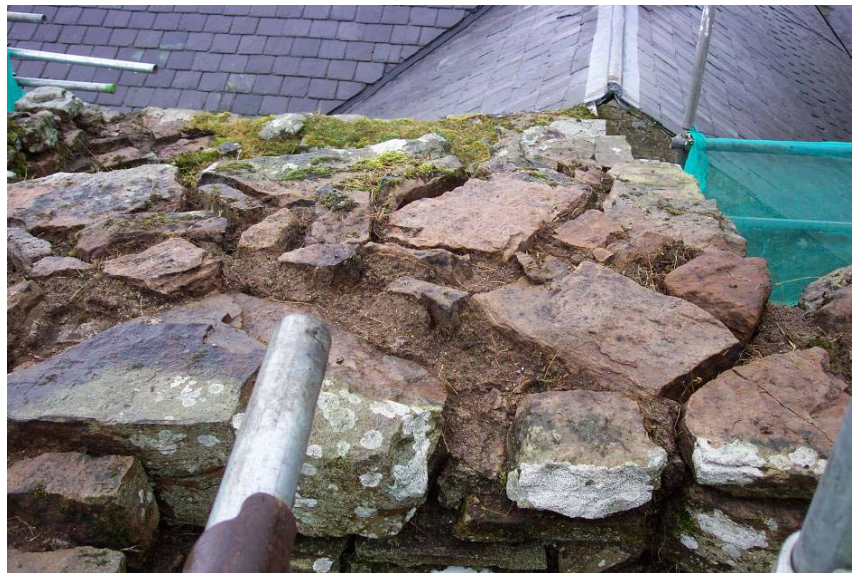
However once cleaned back the wall heads were found to not be in the expected poor state of repair but were actually very solid. The wall head copes and some of the underlying masonry was found to have been re-bedded in a hard cement-based mortar, this evidently relating to earlier consolidation works (*plate 7*). This was perhaps associated with the construction of the pyramidal slated roof seen in the historic photograph of the structure discussed above, *plate 3*, or, possibly more likely, repair works undertaken to cap the wall heads following the removal of the roof – the character of the cementwork might suggest a 20<sup>th</sup> century date. Thus the stones of the upper wall head masonry were found not to be *in situ* though many individual stones were doubtless re-bedded in their pre-existing positions, particularly the moulded cope stones. Clearly some original details must have been lost (such as evidence for the construction of the early roof).

*Plate 7: Detail of the concrete mortar of the wall head after weeding*

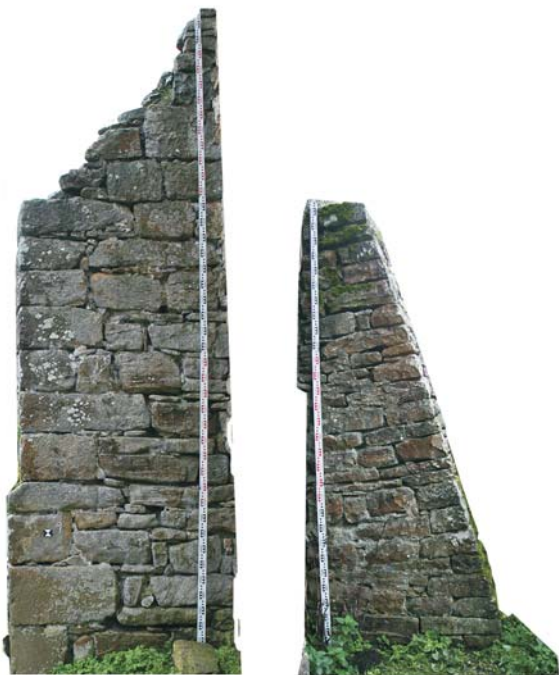
*Figure 24 : South stub wall and south buttress*

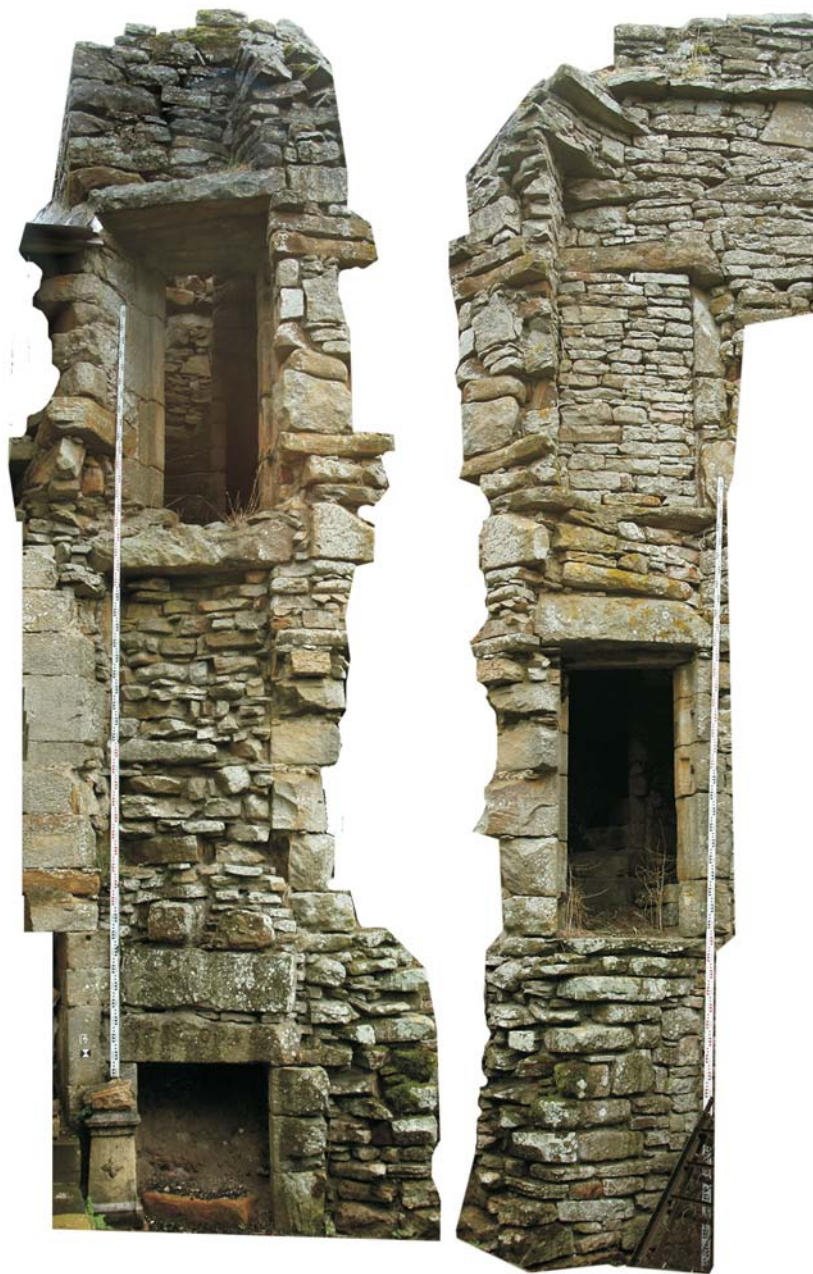
*Figure 25 : North end of west elevation not to scale*
