# Lampits Farm

*Carnwath, South Lanarkshire*

*Archaeological Watching Brief: August 2013*

Data Structure Report

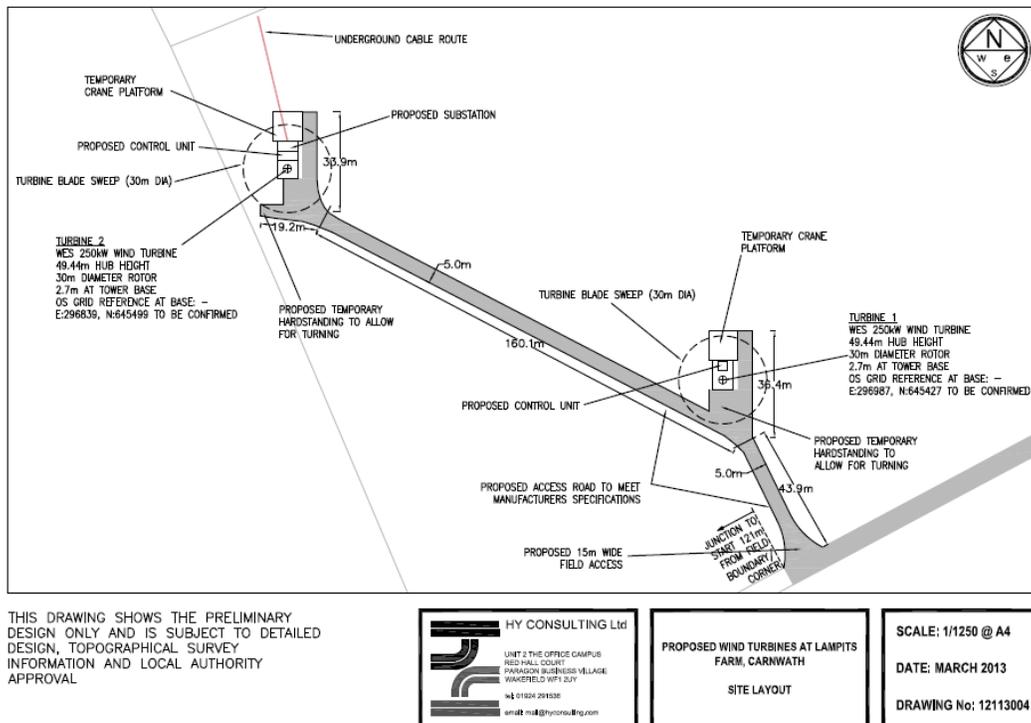
Figure 3 Detailed site lay-out plan (HY Consulting Ltd. as provided by AEC Wind Ltd.)

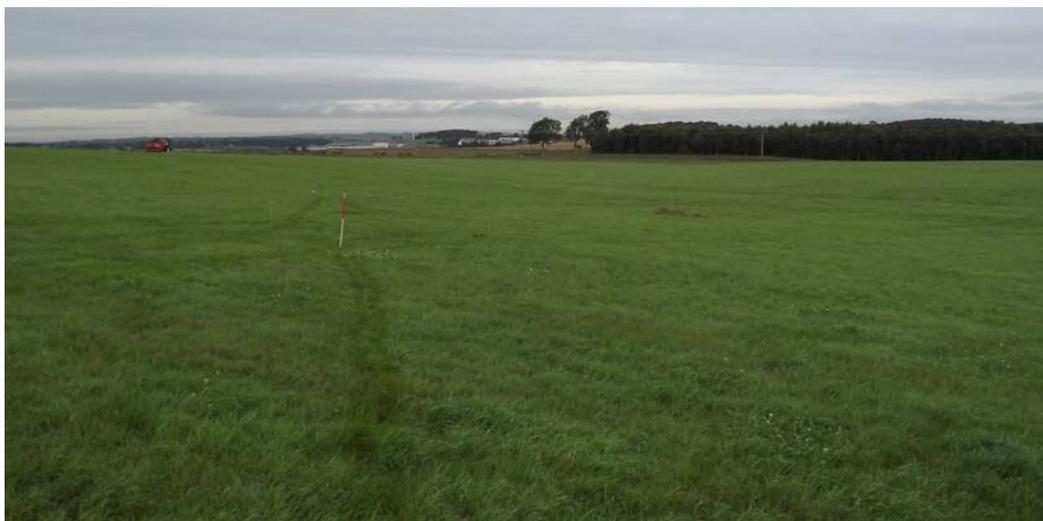
Plate 1 General pre-excitation view across site (Photograph 004)

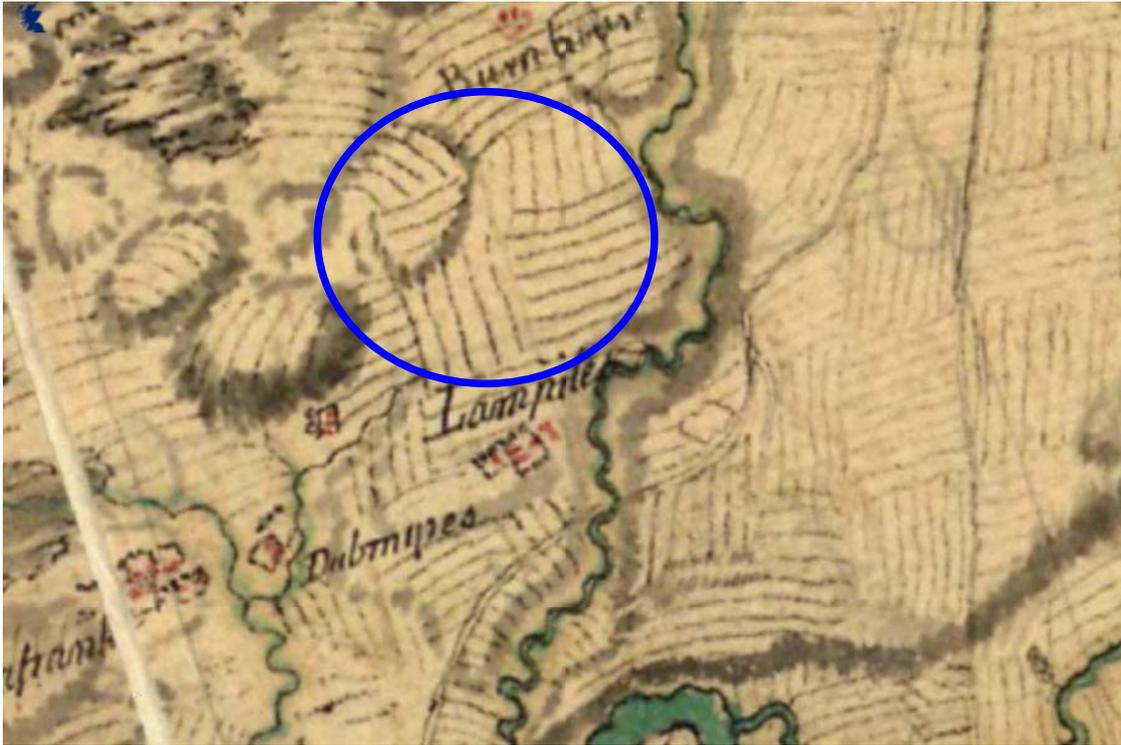
Roy’s map (*Figure 4*) clearly shows the development area, situated between the already existing Burnhouse and Lampits Farms. At this stage the site consists of irregular fields systems, clearly ploughed.

*Figure 4* Lampits Farm shown on the General Roy Military Survey of Scotland, c.1750. © The British Library Board. All Rights Reserved © The British Library Board. All Rights Reserved (Roy Military Survey of Scotland)

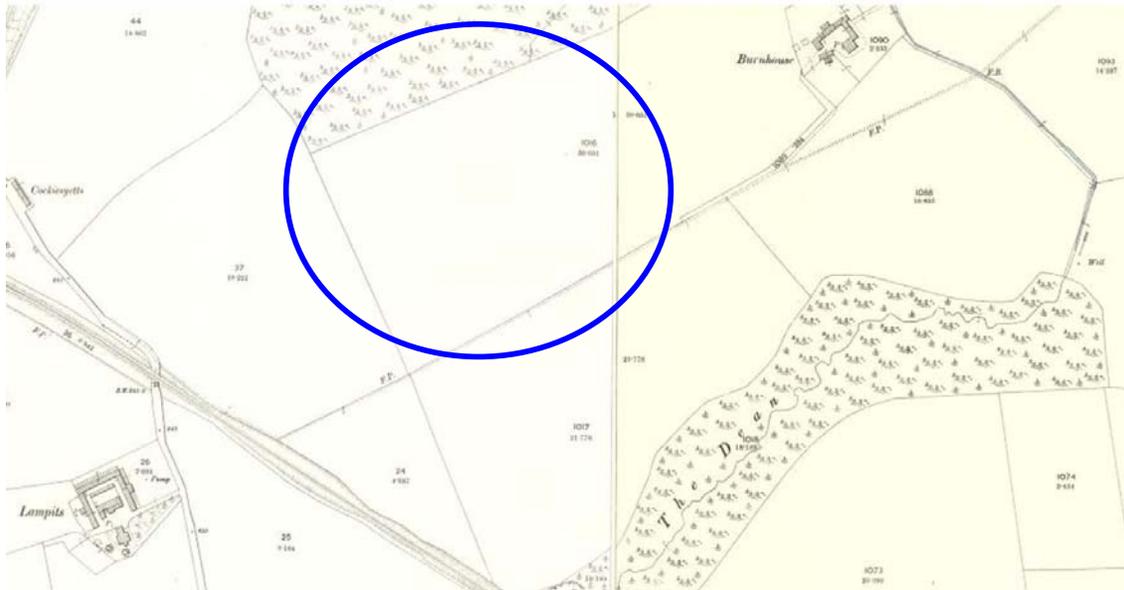
By the 1896 revision (*Figure 6*), the site remains undeveloped with little of interest therein. The southern perimeter of the site is now marked by a footpath and immediately to the SW the railway has been constructed, although neither affect the development area.

Figure 6 Ordnance Survey revision, surveyed 1896. Scale: 25 inches to one mile (NLS).

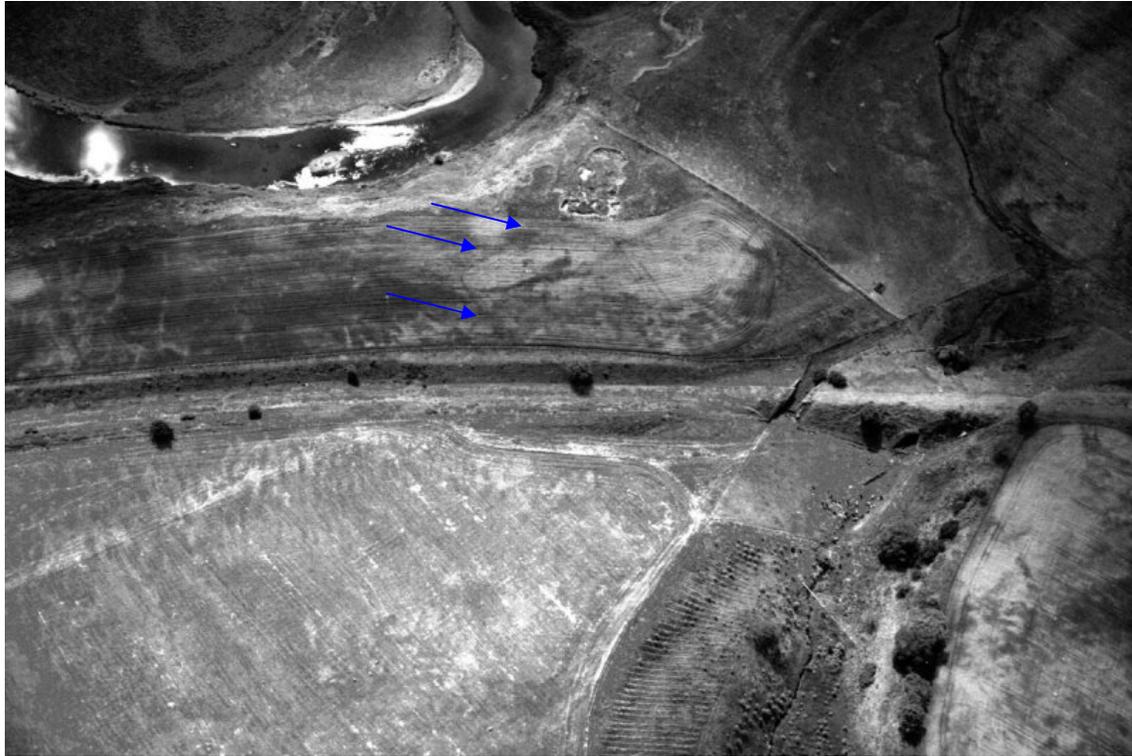
Figure 9 The aerial photographs records the SE corner of the Roman camp or fortlet at Bankhead. CANMORE image SC\_03\_351368.

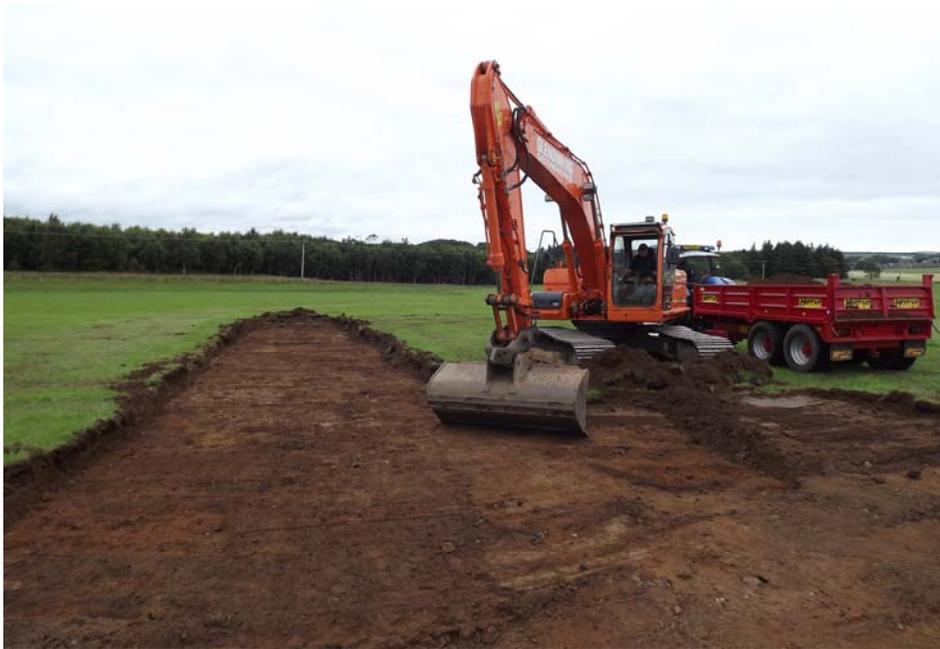
The topsoil consisted of moderately compact mid brown silty sand with rare flecks of stone and a depth of around 0.30m. Recorded as (*001*), this deposit seemed very mixed and clean, particularly at the E end of the site where the transition into the underlying natural subsoil is more gradual. This is indicative of the topsoil having been extensively ploughed to a depth sufficient to disturb the underlying subsoil (*002*).

*Plate 2 Stripping the base for Turbine 1 (Photograph 027)*

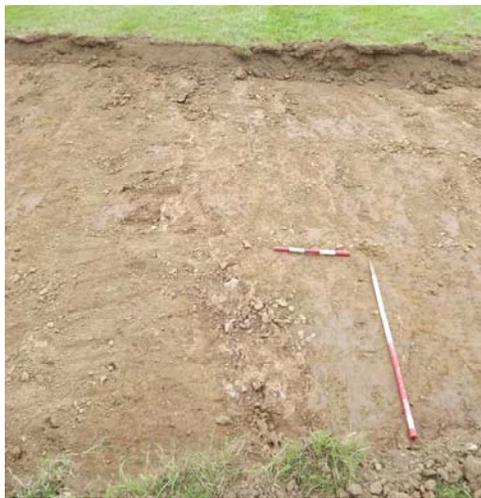
A further linear feature (005) was noted aligned c.N-S across the middle of the access track between Turbine 1 and Turbine 2. This feature was much less discernible than the other features encountered across site, seeming to blend into the surrounding subsoil. A further possible linear feature lay some distance to the W, on the same alignment and even more ephemeral in appearance. Initially it was assumed this feature would prove to be part of a drainage network, but investigation showed it to be an outcrop of mid-red brown sandy silt, so firmly compact it was essentially sandstone. Further investigation showed this to be a naturally occurring deposit.

Plate 3 (005) looking NE (Photograph 064)

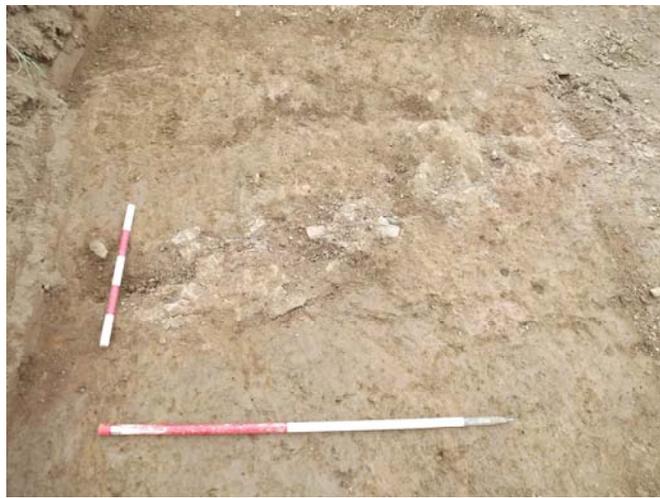
Plate 4 Detailed view of natural outcrop (005) (Photograph 068)

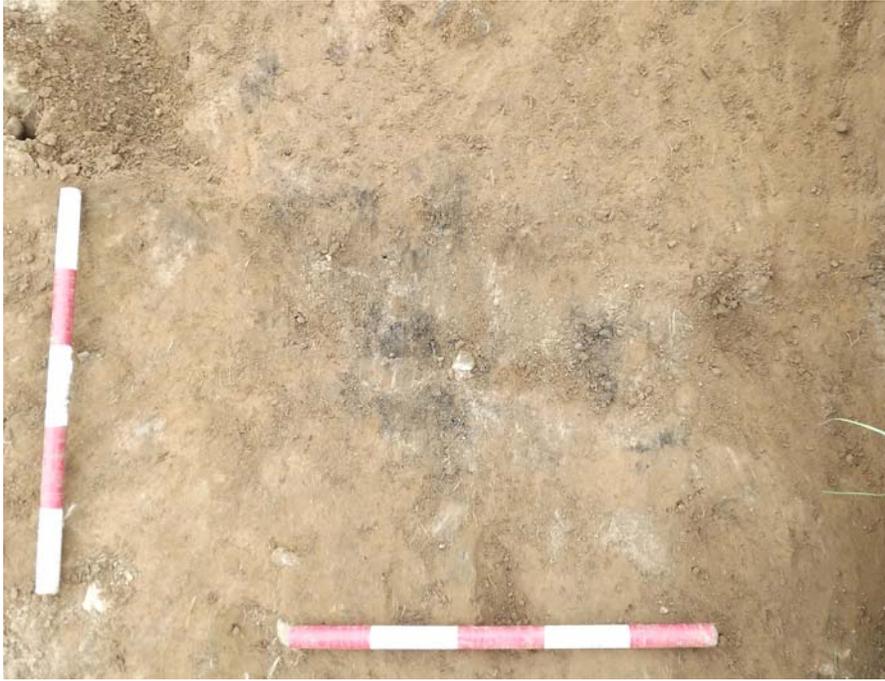
At the southern limit of the site, near where the newly excavated access track meets with the existing trackway that forms the perimeter of the field, an area of heat affected soil was recorded.

*Plate 5 Pre-excavation view of (003) (Photograph 040)*

Excavation of (003) showed this deposit to be clearly mixed within both (001) and (002), with no clear edges. Mottled red brown, white brown and black brown, the moderately compact sandy silt clearly comprised heat affected subsoil, likely further mixed through ploughing. The deposit contained rare flecks of charcoal and a sample was taken.

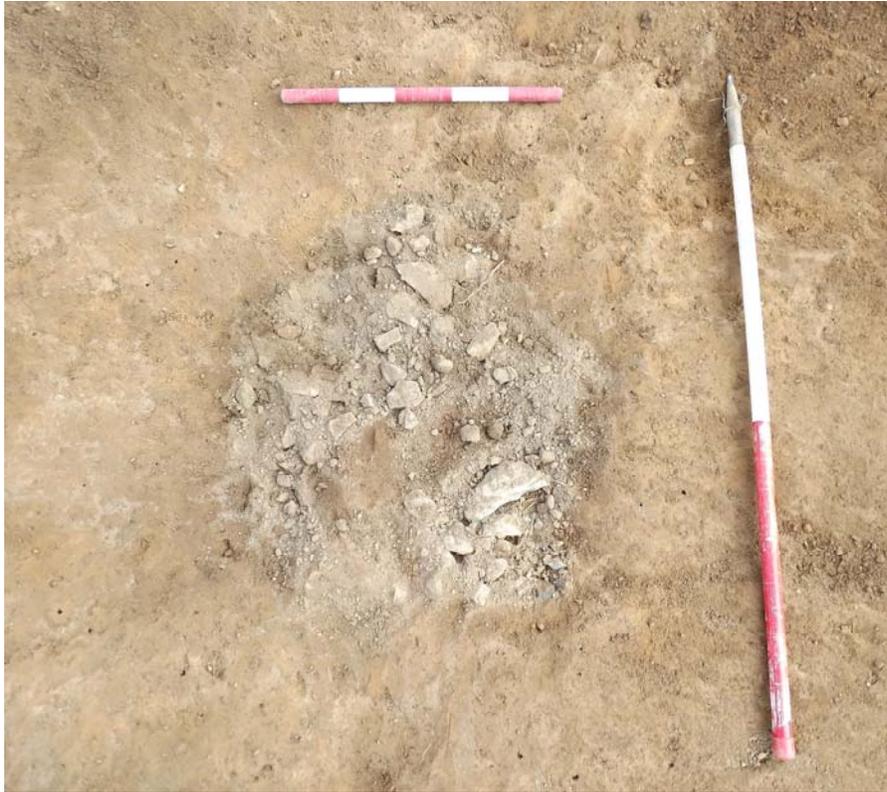
Plate 6 Pre-excavation view of [008/006] (Photograph 055)

Pit feature [008/006] was located midway along the newly excavated track between Turbine 1 and Turbine 2. Roughly circular in shape, the fill (006) proved to comprise a loose to moderately compact mottled mid brown and black brown silty sand with frequent small to medium angular stones and flecks of charcoal. The southern half of the pit was removed, showing the cut to have gradually sloping sides onto a roughly flat base. The depth of the pit was 0.10m with no evidence for the feature within the overlying (001).

The dating and function of the small pit feature [008/006) remains unclear and it is felt that given the proximity of the cropmark site to the development, the samples taken from the feature could benefit from further analysis with the aim of providing the date of the feature. The final decision for such sample analysis rests with WoSAS as the Archaeology Service for South Lanarkshire Council.

Other than the half-section removed during the watching brief, the feature will remain undisturbed by the development, protected beneath the access track.

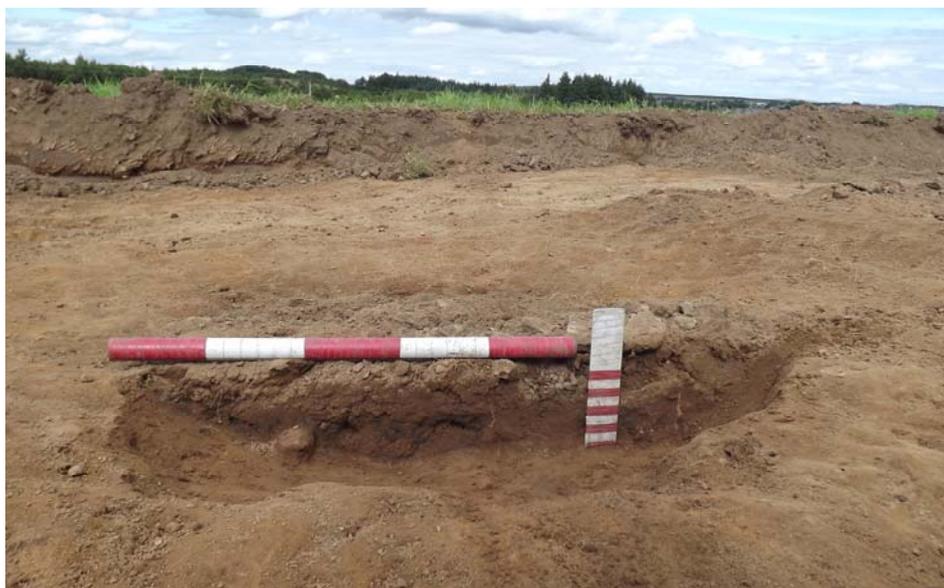
*Plate 7 SW facing section of [008/006] (Photograph 058)*

The function and date of [008/006] are unknown, but clearly the result of human intervention. As discussed above, the site has clearly undergone a significant degree of ploughing (a fact confirmed by landowner, Mr. King) and the shallow nature of [008/006] indicates that much of this feature is likely to have been ploughed away.

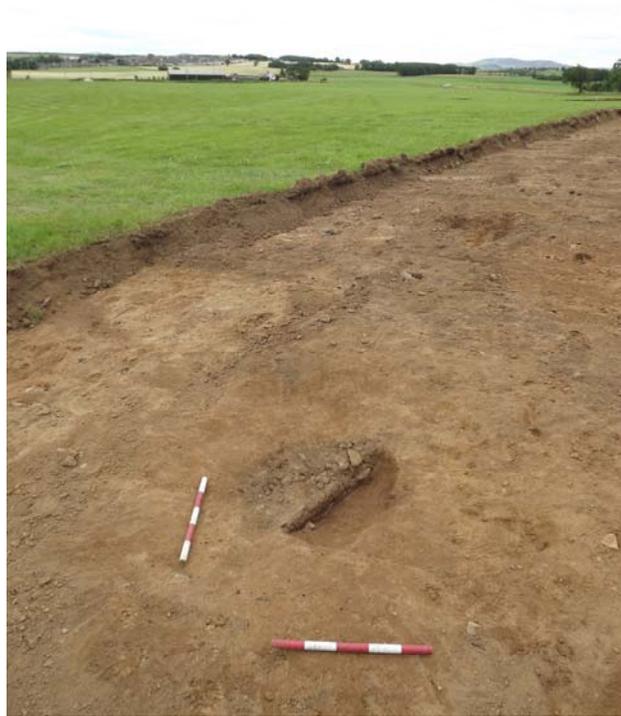
*Plate 8 General post-excavation view of [008/006] (Photograph 062)*

The proximity of known cropmark sites increase the possibility that [008/006) represents the fragmentary survival of a prehistoric feature, but no artefacts were recovered which could confirm this. Two samples were recovered from the fill (006).
