Gamekeepers Cottage, Crookston Mill

Heriot, The Scottish Borders

Historic Building Recording

Historic Building Recording
2091

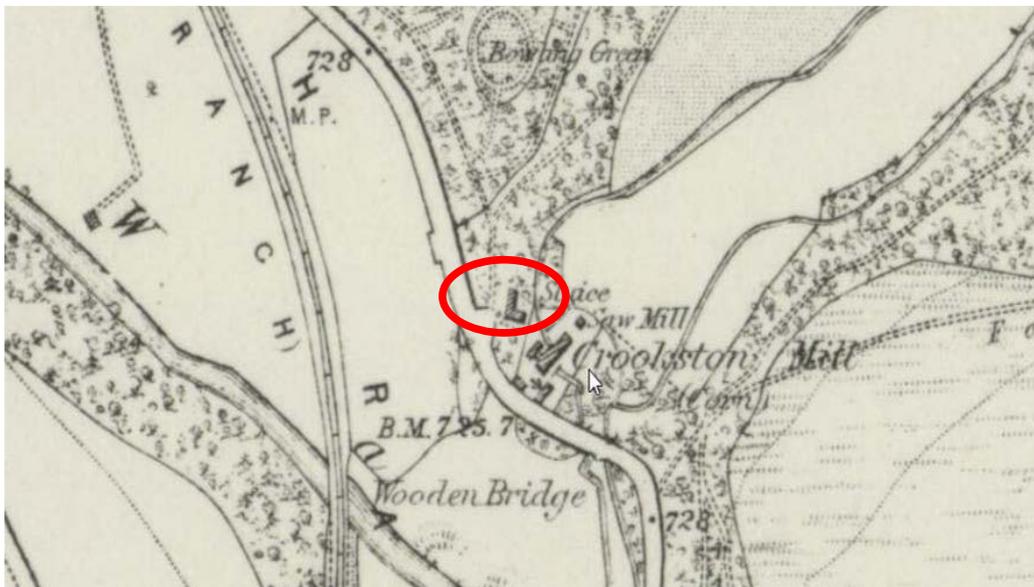
Figure 2 : Detail from 1st Edition OS Map, Berwickshire, Sheet XIII A

By 1853-1857, when the 1st edition Ordnance Survey was carried out, a building can be seen on the site of Gamekeepers Cottage. The layout of the building is quite different from what is visible today, and also different from the building depicted from the 2nd edition OS onwards. Whilst it is possible that the original building shown here has been modified, it may also be that it was demolished between 1857 and 1892 and a new building put up in its place. The Mill, sluice and associated buildings are shown in detail.

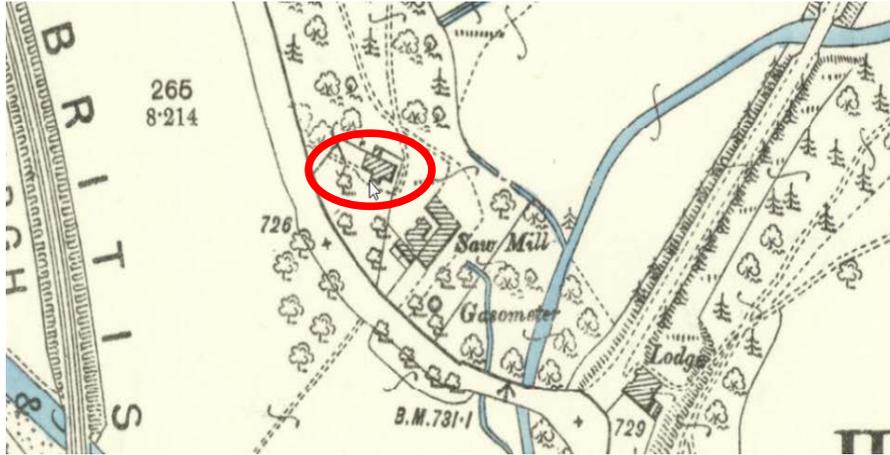
*Figure 3 : Detail from 2nd Edition OS Map, Edinburghshire, Sheet 021.15
Revised: 1892; Publication date: 1894. NLS.*

By the time of the 2nd edition OS the building is very similar in plan to that which exists today, with the exception of a small projection which can be seen at the rear. The map shows the building lies within its own enclosure with tracks leading to the woodland to the north. Crookston Mill, and the buildings around it have also changed form and again are shown in detail.

To the north of the cottage, the remains of a lean to structure are visible. This consisted of a substantial stone wall of similar height to the walls of the cottage. Only an L shape structure survives, however the 2nd edition Ordnance Survey (figure 3) depicts a more square shaped building in this location. A more recent timber log store structure has been built along the north elevation obscuring the two small windows at ground floor level.

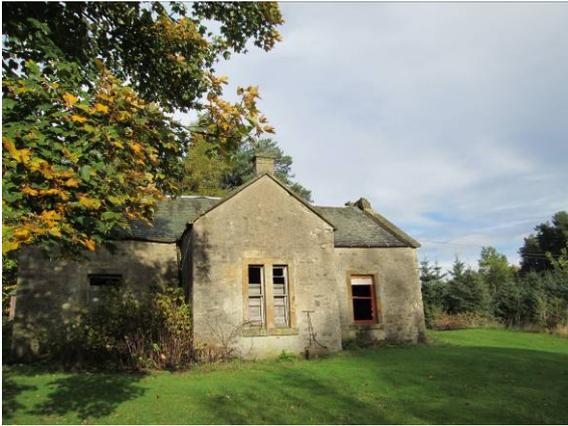
Plate 1; South elevation (104)

The cottage is built predominantly from random rubble in a hard grey local stone. The front elevation is symmetrical with a centrally located porch with twin windows (*plate 1*), and a window on either side. The porch has a false chimney at the front (*plate 1*). The windows and door are surrounded by yellow sandstone dressings detailed with raised margins that are neatly droved (*plate 5,6*). The front and two side elevations have been smeared with a hard grey cement render (*plate 7*). The rear of the cottage is mainly bare rubble therefore it is possible to see the course grey lime mortar. There is also a patch of early lime harling surviving which has been painted with a yellowish lime wash (*plate 8*).

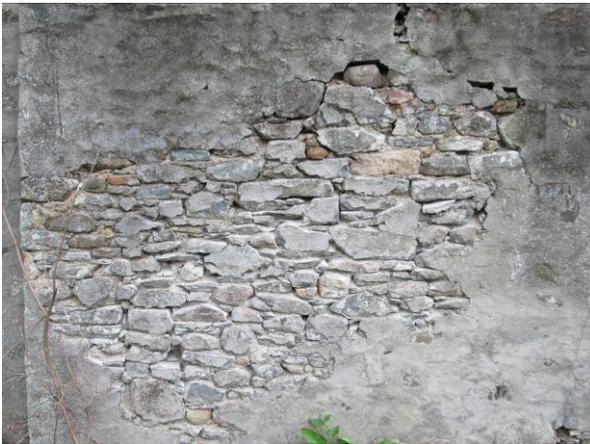
Plate 7; Exposed masonry a cement harl east elevation (035)

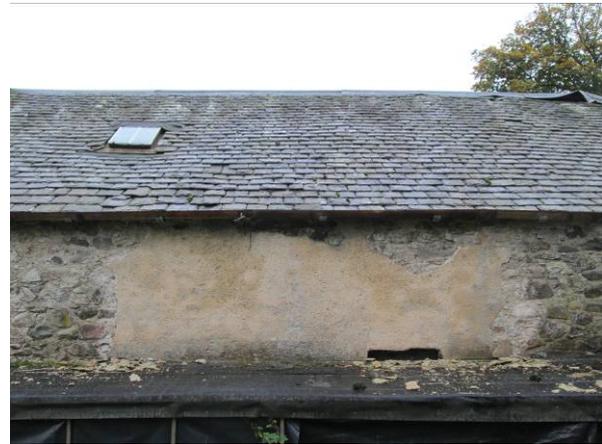
Plate 8; surviving lime harl on north elevation (030)

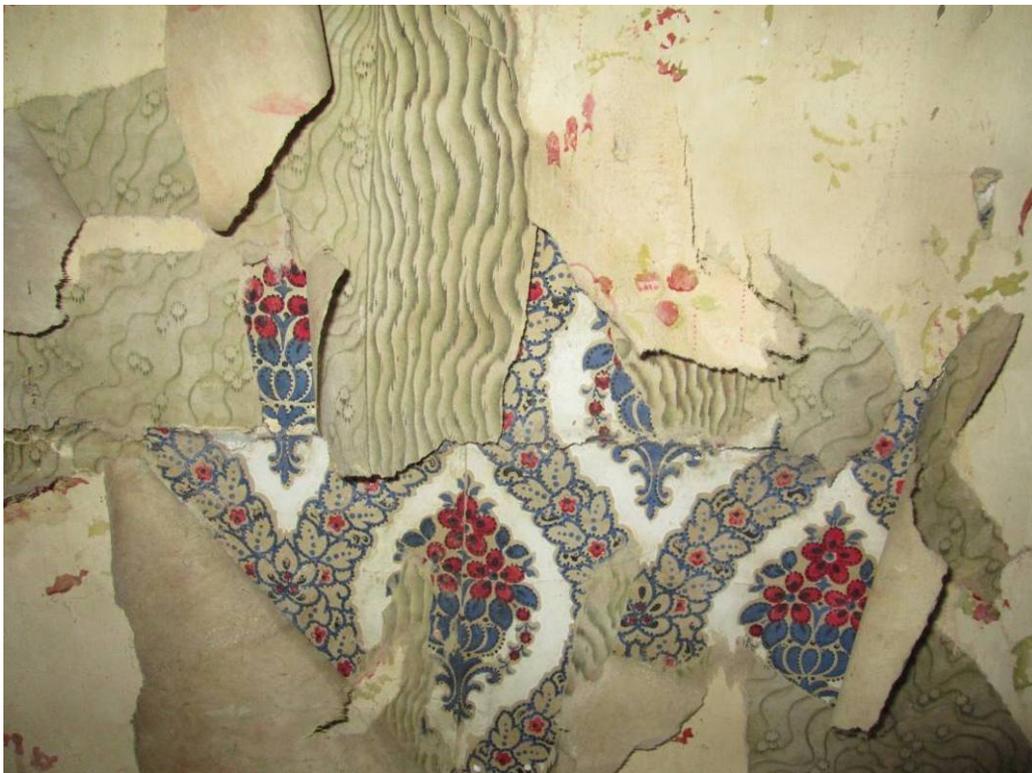
Plate 9 Surviving wall paper in porch (041)

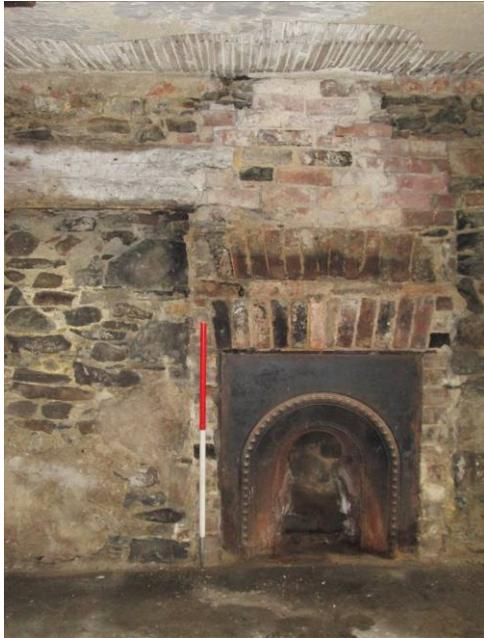
wall which is entirely striped revealing the masonry beneath. The fireplace which sits to the right of centre has several phases of brick blocking above it (*plate 10*). This extends further to the right, slightly above a small deep recess in the wall which has a timber lintel (*plate 11*).

Plate 10 Fireplace in room a (048)

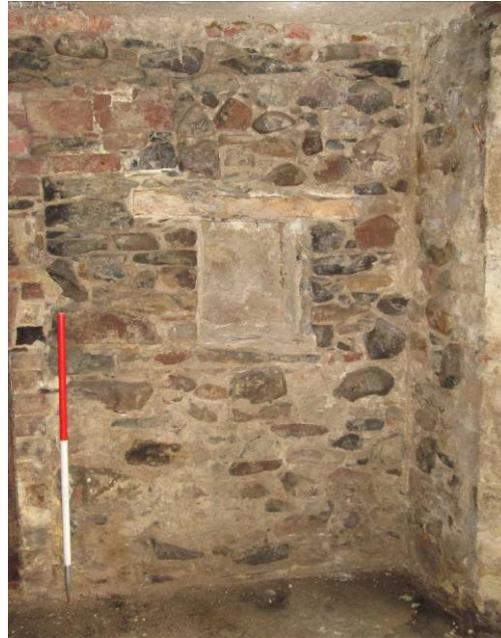
Plate 11 East wall in room a (046)

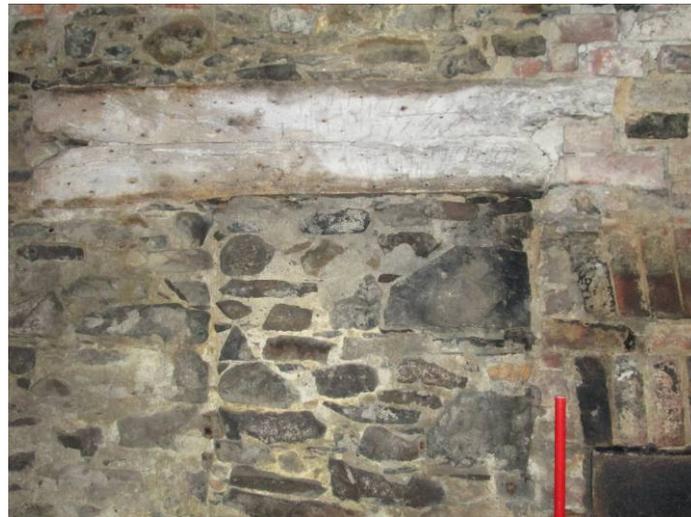
To the left of the fire place there is a substantial timber which appears to have been sawn off at its east end, the full extent of the original timber can be seen in a change in the brick blocking. It would appear therefore that the original timber spanned the fireplace and continued to the left side where a clear joint can be seen in the masonry (*plate 12*). The bottom section is obscured, but it may represent a press alongside the fire.

Plate 12 Timber lintel and joint room c (049)

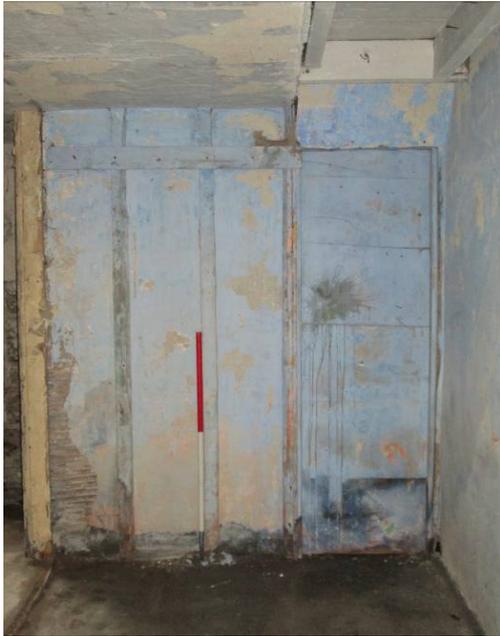
This is the smallest of the downstairs rooms. It is currently entered either through room *a* or room *c* however the timber partition that separates it from the hall originally had a narrow doorway which would have allowed access directly from the hall (*plate 13*). On the room side of the partition, lath

Plate 13 Timber partition (055)

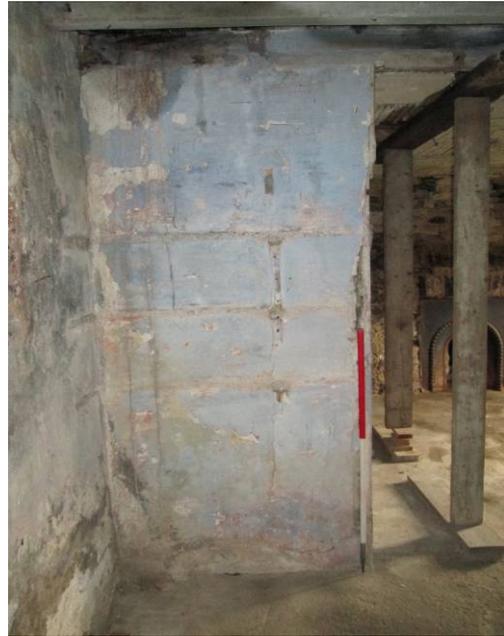
and plaster has been applied between the vertical timber studs. The only other evidence of fixtures and fittings within this room is the outline of a set of shelves in the back right hand corner (*plate 14*).

Plate 14 Scars left by shelving (058)

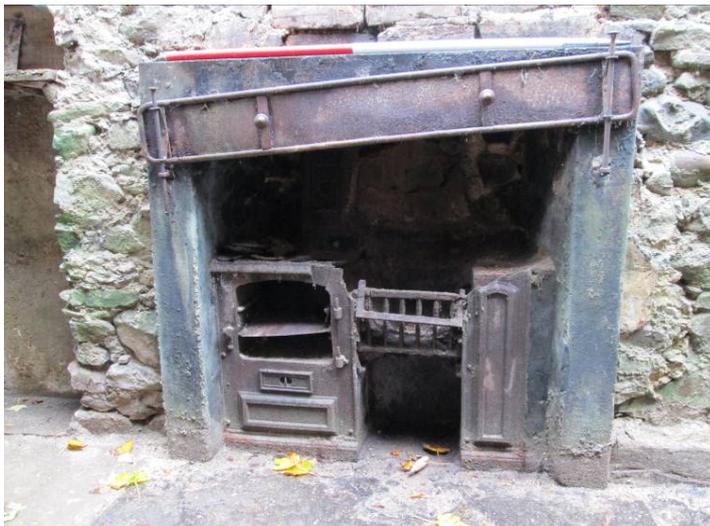
This is the largest of the downstairs rooms, with a cast iron range surviving in the fireplace (*plate 15*) on the west wall, to the right of which is a small deep-splayed window with a cupboard space beneath. The stone hearth slab was visible, this flush with the concrete floor. The north wall has had timber panelling applied, some of which has not survived. This may have been to combat dampness in the wall, or simply for decoration.

Plate 15 Fireplace and range (069)

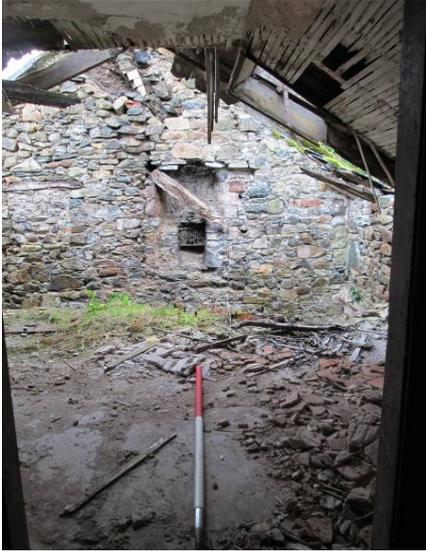
Plate 16 The west room, room e (089)

As previously mentioned the first floor was not accessible due to the roof collapse and unsafe floors. There are two large rooms each with a fireplace in the gable wall and lit by a roof light in the north slope of the ceiling. Both ceilings are coombed leaving a low ceiling height. The fireplace in *room e* is considerably the smaller and has a timber lintel. To the left of it is a small blocked opening also with a timber lintel. There was no trace of this on the exterior, therefore it is not possible to tell if this was a small window or a recess in the wall.

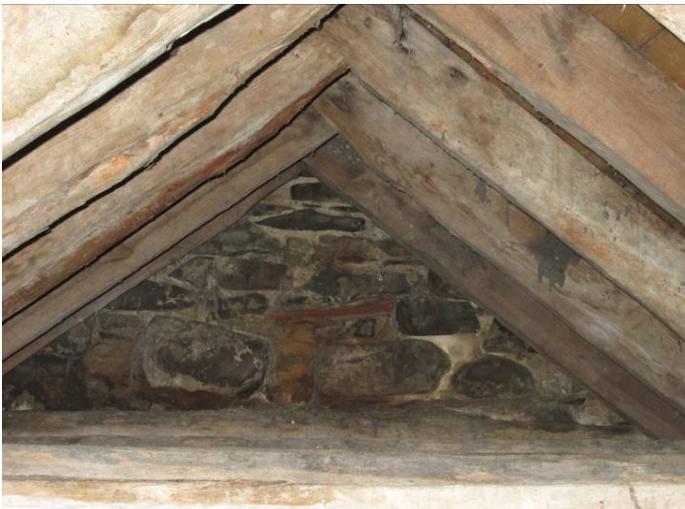
There is a small space in the roof above the lath and plaster ceiling (*plate 18*).

Plate 18 roof space (091)
