*Blyth Battery, Blyth Links, Blyth*  
Northumberland

*Building Recording (December 2008-March 2009)*

Building recording

(project AA. 1641)

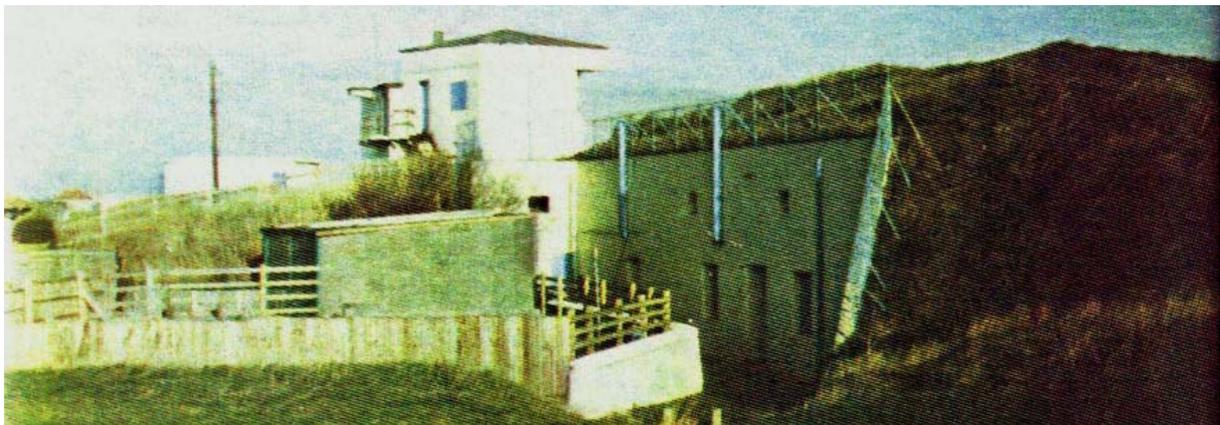
*Figure 8: WWI BOP with low pitched pyramidal roof covering the rotating range turret  
– undated photograph, from an internal file (labelled 'Forts'),  
in Northumberland County Council offices*

The First World War BOP is located at the northern end of the southern battery building group. It is a 6-sided structure of two floors and was originally buried into the dunes to first floor level on the seaward side. Projecting from the roof is a circular rotating turret which housed the range finding equipment. The circular rotating turret was originally covered by a low pyramidal roof in an attempt to disguise the building as utilitarian building in a fishing village; a vertical concrete post extending from the NW corner of the roof was apparently intended to imitate a chimney (see *figure 8*).

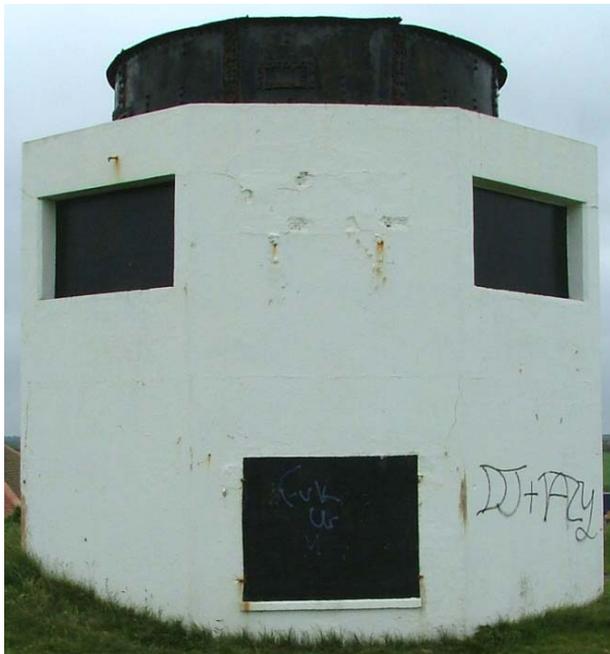
*Plate 1: WWI BOP, view from the E*

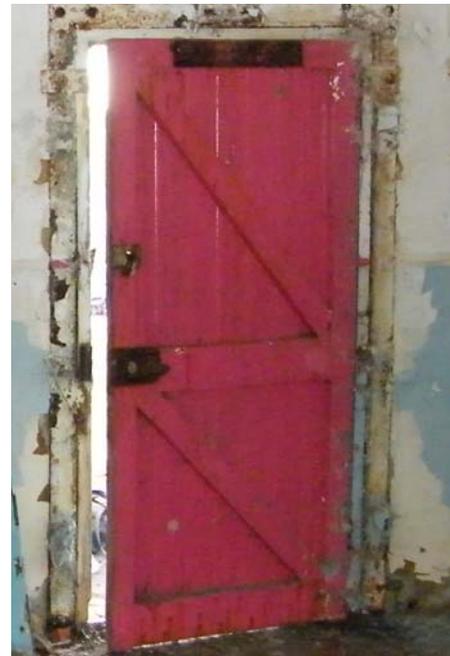
*Plate 2: WWI BOP interior ground floor W elevation, doorway with original framing*

The window in the E wall facing towards the sea is metal-framed, with sixteen panes. This frame presumably relates to the insertion of this opening during the inter-war period, when the use of the building was changed. The window in the W wall originally had metal shutters, as seen from the four hinge-pins positioned either side of the opening (*plate 4*). The framing for this window has been lost but the remains of a 1930s-style sash window is lying on the floor in front of this, having fallen out of the opening following the decay of its frame. The current wooden door is clearly a replacement and the metal framing for the original door is still present. The original door appears to have been a double leaf door as there are hinges on both sides of the framing (*plate 2*).

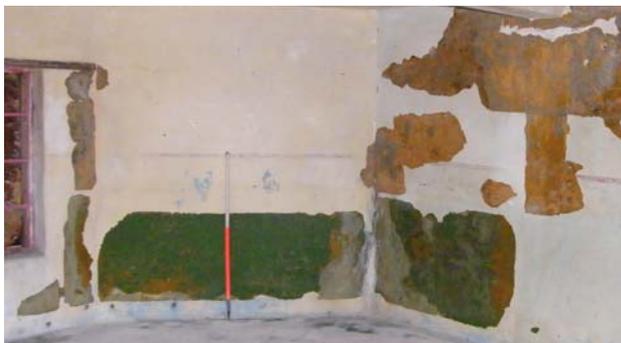
*Plate 3: WWI BOP ground floor, earlier paint schemes and skirting doors visible.*

On the interior the ground floor has a relatively low ceiling with cross beams running east-west and north-south (*Drawing 3*). The original paint scheme appears to have been a deep ochre colour or dark green. Latterly, the interior paint scheme appears to have been cream, before the present scheme of white paint above the red line and blue below. Fixing points and a skirting-level paint line are visible on the E elevations, suggesting the room was formerly fitted out with skirtings (*plate 3*).

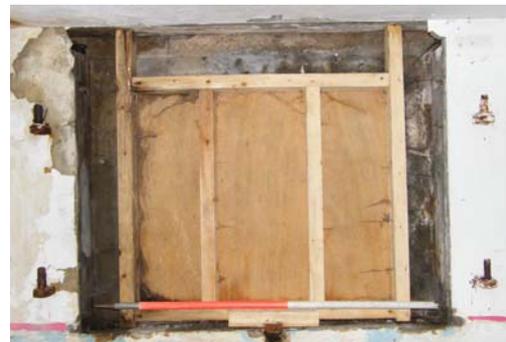
*Plate 4: WWI BOP interior ground floor W elevation, window with pins for original shutters*

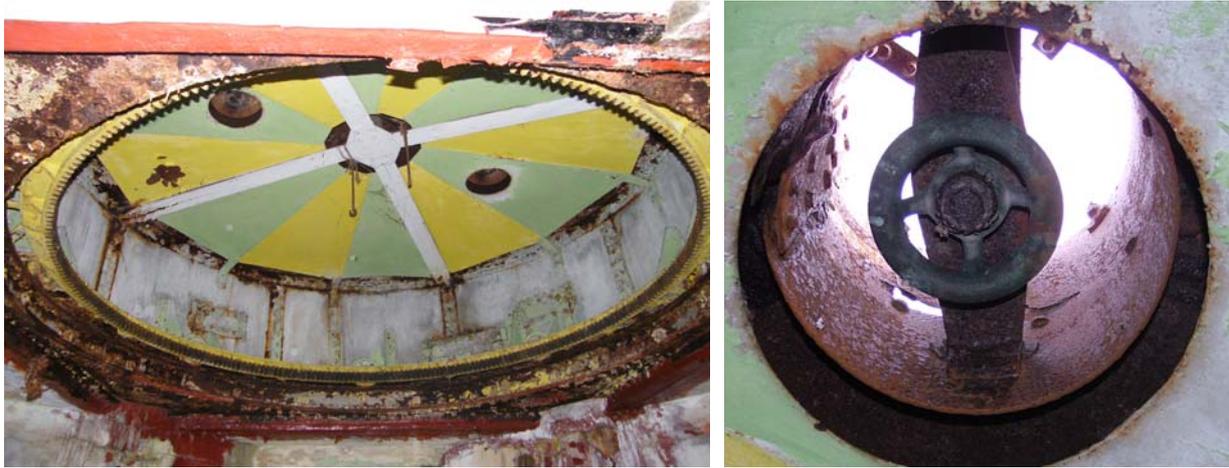
*Plate 5: Rotating turret in WWI BOP*

*Plate 6: Detail of operating wheel in roof of WWI BOP rotating turret*

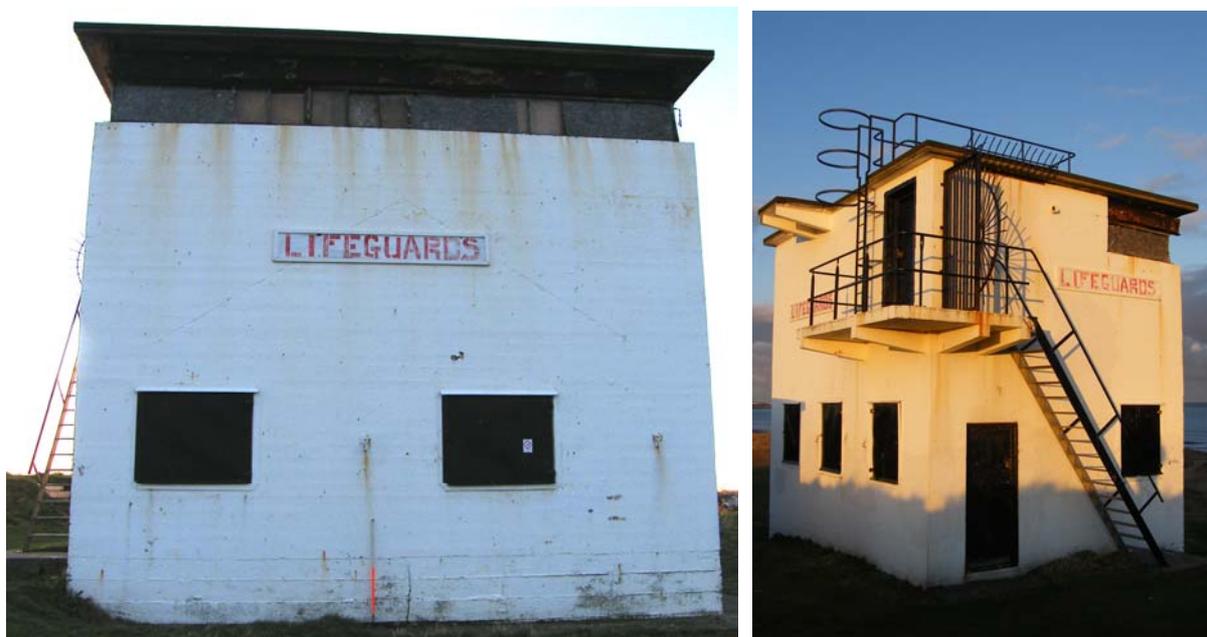
*Plate 8: WWII E (seaward) elevation, with boarded up viewing window and gabled roofline of concealment scheme*

*Plate 9: WWII BOP S and W elevations, view from SW.*

The wall head opening continues round onto the S elevation (*Drawing 8*), where it extends to approximately one-third of the elevation width; this opening is boarded up. To the W of the opening is a small round opening, possibly a vent for an internal stove which has since been removed. There is a door and window on the ground floor, both of which have iron or steel surrounds, although these do not appear to be the originals. The window ground floor window is also covered by a secondary metal shutter. A replacement metal staircase leads up to a cantilevered balcony with metal railings at first floor level. A secondary gate has been fitted here for security reasons (see *plate 9*).

The cantilevered balcony continues round to the W elevation (*Drawing 9*), where it provides access to a doorway at first floor level. A metal ladder provides access to the roof from this point (see *plate 9*). There are three windows at ground floor level, each with replacement metal shutters. There is a metal hook to either side of the central window and one to the north of the southern window; these were presumably for the original double blast shutters. There are narrow vents above each window.

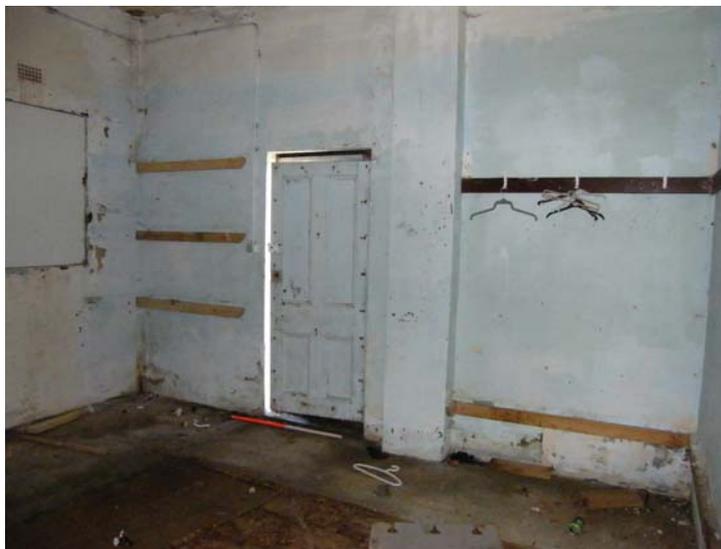
*Plate 10: WWII BOP ground floor room 1, internal pier and reused door in N wall*

The larger N room (room 1) has two openings in the W wall which have been boarded up. The door in the N elevation appears to be a reused four-panelled door with an additional metal plate attached to the exterior side (*plate 10*). An internal pier is situated in the centre of the N wall. There appears to have formerly been a partition in this room, dividing off the E side of the room. It is unclear which phase of the buildings use this dates to. The blocked connecting doorway is visible in the S wall (*plate 11*).

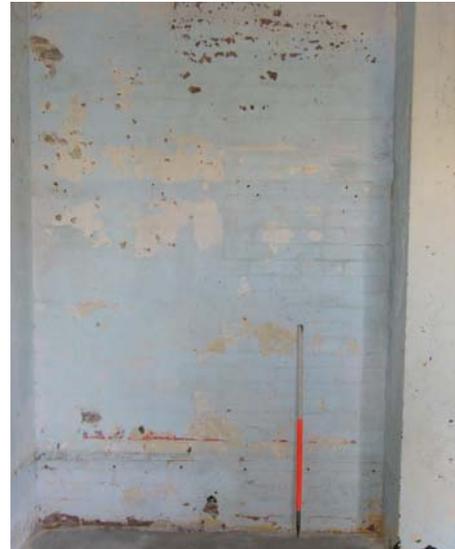
*Plate 11: WWII BOP ground floor room 1, blocked doorway in S wall*

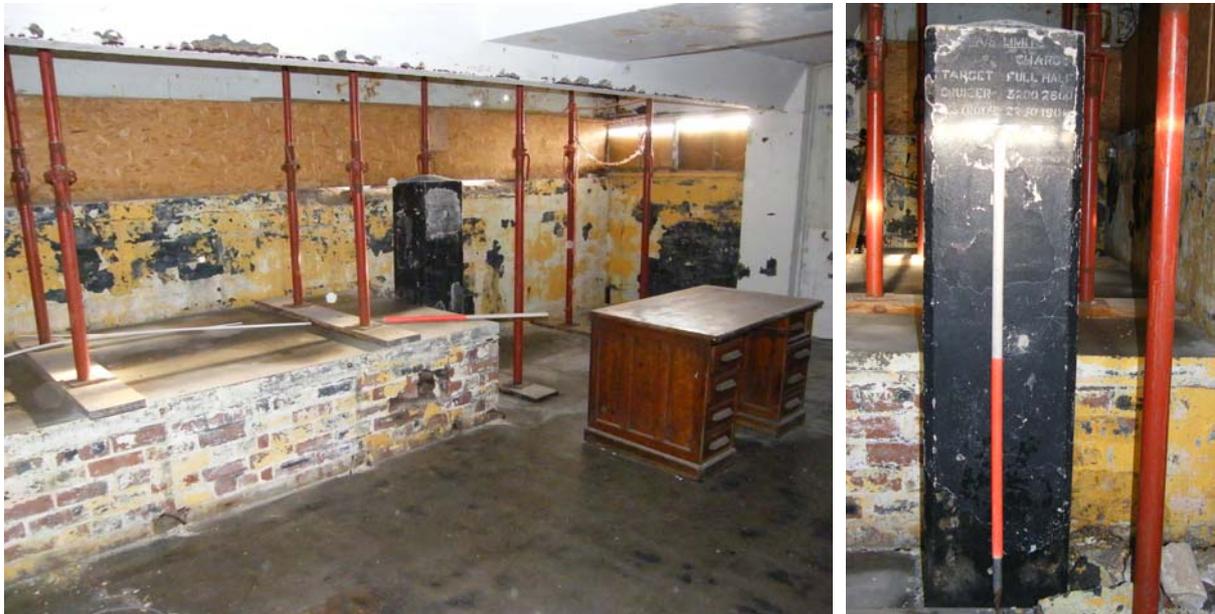
Plate 12: WWII BOP upper floor, E section as viewed from NW, with brick viewing platform and concrete plinth for telescope.

Plate 13: WWII BOP upper floor, concrete plinth for telescope, S faces with remains of stencilling.

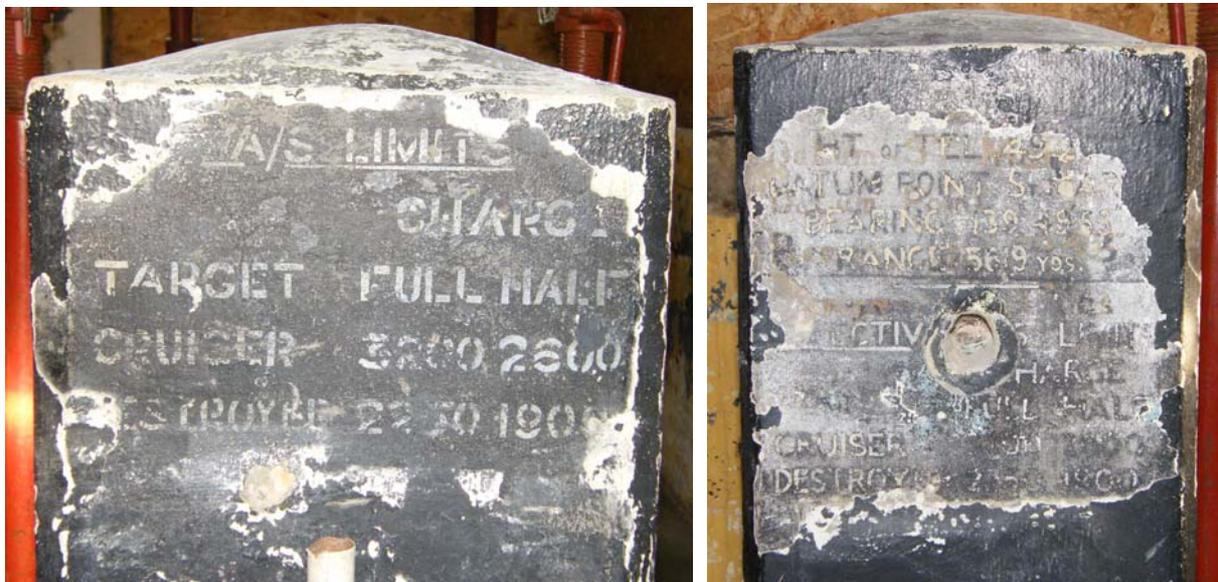
Plate 14: WWII BOP telescope plinth, stencilling on S face

Plate 15: WWII BOP telescope plinth, stencilling on W face

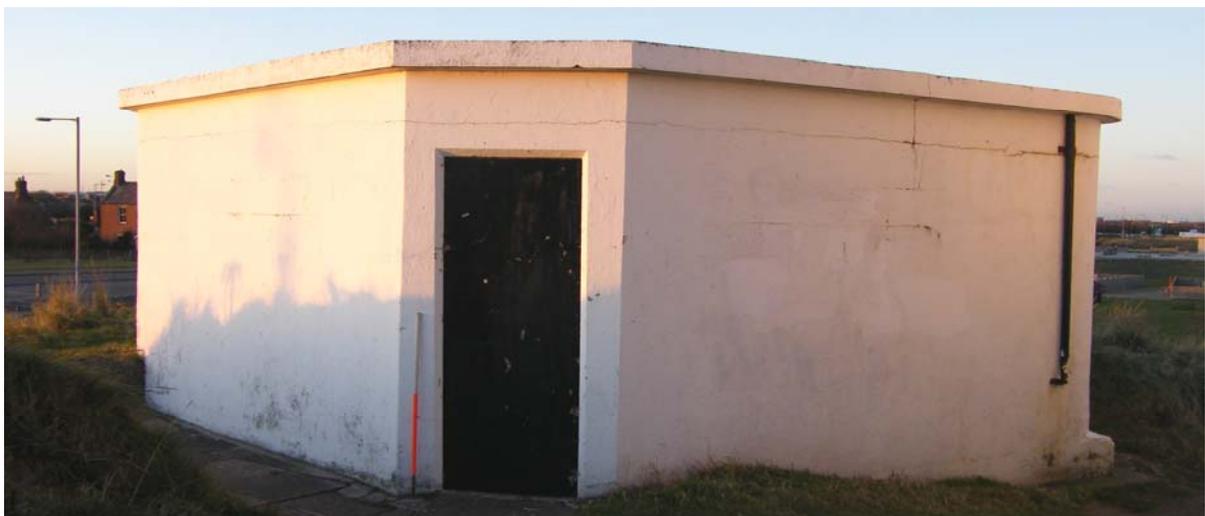
*Plate 16: Blockhouse exterior, view from S; the outline of blocked gun loops are visible to either side of the doorway*

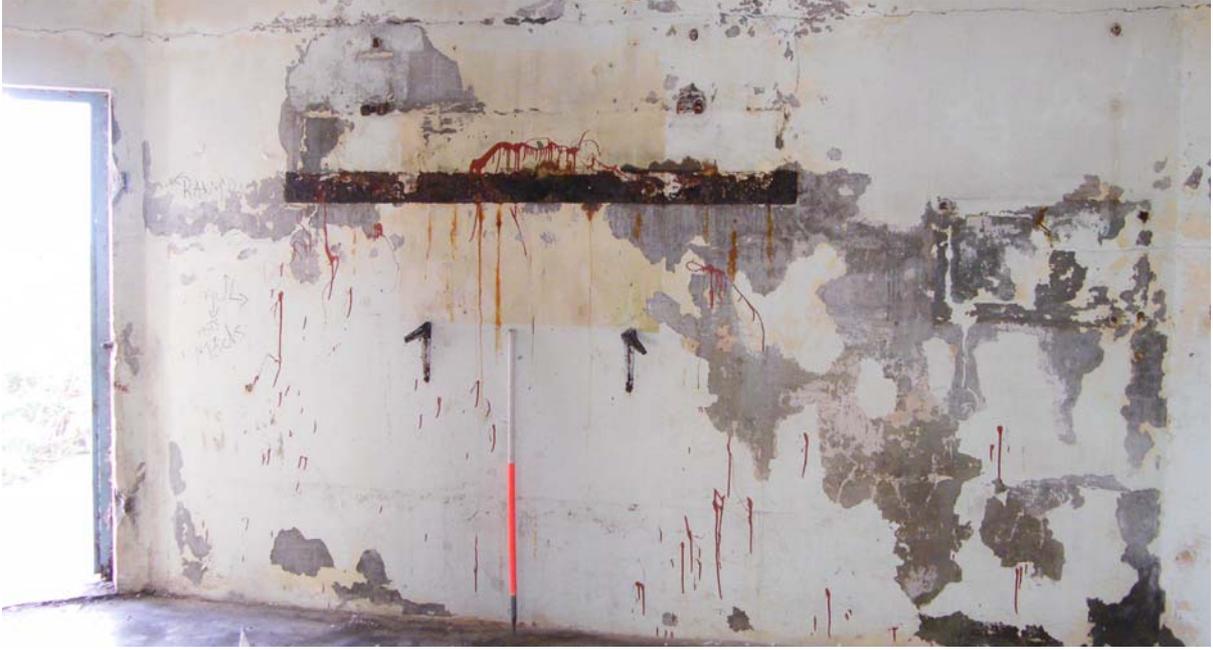
*Plate 17: Interior of blockhouse, SW wall with blocked gun loop and additional blocked loop hole; this possibly accommodated a lamp*

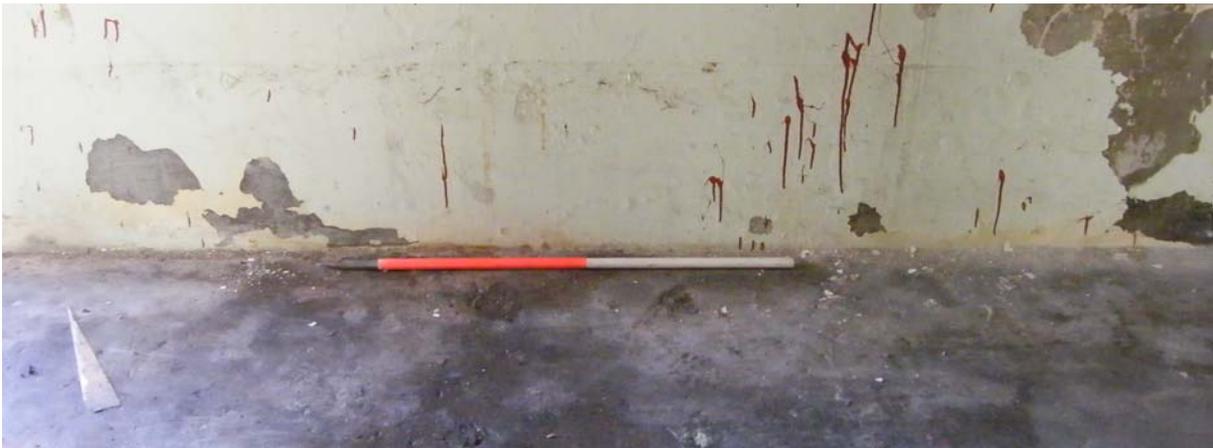
*Plate 18: Bench outline visible on the floor and lower part of the wall beneath blocked gun loops*

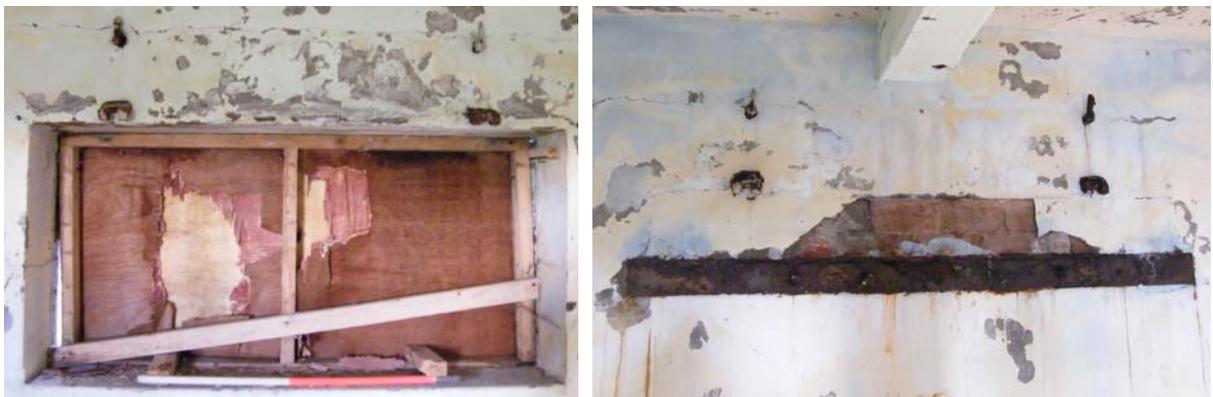
*Plate 19: Blockhouse interior; gun loop widened to form window*  
*Plate 20: Blockhouse interior; blocked gun loop with hinges and hooks above*

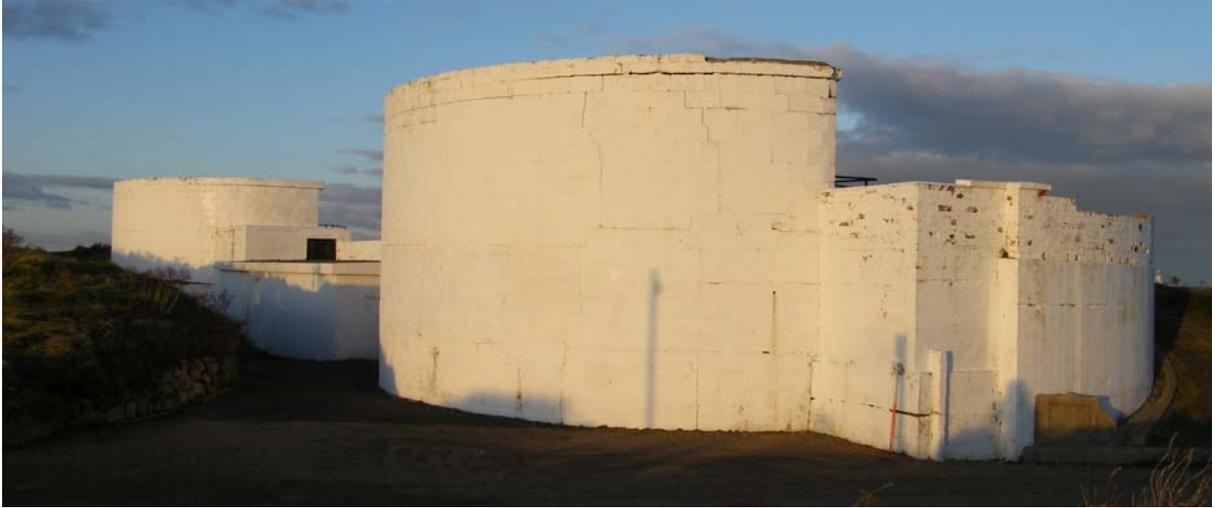
*Plate 21: View of rear of gun emplacements, from SW*

Following the end of WWII the emplacements were adapted into amenity shelters for users of the Links. The sunken central area of each emplacement was backfilled to the current floor level and seating (now gone), and railings (now damaged and partially missing) were added.

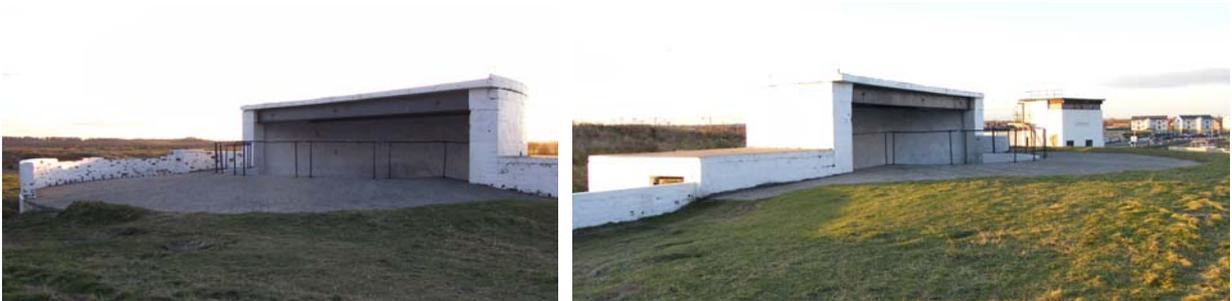
*Plate 22: View of S gun emplacement, from NE*

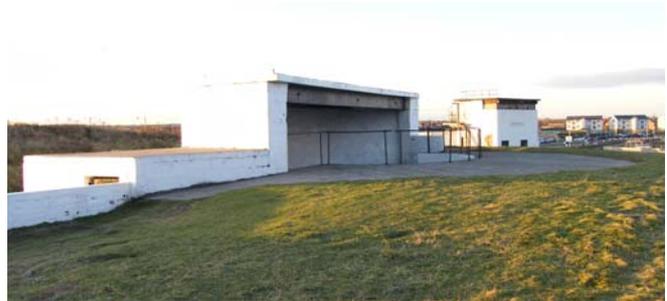
*Plate 23: View of N gun emplacement, from SE*

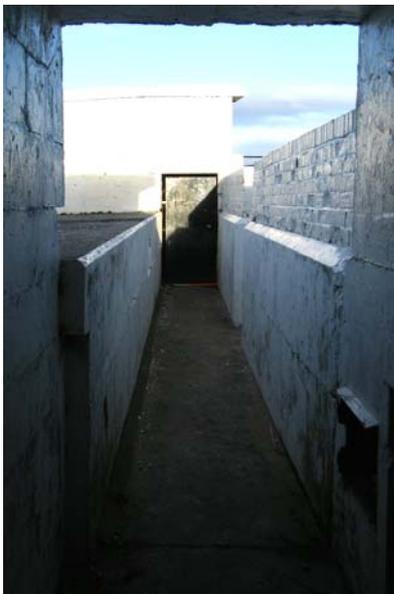
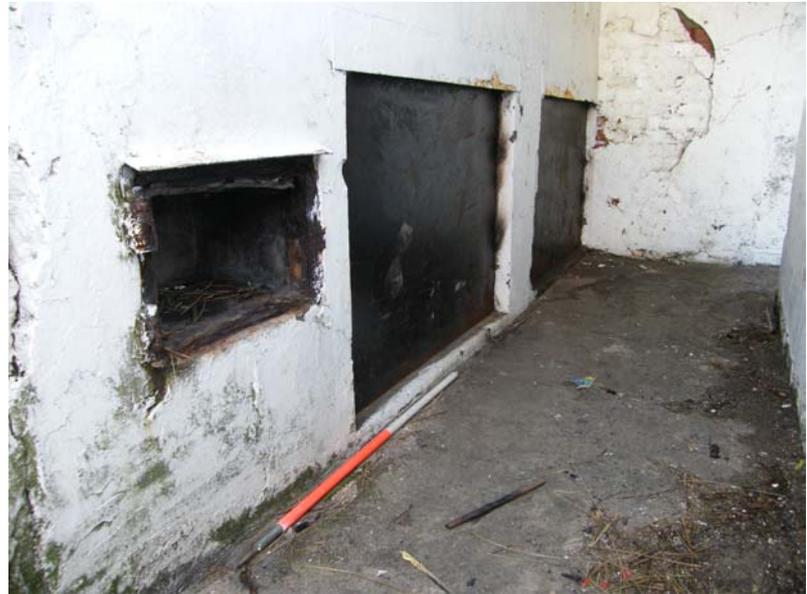
*Plate 24: View along passageway between gun emplacements, looking N to WWII Ammo Lobby*  
*Plate 25: Lockers in retaining wall at S end of passageway*

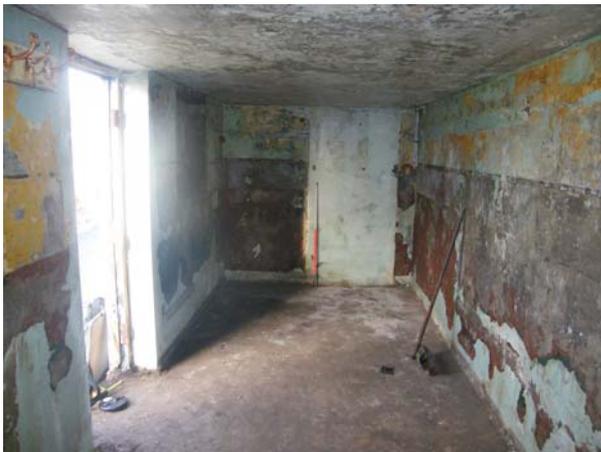
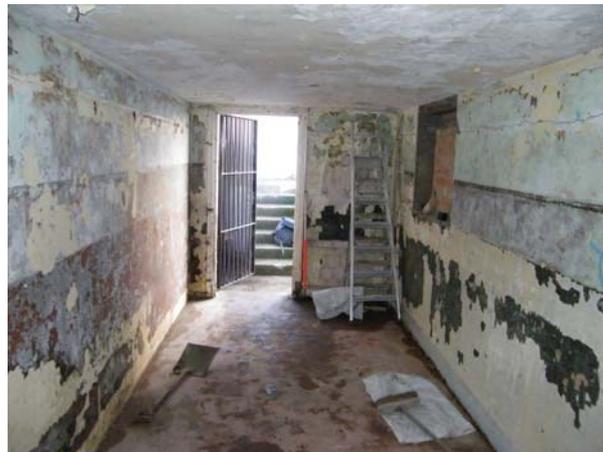
*Plate 26: War Shelter, N room looking N to blocked doorway in N elevation*

*Plate 27: War Shelter, S room looking S to doorway and external access steps*

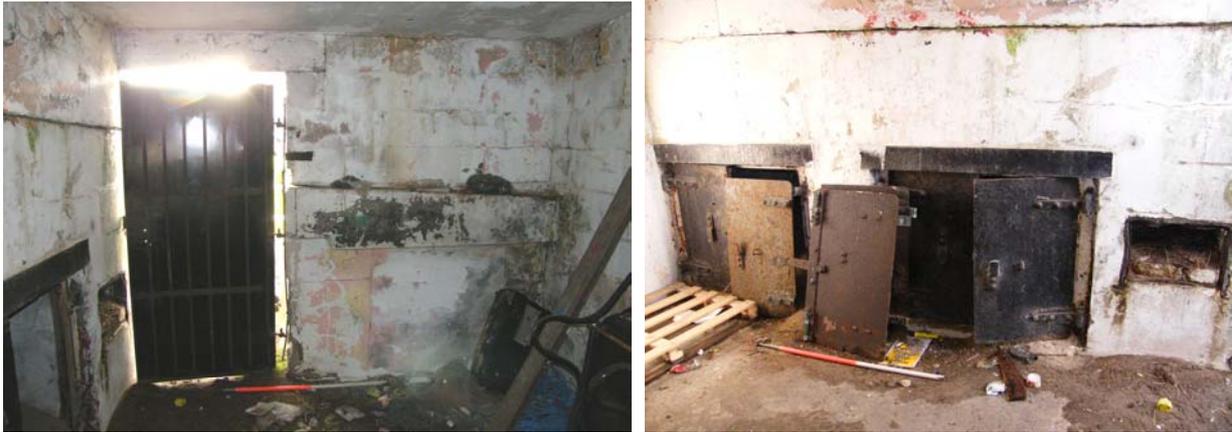
*Plate 28: Ammunition Handling Lobby interior, looking S;  
roofline of lower War Shelter building is visible to the right of the door*

*Plate 29: Lockers in E wall of Ammo Lobby, originally in passageway between gun emplacements*

The Ammo Lobby was constructed to the N of the War Shelter during the WWII phase of use. This was created by infilling the access stairs to the N War Shelter and constructing a wall across the N end of the passageway running between the two gun emplacements (*plate 28*). The lockers at the N end of the retaining wall were thus now housed in the Ammo Lobby (*plate 29*).

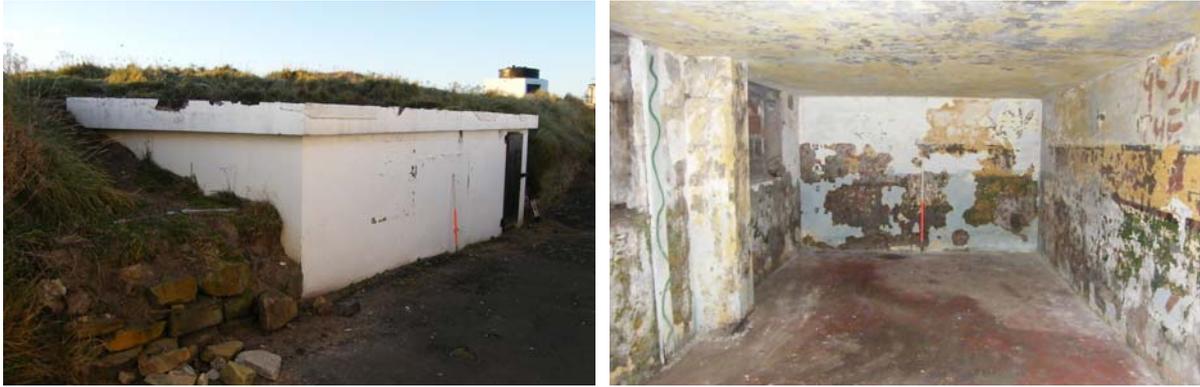
*Plate 30: View of the Royal Artillery Store, from SE*  
*Plate 31: Interior of the Royal Artillery Store, looking S*

There is a flue positioned in the centre of the E wall – this served a stove which was originally positioned here (*plate 31*). Benches and selves were originally positioned along the W wall but these have also been removed (*Appendix B Drawing 6*). On the N and W elevations are the remnants of iron brackets for shelving; the brackets have been sawn off and only the stumps remain.

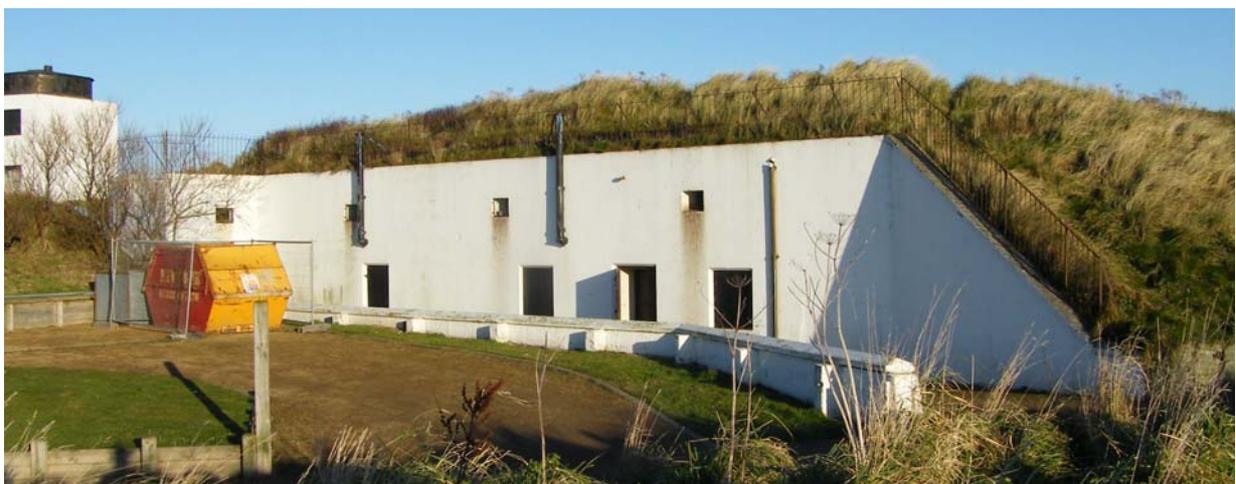
*Plate 32: View of Magazine building, from SW*

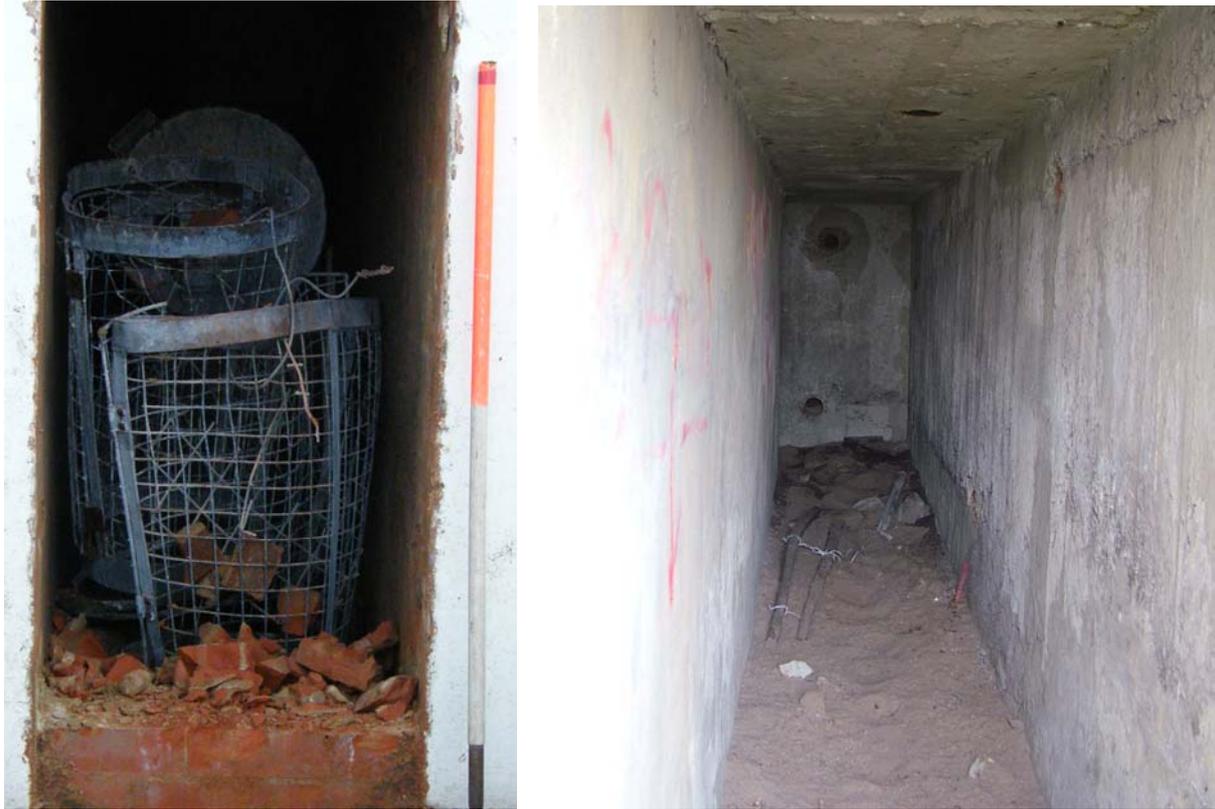
*Plate 33: Opening up of doorway to blast chamber in Magazine building  
Plate 34: Inside blast chamber at Magazine building*

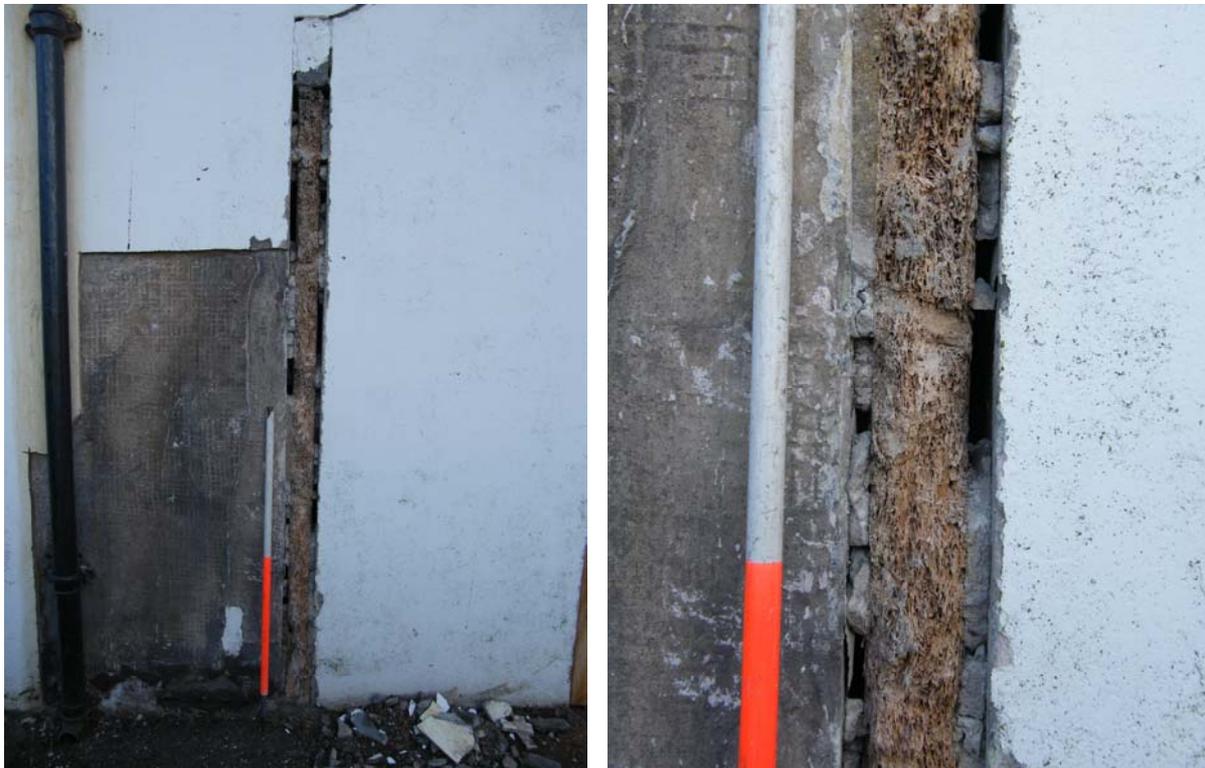
*Plate 35: 'Air space' in Magazine building revealed.  
Plate 36: detail of 'air space' construction*

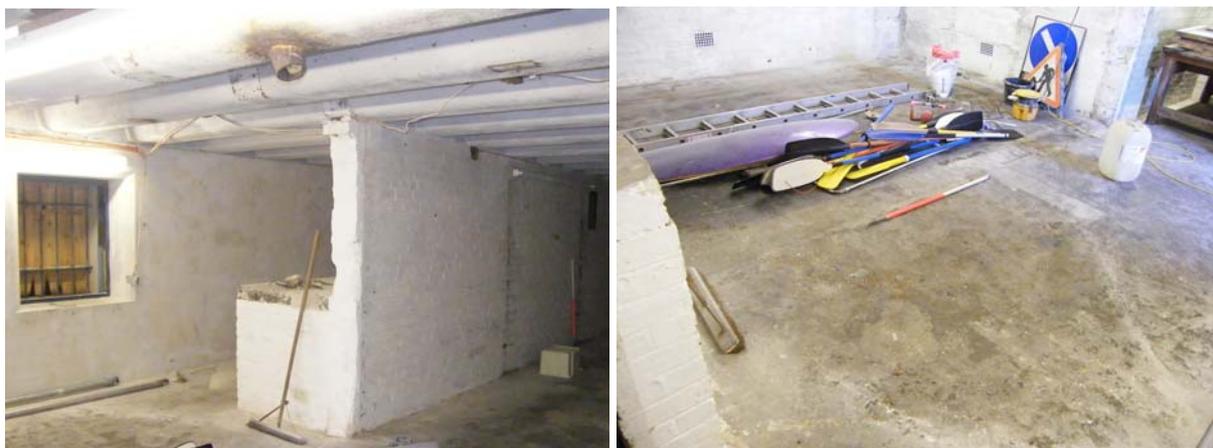
Plate 37: Magazine building interior, showing truncated central partition wall and shell bench and wall scar on ceiling.

Plate 38: Magazine building interior, scar of removed central partition wall on floor.

The interior has been subject to much alteration since the building was given over to public use. A partition wall originally ran the full length of the building, dividing the Magazine from the Shell Store, with the Issue Door at the S end. A shell bench ran along the W side of this wall, in the Shell Store. This terminated in line with the S doorway. The S end of the partition wall has since been removed, along with the S section of the shell bench and a short brick wall to the S of the shell bench. However, the outline scars of the walls are visible on the ceiling, floor and end walls (*Drawings 15 and 16*, *plates 37 and 38*).

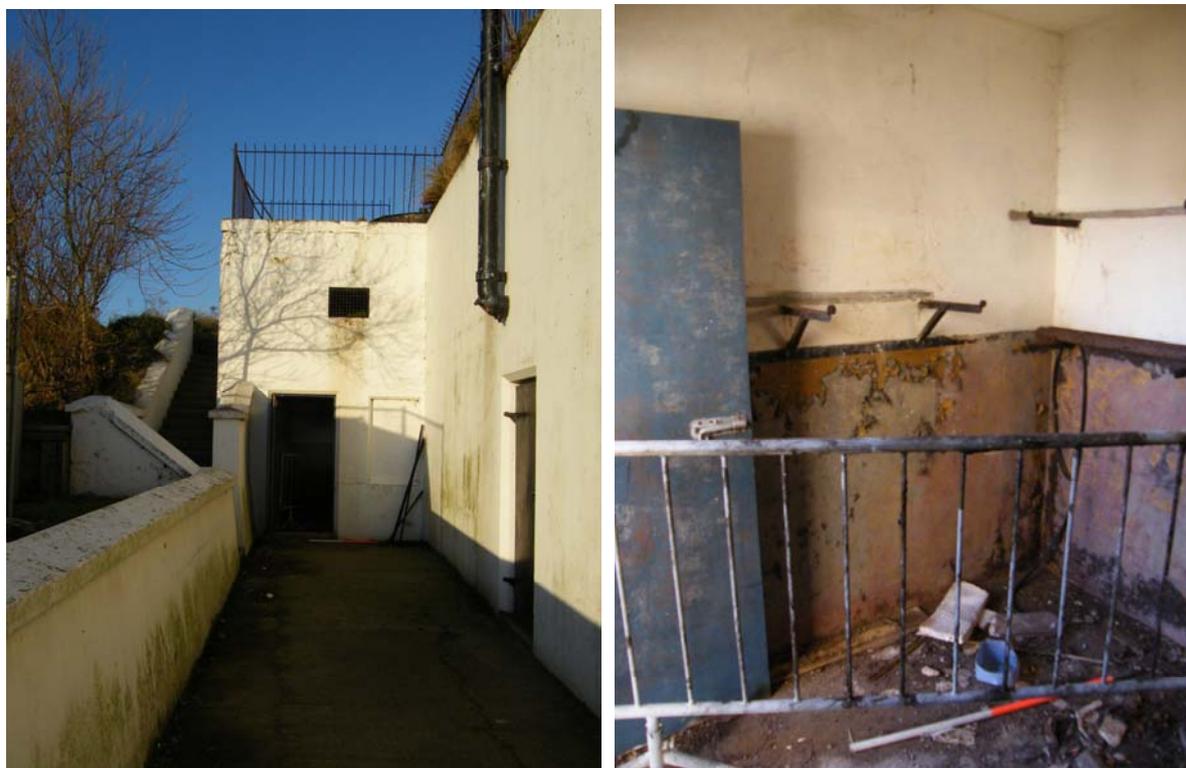
Plate 39: Lamp room, S elevation

Plate 40: Interior of Lamp room, with shelving brackets

This room has a doorway and window (now blocked) on the ground floor (S elevation) and a vent for the blast chamber nearer the wall head (*plate 39*). There were shelves and benches for storage against the interior elevations – the shelf brackets which remain may be original (*plate 40*).

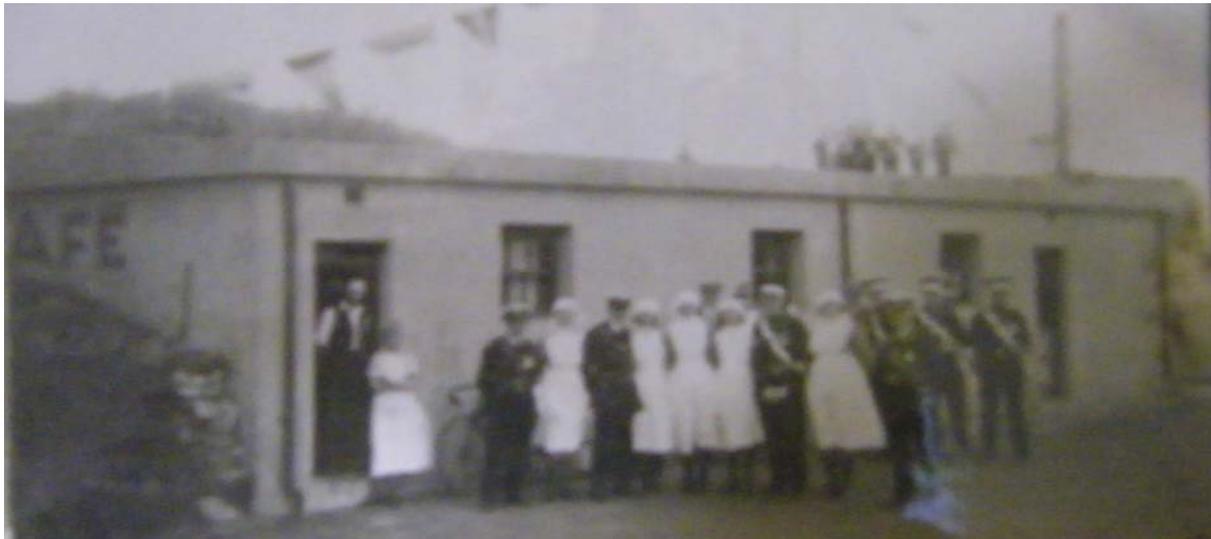
*Figure 10: undated photograph of the Shelter prior to conversion to public toilets. The partially visible café sign is possibly part of the concealment scheme<sup>xiii</sup>.*

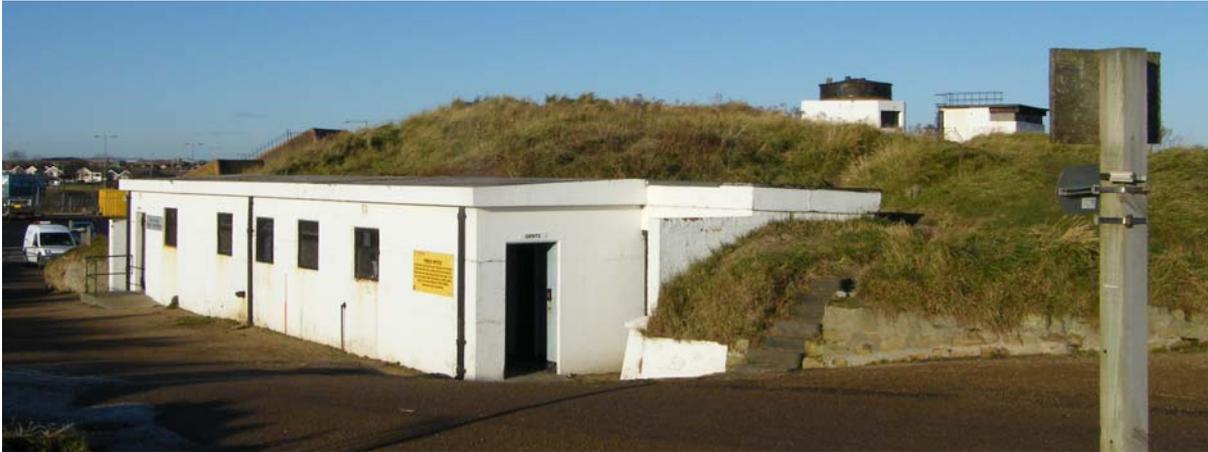
Plate 41: Shelter frontage (S) elevation, view from SE

The Shelter is a rectangular single-storey concrete building surrounded by dunes on all but the frontage (S) elevation (*plate 41*). The dunes originally extended up to the W elevation but these were partially dug away after the conversion of the building to public toilets during the interwar period. The digging away of the dunes allowed an access area to be created at the W end, with a brick retaining wall; this area allowed access to a later insertion doorway in the W elevation.

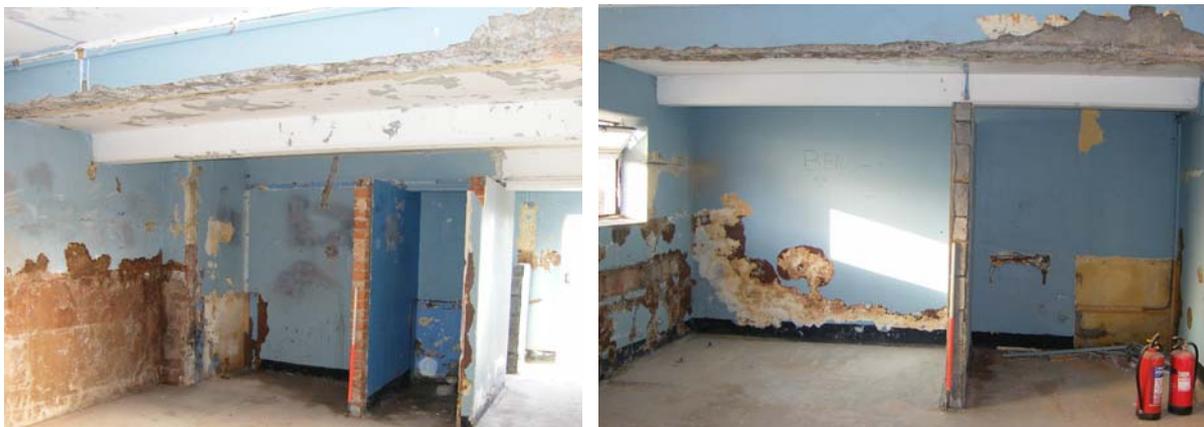
*Plate 42: Interior of gents' toilets in the Shelter, during removal of later partitions and fittings, view looking E*

*Plate 43: Interior of gents' toilets in the Shelter, during removal of later partitions and fittings, view looking W*

All the later insertion partitions and toilet fittings were removed as part of the current scheme of works (*plates 42-45*). The removal of these partitions allowed original paint schemes to be examined beneath; it appears that the walls may have originally been painted brown below a black dado and white above. The original flue for the stove in the Men's Shelter was also fully exposed (*plate 44*).

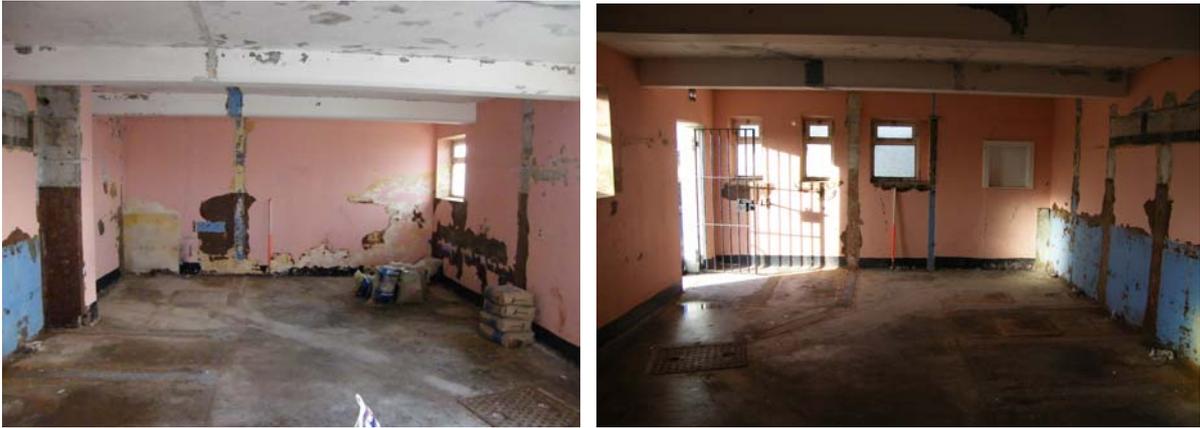
Plate 44: Interior of ladies toilets in the Shelter, after removal of later partitions and fittings, view looking E

Plate 45: Interior of ladies toilets in the Shelter, after removal of later partitions and fittings, view looking W

The Men's Shelter (now the ladies toilets) was entered through the current doorway at the W end of the S wall. There were also two windows in this wall. Shelves were positioned around the S, W and N walls and there was a stove against the centre of the N wall – the flue for this is still in place (*plate 44*). The Officer's Shelter (now part of the gents toilet) was entered through the doorway at the E end of the S elevation (this has been partially infilled to form a window). There was a window to the W of this. There were shelves and clothes pegs arranged around the walls and a stove against the N wall. The sergeant major's area was entered through a doorway in the E elevation. There was a window to the N of this doorway. This room had a stove in the SW corner and a shelf in the NW. The latrine was located in a small room to the N of this, accessed through a doorway in the E elevation.

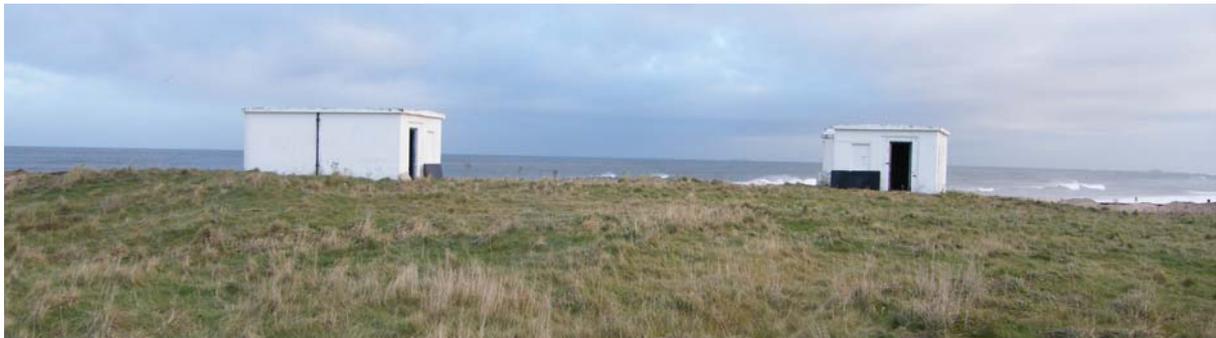
*Plate 46: view of the twin searchlight buildings from the W*

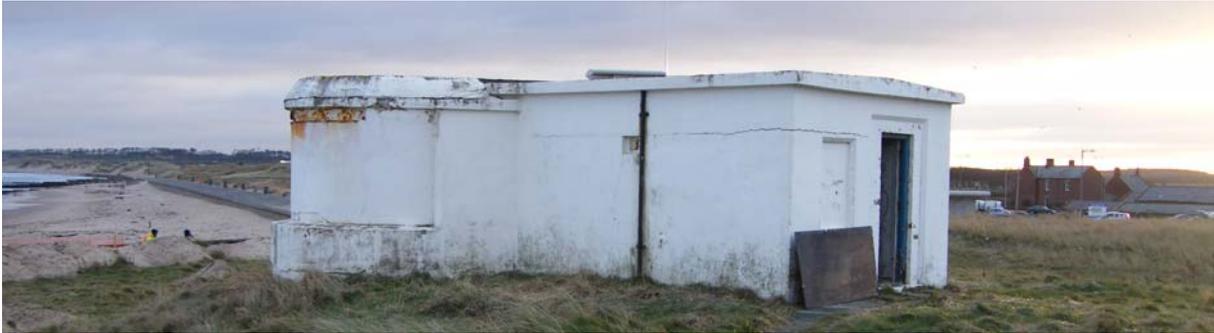
Plate 47: S searchlight building, view from the N

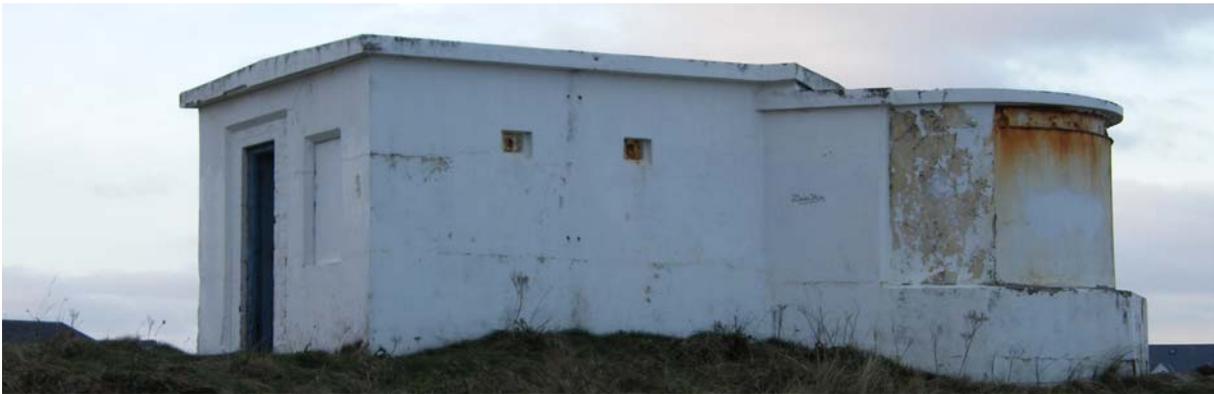
Plate 48: N searchlight building, view from the S

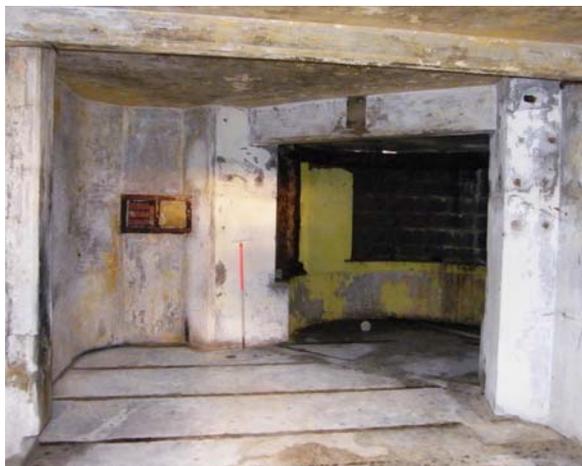
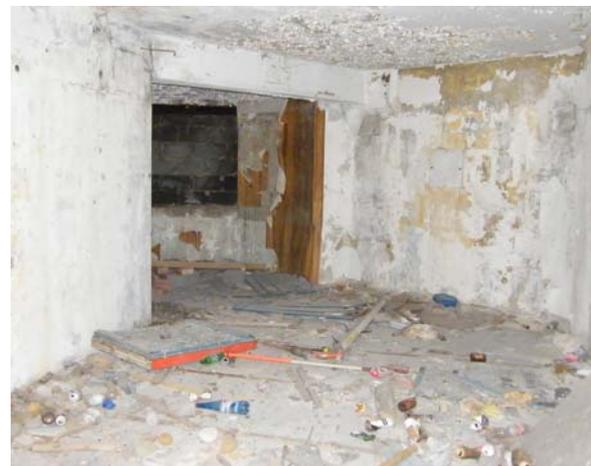
*Plate 51: N searchlight building interior, looking N*  
*Plate 52: S searchlight building interior, with wallpaper visible in searchlight area, looking E*
