*Blyth Battery, Blyth Links, Blyth*  
Northumberland

*Building Recording (December 2008-March 2009)*

Building recording

(project AA. 1641)

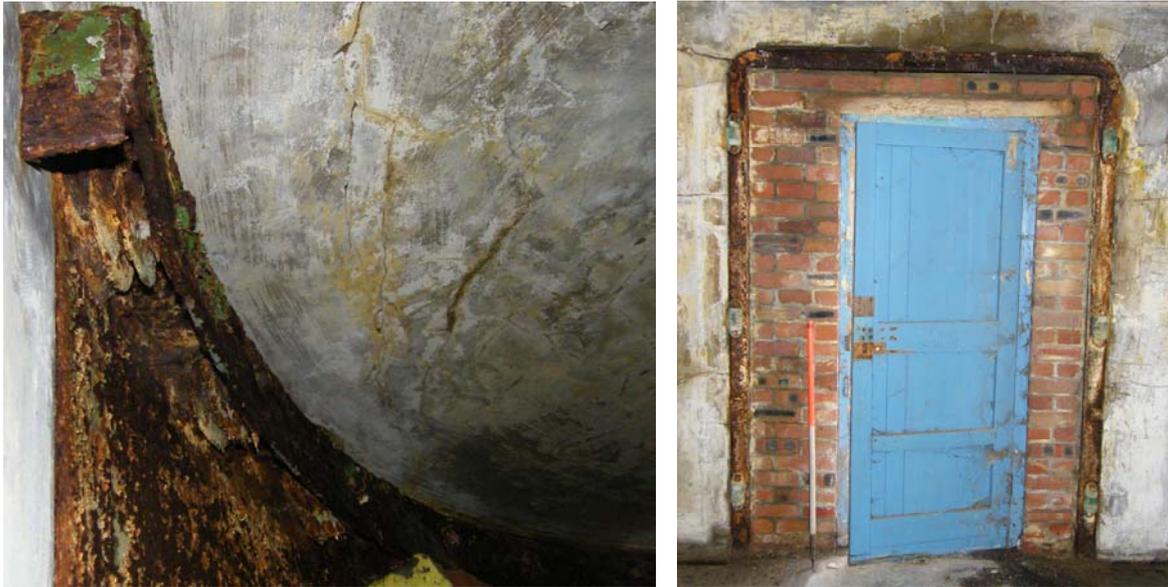
*Plate 53: Wheel mechanism for searchlight shutters in N searchlight building*

*Plate 54: N searchlight building, reduced doorway in S elevation with original metal framing*

shutter mechanism is better preserved in the N searchlight building than in the S building (*plate 53*). In the N building two of the original shutters survive, although these are heavily rusted. Above the shutters are sliding wheels set within a channel which extends around the whole searchlight opening. This channel survives at the ends of the curves but has rusted away in the centre. There are outlines on the floor in the circular areas indicating the position of the searchlights (*Drawing 21*).

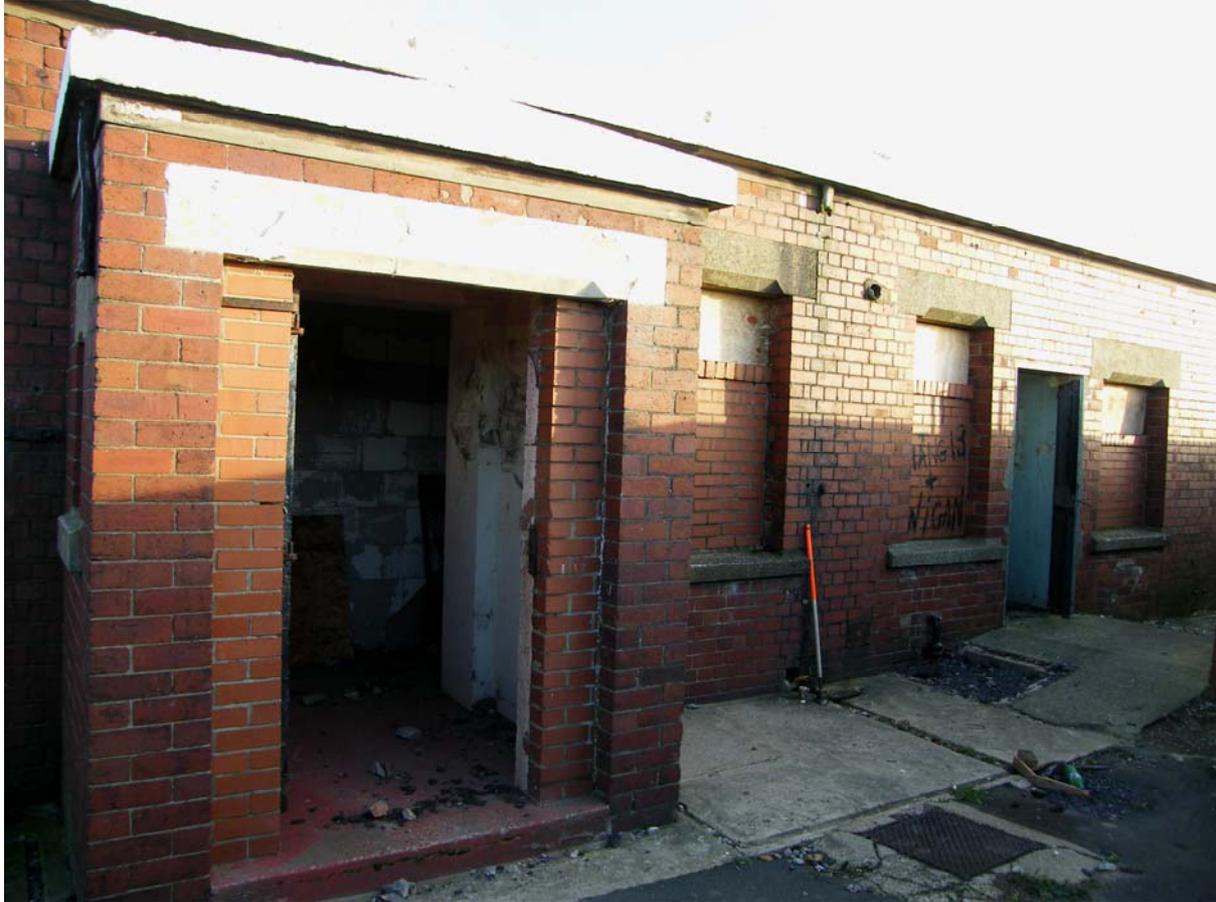
*Plate 55: Engine House, W elevation, view from NW*

The doorway and small windows in the S elevation are later insertions, likely associated with the conversion of the building to public toilets. Three small window openings have been inserted into the E elevation and a row of windows has been inserted in the N elevation near the wallhead, all likely to be associated with the conversion of the building.

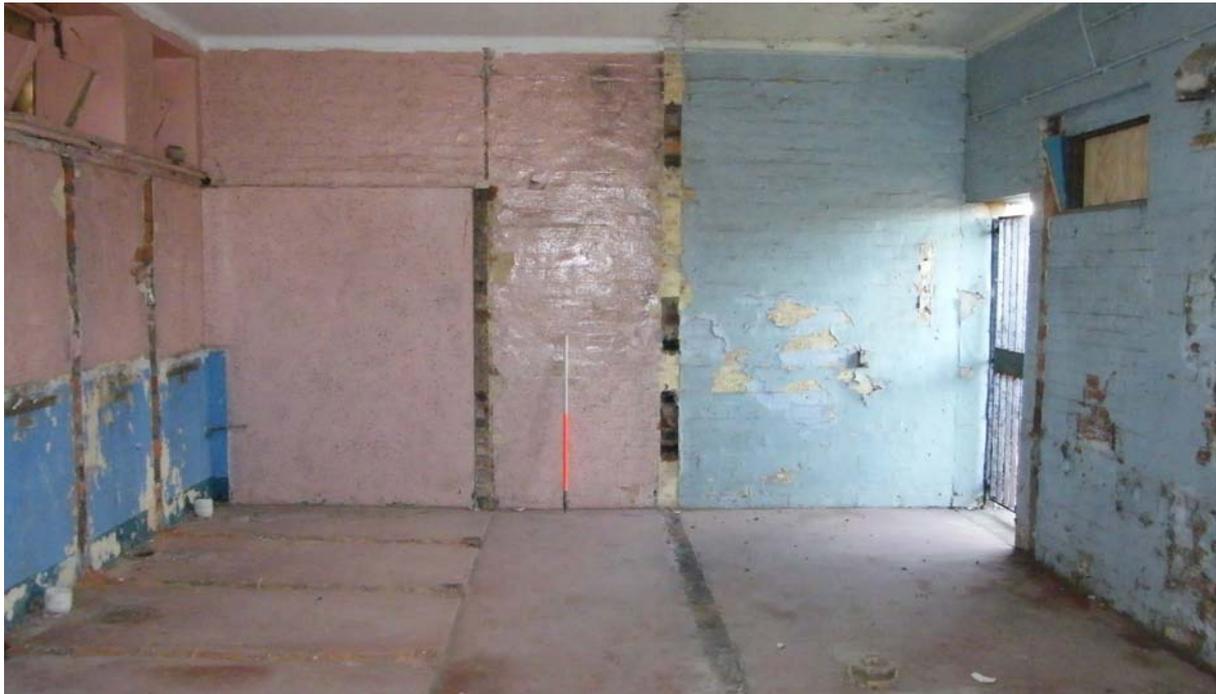
*Plate 56: Magazine building, generator room, following removal of later toilet cubicles and fittings. The later slapping doorway is visible in the W (right) elevation – this provided access to the disabled toilets.*

All the later insertion partitions were removed as part the current phase of works (*plates 56 and 59*). A large opening was also created through the original dividing wall between the generator room and the Accumulator room (*plate 59*), that which latterly formed the division between the ladies and gents toilets.

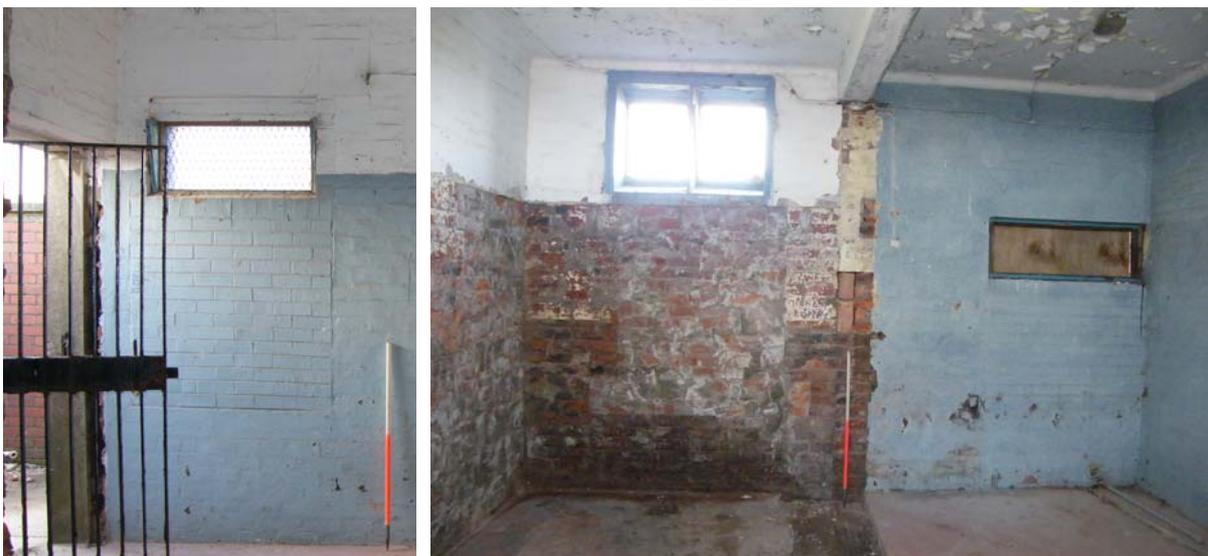
*Plate 57: Blocked window in W elevation, gents toilets, originally lighting the Workshop  
Plate 58: Blocked doorway and window in W elevation, gents toilets, originally located in Accumulator Room*

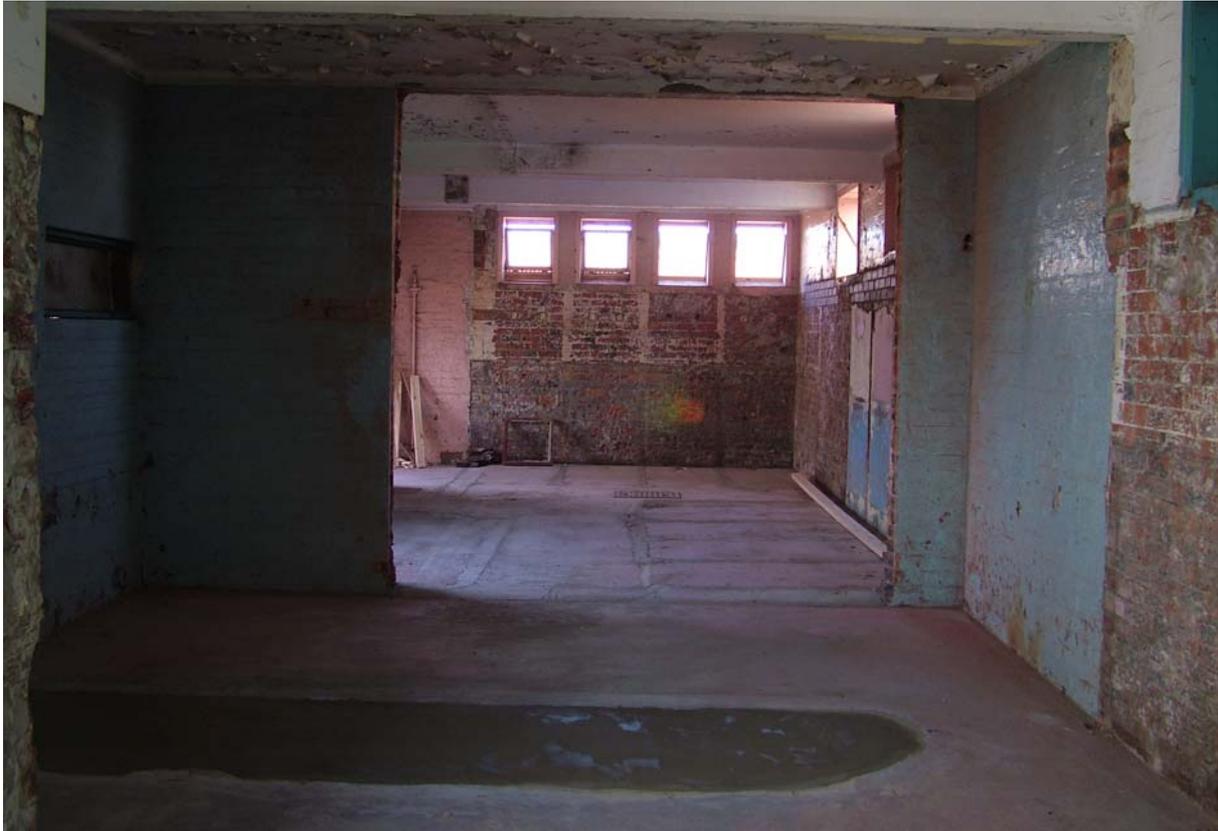
*Plate 59: Magazine building following removal of later cubicle partitions and fittings, view from S. Later insertion windows also visible in N elevation*

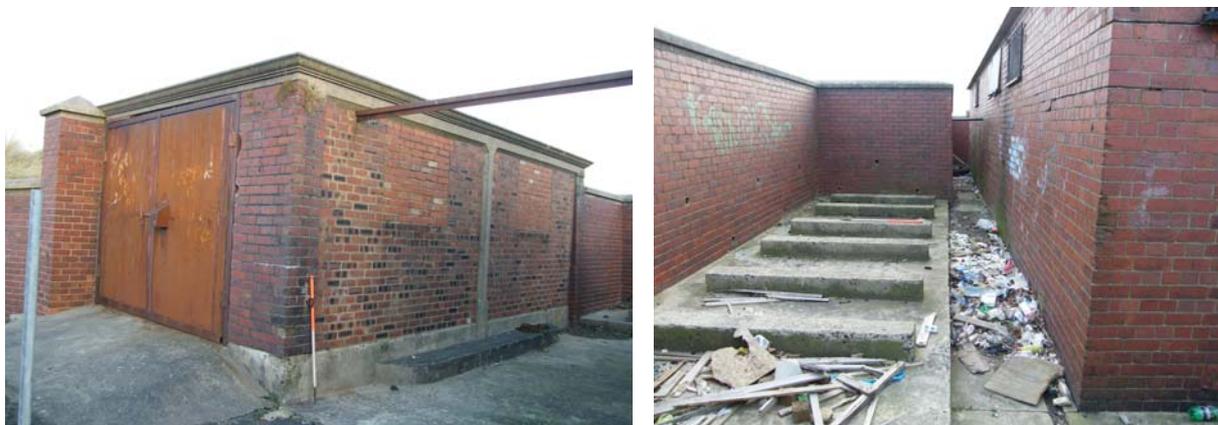
*Plate 60: Cooling tank store to the N of the engine house building  
Plate 61: Storage area to E of the engine house*

The store to the N is also brick built with a narrow concrete cornice (Appendix B *Drawing 13*). This is built against the retaining wall, with this forming the N and E elevations of the building. The S elevation was originally open, but this was latterly infilled with brick, leaving two window openings. These were subsequently filled with brick. It was possibly at this time that the wide doorway was slapped through the W elevation.

There is a further storage area to the E of the engine house building. This was used for storing petrol and oil tanks and is formed from a low concrete platform with raised beams dividing it into sections.

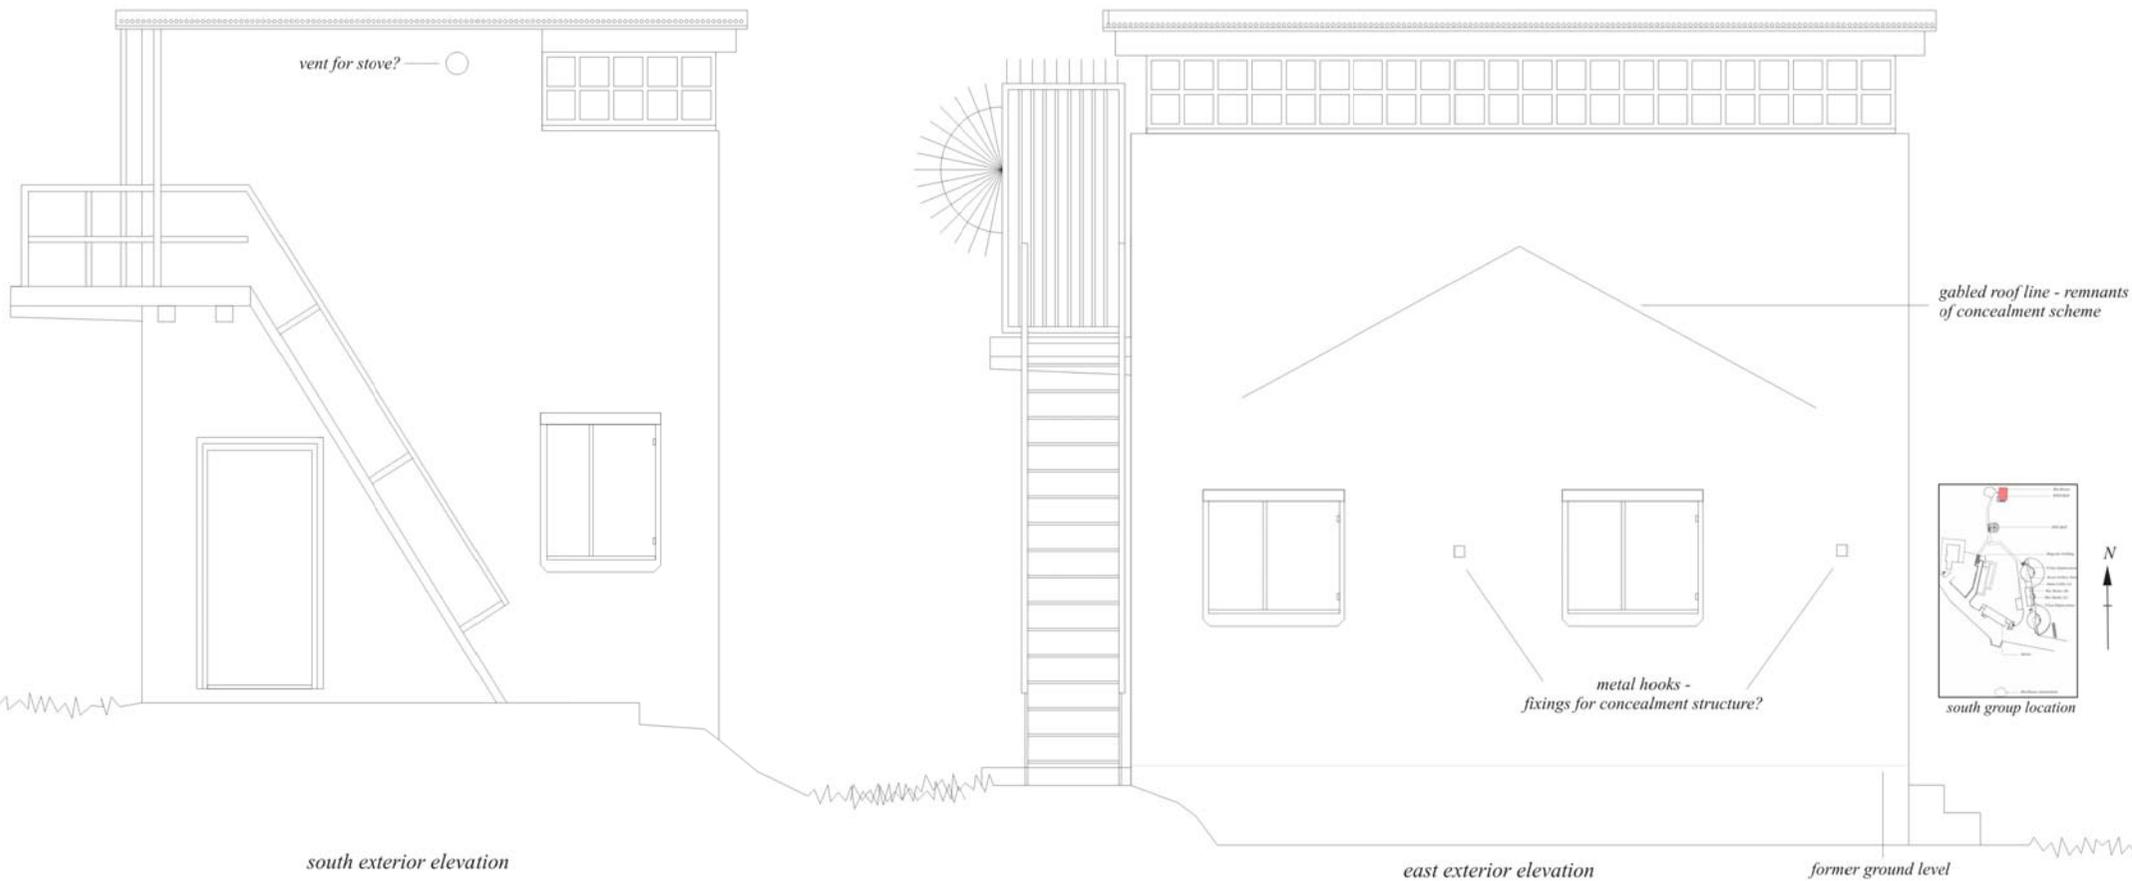
Blyth Battery, Drawing 8:  
WW II B.O.P., exterior elevations

south exterior elevation

east exterior elevation

The seaward facing E elevation (Drawing 8) has a narrow, full width observation opening at the wall head; this sits immediately below the overhanging flat roof which is itself supported by a long iron beam. Presumably this was originally open, but it now contains timber framed windows which are boarded over on the exterior (see *plate 8*). At ground floor level are two windows with metal surrounds covered with replacement metal shutters.

The wall head opening continues round onto the S elevation (*Drawing 8*), where it extends to approximately one-third of the elevation width; this opening is boarded up. To the W of the opening is a small round opening, possibly a vent for an internal stove which has since been removed. There is a door and window on the ground floor, both of which have iron or steel surrounds, although these do not appear to be the originals. The window ground floor window is also covered by a secondary metal shutter. A replacement metal staircase leads up to a cantilevered balcony with metal railings at first floor level. A secondary gate has been fitted here for security reasons (see *plate 9*).

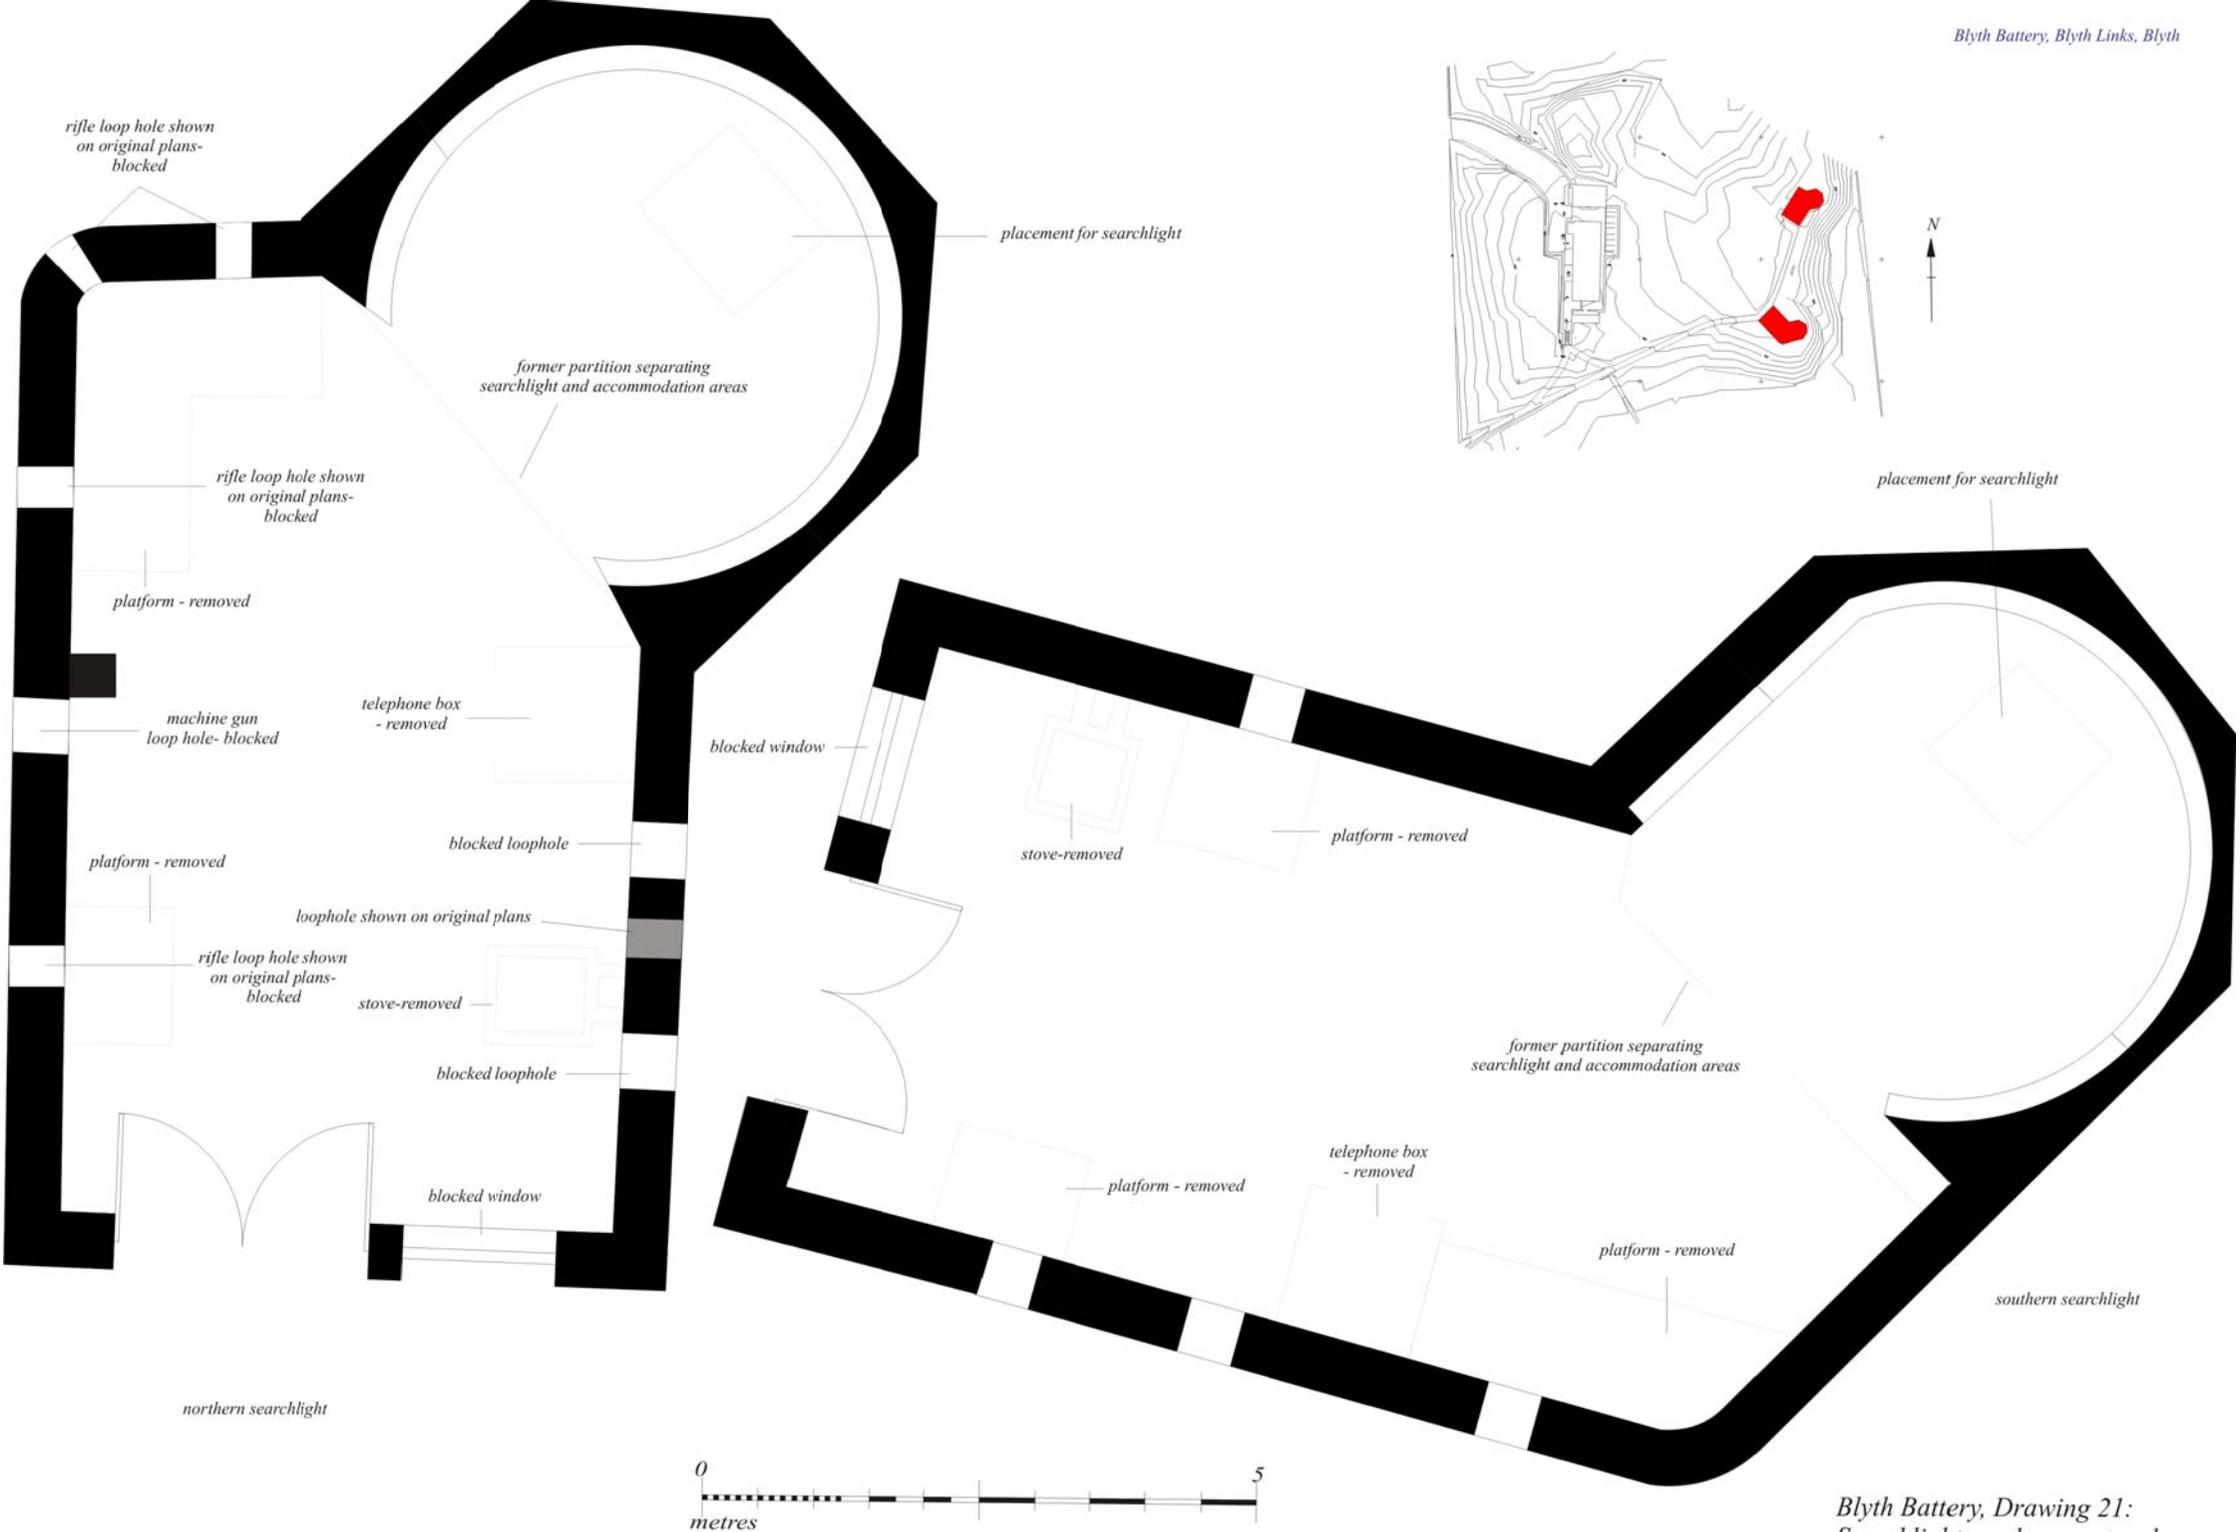
Blyth Battery, Drawing 21: Searchlight emplacements, plans

rifle loop hole shown on original plans - blocked

placement for searchlight
